**AMERICORPS  
USDA  
NATURAL RESOURCES CONSERVATION SERVICE  
Lancaster Field Office  
44811 N. Date Ave Suite G  
Lancaster, CA 93534  
(805) 945-2604**

**AMERICORPS ACTIVITIES**

SUMMARY OF 1993-94 FLOOD PREVENTION  
AND  
RECOMMENDATIONS FOR 1994-95 RAINY SEASON  
Altadena / Kinneloa Fires

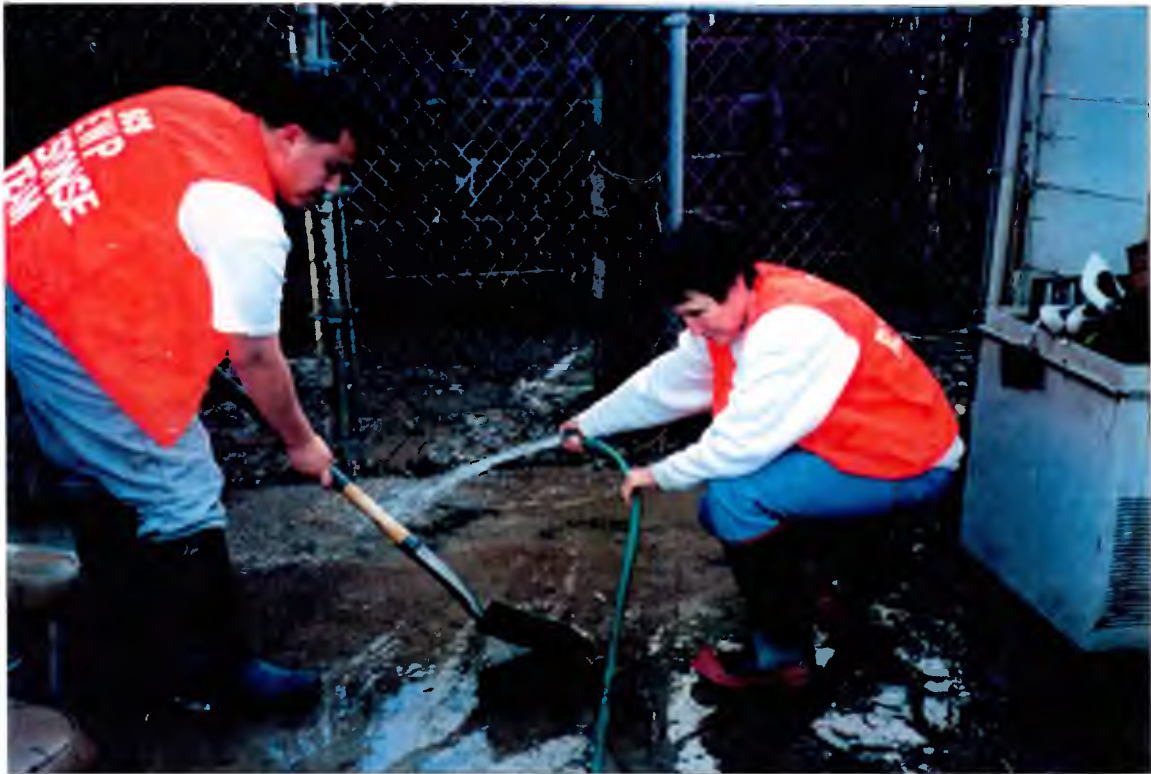
Phillip Sam and Sandy Haynes cleaning up mud damage at a business along Laguna Canyon Rd. in Laguna Beach. 1/21/95

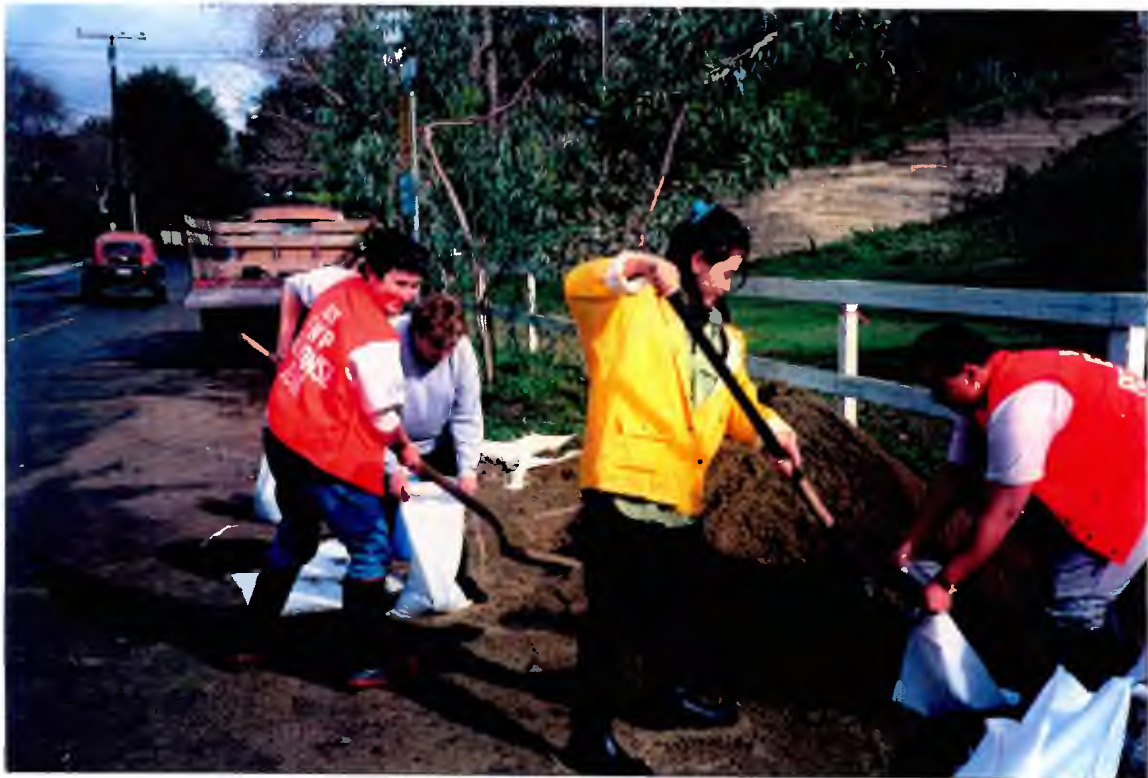
Sandy Haynes and Phillip Sam assisting local residents with sandbagging in the Sun Valley community in Laguna Beach. 1/21/95

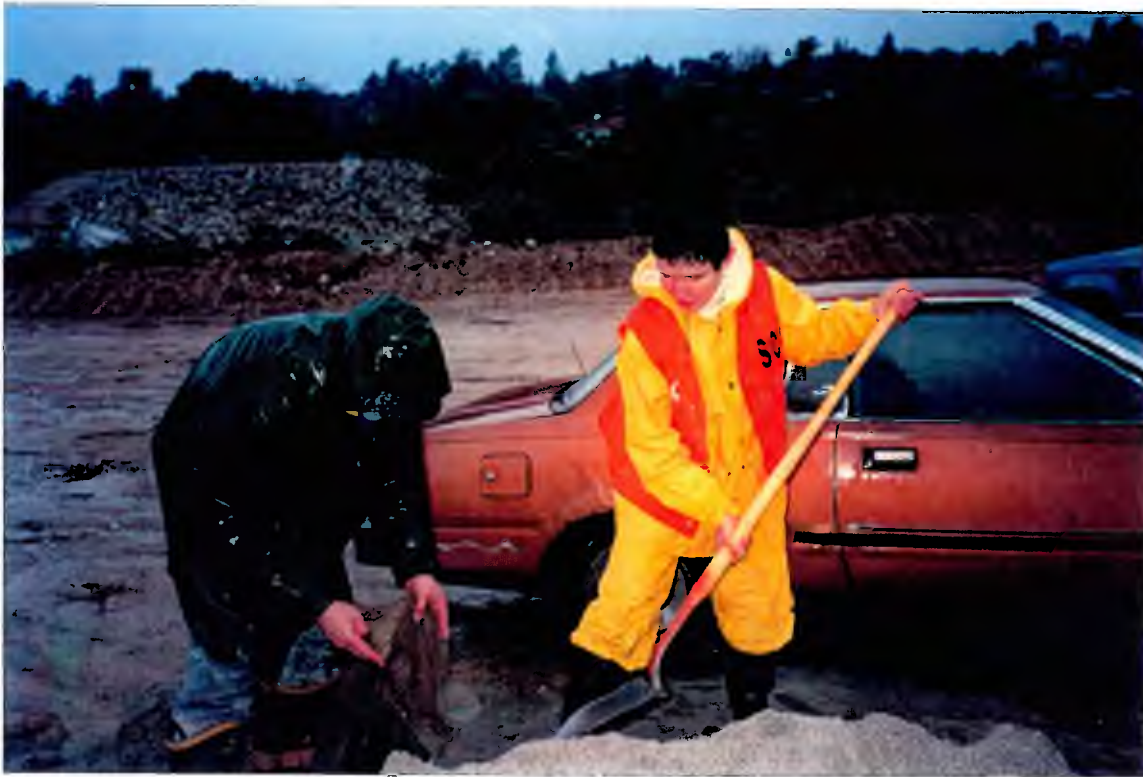
Sandy Haynes and Phillip Sam assisting Altadena residents with sandbagging at Rubio Debris Basin in Altadena. 1/10/95

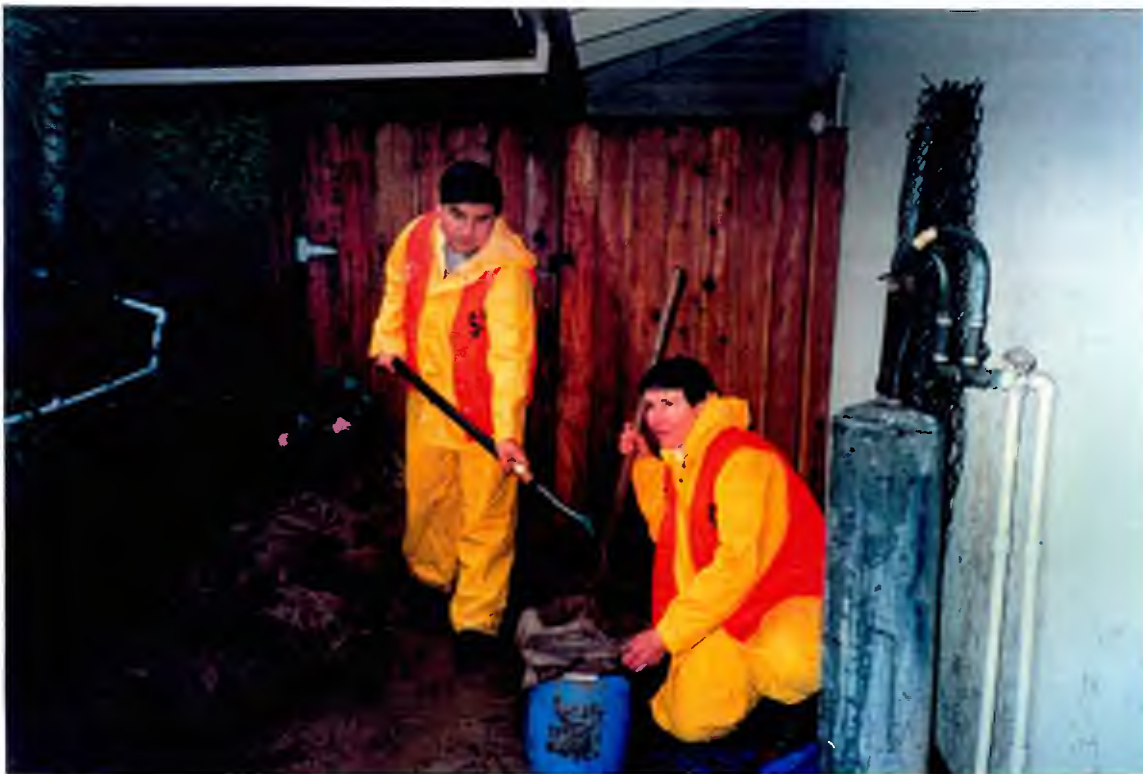
Phillip Sam and Sandy Haynes doing emergency sandbagging to prevent mud and water from getting in a house on Kinneloa Canyon Rd. in Pasadena. 1/10/95

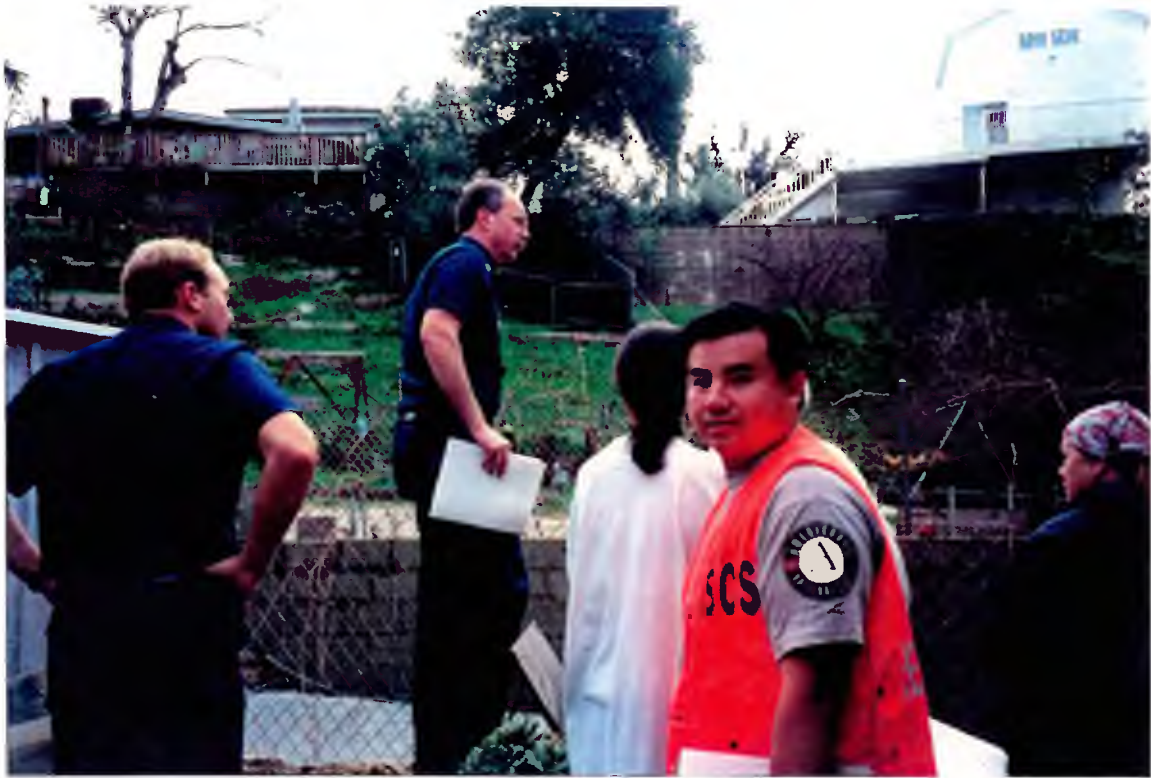
Phillip Sam inspecting a debris flow channel in the back a resident's home on Alzada Dr. in Altadena with members from the L.A. County Fire Department. 1/14/95

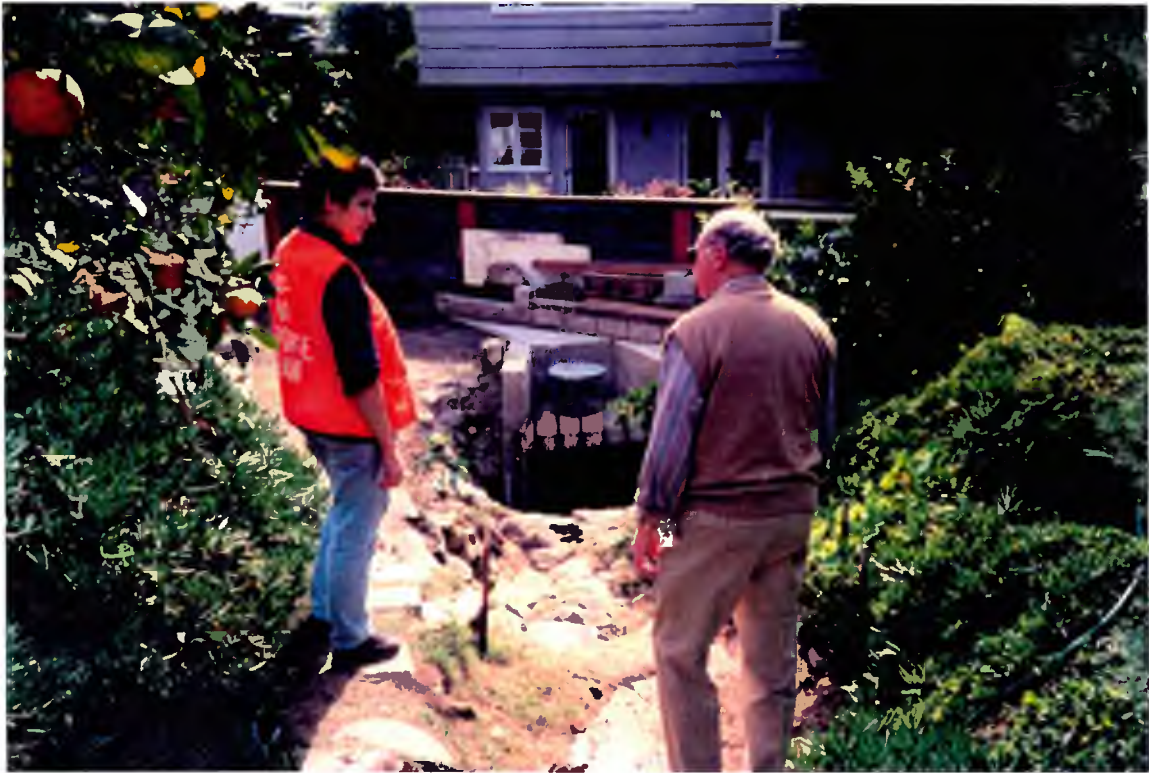
Sandy Haynes inspecting a storm drain in the backyard of a resident on High Street in Laguna Beach. 1/19/95

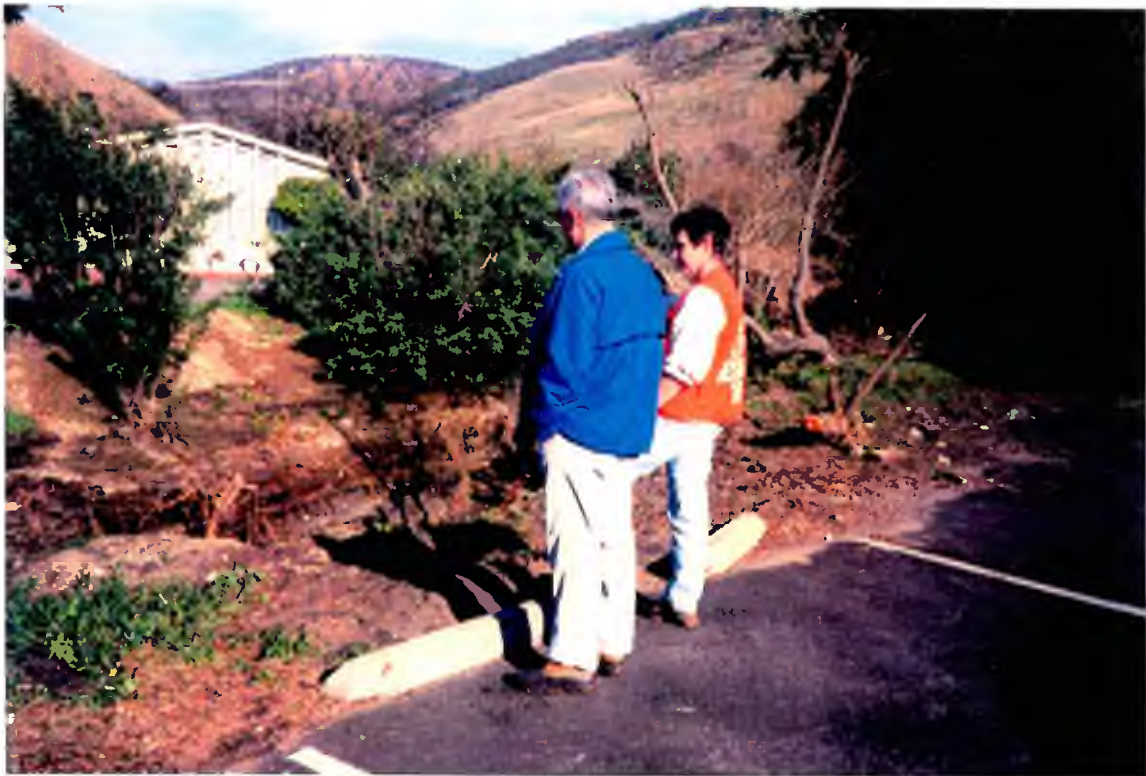
Sandy Haynes talking to a long time resident on the erosion cause by the storm at the El Morro Trailer Park in Laguna Beach. 1/18/95

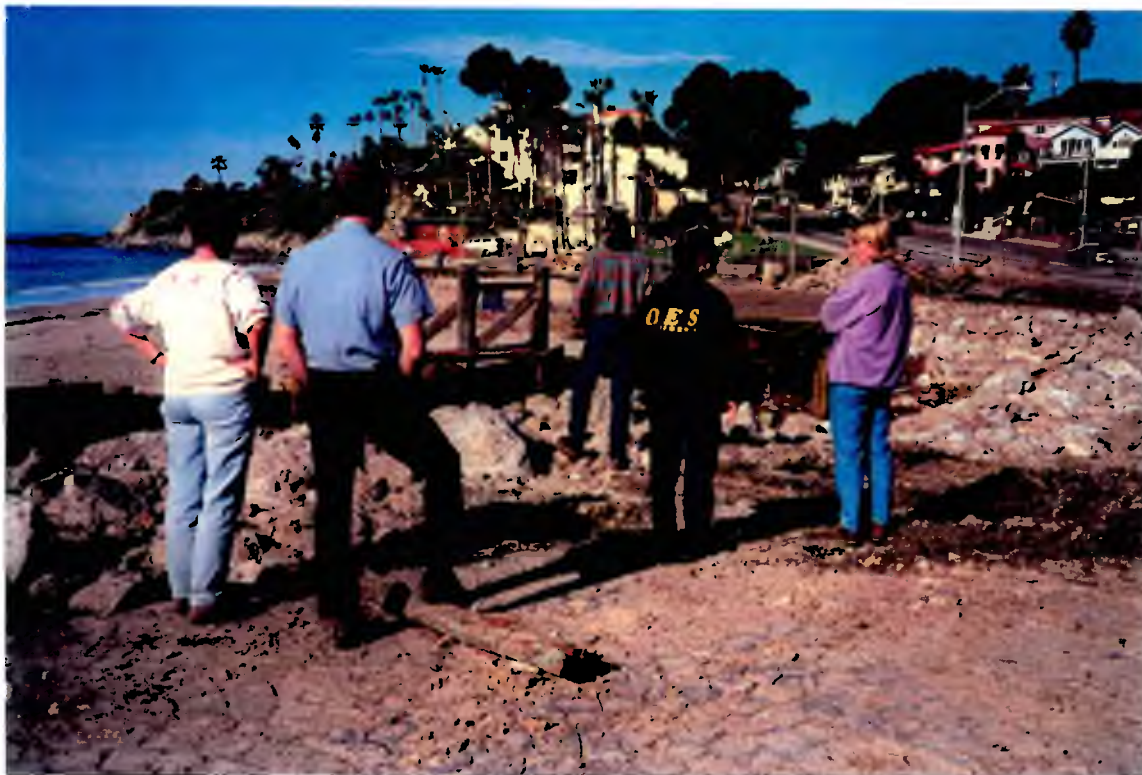
AmeriCorps and NRCS staff inspecting flood damage along the boardwalk at downtown Laguna Beach along with members from OES and Laguna Fire Department. 1/18/95

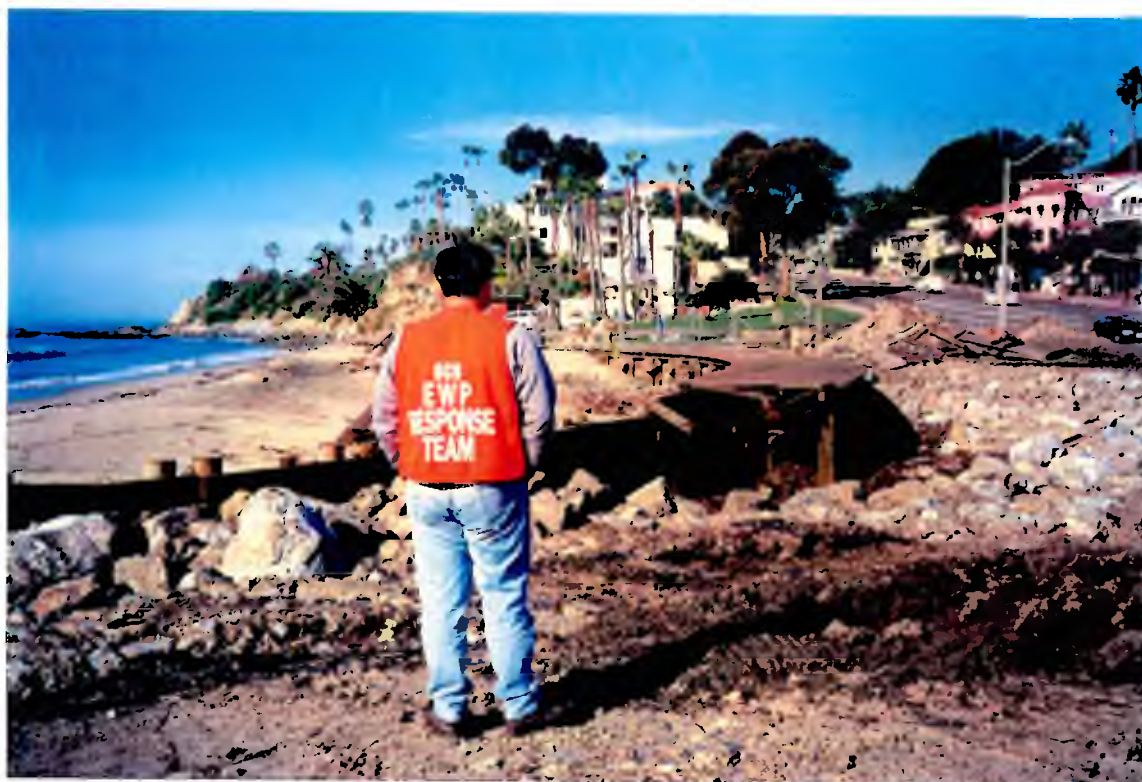
Phillip Sam looking at the powerful destruction caused by the flood water in downtown Laguna Beach. 1/18/95

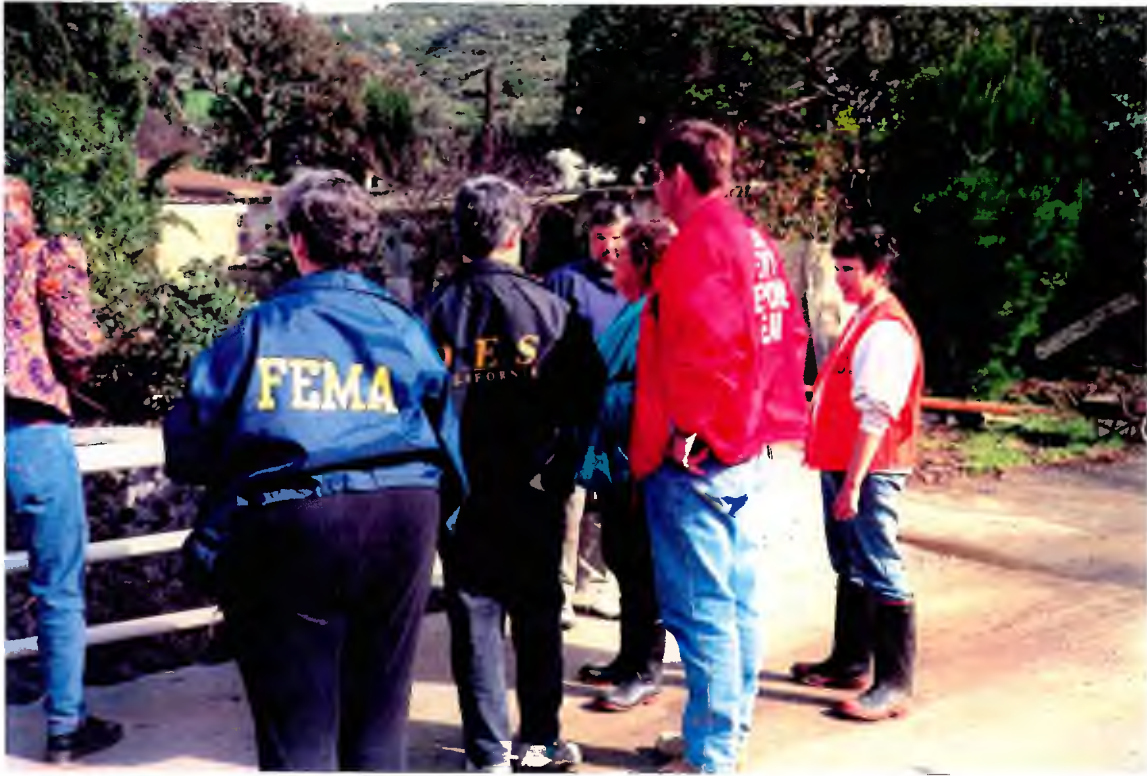
AmeriCorps and NRCS staff, and members from FEMA, OES, and Laguna Beach Fire Department, inspecting flood damage areas in Laguna Beach. 1/21/95

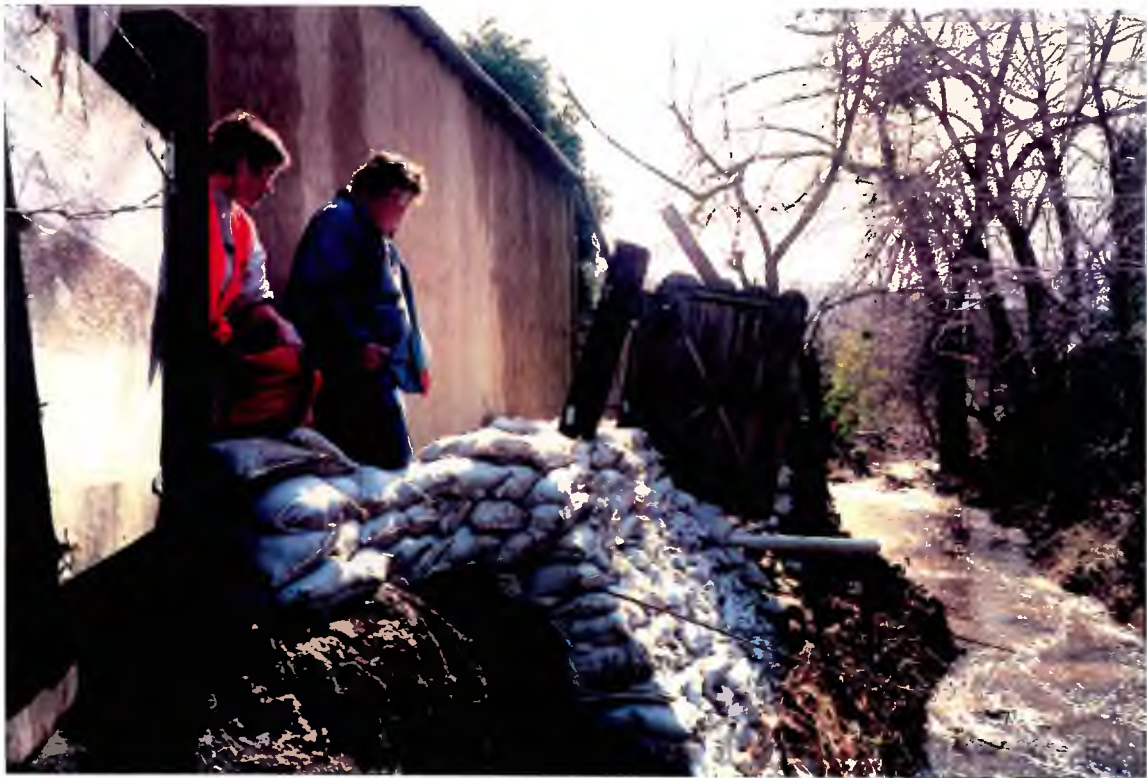
Sandy Haynes inspecting a house which is endangered of sliding down into the creek in Laguna Beach. 1/21/95

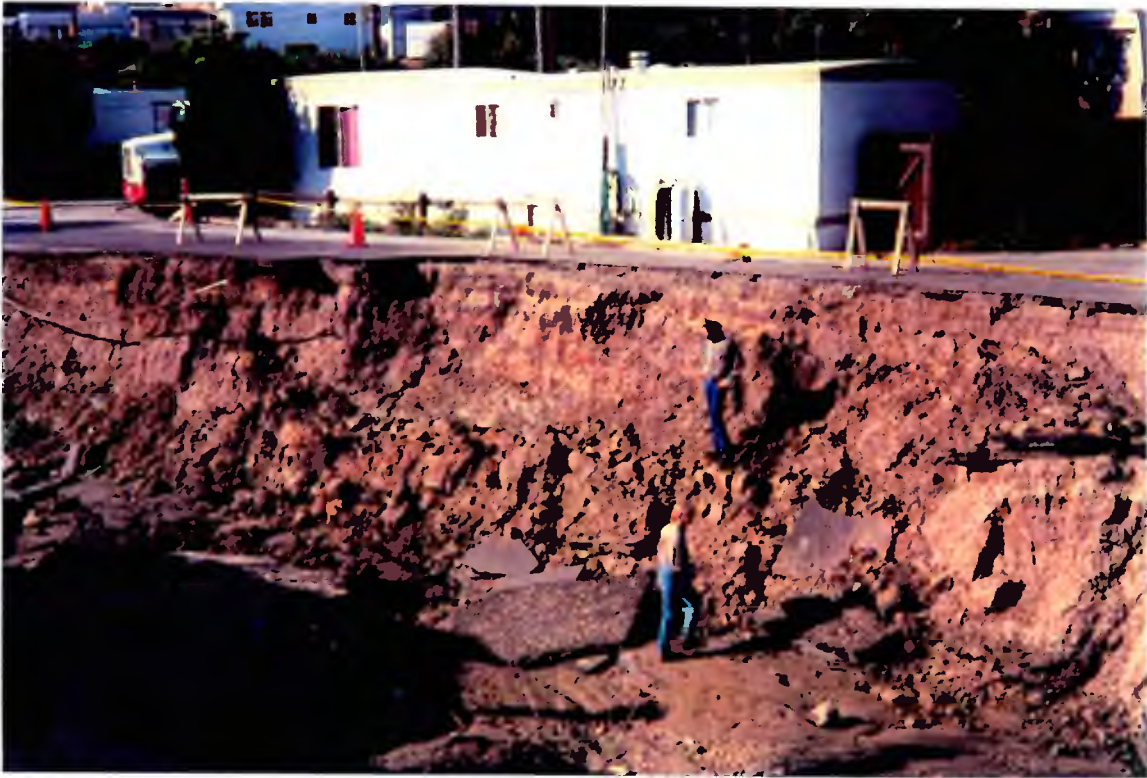
AmeriCorps and NRCS staff doing EWP investigation at the El Morro Trailer Park in Laguna Beach. 1/18/95

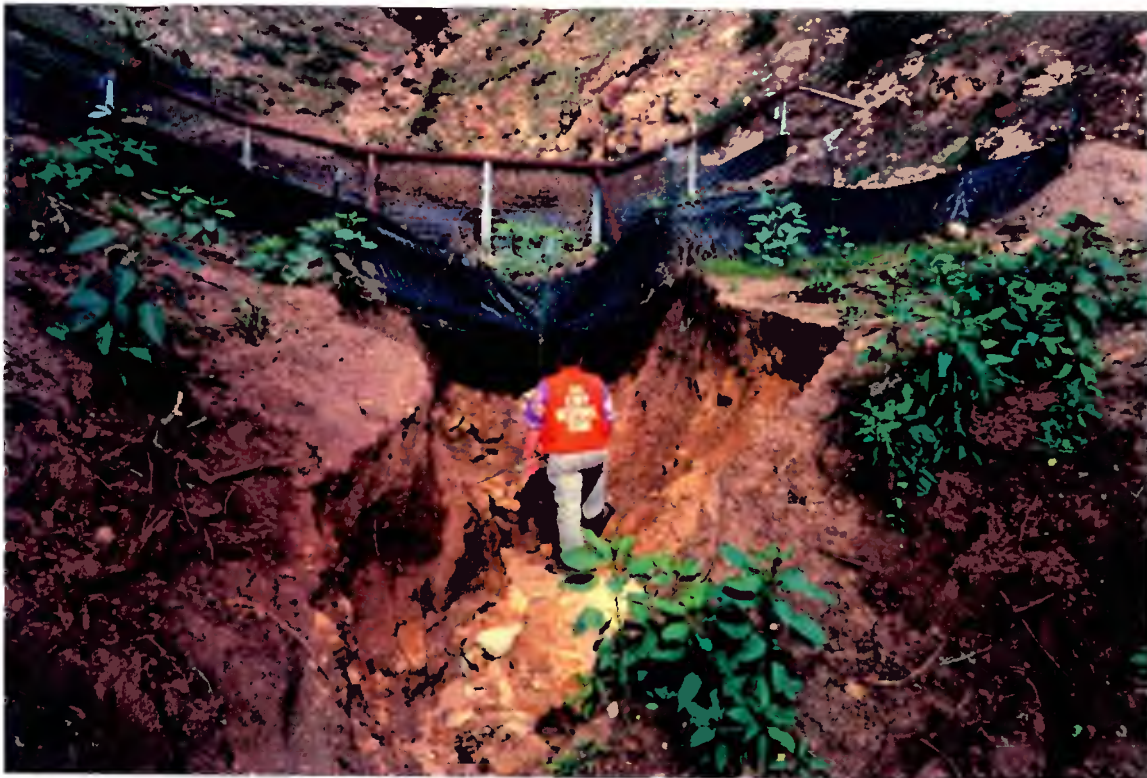
AmeriCorps and NRCS staff doing EWP investigation in Laguna Beach. 1/18/95
