**EVALUATION OF WATERSHED CONDITIONS AND HAZARDS**  
**and**  
**RECOMMENDATIONS FOR ADDITIONAL PROTECTIVE**  
**MEASURES**

**for the**  
**LAGUNA FIRE AREA**  
Orange County, California

January, 1995

Prepared by:  
USDA, Natural Resources Conservation Service  
and  
AmeriCorps National Service  
Lancaster, California

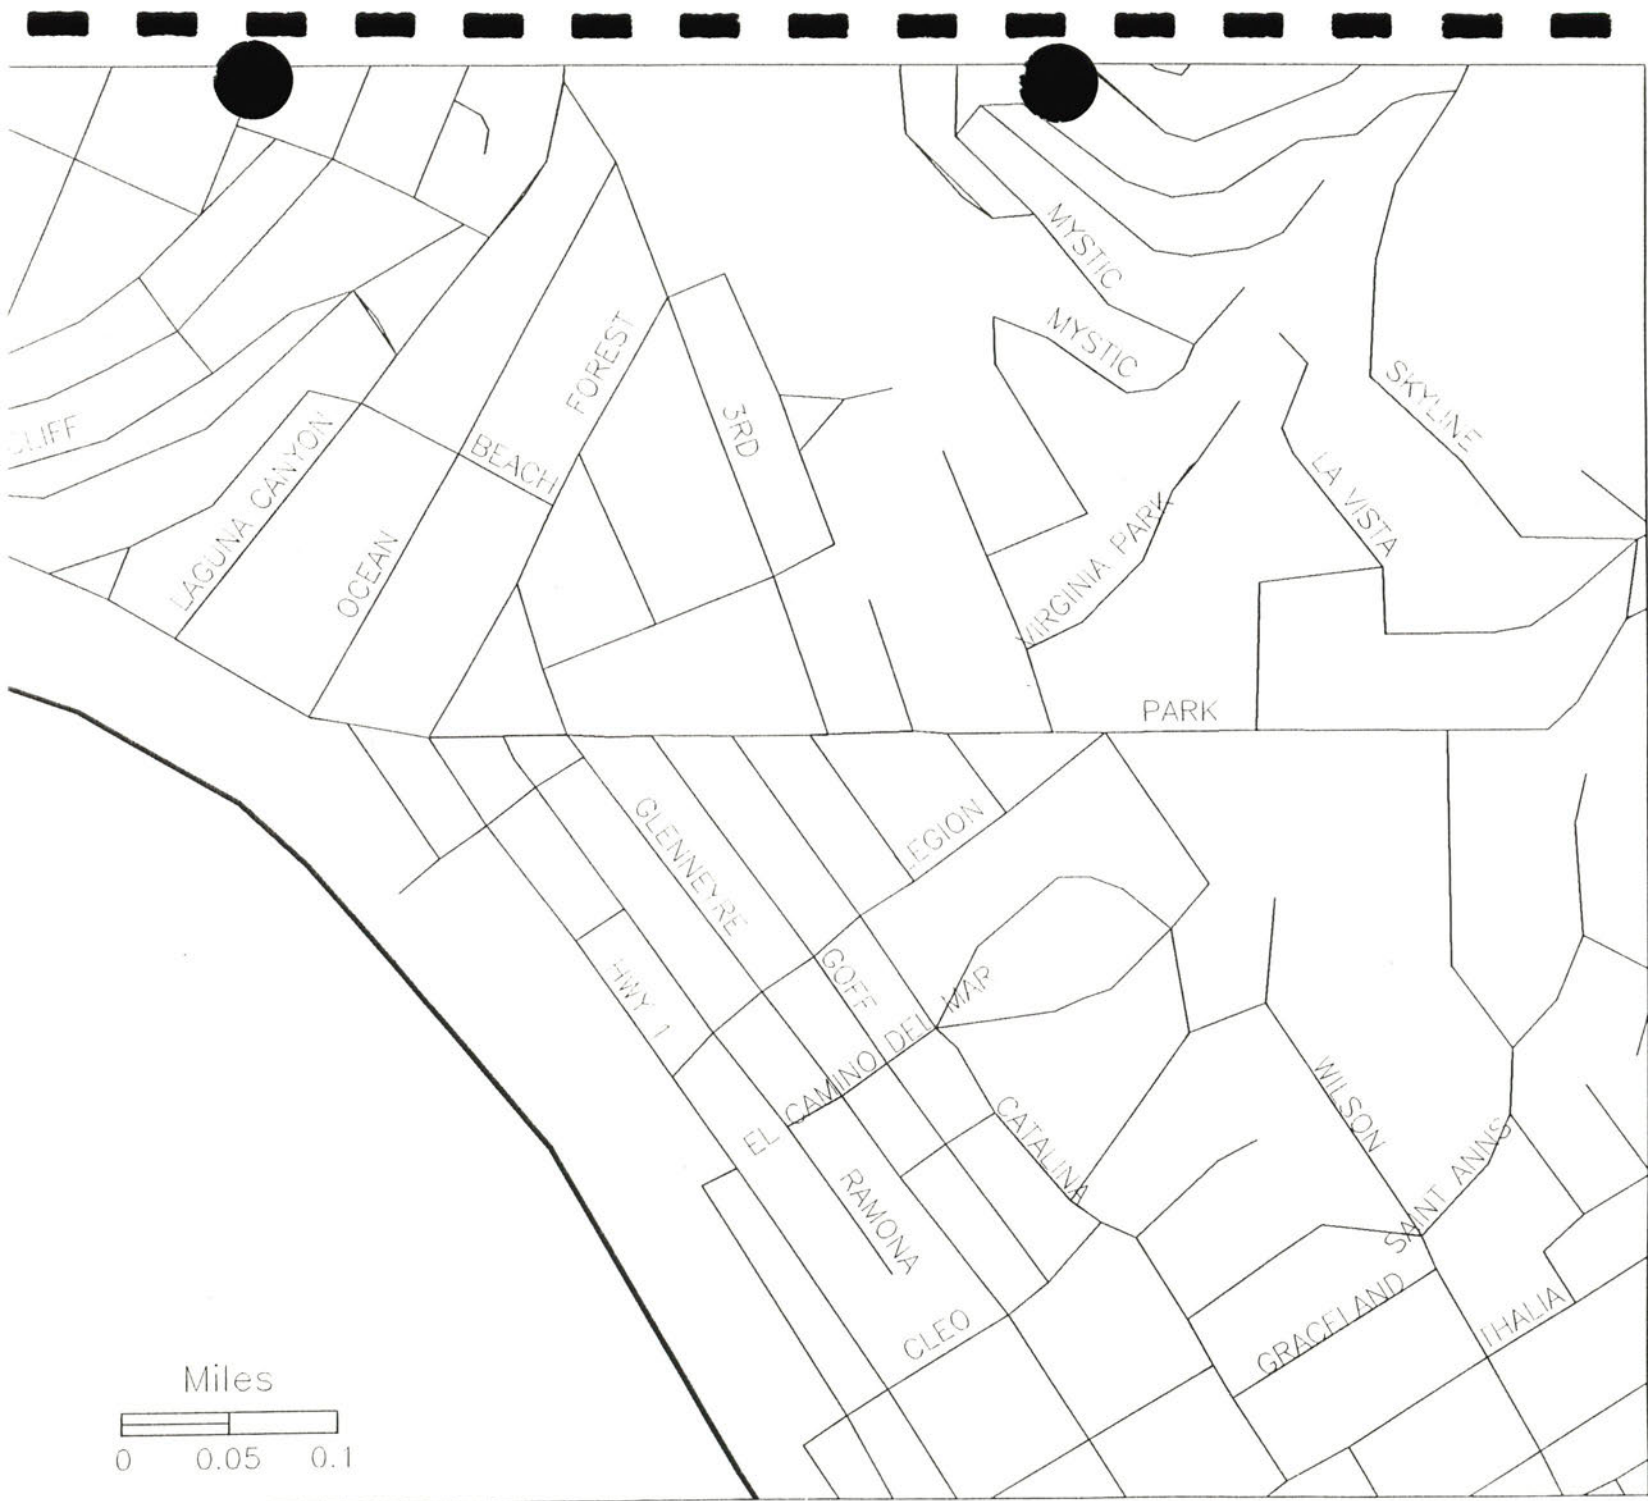
**9**

Park Avenue/Browncroft Burned Area - Maps A, 8, & 9

The small watersheds within this burned area have experienced very rapid vegetative recovery and the hydrologic condition has greatly improved.

Coral Drive and Park Avenue - Remove all sandbags on slope between these roads. Sandbags are unstable and may cause a hazard to motorists.

Griffith Way - This street should have a permanent drainage system installed to direct and control flows that now travel along the roadway. All residential sandbags should be maintained or replaced with pipe and plywood deflector walls along the edge of the roadway. A two foot tall headwall should be installed behind 605 and 610 Griffith Way. An inlet structure located behind these homes is set at an elevation only slightly lower than that of the homes and may plug and cause flooding.

945 Park Avenue - Masonry or pipe and plywood deflector walls should be placed behind the residence on Park Avenue and the doorway should be sandbagged for additional protection. The flow path from the Park Avenue overflow is only three inches below the lower story glass doorway, and water flowing through may cause damage to the home.

Hidden Valley Canyon - All loose and unstable straw bales on the hillside should be removed, as they are a hazard to the residents below. Straw bales may be opened and the straw spread for mulch on site.
