# ***FOUNDRY DEFECTS*** ***(Some Tips)***

Practical Causes, Observations and Remedies

**Prepared by: P. Arul Mozhi Devan**

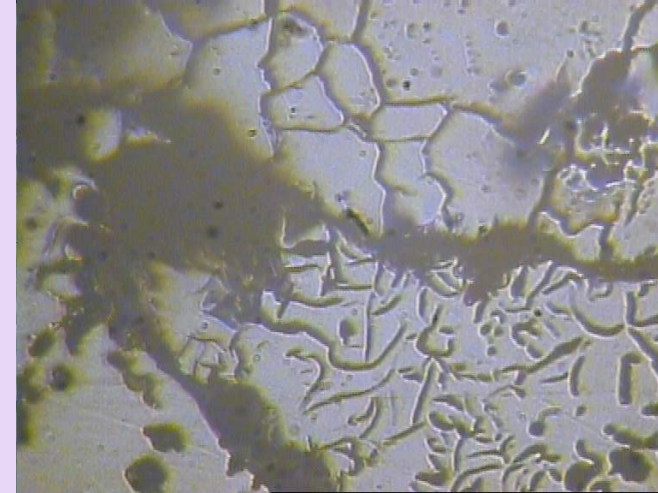
Heavy Manganese Sulphide slag in between the slag flake graphite .Around the slag Nodularity fully deteriorated.

- A number of parts having slag inclusions and the location depends on the orientation.
- Complete slag removal is very difficult even in the melting furnace, ladles and in the pouring furnace. Insufficient filtering in the gating system, filter quality and choke (slag trap) in the gating system.
- Insufficient slag trap in the metal

- Improved gating system to filter all slag in the gating system itself.
- Selection of filter.
- Too much ladle addition and stream inoculation to be controlled..
- Improve the slag trap in the metal handling and pouring process.
- Maintain Mn 0.6 to 0.7% for grey iron and Mn 0.4% for SG iron.

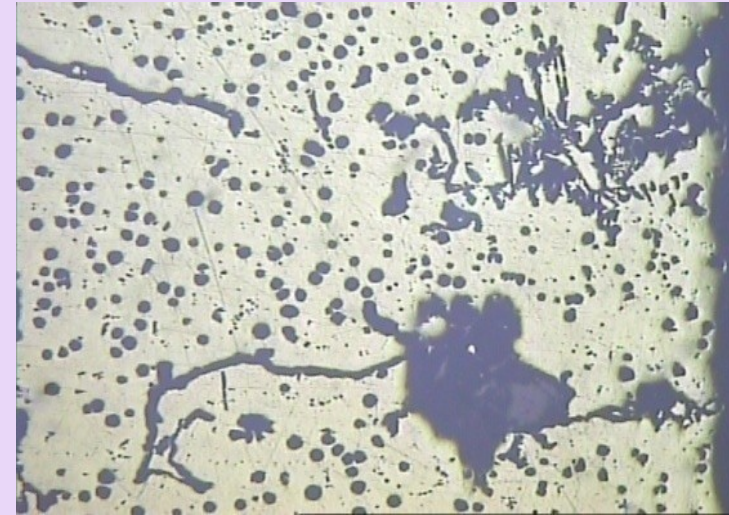
Cupola slag mainly oxides of potassium, sodium and calcium and basic in nature. So there is no deterioration of nodules around the slag.

Cupola metal having more liquid slag.

- Slag off the metal before tapping into the ladle, from the ladle before transfer into the pouring furnace, and pouring spout.
- Metal height Min. 200 mm to be maintained in the pouring furnace.
- Metal level in the pouring spout to be maintained maximum (to the reference level) while pouring.
- Gating system have slag trap (choking) before filling the cavity and Filter can be used.

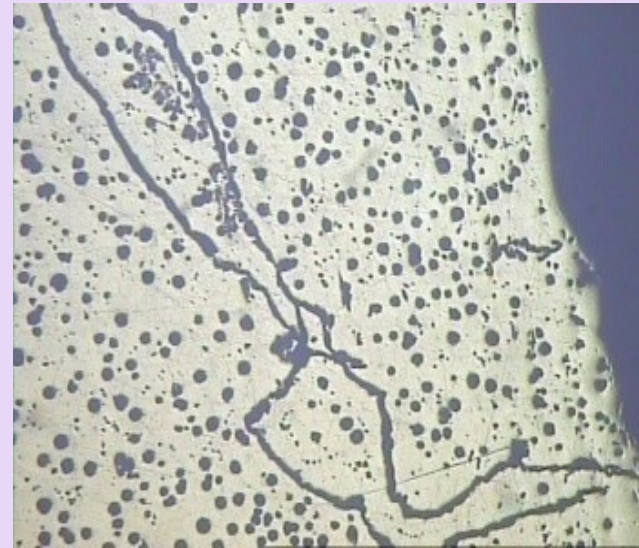
The Magnesium silicate slag as spread as stringers without any deterioration of nodules in and around the slag

Slag Inclusion (Dross). Due to turbulence, while filling the cavity, the Mg treated metal forms Magnesium oxide with the available air in the cavity and settle as slag.

- Ensure the liquid metal filling is quite and through bottom filling.
  - Maintain Min. 1400°C as pouring Temperature to reduce the dross formation and to bring the dross to the top of the riser. Ensure pressurized gating system so that there is no air gap in the running system during metal filling.
- Maintain max. R.Mg. 0.045%

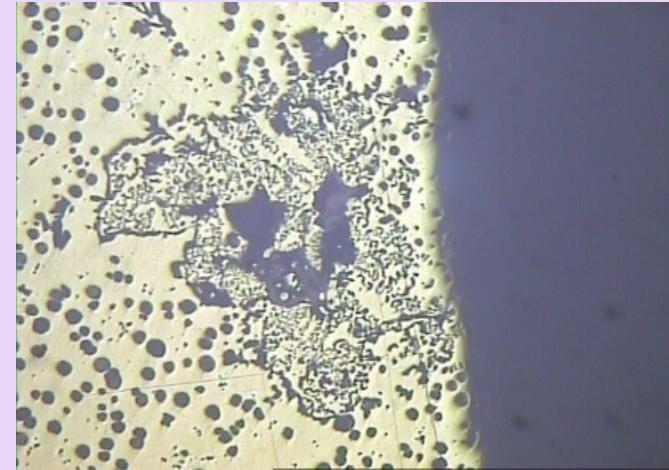
The fracture surface on micro 100% flake graphite. In the pattern layout the tie rod arm boss at the bottom most point of each cavity and ingate provided above and away from the tie rod arm boss, at ball joint boss. This means that the first metal is most likely to reach and get at the tie rod arm boss and has got very little chance to get mix-up with the rising stream of fresh metal. The first metal of the first mould poured when restarted every time after a delay has got some chance to carry the slag from the snout.

Around the slag the Nodularity was destroyed and flakes forms was found.

A cold out provided at the tie rod arm boss to collect the first metal

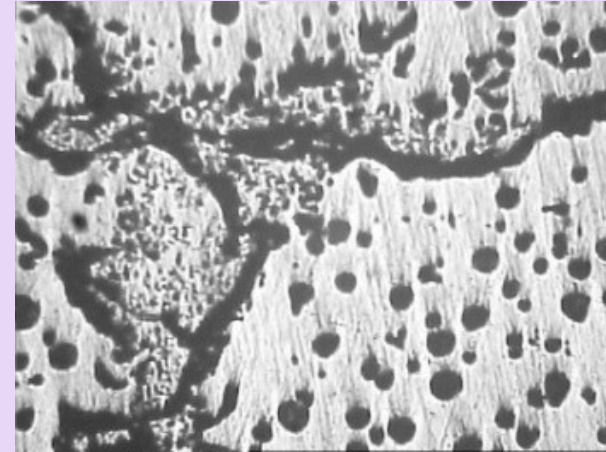
CAUSES: Slag Inclusion) Poor refractory materials, furnace lining materials, Ladle lining materials, presspour lining materials and Nozzle materials gets fused and forms slag in the metal .

OBSERVATIONS:  
Nodularity not affected around the inclusions.  
Nodules count was found small in size and more.

REMEDY  
High Refractory materials to be used

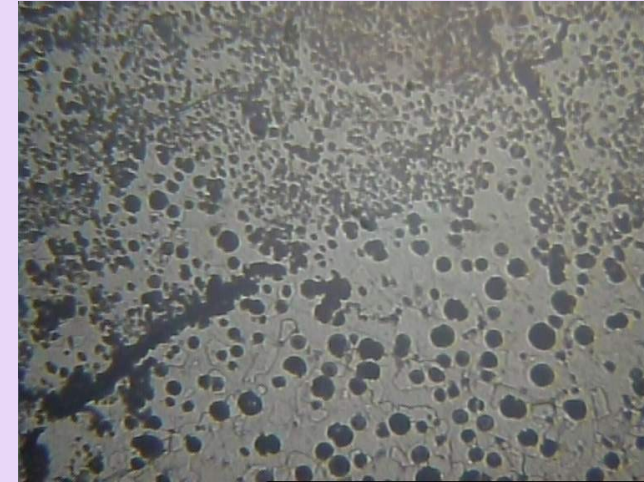
**CAUSE.** Undissolved ferro-silicon inclusion. Machined surface showing shiny particles. Inoculation and alloying are essential processing and metal preparation stage but excess addition or incomplete dissolution leads to undissolved inoculants particle appear as "shiny" particles .

Undissolved but disassociated Ferro-silicon precipitated as fine silicon during solidification and after machining it appears as shiny particles.

Stream inoculation is selected carefully with respect to size and composition. Pouring Temperature Min. 1390°C. Quantity of inoculants is specified

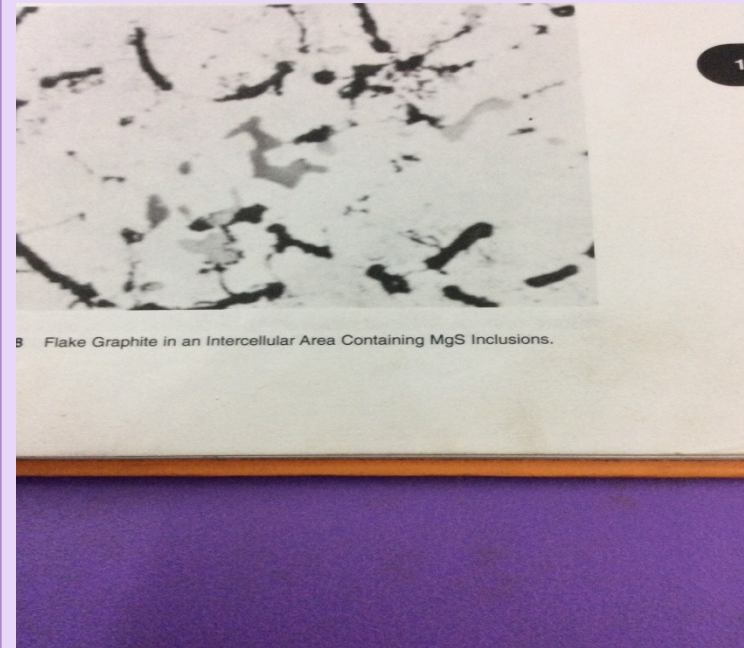
Intercellular graphite inclusions. Ductile iron freezes with a cellular structure. The last iron to freeze between the cells is the richest in elements which cause degenerated graphite, carbides or other non metallic inclusions. The inclusions are caused by high level of tramp elements and can be very detrimental to mechanical properties. Intercellular Flake graphite inclusion..

- Improve the gating system so as no turbulence, Control the Magnesium to max. 0.05%. Ensure slag off before pouring into moulds. Control the tramp elements from the source itself.

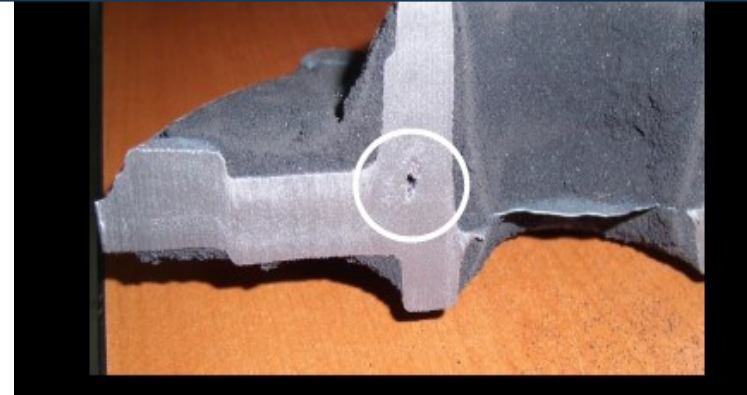
Shrinkage or porosity in the hub centre which was found isolated section and it cannot be feed from OD.

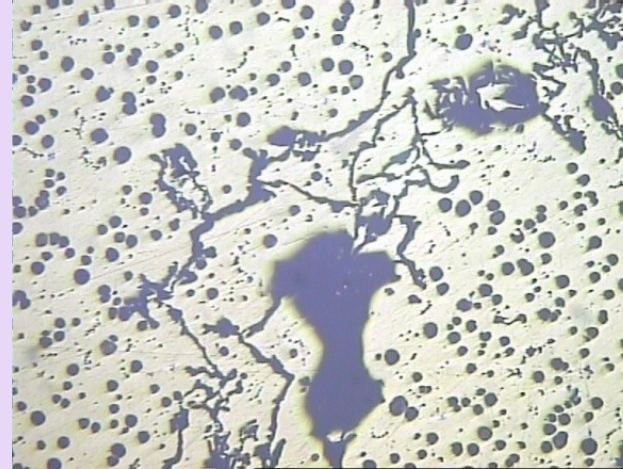
Using salt tube to break the heavy blockage of slag , agitated the mass slag into loose and then get entry into the mould

Ensure the Slag off at every stages before transfer into press pour.and salt tube inserting,launcing with oxygen are to be controlled.

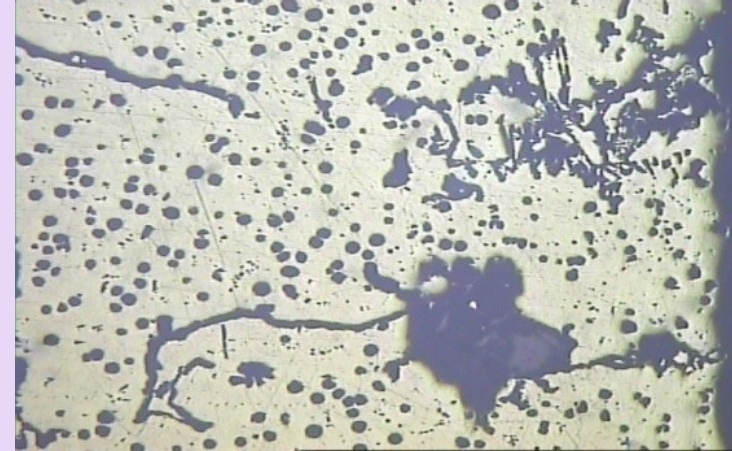
- . Slag inclusion  
Cupola metal having more liquid slag

Slag off the metal before tapping into the ladle, from the ladle before transfer into the pouring furnace, and pouring spout. Spout height Min.200 mm to be maintained

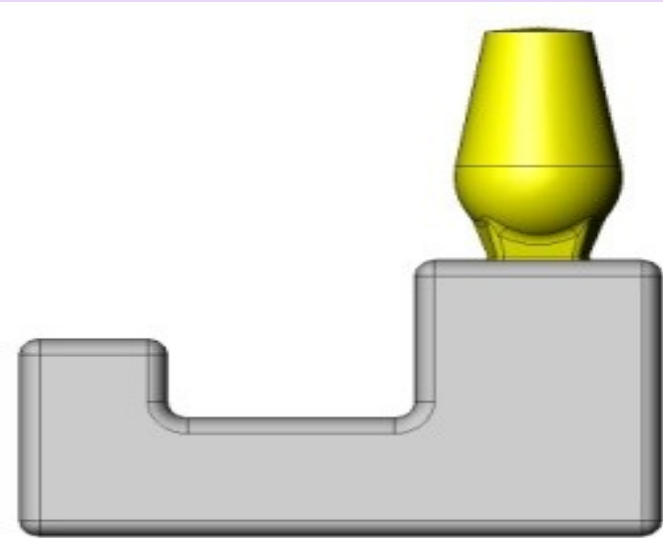
Shrinkage at junction  
Insufficient feeder volume

Feeder volume increased

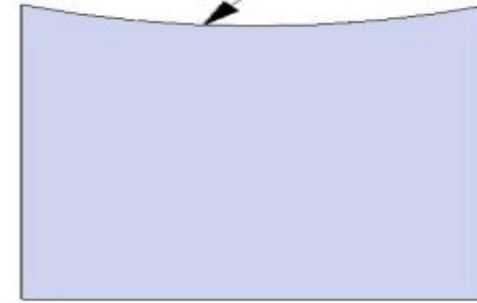
Depression NG

Depression like shrinkage defects by premature freezing of the riser or the casting - riser contact area.

The defect appears at the heaviest section which remains hot longest during solidification.

Either to increase the riser contact modulus, the riser size or prevent the top of the riser from freezing.

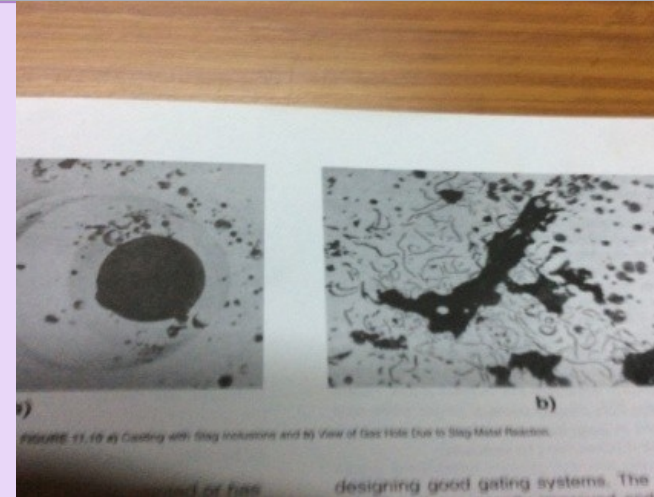
If there is a considerable heat concentration in one or more segments of the casting (hot spot) the secondary shrinkage may appear in the form of holes rather than porosity.

Modifying the gating system so as to make uniform heat concentration.  
Improve mould hardness.

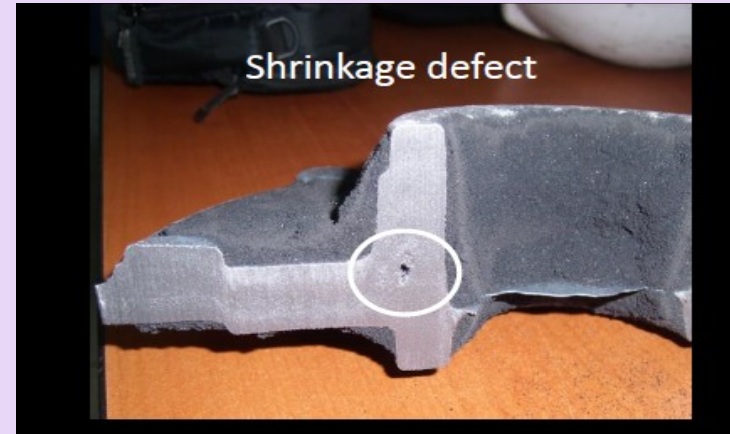
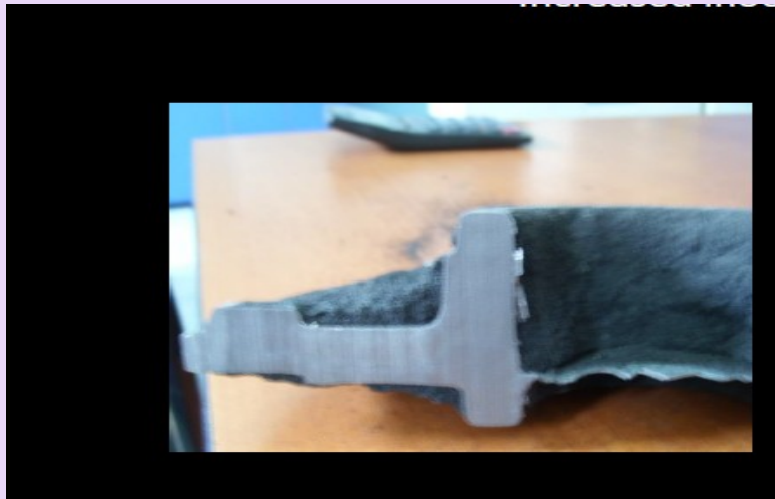
Shrinkage or porosity due to isolated heavy sections

Control the chemistry free from contamination. Control the pouring Temperature. Slightly modify the section so as to make the section more or less uniform

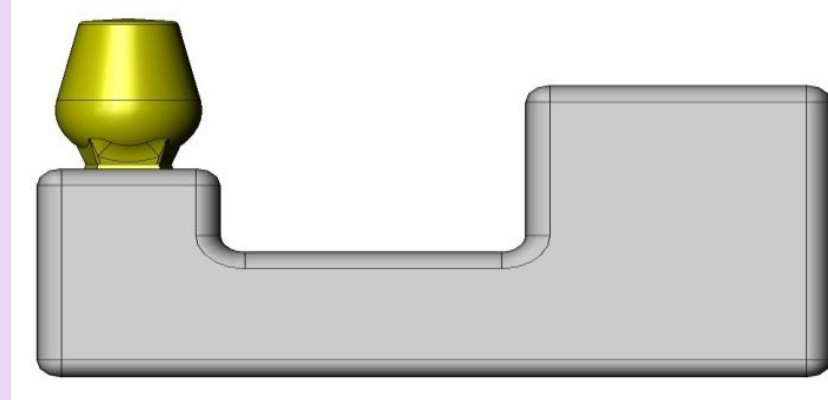
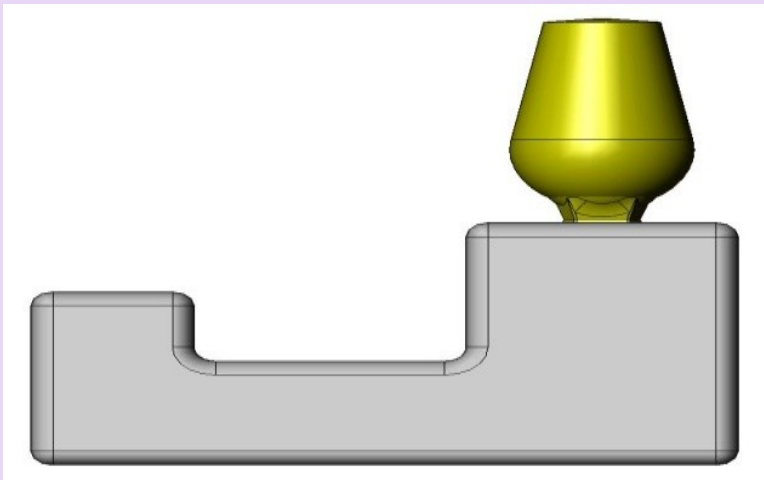
Selection of feeder location wrong

Orientation changed for better feeding

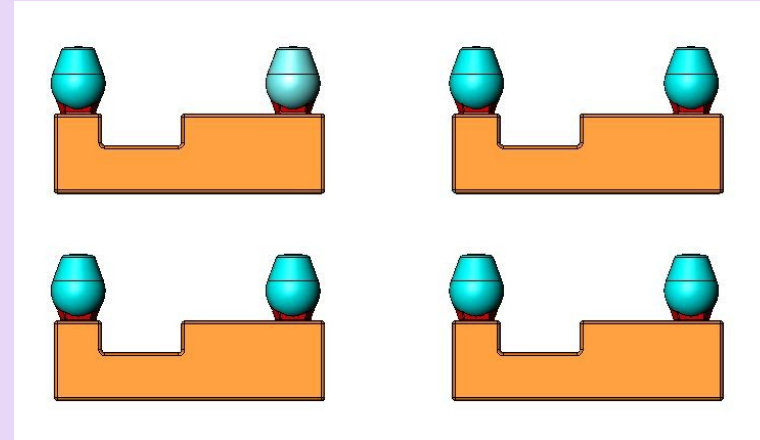
Top cavities having more or less no Ferrostatic height and easily subject to process variation like pouring temperature, pouring time etc., leading to this type of shrinkage.

Pouring cup diameter increased.  
Monitoring of process parameters like chemical composition, pouring temperature, pouring time and mould hardness etc.

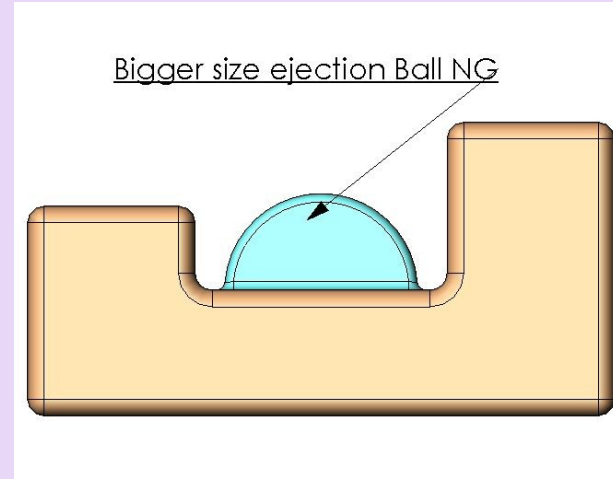
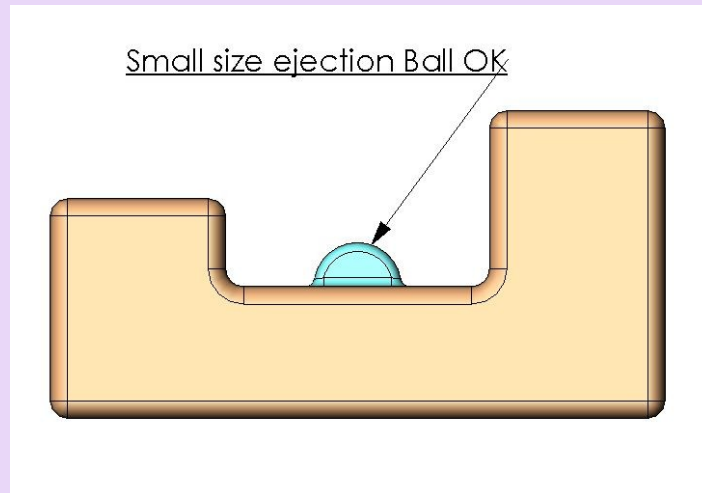
Since bigger size ejection ball provision leading to less sand thickness keeping the location hot during solidification.

Bigger ejection ball is replaced by a small one

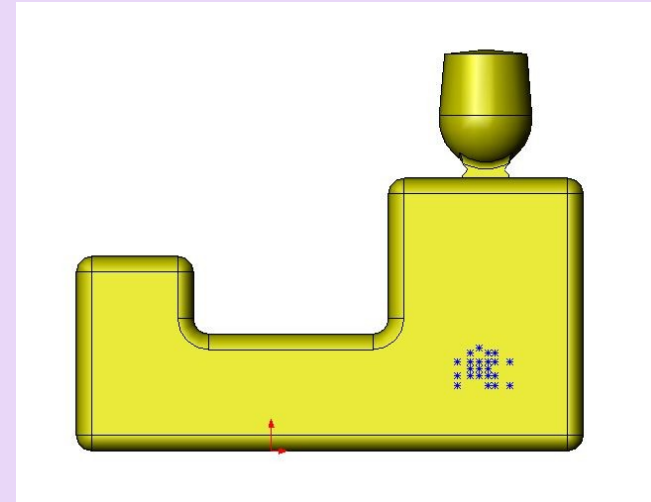
Porosity (secondary shrinkage) on the arms  
reducing Tensile Strength and elongation  
Insufficient feeding and not uniform cooling

- Connectivity improvement from riser neck to porosity affected zone.
- Hot or cold riser provided at the boss.

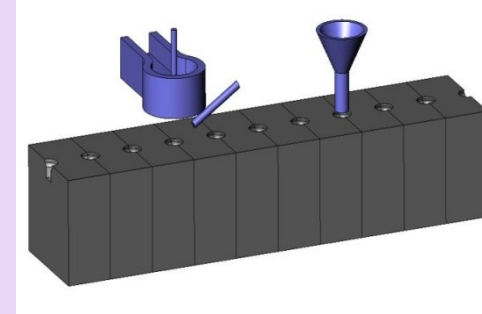
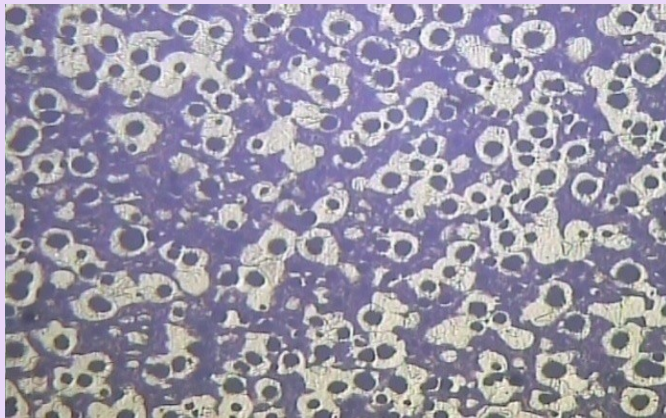
Since stream inoculation synchronized with joystick which is used for opening the nozzle to pour liquid metal into moulds. Nozzle leak metal did not initiate the pouring or inoculation to the first metal.

Continuous inoculation and  
In mould Inoculation introduced

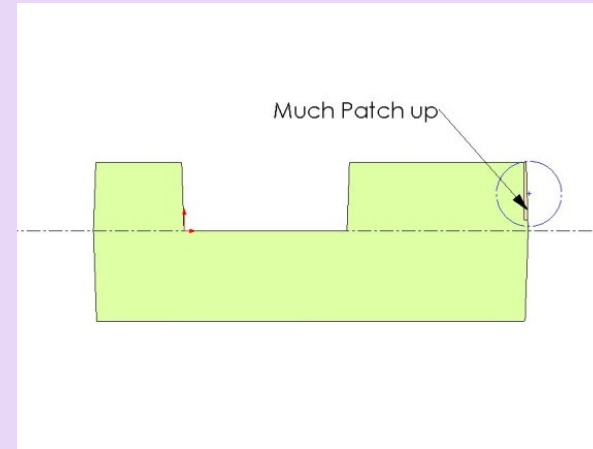
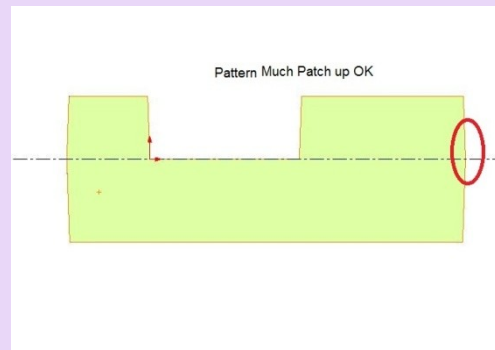
Too much patch-up on the tooling

Minimise the patch up work on the tooling.

After method proving Chromium or Nickel plating can be done.

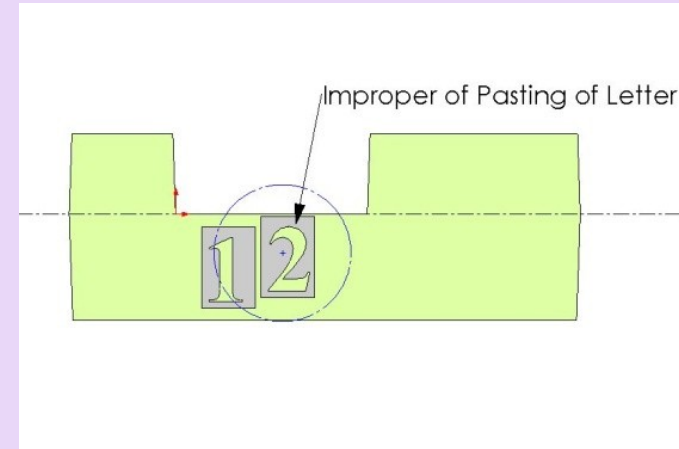
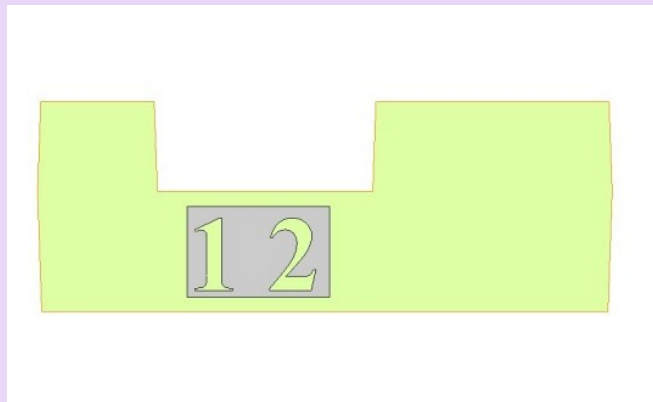
Improper pasting of letters.

Proper pasting of letters.

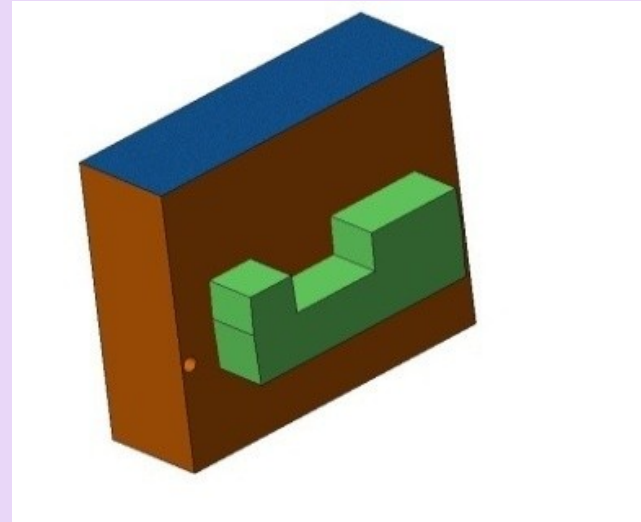
Pattern plate top worn-out

Pattern plate top height corrected by milling and replacing a strip or replacing the pattern plate.

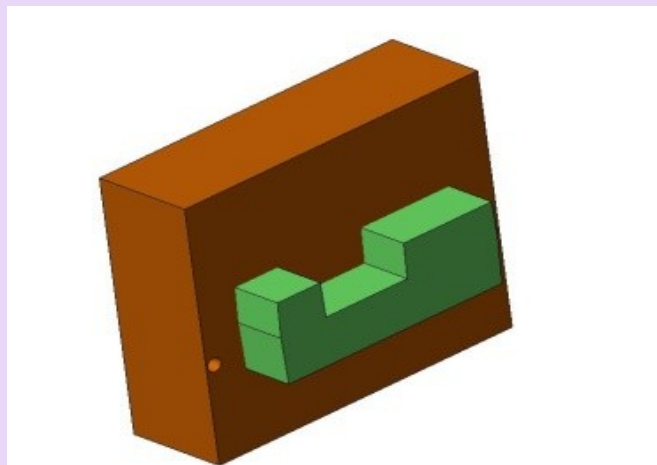
Pattern plate top worn-out

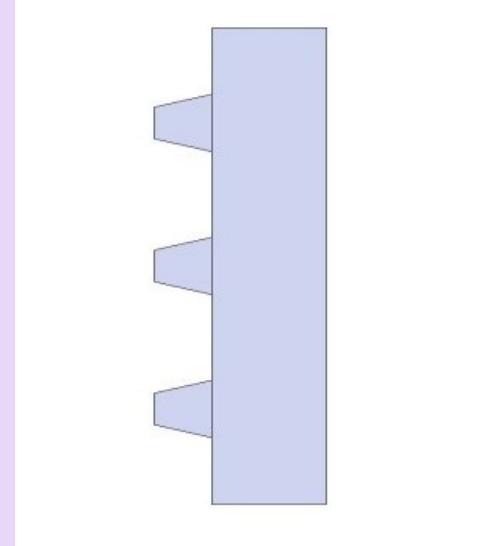
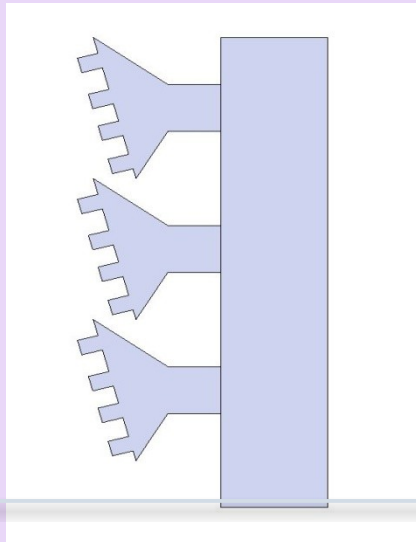
Excess air pressure is used as air cleaning and air nozzle not designed properly.

Air pressure controlled. Standard nozzle to be used

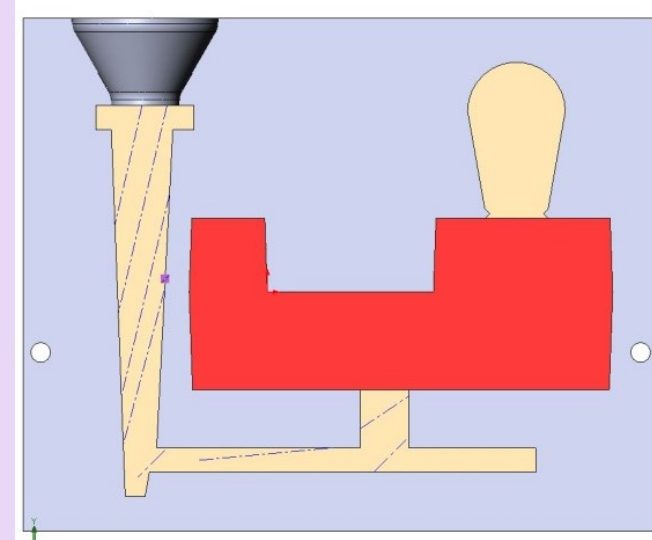
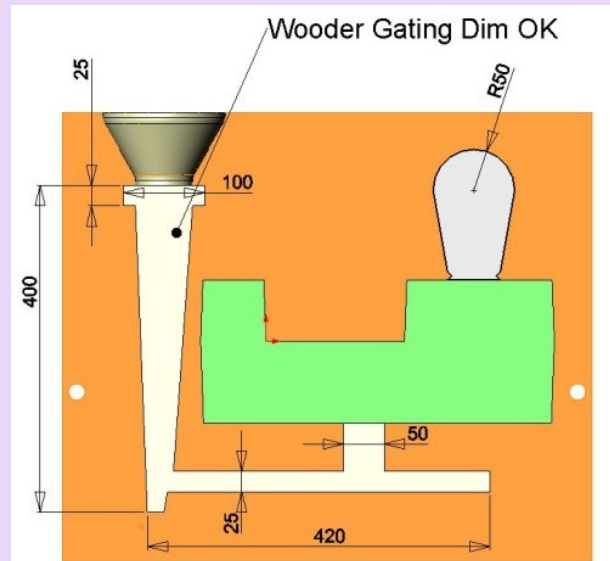
Worn-out wooden gating system having line marks and hence sand sticking.

Wooden gating system is replaced by metal.

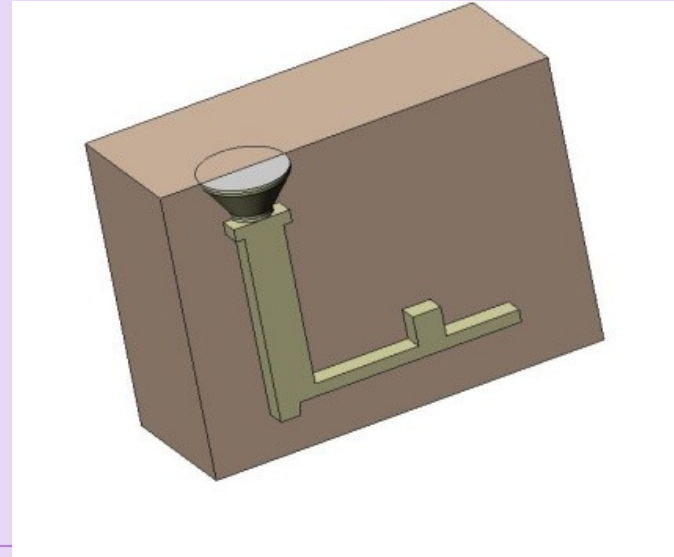
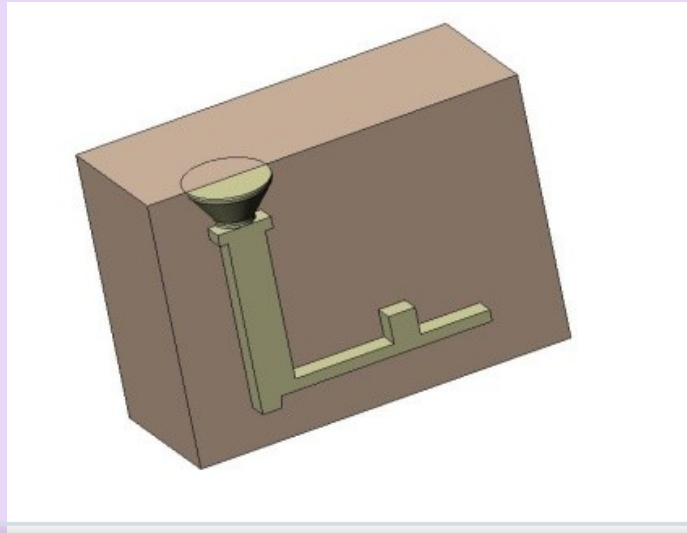
Pouring cup top worn-out due to sand shooting directly hit on it.

Periodical change of pouring cup or top 10 mm only replaced.

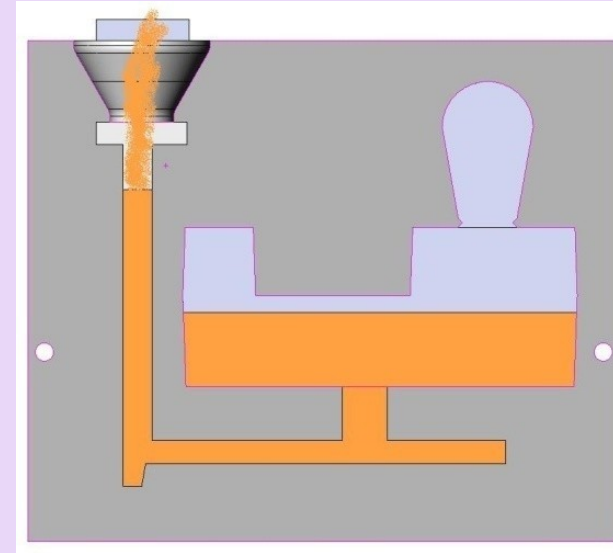
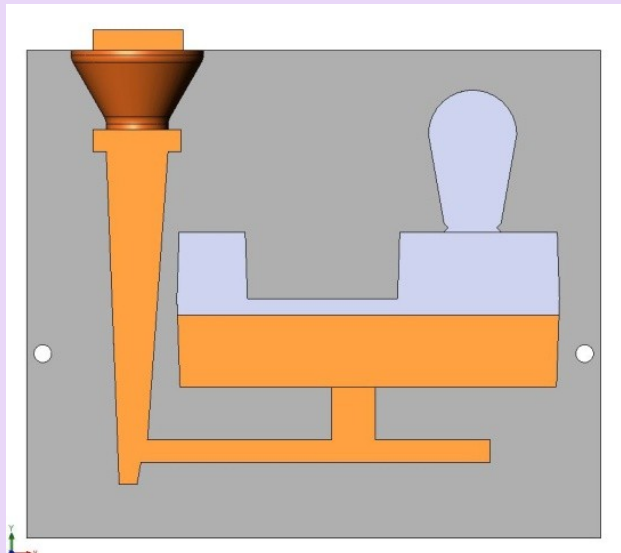
The gating system is not kept full hence not allowing the sand particles to float to the upper surface of pouring cup and runner. Incorrectly sized gating area make it impossible to keep the gating system continuously filled with metal. Too high content of inactive fines makes the sand weak and brittle. Sand tears off or crack during molding.

Standard gating ratio to be followed

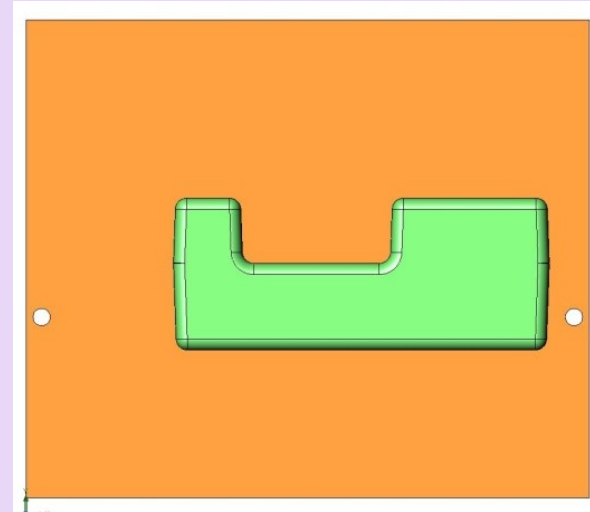
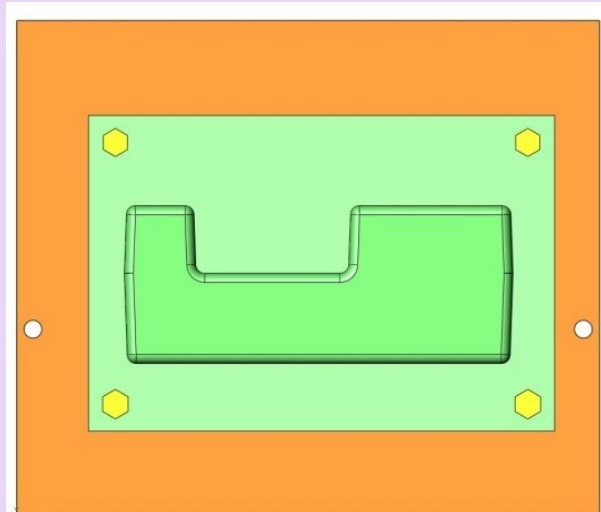
In case of separate tooling tool mounting hole loosened.

Tightened the bolts & nuts.If possible provide lock nuts.

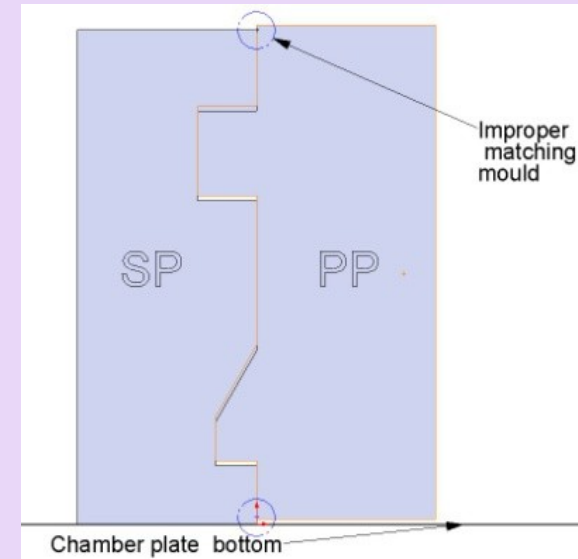
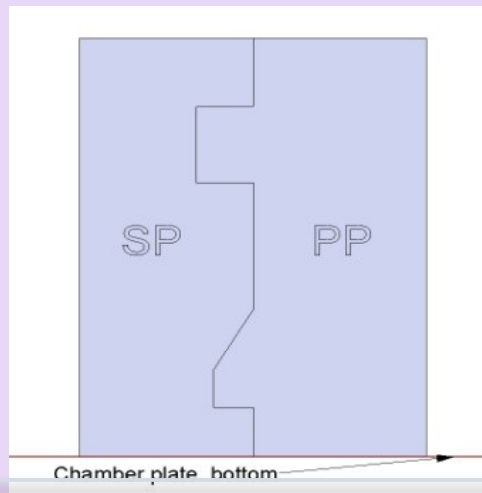
Improper matching of the contour of the print on sp and pp plate.

Identify the mould crush after closing and then opening and crushing pad to be provided to avoid sand falling

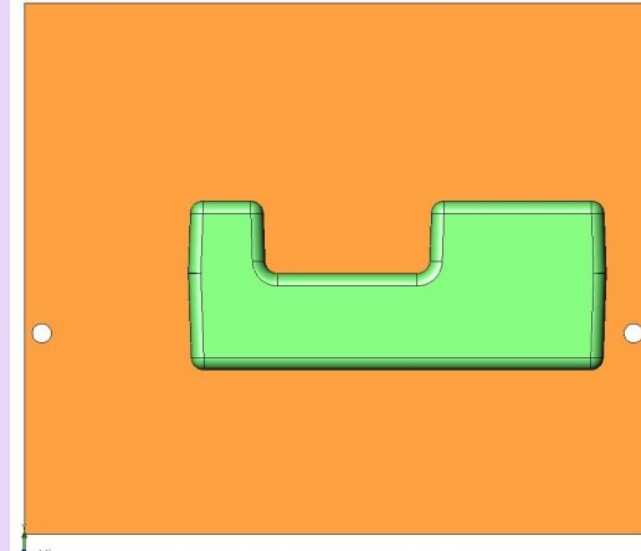
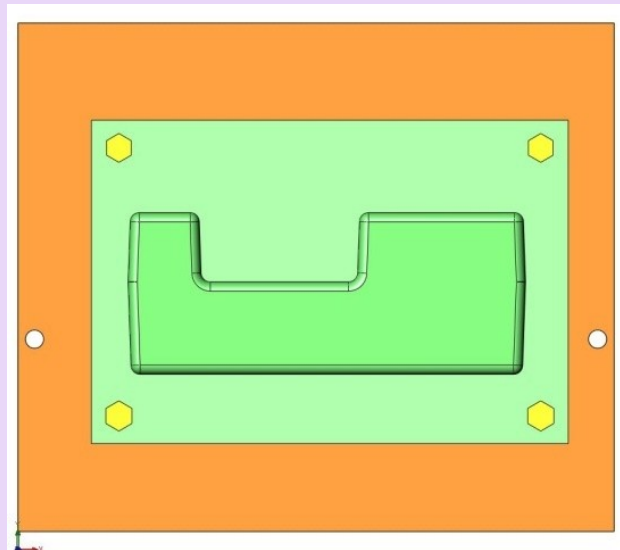
Improper tightening of bolt and nuts on the tooling.

Pattern workers are trained for perfection

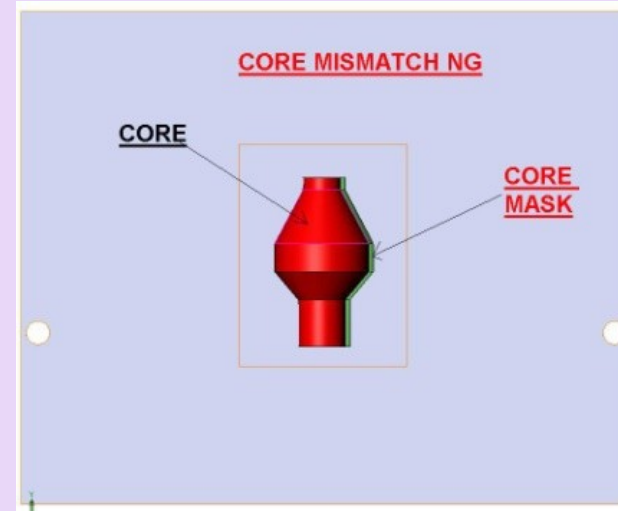
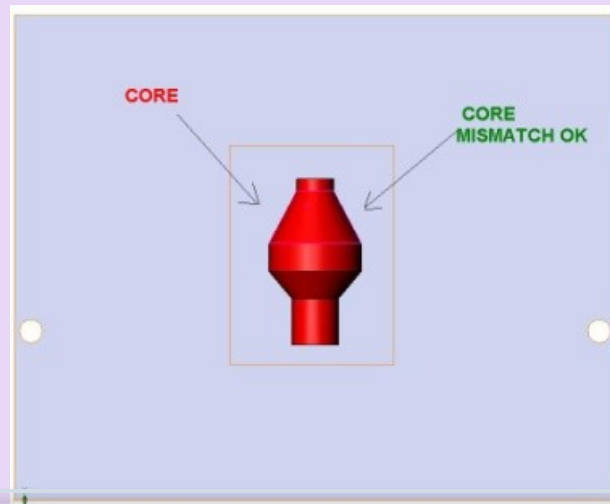
Core setter mismatch causes core loaded on the green sand mould ending sand falling.

Core setter mismatch corrected

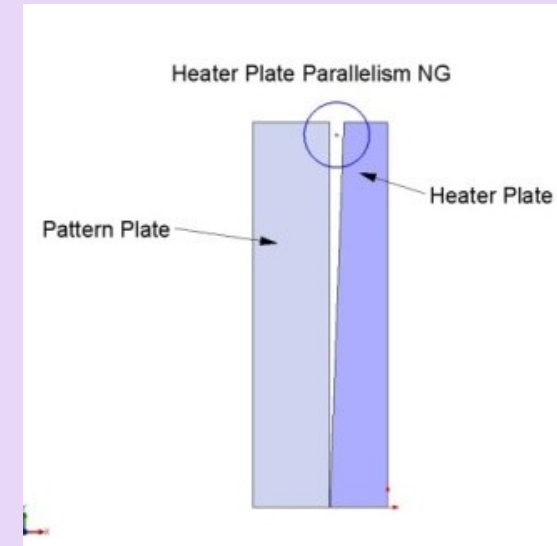
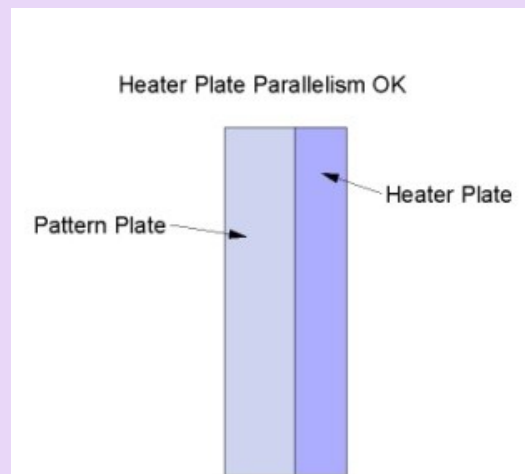
Heater plate parallelism more than 0.5 mm leads to self core broken

Periodical replacement of heater plate.

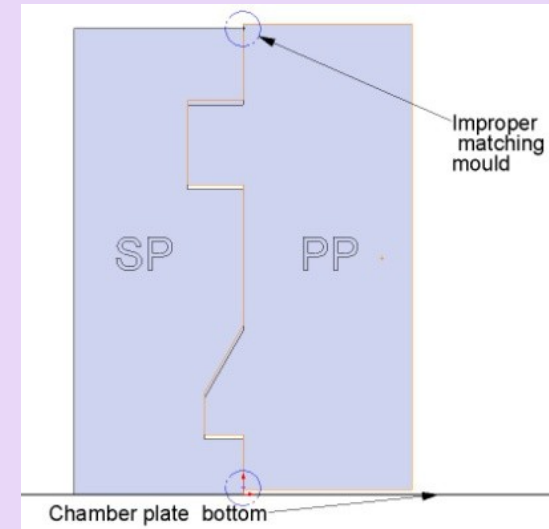
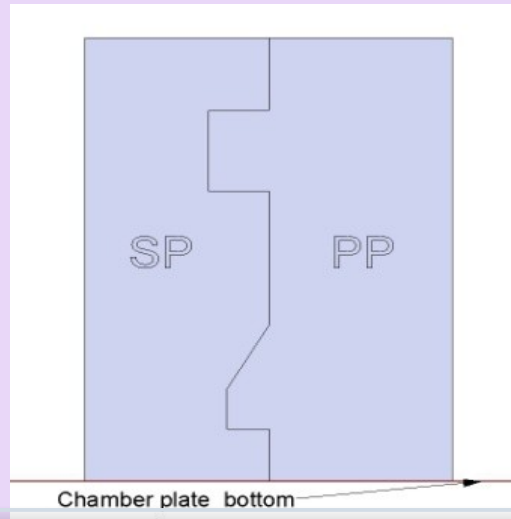
Improper matching of the contour of the print on sp and pp plate.

Identify the mould crush after closing and then opening and crushing pad to be provided to avoid sand falling.

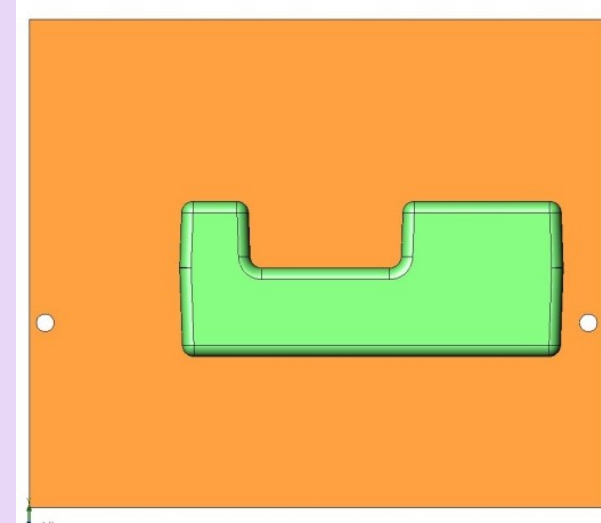
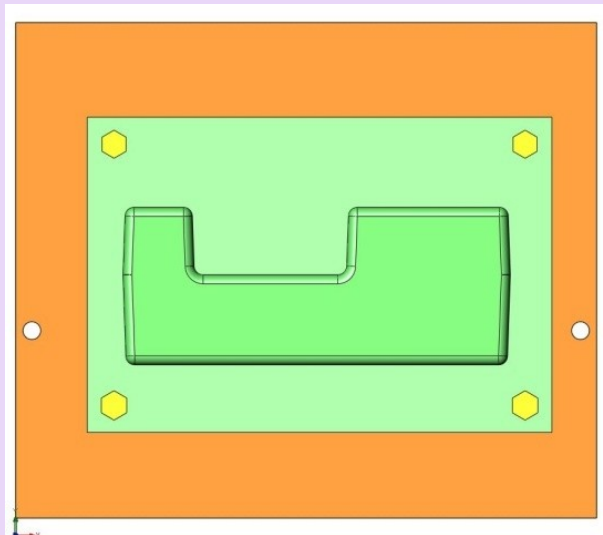
Improper tightening of bolt and nuts on the tooling.

Pattern workers are trained for perfection

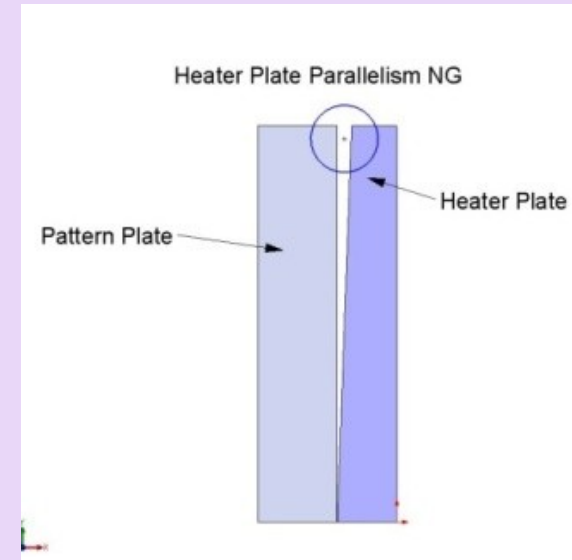
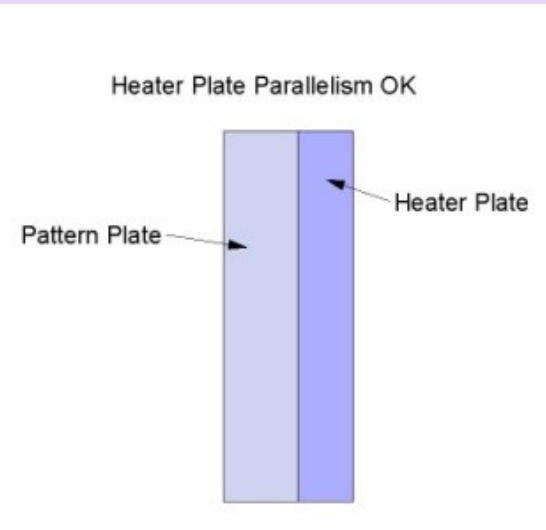
Heater plate parallelism more than 0.5 mm leads to self core broken.

Periodical replacement of heater plate

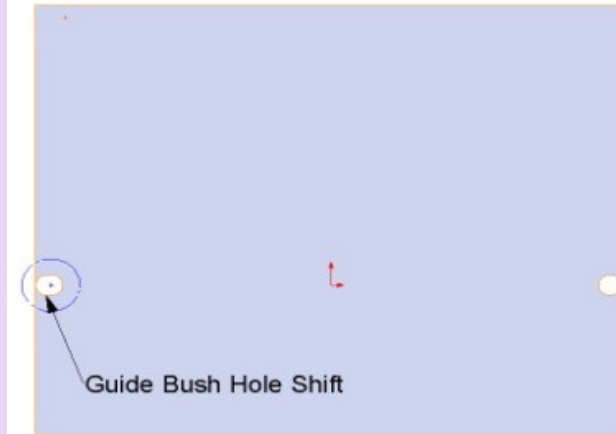
Guide Bush Shift - NG

Guide Bush shift or worn-out

Guide Bush Hole Shift

Replacement by new one

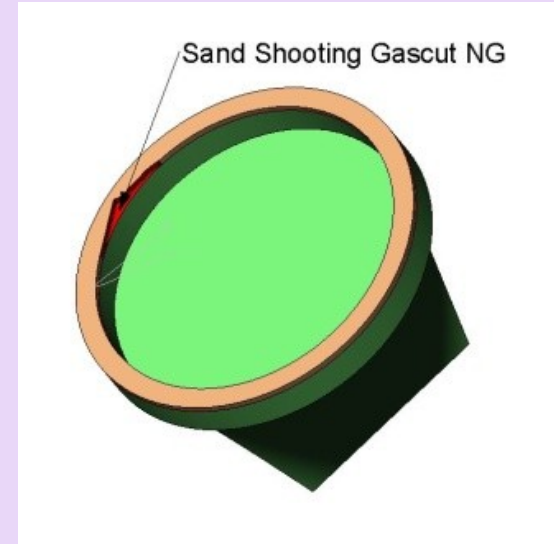
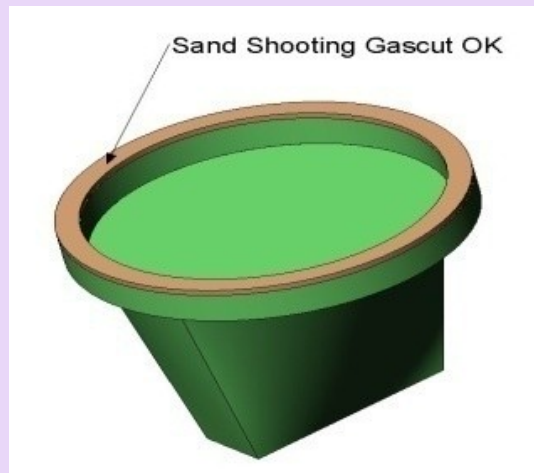
Sand shooting valve problem. Gascut worn out.  
Shooting valve diaphragm reversely fitted and sand conveying to the doom one side

Periodic check-up shooting valve

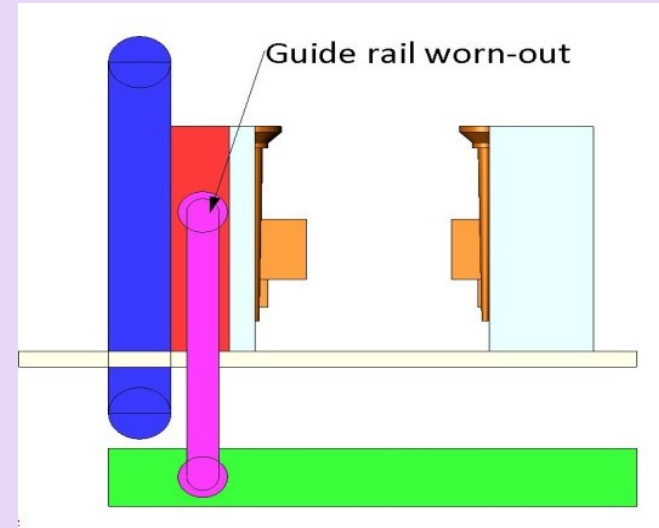
SP arm guide rail worn-out

Replacement by new one.

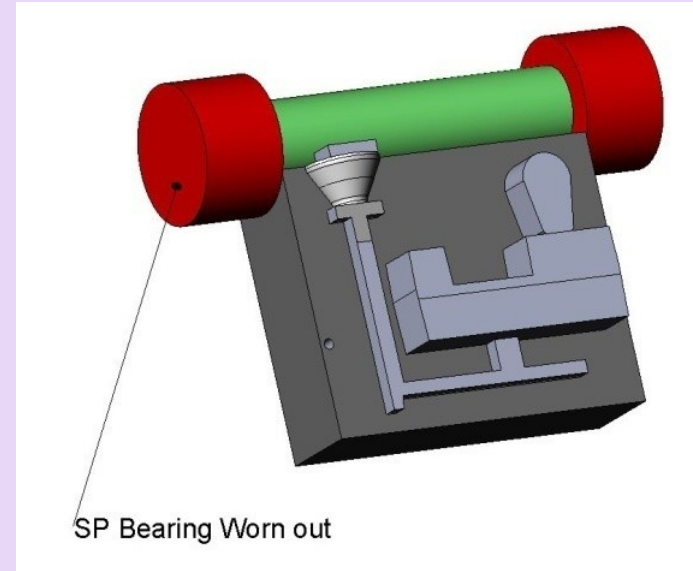
SP arm Bearing worn out

•Bearing replaced

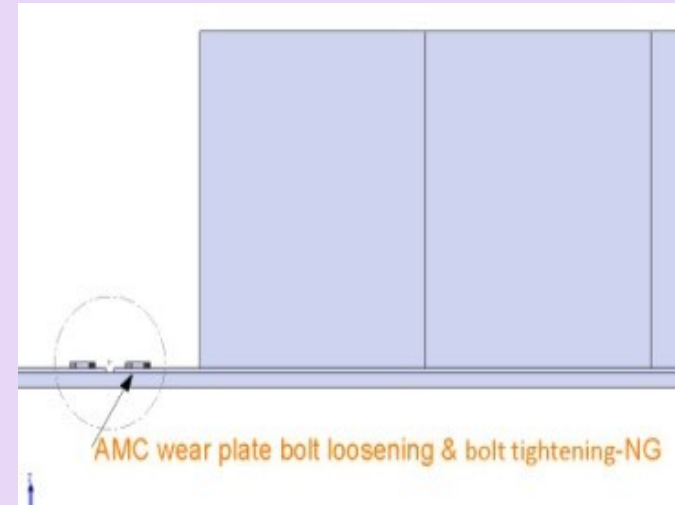
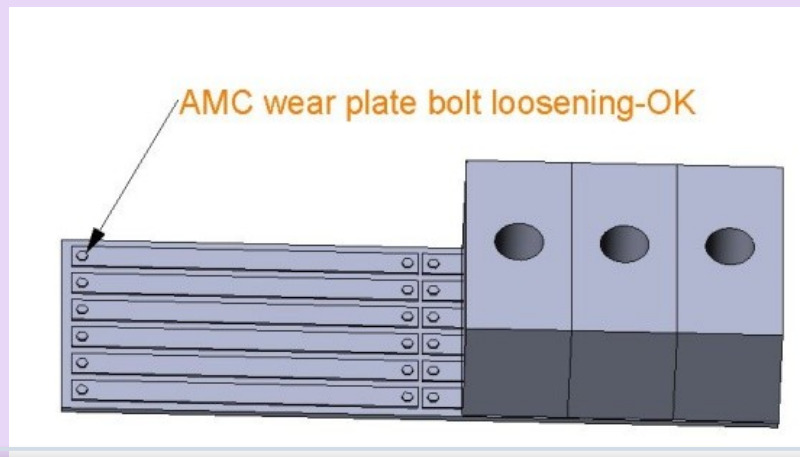
AMC wear plate bolt loosening, leading to mould shaking and hence crush.

AMC wear plate bolt tightening

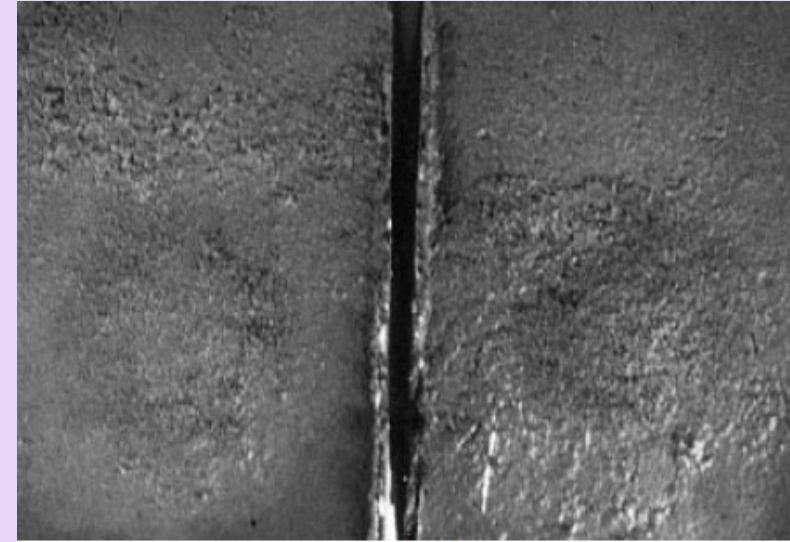
Fig. 6: Sample grey iron casting for testing of erosion with a clay-bonded moulding sand.  
Scale: 10 mm  $\pm$  10 mm

- Sand Erosion :
- The binder is not able to hold the sand grains they are flushed out and dispersed to the remote areas of the castings.

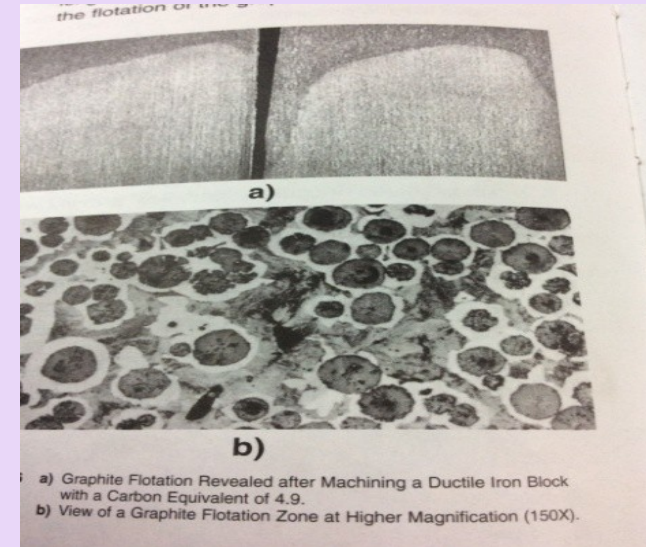
Carbon Equivalent is more than 4.5% flotation starts in thick castings more than 1"

Control the carbon equivalent  
Pouring Temperature to be reduced.  
Gating system to be modified so as to ensure uniform heat distribution.

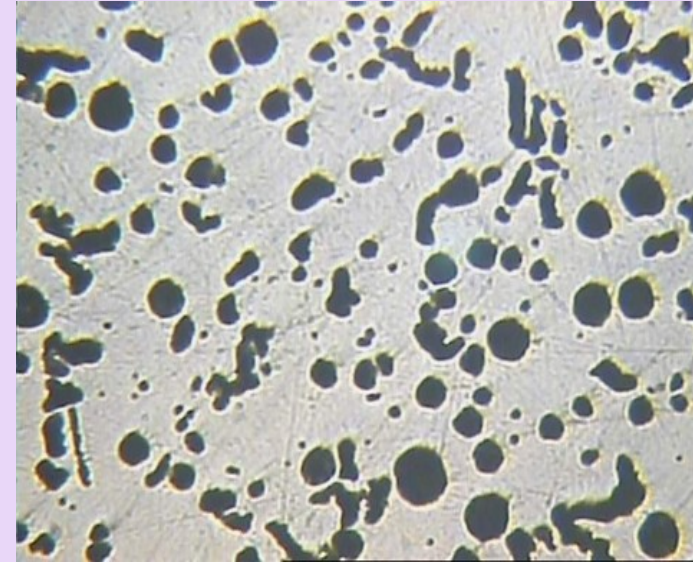
\_FLAKE Graphite in Nodular Iron.

Low residual Magnesium ,  
High Sulphur content of base iron/mould  
High Treatment Temperature  
Associated with slag inclusion

\_Increase the residual magnesium  
Treated metal pouring within 7 minutes.  
Base metal sulphur should be  
low.Incoming charge materials to be  
checked.  
Sulphur in coal dust max.0.2%

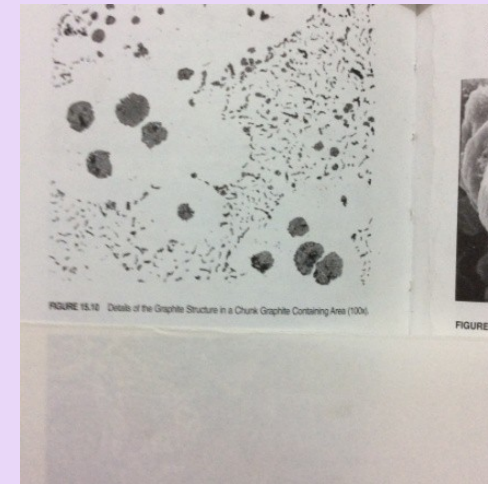
Chunk graphite is usually found at the thermal centre of heavy section casting

Carbon supersaturation and high local undercooling and elements like silicon, Cerium/mishmetal in Mg treatment also favours chunk graphite formation. More purity of iron also prone to occur this type.

The addition of elements that accumulate around the graphite nuclei, such as Antimony, Tin, copper was found to inhibit the growth of chunk graphite cluster
