# ***FOUNDRY DEFECTS*** ***(Some Tips)***

Practical Causes, Observations and Remedies

**Prepared by: P. Arul Mozhi Devan**

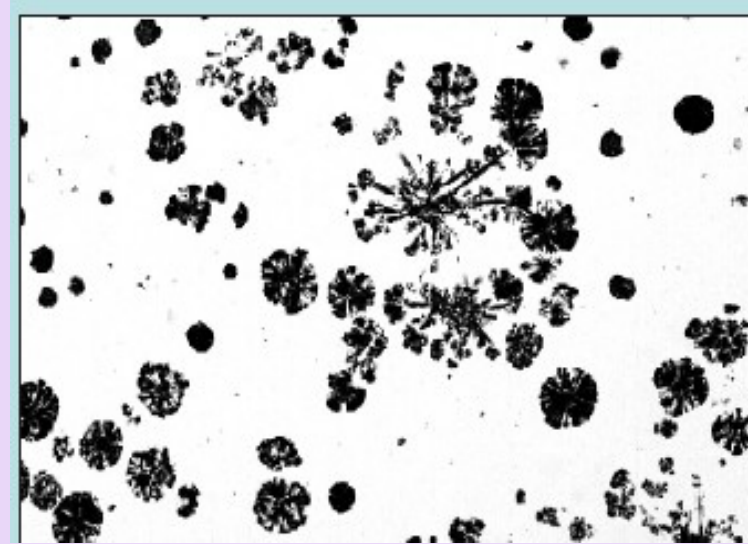
Exploded graphite / or spiky graphite  
observed due to purity of metal  
High carbon Equivalent with high pouring  
Temperature  
Presence of more Cerium or mishmetal

The addition of Copper, or Tin or Antimony was found to inhibit the growth of exploded graphite. In melting M.S. scrap from same source other source also charged to avoid exploded graphite

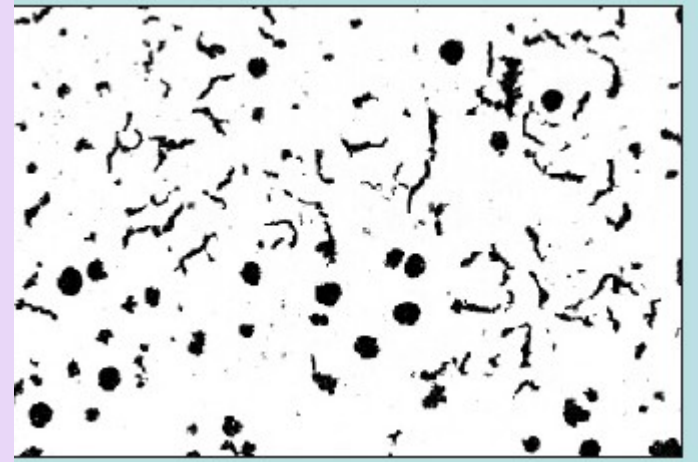
Degenerated graphite Nodular  
(Vermicular graphite)

The ideal graphite structure are properly round nodules and many specification require minimum 85% nodularity. Nodule irregularity above the limit due to low residual Mg. less than 0.03% in our process causes this type of structure.

Increase the residual Magnesium

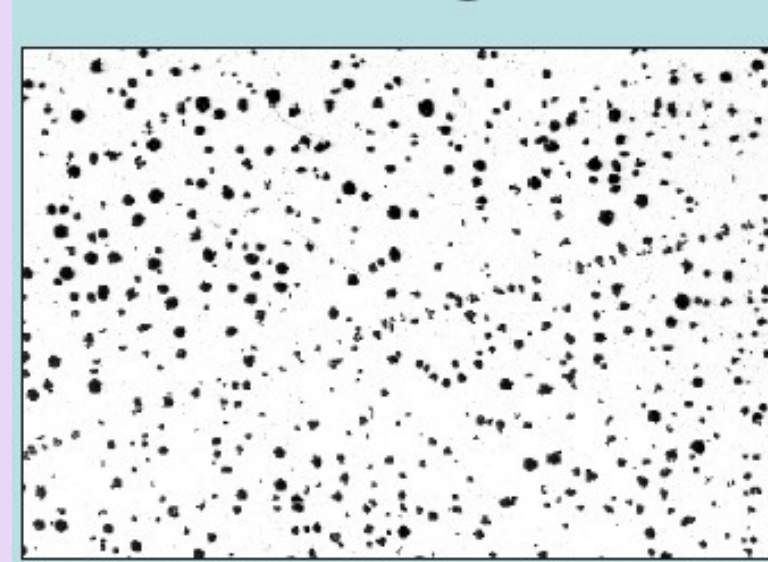
The surface of the plate fracture is studded with graphite spheroids which are smaller than those in the rest of the area, irregular in shape and are arranged in an almost crystal-lattice-like accuracy.

On a microscopic examination, a definite alignment of the nodules embedded on a ferritic band. This is found at locations such as riser neck connections or within casting often at the junction between two sections.

High incidence of inclusions in and near the ferrite bands surrounding the plate fracture.

- Low carbon equivalent
- Under inoculation
- High pouring Temperature
- Causes this type of structure

Changing the riser neck location and change the mould filling & running system
