ANALYSIS OF TRADITIONAL BUILDING TECHNIQUES AND DAMAGE ASSESSMENT OF TRADITIONAL TURKISH HOUSE: The Study of Timber-framed Kula Houses

Mine Tanac Zeren, Ozgul Yilmaz Karaman

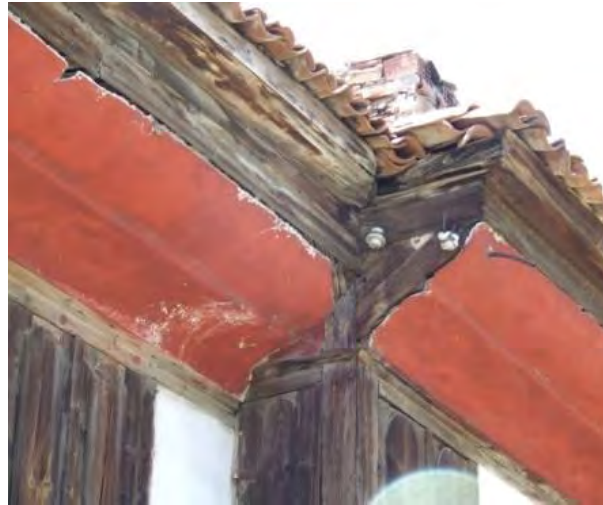
It can be seen that now that the building ensured the continuity of its building use, the deteriorated architectural elements are replaced with new elements during the historical process. By this attempt, the original first floor windows and doors, the floor coverings of sofa space and the staircase are replaced with new timber elements. The repairs that have been maintained by the owner the house are made by using the same quality wooden structural and architectural elements. These attempts lead the building to be preserved to nowadays with its original features. Even if the periodical repairs have been done during the process, some deterioration on the facades of the building caused by atmospheric conditions such as colour changes on wooden elements can be occurred (see Figure 13).

Figure 13. Color change of the wooden eaves
(Source: Authors, 2008).

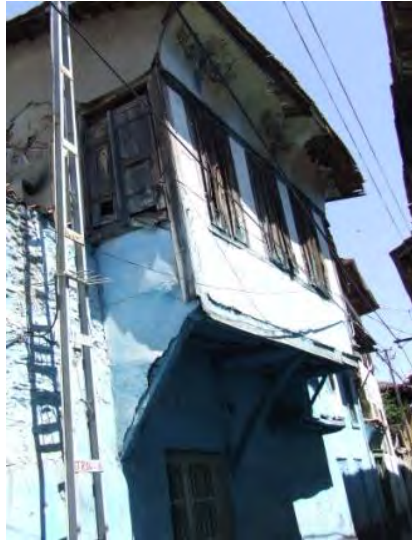
material loss. The wooden materials of roof coverings, eave coverings are partly lost, there are colour changes obtained on the architectural façade elements.

Figure 14. Case 02 The entrance façade of the building (Source: Authors, 2008).

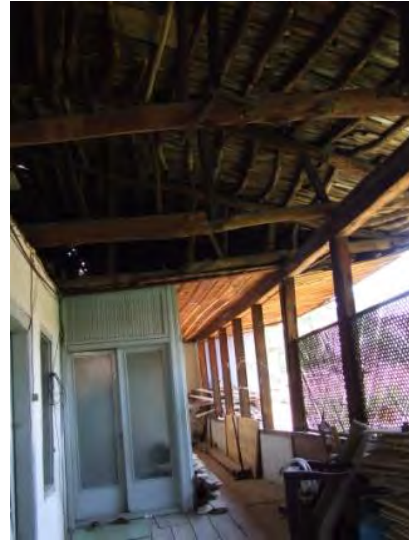
The structural system details of roof structure can be easily seen from outside because of the loss of roof coverings, according to this the rafter elements are used as they are taken from the forest without any carpentry work, and placed in intervals randomly according to the size and section of the timber element. The most important degradation type observed in the house is

Figure 15. Case 02 the external sofa and the roof structure (Source: Authors, 2008).

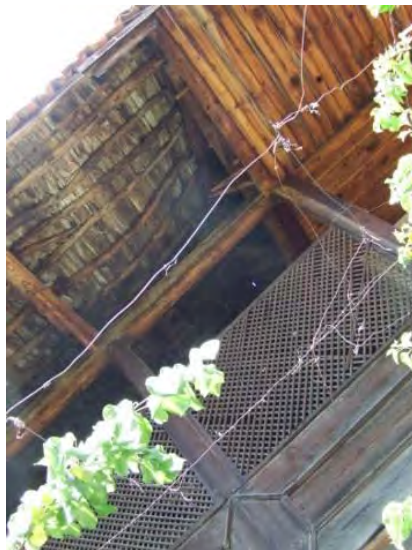
Figure 16. Case 02 Timber roof structural elements and wooden fences (Source: Authors, 2008).

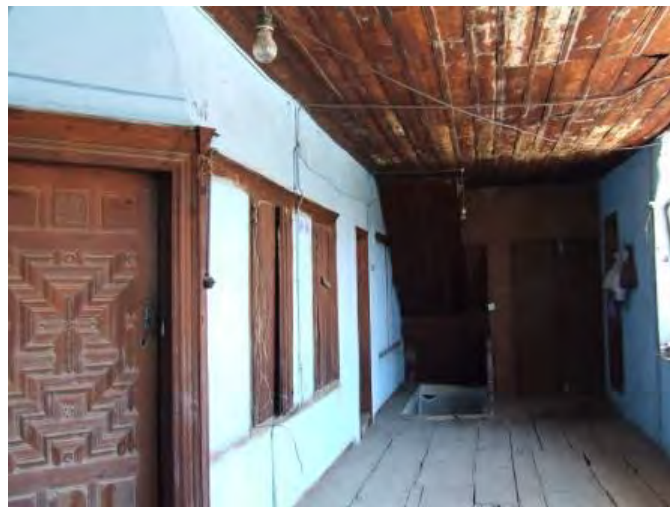
The owners of the house live in a one storied new house which they have built in the courtyard of the building during the recent years. During this process, the building has also suffered from wrong repair attempts as well. The external sofa space is partly closed, the hayataltı space is closed with a concrete extension, and some new openings are added to the façade of the building. The atmospheric conditions caused to degradations as well such as the material loss and colour changes on the wooden eaves, ceiling coverings and floor coverings.

Figure 19. Case 03 Situation of external sofa space, deterioration of the wooden material of sofa ceiling (Source: Authors, 2008).

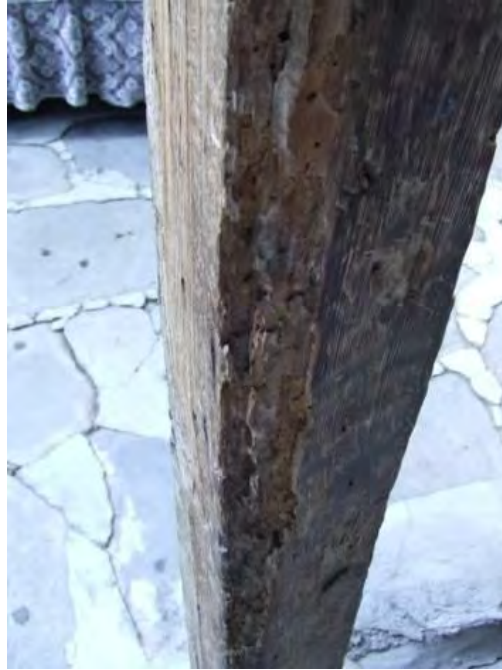
The deterioration types that have been identified can be listed as, fungi attacks, infestation, material loss, colour changes. There are fungi attacks, colour changes and infestation on the post elements carrying the Sofa. There are material losses and colour changes on the coverings of the eaves. There is deflection on the first floor carrying system, and some material losses and colour changes on the floor coverings.

Figure 21. Deterioration Problems of the Posts (Color change, holes caused by insects and sectional material loss) (Source: Authors, 2008)

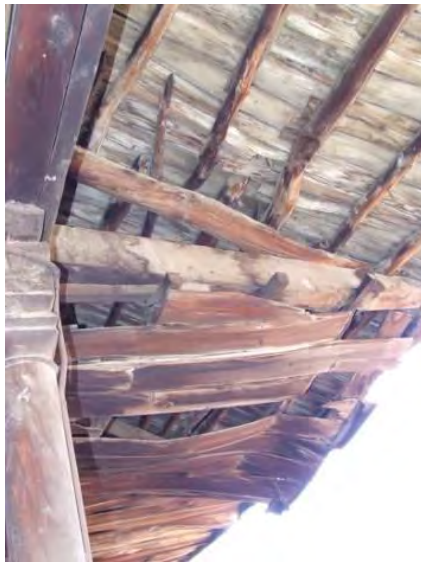
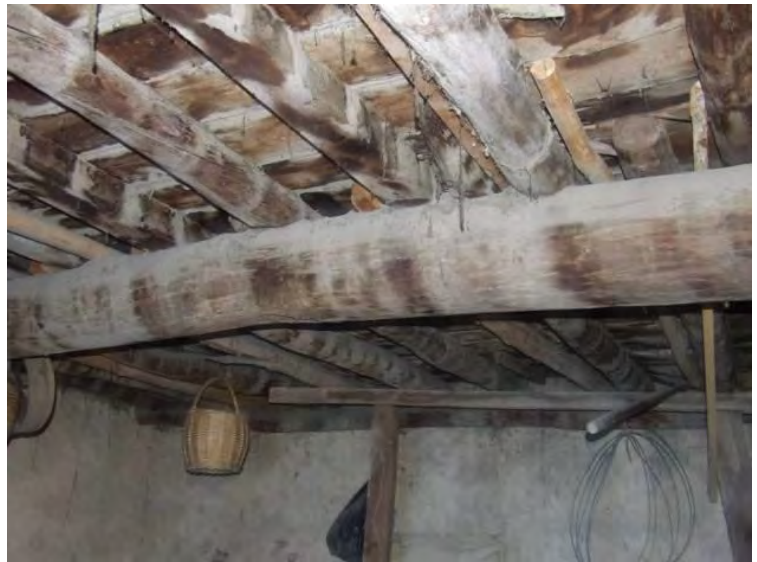
Figure 22. Case04 Deterioration Problems of the Roof (left) and Floor (right) (Color change) (Source: Authors, 2008).

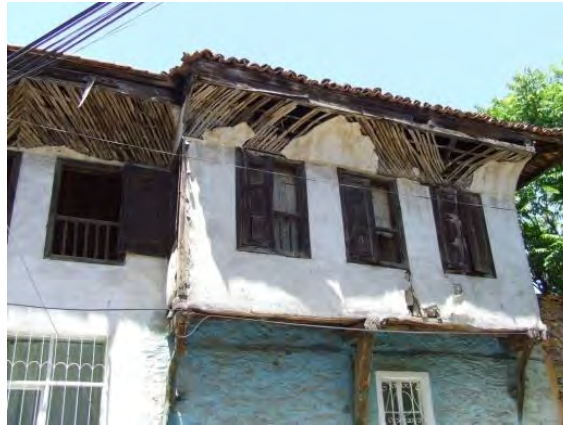
The ground floor of the building ensured the continuity of the building life so some new windows are opened on the stone masonry wall surfaces while transforming the ground floor uses (space organization) to first floor uses with wrong workmanship, and with a wrong restoration manner.

Figure 25: Case07 Exterior view and Material Loss on the Eaves of the building
(Source: Authors, 2008).

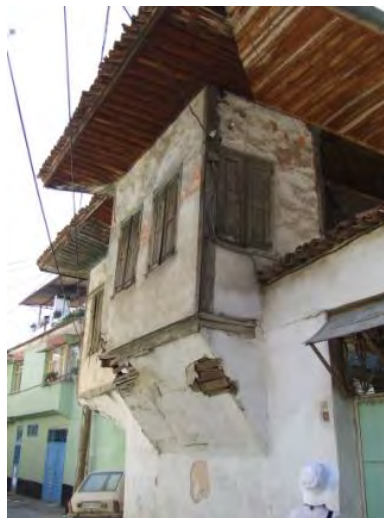
The deteriorations started from the roof structure of the building, the plasters and the bagdadi coverings of the eaves have material losses and colour changes. The causes of rain can be easily seen from the shelter of the building such as; colour changes on all the wooden architectural elements like wooden shutters, wooden balustrades, and wooden façade elements. All of the projections are established very simple supported by three curvilinear timber elements, and the covering materials of the projections are lost due to the physical deterioration factors.

Figure 25. Case08 Exterior View of the building
and Deteriorations on façade (Source: Authors, 2008).

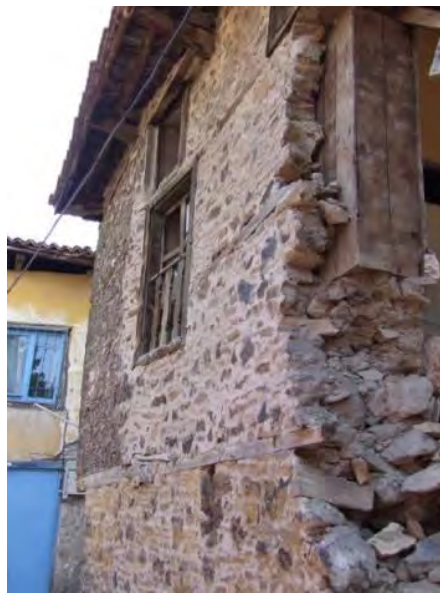
The building is an external sofa typed, two storied house with a courtyard. The construction system of the ground floor is stone masonry supported by timber post beams (Hatıl Construction Type); second floor of the building is timber frame structure. The building is desolated and because of that reason the masonry wall facing the street has collapsed. Especially the deteriorations on timber elements caused deformation of the structural system.

The main deterioration factor can be seen within the case is suffering from humidity. Humidity caused colour changes, fungi attacks on timber element. Different from other cases, insect invasion can be obtained in this case on the timber beam elements that support the masonry stone wall. The insect invasion fragmented and reduce the cross section dimension of timber elements.

Figure 26: Case09 The collapsed part of the house (Source: Authors, 2008).
