CASE STUDY:  
HOUSE NO. 1287, KIPONDA

THE AGA KHAN TRUST FOR CULTURE

## INTRODUCTION

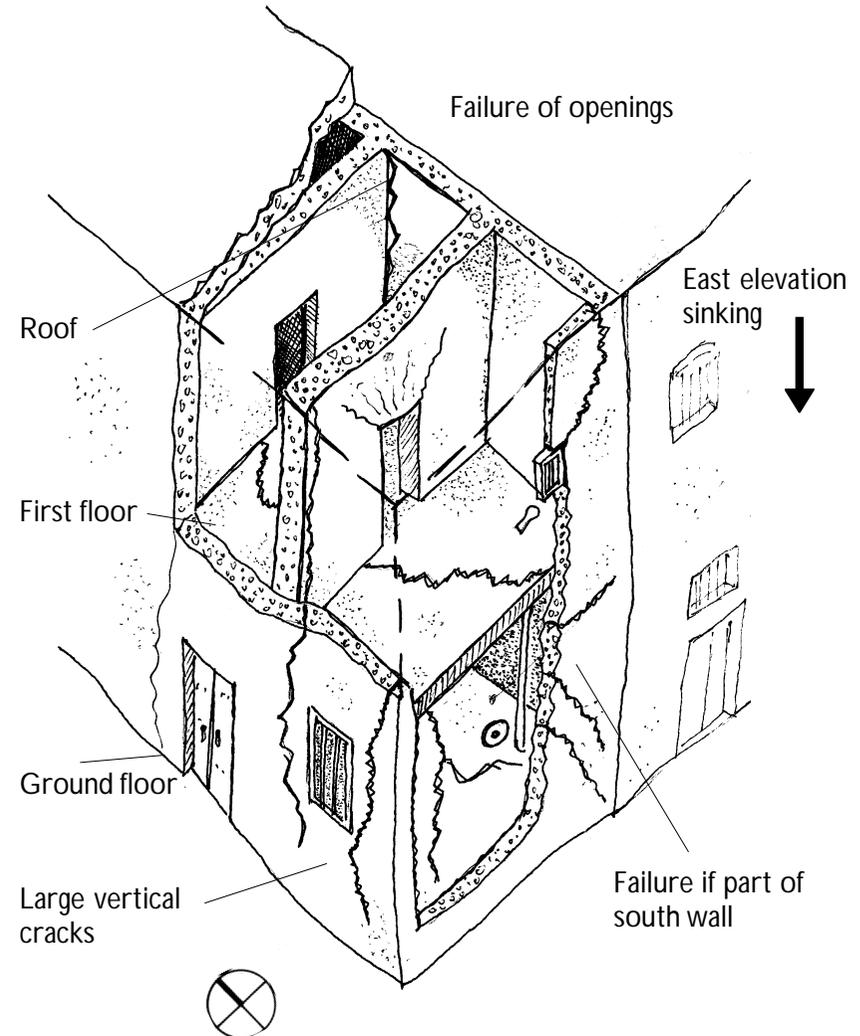
## Synopsis of problems

The exterior lime render is heavily patched with unsightly cement mortar. It is extensively employed in all elevations and gives the building a shabby and derelict appearance. Many open cracks can be seen in all the elevations. Salt crystallisation and abrasion scar the lower 3m to 4m of exterior elevations. Inside the building, numerous open cracks are visible. The southerly sections of the ground floor, first floor, and roof slab are all badly cracked and inclined towards the south east corner. The south wall leans out significantly.

Examination of crack patterns, deflections in the floor slabs, and deformed door jambs and lintels, etc., suggest an active differential settlement in the south east corner of the building. The most likely cause of this is a collapse of the pit associated with the earth closet, which is located in the extreme south east corner of the building. It is also probable that traffic vibration has played a part in inducing the collapse and furthering ongoing damage. Although the collapse of the toilet pit is responsible for the bulk of the damage observed, it must be borne in mind that the failure has disturbed the delicate equilibrium existing between various elements of the structure and has given rise to significant 'knock-on' effects that will exploit intrinsic structural and material weaknesses elsewhere in the building. If the current rate of rotation in the south elevation and growing instability is maintained, the south elevation will shortly be in danger of collapse.

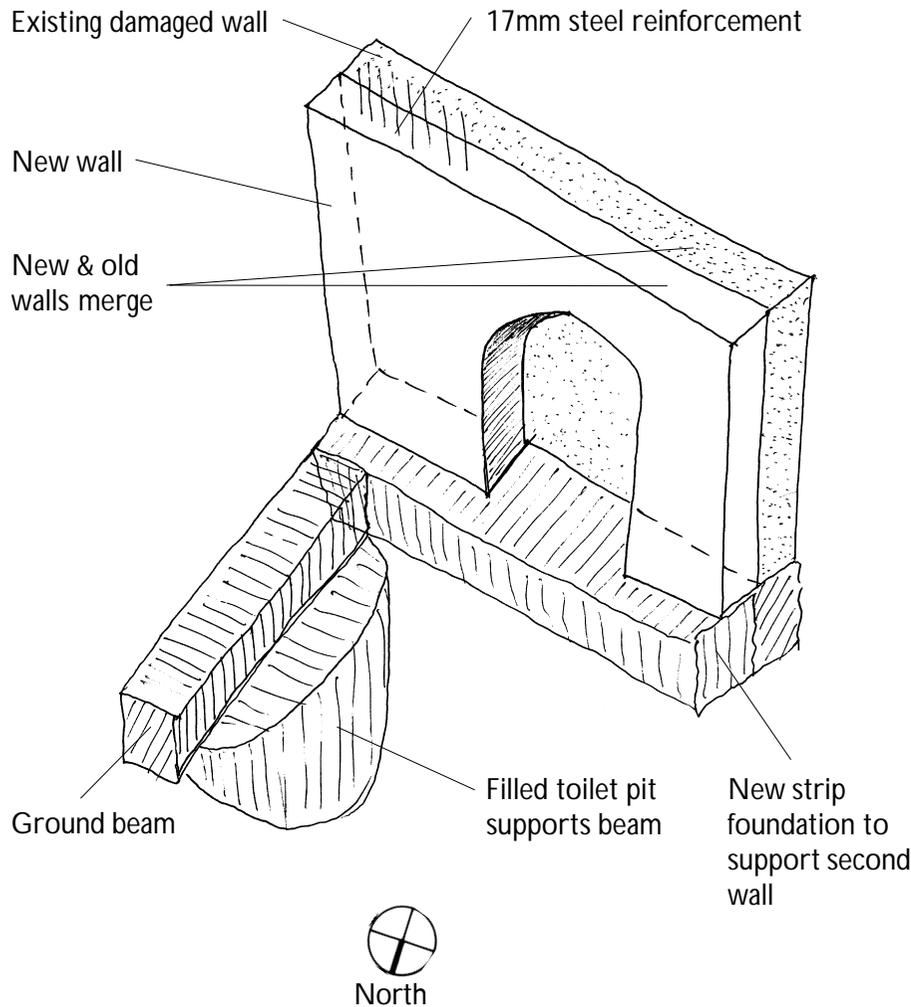
Foundation and Wall Repairs

The pit was found to be extensive and shared with the house next door. Its failure had undermined and left entirely unsupported the whole of the south east section of the party wall between the two buildings. Provision of new foundations under this side of the building would require the toilet-pit to be filled with concrete and hardcore.

In addition to filling the pit, the dead mass of concrete was used to support a 300x500mm ground beam and needle, penetrating and supporting the east of the south exterior wall and the east of the entrance room wall. Concrete was shot into the pit by the bucket-full and roughly compacted with timber rams. In order to pre-stress the wall and avoid residual settlement, the concrete was cast to within one foot of the underside of the existing foundation. It was then allowed to set for one day, and three lorry jacks placed on top of it, directly below the original foundation. The jacks were tightened to stress the wall. Concrete pouring continued to a slightly higher level than the bottom of the original foundation in order that it could be compacted under it. The jacks were lost.

In preparation of the works to strengthen the south wall, a strip foundation was also constructed parallel to that of the interior south wall. This work extended the same depth below ground as the original construction and was attached to it at numerous points by coral ties.

The severely weakened south wall was strengthened by 'grafting' onto it a second wall, constructed to the interior and to the full height of the kitchen. In the east of the elevation, the new wall entirely assimilated the existing work. To the more stable centre and west, a large blind arch was formed in the new work to maximise the space available in the kitchen. The two walls were firmly married by the insertion of wall ties. Below 1.5m above ground level coral ties were employed. Above that level, 17mm steel reinforcement bars protected by two coats of Alkyd paint were used. In addition to the steel ties, coral needles were also used to help transfer and share the load of the existing wall. In the extreme south of the elevation the two walls merge.
