## TIMUR SHAH'S MAUSOLEUM AND THE AFGHAN FUNERARY BUILDING TRADITION

## THE ARCHITECTURE OF TIMUR SHAH'S MAUSOLEUM

## TECHNICAL APPROACHES IN CONSERVATION OF THE MAUSOLEUM

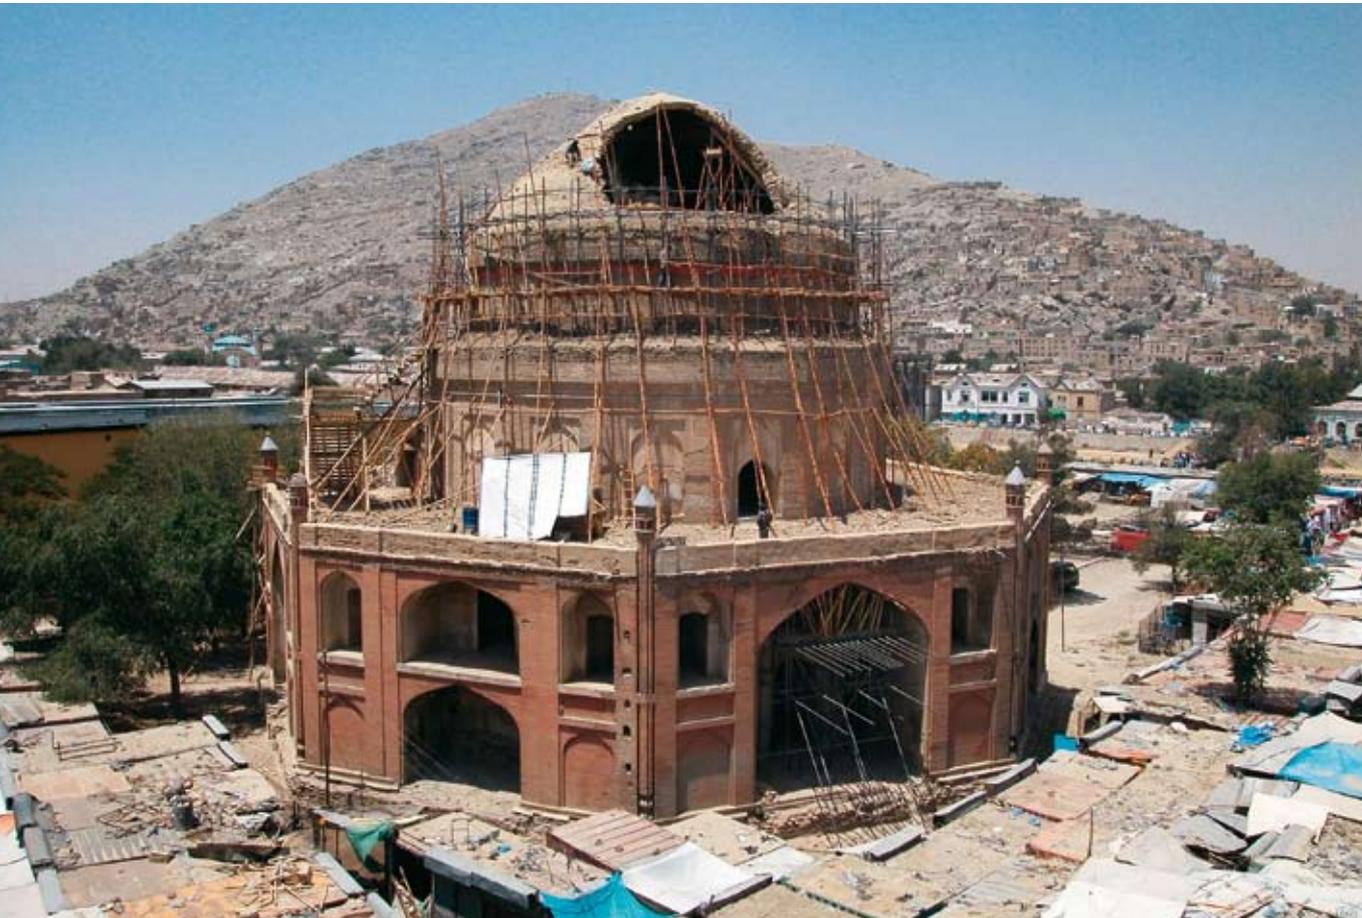
*Sections of the damaged upper dome were removed during conservation works. All materials were manually carried to the upper levels up a temporary timber stair.*

Based on an analysis of the structure, it was decided to remove the unstable edges of the damaged section of the upper dome and part of the masonry drum, and re-build these in a manner that as closely as possible matched the original. Newly made bricks of the same size (20 × 20 × 3.5 centimetres) as the originals, fired to a relatively low temperature (in order to match the strength of the surviving masonry) were laid in lime mortar prepared with putty from local sources that had been slaked for a minimum of eight weeks. The geometry of the new section also needed to match the existing masonry, which comprised of six layers of brickwork at the springing, reducing to two at the apex. The

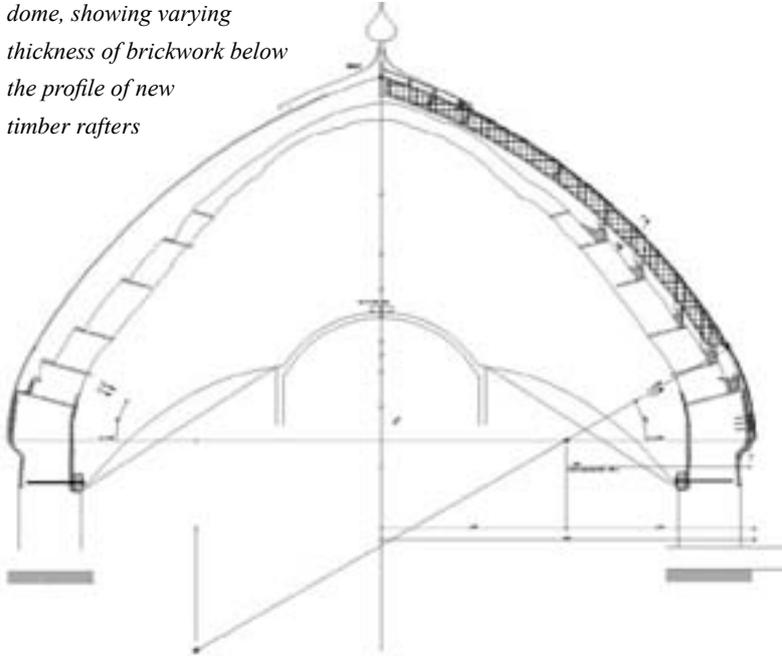
*Cross-section of the upper dome, showing varying thickness of brickwork below the profile of new timber rafters*

The upper dome rises from the cylindrical drum, where a number of horizontal timber ties were found within the brick masonry. With evidence of extensive repair, the dome is of varying thickness, narrowing towards the apex. A structure of timber joists had been erected over the upper dome, supporting a protective outer layer of iron sheets.

In order to determine an appropriate profile for the final covering, a harmonic curve was identified to match the geometry and proportions of the structure below. This geometry formed the basis for the fabrication of composite timber rafters that support a new 'shell' roof, which effectively spans over the repaired dome and transfers horizontal forces only to the newly reinforced masonry at the top of the drum. A series of concrete upstands were constructed on the upper surface of the dome in order to provide a level base for positioning a total of thirty-two timber rafters, of varying lengths, supporting the shell roof. The tensioning belts that had been used around the drum during the dome repairs were repositioned around three of the upstands, to ensure compression between the old and new sections of brick masonry on the upper dome.

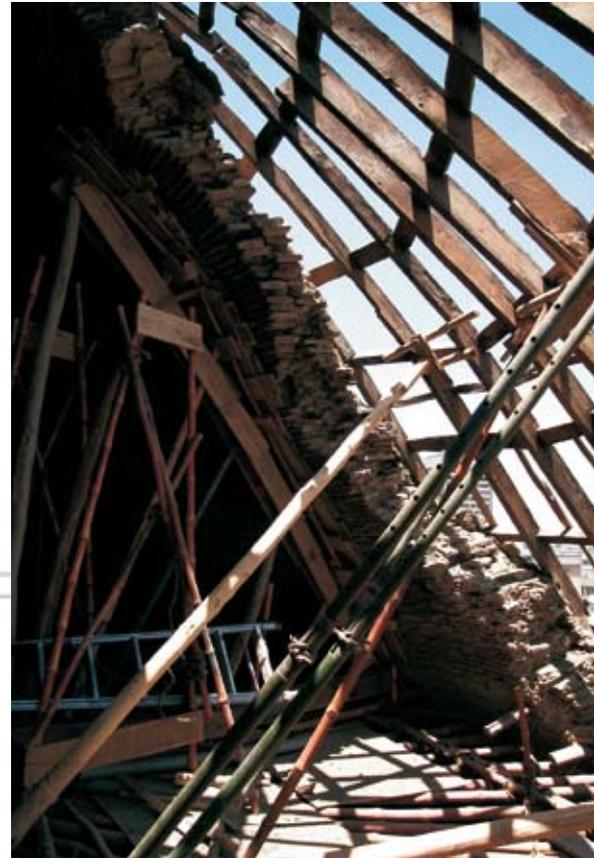
*Prior to removal of unstable brick masonry, the damaged upper dome was propped.*

One of the first issues to be addressed in the conservation of the mausoleum was repair of the upper brick dome, whose partial collapse was affecting the structural integrity of the building. Initial structural assessments undertaken in the autumn of 2002 confirmed that the damaged section of the dome could indeed be re-built. It appeared that the dome had been constructed in stages, using 'skins' of brick masonry laid in relatively weak lime mortar, which had subsequently been repaired in parts. In order to plan for conservation, it was necessary to establish how the force from these layers of brickwork was transmitted to the supporting drum, which was cracked in a number of places.

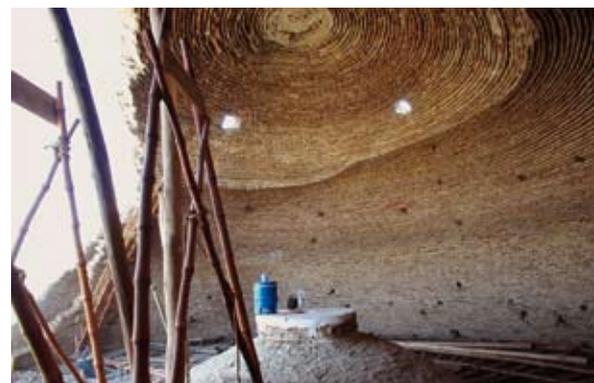
*The interior of the upper dome shows signs of having been built in stages.*

The removal of the damaged roof sheeting and timber structure, as well as the mud plaster that had been applied to help waterproof the damaged structure, allowed for a detailed inspection and measurement of the upper surface of the dome. This exercise confirmed that the dome had been built over a period of time, and that the masons seemed to have had difficulty in completing it, as it weathered and deflected, distorting its geometry.

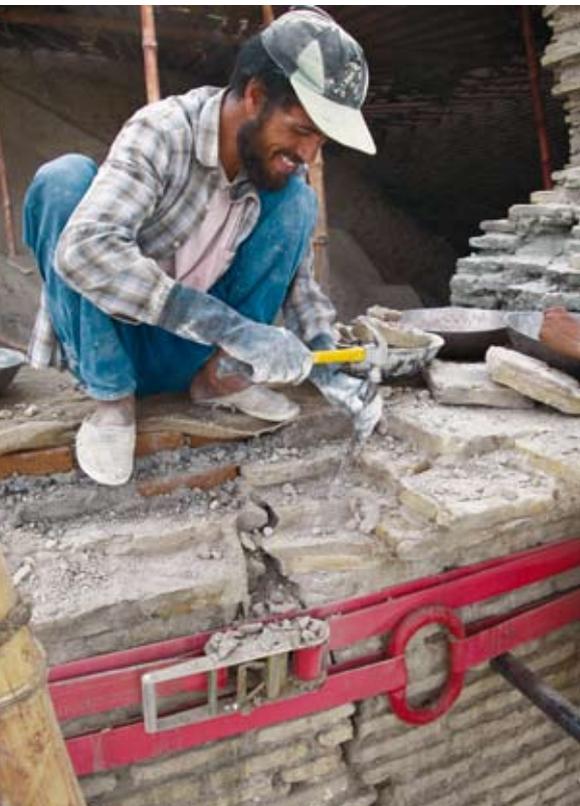
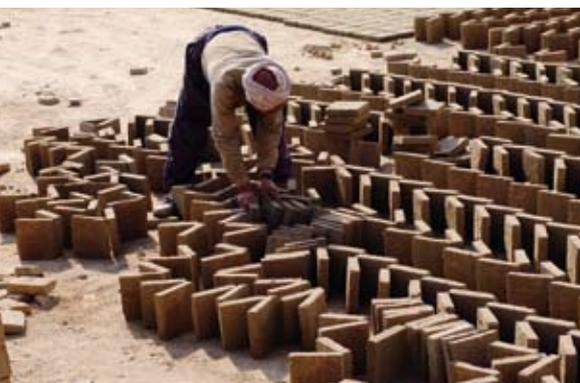
*The drum of the upper dome was temporarily strapped during repairs to the masonry, for which specially fired bricks (below) were set in lime mortar.*

In order to access the damaged masonry, a bamboo platform was erected over the lower dome, using apertures that had been left in the inner face of the drum at the time of the original construction. Traces were found of two timber ring-ties, virtually destroyed by dry rot, laid within the brick masonry of the drum. In order to maintain the stability of the undamaged brick masonry, two temporary belts were installed and tensioned around the outside of the drum. A reinforced concrete beam was then poured (at a height of 15.5 metres above ground) on the inside ledge of the drum, and anchored into the brick masonry with 48 stainless steel anchors, tensioned to 20 tons.

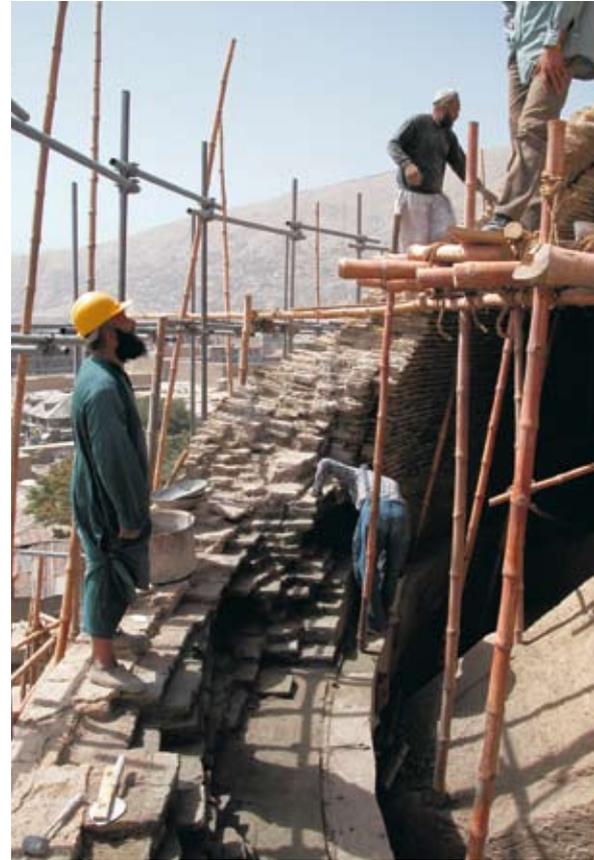
*New brickwork being laid to match the coursing of the original dome.*

repairs were further complicated by the fact that ring forces on which such structural membranes would normally rely on for equilibrium could not be transferred between old and new brick masonry. Experienced masons from Herat were engaged to undertake the repairs, and were made familiar with the distorted geometry and unusual characteristics of the original masonry, in order to ensure a good match.

The damaged sections of the masonry were closed at the end of October 2003, after which the exposed dome was temporarily covered for the winter. Upon inspection in the spring of 2004, joints around those bricks that had loosened due to shrinkage were again filled with lime mortar.

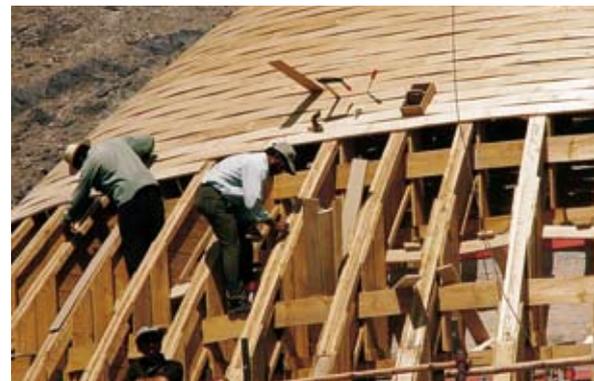
*Fixing timber planking to the radial rafters, before galvanised iron sheeting was laid over the dome.*

The design and fabrication of this lightweight structure was subject to a degree of trial and error, as it was necessary to explore the potential of locally available materials and fixings. The rafters themselves were built of Russian pine boards laid at right angles, screwed and glued, with attached timber webs. All rafters, the largest of which measures some 13 metres long, were hoisted by hand to the top of the building, as no crane with adequate reach was available in Kabul at that time. Once aligned and fixed in place, timber boarding was screwed in a circumferential pattern over the rafters, as a base for the fixing of galvanised sheeting.

A batten seam system of galvanised iron sheeting, which was familiar to local craftsmen, formed the final weatherproof covering of the dome. The lower edge of the shell roof was extended below the base of the rafters by means of timber boards that were bent, glued and screwed to the required radius, and fixed back to the drum masonry. This enabled protection of the drum masonry, while providing for ventilation around the entire lower edge of the roof.

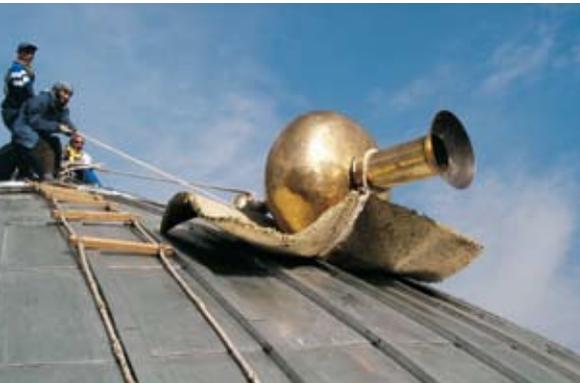
*The repaired finial being raised to the apex of the dome and, below, the restored mausoleum with its new terrace at ground level.*

In order to protect the damaged lower sections of masonry, and to facilitate public access, an octagonal brick platform was built extending some seven metres around the mausoleum, with stairs or ramps introduced on four sides, including the entrance to the vault leading to the crypt on the eastern elevation.

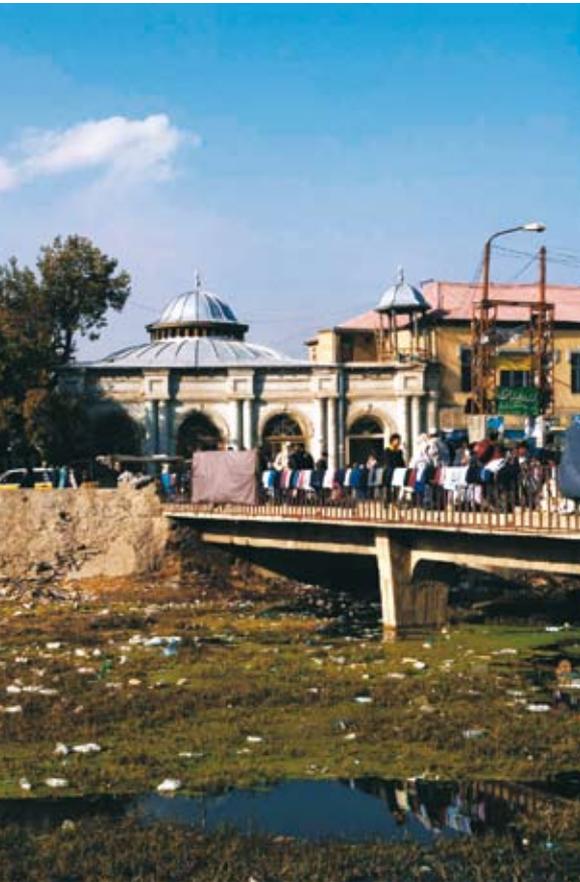
*The Andarabi Mosque with its roof restored, in 2004.*

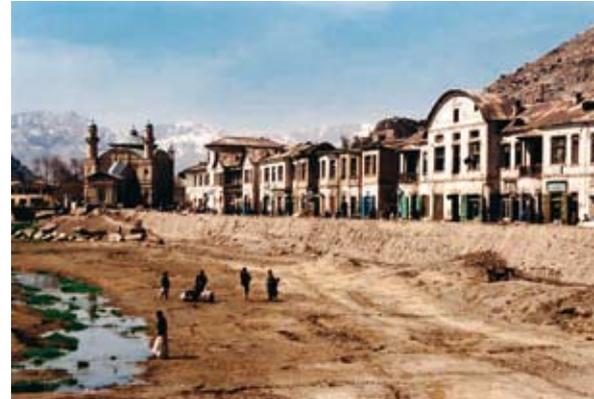
*Early 20th-century facades along the Kabul River, adjoining the Timur Shah Mausoleum, have been renovated.*

This double-storey range of riverfront buildings, with workshops over shops on the street level, is an important vestige of the introduction of western concepts of urbanism to Kabul. In recognition of this, the entire frontage was surveyed, damage assessed and the ownership of the various shops and workshops registered during 2004. Support was provided in 2005 for the repair of one of the central bays, both as demonstration of the potential of the building and as a deterrent to municipal planners, whose proposals for widening of the street envisaged wholesale demolition of the historic frontage.
