AGA KHAN CULTURAL SERVICES - AFGHANISTAN

FINAL NARRATIVE REPORT

Restoration and Stabilization of the Khwaja Parsa Shrine, Balkh

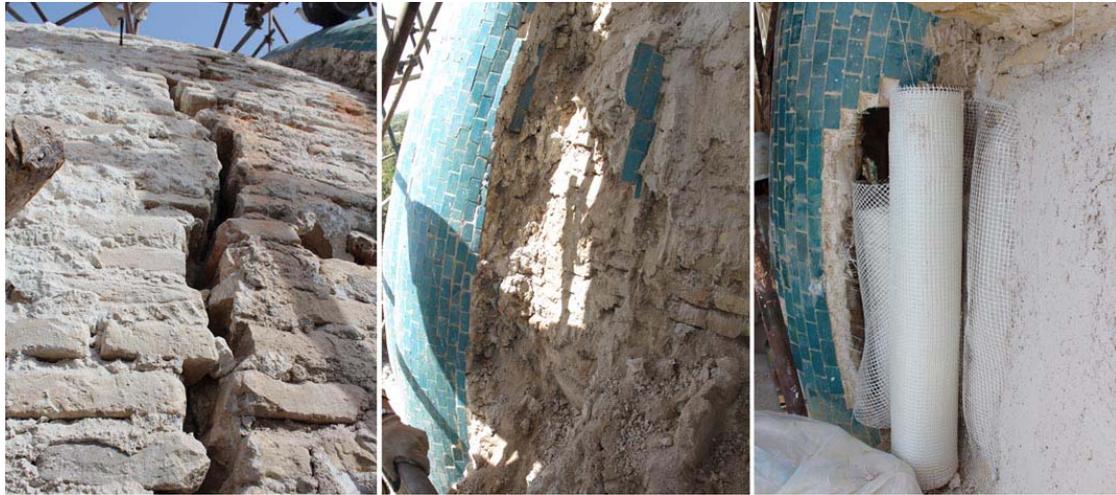
(c) Structural “stitching” of large cracks:

Minor earthquakes, the removal of timber supports, the cutting back of the thickness of the masonry and the addition of dead load on the surface if the masonry had all contributed to the formation of large vertical cracks in the brick structure of the Dome. In one instance, the space between a single crack that ran across the height of the Dome was more than 10 centimeters at its widest point. It became evident that previous efforts to re-tile the Dome had simply covered up such defects in the structure. It became immediately evident that the long-term safeguarding of the Shrine and Mosque depended on the consolidation of the Dome. Had the structural defects gone unaddressed, it would have simply been a matter of time before the Dome had collapsed as it had done on several occasions in the past.

Having already improved the structural integrity of the Dome through consolidation and reconstruction works undertaken internally, masons commenced the urgent task of removing debris and damaged masonry from within the structural cracks and preparing the area for repair works. The work of “stitching” the masonry together required the careful removal of bricks on either side of the cracks and the laying of new bricks that wove the new and old masonry together. In order to reduce the risk of further damage to the structure, this was undertaken in segments of less than 1 meter at a time and the masonry was allowed to dry, gaining sufficient strength, before the next segment could be repaired. In total more than 40 linear meters of structural cracks were repaired in this manner.

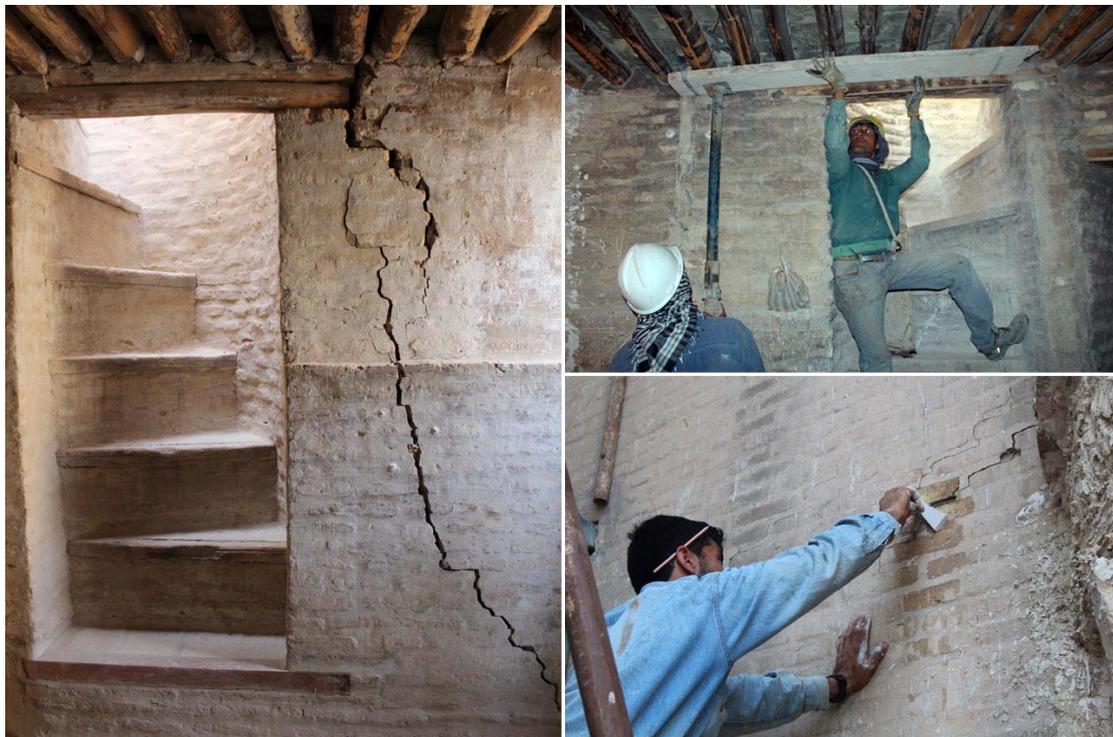
The *iwan* portal and minarets, believed to be a 16th century grandiose addition to an otherwise simple mausoleum, remain the most iconic and architecturally visible element of the structure. A detailed assessment has revealed the formation of large cracks affecting the structural integrity of the main *Iwan* arch and Minarets as listed:

- Two substantial vertical cracks running down the elevation on both the north and south sides of the *Iwan*.
- Another horizontal crack on the front of the *Iwan* both inside the portal and above the uppermost arch on the outside of the portal.
- Other significant vertical cracks exist on the inside of the Minarets - in the stairwell walls at the same level as the top of the *Iwan* arch, stretching for approximately 1m vertically and as wide as 60mm to 80mm.

The orientation of cracks at the front of the portal indicates that the main *iwan* or portal is moving and may also be partially detaching from the front of the mausoleum. This has also affected the structural stability of the two adjacent minarets, which are settling to the north and south away from their original vertical position.

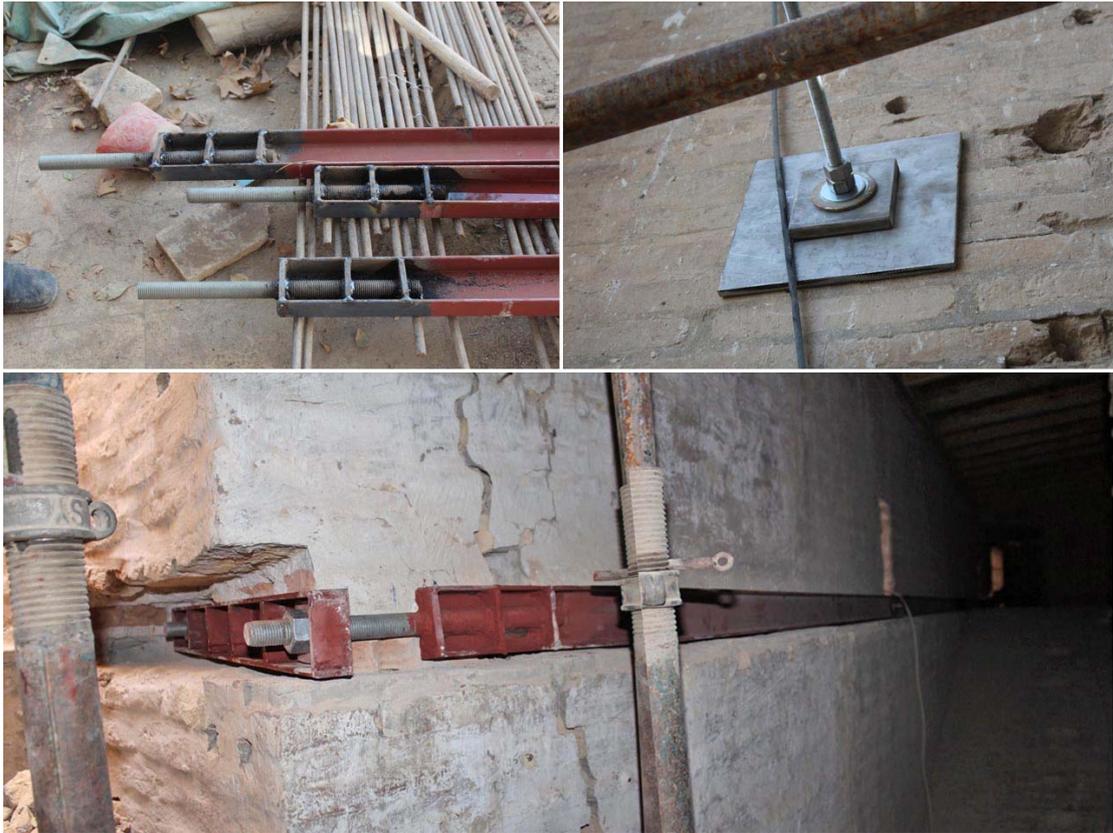
This movement is a result of severe settlement problems identified earlier in this report. The construction of the north and south wings of the mosque have made a significant contribution towards resolving the settlement problem by providing structural buttresses on either end of the Shrine and in the direction of the movement. The removal of concrete surfaces surrounding the building and the repaving of this area with brick has reduced water-logging problems and the build-up of moisture that had previously led to the softening of the earth beneath the building and eventual settlement.

While movement was detected in the vertical cracks in both the *Iwan* and in the staircase area of the minarets at the beginning of conservation works, continued monitoring of active structural breaks following the reconstruction of the historic and new mosque wings indicated that the lateral movement became insignificant. This information indicated that the conservation team's objective of using the new wings of the mosque as buttresses against lateral forces in the *Iwan* and minarets functioned accordingly.

The final step of completing the structural consolidation of the this area entailed "stitching" of the vertical cracks with baked bricks and the insertion of steel rods and ties into the brick masonry in order to prevent future damage in these weakened areas in the advent of earthquakes. Based on designs prepared by a qualified structural engineer, the measures included; (1) using steel "tie-rods" to link the internal staircases of the two minarets through the main load bearing "back wall" of the *iwan*, and (2) using galvanized steel "tie-rods" to link the main "back wall" and the "front wall" of the *iwan* together.

Measures were carried out by drilling holes up to a depth of 100 centimeters in key intersections between the stairwell of the minarets and the vertical load bearing walls of the *Iwan*. Additional cuts were made along the length of the walls and two parallel “ties” were designed using U-channel steel profiles. These “ties” were joined by threaded 33mm / 16mm steel rods that were fastened in place using base-plates, washers and bolts. Base plated exposed to the elements were made of stainless steel so as to avoid rusting.
