SUMMARY

432 Maple Ave, Owensboro, KY 42301
Mary Bryan Hood Estate Tom Neal Executor
05/08/2025

David Johnson
KY#270106 IN#HI02100119 TN#2494
Bluegrass Home Inspections LLC
2702310825
bluegrasshomeinspectionsllc@gmail.com

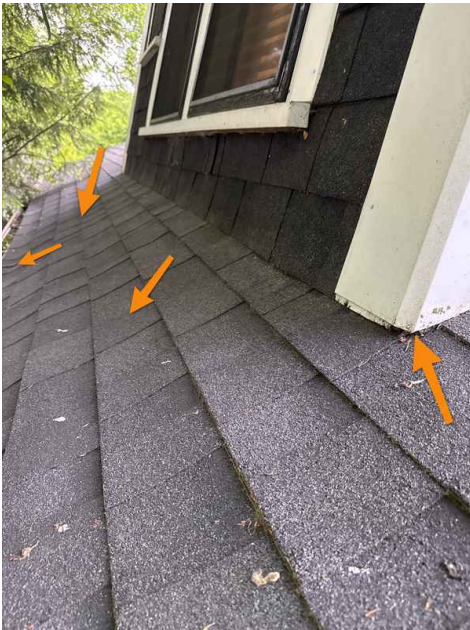
2.2.1 Coverings

EVIDENCE OF WATER INTRUSION

Evidence of water intrusion noted during the inspection. Recommend further evaluation by a qualified contractor.

Contact a qualified roofing professional.

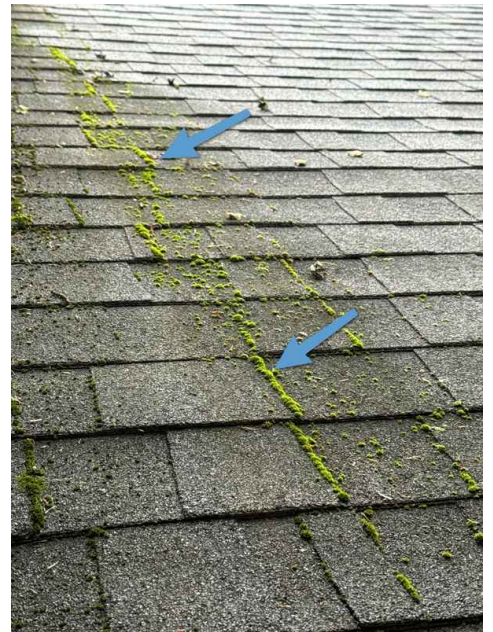
East

2.2.2 Coverings
MOSS/MILDEW

Moss/Mildew observed on roof during inspection. This is most commonly observed on the north or shaded side of the structure. One option is to use noninvasive cleaners to remove moss/mildew. Recommend further evaluation by qualified contractor.

Recommendation
 Contact a qualified professional.

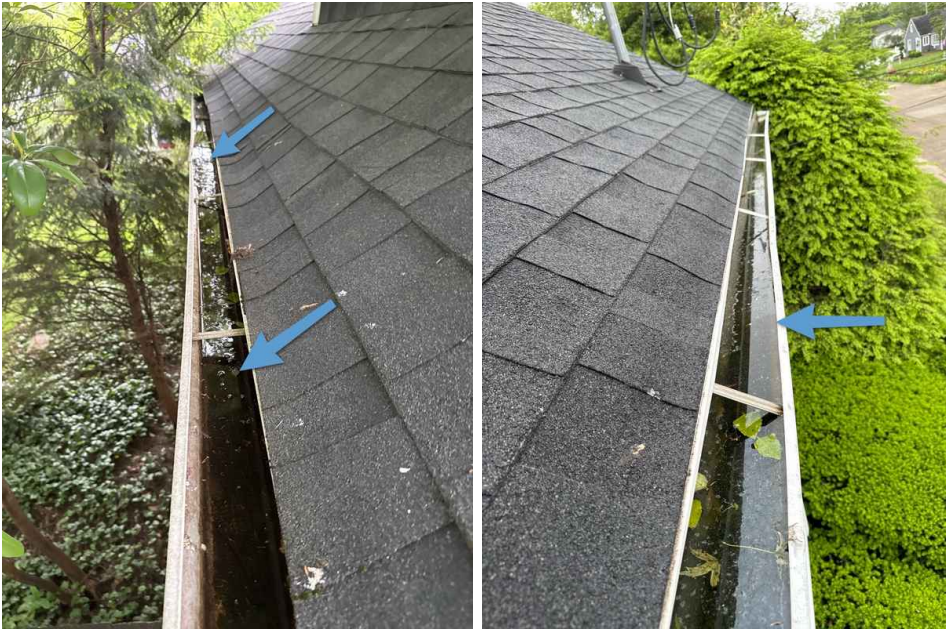
Debris accumulation observed in the gutters during the inspection. One option is to clean gutters to facilitate water flow. Recommend further evaluation by a qualified contractor.

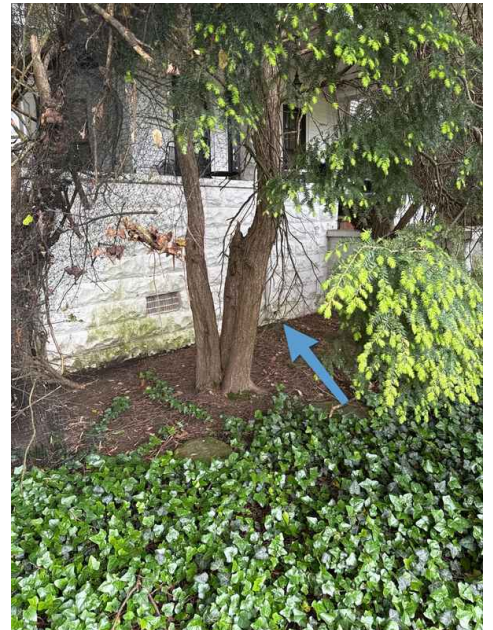
2.3.2 Roof Drainage Systems
DOWNSPOUTS DRAIN NEAR STRUCTURE

One or more downspouts drain near the structure's foundation. This can result in excessive moisture in the soil at the foundation. One option is to adjust downspout extensions to drain at least 6 feet from the foundation. Recommend further evaluation by a qualified grading contractor.

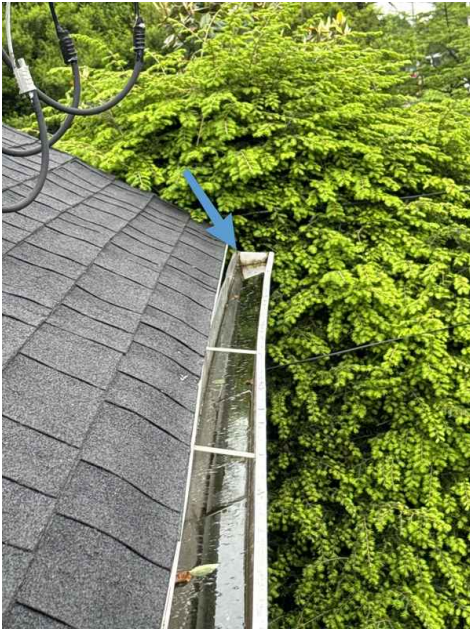
Southwest

2.3.3 Roof Drainage Systems
GUTTER DAMAGED

Gutter damage noted during inspection. This can result in over capacity and excessive moisture in the soil at the foundation, which can lead to foundation/structural movement. Recommend a qualified contractor evaluate and repair.

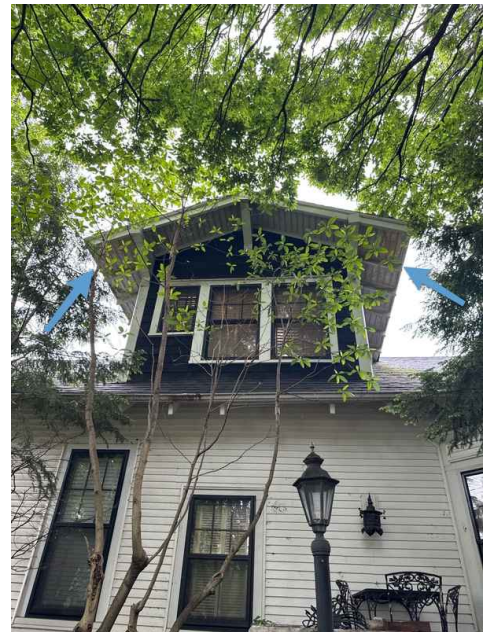
GUTTERS MISSING

There are gutters missing on the structure. Gutters are recommended because they collect rain water from the roof and direct it away from the building. Recommend further evaluation by a qualified contractor.

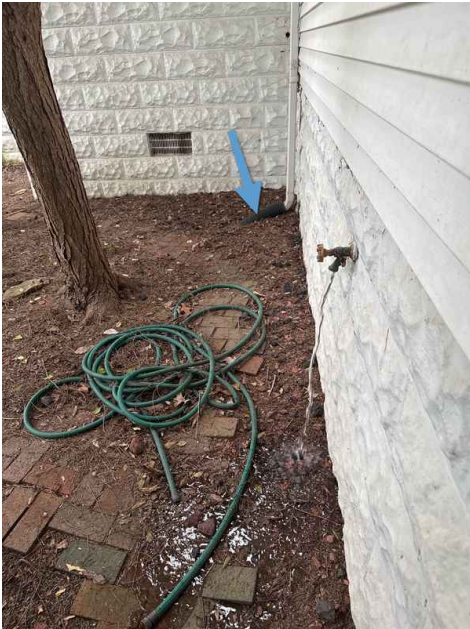
UNABLE TO CONFIRM DRAINAGE OUTLET

Unable to confirm drainage outlet at time of inspection. One option is to monitor during the next rain event. Recommend further evaluation by a qualified contractor.

Recommendation
Contact a qualified professional.

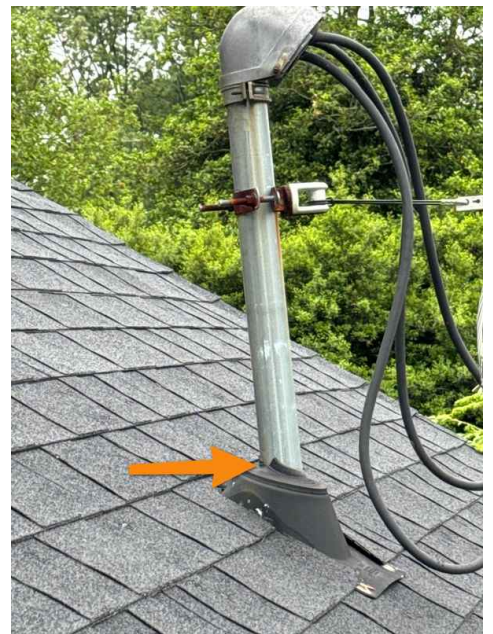
Southwest

2.4.1 Flashings
LOOSE/SEPARATED

Loose/Separated flashings observed during the inspection. One option is to ensure flashings are properly mounted, sealed, and secured to prevent moisture intrusion. Recommend further evaluation by a qualified roofing contractor.

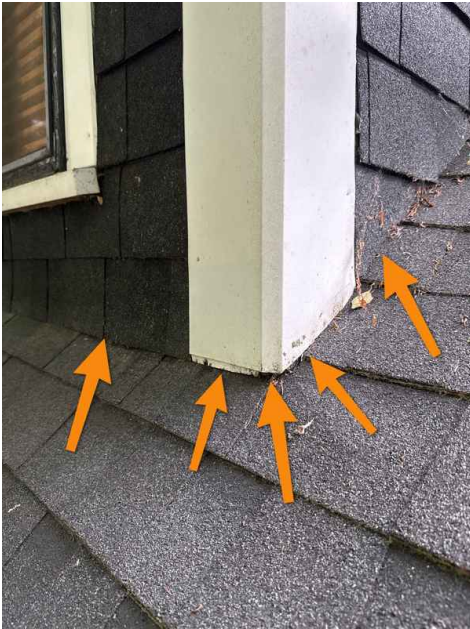
East

2.4.2 Flashings
MISSING

Flashings were missing at time of inspection. Flashings provide protection against moisture intrusion. Recommend a qualified roofing contractor evaluate and remedy.

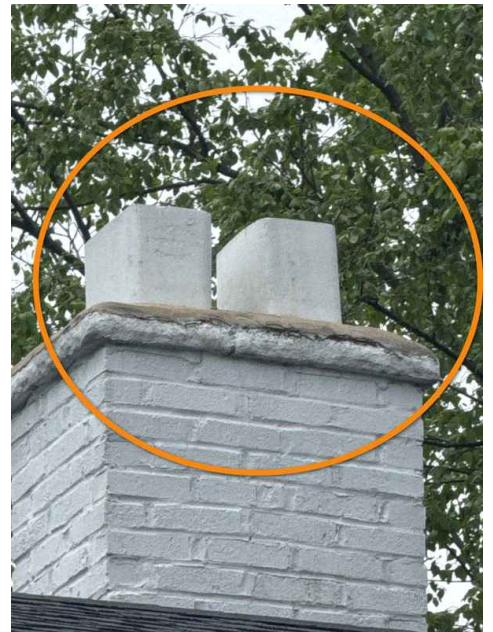
West

CHIMNEY CAP MISSING

No chimney cap was observed. This can protect from moisture intrusion and protect the chimney. Recommend a qualified roofer or chimney expert install.

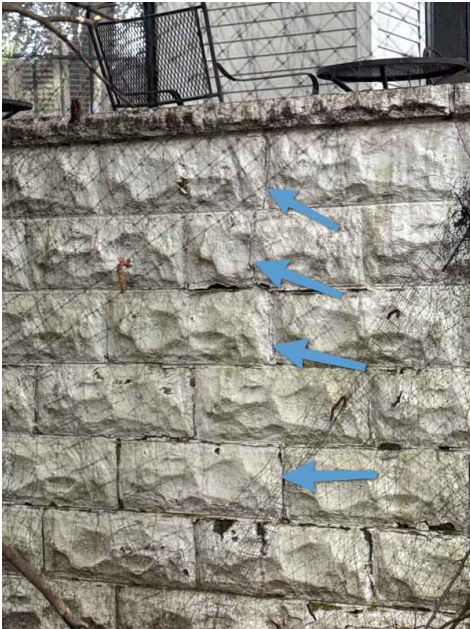
Northeast

CRACKING - MINOR

Masonry cracking observed in one or more places. This is often a result of temperature changes and/or poor drainage. This is also typical for structures with significant age. One option is to tuck-point new mortar. Recommend monitoring and/or further evaluation by a masonry contractor.

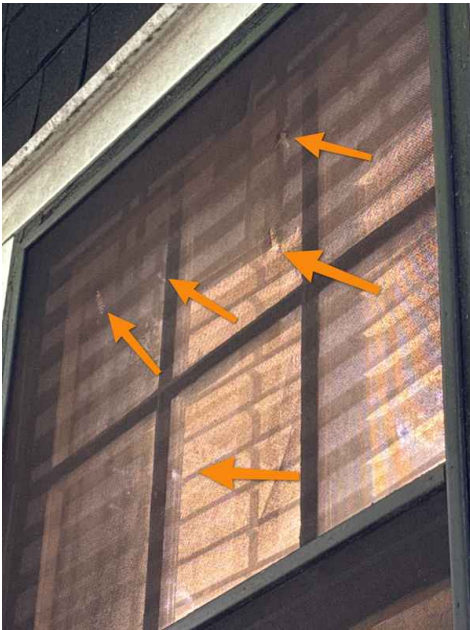
East 2nd Floor

HAIL DAMAGE

Hail damage observed during the inspection. Inquire with current owner/representative for past history. Recommend further evaluation by a qualified exterior contractor.

Contact a qualified siding specialist.

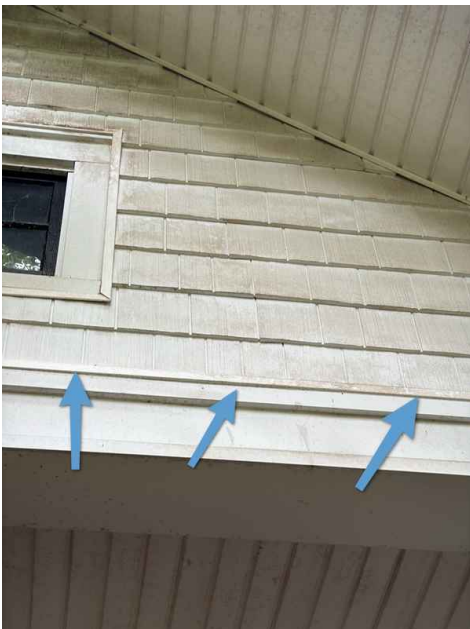
North

J-channel was used instead of a starter strip for the very bottom run of vinyl siding. This can trap water and cause moisture intrusion. Exterior siding manufacturers recommend drilling a 3/16" hole every 12 inches along the J-channel to allow drainage. Recommend further evaluation by a siding contractor.

Recommendation
Contact a qualified professional.

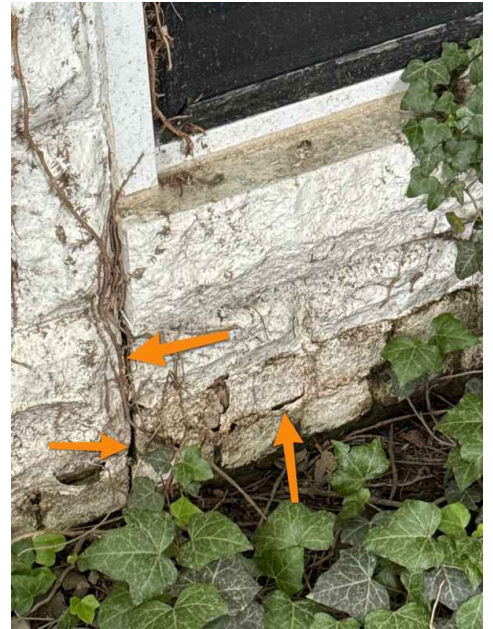
East

MASONRY DETERIORATION

Masonry deterioration noted in isolated areas during the inspection. One option is to tuck point new mortar into affected areas. Recommend further evaluation by a masonry contractor.

Contact a qualified masonry professional.

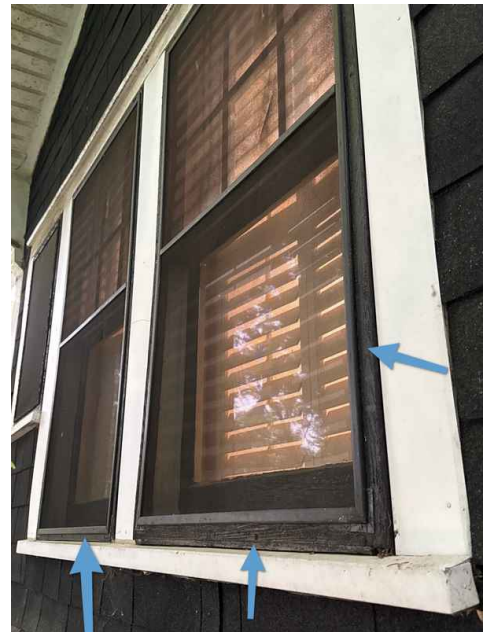
East 2nd Floor

Some materials in an exterior setting require more maintenance than other siding. One option is to Scrape, Caulk, and Paint (SCP) some exterior materials such as steel or wood to ensure full life expectancy. Recommend further evaluation by a painting contractor.

Contact a qualified professional.

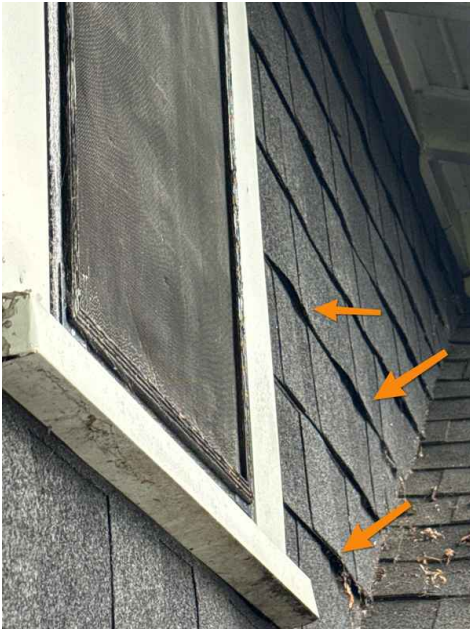
East 2nd Floor

Evidence of water intrusion noted during the inspection. One option is to repair exterior siding and/or flashing. Recommend further evaluation by a qualified contractor.

Contact a qualified professional.

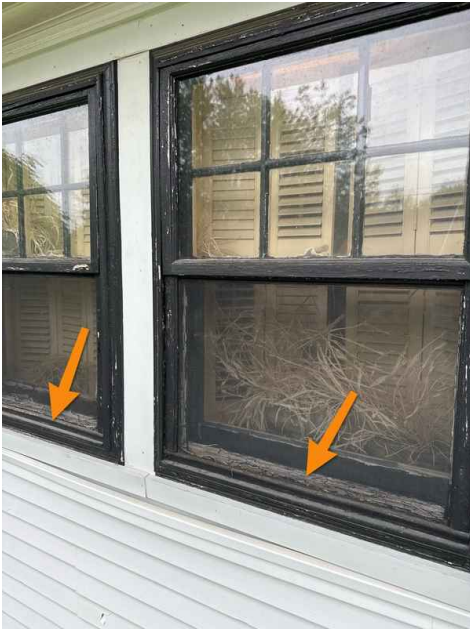
West

3.2.7 Siding, Flashing & Trim **WOOD ROT**

Wood rot noted during inspection. One option is to replace with a composite material that can withstand constant weathering. Recommend further evaluation by qualified carpenter.

Recommendation
Contact a qualified professional.

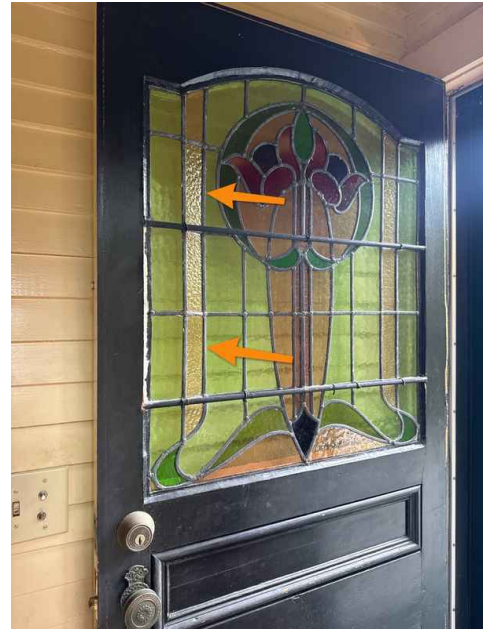
South

TRIM DAMAGE NOTED

Exterior door trim damage noted at time of inspection. Recommend further evaluation by qualified contractor.

Recommendation
Contact a qualified professional.

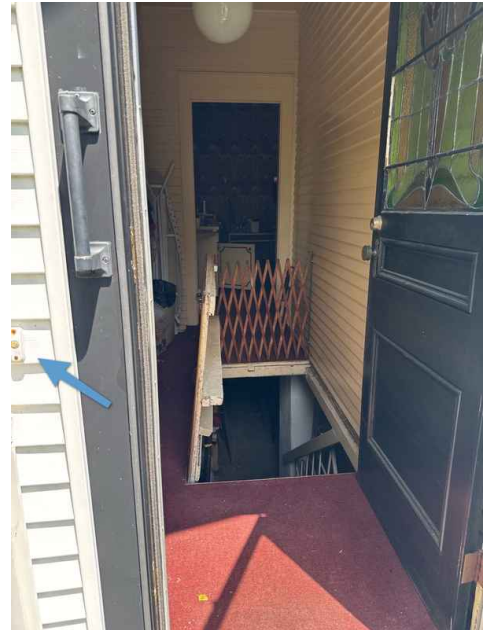
South

Doorbell not operational at time of inspection. One option is to repair/replace doorbell. Recommend further evaluation by a qualified contractor.

Recommendation
Contact a qualified professional.

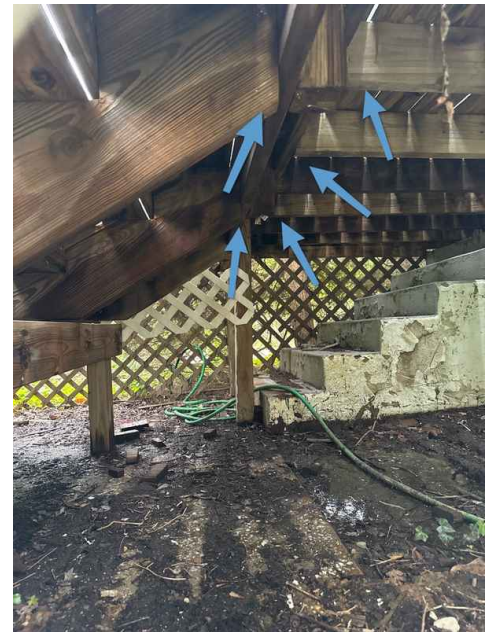
South

JOIST HANGERS

Joist hanger(s) are missing or improperly installed. Fasteners are not structural and are not permitted through veneers. This could cause the structure to fail. Recommend that joist hangers be properly installed by qualified contractor.

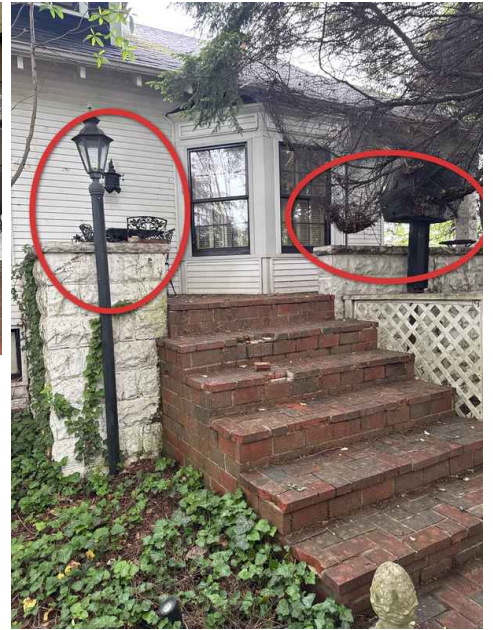
GUARDRAIL MISSING/DAMAGED

Guardrails are missing in one or more locations. Handrails/guardrails are required if there are four or more stair risers, OR 30" of vertical separation. One option is to provide positive separation between pedestrian routes and vertical separations greater than 30". Recommend further evaluation by a qualified contractor.

Recommendation
Contact a qualified professional.

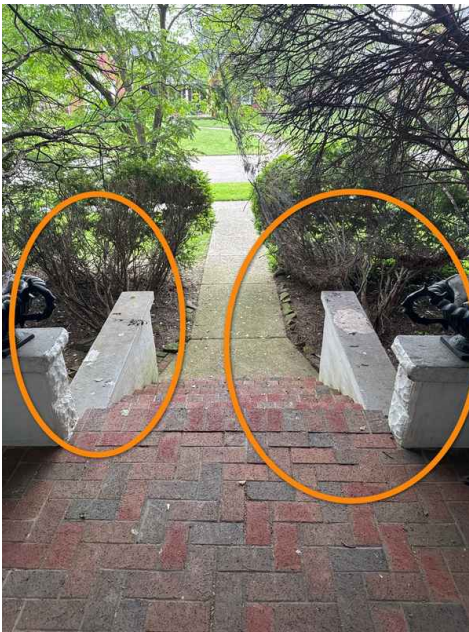
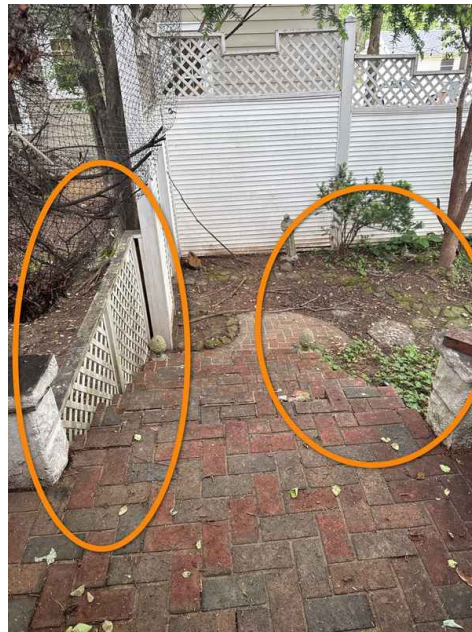
3.5.3 Decks, Balconies, Porches & Steps
GRASPABLE HANDRAIL

Any elevated surface greater than 30 inches or having four or more step risers require a graspable handrail. 2 x 4 and 2 x 6 dimensional lumber is not considered graspable. Recommend further evaluation by a qualified contractor.

Recommendation
 Contact a qualified professional.

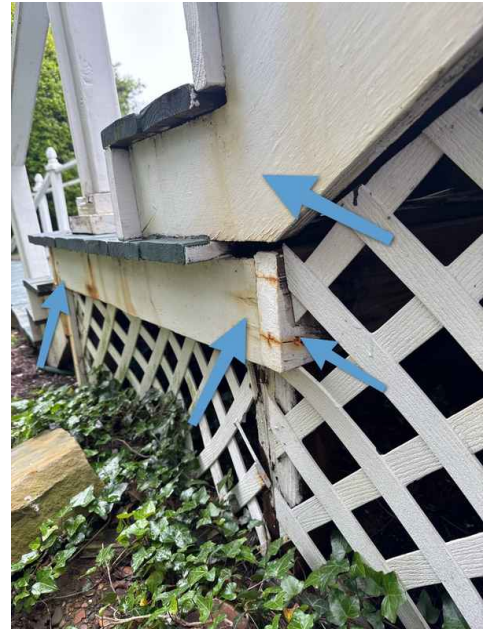
3.5.4 Decks, Balconies, Porches & Steps
MISSING BOLTS

Bolts missing through boards. It is recommended to have bolts through the skirt/ledger boards and into the structural points. One option is to add bolts at beam/structural connections. Recommend further evaluation by qualified carpenter.

Contact a qualified professional.

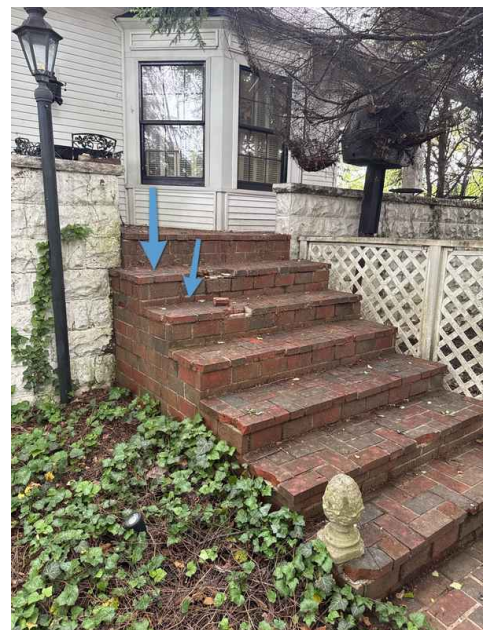
East

Minor concrete step/porch settlement observed during inspection. This is not abnormal to see on a structure of this age. Recommend further evaluation by qualified contractor.

Contact a qualified professional.

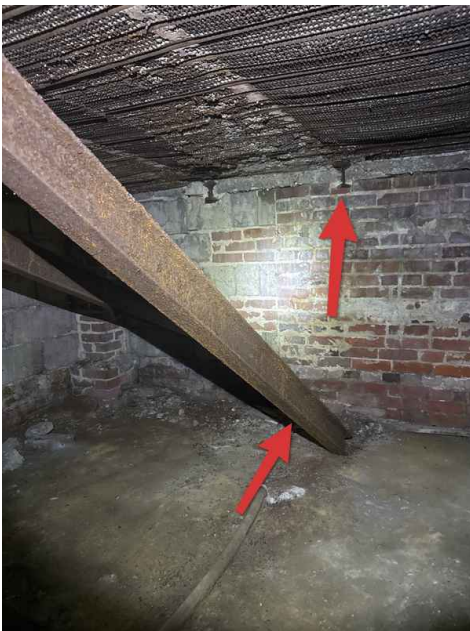
North Crawlspace

EVIDENCE OF STRUCTURAL DAMAGE

Structural damage was observed in the underlying floor structure. Recommend further evaluation by a qualified carpenter.

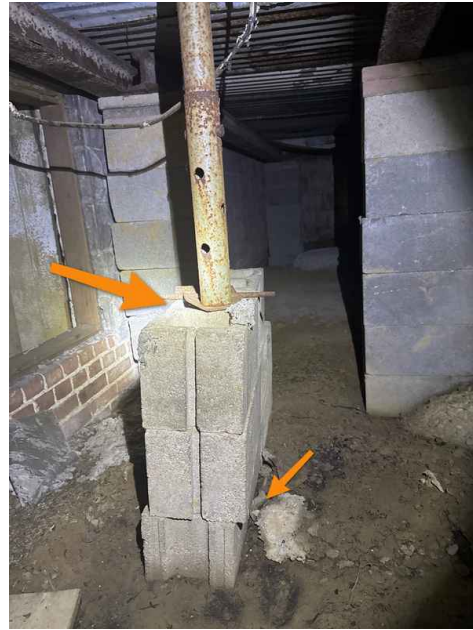
East Crawlspace

Pillar blocking is not on concrete. Soil conditions cause elevations to sag. Recommend further evaluation by qualified carpenter.

Recommendation
Contact a qualified professional.

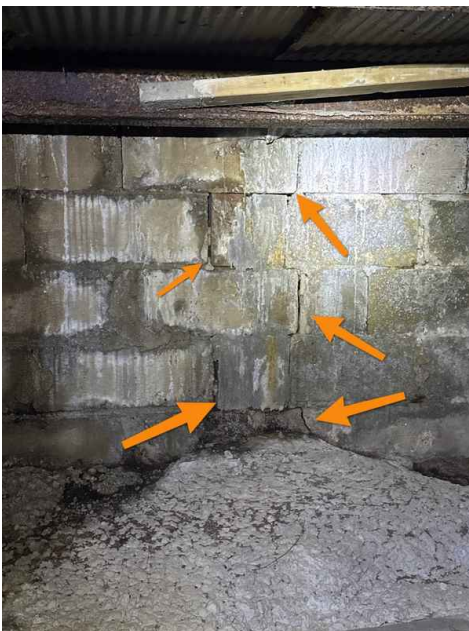
East Crawlspace

4.5.1 Wall Structure
CRACKS - MAJOR

Major cracking observed in wall structure. This could be from moisture intrusion at the structure and/or extreme temperature fluctuation. Recommend further evaluation by a qualified contractor.

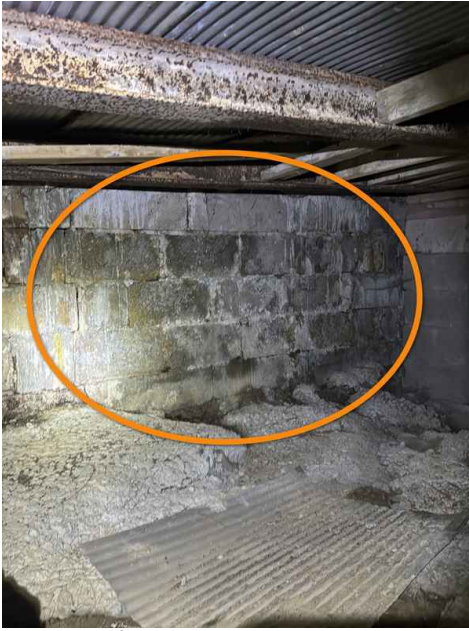
East Crawlspace

Evidence of water intrusion noted. One option is to ensure water is flowing away from the structure. Seek previous history from current owner and/or continue to monitor. Recommend further evaluation by a qualified contractor.

Recommendation
Contact a qualified professional.

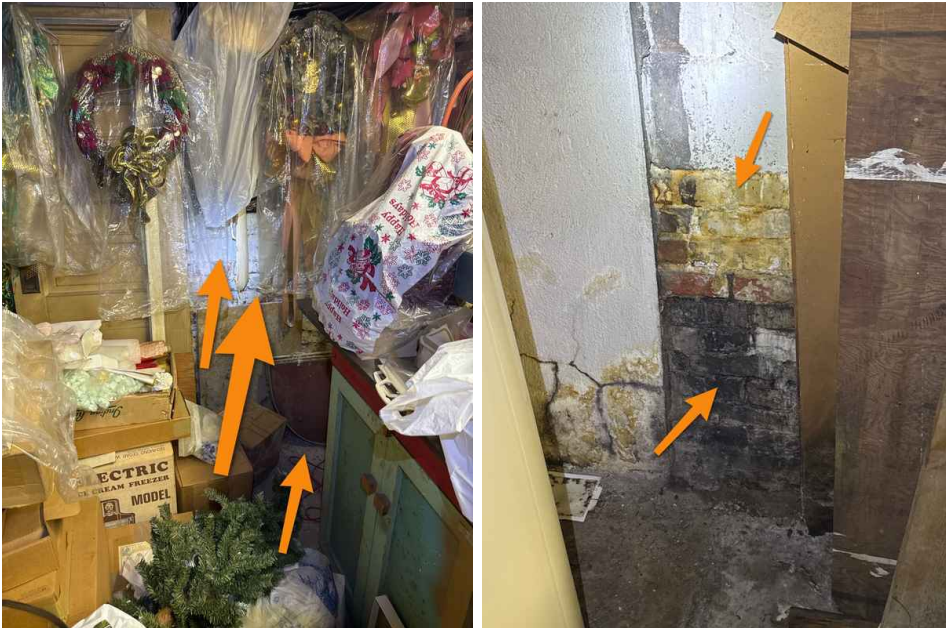
Evidence of possible lime mortar used in masonry. One option is to tuck-point cement mortar in deficient masonry areas. Recommend further evaluation by a qualified masonry contractor.

Recommendation
Contact a qualified professional.

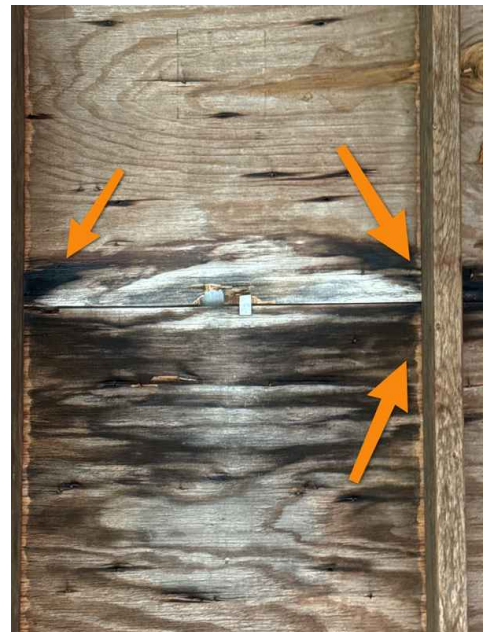
Garage

4.6.1 Ceiling Structure
EVIDENCE OF WATER INTRUSION

Evidence of water intrusion observed during inspection. One option is to properly flash roof to prevent moisture intrusion. Recommend further evaluation by a qualified roofing contractor.

Recommendation
Contact a qualified professional.

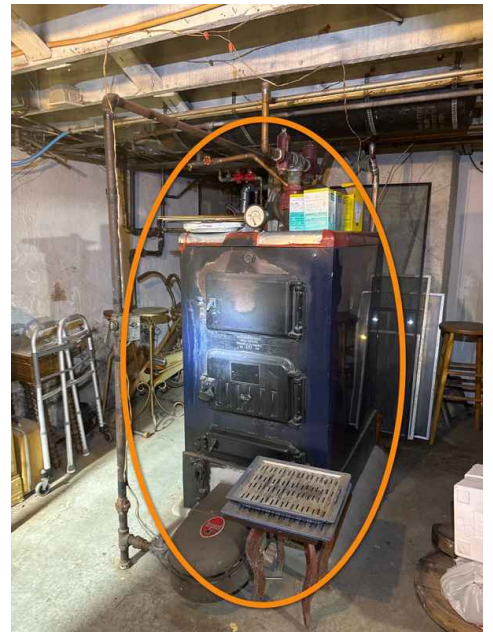
Basement

Unit is near the end of its service life. Unit is operational during inspection, and generally has a life expectancy between 15-20 years of age. Recommend further evaluation by qualified, HVAC technician.

Contact a qualified HVAC professional.

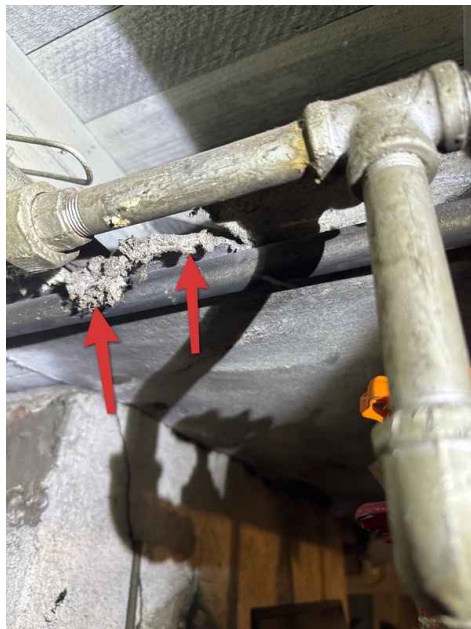
Basement

Unknown material observed in isolated areas. One option is to have it tested for asbestos like materials. Recommend further evaluation by qualified contractor.

Recommendation
Contact a qualified professional.

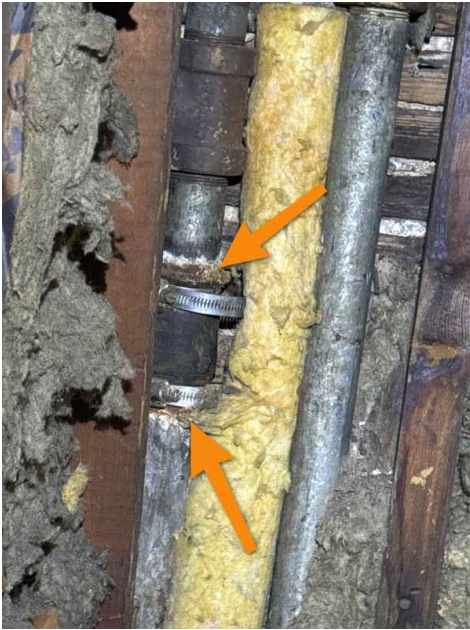
Southeast Attic

7.3.1 Drain, Waste, & Vent Systems
EVIDENCE OF A LEAK

Evidence of a leak observed during the inspection. One option is to repair plumbing to prevent moisture damage. Recommend further evaluation by a qualified plumber.

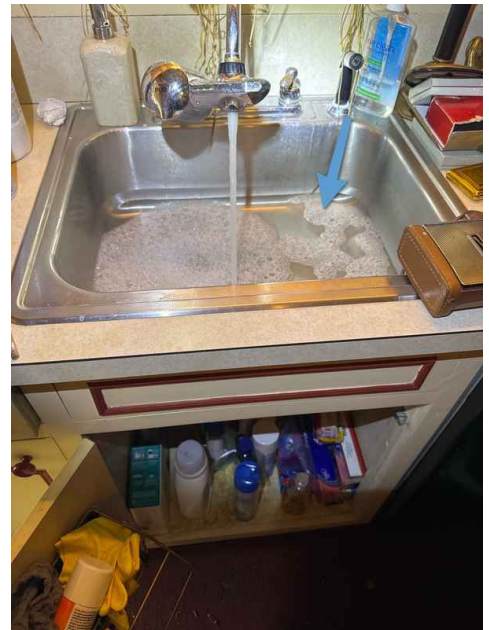
Kitchen

Sink had slow/poor drainage during the inspection. One option is to clean drain of possible obstructions. Recommend further evaluation by a qualified plumber.

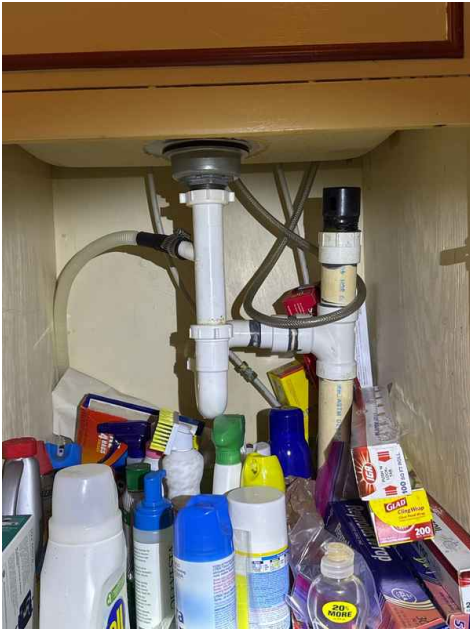
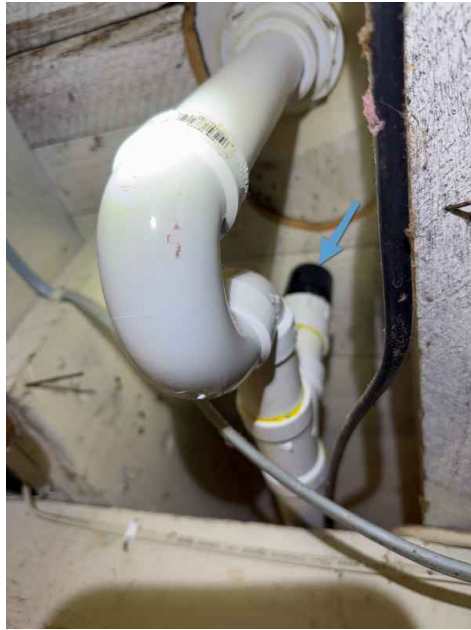
Basement Laundry Room

At the time of inspection, one or more air admittance valves were Observed to be installed below the 4 inch minimum required above the horizontal branch drain. One option would be to raise the location of the air admittance valve so that it is above the 4 inch required minimum. Recommend further evaluation by a licensed plumber.

Recommendation
Contact a qualified professional.

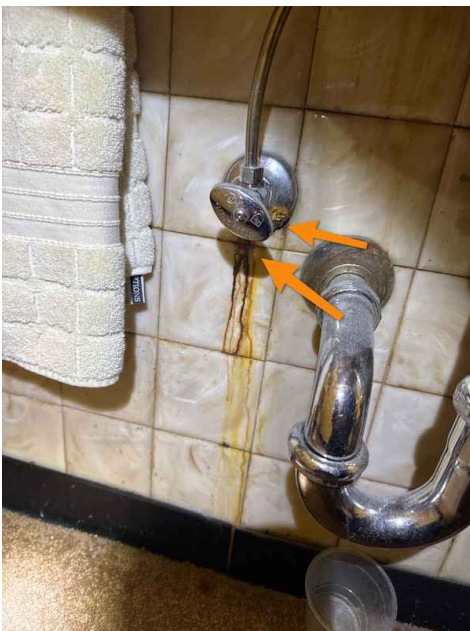
2nd Floor Bathroom

DISTRIBUTION PIPE LEAKING

Distribution pipe leak observed during the inspection. One option is to repair damaged connections and/or pipe material. Recommend further evaluation by a qualified plumber.

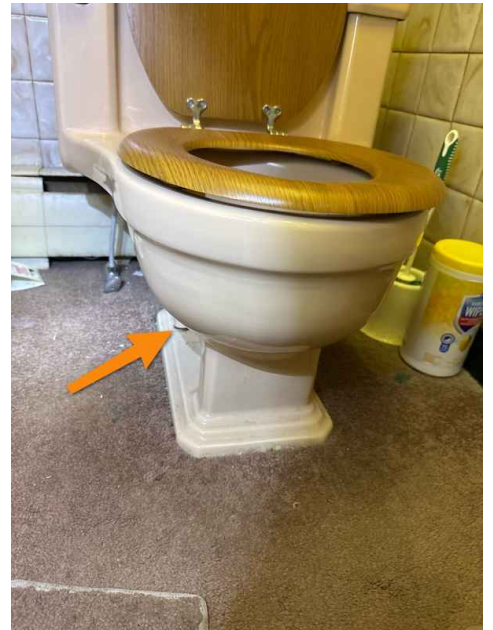
2nd Floor Bathroom

TOILET LOOSE

Toilet is loose and/or leaking at the base. One option is to tighten anchor points and monitor. Recommend a qualified plumber evaluate and repair.

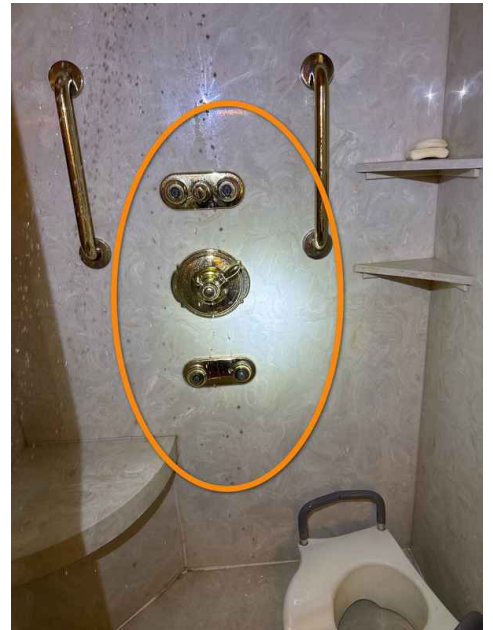
LOOSE/DAMAGED FIXTURE

Loose/damaged fixture components noted during the inspection. Recommend further evaluation by a qualified plumber.

Contact a qualified professional.

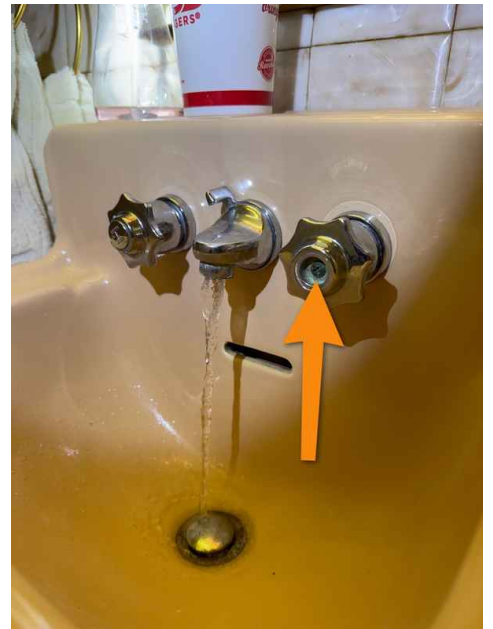
2nd Floor Bathroom

Fixture controls inoperable at time of inspection. Recommend further evaluation by qualified plumber.

Recommendation
Contact a qualified professional.

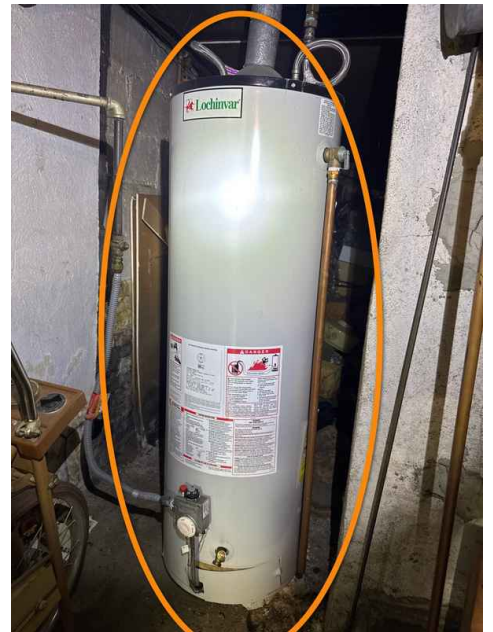
22 yrs. Old.

Water heater showed normal signs of wear and tear. Though the hot water heater is properly working under normal operating conditions, hot water heaters have a life expectancy between 20 and 25 years. Recommend monitoring it's effectiveness and replacing in the future.

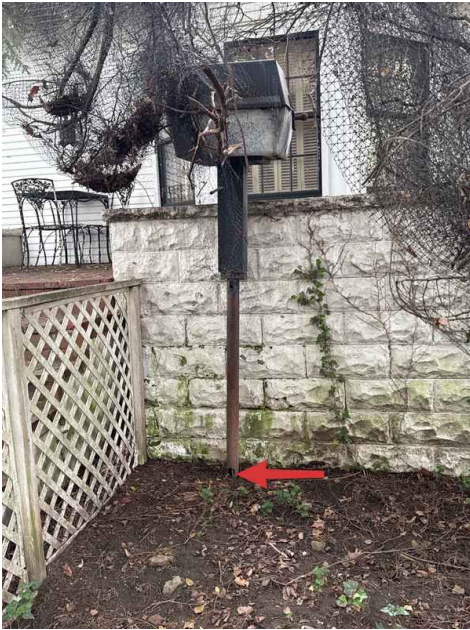
Northeast

Copper gas line exposed and susceptible to damage by yard maintenance equipment. Recommend further evaluation by a qualified contractor.

Recommendation
Contact a qualified professional.

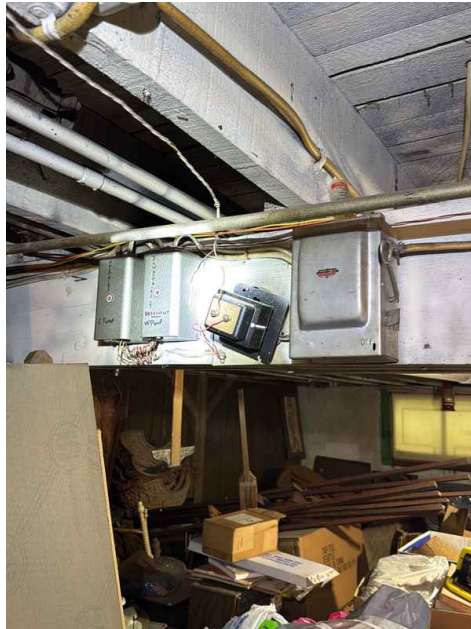
Fuse panel observed during inspection. As you perform upgrades to the electrical system, consider upgrading fuse panel to circuit breakers. Recommend further evaluation by a qualified electrician.

Recommendation
Contact a qualified professional.

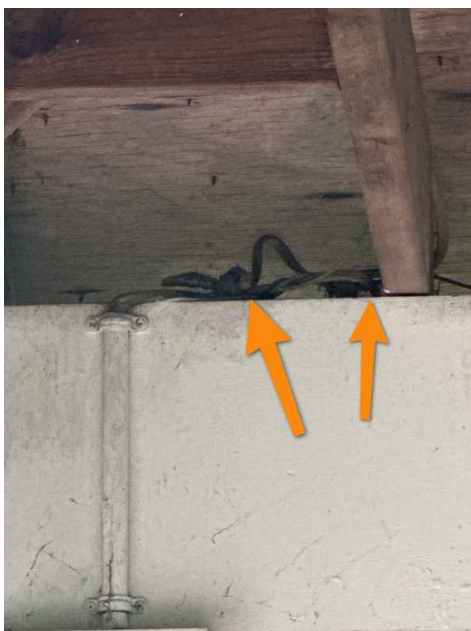
Garage

Branch wiring splice/termination observed outside of junction box in one, or more locations. One option is to properly secure and terminate branch wiring inside a readily accessible junction box. Recommend further evaluation by a qualified electrical contractor.

Recommendation
Contact a qualified professional.

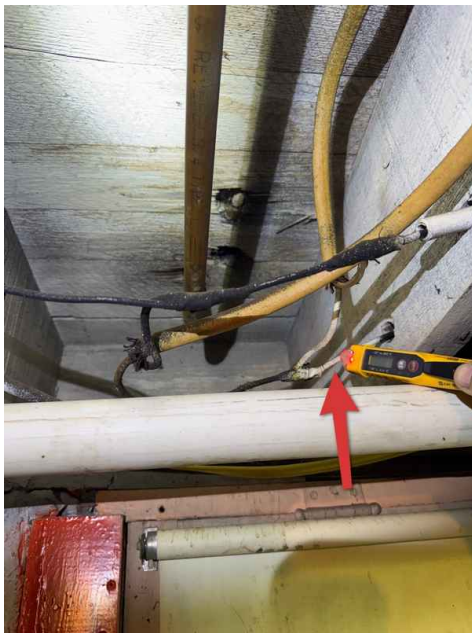
Basement

"Knob and Tube" (K&T) wiring observed during the inspection in one or more locations. K&T wiring is designed to dissipate heat into free air, and insulation will disturb this process. Insulation around K&T wires will cause heat to build up, preventing heat dissipation. K&T wiring also utilizes a cloth material as wire sheathing. Cloth sheathing generally is nearing the end of its life expectancy and can cause live wiring exposure. The 2008 National Electrical Code (NEC) requires that this wiring system not be covered by insulation. Specifically, it states that this wiring system should not be in hollow spaces of walls, ceilings and attics where such spaces are insulated by loose, rolled, or foamed-in-place insulating material that envelops the conductors. One option is to upgrade wiring. Recommend further evaluation by a licensed electrician.

Recommendation
Contact a qualified professional.

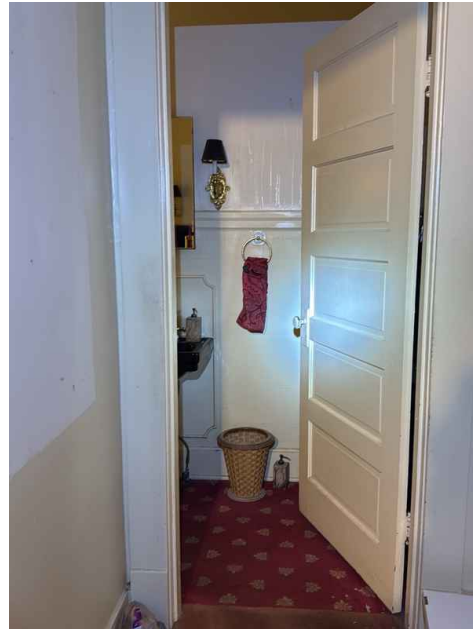
One or more interior doors need adjustments to close and function properly. Recommend further evaluation by a qualified carpenter.

Recommendation
Contact a qualified professional.

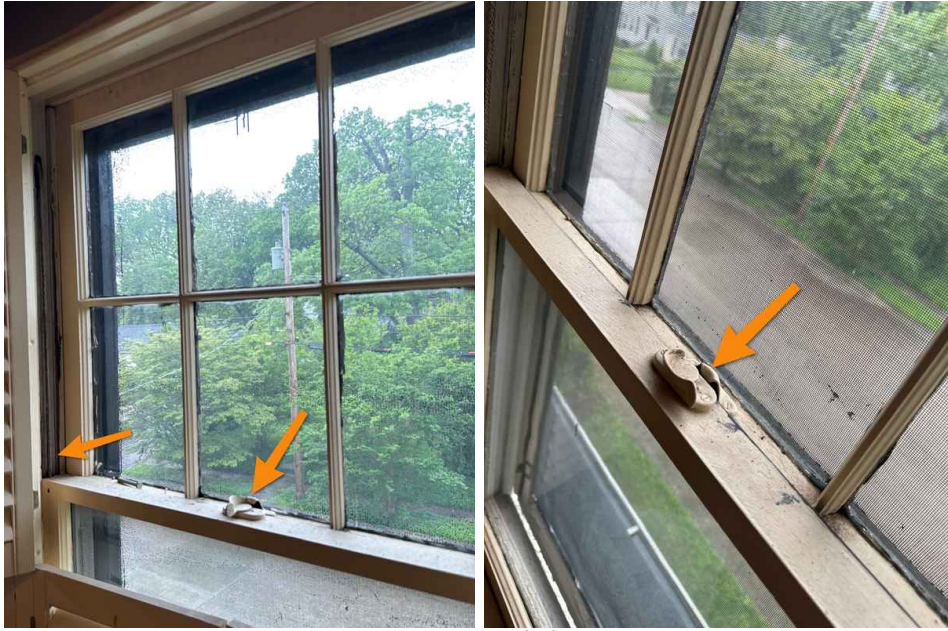
2nd Floor

WILL NOT LOCK

One or more of the windows will not lock. One option would be to repair window lock. Recommend further evaluation by a qualified contractor.

Recommendation
Contact a qualified professional.

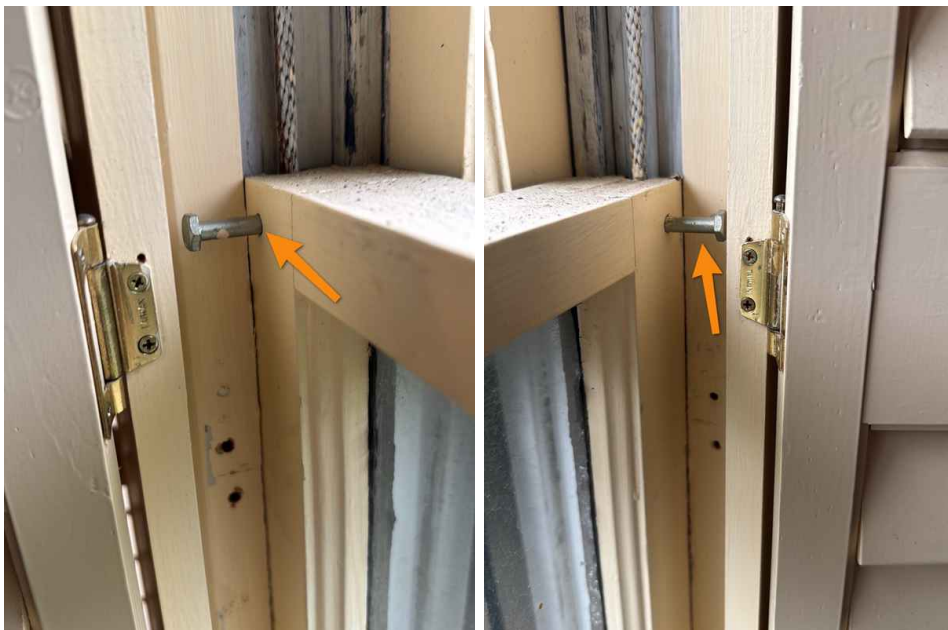
2nd Floor

10.3.2 Windows
UNABLE TO OPEN

Unable to open window under normal operating conditions. Recommend further evaluation by a qualified carpenter.

Recommendation
Contact a qualified professional.

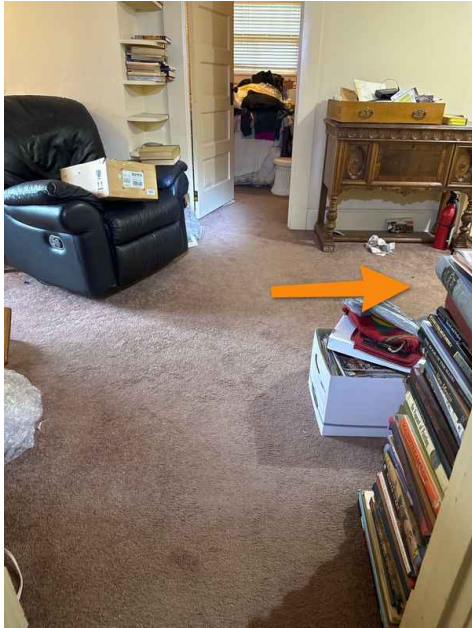
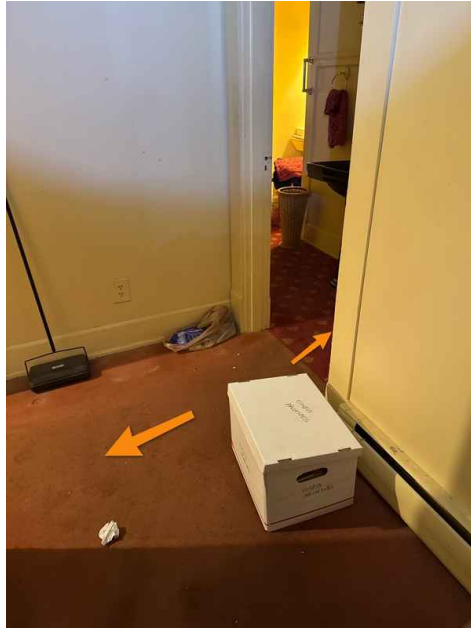
2nd Floor

10.4.1 Floors
FLOOR DEFLECTION

Floor deflection noted during inspection. Recommend further evaluation by a qualified contractor.

Recommendation
Contact a qualified professional.

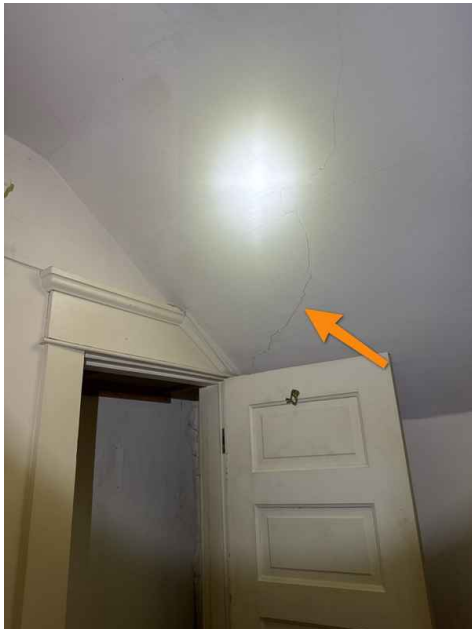
2nd Floor

MAJOR CORNER CRACKS

Cracking visible at the corners of doors and windows. Recommend further evaluation by a qualified contractor.

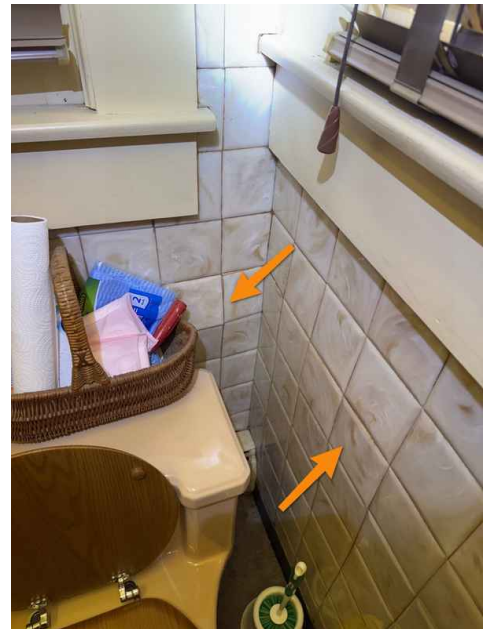
2nd Floor Bathroom

MOISTURE INTRUSION EVIDENCE

Moisture intrusion observed at time of inspection along one or more locations. Recommend further evaluation by a qualified contractor.

Recommendation
Contact a qualified professional.

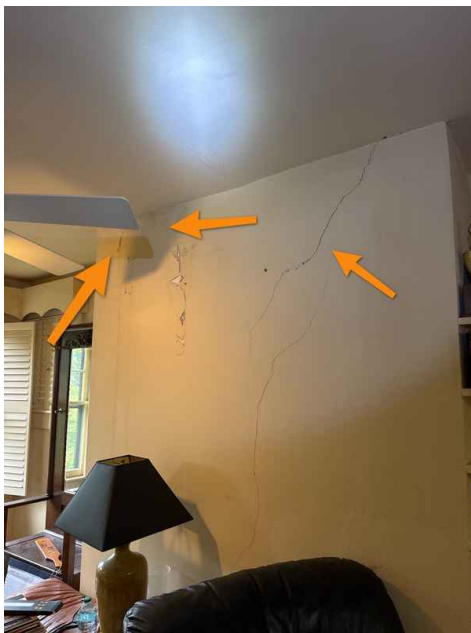
2nd Floor

ROOF/EXTERIOR/PLUMBING LEAK DAMAGE

Stains on the interior appear to be the result of roof/exterior/plumbing leaks. The source of leakage should be identified and corrected. Recommend further evaluation by a qualified contractor.

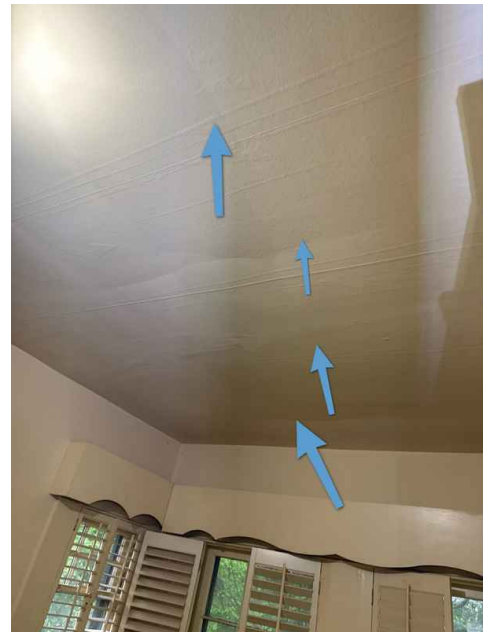
2nd Floor

Exposed tape joint/corner bead noted during inspection. This is not abnormal to see in a structure of this age. Recommend further evaluation by a qualified contractor.

Recommendation
Contact a qualified professional.

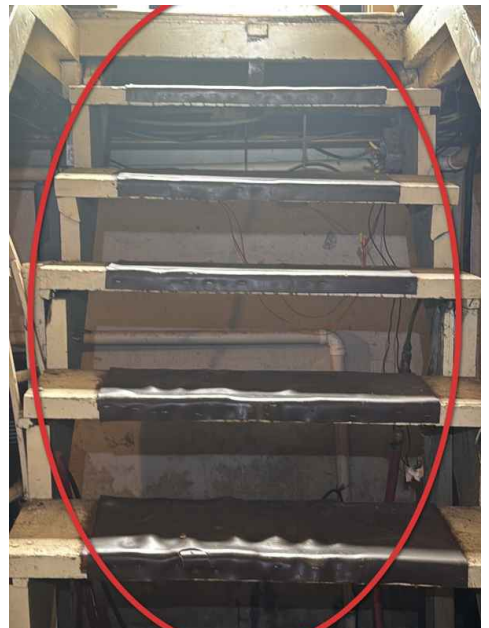
Basement

10.7.2 Steps, Stairways & Railings
DAMAGED STAIR SUPPORTS

Damaged stair supports/components observed during inspection. One option is to correct damaged areas. Recommend further evaluation by qualified Carpenter.

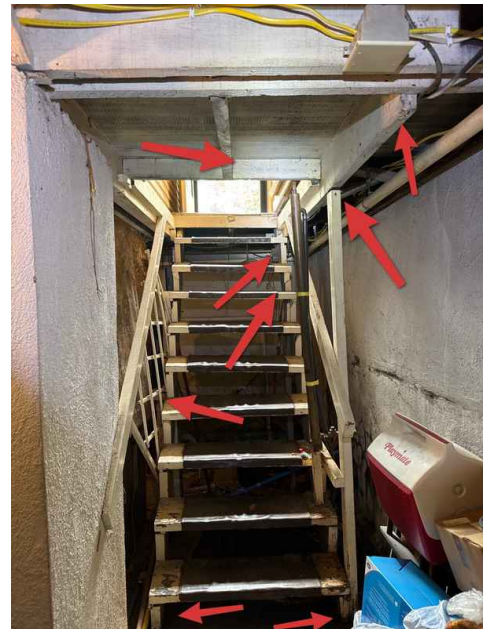
Basement

10.7.3 Steps, Stairways & Railings
UNSAFE STAIRWAY

Recommendation
Contact a qualified professional.
