# Laser Engineered Net Shaping® for Repair and Hydrogen Compatibility

*LENS technology seems well suited for repair of overbored reclamation-type materials, but additional process development is required for other types of repairs*

BY P. S. KORINKO, T. M. ADAMS, S. H. MALENE, D. GILL, AND J. SMUGERESKY

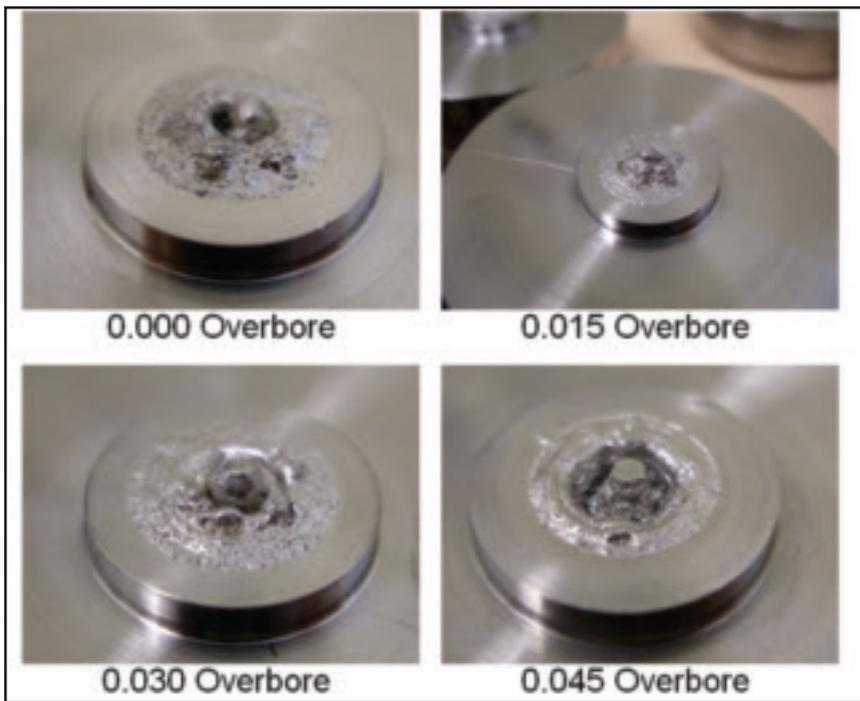
Fig. 5 — The repaired bores had excellent adhesion to the walls and bottom of the bore, but the material was not high quality at the center.

Figure 5 shows the as-repaired condition of the deposit from a macro standpoint. It is important to note that differences in the appearance and the apparent density and crowning of the fill are not due to the diameter of the oversize bore, but are instead due to process improvements made throughout the repair of these components. The 0.045-in. (1.14-mm) overbore bases were done first and have the least desirable center bump. The 0.030-in. (0.76-mm) overbore bases had the improvement of higher rotational speed near the center of the deposit, and the 0.000- and 0.015-in. (0.38-mm) overbore bases had further improvements in that the center of the bore did not have additive material for the first layers. The zero overbore sample has a slightly improved definition of where the final radius should be for each layer. A difficulty for the process development was that the LENS material deposition team only had two process setup pieces, which was insufficient for optimizing the deposition approach. As shown by Fig. 5, considerable improvement in the appearance of the

samples is evident from the 0.045-in. (1.14-mm) overbore to the 0.015-in. (0.38-mm) overbore, or from the first to the seventh component (the first of the 0.015-in. overbore repairs). Additionally, as the amount of overbore changed, the diameters of the deposited rings changed, which added another variable to the process development challenges.

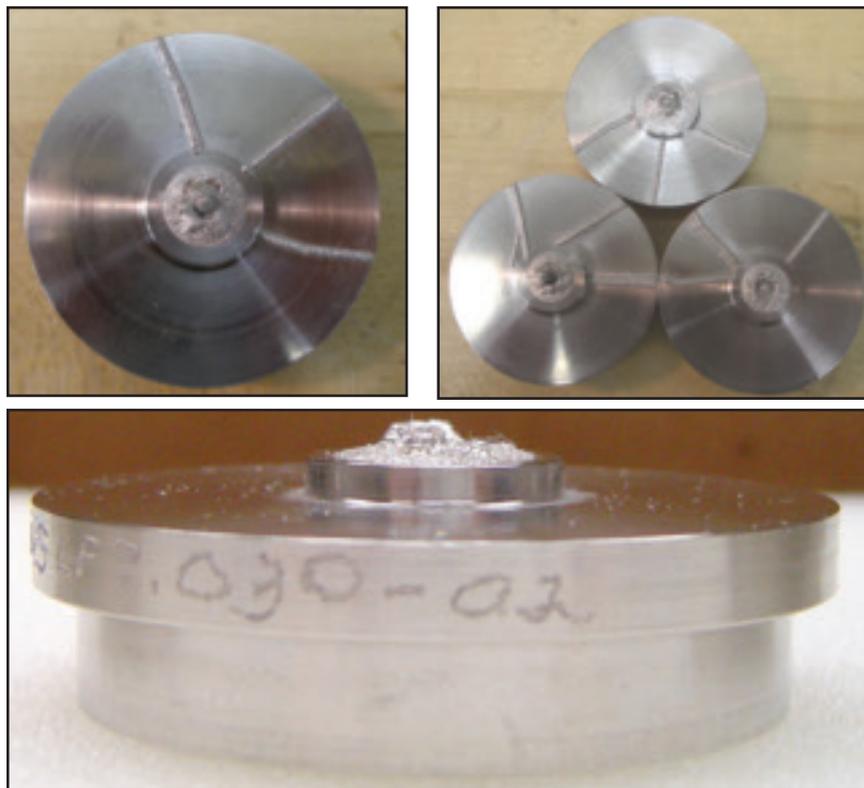
Fig. 6 — Bore and radial repaired scratches on the surface of the weld bases.

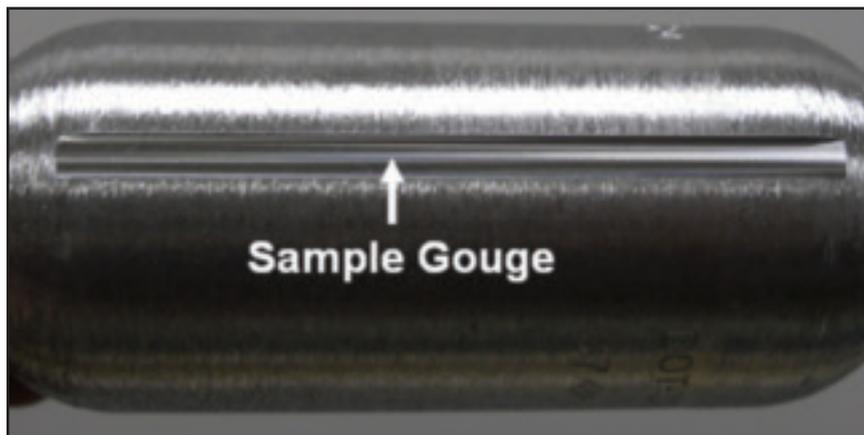
Fig. 7 — Sample gouge in sample gas bottle. Gouges were 0.125 in. wide and either 0.010 or 0.020 in. deep.

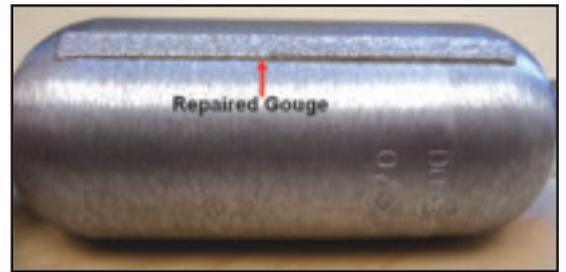
Fig. 9 — Repaired gouge in sample gas bottle.

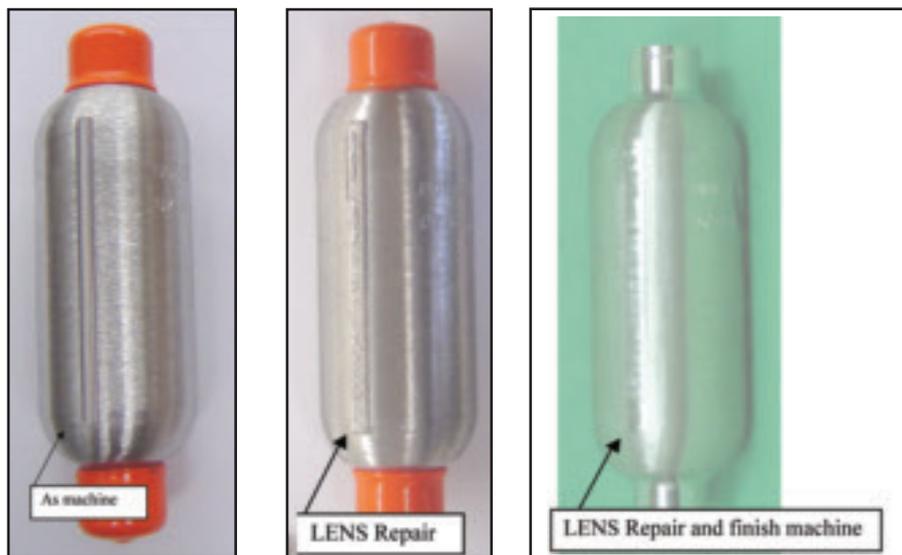
Fig. 14 — As-machined (notched), as-LENS-repaired, and as-final-machined gas sample bottles.

tics. Sample bottles were prepared for LENS repair by milling a  $\frac{1}{8}$ -in.-wide notch to a depth of either 0.010 or 0.020 in. deep and LENS repairing the notch. This defect represents a worst-case scenario for small scratches on a reservoir that would result in rejection of the reservoir. The vessels were turned to remove the excess LENS material. The surface condition of the gas sample bottles in the as-milled, as-welded, and as-final-machined conditions is shown in Fig. 14. The vessels were machined to the extent needed to remove the weld reinforcement; no vessel wall material was removed. Since only the minimum material was removed, the entire LENS repair did

not clean up. The residual stresses due to the repair process are the most likely cause for the remaining depression in the vessel.

The LENS repairs for the sample gas bottles were generally successful with the repaired gouges having an acceptable appearance as shown in Fig. 14. Upon hydrogen charging and burst testing, the bottles all passed the required pressure before bursting, but the bottles did burst along one edge of the gouge. Further analysis and sectioning showed that the LENS material did not quite fill the bottom corner of the gouge in some cases. This bottom corner of the gouge acted as a stress riser causing failure to initiate at the site. To achieve better results in the future, it is suggested that a ball end mill or angled mill be used to make the bottom corner easier to fully fill with LENS material and to reduce the stress riser. It is expected that this modification would make the failure much less likely to occur at the gouge location.

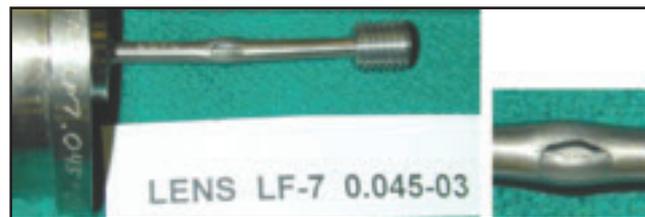
Fig. 18 — Burst tested 0.045-in. overbore and LENS-repaired and reclamation-welded sample.

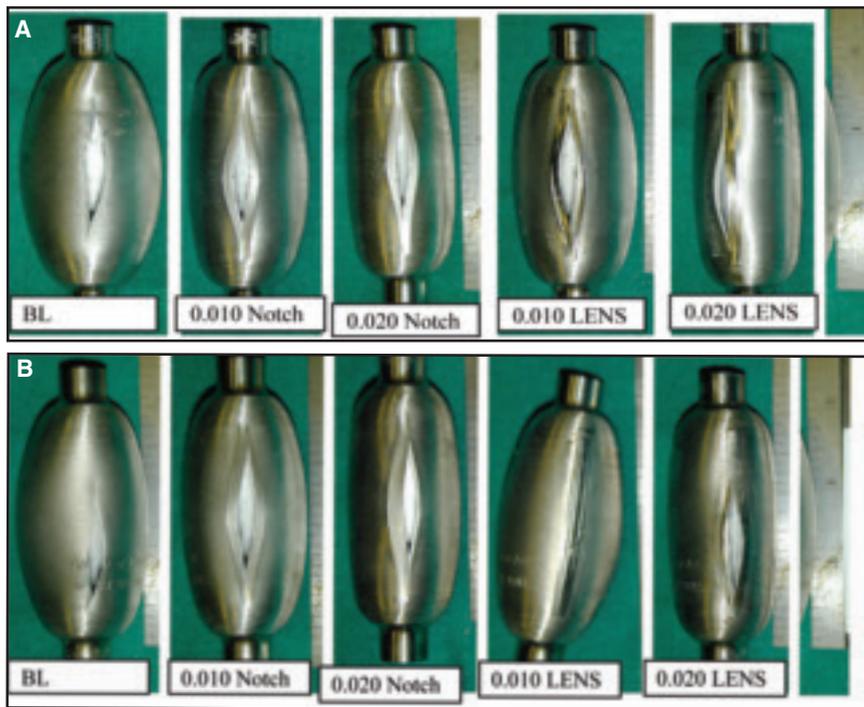
Fig. 21 — Burst test gas sample bottles: A — As received; B — hydrogen charged.

The appearance of the burst tested gas sample bottles exhibited the expected failure with the bottle opening up axially; in addition, all of the samples with notches failed in the notch. There was one exception for the LENS-repaired samples: Sample 0.010 LENS-repaired 1, which failed in the vessel body away from the LENS repair, suggesting an excellent repair and no adverse impact on strength. Macro photographs of the burst-tested vessels are presented in Fig. 21. The baseline samples are presented in Fig. 21A, and the hydrogen-charged samples are presented in Fig. 21B. The change in sample diameter growth, i.e., direct indication of strain, is apparently lower as the extent of the defect increases.

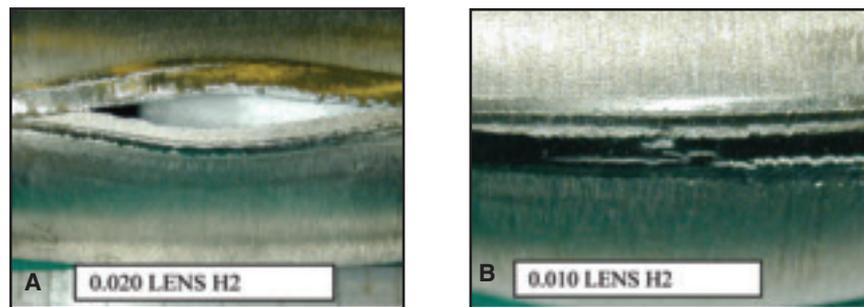
Fig. 22 — Expanded view of hydrogen-charged and tested samples: A — Repaired over a 0.02-in. notch; B — repaired over a 0.010-in. notch that failed in the body, not the repair.

The fracture surfaces of the LENS repaired surfaces were also examined. The LENS material appears to have cracked axially and some of the samples exhibit a possible delamination. This failure mode may be indicative of the deposition method and deposition direction. The cracking and onset of delamination of sample 0.010 LENS H<sub>2</sub> that did not fail in the LENS repair area is shown in Fig. 22.

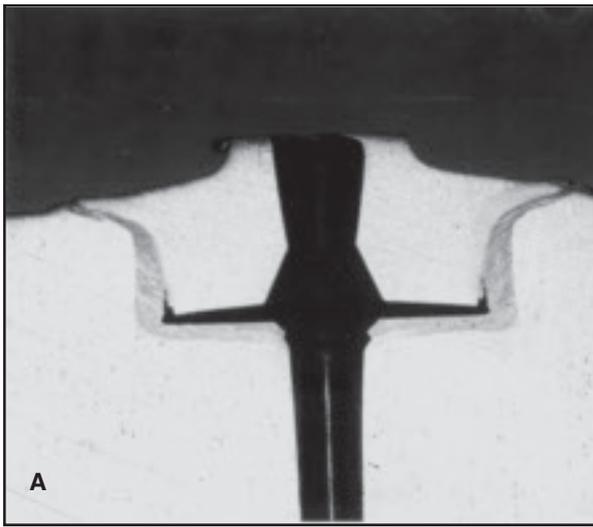
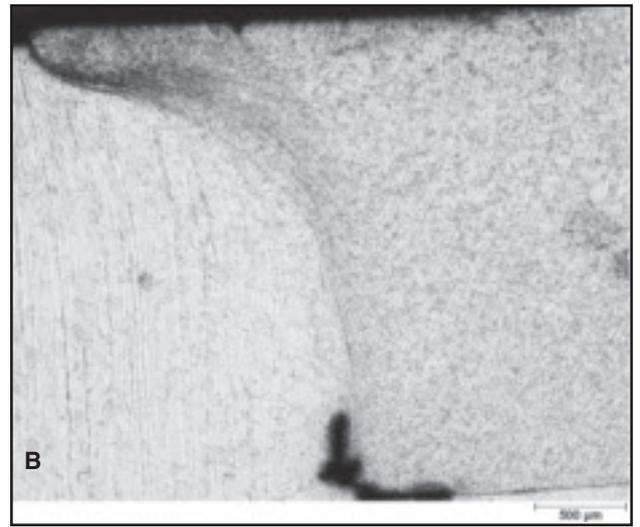
Fig. 23 — A — Metallographic cross section of a burst tested, LENS-repaired 0.045-in. overbore reclamation weld; B — typical Type 304 SS reclamation weld in the as-welded condition (note parallel nature of foot base and reclamation base).

A comparison of the microstructure from a typical Type 304L SS reclamation weld reveals similarities and differences. The flow lines for both the stem foot as well as the base material are apparent. There are perceived differences in the relative amount and location of the material for the LENS-repaired sample compared to the standard base. The presence of flow lines in the LENS material is less apparent than for the fill stem bare stock. Note also the presence of fine porosity in the “corner” of the reclamation test base/LENS material. The LENS material seems to have machined well as there is no indication of smearing on the chamfer at the bore centerline.

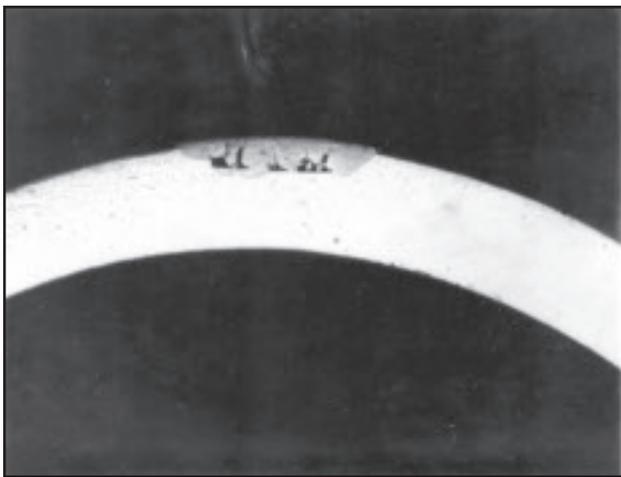
Fig. 24 — Typical area of a LENS-repaired sample that had a 0.020-in.-deep notch machined into it.

The sample bottles were also examined metallographically. A typical LENS repaired and machined sample is shown in Fig. 24. This sample exhibits some voids and porosity in the repair area. At least two different sample elevations were examined to verify the presence of these anomalies. The voids appear to be due to incomplete fusion of the laser-sintered powder to the bottle substrate. Higher magnification images clearly indicate that the bond is intermittent. The shape of the

voids also indicate incomplete fusion as opposed to gas formation voids. It is surmised that a change in the bottle slot geometry to make the defect more weld repairable would have improved the nature of this repair. It is further expected that radiographic examination of the bottles prior to testing would have revealed these defects and perhaps have enabled a secondary fusion cycle to “heal” the voids. An optimized process certainly would have enabled higher-quality LENS repair techniques and material application to be implemented.

Additional process development is required for weld repair of notched gas sample vessels. This development should include joint preparation in addition to thermal inputs and translation rates.

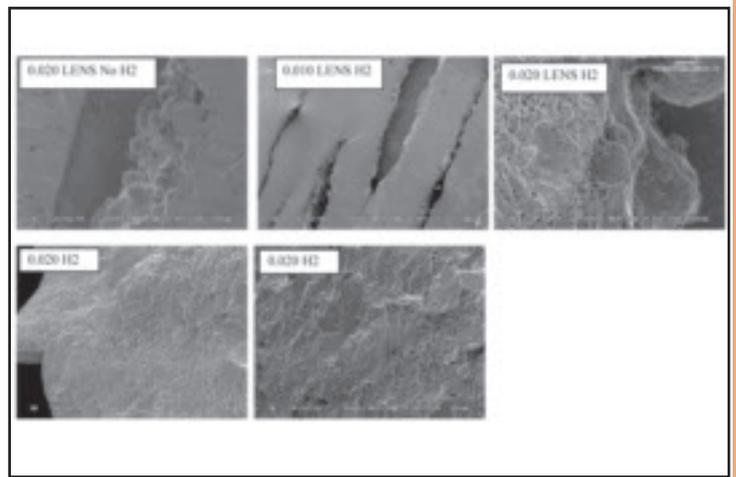
Fig. 25 — Burst test sample fractography.

To better understand the nature of the fractures that were observed in the bottle burst tests, the fracture surfaces were examined using the scanning electron microscope. This examination revealed interesting results that support the findings of incomplete fusion that were observed in the optical microscopy. In Fig. 25, the edge of the machined notch can be seen adjacent to the powder fill that still shows sintered particles that retained their spherical geometry.

Ductile rupture was apparent for both the baseline and hydrogen-charged samples. There was no obvious change in the dimple size between the hydrogen-charged samples and the baseline samples. In a well-bonded area of the LENS-repaired sample, there is evidence of ductile rupture with a very fine dimple size.
