# CONSERVATION OF THE WAZIR KHAN MOSQUE LAHORE

PRELIMINARY REPORT ON CONDITION AND RISK ASSESSMENT

AGA KHAN TRUST FOR CULTURE AGA KHAN CULTURAL SERVICE - PAKISTAN

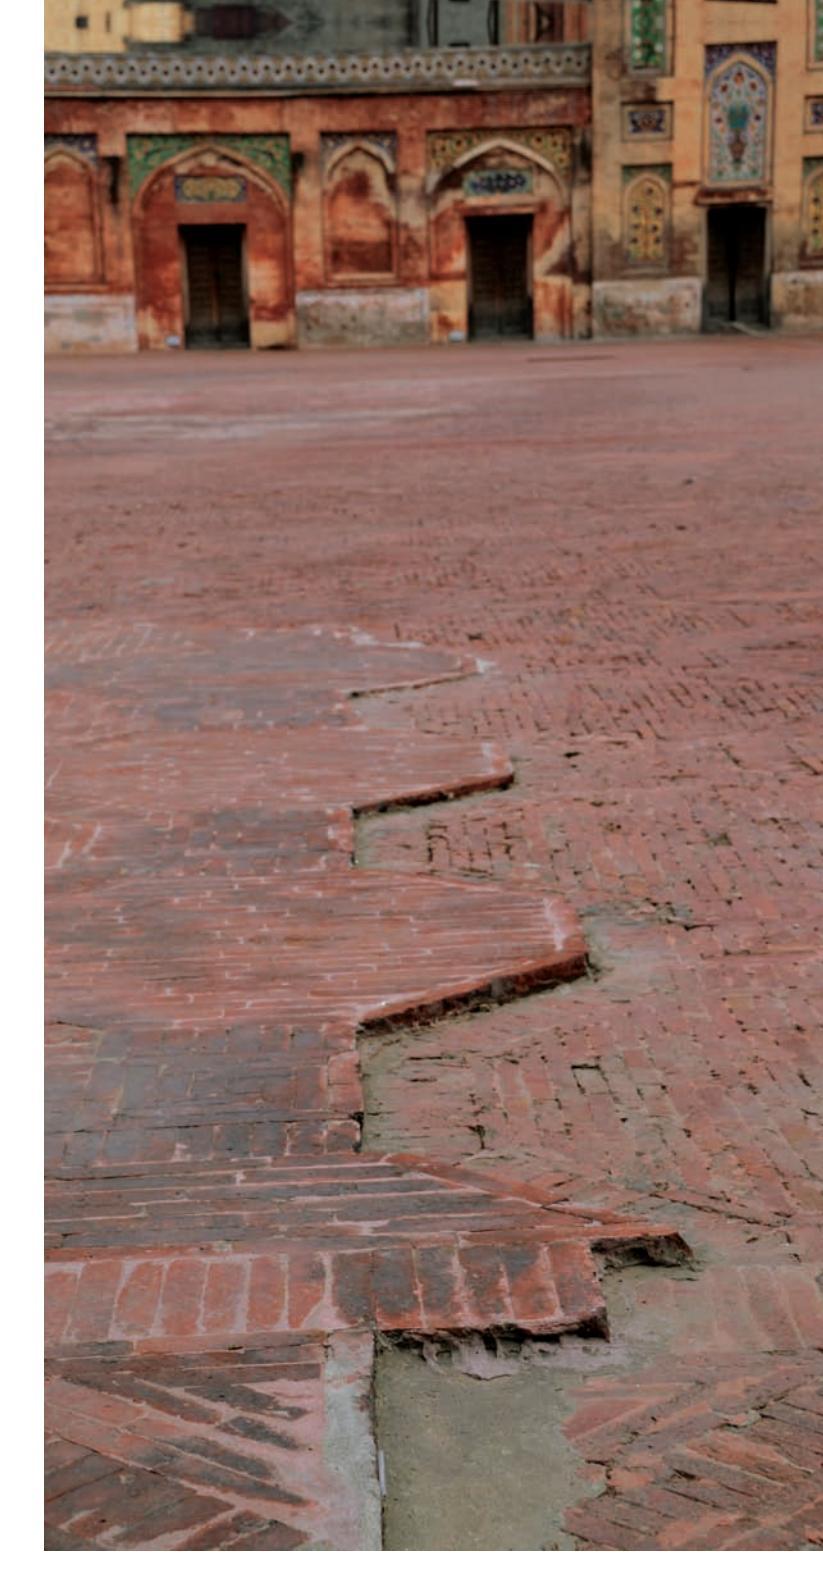
Above: Subsidence and floor repair in the north-west corner of the courtyard has created different levels with badly finished edges.

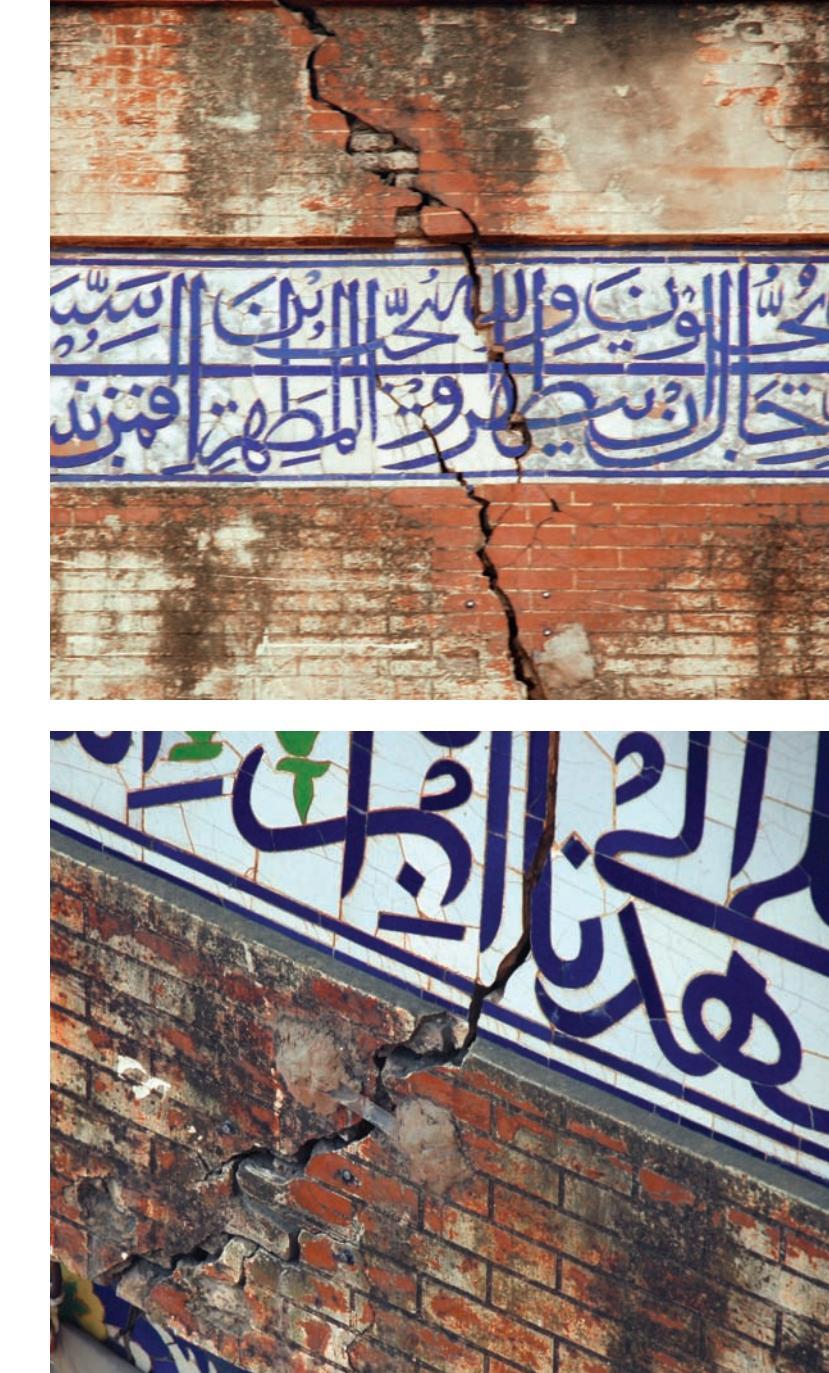
*Top:* The crack in the apex of the arch forming the southern most entrance into the prayer chamber.

Above: A similar crack affecting the apex of the arch forming the northern most entrance. Both these are instances of the powerful lateral pull exerted by the respective minars.

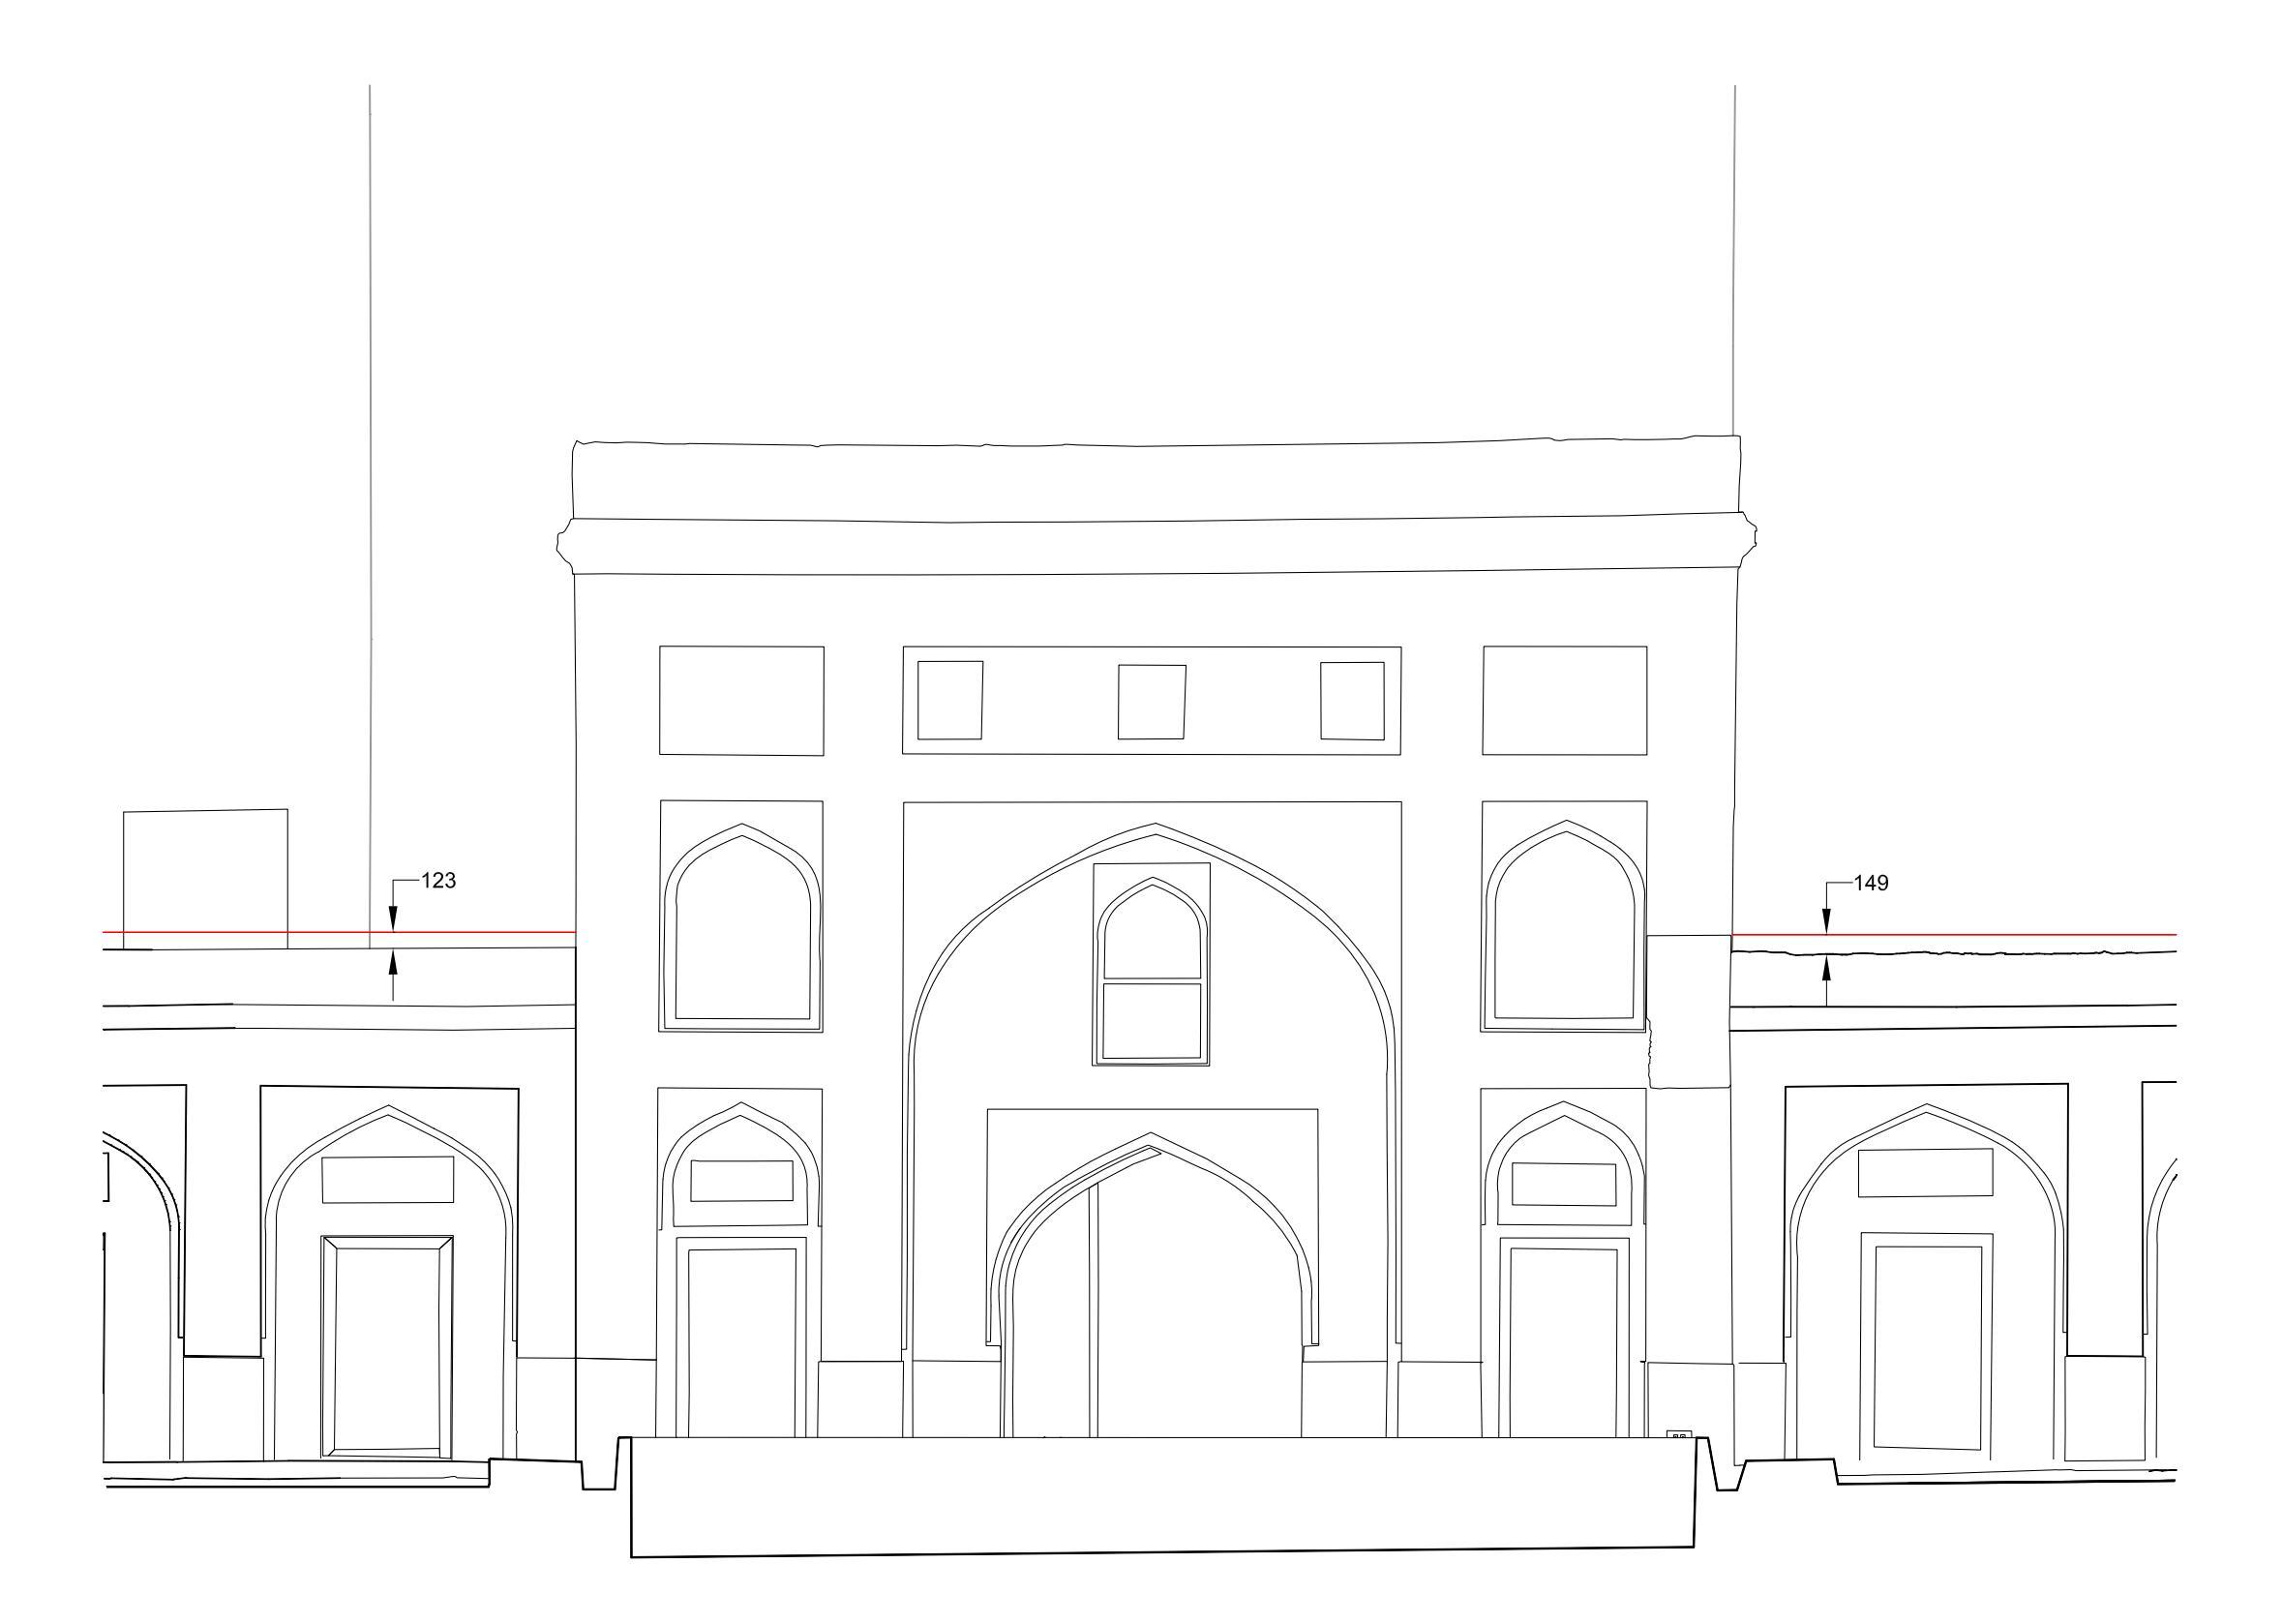
# SUBSIDENCE IN THE SOUTHERN ROW OF HUJRAS

Opposite page: detail of the southern hujras and the southern central pavilion. Note the subsidence experienced on this side. The two wings of the hujras on the south side of the courtyard have subsided as shown with respect to the central pavilion. Subsidence is shown in millimetres with reference to a horizontal line (in red) drawn from the point where the parapets end against the base of the south-east and south-west minars.

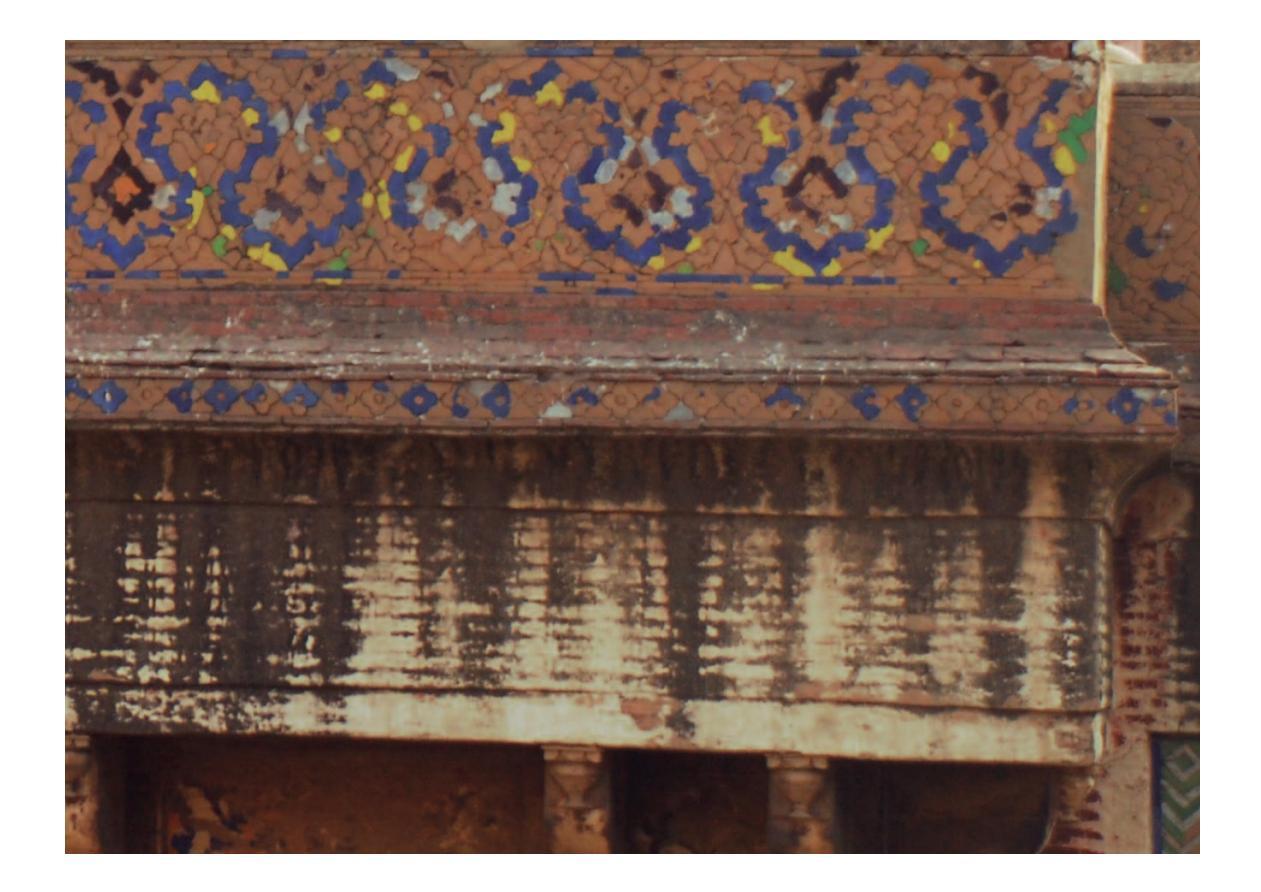
Bottom: Efflorescence caused by the drying of render and the leeching of salts contained in inappropriate mortar.

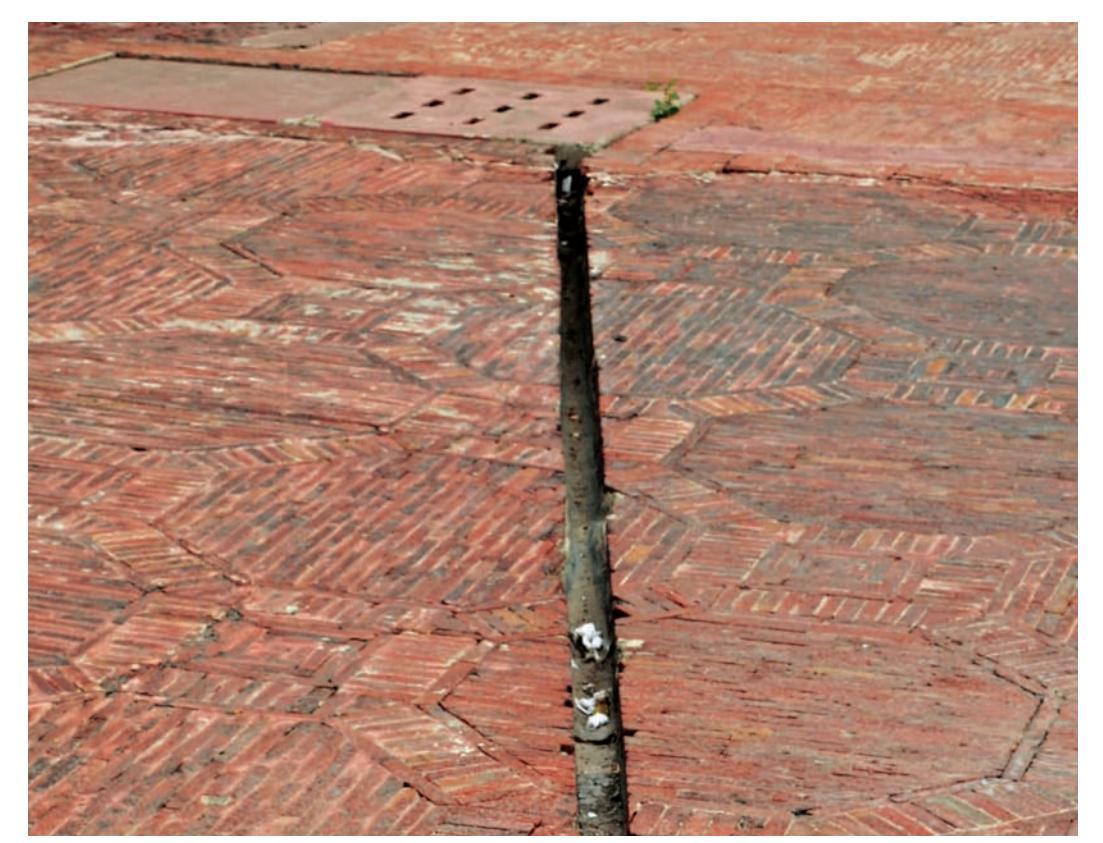
Poor detailing of waste and storm water disposal grating.

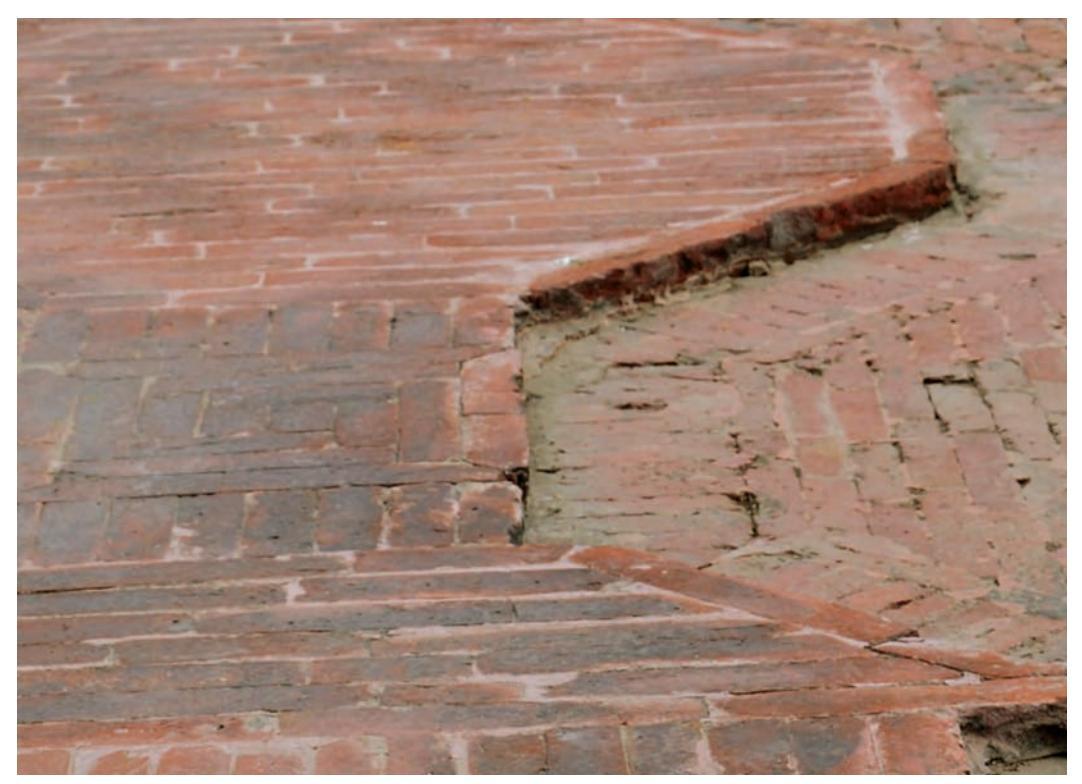
Cutting up the patterned floor to accommodate a collector drain. A better and well distributed system of under floor drains is required.

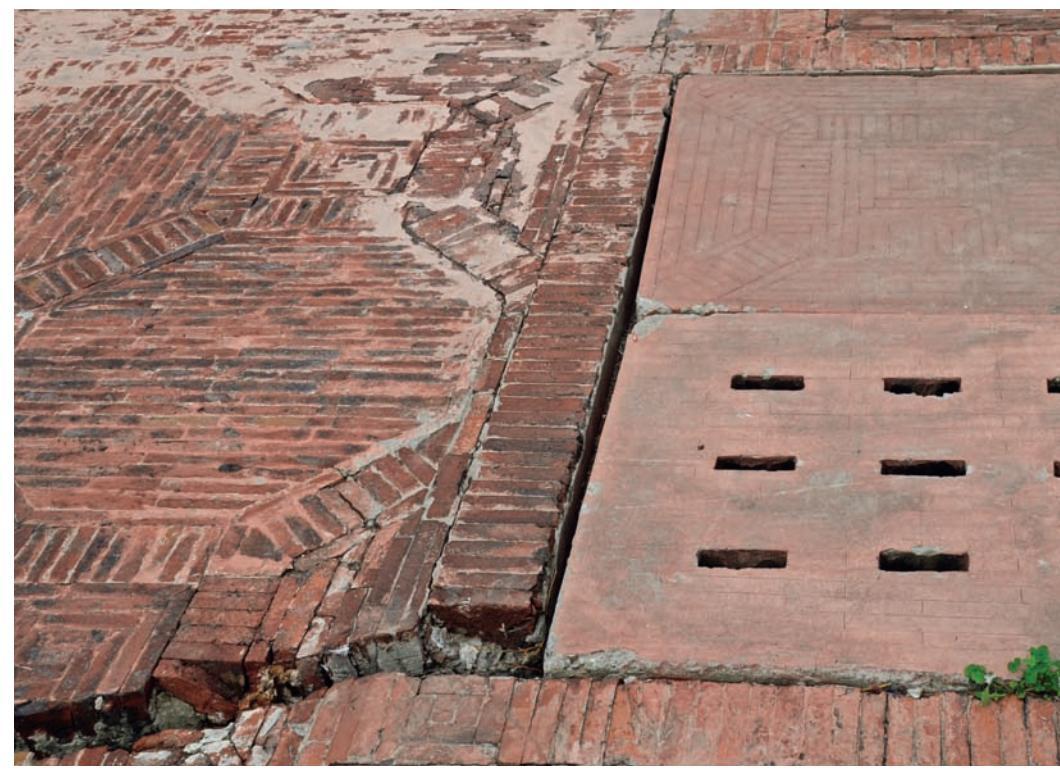
Subsidence and inadequate repair at different levels.

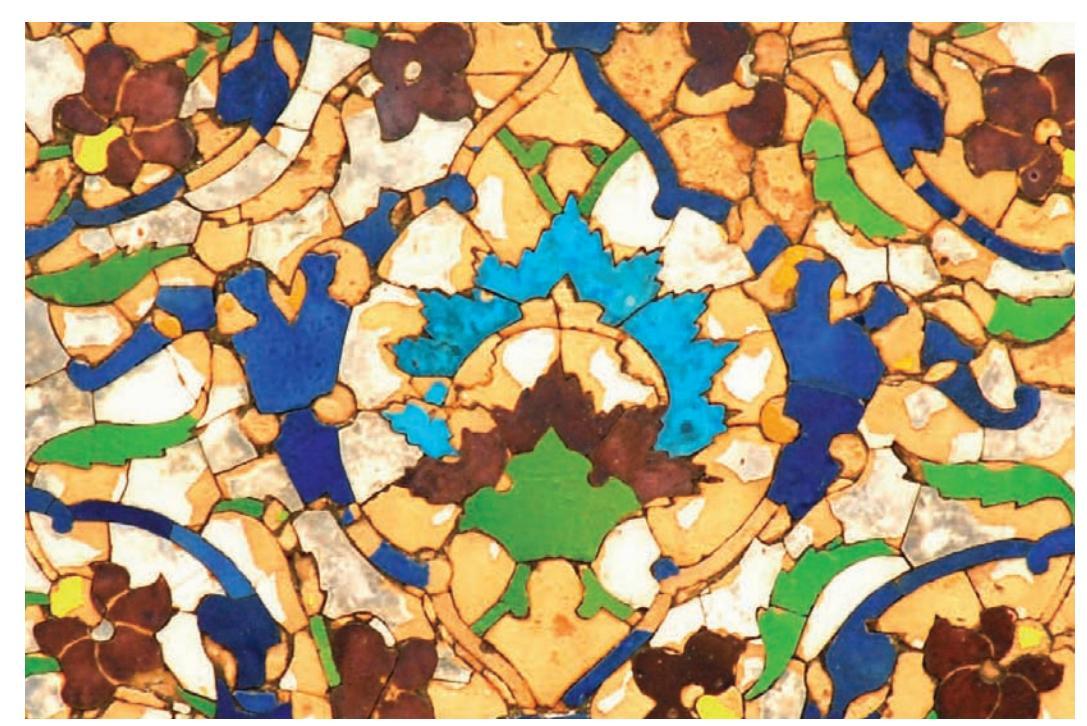
Hairline cracks on the glazed surface of tiles. These cracks are sometimes indistinguishable from the fine joints of the cut-to-shape tiles, but could be the beginning of more advanced weathering processes.

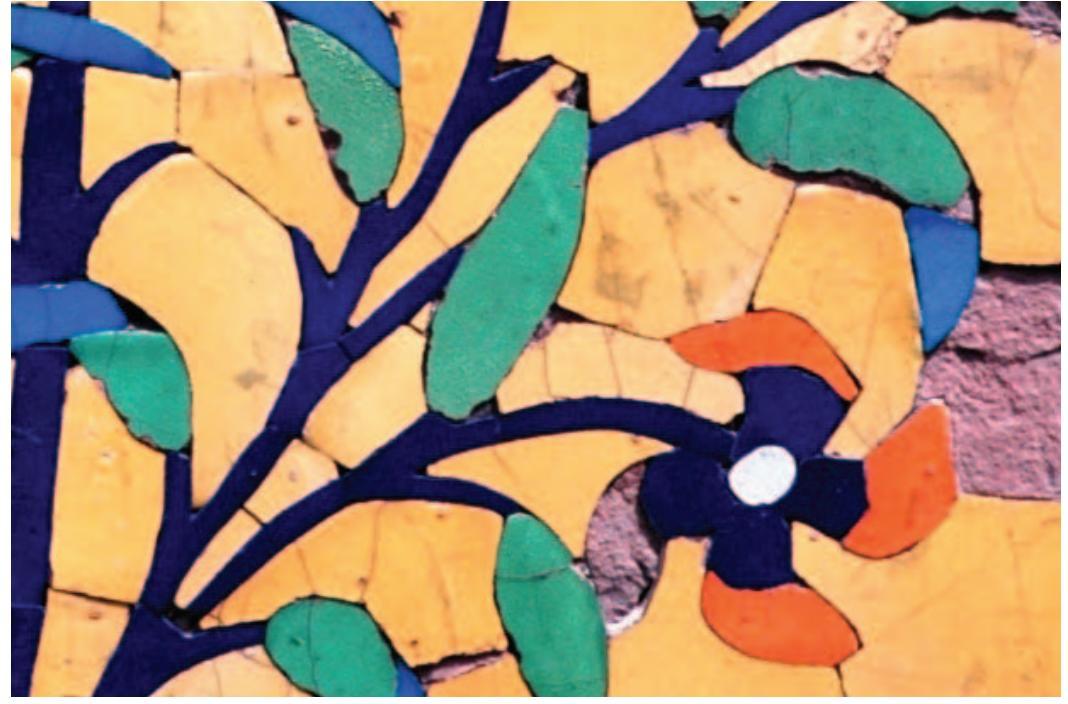
Exfoliation of glaze from the terracotta body of the tile is the most common damage type on glazed tiles. In many instances concurrent existence of exfoliated glaze and tiles with glaze still intact presents a characteristic agevalue of some interest and this situation could be one of the lower priority interventions to be addressed.

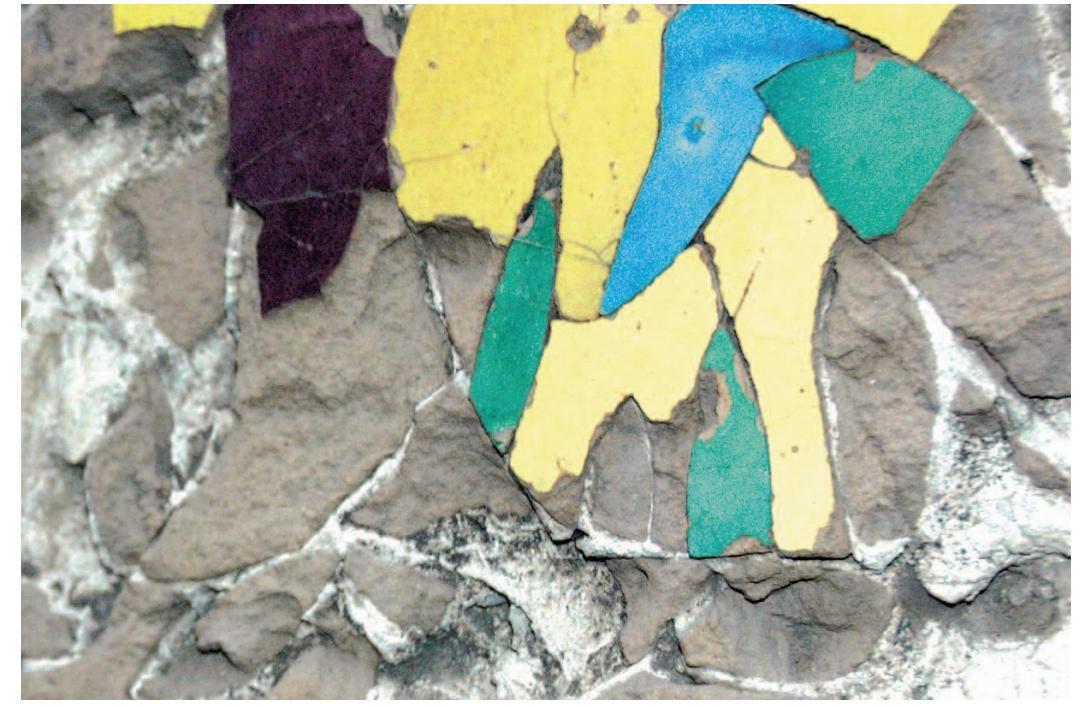
Pitting and spalling of thin layers of terracotta body of the tile. At this stage of deterioration, piece-meal replacement of sections of tile may be considered.
