SUPPLEMENT TO THE WELDING JOURNAL, NOVEMBER 1970

## Stress Corrosion Characteristics of Maraging Steel Weldments in Air and Pentaborane

BY S. M. TOY AND A. PHILLIPS

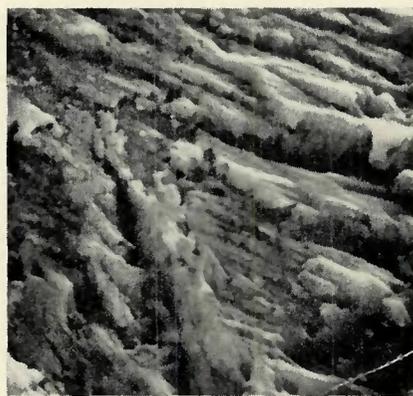
Fig. 4—Specimen 36 showing flat cleavage facets of austenite island (dark grey triangular area).  $\times 10,000$  (reduced 41% in reproduction)

The austenite islands in the "cored" grain boundaries encircling the martensite phase appear to be cleaved. An examination of the fractured surface revealed it to be a flat cleavage facet—Fig. 4. A step-wise quasi-cleavage mode of the martensite can also be observed. The brittle behavior of austenite islands is associated with hydrogen and strain induced transformation of austenite to martensite. Hydrogen was found to emanate from the austenite islands. A similar mode of failure in air for the 300 grade 18 Ni

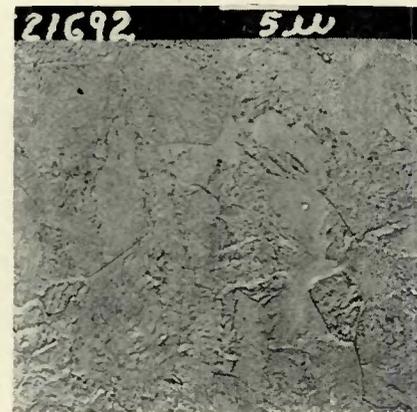
Fig. 14—Specimen 12 (250 Grade 18 Ni) base metal microstructure

Figure 14 is an electron micrograph of 300 grade 18 Ni weldment (specimen 52B) which failed in air and 250 grade 18 Ni base metal next to the weldment (specimen 12).

The absence of austenite islands and the cored cast structure of the original weld are observed. The local precipitation appears to be general.

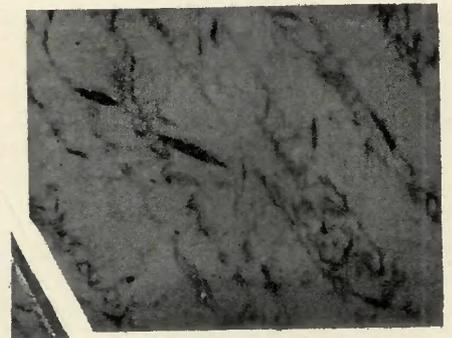
Fig. 20—Specimen 2-6, 2-7 (250 Grade 18 Ni) showing hydrogen emanation and distribution along crystallographic directions

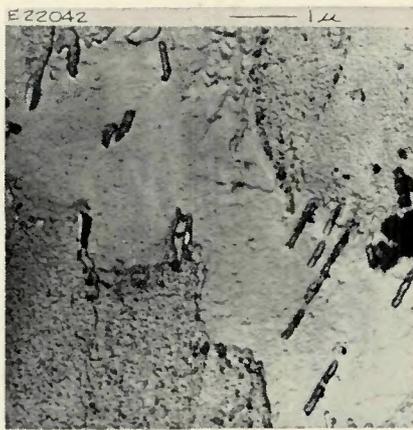
Fig. 21—Upheaval of austenite polished surface by strain-induced martensite transformation in H<sub>2</sub> cathodically charged maraging steel weldment
