DISASTER PREVENTION AND MITIGATION STRATEGIES FOR ARCHITECTURE HERITAGE CONCENTRATED AREAS IN CHINA

Xiwei Xu, Tim Heath, Qing Xia, Youtian Zhang

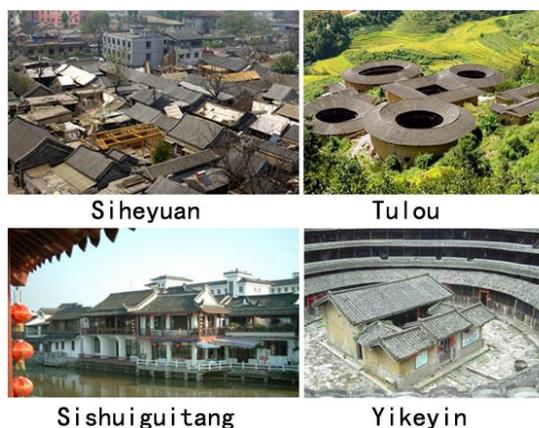
Figure1. Chinese traditional courtyard houses forms (Source: <http://image.baidu.com>).

Firstly, in most Chinese residential buildings of wood or brick-wood structure there are often many positions where wood structure is directly exposed to air, resulting in a low fire resistance rating and easy spontaneous combustion or ignition in dry air, continued high temperature, lightning strike or open fire. Secondly, most buildings in historic districts were built by the residents themselves, and lack necessary earthquake protection due to no design standards or restrictions in cost. After decades or even hundreds of years of weathering, these buildings often have damage to their structural parts, especially wooden parts, leading to greatly reduced disaster resistance. Thirdly, most traditional residences in China have different forms of courtyard combination, such as Siheyuan in Beijing, Tulou in Fujian, Yikeyin in Yunnan, and Sishui Guitang in South China. Such combined architecture forms increase the possibility of fire spread, and make it more difficult to evacuate in case of geological disasters such as earthquakes and mudslides (see Figure 1).

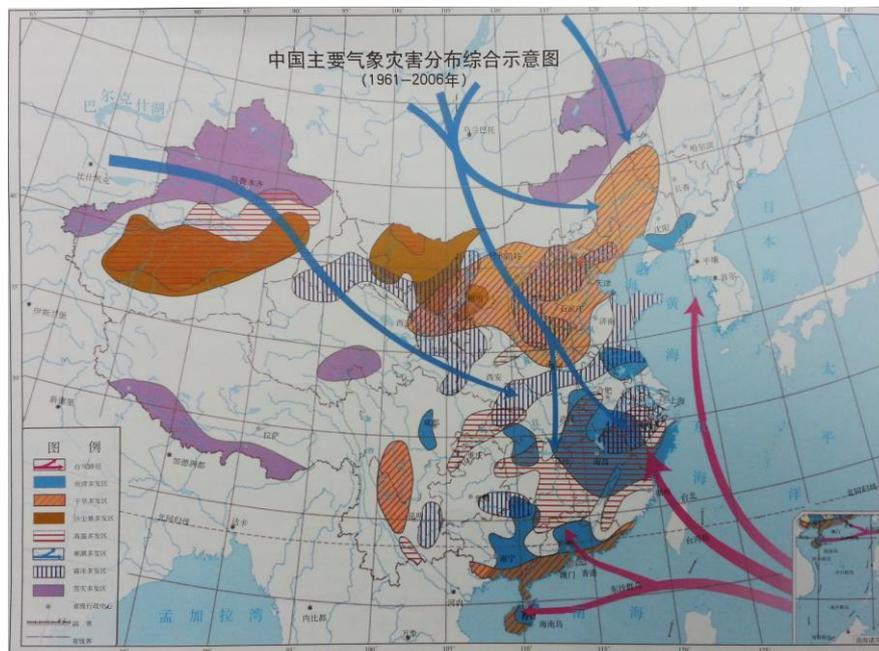
Figure3. Distribution of major meteorological disasters in China (Source: Comprehensive Volume of Chinese Meteorological Disaster Records).

With respect to space-time distribution of disasters, the region and time features of fire disaster are not obvious, whereas more meteorological disasters occur in coastal areas in some of the seasons. Geological disasters, however, tend to occur in inland areas such as Southwest China and Northwest China. The impacts of human factors in these disasters are more complicated. For example, some serious damage to architecture heritage caused by floods are due to raised surrounding areas arising from urbanization, blockage of drainage system, changed elevation of district, or other human factors.

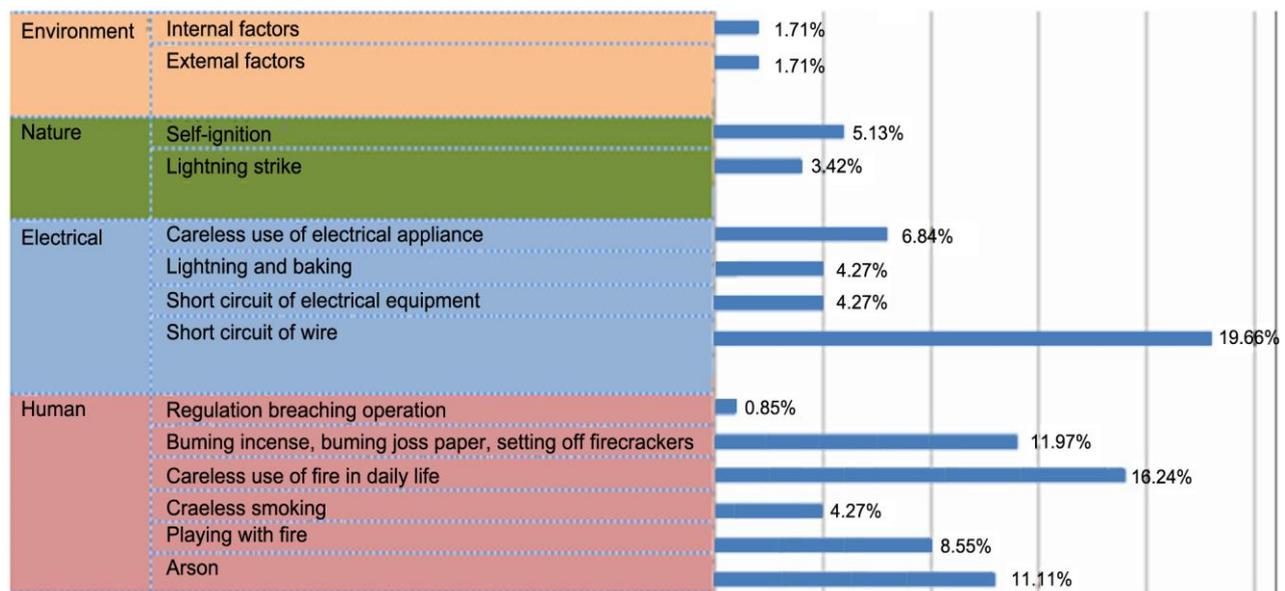
Figure 4. Cause for fire (Source: Authors).

On the cause: Among 210 fire disasters of architecture heritage that have occurred in last 30 years, causes for 117 cases have been identified, which included natural factors, environmental factors, human factors and electrical factors. Of these, 62 cases were caused by human factors, 41 cases were caused by electrical factors, 10 cases were caused by natural factors, and 4 cases were caused by environmental factors (see Figure 04).

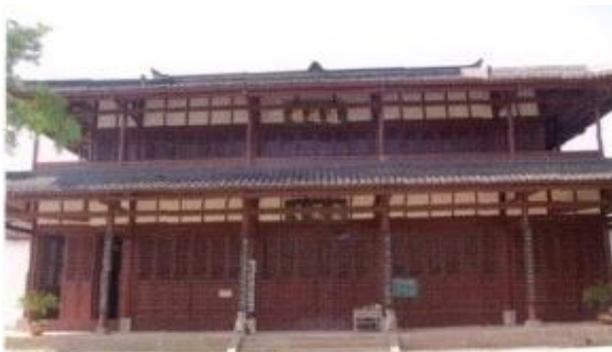
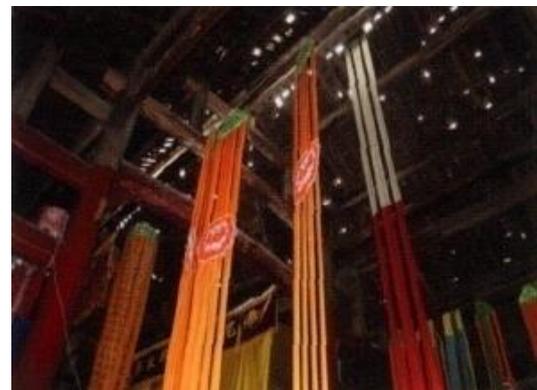
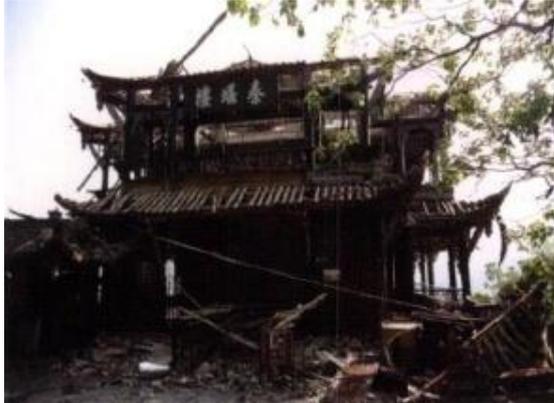
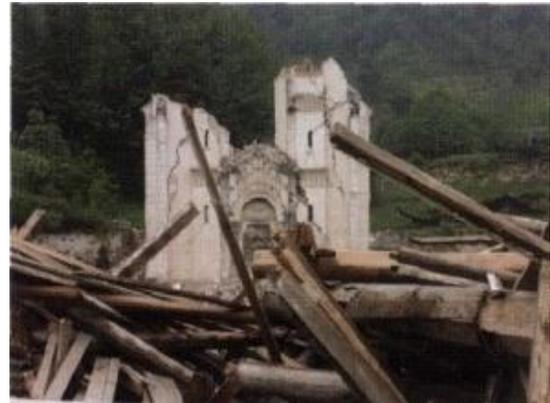
Figure 5. Xiaoyao Building - located in Guangyuan City, Sichuan Province; wood structure (Source: <http://image.baidu.com>).

Figure 6. Fazang Temple - located in Pengzhou City, Sichuan Province; wood structure (Source: <http://image.baidu.com>).

Figure 7. Qinyan Building - located in Dujiangyan City; wood structure (Source: <http://image.baidu.com>).

Figure 8. Lingbao Seminary - located in Pengzhou City; brick-wood structure (Source: <http://image.baidu.com>).

Based on study of damage to architecture heritage caused by earthquakes, it can be found that the following damage is very common(see Figure 5-8): 1) In buildings of rock structure: wall crack, tilt, peeling, foundation settlement, step rupture, and even collapse; 2) In buildings of rock-wood structure: rupture or disconnection of wood structure, wall tilt, serious distortion of building structure, roof tile side slide, tile falling, and so on; 3) In grottos: crack of rock body, water penetration, mountain collapse, and so on; 4) In buildings of brick-rock structure: tilt, rupture or collapse of the main body, 5) Foundation destruction: pillar bottom sideways movement, pillar tilt, loose node connection, fitment rupture, girder tilt, tile falling, and so on; 6) In soil relics, secondary hazards such as slide and mudslide (Cultural Heritage Planning and Research Center of Sichuan Cultural Relics and Archaeology Research Institute, 2008).

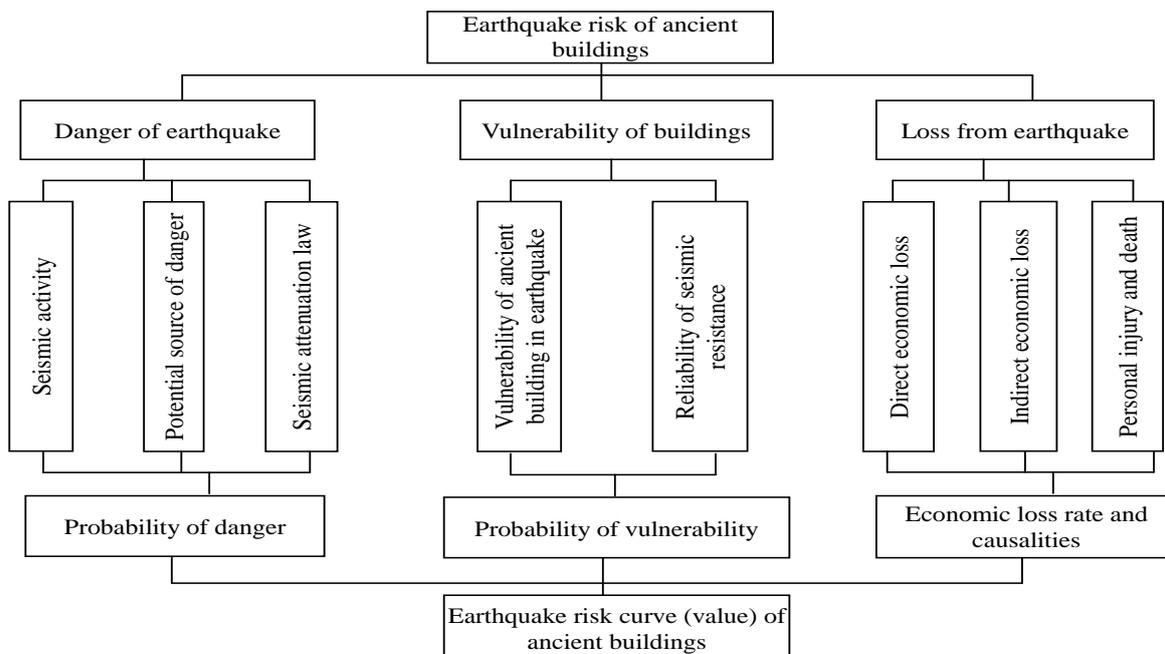
Figure 9. Composition of earthquake disaster risk of ancient building (Source: drawn by the authors).

Earthquake risk evaluation factors for architecture heritage mainly involves analysis of the disaster causing risk, study on vulnerability, and an evaluation of disaster loss. Analysis of disaster causing risk refers to the analysis on earthquake danger, aiming to determine the possibility or cycle of earthquakes in the area where the historical building is located. Study on vulnerability aims to evaluate the earthquake resistance of the historical building based on the structural features and value of the building as well as the earthquake resistance mechanism of the building itself and the interior parts. Evaluation of disaster loss refers to the evaluation of the potential times of earthquakes in the area in a given period as well as the potential loss that may be caused to the historical building. The first two factors focus on probability of earthquake hazards, while the third factor focuses on consequences of the earthquake hazard (Liu, 2010). (see Figure 9).

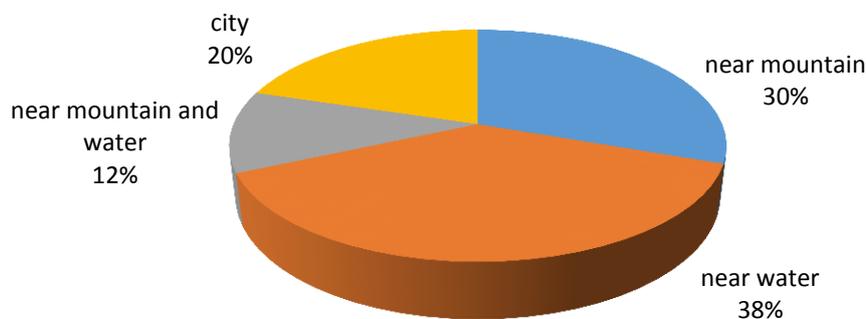
Figure10. Geographical distribution of historic buildings damaged by lightning (Source: Authors).

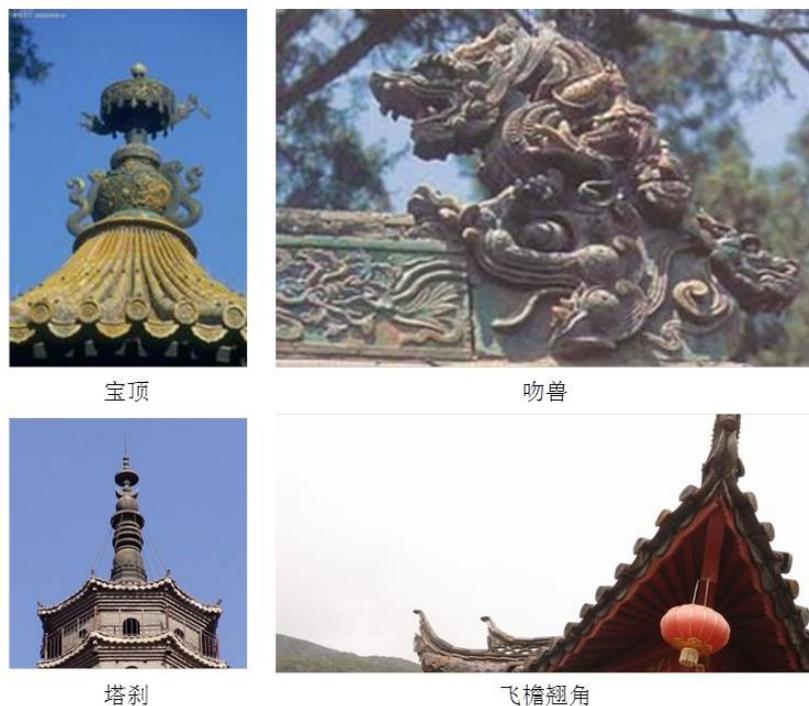
Figure11: Vulnerable positions of architectural heritage to lightning (Source: Authors).

The location, shape, structure and equipment of historical buildings may impact on the likelihood of the occurrence of lightning disaster. For practical reasons, traditionally in China, people often chose hillsides or mountain bottoms to locate their buildings and these were often surrounded by water. These factors also make historical buildings vulnerable to lightning disaster. Among the 80 lightning strike accidents mentioned in Analysis on Lightning Disaster Features of Historical Buildings, 80% of the buildings struck were beside mountains, water, or both (see Figure 10). In addition, the structure and shape of architecture heritage also has an impact on the parts damaged by lightning. Protruding parts on the roof are highly vulnerable to lightning in historical buildings (see Figure 11). In addition, buildings with metal decorated parts are particularly vulnerable to lightning. Among the buildings struck by lightning, 30% were struck on a protruding part of their fabric and significantly, most architecture heritage does not meet modern safety standards (Tong, 2007).
