Restoration of Al-Abbas Mosque

Asnaf, Yemen

2004 Report: Reha Günay

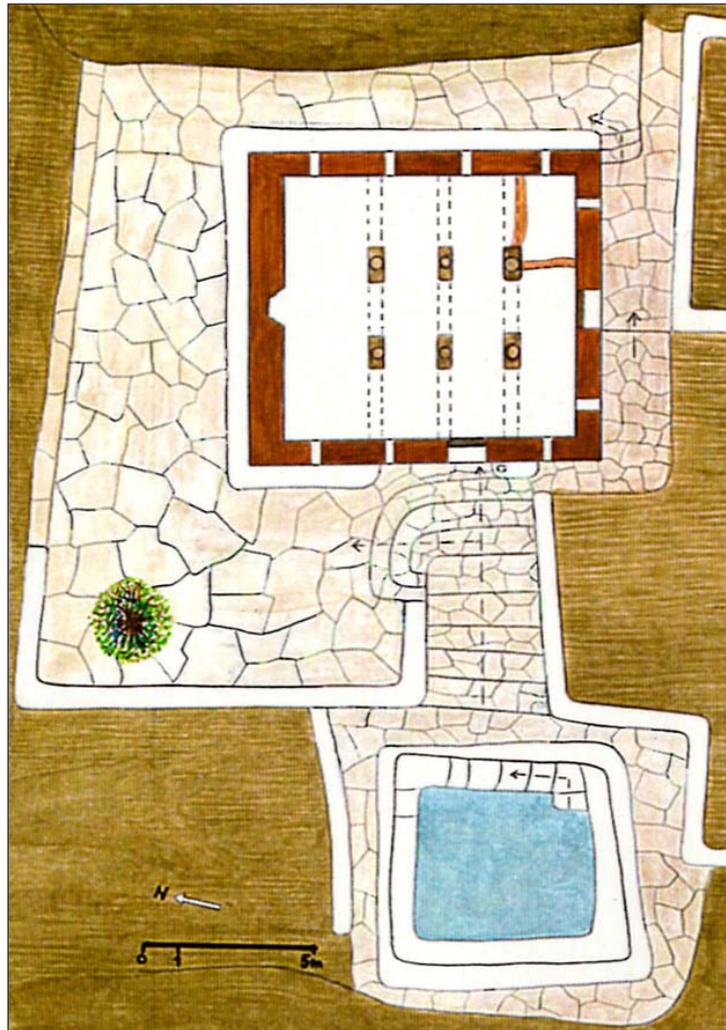
Plan

The mosque has an almost square plan with external dimensions of 10.4 to 10.6 metres by 9.35 metres, and a height of 6 metres. The roof is flat, making the building cubic in shape. The *qibla* wall is 90 centimetres thick, and the other walls are about 70 centimetres thick. Stone walls rise up to the door lintels, which are level with the base of the windows; above this the walls are of brick. The lower walls are constructed in cut-stone masonry of irregular size, while the bricks measure 18 x 18 x 5 centimetres. At the very top, in the restored building, bricks have been laid to form a crenellation pattern. Before the restoration, six merlons were recorded at various points on the roof. The mosque has two entrances: one on the south and the other on the west side. The eastern and western elevations each have four windows, and the southern one has three. The windows are very small and, according to documentation by archaeologist Barbara Finster, two of them originally had window panes formed by ornate sheets of alabaster.

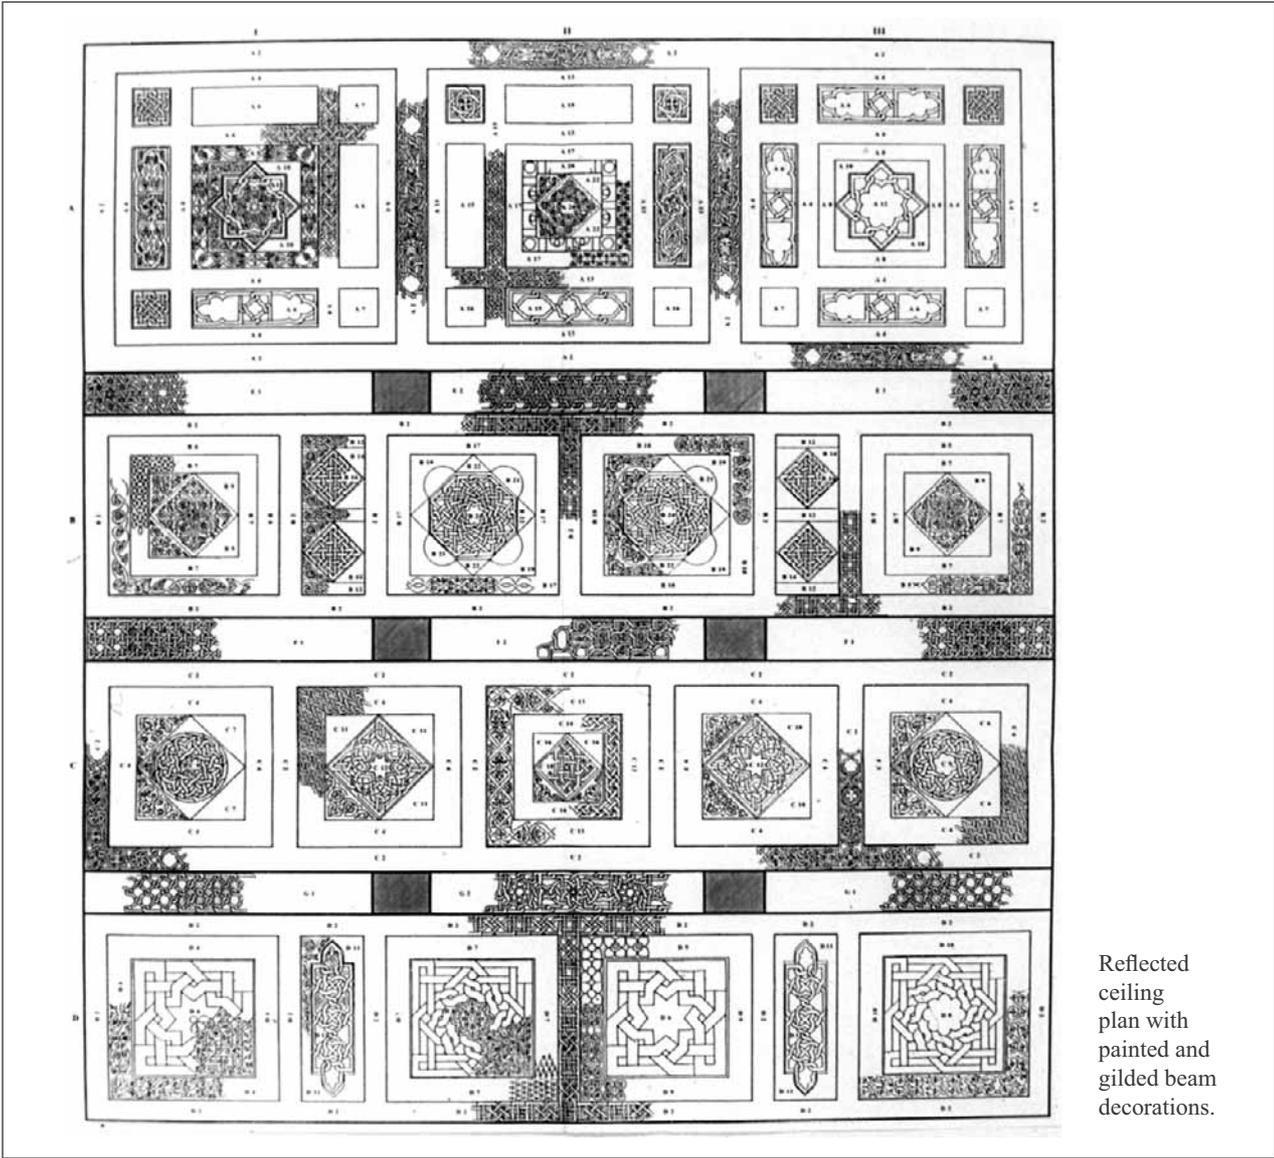
Reflected ceiling plan with painted and gilded beam decorations.

The ceiling beams run parallel to the *qibla* wall and rest on column capitals, 4 metres above the floor. The whole ceiling is divided into four sections running parallel to the *mihrab*. The section in front of the *mihrab* is larger than the others. Starting at the *mihrab*, the first section has three square bays or caissons; the second nave has four large and four small square caissons, the third has five square caissons, and the last one has four square and two rectangular caissons. Each caisson is separated from the others by beams, and rises in several steps like a pyramid; in other words it is a coffered ceiling.

Beginning from the entrance, the caissons keep rising as they approach the *mihrab*; the caisson in front of the *mihrab* is the highest and has seven steps, pointing to the *mihrab*. According to Islamic symbolism, this succession can be interpreted as the seven layers of heaven.

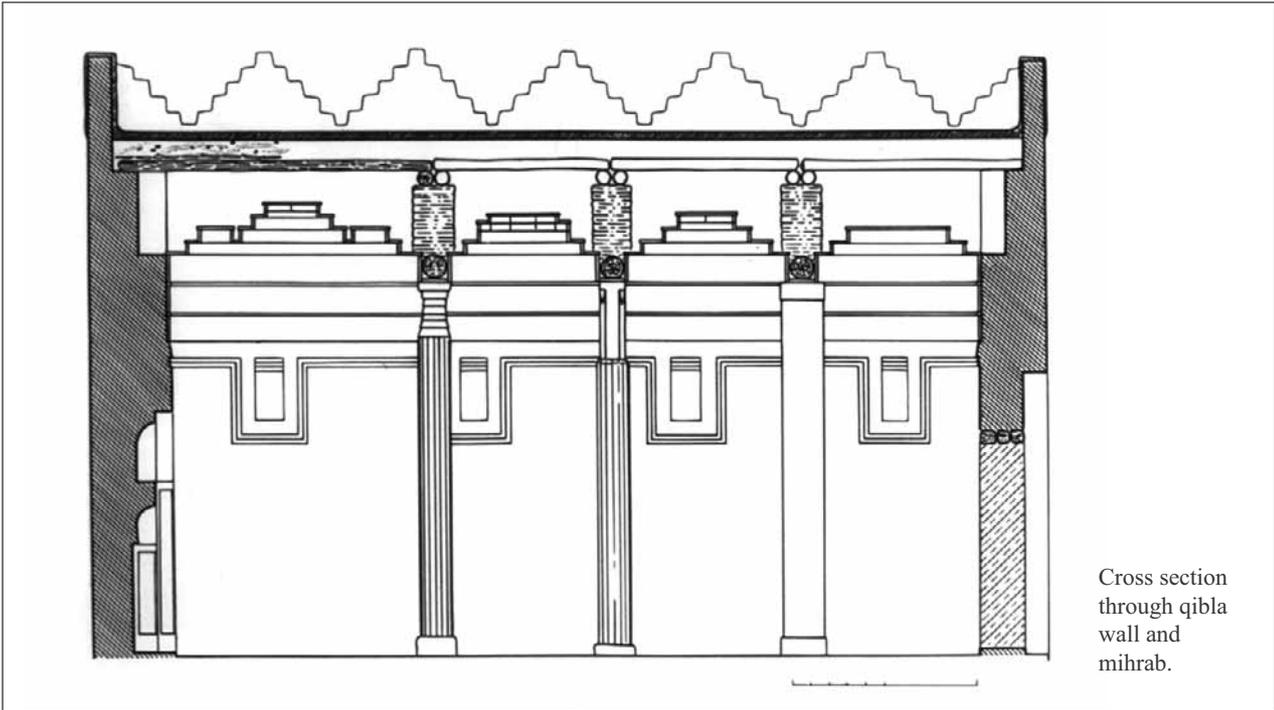
Cross section through qibla wall and mihrab.

The *mihrab* is formed by a double recess in the thick wall, which is not visible from the outside. At its corners are four brick pilasters. On top of these, two pointed arches, one inside the other, crown the *mihrab*. Around the arches is inscribed the name of the architect. An inscribed frieze delineates the rectangular frame of the *mihrab*.

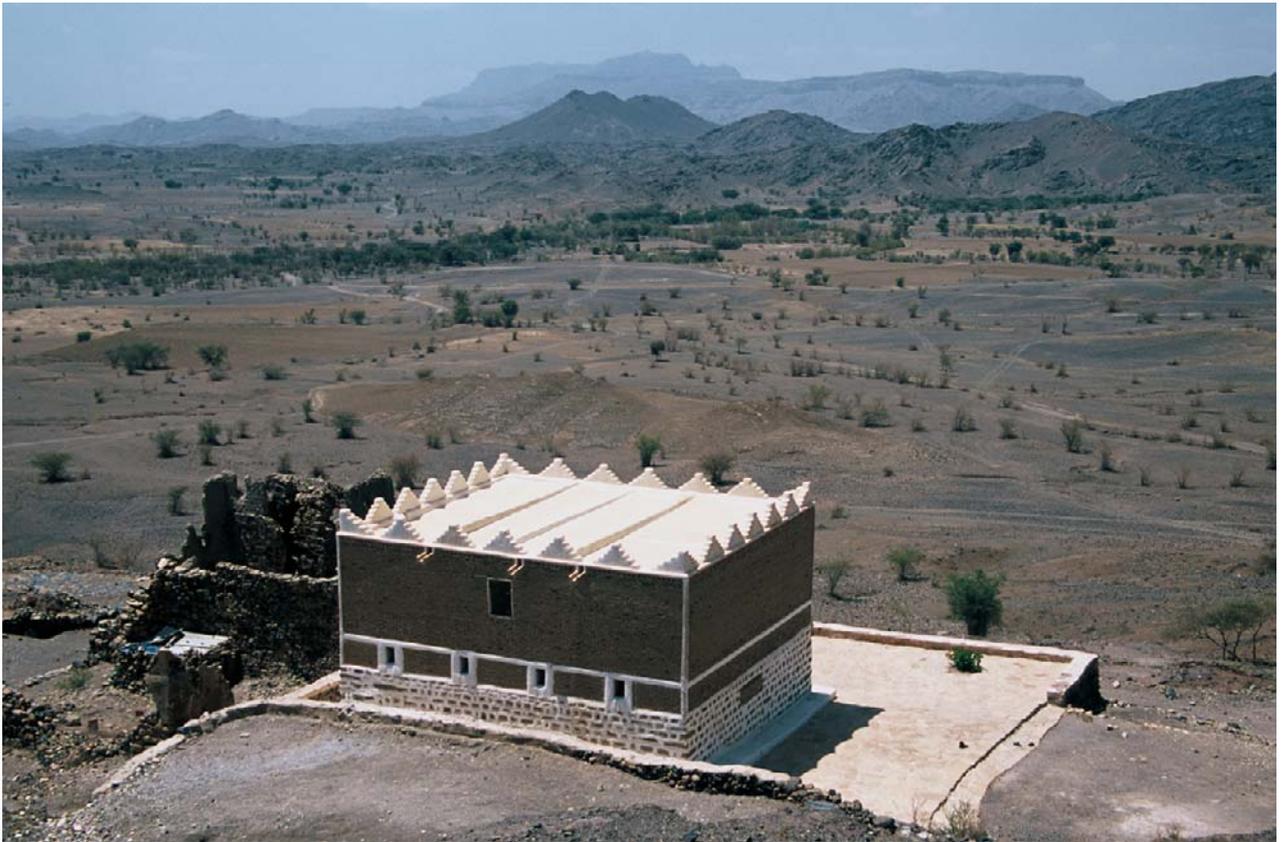
(After restoration) Al-Abbas Mosque is located 38km southwest of Sana'a near the village of Asnaf. The ruins of an earlier mosque and a stable can be seen at the left of the mosque.

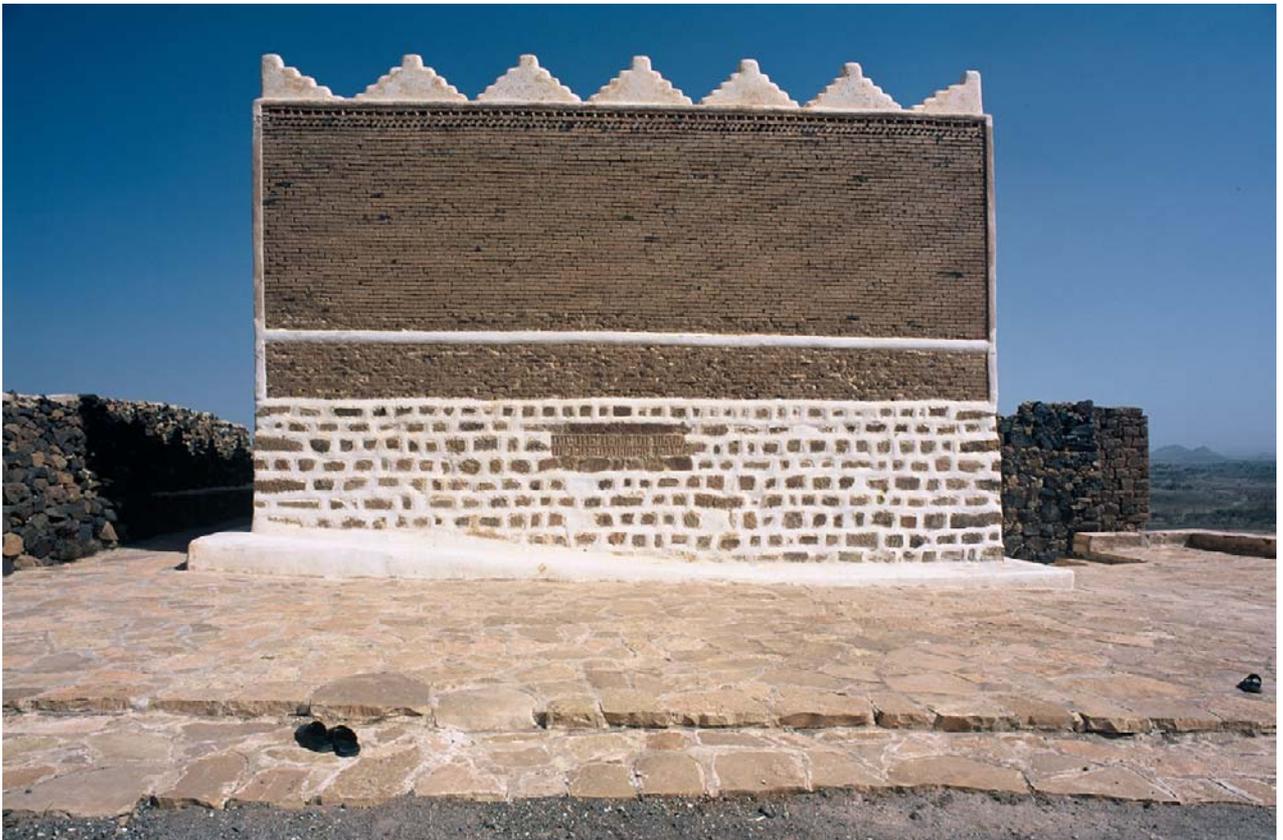
The north (qibla) wall after restoration. The outer façade of the qibla wall features an engraving in Arabic; the epigraph dates to the 2nd century.

On the exterior face of the *qibla* wall an inscription – actually an antiquity from southern Arabia, dating to the second century AD – is set at eye level. The inscription tells of the foundation of a meeting room at the time of a king of Saba and Dhu Raydan. A stone bench, around 30–40 centimetres in height, surrounds the mosque. A sunken water jar just outside the west door is used by worshippers to wash their feet before entry.

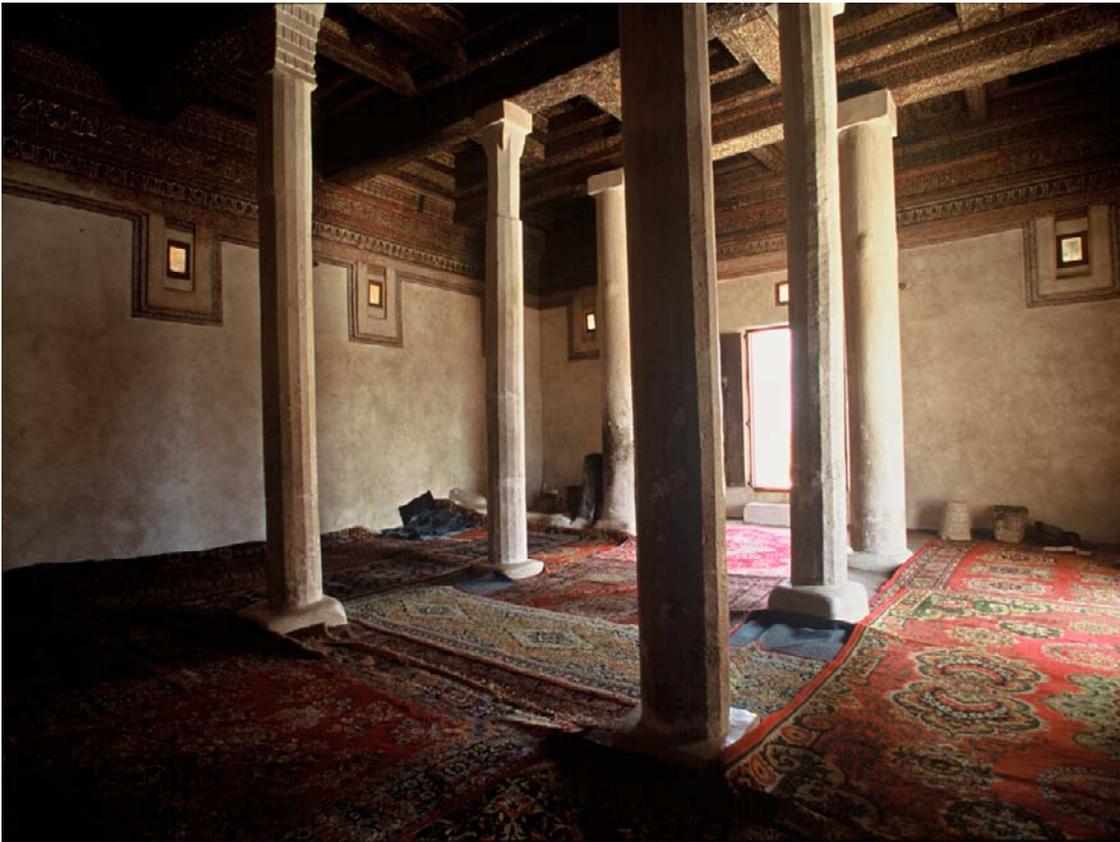
Prayer hall interior, rising to a height of four metres. (After restoration.)

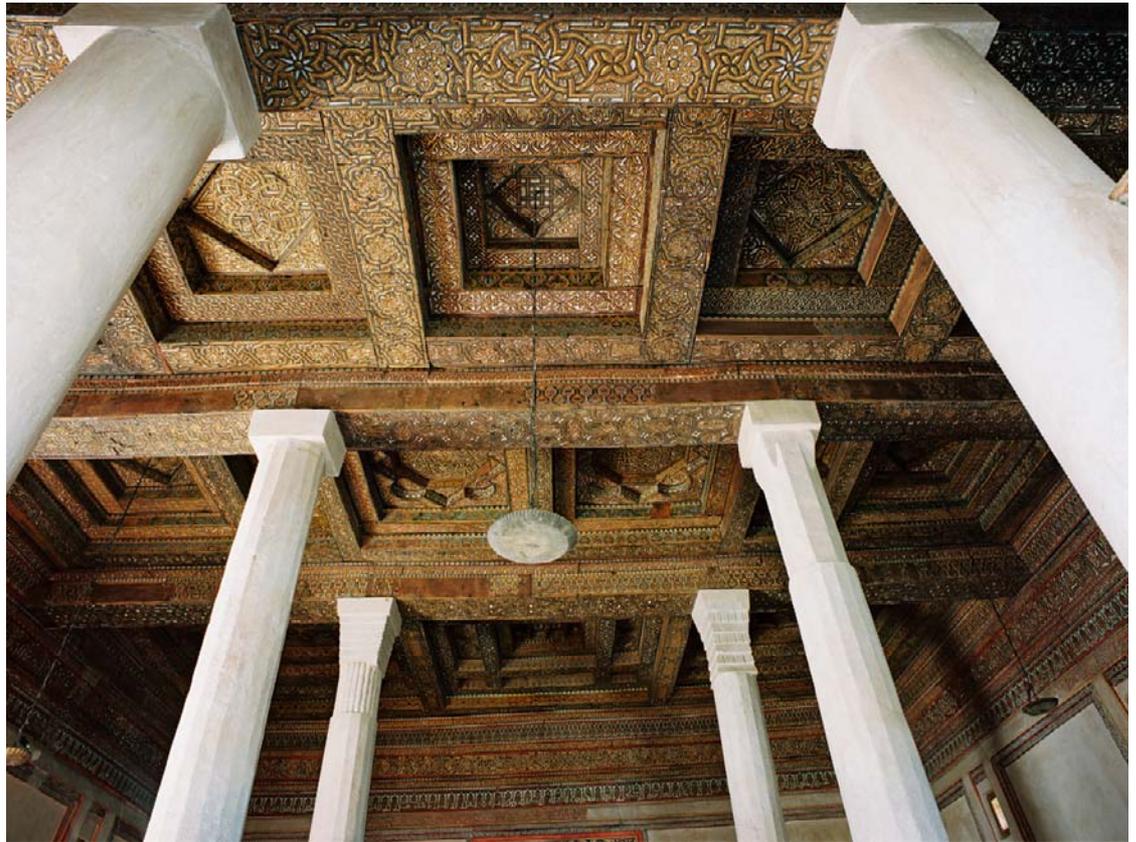
View of the coffered ceiling after restoration.

The restoration of the ceiling consisted of cleaning, consolidation and replacing any damaged pieces of wood. The most important tasks here were to reassemble a thousand or so individual pieces, and to support the aged and weakened boards by putting a new carrying structural case inside the old one – a rather ingenious invention.

After the completion of the roof, the pieces of ceiling were painstakingly assembled in the museum like a puzzle and then numbered. (The task was all the more difficult since, in the rush of removing the original pieces, no attention had been paid to numbering them.) They were then transported to the mosque, one row at a time. At first the U-shaped supporting boards, then the decorated beam enclosure boards, and finally the caissons were put in place. The supporting system that was used is a very sophisticated one. By inserting U-shaped boards into the old weak boards, an invisible support was provided.

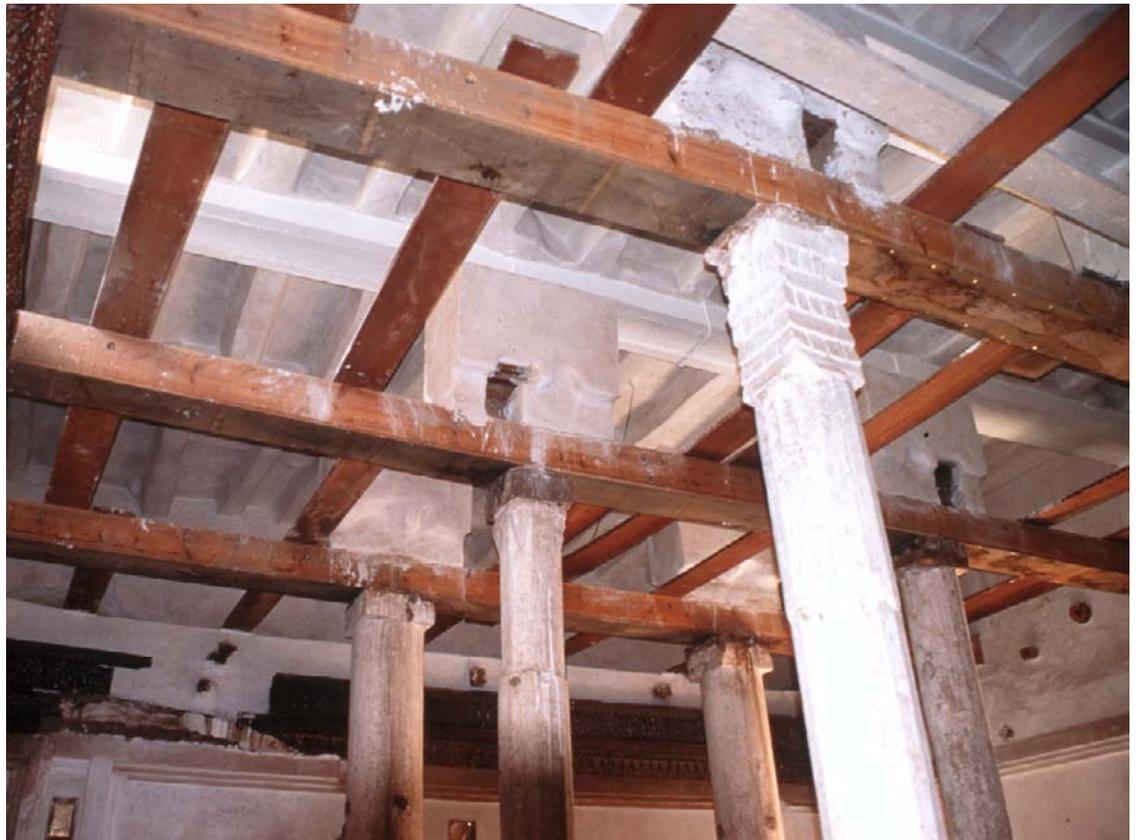
During restoration, the ceiling was entirely dismantled and removed to the National Museum in Sana'a for cleaning and repair.

The aim of all interventions was to eliminate the damage to the ceiling and the overall structure. In 1986 the coffers on the ceiling were dismantled and transported to the museum in Sana'a. Before putting the restored pieces in place, it was evident that major repairs would have to be made to the roof. At that point the restoration of the building came to life.

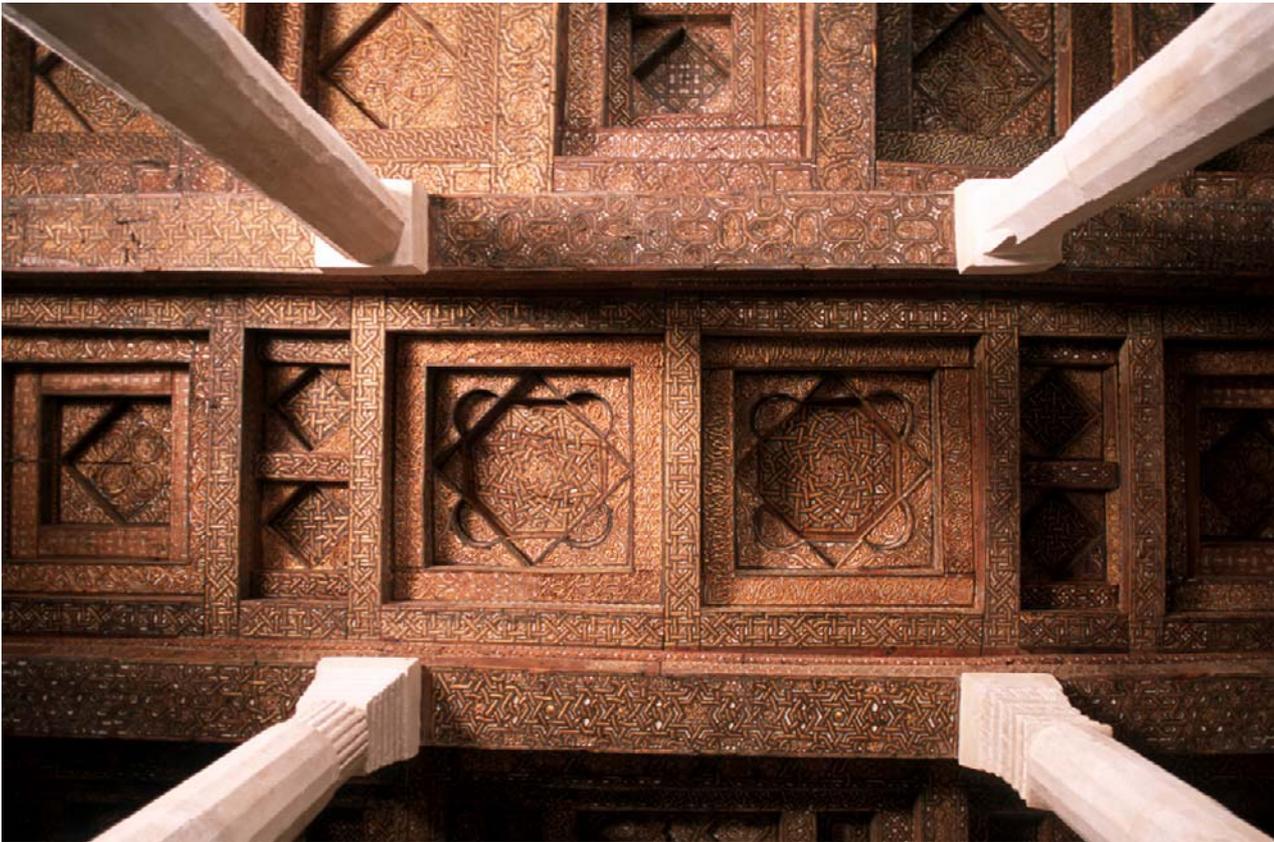
View of the central caissons of the ceiling, after restoration.

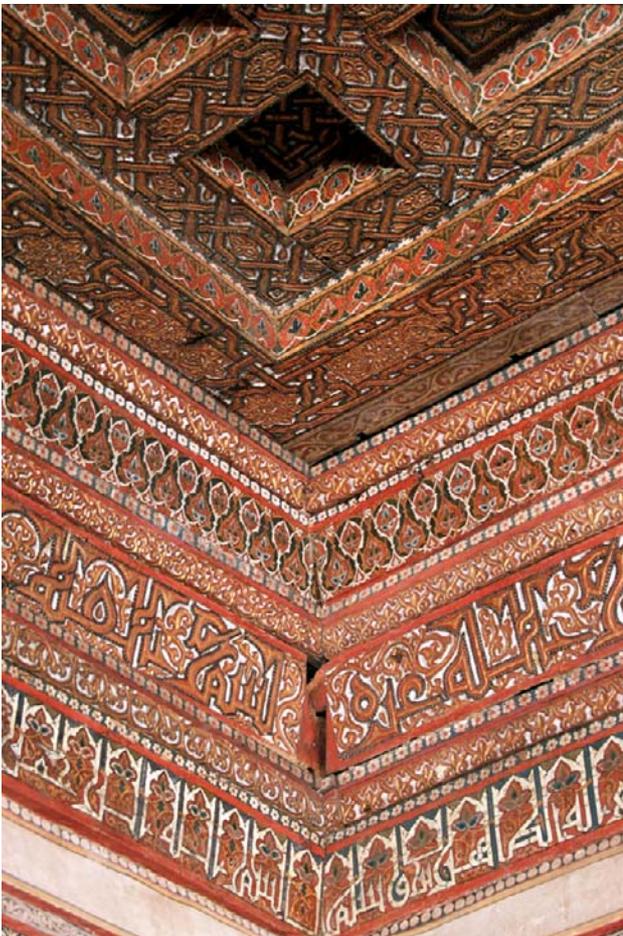
Corner detail showing the triple-band frieze at the top of the wall with floral ornaments and Kufic inscriptions, after restoration.

A triple-band frieze runs around the top of the inside walls, directly below the ceiling beams. The lowest band is made of gypsum, the same material as that used around the windows. At the outer edge of the band are floral ornaments, while the inner edge has inscriptions (faded in places). Next to this gypsum band are two parallel wooden bands bearing Kufic inscriptions in two different styles. Together the bands measure 90 centimetres in width. Since they share the same colours and style as the ceiling, the overall effect is to make the ceiling look much larger.

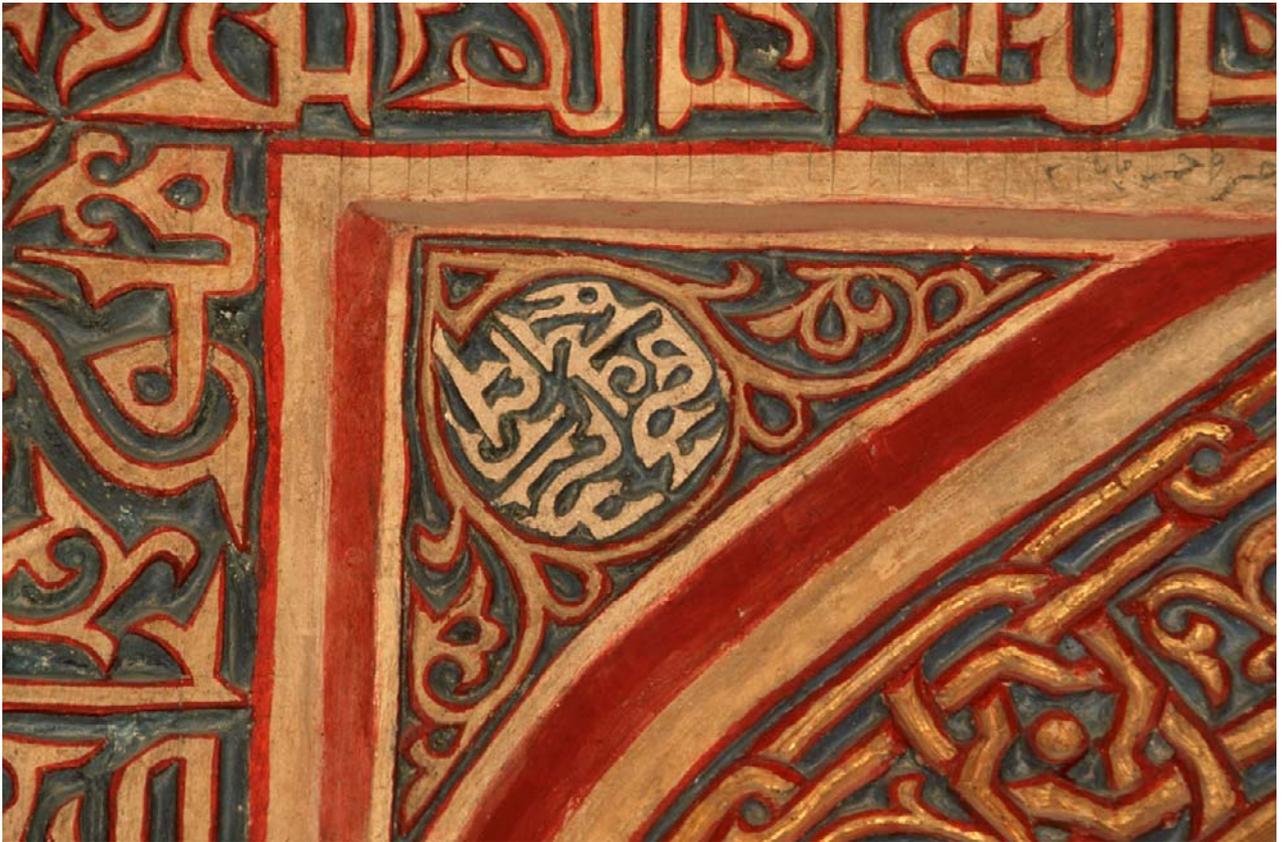
Detail of the carved plaster ornamentation, painted and gilded, after restoration.

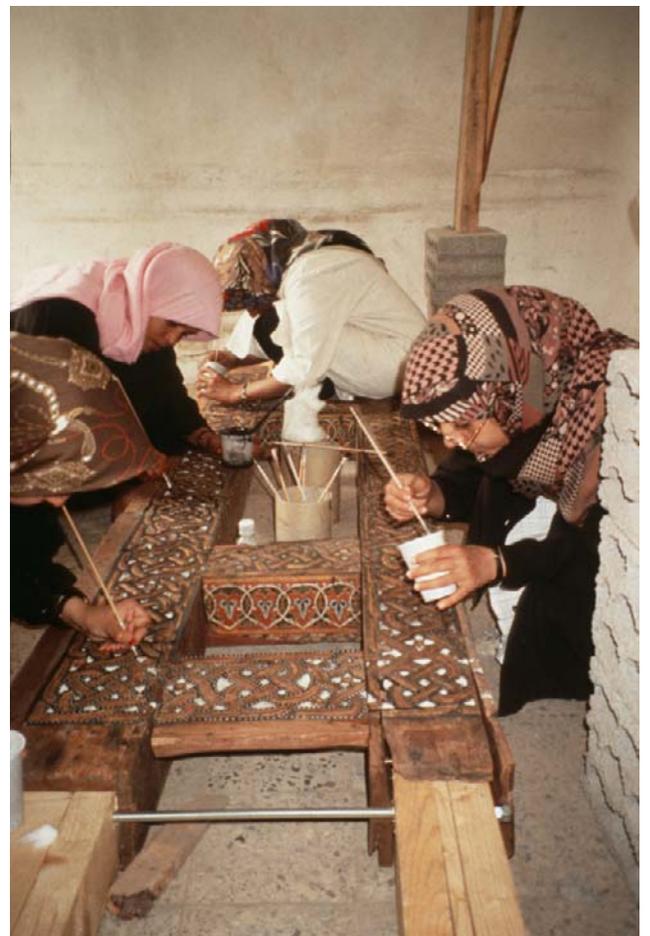
Cleaning and repair of the dismantled ceiling took place in the National Museum in Sana'a, training Yemenis in modern restoration techniques.

Modern techniques and materials, of course, were used for cleaning and repairing the ceiling. Cracked pieces of wood were either reinforced with another layer added to the back or with thin, short strips of wood placed at right angles at the back of the crack, so that the board would become stronger but not too rigid. The ceiling boards, however, had disintegrated over the centuries and were thus too fragile to fix with nails, and so stainless steel screws were used. Some boards did not need any reinforcement and so were left alone. New oak for the vertical support of the beams was imported from France, and spruce for the horizontal elements came from Sweden. All new timber that is not seen from the outside is treated against fungi and insects.

For the repair of the decorated panels, old timber was used wherever possible. Different methods were applied to clean away dust and soot. A mixture of solvents was applied with a cotton swab. Where the paint was powdery and flaky, it needed to be softened with a solvent before being fixed with a diluted resin. The cleaning process was slow and required much patience. The museum provided a suitable place for this work. If the original paint had been washed off, it was left as it was. If a new board was used, it was either left without any ornamentation or decorated only on the two ends with watercolour, leaving the middle part unpainted. Some parts of the decoration were left untouched so that the difference between 'before' and 'after' could be seen. One board with a very well-preserved original decoration was left in the museum as a safety precaution against fire. The new watercolour decorations, either on the *mihrab* or on wood, were made waterproof chemically. If a new board was used to replace a carved, painted and gilded horizontal element, it was not carved but painted to create a three-dimensional *trompe l'oeil* effect. Xylophene was used as insecticide and Xylamon as an insecticide and a reinforcing medium. Sader R 41 was the wood glue; Paraloid B72 mixed three per cent to ten per cent in perchloroethylene, or sometimes in acetone, was the fixing material available in Sana'a. A mixture of ethyl alcohol with various quantities of dimethyl formamide was used to clean the paint. To fix some surfaces perchloroethylene and acetone were used.

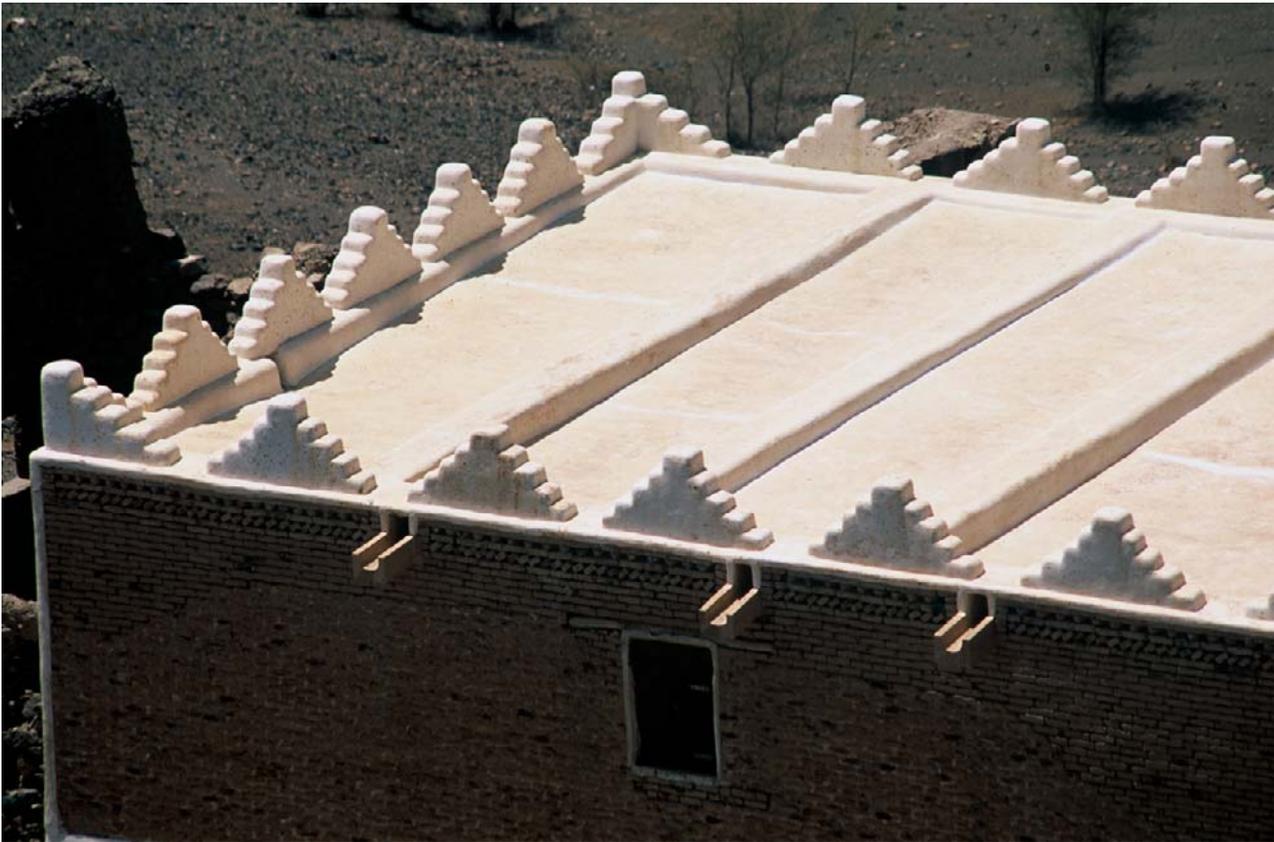
View of the roof after restoration. The exterior was finished with “quadad” plaster; some of the crenellated merlons that were missing were reconstructed.

Renewal of the roof was possible only after the ceiling's old beams had been supported with new ones. Over the column capitals, brick piers were rebuilt in the original size to hold the beams of the new roof. The roof was constructed in the same way as the original one. Earth was laid on the roof and given five months to settle down before the application of *qadad*. The only thing that is different from the old is the plastering inside the attic. This plaster coat preserves the wood of the roof and prevents dust from falling onto the ceiling.

On the old roof there had been only one rainwater outlet, via a channel on the west wall. This was considered insufficient because of the risks that water penetration poses in preservation. So shallow walls were built to divide the roof into four sections, and a waterspout attached to each of three sections. For the fourth section, the old water channel on the wall was re-utilized. These stone waterspouts are the only new elements in the restored building. Also restored were the merlons that form the crenellation on the roof. From the six merlons that survived in different parts of the roof it was possible to tell the exact shape and location of the originals, so that the missing ones could be placed correctly. All new merlons were built out of bricks, as previously.

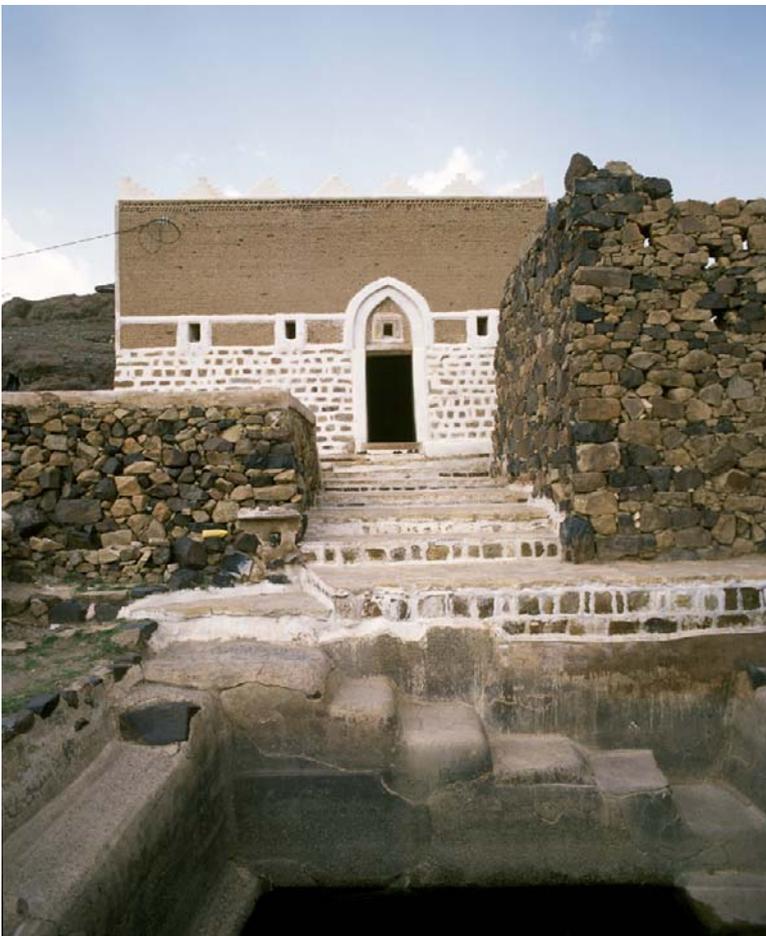
After restoration. View of one of the two entrances to the mosque, this one on the west façade. The cistern or ablutions tank can be seen in the foreground.
