AGA KHAN TRUST FOR CULTURE

# HERAT OLD CITY: MALIK COMPLEX

## ■ MALIK MOSQUE & CISTERN, BAR DURRANI QUARTER

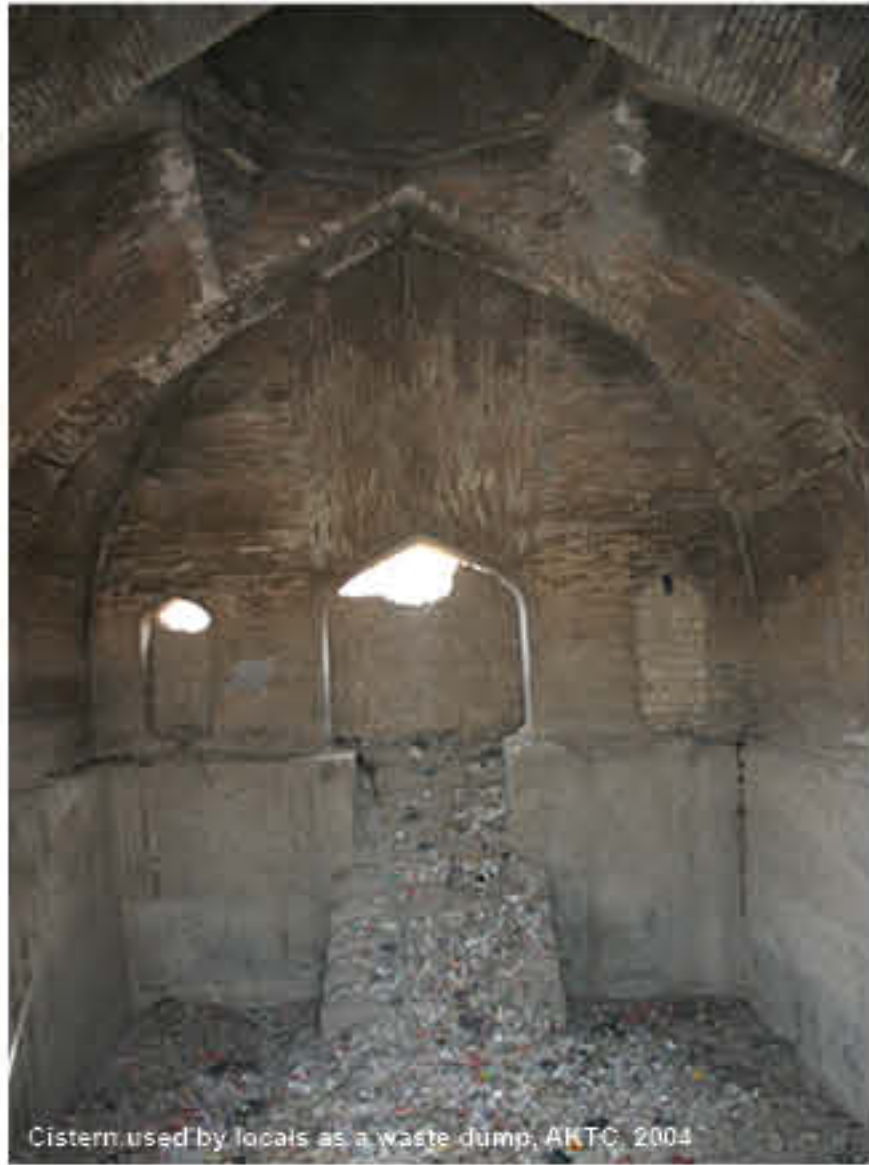
Cistern used by locals as a waste dump, AKTC, 2004

Restoration of the Malik complex began in early 2005 with the clearing of waste from the interior of the cistern and removal of accumulated earth from the dome. Following inspection, work was begun to support the brick dome spanning over the semi-underground rectangular cistern, with repairs carried out using traditional fired bricks laid in lime mortar. During the course of repairs, traces were found of a plinth that had been reconstructed in order to protect the building from traffic along the adjoining street. Restoration work on the Malik Cistern was completed at the end of 2006.

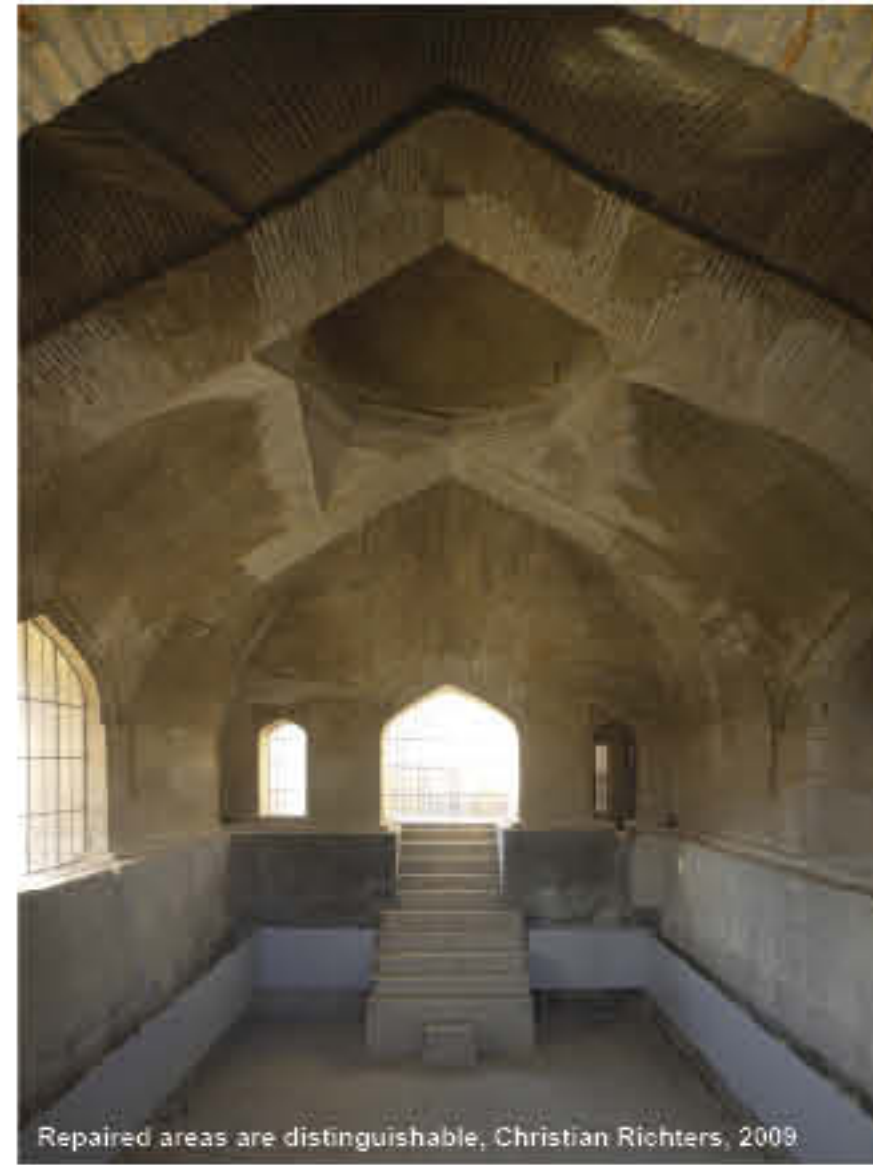
Repaired areas are distinguishable, Christian Richters, 2009

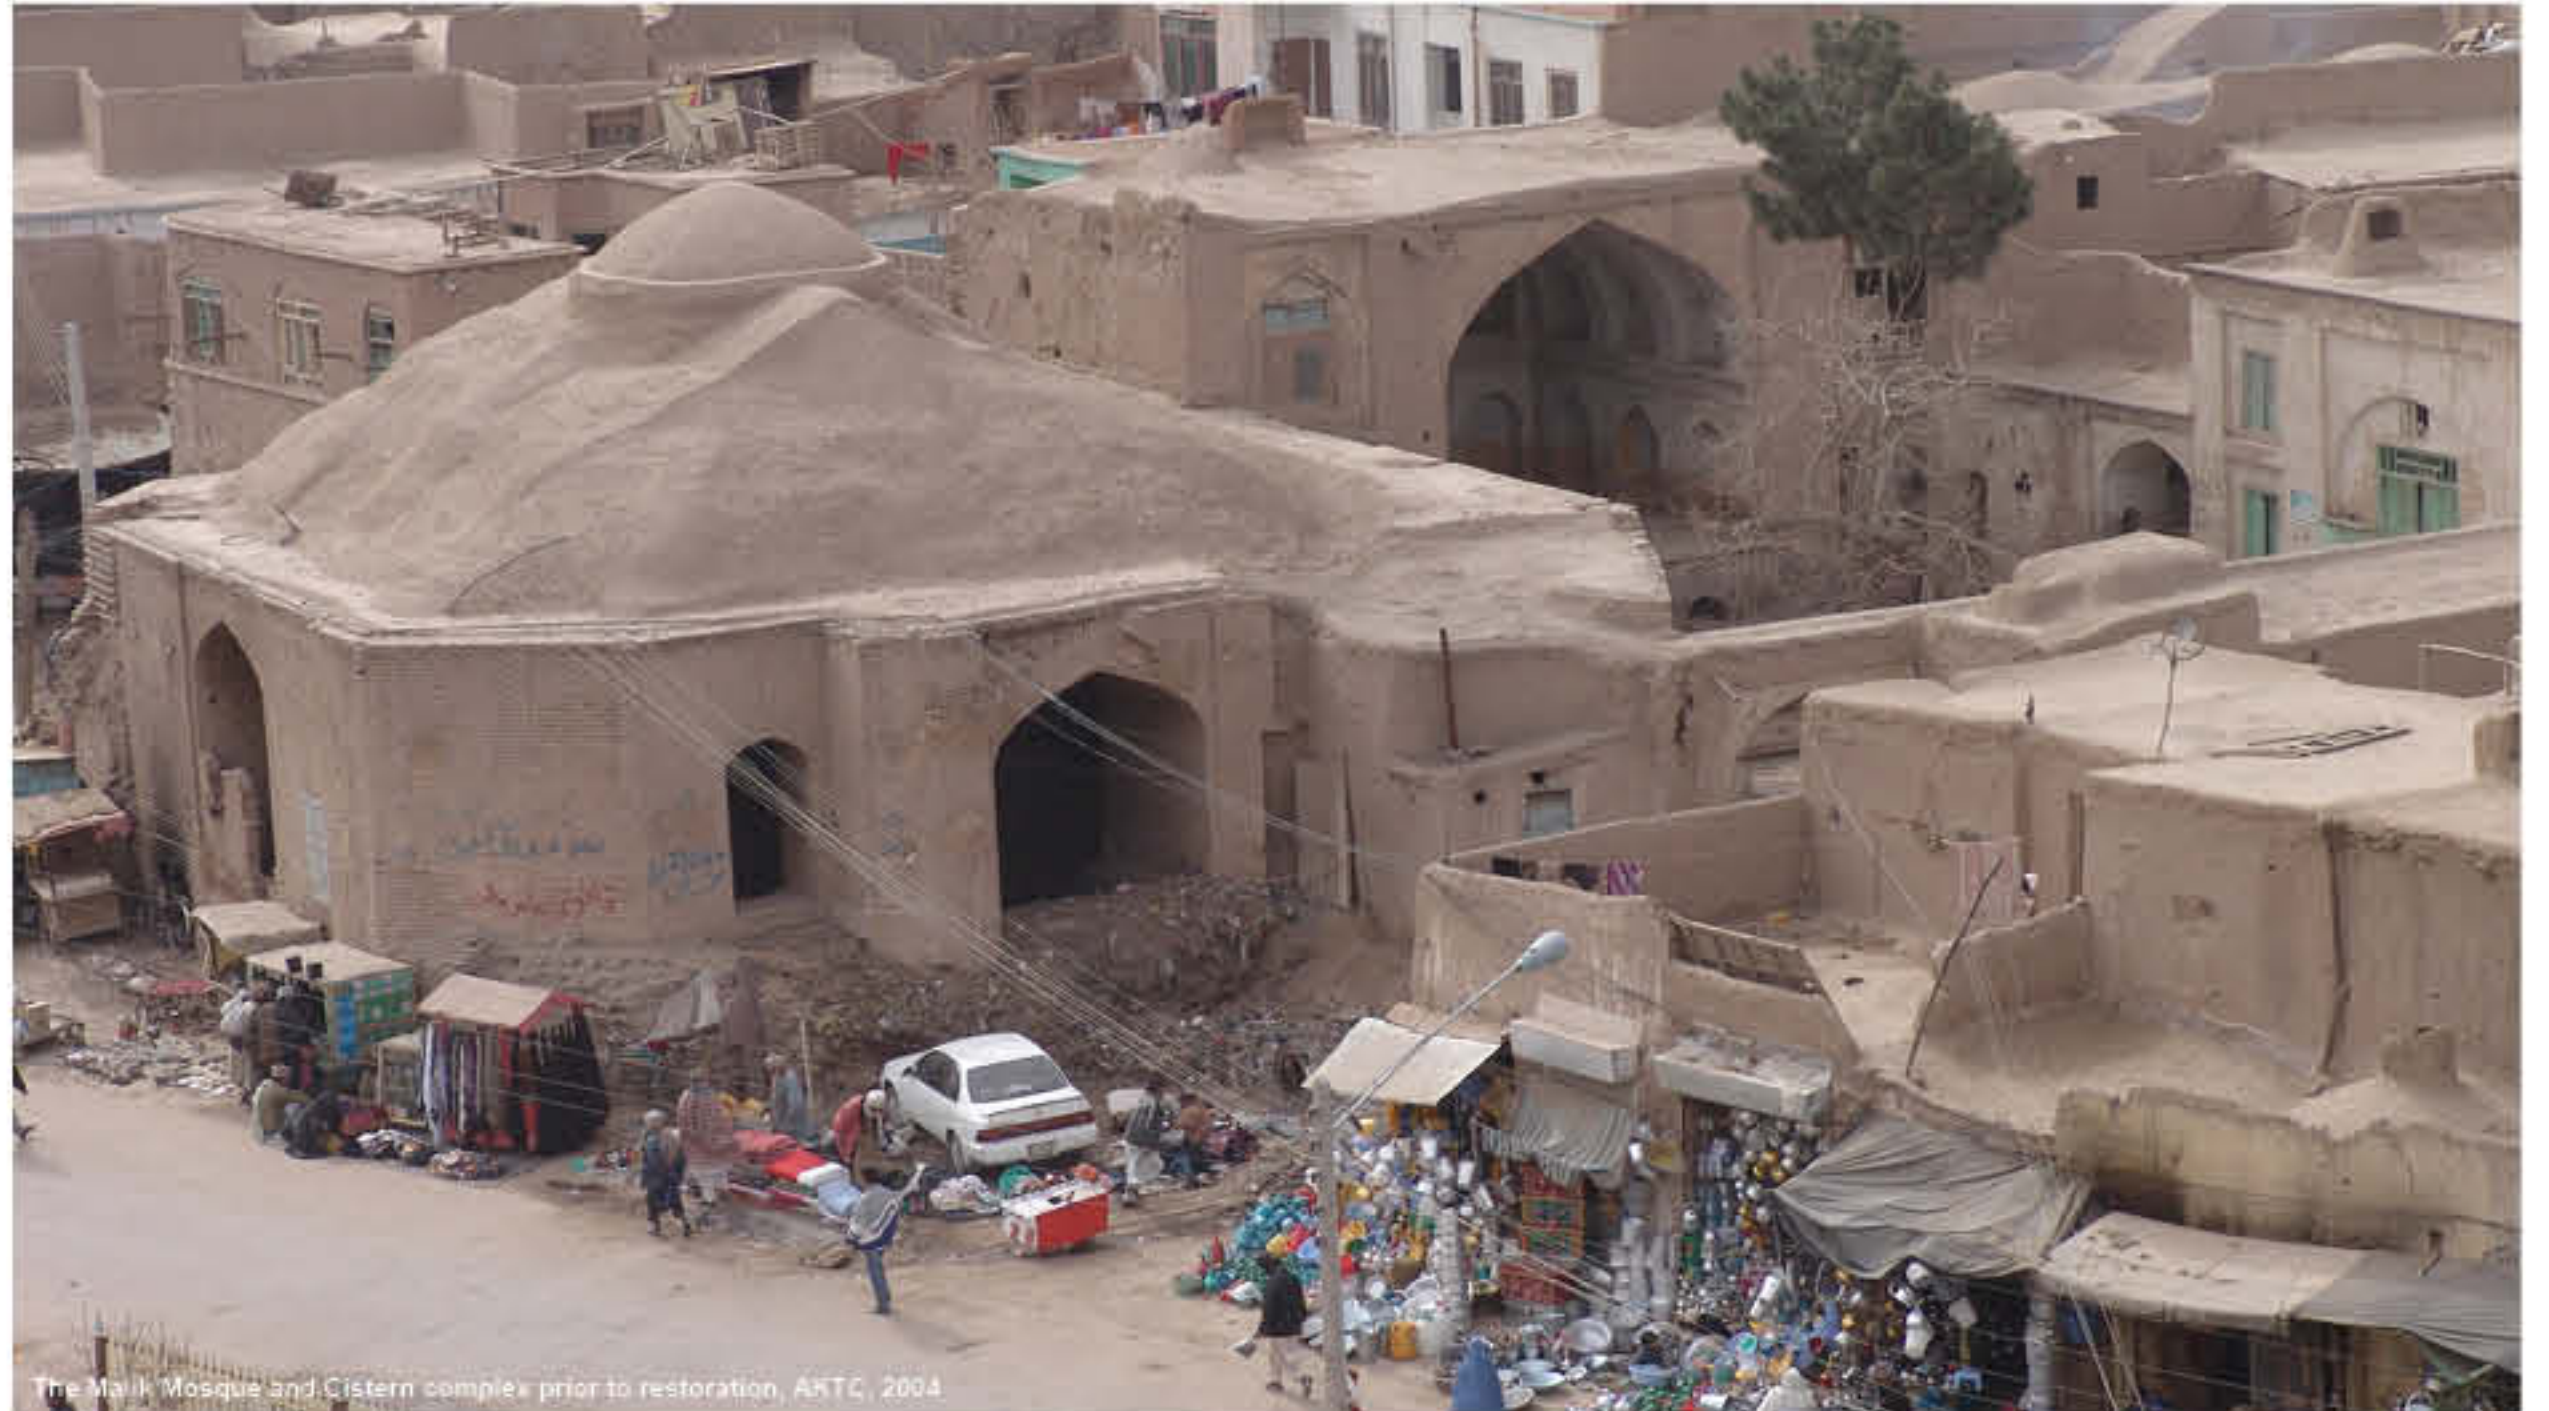
The Malik Mosque and Cistern complex prior to restoration, AKTC, 2004

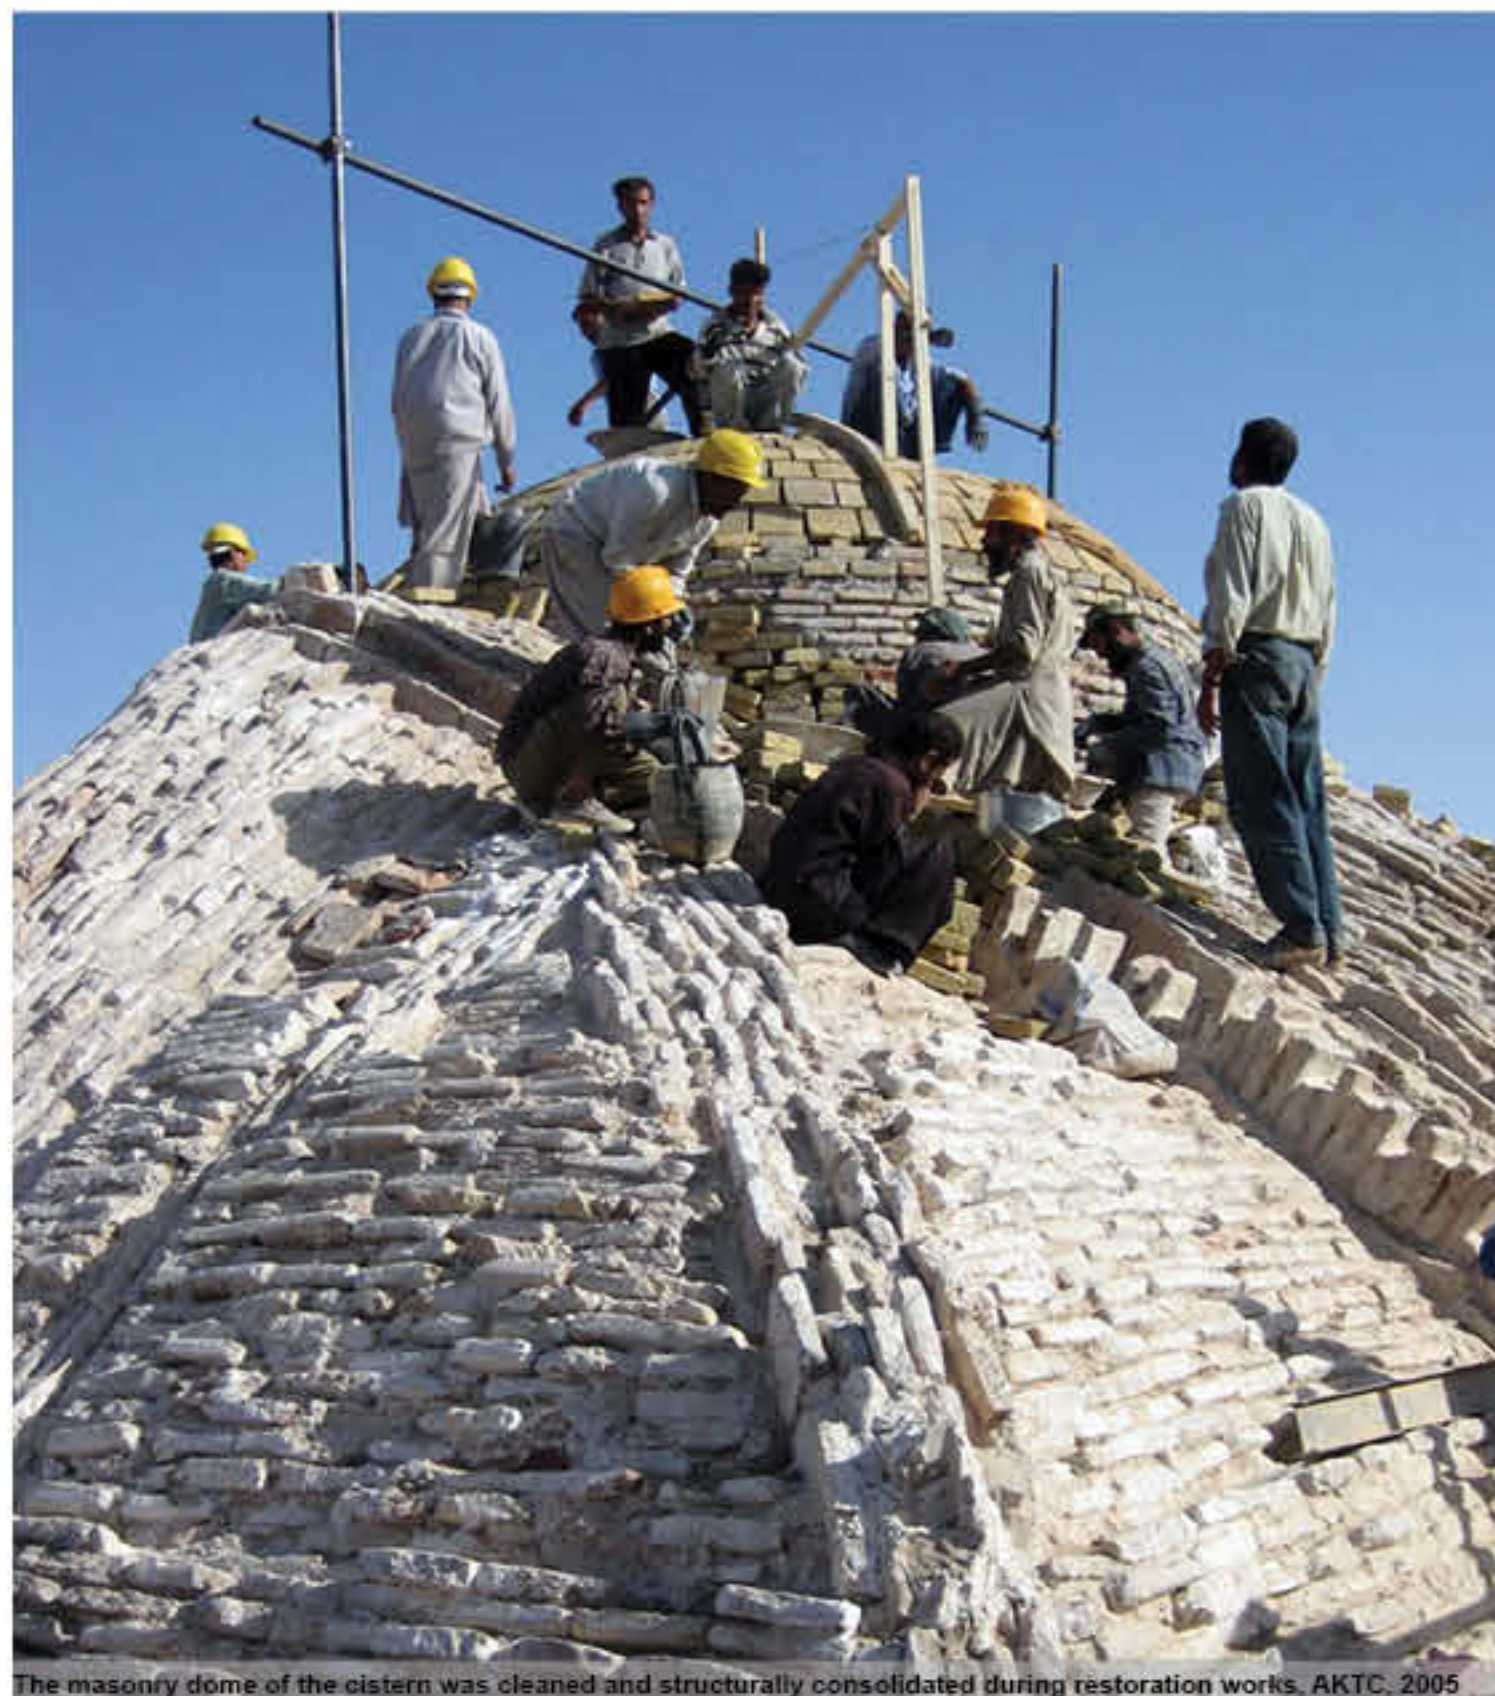
The masonry dome of the cistern was cleaned and structurally consolidated during restoration works, AKTC, 2005

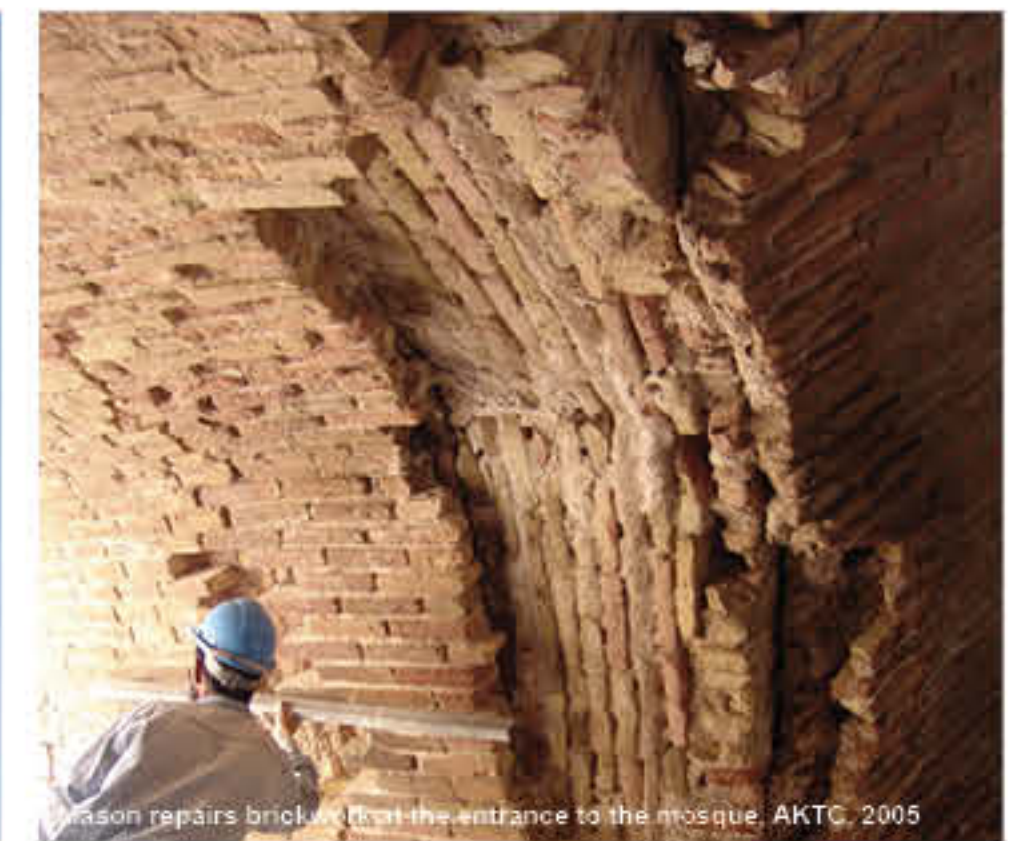
Mason repairs bricks at the entrance to the mosque, AKTC, 2005

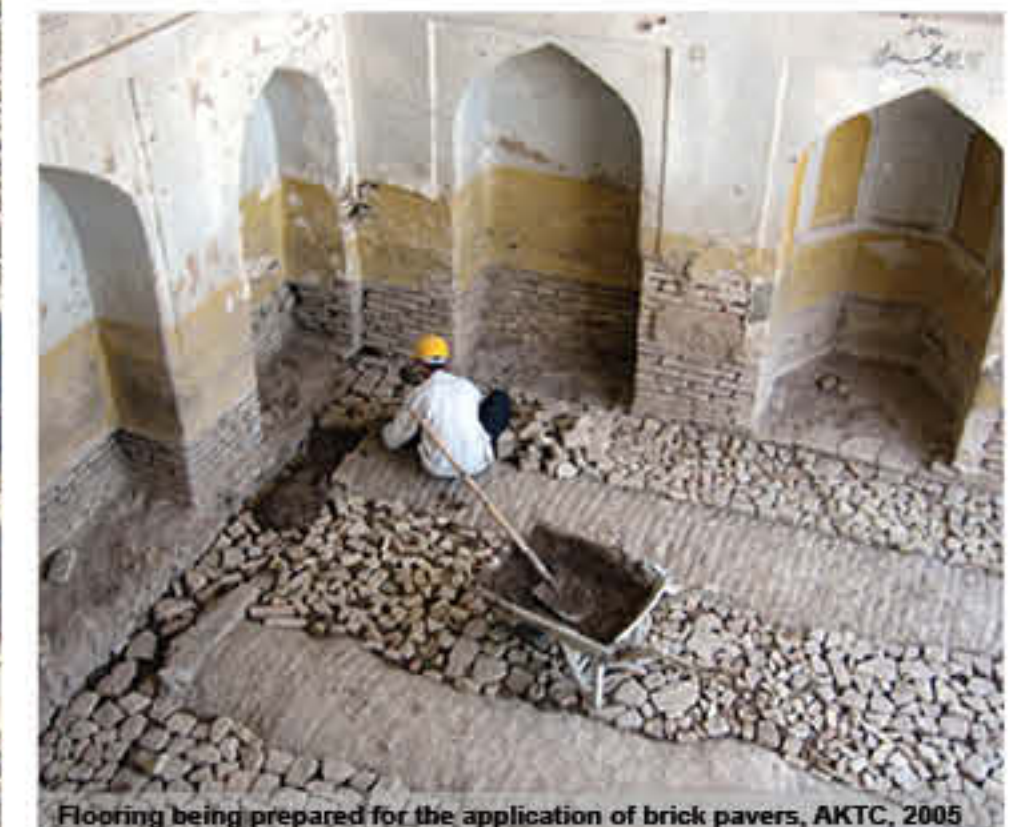
Flooring being prepared for the application of brick pavers, AKTC, 2005

Restoration work was initiated in early 2006 on the summer mosque. Using fired bricks applied with lime mortar, repairs were carried out to the *ivan* over the main prayer space. Following the removal of a modern concrete floor in the prayer space, the substructure of parallel brick vaults was repaired, and the area was repaved. Prayer rooms on the upper level were repaired and their wooden screens were restored. Restoration work was completed by early 2007. During the course of work in 2006, modern cement plaster and flooring were removed from the interior of the winter mosque, and modern plaster on the east elevation was removed. The restoration of this elevation has entailed the reopening of the central arch to the courtyard and the installation of traditional windows in the openings on the upper floor. This project received an Award of Excellence in the 2008 UNESCO Asia-Pacific Heritage Awards for Cultural Heritage Conservation.

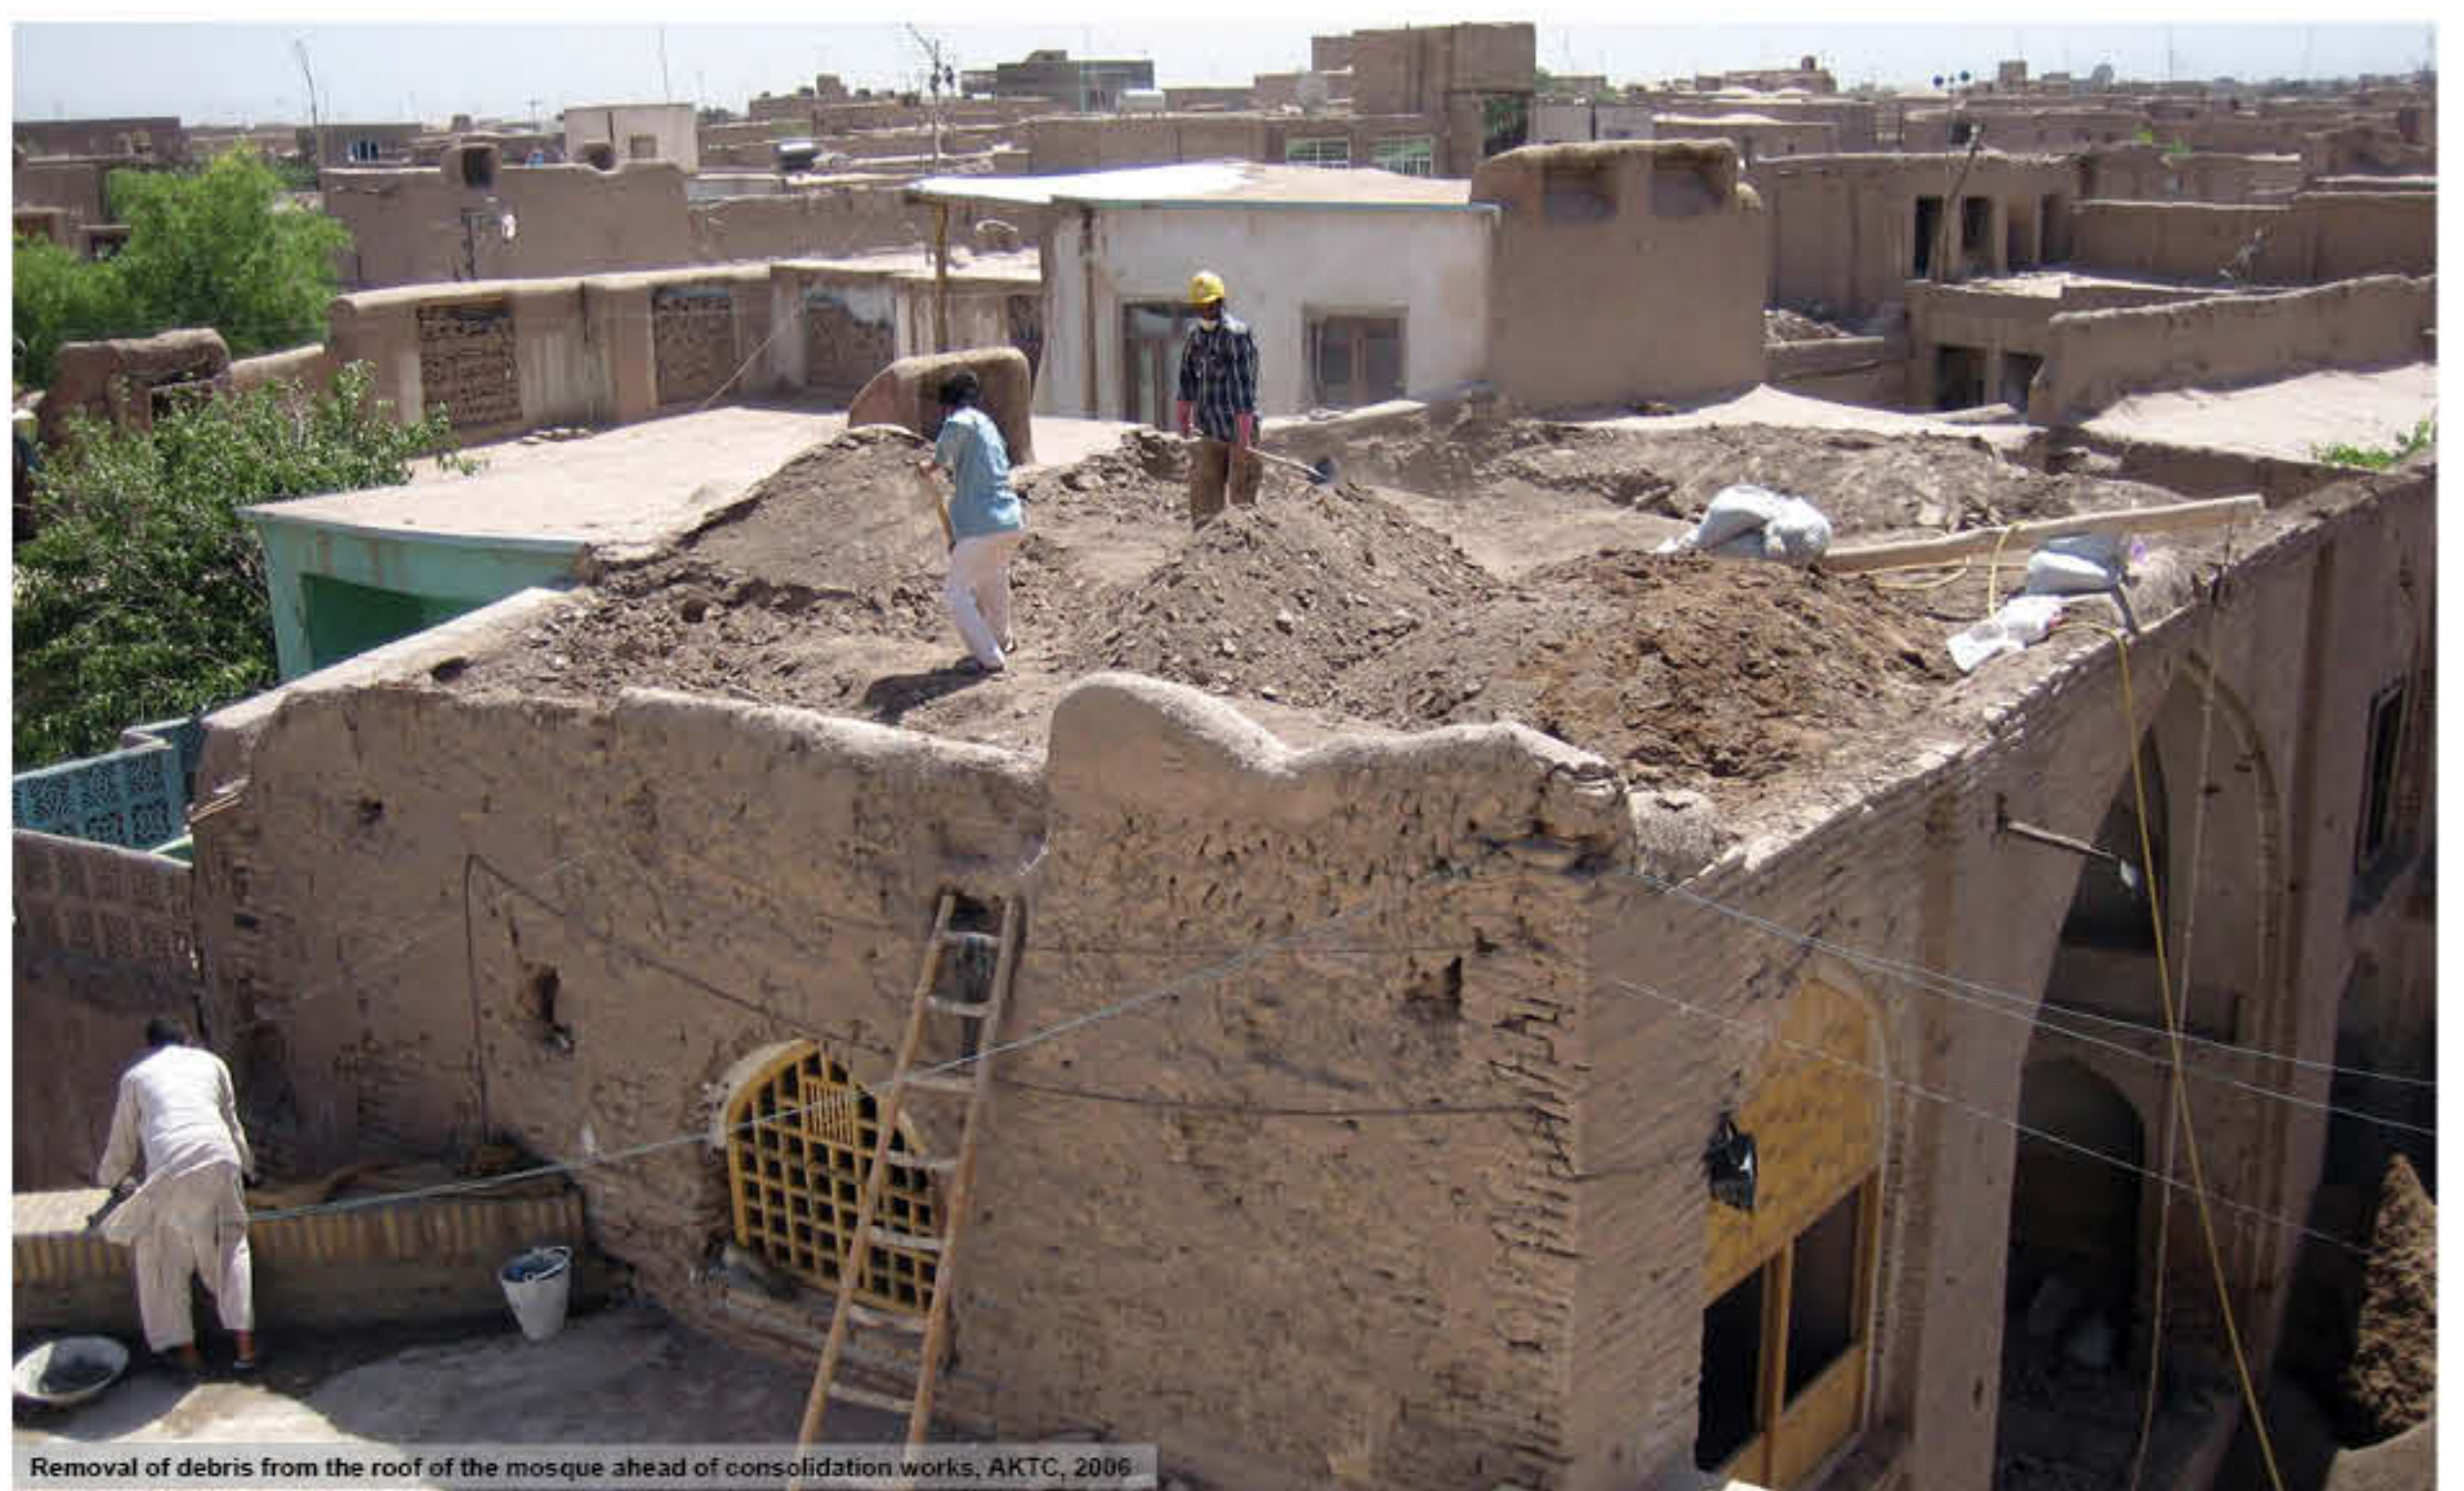
Removal of debris from the roof of the mosque ahead of consolidation works, AKTC, 2006

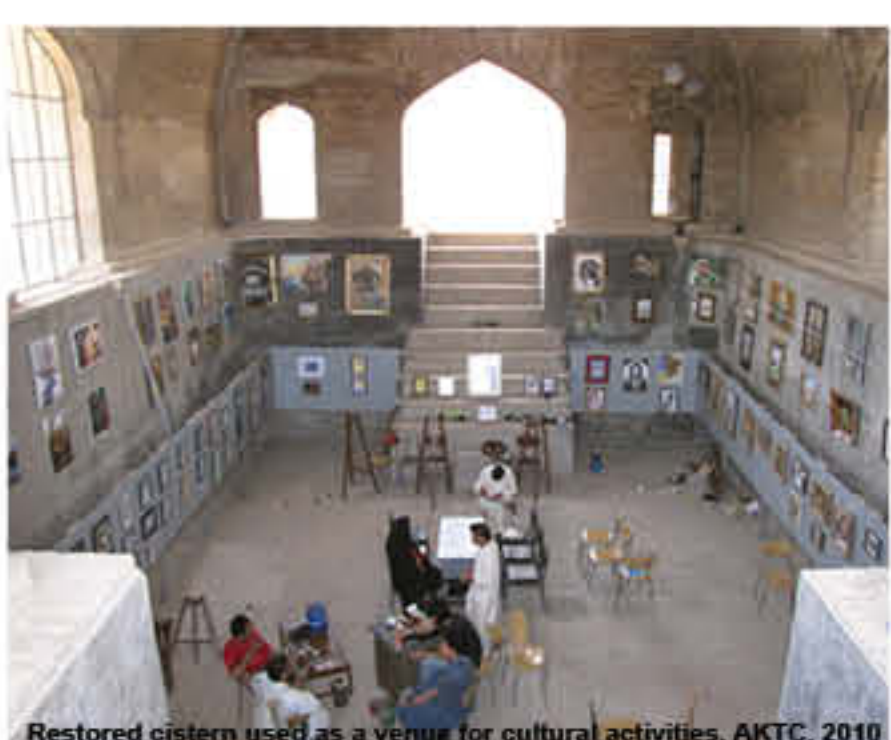
Restored cistern used as a venue for cultural activities, AKTC, 2010

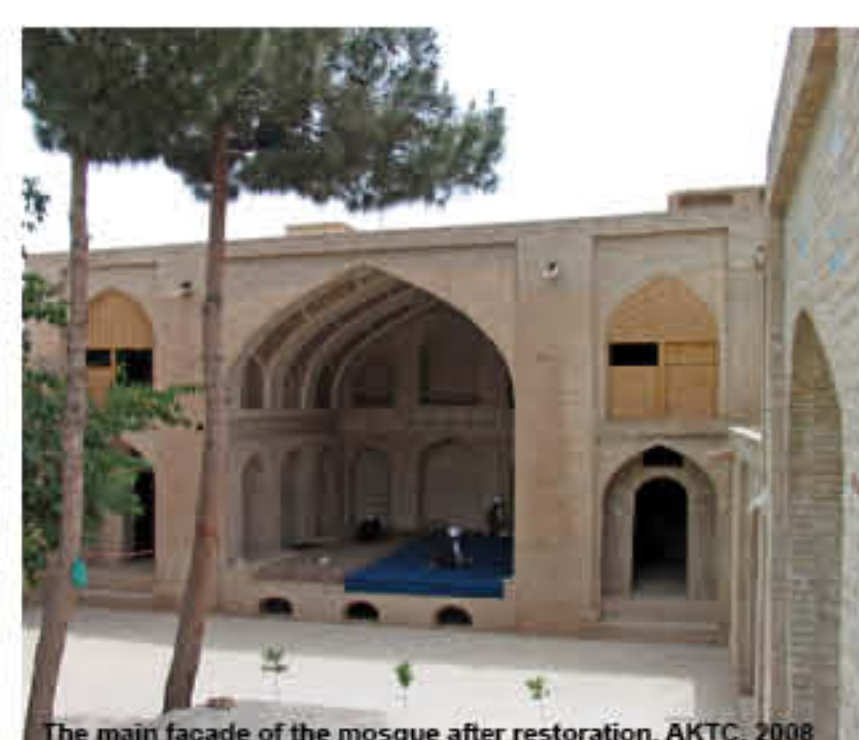
The main façade of the mosque after restoration, AKTC, 2008

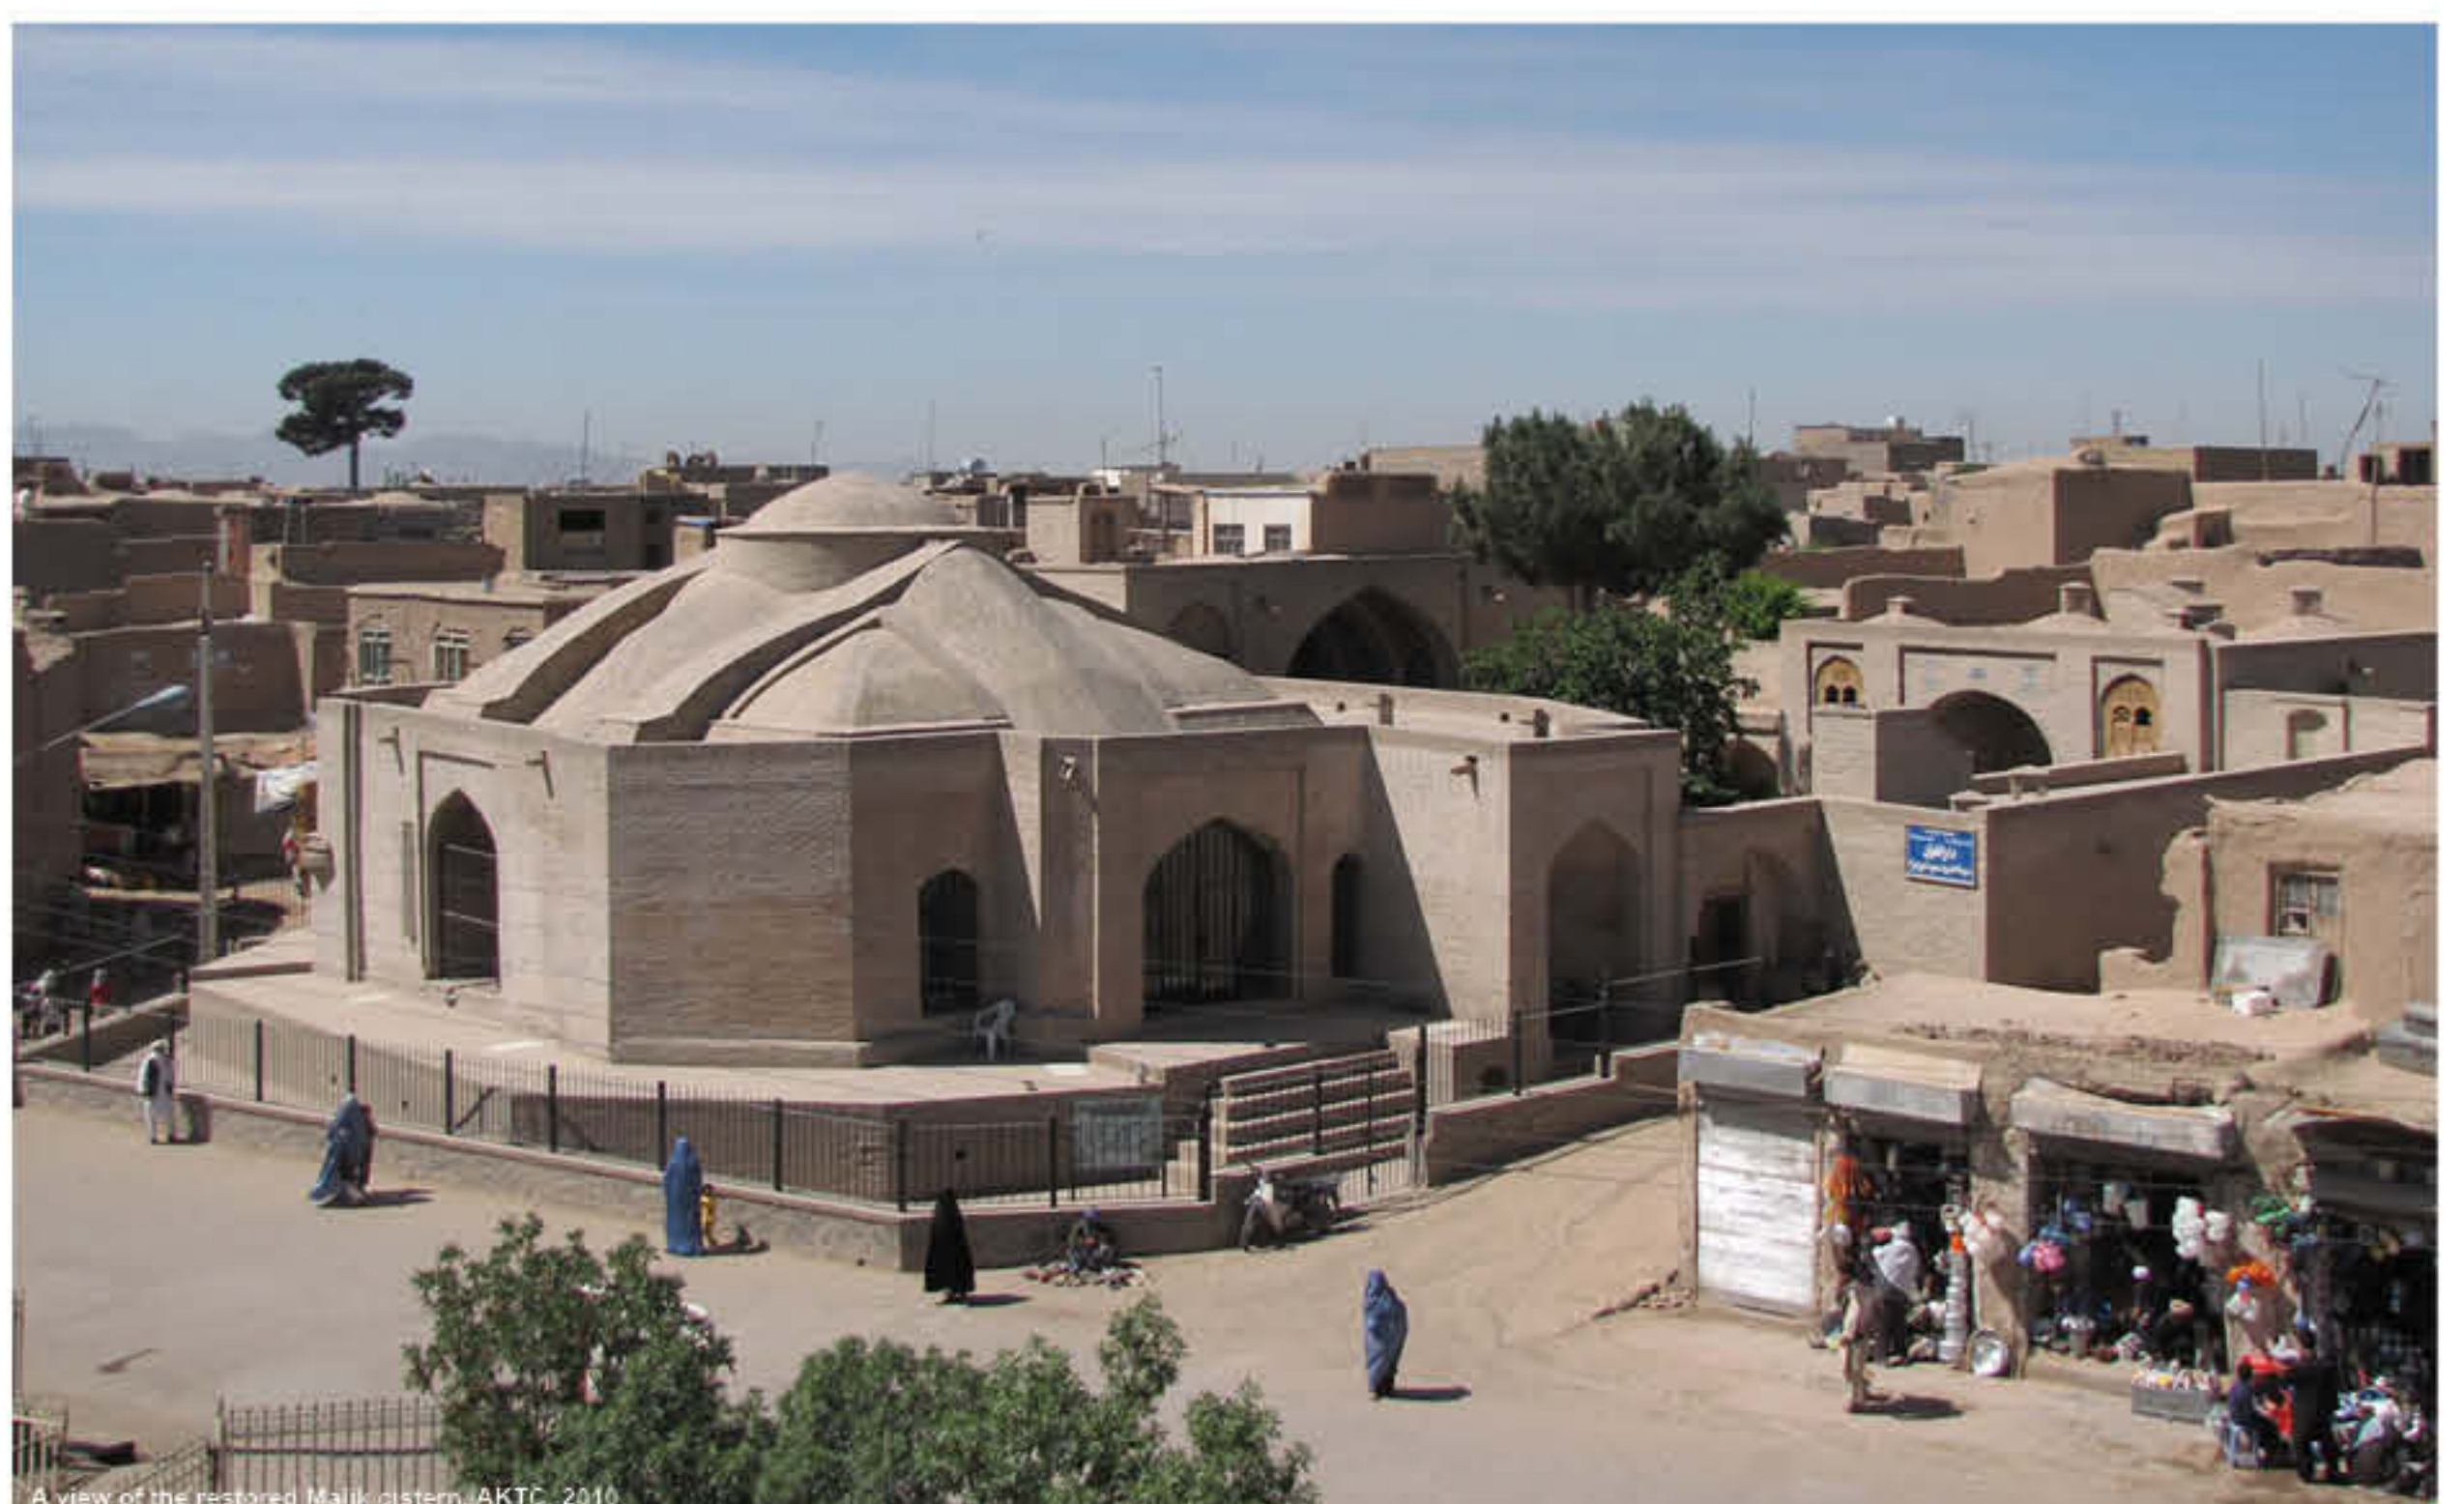
A view of the restored Malik Cistern, AKTC, 2010
