AGA KHAN TRUST FOR CULTURE
AGA KHAN CULTURAL SERVICE - PAKISTAN

CONSERVATION OF THE LAHORE FORT PICTURE WALL

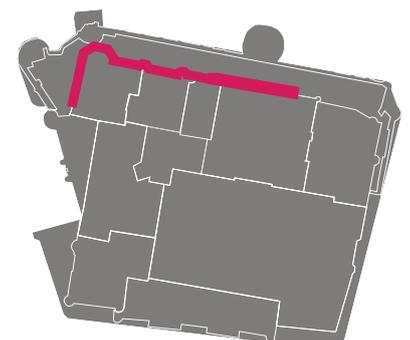
Below: Plan showing location of the picture wall in the context of the Lahore Fort

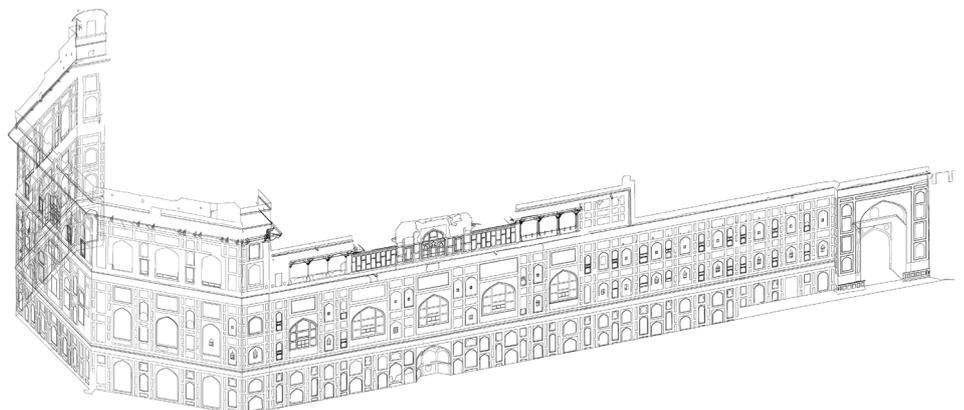
Right: Isometric drawing of the Picture Wall

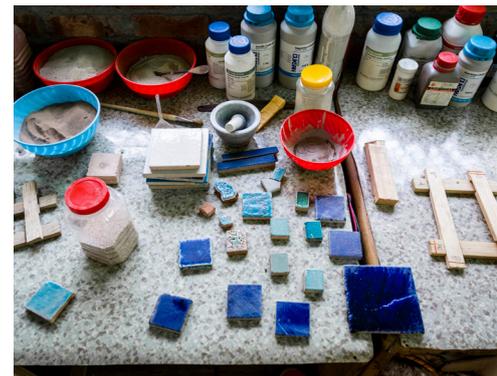
Above: A conservator carrying out material tests for the conservation of glazed tiles

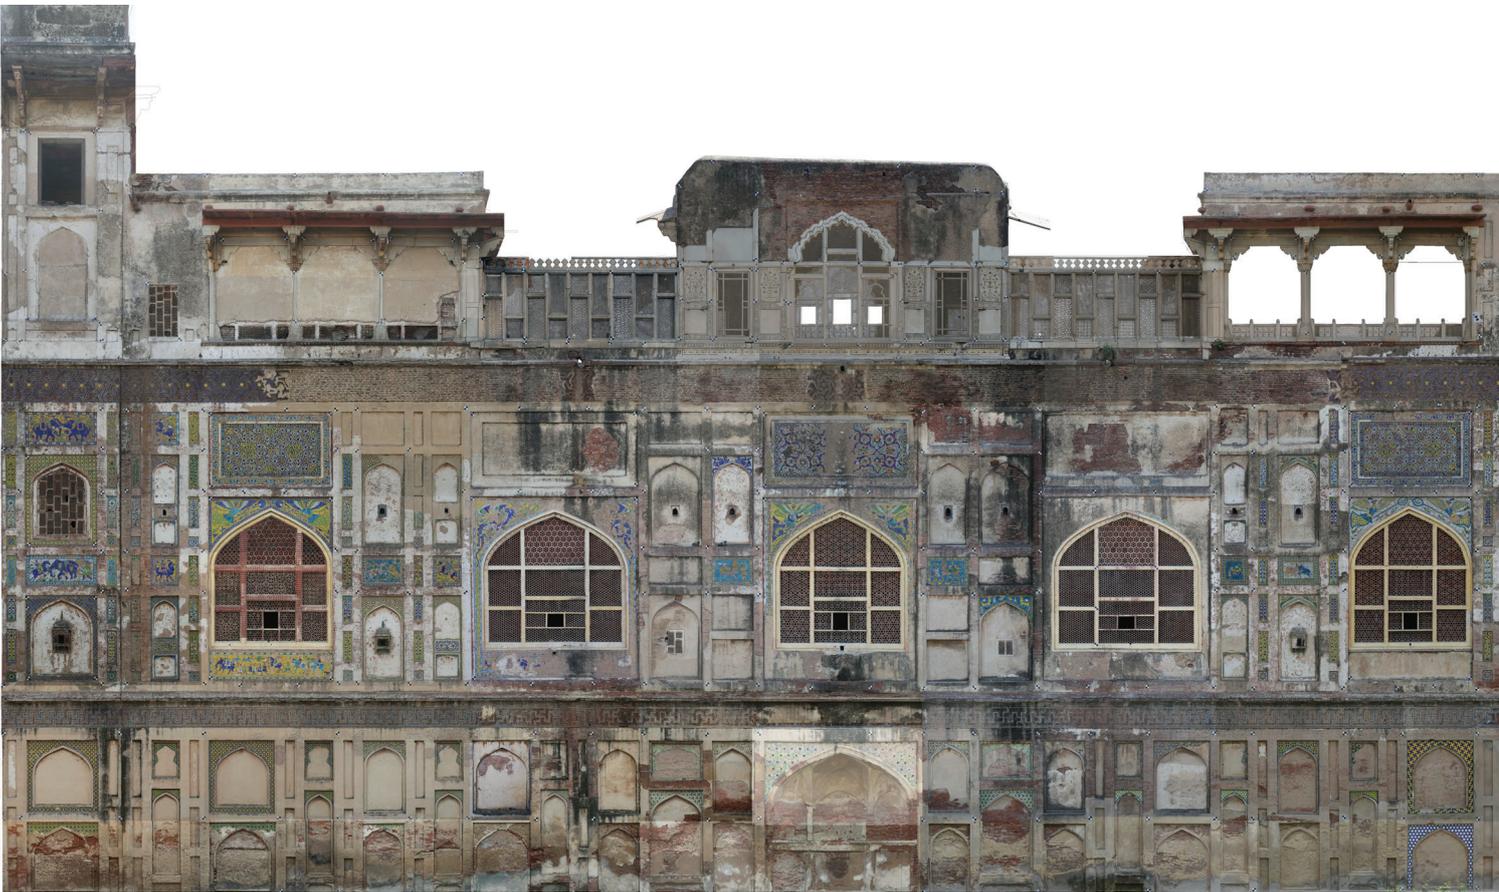
Above: Documentation of the as-found conditions of the Picture Wall's western façade, using high-resolution orthorectified photographs

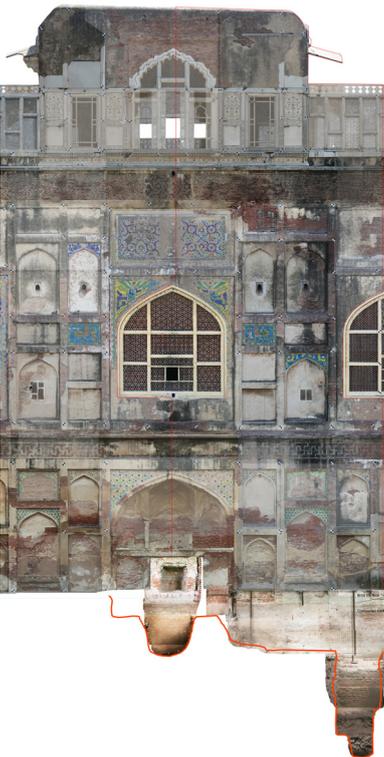
Below: As-found condition of 'prototype' area, also showing archaeological excavations

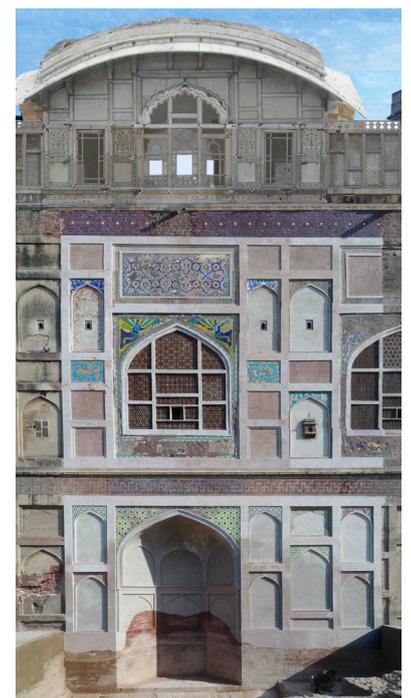
Below: Virtual conservation of the 'prototype' area developed after international workshop
