# KABUL

**INTRODUCTION**

**PHYSICAL CONSERVATION  
AND RESTORATION**

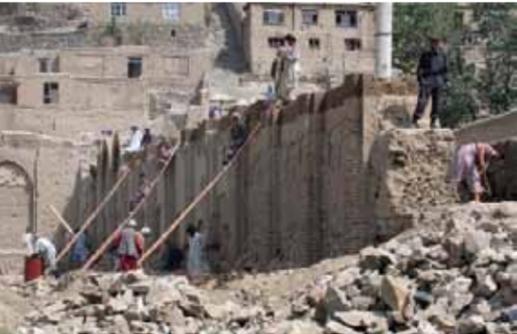
Top, at more than 1.6 kilometres, the compacted-earth perimeter wall around Babur's Garden employed local masons applying traditional building techniques.

Although it is not clear how Babur originally defined the extent of his garden, the perimeter walls that now surround it follow the tradition of enclosure of formal Persian gardens. Jahangir's instruction in 1607 that walls be built around several gardens in Kabul included the construction of walls around Babur's Garden. The scale and alignment of these walls has doubtless changed, but surviving sections of compacted-earth (*pakhsa*) walling were surveyed in 2002. With many sections found to be close to collapse, nearly 1.6 kilometres of walls (parts of which are nearly eight metres high and over two metres thick) were rebuilt or repaired by hand using traditional techniques and materials.

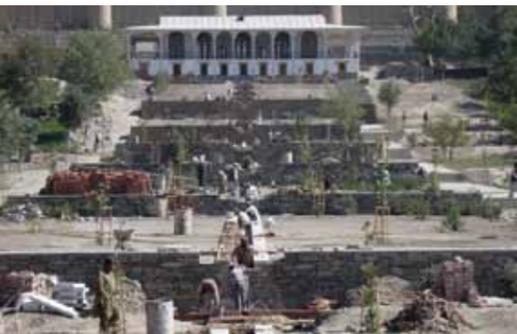
Middle, reconstruction of the central water channels, chutes and tanks in Babur's Garden was based on detailed archaeological evidence.

the central axis and its main water channel, allowing water to flow once more through the site, as it did in Babur's time. This has been achieved without significantly disturbing the surviving archaeological remains, which were protected and backfilled after thorough documentation.

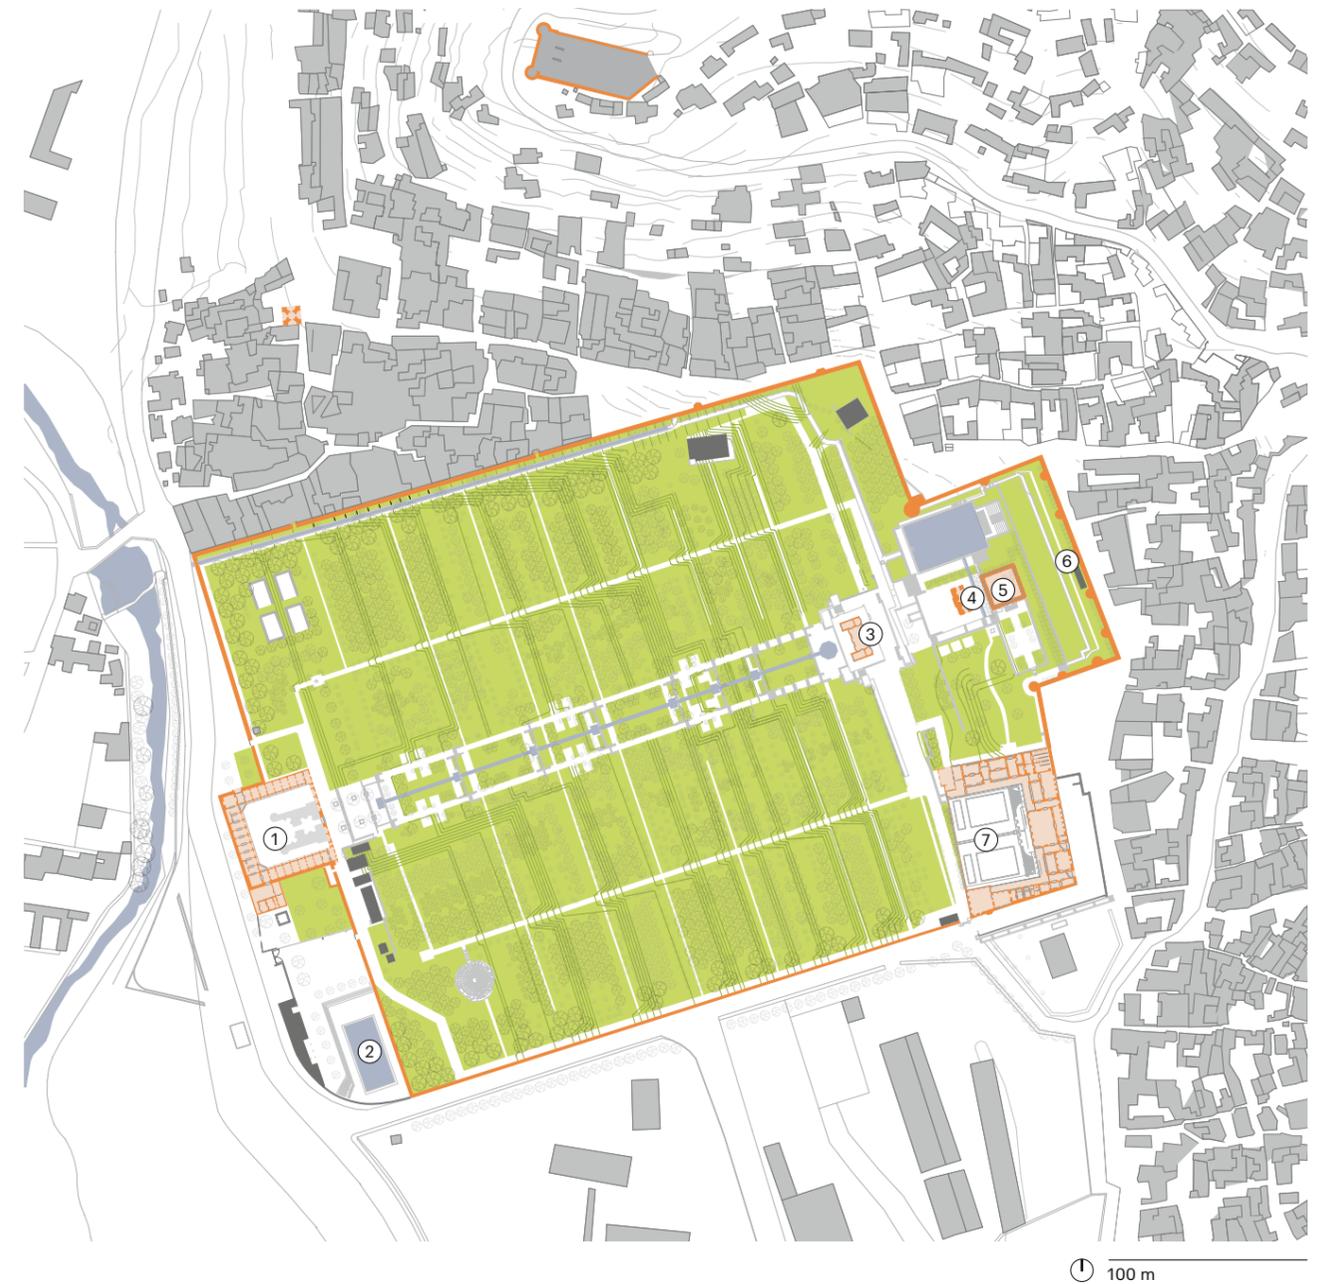
**Key facilities and monuments.**

- 1 Caravanserai complex
- 2 Swimming pool
- 3 Garden pavilion
- 4 Shah Jahan Mosque
- 5 Babur's grave enclosure
- 6 Perimeter wall
- 7 Queen's Palace

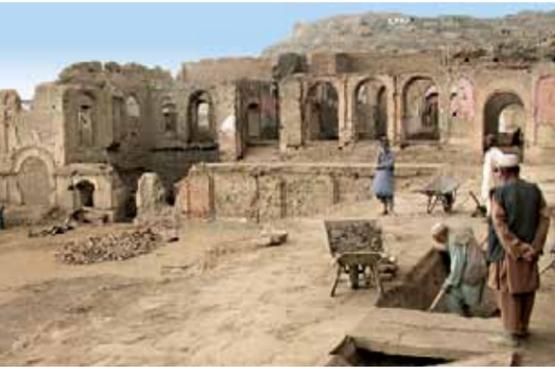
**Above, clearance of debris from the destroyed Queen's Palace, prior to its restoration.**

Following the clearing of unexploded ordnance and mines, the collapsed sections of the *haremserei* roof were removed and the entire complex surveyed. Following consolidation of the ruined structure, reconstruction work began in early 2006. While respecting the architectural character of the original building, it was possible to incorporate a range of alternative uses into the reconstructed complex and integrate

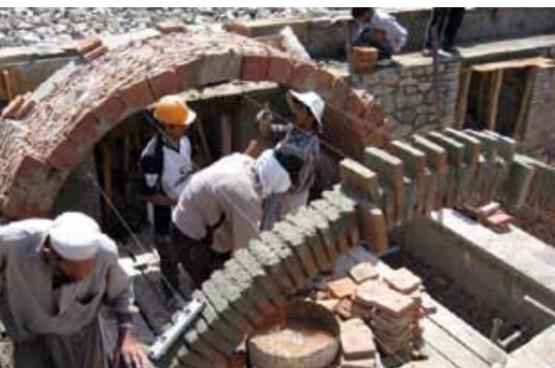
**Below, masonry vaults being reconstructed using traditional techniques and especially prepared square bricks, Queen's Palace.**

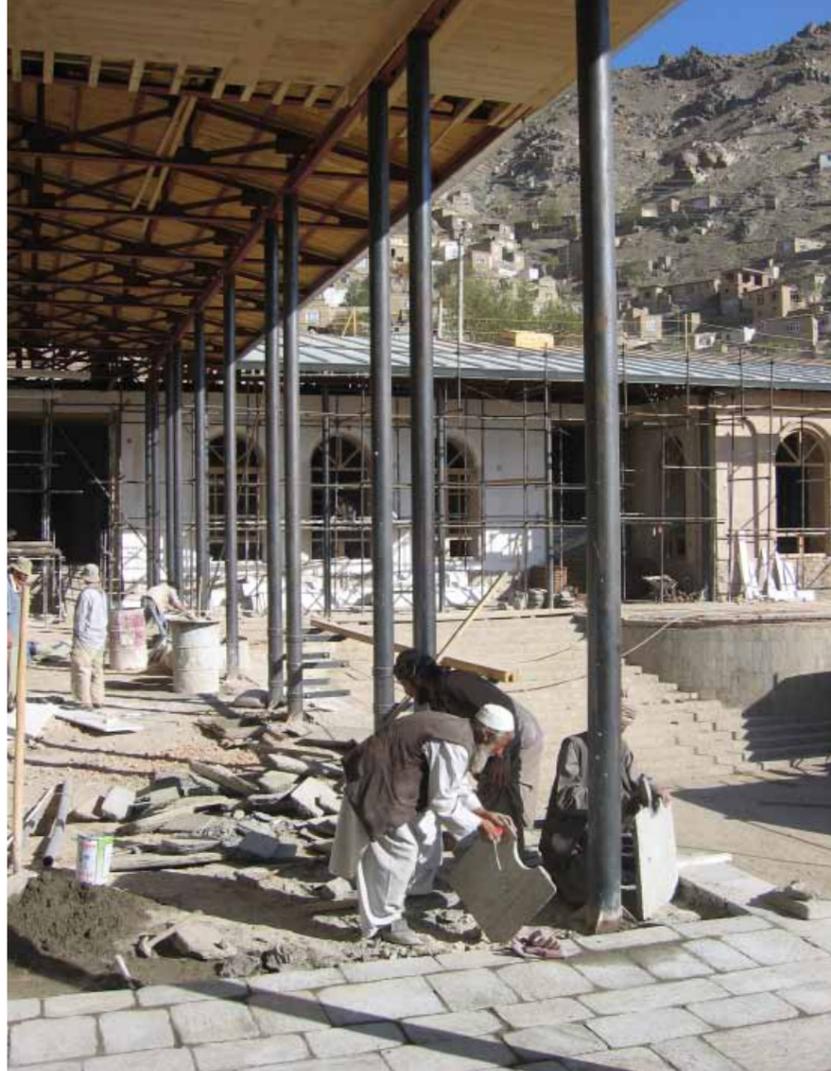
**Right, craftsmen work to lay local sandstone on the terrace of the Queen's Palace.**

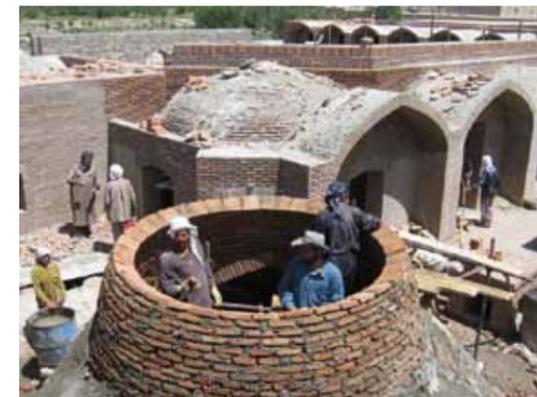
**Above, the caravanserai building at the entrance to Babur's Garden was constructed on the site of a destroyed late-19th-century structure.**

Photographs of the garden from around 1915 identify a double-storey caravanserai structure built around a courtyard at the base of the garden adjacent to the river. Although the caravanserai no longer existed, archaeological excavations revealed foundations of an earlier structure corresponding to a passage in the *Padshahnama* referring to a building commissioned by Shah Jahan in which the destitute and poor should "eat their food in those cells sheltered from the hardships of snow and rain". This was the inspiration for a new caravanserai complex constructed on the site to house a range of modern facilities required for contemporary visitors to Bagh-e Babur. Drawing on traditional built forms and brick-masonry techniques of the region, it houses an exhibition and information centre, offices, commercial outlets and public facilities.

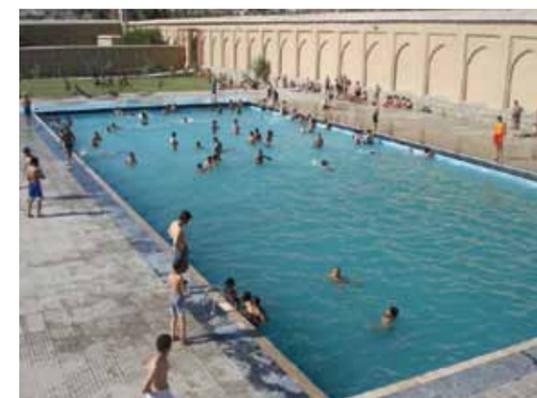
**Below, a new swimming facility was constructed on the external perimeter of Babur's Garden, replacing a dilapidated late-1970s pool within the site.**

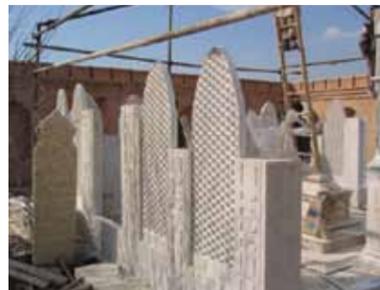
Below, the reconstruction of Babur's grave enclosure was based on visual and archaeological evidence including discovery of key sections of the original marble enclosure during archaeological excavations.

Based on archaeological excavations and a review of earlier documentation, the work undertaken over the course of the project aimed to re-establish the original character of the grave area in a manner that conformed to international conservation practice. The thirty-one marble fragments found in the grave area yielded important evidence as to the style and workmanship of the original enclosure around Babur's grave. Together with documentary material, the fragments have enabled the reconstruction of the enclosure, carved from Indian Makrana marble used in the original structure, which has been erected *in situ* on the original grave platform. Measuring 4.5 metres square, the elevations of the reconstructed enclosure comprise a central arched opening on the southern elevation flanked by pairs of marble lattices (*jali*)

screens. Now replanted with Judas trees, the area between the marble screen and the outer masonry enclosure provides a tranquil space in which visitors can pay their respects; and here, among others, the grave of Babur's son Hindal also survives.

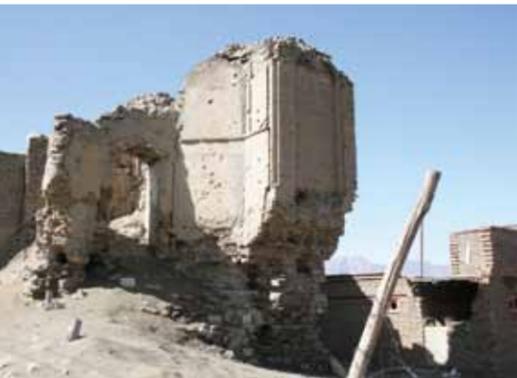
Remains of the Burj-e Wazir, partially submerged beneath accumulated rubble.

While the structure had been extensively damaged in the armed conflict in the early 1990s, photographs from the turn of the twentieth century show the tower in a ruined state. As the structure was further threatened by modern encroachments built using stone and fired bricks removed from the tower, conservation work started with the preparation of a detailed physical survey of the site.

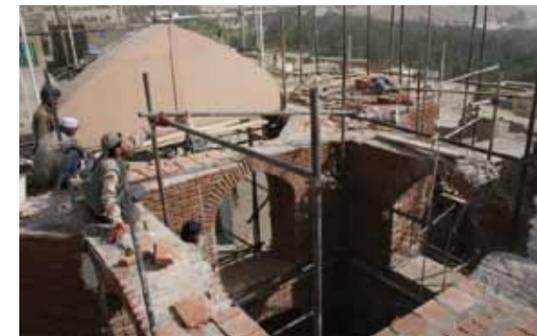
Top right, in order to prevent further damage to the original remains of the structure, collapsed sections of arches were rebuilt using traditional materials and techniques.

masonry were carefully laid adjacent to the original structure and treated in a manner that would enable visitors to distinguish between old and new brickwork. Once the arches and masonry dome had been rebuilt, a timber substructure was constructed and finished using galvanized metal sheeting. The site was further protected with the construction of a low stone-masonry wall topped with a steel railing. Rising above the village of Guzargah, the restored Burj-e Wazir forms an imposing landmark in southern Kabul. The project also provided an excellent opportunity to train young conservation architects and a team of archaeologists in documentation, archaeology, restoration and project planning activities.

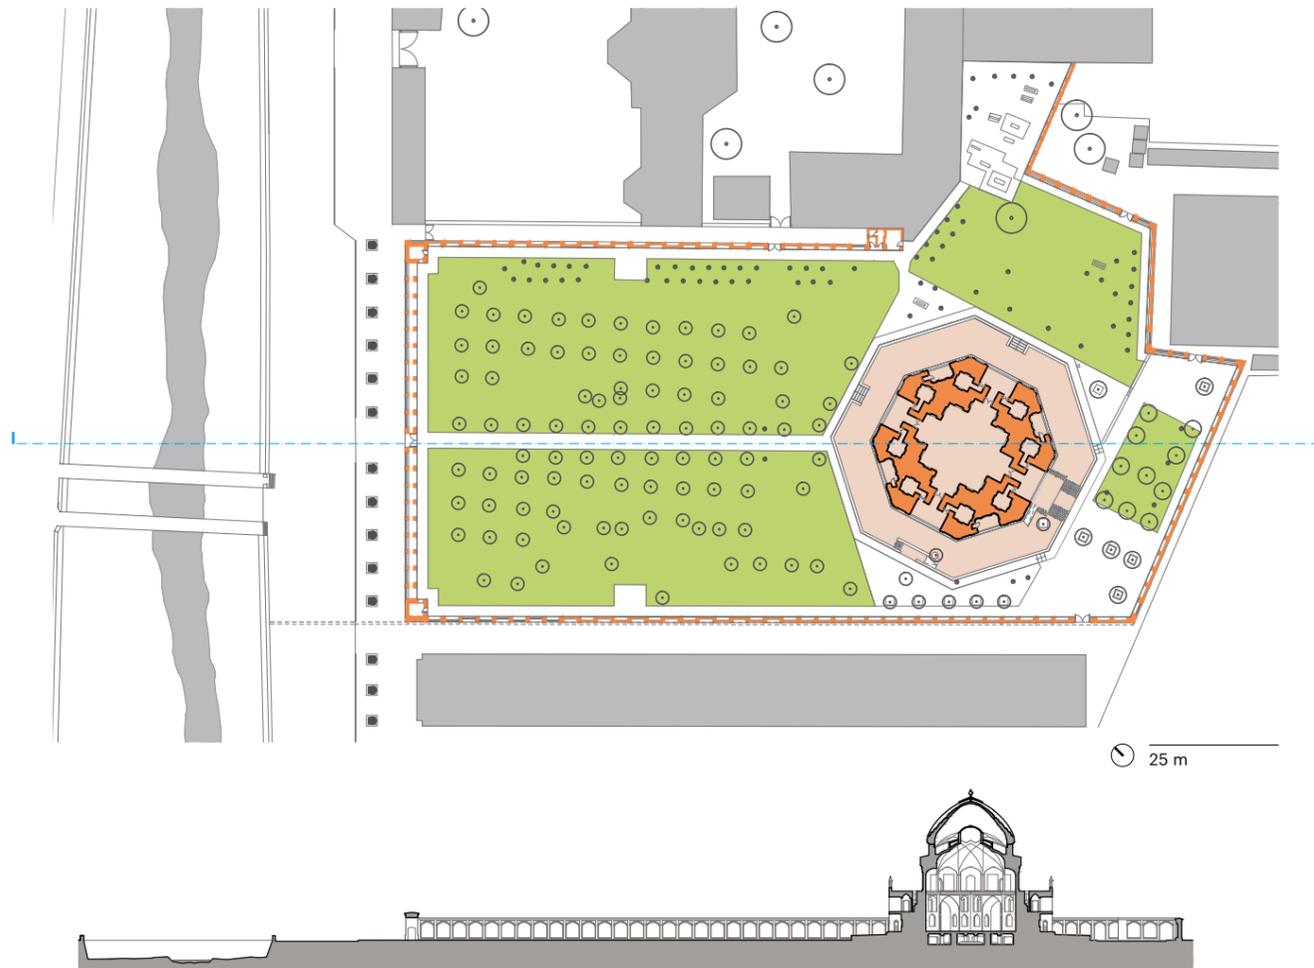
Above, Timur Shah Mausoleum and Park, site plan and section.

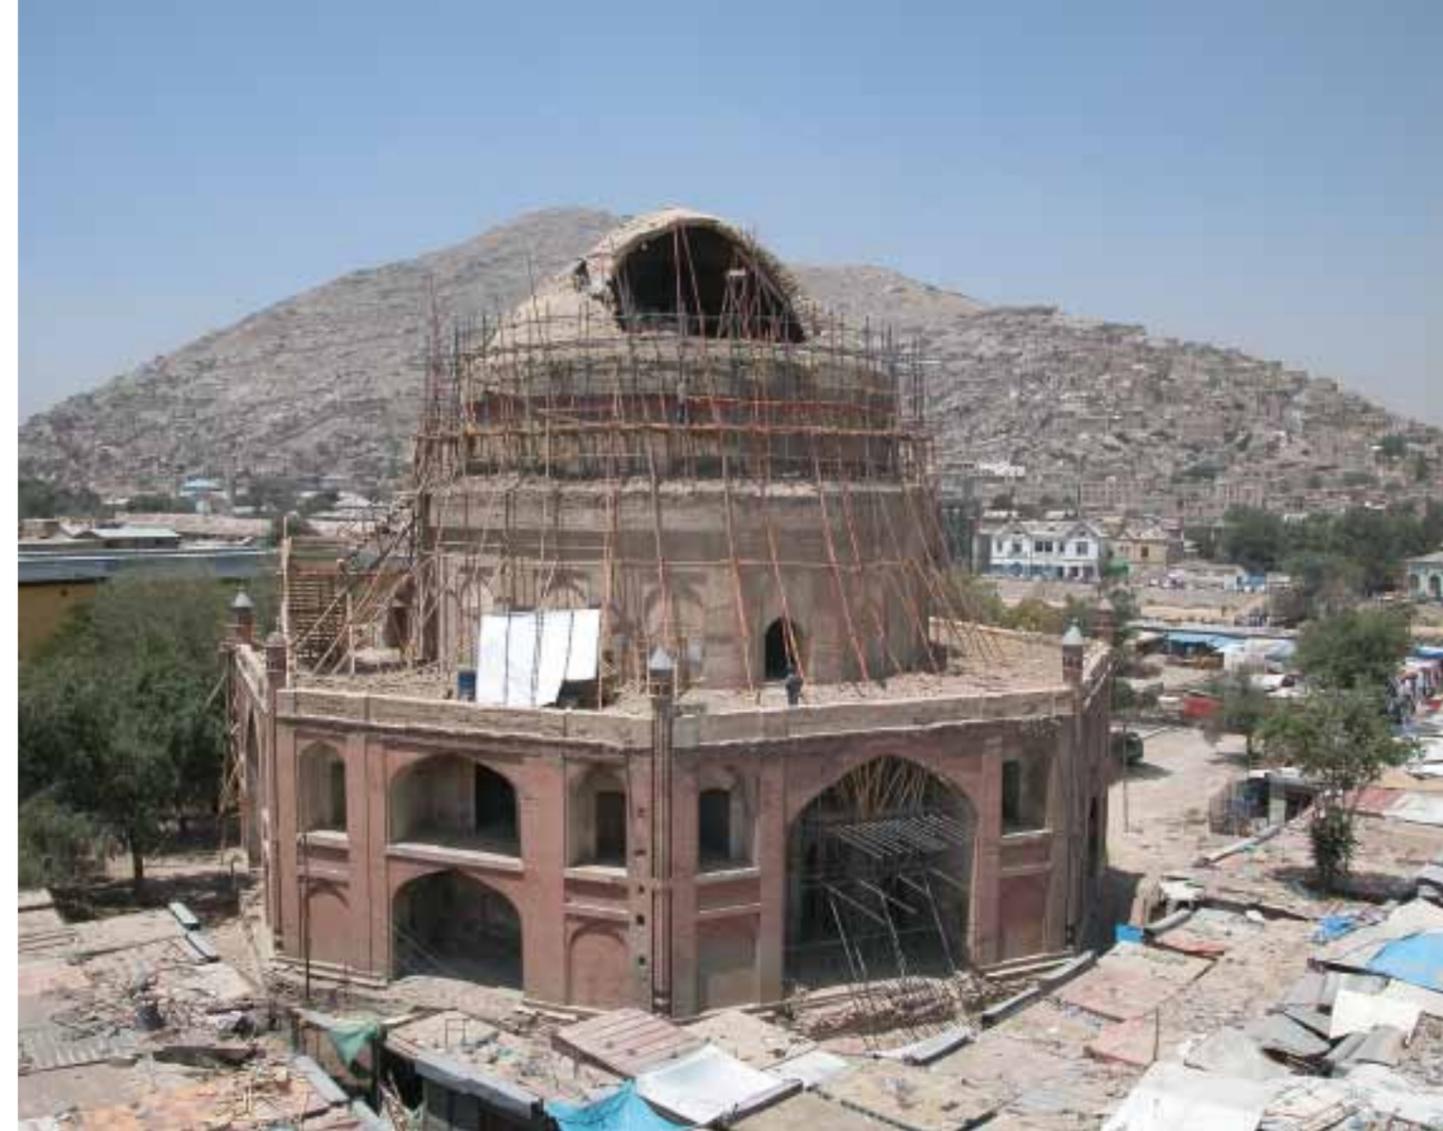
Above, the double-skin dome of the mausoleum had been damaged by artillery fire and required urgent conservation and reconstruction.

area was therefore the focus of the initial conservation work, once the damaged roof sheeting and timber structure had been removed. Examination of the upper dome revealed that it had been built in stages, using 'layers' of brick masonry laid in relatively weak lime mortar. After the erection of a bamboo platform over the lower dome, and installation of two temporary tension-reinforcement belts around the drum, a reinforced-concrete beam was poured around the inside, anchored into the brickwork with forty-eight stainless-steel anchors. Unstable sections of brickwork in the upper dome were removed, and repairs undertaken to match the original structure, using specially produced bricks laid in lime mortar. The original geometry, comprising six layers of brickwork at the springing, reducing to two at the apex, was reproduced in the repairs.

As the final external finish of the upper roof had originally remained incomplete, a new geometry was devised for its profile, based on a harmonic curve that matched the proportions of the main structure. A total of thirty-two laminated timber rafters, measuring up to thirteen metres, were produced to support a new 'shell' roof, which now spans the repaired dome. Timber boards were then screwed in a circumferential pattern over these rafters, prior to the fixing of galvanized sheeting.

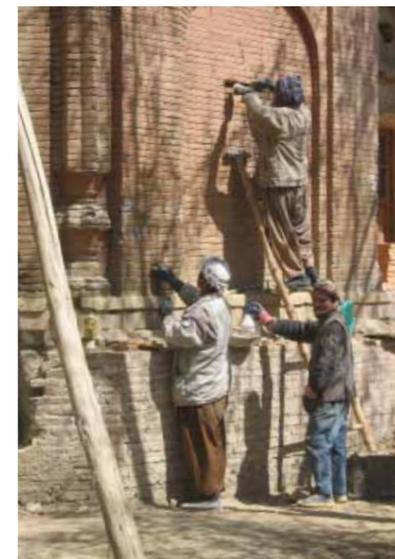
Left, teams of masons work to clean and repoint the exposed brick elevations of the mausoleum.

While work proceeded on the main dome, repairs were carried out on the flat roofs and supporting vaults. Areas of facing brick on the elevations were also repaired, as

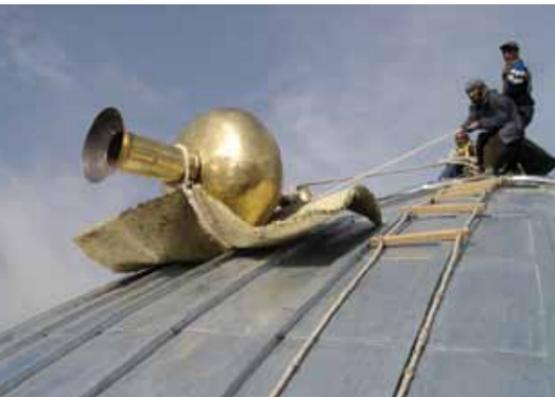
**Above, the repaired finial being raised to the apex of the dome.**

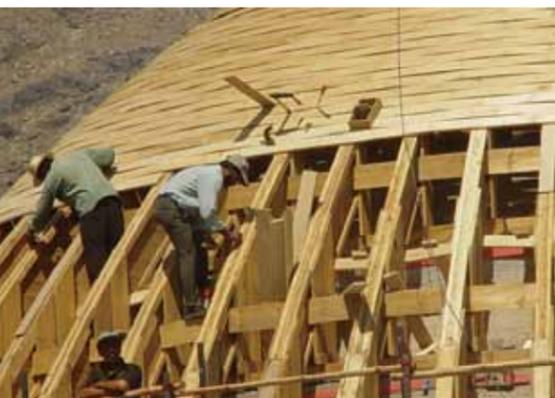
**Below, prior to the installation of galvanized iron sheeting, timber planks were fixed to rafters.**

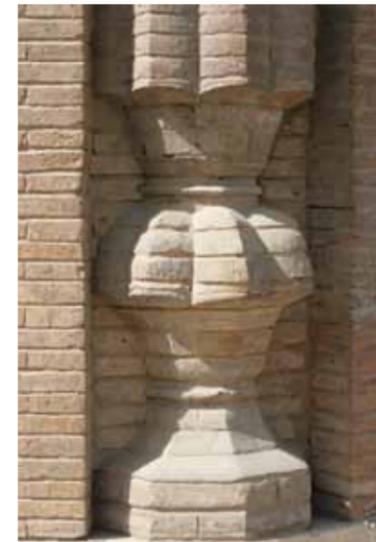
**Left, decorated column bases were originally constructed using shaped bricks cut to size.**

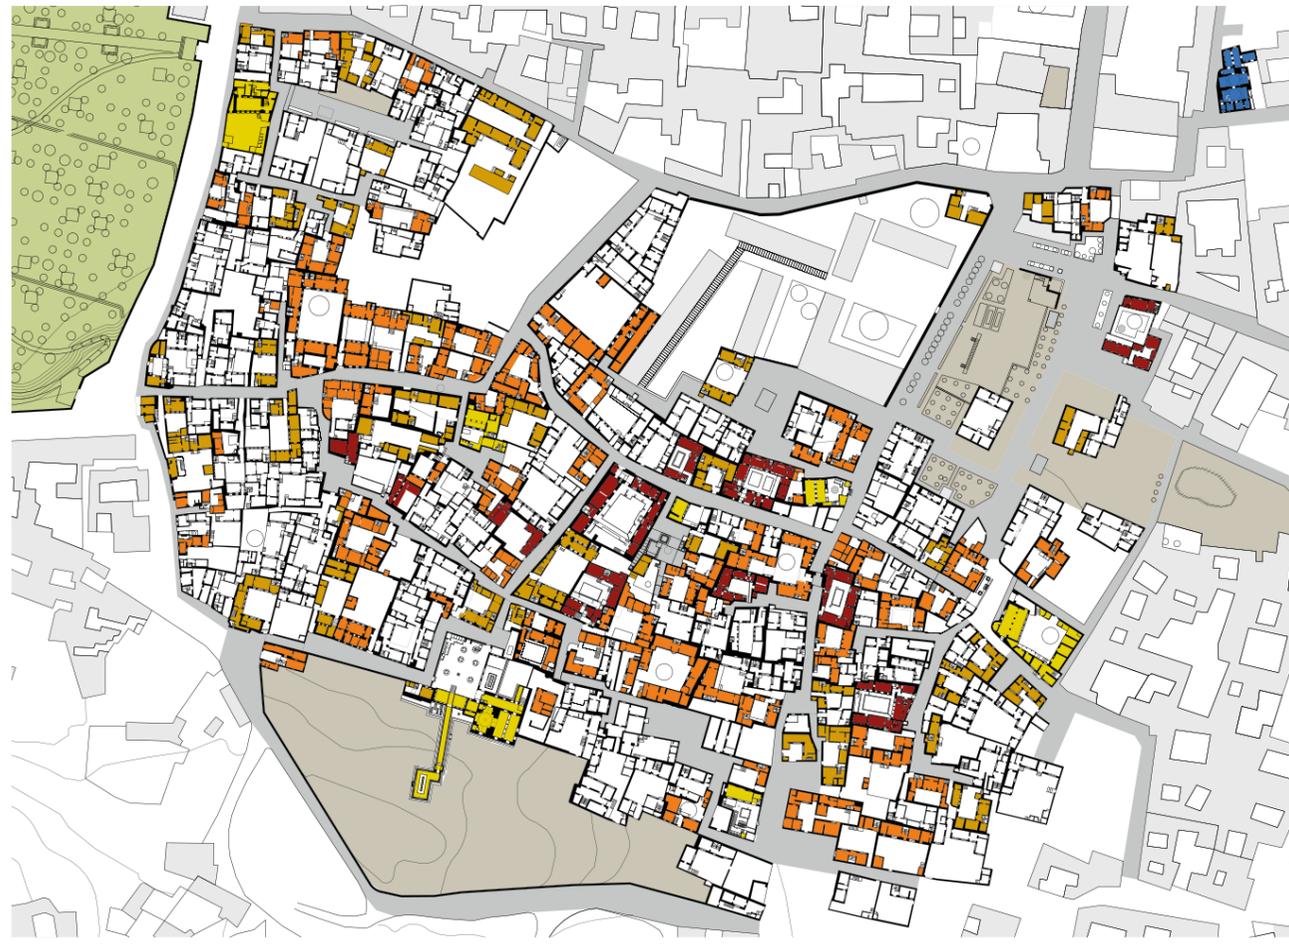
Above, Asheqan wa Arefan neighbourhood: conservation and upgrading improvements.

- Conservation of religious buildings
- Conservation of public buildings
- Full-scale residential conservation
- Small-scale residential repairs
- Building advice
- Public access and infrastructure improvements
- Open public space
- Open green space rehabilitation

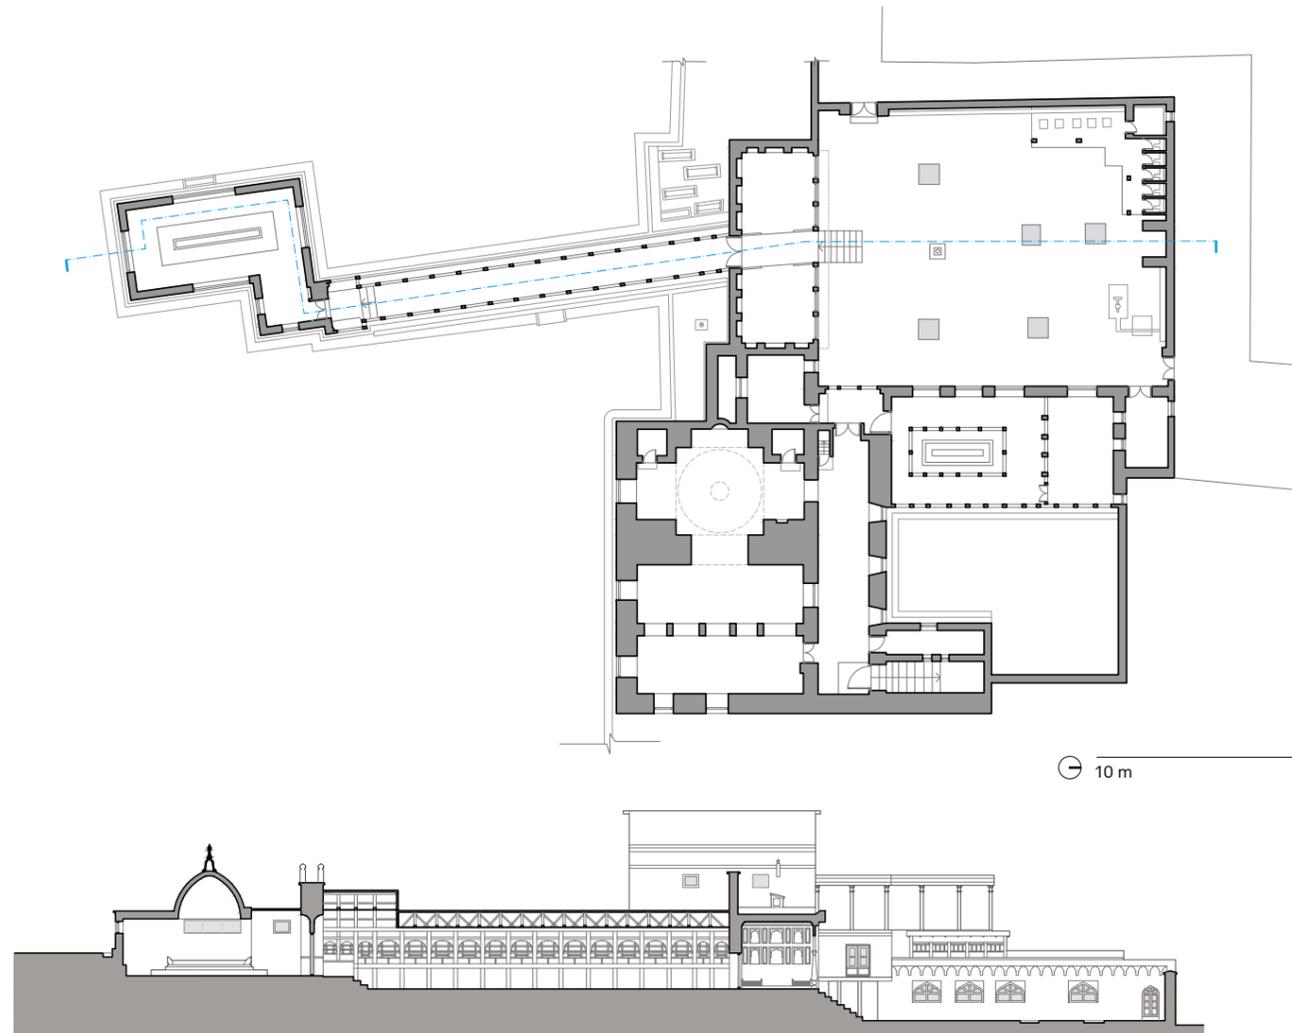
Asheqan wa Arefan Shrine, ground-floor plan and section.

Found to be in a poor state of repair, the distinctive colonnaded entrance and passage that leads to the grave of Khwaja Abdus Salam (Asheq) required extensive structural repairs, while the lower grave of Khwaja Abdus Samad (Aref), which retains its traditional wooden enclosure, was re-roofed, as were those of the adjoining summer and winter mosques. A stone retaining wall was built along the length of the corridor leading to the grave of Khwaja Abdus Salam (Asheq) in order to protect the timber screens, which were cleaned and repaired, along with the finely carved timber entrance door. During the course of repairs to the plasterwork of the portico, a series of decorated plaster niches were uncovered and restored. The entire roof over the lower grave of Khwaja Abdus Samad (Aref) was rebuilt and its internal plaster and marble decoration restored. Extensive repairs were also carried out on the roof of the adjacent summer mosque, which retained fine decorated plasterwork on the prayer niche (*mihrab*), the domed winter mosque beneath, and its long corridor.

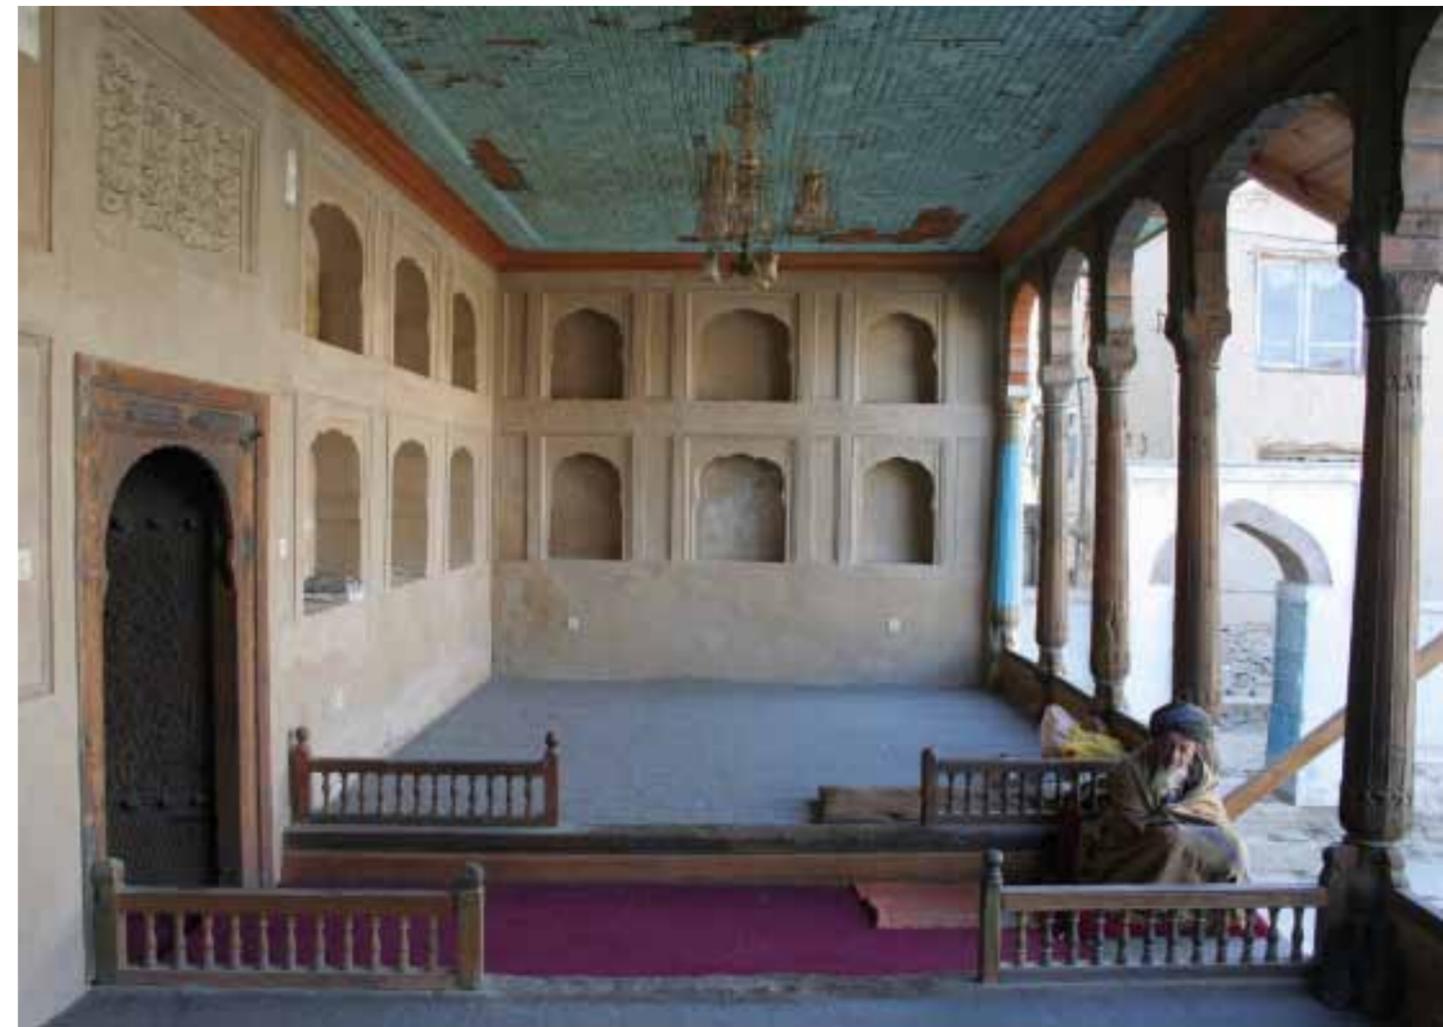
Above, the entrance portico to Asheqan wa Arefan Shrine, with its series of decorated plaster niches, was uncovered during the course of repairs and restored.

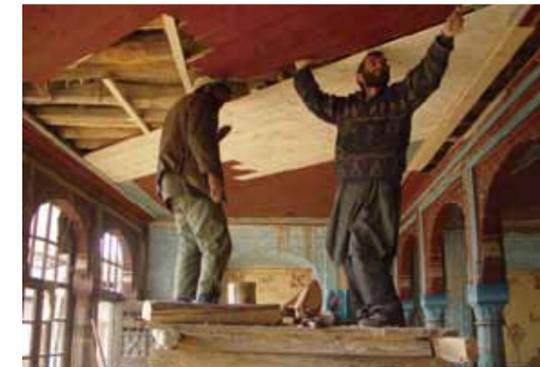
Top right, damaged areas of the timber ceiling of the summer mosque were replaced.

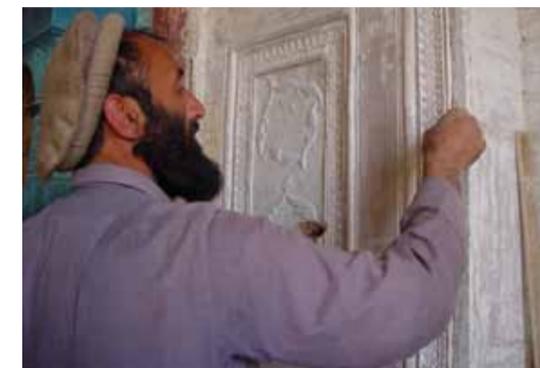
Above, sections of fine plaster decoration, uncovered during conservation work, were cleaned and repaired.

During the course of initial repairs to the timber roof of the mosque, intricate moulded plaster decoration was found on the walls — hidden beneath layers of modern plaster and oil-based paint — and preserved using traditional techniques. Careful removal of paint from timber columns and arches supporting the roof revealed finely carved, wooden, decorative elements, which were left exposed and sealed using locally available linseed oil.

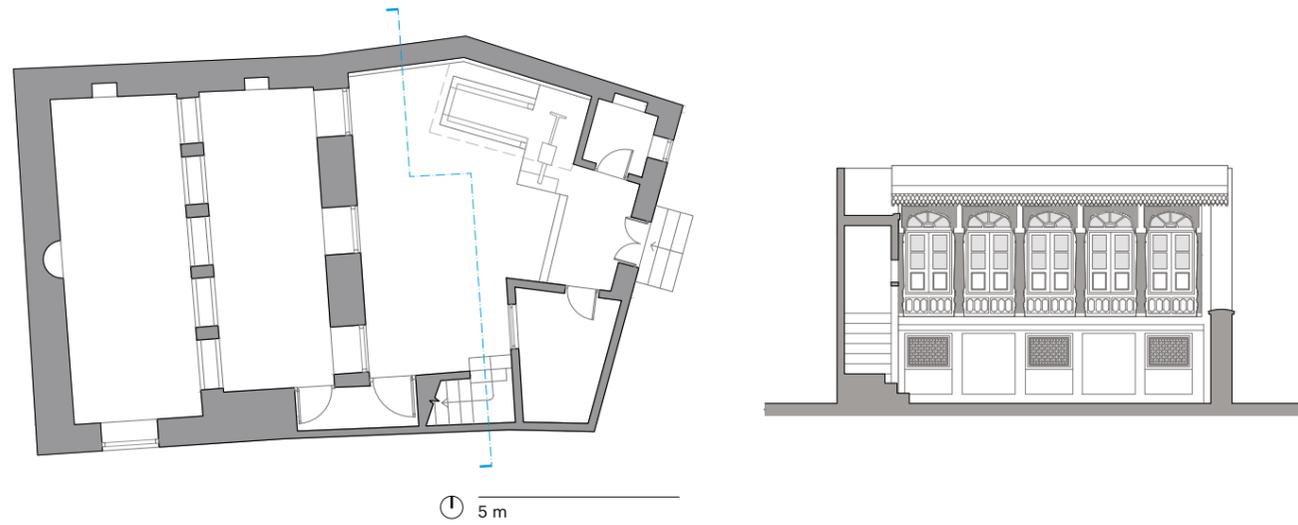
Above, ground-floor plan and section.

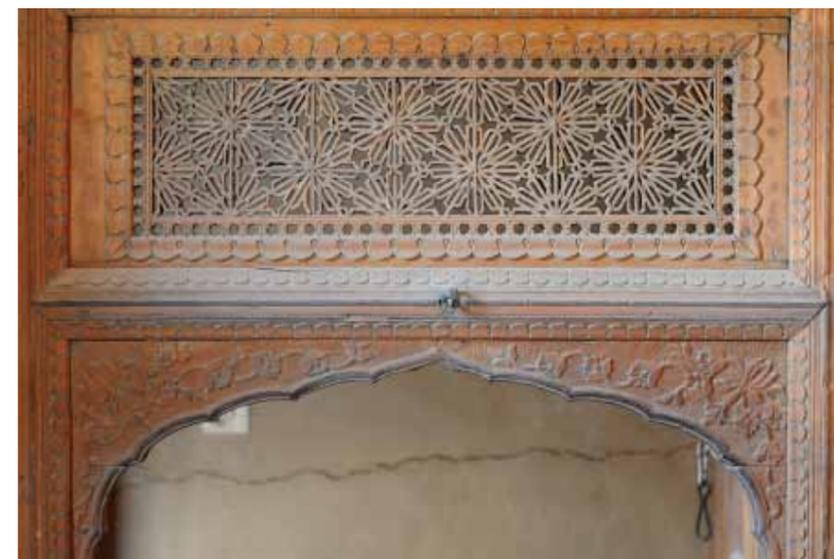
Below, a repaired timber lattice screen installed at the entrance to the mosque.

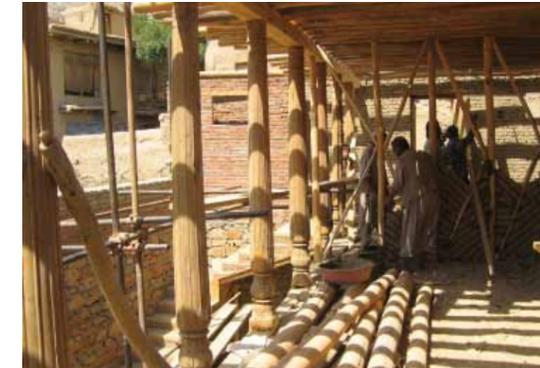
Top right, restoration work entailed structural repairs to the timber-frame construction of the mosque.

Conservation work commenced in 2005 with the clearance of debris from the site, making possible a detailed physical survey. Measures required to restore the building included stabilization of stone foundations, removal of excess earth from above the roofing allowing the replacement of damaged rafters, and reassembly of the structural timber frame and replacement of infill brickwork where required. Structural work was followed by the cleaning, repair and replacement of sections of damaged timber decorative elements and the partitioning of the upper floor to create living quarters for the custodian of the site. Internal elevations of the mosque were levelled by applying traditional mud-straw plaster (*kahgil*) and finished with a fine mud plaster (*simgil*).

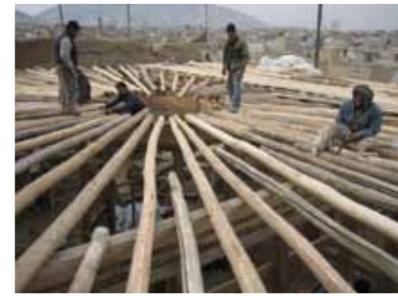
Top left, due to extensive structural damage, the roof of the shrine was rebuilt using traditional building techniques.

was stripped and key structural timber elements were dismantled to allow for repairs. This permitted the reconstruction of damaged stone walling on the east and south walls of the shrine, and the improvement of drainage from the steep hillside above the complex.

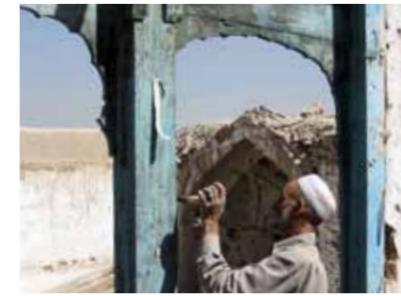
Top right, damaged sections of the timber screens were removed for repair.

The removal of the roof made it possible to dismantle the central screen, parts of which were cleaned and repaired before being reinstalled. Once the base of the structural frames (most of which proved to be affected by rot) had been replaced, it was possible to refit the rafters over the entire building, fix timber boarding and lay a traditional earth finish prior to the first snowfall. Internal stone elevations of the shrine area were repaired and pointed using a lime-based mortar. Two sections of wooden screens (*pataii*) to the east and west of the octagonal enclosure of the shrine were cleaned. Structural consolidation work entailed the repair of sections of the brick-masonry partition between the shrine and the prayer area to the north, which, together with repair work on the *mihrab* wall, was finished using gypsum plaster. Layers of paint were removed from the main external elevation of the building and the wooden fenestration was repaired and preserved using locally available linseed oil. Internal floor areas of the building were finished with paved brick.

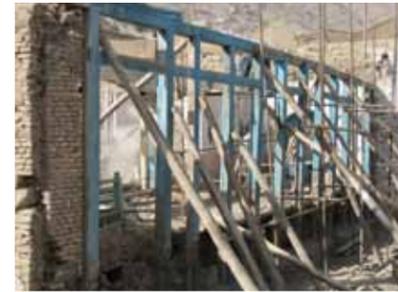
Middle left, assembled as a 'kit of parts', large sections of the woodwork were carefully dismantled, repaired and reinstalled as part of restoration activities.

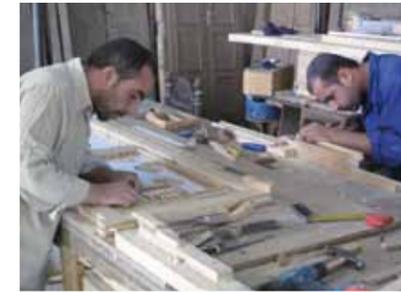
Middle right, carpenters work to reconstruct missing sections of an intricate latticework screen.

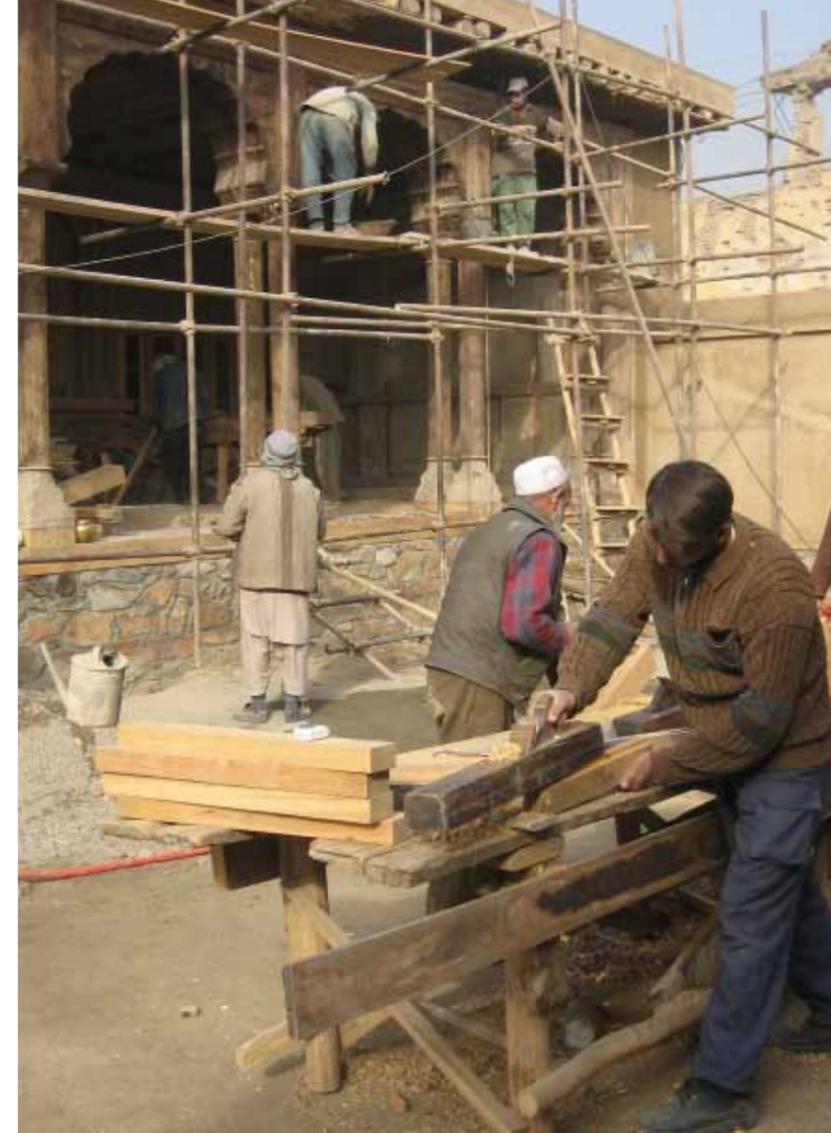
Top left, carpenters work on site, carrying out repairs to the fine double-column colonnade enclosing the summer prayer area.

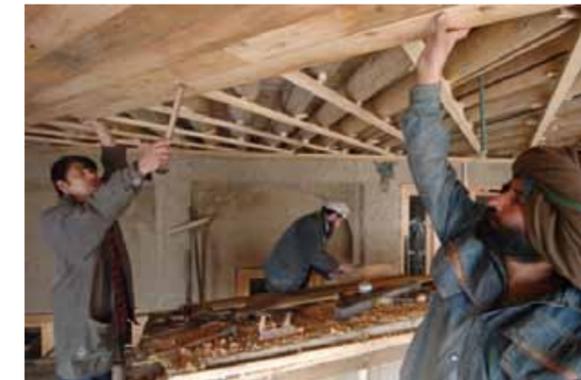
Top right, construction of timber ceiling over the summer prayer area.

Double rows of timber beams (*katiba*) were fixed along the top of all structural load-bearing walls in order to mitigate damage in case of seismic activity, after which roof beams were relaid and fixed in place. Timber boards were then laid across these beams providing a decking for the application of a traditional layered mud-straw roof. The timber colonnade, which had settled as a result of damage to its foundations, was subsequently dismantled using temporary supports, repaired, and reattached to its marble column bases. Timber boarding (some of which was retrieved from the original structure) was fixed to the ceilings of the winter and summer prayer areas. With the structure of the mosque repaired, conservation focused on the restoration of the internal finishes, including extensive areas of moulded plaster. In addition to cleaning and repairing existing areas of plaster, new moulds were prepared and used to replaster areas that had been completely destroyed. When the bulk of the internal plasterwork was restored, the floor of the external prayer area was paved with fired bricks, and the internal space paved with traditional lime concrete. The construction of ablution facilities, a water well, and a separate space for the custodian of the site preceded the paving of pedestrian areas in the courtyard using locally available stone.

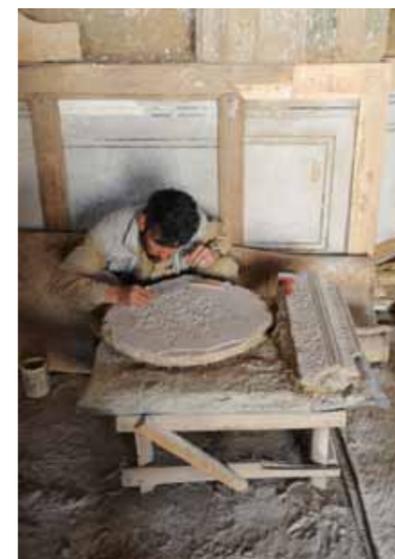
Bottom left, preparation of a plaster mould for use to repair damaged areas of decoration.

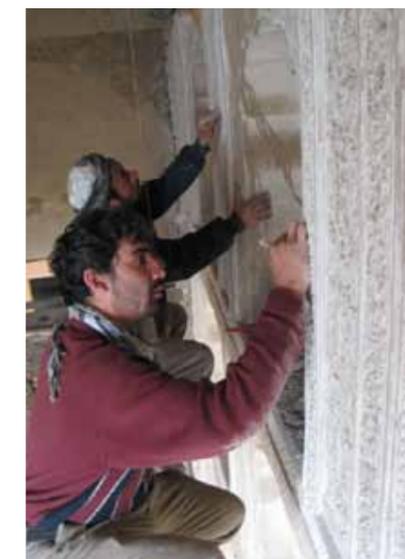
Bottom right, intricate plaster reliefs being cleaned and repaired.

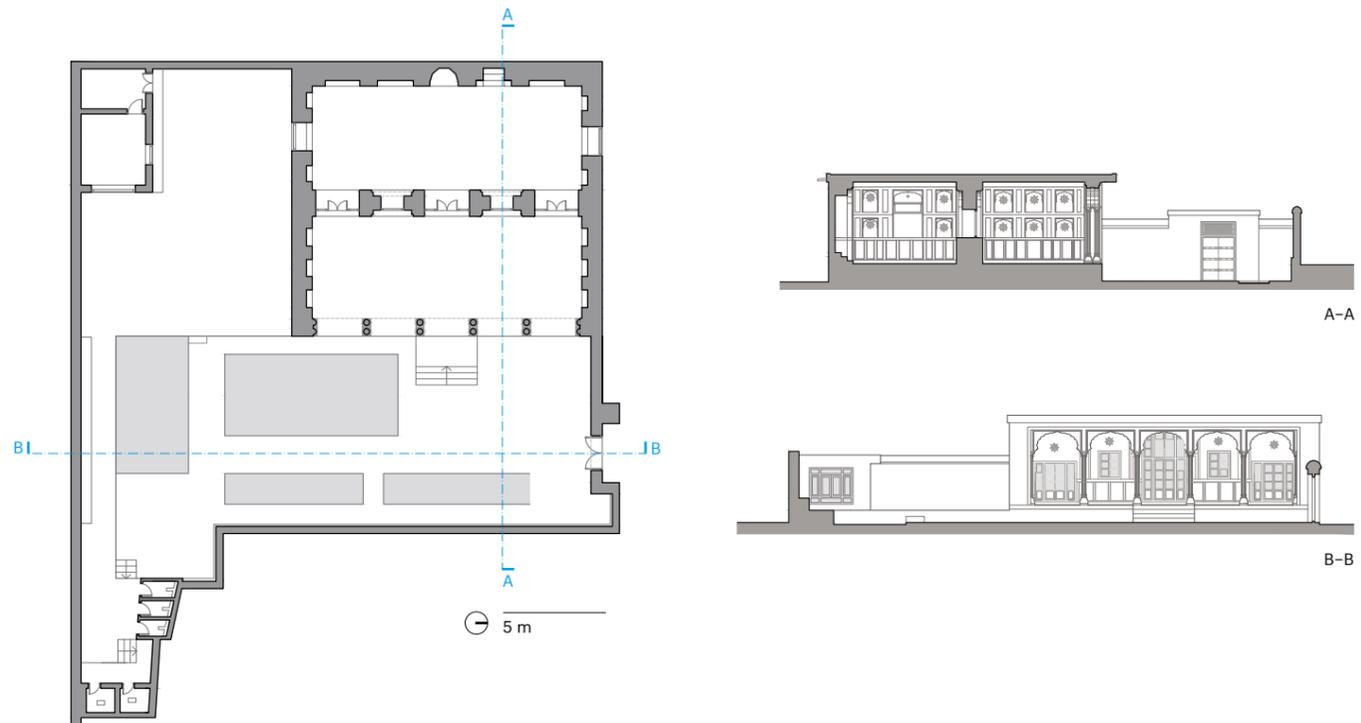
Above, ground-floor plan and sections.
