# KABUL

**INTRODUCTION**

**PHYSICAL CONSERVATION  
AND RESTORATION**

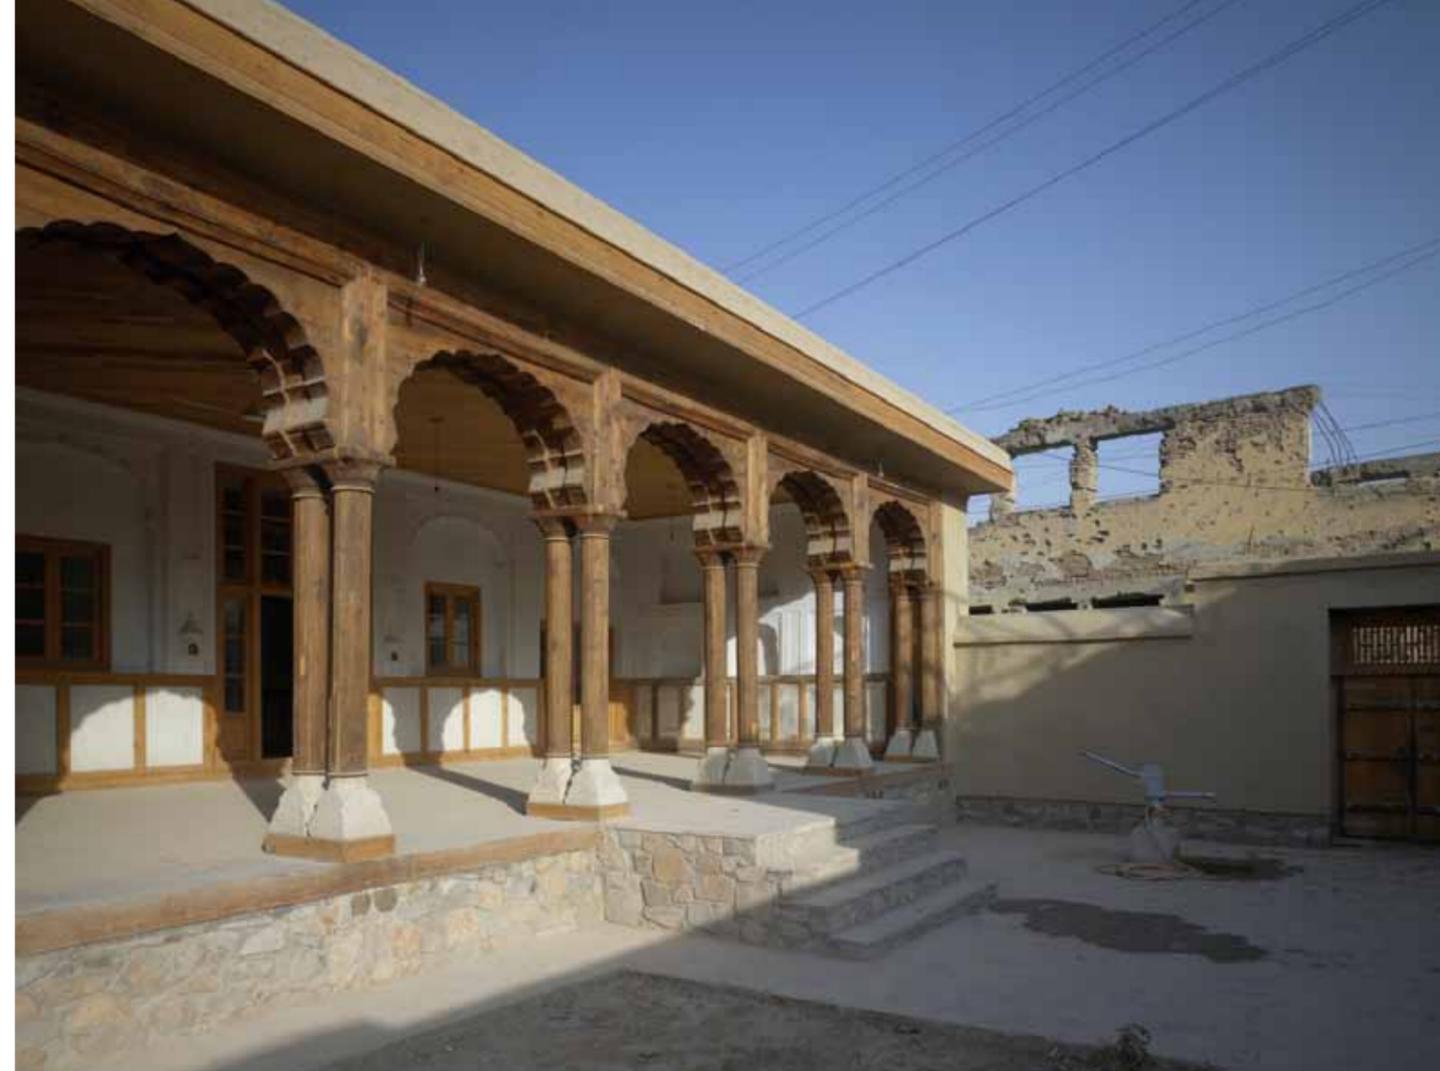
Above, view of the restored mosque showing the elevated summer prayer area.

Double rows of timber beams (*katiba*) were fixed along the top of all structural load-bearing walls in order to mitigate damage in case of seismic activity, after which roof beams were relaid and fixed in place. Timber boards were then laid across these beams providing a decking for the application of a traditional layered mud-straw roof. The timber colonnade, which had settled as a result of damage to its foundations, was subsequently dismantled using temporary supports, repaired, and reattached to its marble column bases. Timber boarding (some of which was retrieved from the original structure) was fixed to the ceilings of the winter and summer prayer areas. With the structure of the mosque repaired, conservation focused on the restoration of the internal finishes, including extensive areas of moulded plaster. In addition to cleaning and repairing existing areas of plaster, new moulds were prepared and used to replaster areas that had been completely destroyed. When the bulk of the internal plasterwork was restored, the floor of the external prayer area was paved with fired bricks, and the internal space paved with traditional lime concrete. The construction of ablution facilities, a water well, and a separate space for the custodian of the site preceded the paving of pedestrian areas in the courtyard using locally available stone.

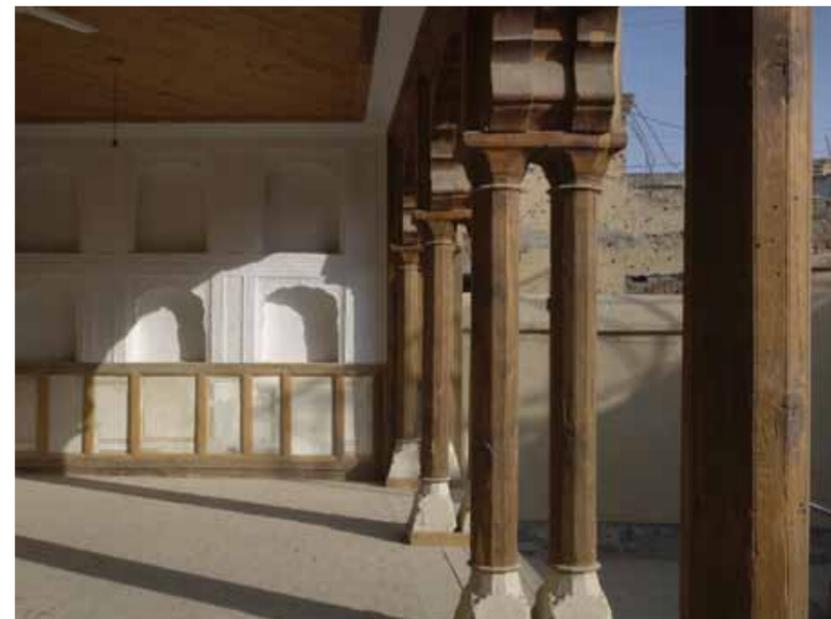
Below, view of the restored mosque showing timber arches and plaster decorated niches.

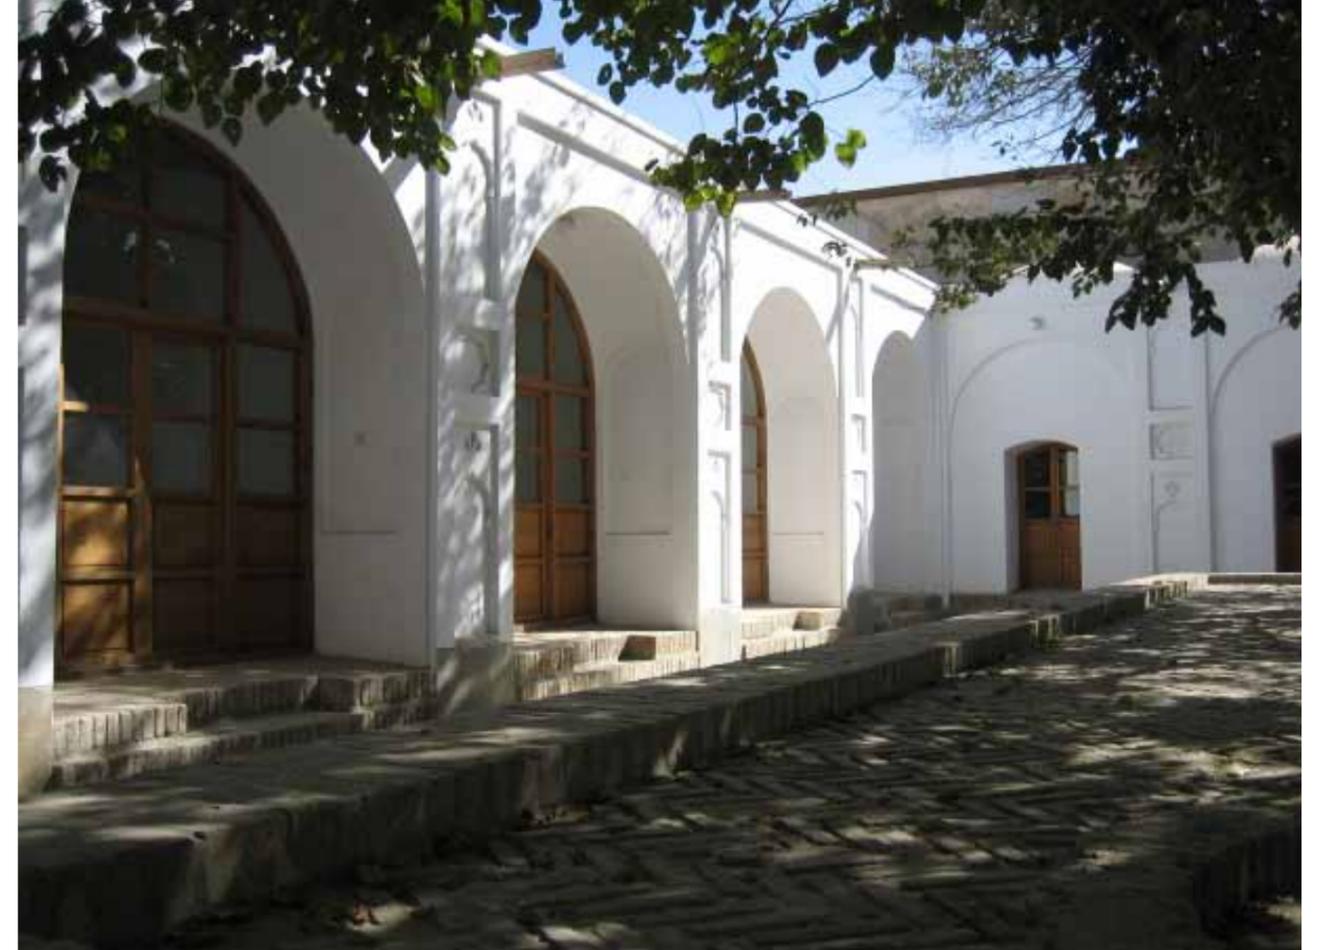
Top, used by local children for religious education, the restored madrasa is organized around a central courtyard planted with mulberry trees.

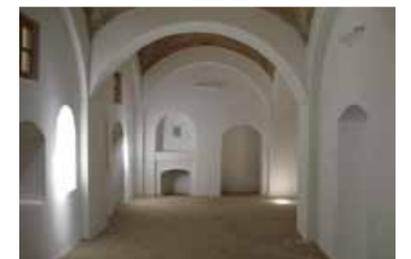
Above, built using thick masonry walls and domes, the internal restored spaces of the madrasa are ideally suited to the climatic conditions of Kabul.

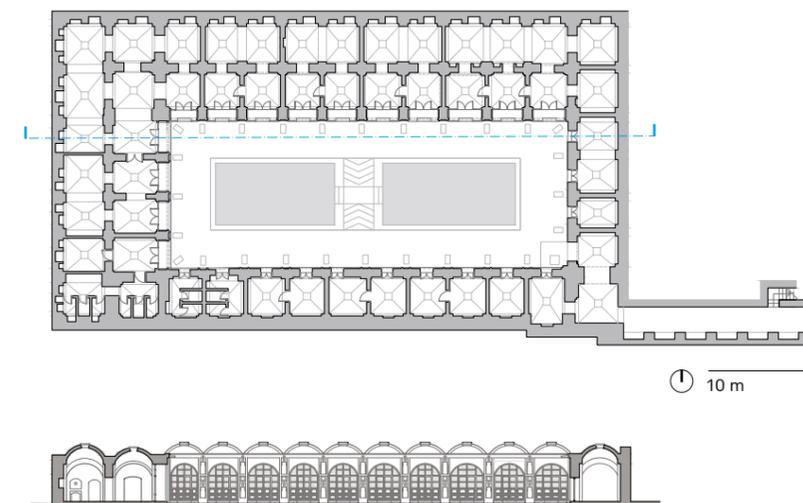
Left, ground-floor plan and section.

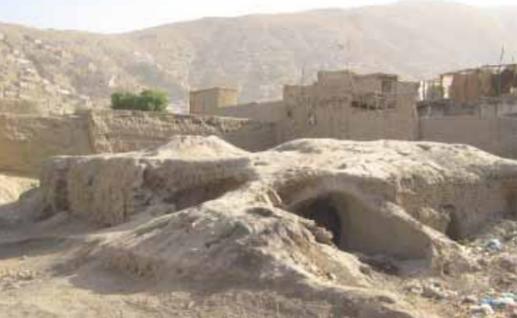
Above, the ruined Shanasazi Hammam was being used as a waste dumping site before its restoration.

In 2008, agreement was reached with the owner of the Shanasazi Hammam in the Old City of Kabul to reconstruct and recommission the derelict property as a community-managed facility. Rehabilitation work started with the clearance of accumulated debris and waste so that the condition of the existing structure could be assessed. Excavations revealed two brick-domed spaces surrounded by smaller rooms for private bathing and services. Once cleared of waste and rubble, the system of under-floor ducts for heating the hammam was found to be largely intact. A boundary wall was constructed before structural repairs were carried out on damaged sections of brick-masonry domes and external load-bearing walls. On completion of the external building work, the hypocaust flooring, chimneys and vents were reconstructed. Internal elevations of the hammam were replastered using a damp-proof lime mortar and marble flooring was installed throughout the space.

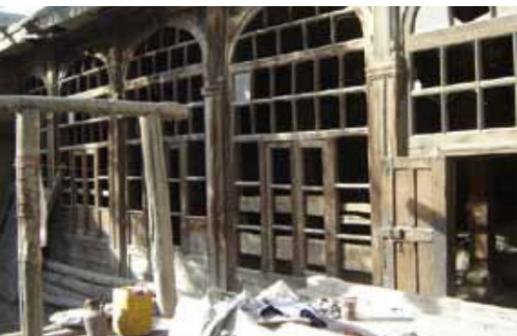
Below, left abandoned due to its condition, the Shanasazi Mosque required extensive structural repairs.

Following a detailed physical survey of the mosque building in 2009, structural repair work was undertaken entailing the strengthening and stabilization of stone foundations, the rebuilding of collapsed masonry walls, and reconstruction of the roofing structure. During removal of timber wainscoting and ceiling woodwork, more than twenty-five carved timber joists dating from an earlier mosque on this site were discovered together with white marble column bases in the Mughal style. The main

elevation of the mosque, containing intricately carved timber columns and arched fenestration, was carefully repaired *in situ*. Later additions on the main elevation and internal walls of the mosque were removed, revealing original characteristics of wooden and plaster decorative elements that were systematically conserved. Exposed sections of masonry walls were finished using traditional fine mud plaster (*simgil*) and gypsum plaster applied to the *mihrab* niche. The internal floors were levelled and a lime-based mortar was applied as a moisture-proof finish, enabling the custodians of the mosque to install locally procured furnishings in the area. In the courtyard, several Mughal-era, marble, column bases unearthed during excavations were incorporated in new stone paving. Ablutions and toilet facilities were built and an existing well was upgraded on the perimeter of the courtyard.

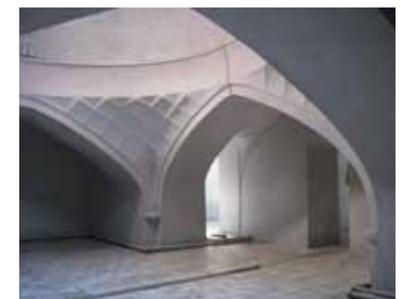
Partial reconstruction of domes and an internal view after completion.

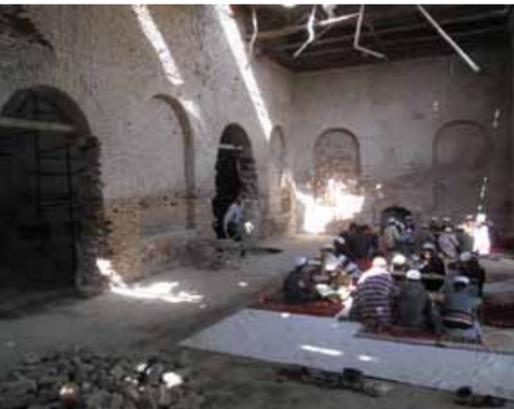
The Ulya Madrasa and Mosque continued to be used for religious education prior to its restoration.

Ad hoc temporary structures were carefully demolished and work commenced to strengthen and consolidate sections of the building that had been damaged. This included reconstructing sections of brick-masonry walls and stone foundations and enabled the carpentry, steel repair and installation work to begin. A new perimeter wall was built and facilities for use by worshippers and custodians were incorporated in the site. Large sections of the metal roofing and the steel trusses had been damaged beyond repair and these elements were reconstructed on site, where a

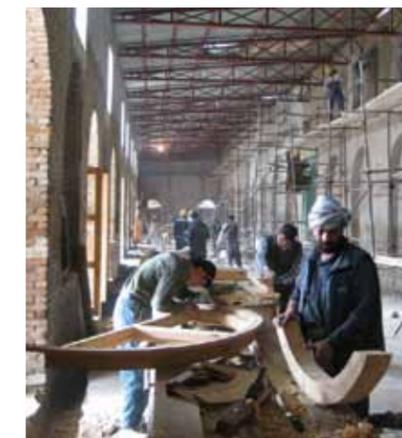
Left, built as a congregational mosque able to house up to 400 worshippers, original ventilation covers were repaired and reinstalled as part of the work done.

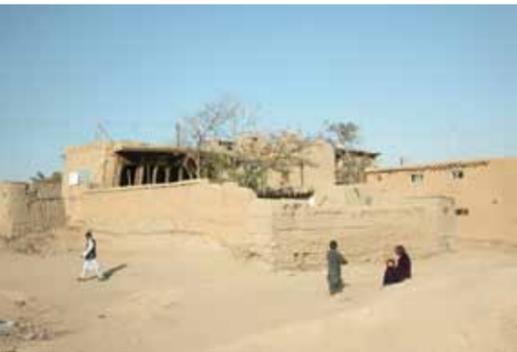
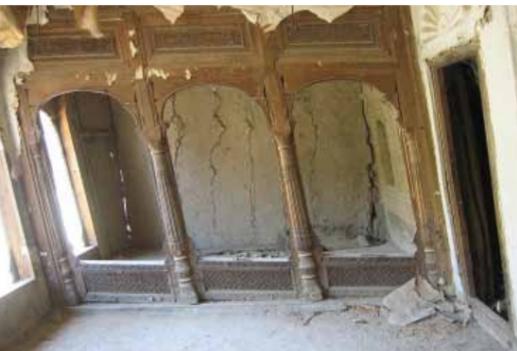
The Wasay House was close to collapse prior to restoration.

As the house was occupied at the time of documentation, a series of single-storey rooms were built across the courtyard to the south in order to house the family during the course of the conservation work. When this work commenced, the first task was to remove thick layers of earth material from above the roof, prior to installing temporary props beneath the timber structure, which had undergone serious deflection due to the added weight, causing structural failure in a mud-brick gable

wall. Adding layers of mud-straw plaster to the roof of a dwelling is a common practice that prevents water from seeping into the building. But this traditional technique requires owners to also remove layers of plaster every ten years, failing which, the added weight of layers of plaster risks causing structural failure.

Once the gable wall was rebuilt, the timber frame was gradually shifted back in stages close to its original position, to regain its stability. To limit damage to plaster decoration in the upper space, sheets of soft polyurethane foam were fixed over the walls during the course of shifting the frame. Once upright, excess plaster and whitewash was carefully removed by hand, exposing sections of fine moulded decoration. This enabled the reconstruction of a replica decoration surviving on the internal east elevation of the space. As with many homes of this era, a series of recessed *chini khana* could be found in the main space, which was divided by carved timber screens. Following restoration of the internal plaster, work began on repairs to the two levels of sliding timber panels (*patai*) that make up the south elevation of the house. Damaged sections of carved woodwork were replaced in places, and new shutters were made from cedar wood (*archa*) and installed. Following the completion of conservation, the dwelling was returned to its owners, who presently occupy the house.

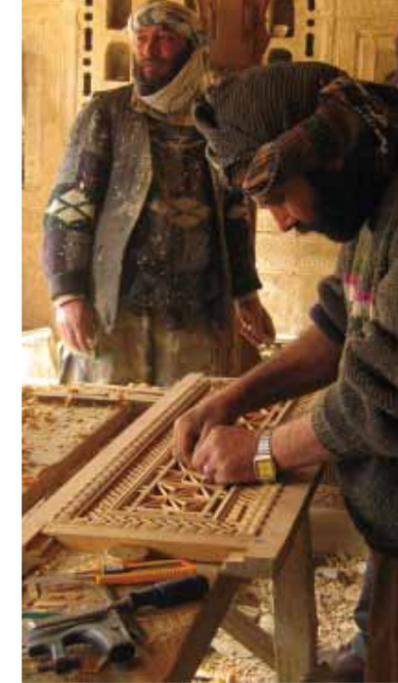
Right, carpenters work to reconstruct missing sections of an intricate latticework screen.

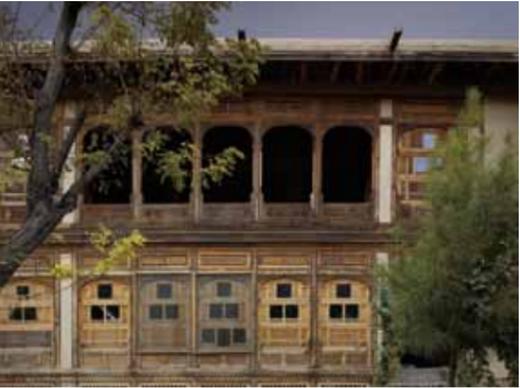
Above, the Wasay House was restored to be used as originally intended, with an upper living area with sliding screens for use in warmer months.

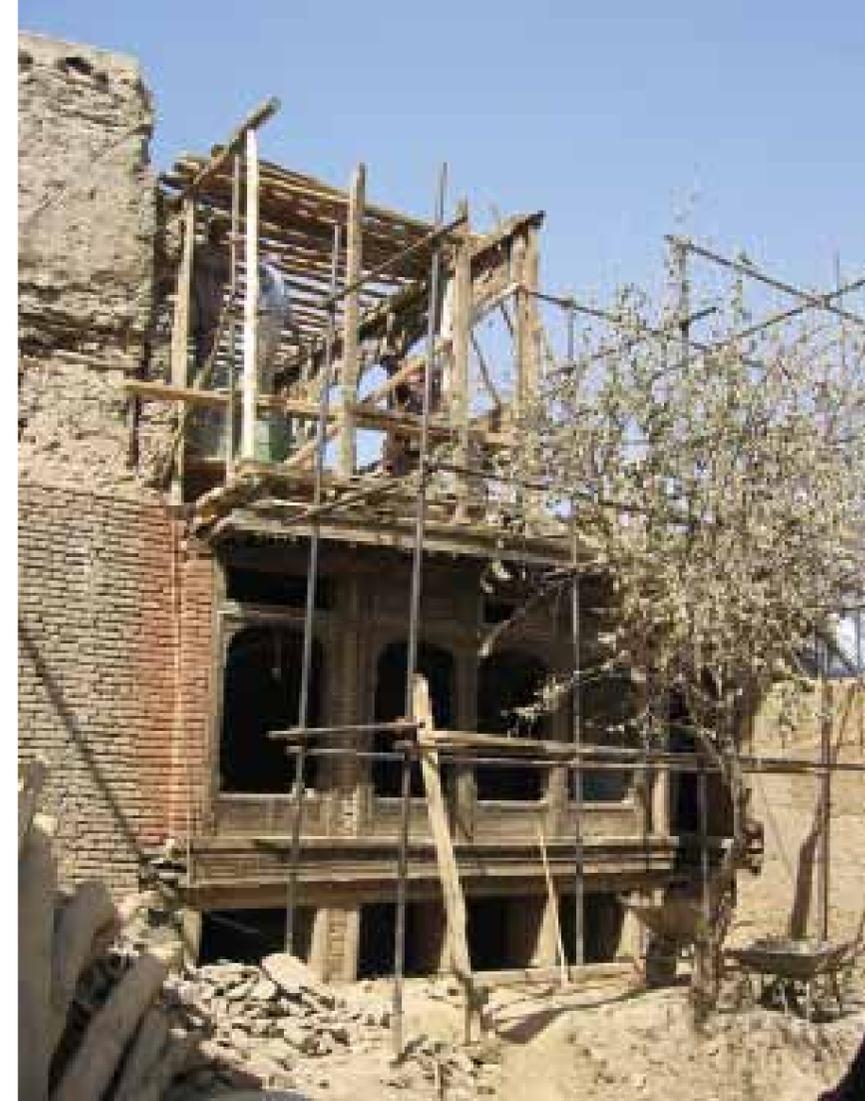
Top left, repair to the timber-frame construction of the house entailed removal of damaged sections of timber and retrofitting of wooden reinforcement.

Restoration work required complex structural retrofitting and stabilization of the traditional wood-frame construction. Large sections of the masonry walls had to be replaced with fired brick and the upper floor of the house was rebuilt, retaining original architectural elements. Chronic structural problems had forced occupants to fill openings with mud brick for fear of collapse of a wall. These areas were consolidated and historic windows were reinstalled enabling the upper floor to benefit from cross-ventilation in the warmer months. Internal gypsum plaster decoration was carefully cleaned and damaged sections repaired using fine mud plaster (*simgil*). Timber columns and screens were cleaned, repaired and preserved using linseed oil. Conservation work was completed in 2005 and the dwelling was returned to its owners, who presently occupy the house. As part of the conservation process, historic homes restored by AKTC in the Old City are registered as national monuments with the Ministry of Information and Culture, providing protection against further destruction and technical support for maintenance.

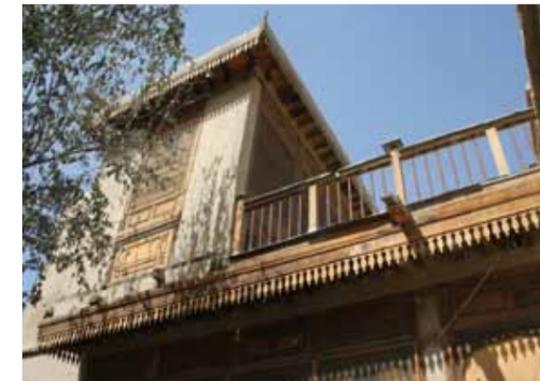
Top right, built into a sloping hillside, the Shukur House benefits from multiple orientations, with the upper floor facing east.

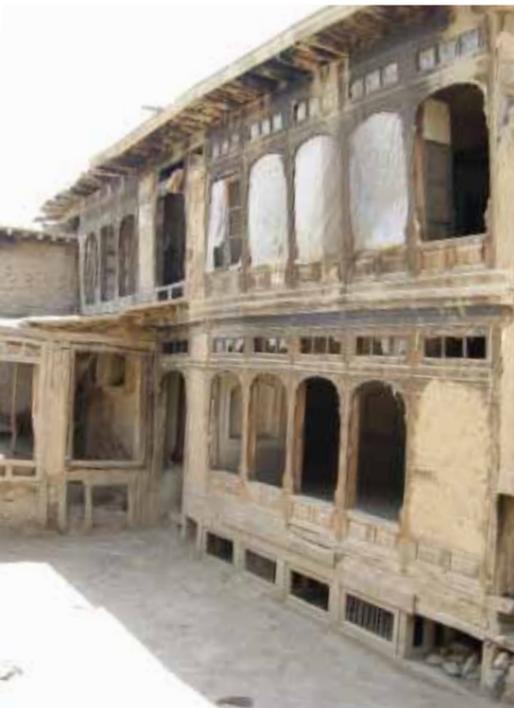
The Ruhullah House is one of the largest historic homes in the Old City, prior to restoration.

The rehabilitation of the Ruhullah House entailed the rebuilding of the eastern wing, the reconstruction of its roofs, and the restoration of the timber screens on the south and north courtyard elevations. Work commenced with the removal of debris and careful dismantling of timber architectural elements for repair in a carpentry workshop established in the courtyard of the building. Decorated wooden structural posts and fenestration was stabilized *in situ*, cleaned and repaired before wooden joists were reattached internally to support floors and the roof. Infill walls were reconstructed and existing sections of masonry walls with stucco decoration were stabilized and repaired. Roofing was constructed using traditional methods and materials before face boards and timber railings were installed. Exposed surfaces of timber decorative features were preserved and missing sections of sliding shutters were fabricated and installed.

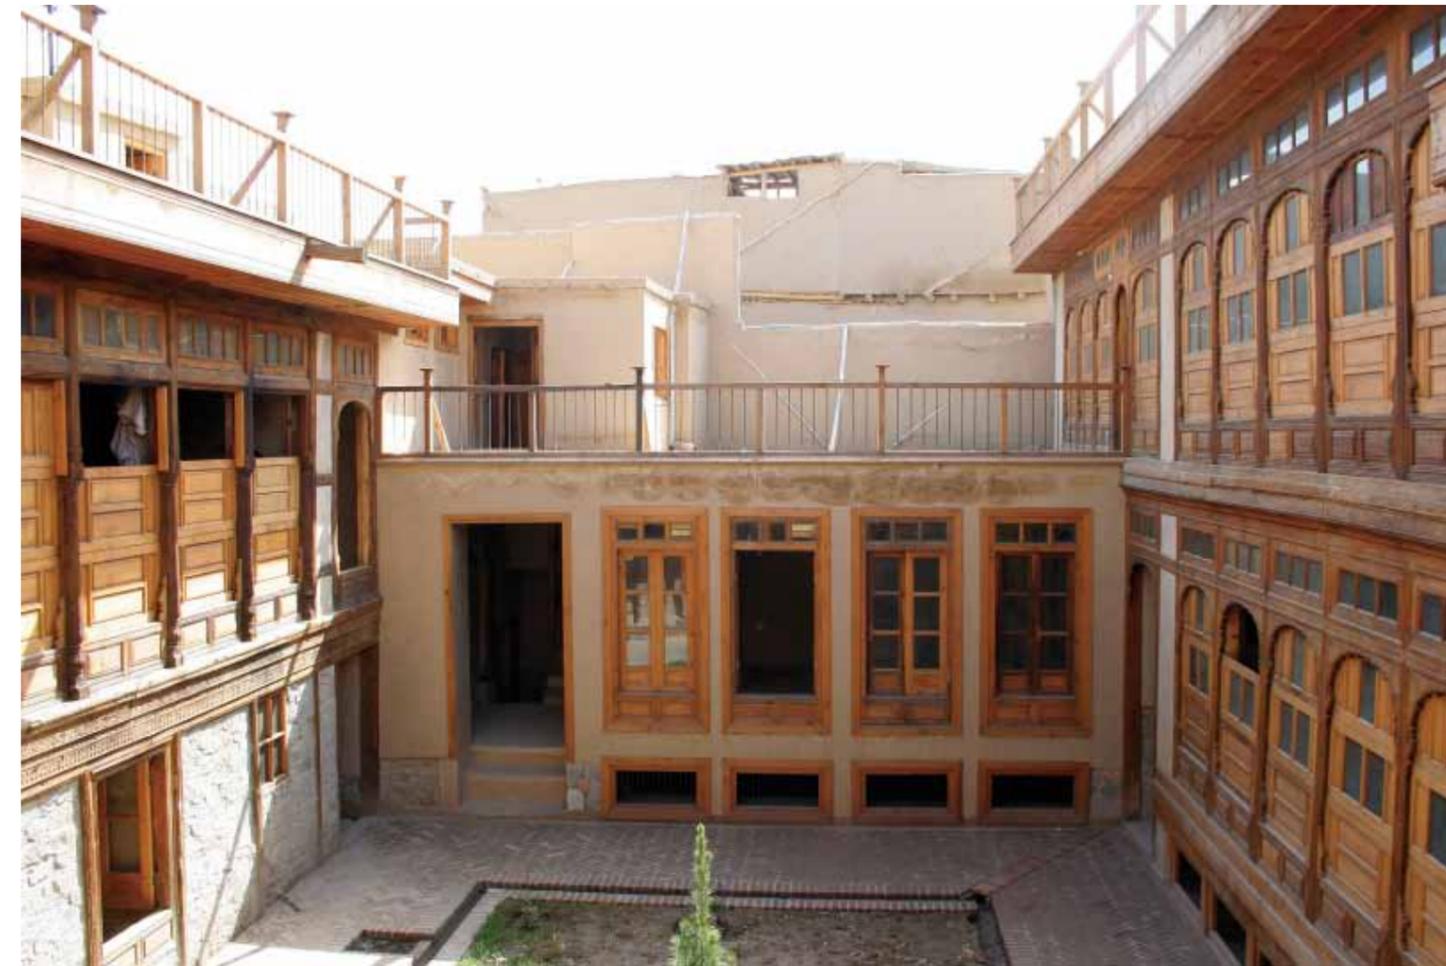
Above, built within the dense fabric of the Old City, the restored house is organized around a private internal courtyard.

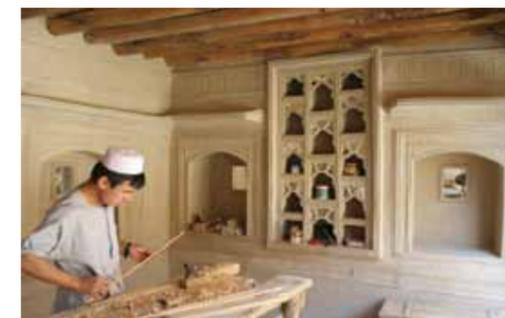
Below, a carpenter's apprentice at work repairing timber screens.

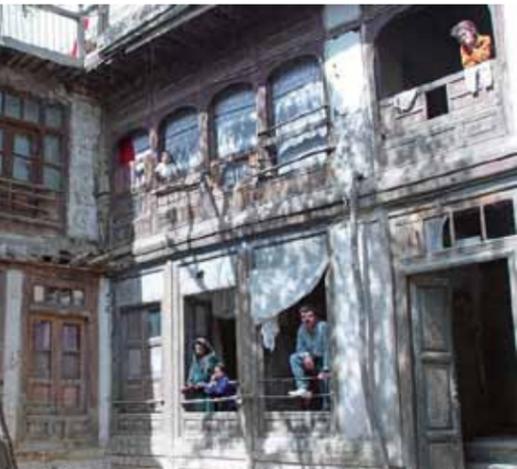
The Jelan House was partially occupied by multiple families prior to restoration, who remained in the residence throughout all the work.

With residents continuing to occupy the house during conservation, work proceeded in phases requiring the completion of one segment and the relocation of the family into restored quarters — before the next section of the building could be restored. Rehabilitation of the Jelan House entailed the removal of debris and careful dismantling of timber structural elements for repair. Decorated timber posts and screens were stabilized and repaired *in situ*. Where damaged, infill walls were reconstructed and existing sections of stucco decoration were stabilized and repaired. Roofing was constructed using traditional methods and materials and timber railings were installed. Timber decorative features were preserved and missing sections of sliding shutters and screens were fabricated and installed. Restoration work was completed in 2007 and the house was returned to its owners, who presently occupy it.

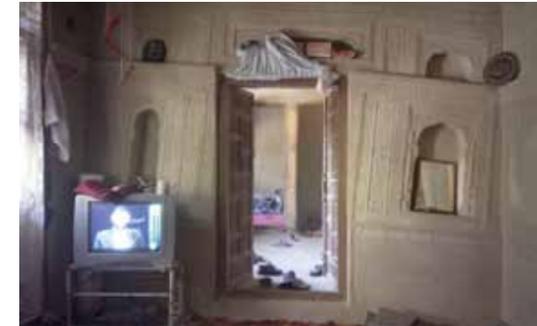
Below, damaged sections of decorative stamped plaster were consolidated *in situ*.

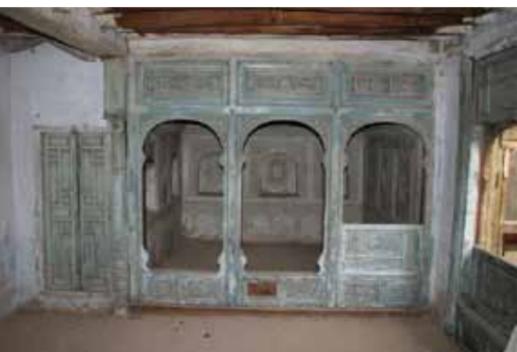
The Shekeba House prior to restoration.

As with other historic homes restored by AKTC, the main cause of damage in structures built using traditional methods is subsidence of masonry walls or deterioration of timber structural elements due to a general lack of maintenance. Areas affected by the intense conflict in Kabul were often abandoned for an extended period, which resulted in further deterioration of structures that might otherwise have been easily repaired. Traditional homes use the *sinj* construction technique and are built as a 'kit of parts', with timber-frame elements and wooden fenestration fabricated in workshops and then installed *in situ* on top of masonry walls, where the final layers of masonry infill and roofing are applied. Full-scale conservation of traditional structures requires the careful removal of damaged masonry and the repair of the timber 'skeleton' of the building before the application of new masonry and final finishes. The Shekeba House required extensive rebuilding of the eastern wing, which had subsided, and the reconstruction of an entire timber screen on the south courtyard elevation. Over the course of AKTC's work in the Old City, wooden architectural decoration, including screens and shutters, was salvaged from dozens of destroyed properties that were beyond repair. These items were often repaired and reinstalled in historic homes that were being conserved and that had similar architectural features. Building and conservation work was completed in 2006, when the property was handed back to its owner. Since then the property has changed hands again and is currently being used as a permanent storage for a collection of historic architectural artefacts and decorative items intended for public display.

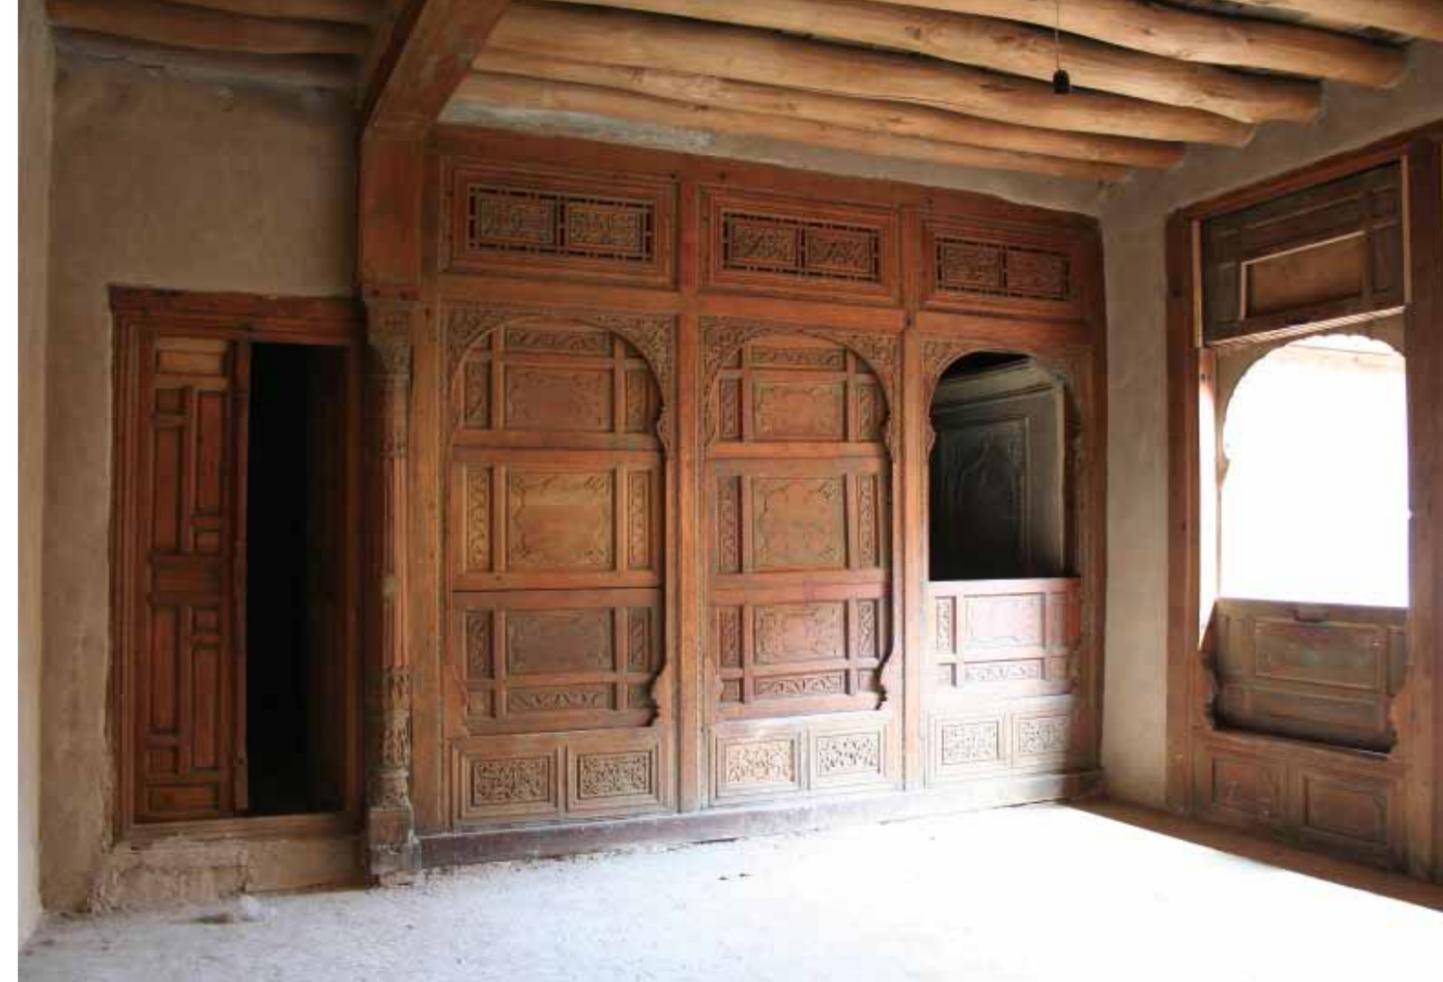
Above, internal living spaces are separated by timber screens, which can be opened to create larger spaces or closed to provide privacy.

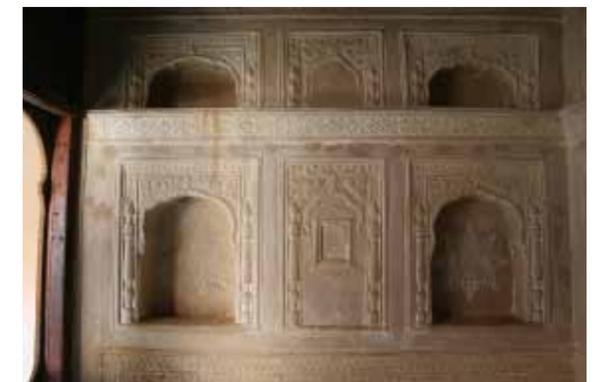
Below, stamped plaster decorations were cleaned and consolidated as part of restoration activities.

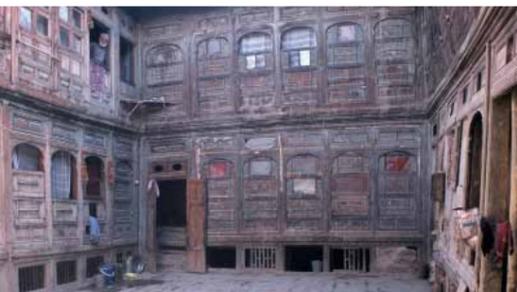
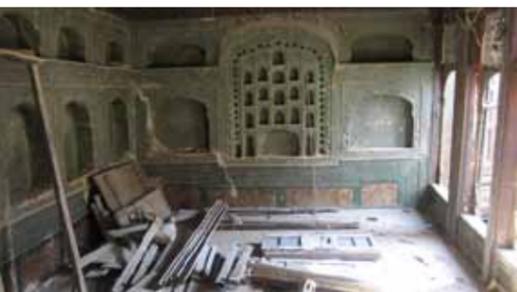
Above, the Rambu House was spared the worst during the conflict that destroyed large parts of the Old City. However, lack of maintenance and having remained vacant for prolonged periods resulted in damage to the structure of the house, which was in a poor state prior to conservation.

At the time surveys were conducted in 2003, nine households inhabited the Rambu House. The building was in a poor state of repair and presented safety concerns for the families living there, and restoration commenced in 2006. As with other homes restored by AKTC, the project was divided into phases enabling families to continue to occupy various segments of the house during the conservation process. Condition assessments had revealed severe structural problems in the western wing of the property, which became the focus of the first phase of building. Damaged sections of the house were temporarily propped up using jacks and scaffolding, while affected areas of masonry construction were removed and rebuilt. Timber posts and joists were examined for decay and replaced where necessary before a protective layer of tar was applied to sections embedded in masonry walls to prevent future damage. Wooden boards were placed above timber joists and covered with a layer of straw-matting, before a final layer of compacted mud was applied to internal floor areas and

Once the masonry elements of the building had been consolidated and the structure provided with a roof, conservation work focused on internal plaster decoration and timber fenestration. Original sections of the woodwork were carefully dismantled and transferred to a carpentry workshop established in the courtyard of the property, where they were cleaned, repaired and later reinstalled. Sections of the facade that could not be removed for structural reasons were repaired *in situ* and sections that had been damaged beyond repair were replaced with newly constructed cedar elements. Once all the wooden elements had been repaired and installed, linseed oil was applied as a protective layer against damage from rain. As with many homes of this era, a series of recessed niches used for the display of porcelain (*chini khana*) was found in the main space. Together with other areas of plaster decoration, these were carefully cleaned and conserved. Sections of plasterwork that had become detached from the masonry walls were consolidated *in situ*.

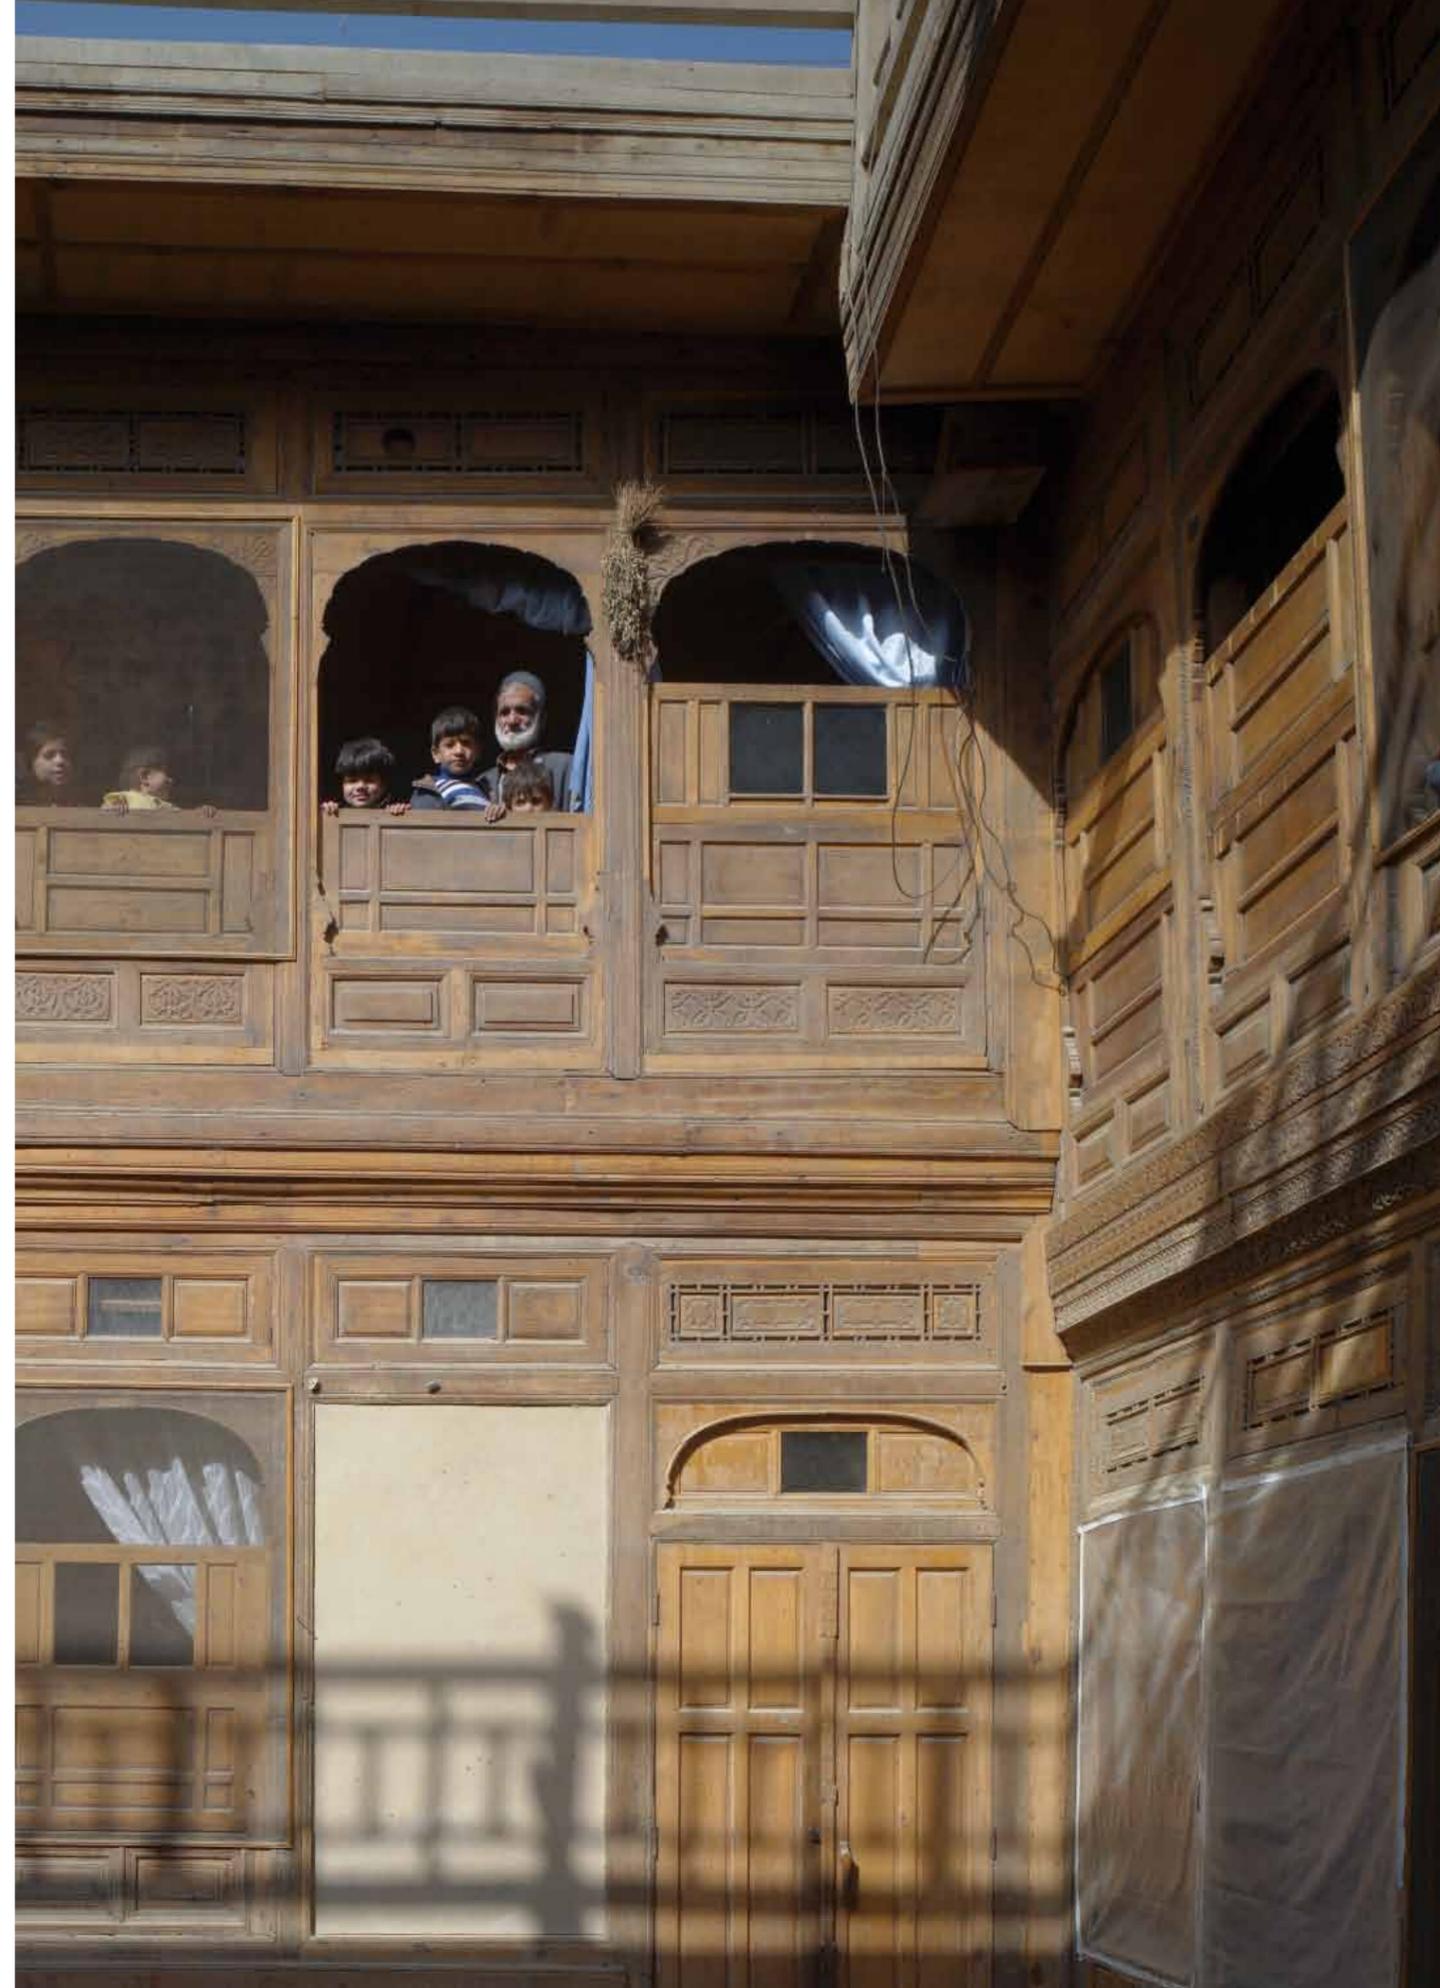
Above, ground-floor plan and section.

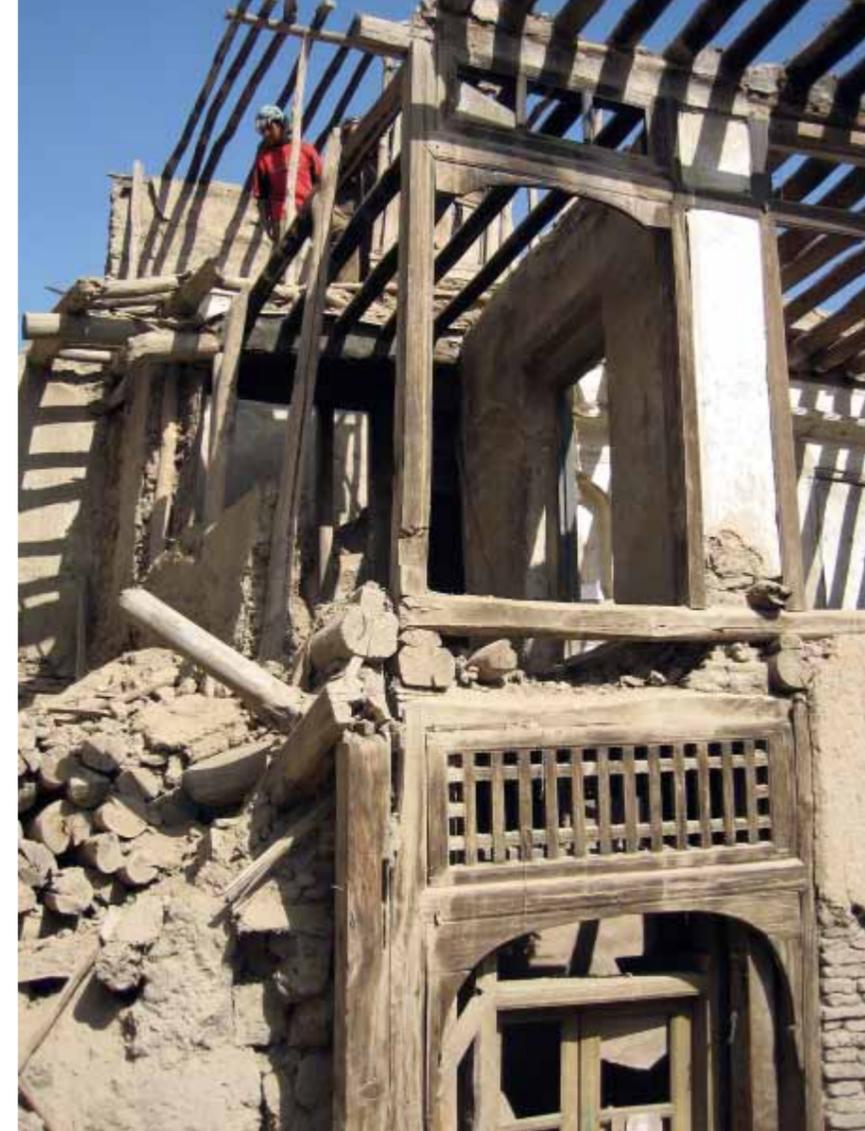
Above, arched timber screens were repaired on site and reinstalled prior to the application of a finishing layer of plaster on the main elevation and the roof of the house.

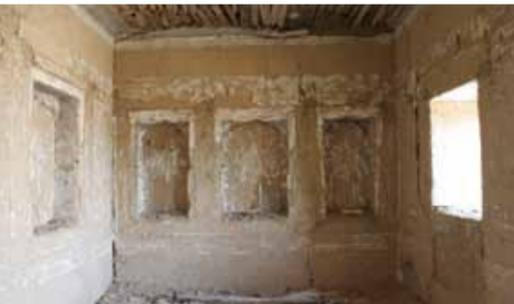
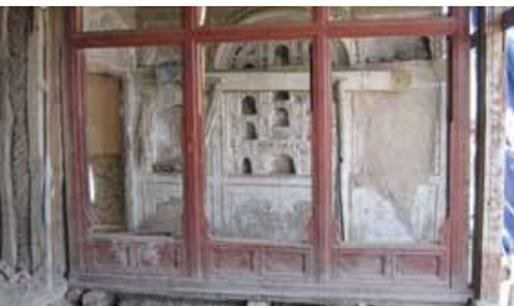
Built into the hillside, the Khaluddin House prior to restoration. Unusual for historic residences in the Old City, decorative elements in the house included plastered and inlay woodwork ceilings.

Restoration by AKTC started in 2006 with the stabilization of the south wall, followed by the repair or replacement of timber facade elements and repair work to the roof structure and covering. Internally, the chimney and fireplace on the ground floor were repaired, and ceilings and walls were replastered. On the first floor, special attention was paid to the restoration of the fine plasterwork and repair of the damaged or missing sections of decorated timber. Teams of carpenters established a workshop on the second floor of the house, enabling them to dismantle damaged sections of the woodwork and replace missing or repaired elements. During the final stage, the courtyard was paved with local stone and landscaped with greenery. Restoration work was completed in 2008 when the property was registered as a historic monument and handed back to its owners.

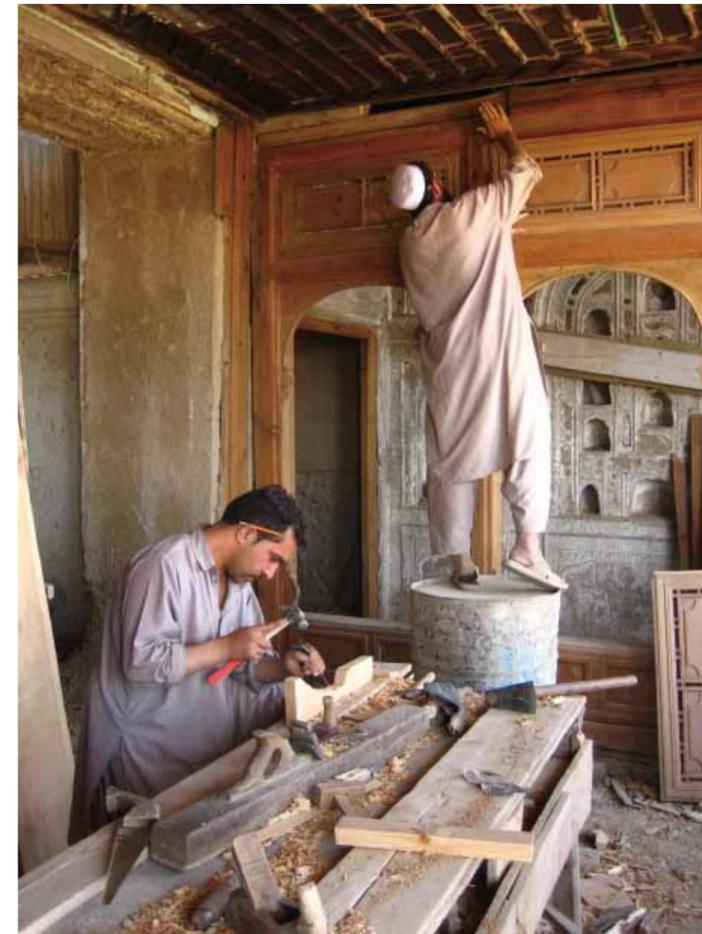
Top left, carpenters work to restore timber partitions.

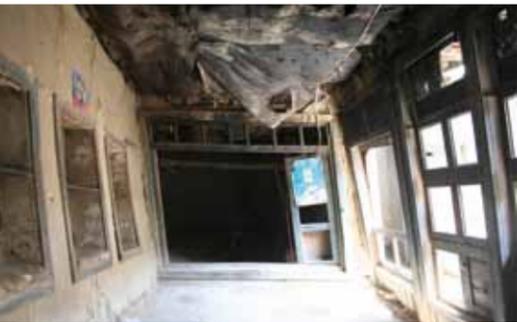
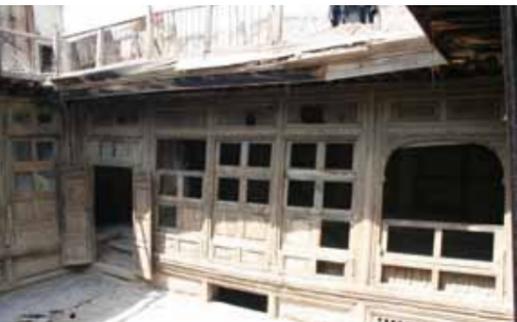
Initially surveyed in 2003, the structure of the Muneeb House was found to have been damaged during the conflict in the area. The multi-level home retained large sections of its original timber screens.

Work on the house started in early 2007 with the removal of doors and windows, followed by stabilization of the structural load-bearing walls and roofs. A condition assessment had shown that the upper floors of the south wing, stretching over the street and forming a passageway for the public, had to be entirely rebuilt. Rooms on the roof level, which traditionally served as an extension of the living space during the summer months, were reconstructed using traditional building methods.

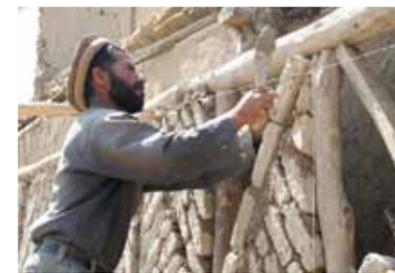
Left, a craftsman laying mud bricks between the timber-frame construction, a technique widely used in traditional homes in the Old City.

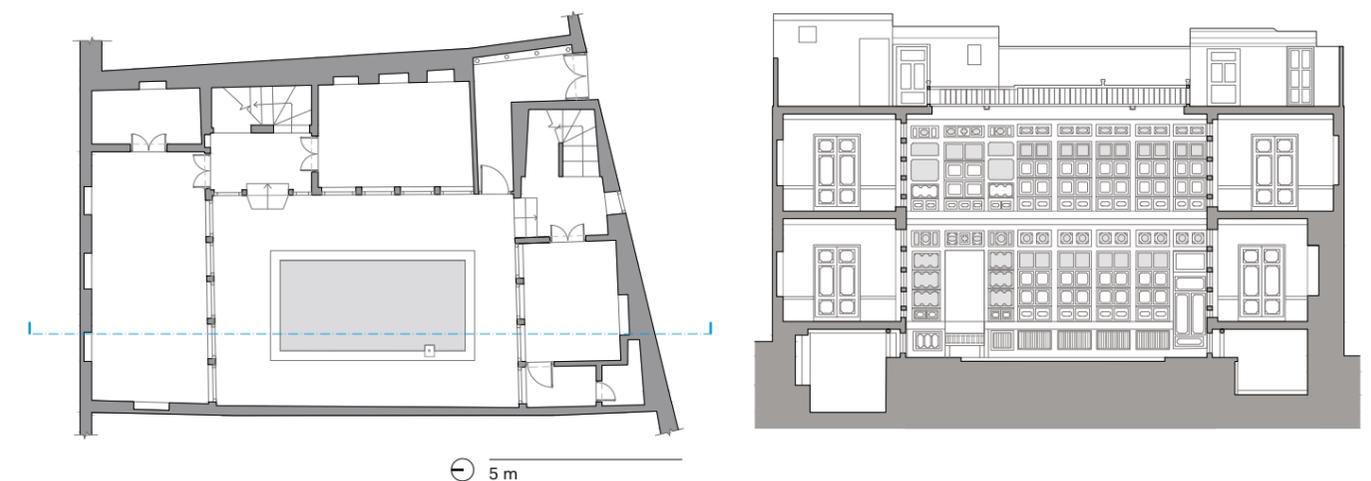
Bottom, first-floor plan and section.

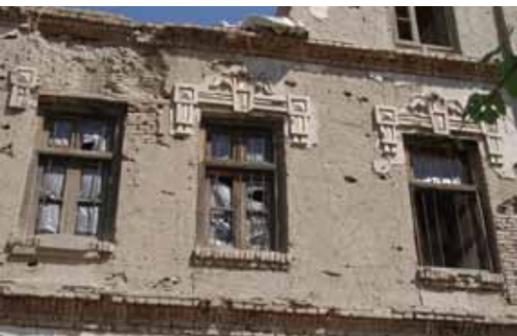
Below, built in the early 20th century, the fort was occupied by warring factions and damaged extensively during the early 1990s.

As part of supporting conservation around Babur's Garden, AKTC surveyed the property in 2005 and shortly afterwards undertook the conservation of the historic residential complex. In agreement with the current owners of the subdivided property, internal partition walls were dismantled commencing a phase of clearance and removal of debris and rubble. While some work had been carried out after 2002 on the main residential block, the southern tower of the *qala* required structural consolidation and partial reconstruction. From the remains of the original architectural features, it was possible to restore the southern tower to its previous character. Segments of a high perimeter wall built with compacted mud was partially reconstructed and restored. Because it was not possible at the time, the second
