# KABUL

**INTRODUCTION**

**PHYSICAL CONSERVATION  
AND RESTORATION**

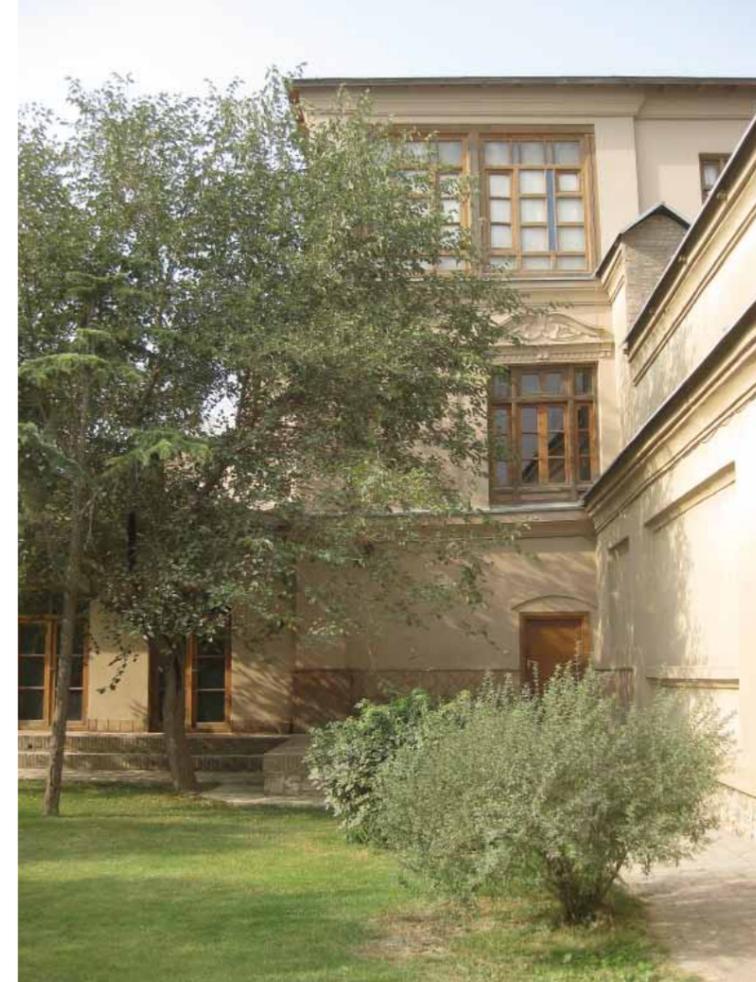
Left, one of two restored residential towers, partially connected to a compacted-mud wall enclosing its large garden.

residential tower was reconstructed in 2011, completing the restoration of what remained of the original dwelling. As a fine example of residential architecture of the early twentieth century, the complex was registered as a historic monument with the authorities.

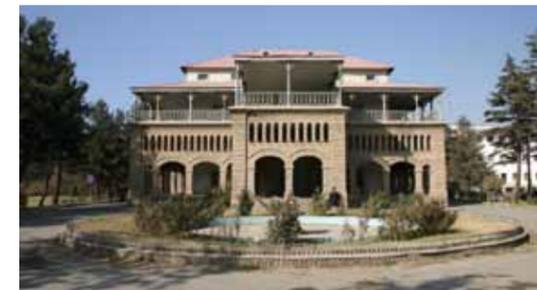
Below, the palace remained partially used and extensively transformed by ad hoc repairs prior to conservation.

Poor workmanship and the use of inappropriate materials during the third phase of the expansion of the palace had resulted in extensive damage to the roof area and the main elevations of the building. Ad hoc internal partitions created using material recycled from other buildings had caused extensive damage to decorated wooden ceilings, which had been painted over several times. By the time a physical survey and condition assessment were prepared by AKTC, the palace was dilapidated, with many areas of the building affected by structural problems and damage resulting from water seepage from the roof. The area surrounding the palace had been transformed into a road and re-asphalted on several occasions without removal of previous layers of road construction, resulting in the partial covering of the palace beneath forty-five centimetres of asphalt. This resulted in extensive damage to lower sections of the brick-masonry construction, which, together with vibrations caused by the regular traffic of heavy vehicles, had caused areas of the palace to subside.

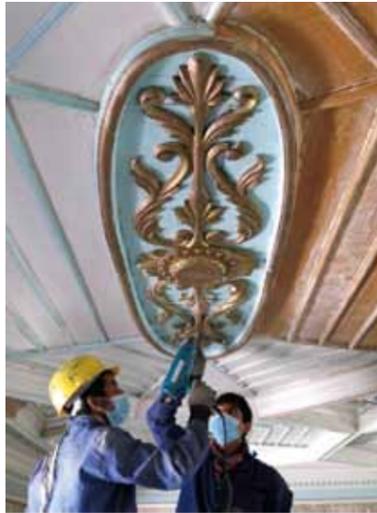
Above, restoration work involved stripping modern paint from the decorated timber ceilings.

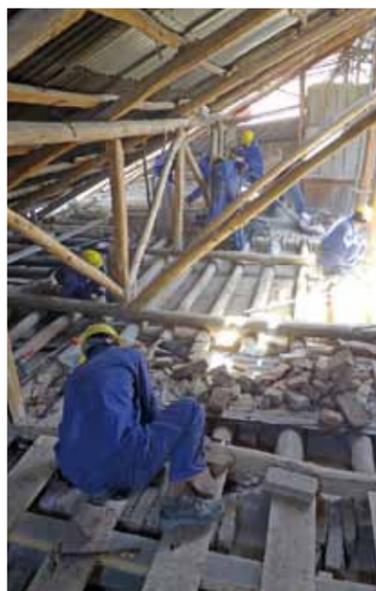
Left, extensive structural repairs were made to the roof of the building.

To this end, the structural consolidation of existing walls, floors and roof trusses became the first priority of the rehabilitation activity. In areas where significant damage had occurred, sections of the building were carefully dismantled and reconstructed using comparable materials. Large areas of the roofing structure that had been damaged or that had been built using inappropriate details were strengthened through the insertion of reinforced-steel framing. Once the structural elements of the roof were consolidated, timber decking was added and protected with a layer of tar-paper. Corrugated galvanized metal sheeting was applied to the roof and a network of gutters and downspouts was added.

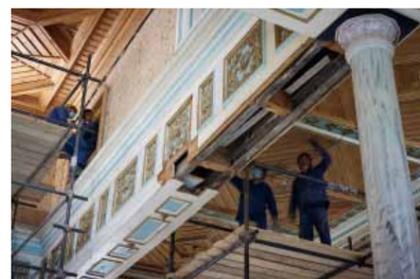
Right, above, the timber ceiling above the main reception hall was repaired and treated with beeswax.

Internally, historic features — including coffered timber ceilings and fenestration, cast-iron and brass elements, decorated fireplaces and original marble floors — were meticulously cleaned, repaired and protected. Inbuilt furniture, including large decorated wood-frame mirrors and cabinetry, was also cleaned and protected with beeswax. Thick layers of paint were removed from the surface of pressed-metal ceilings, followed by repair of areas corroded by rust, before the application of filler material and repainting of the ceiling on the ground floor. Although damaged, the pressed-metal ceiling located on the first floor of the palace was not corroded, making it possible to leave the burnished metal exposed.

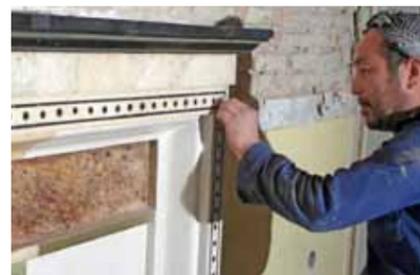
Right, below, restoration work within the building entailed removal of paint from marble and stone surfaces.

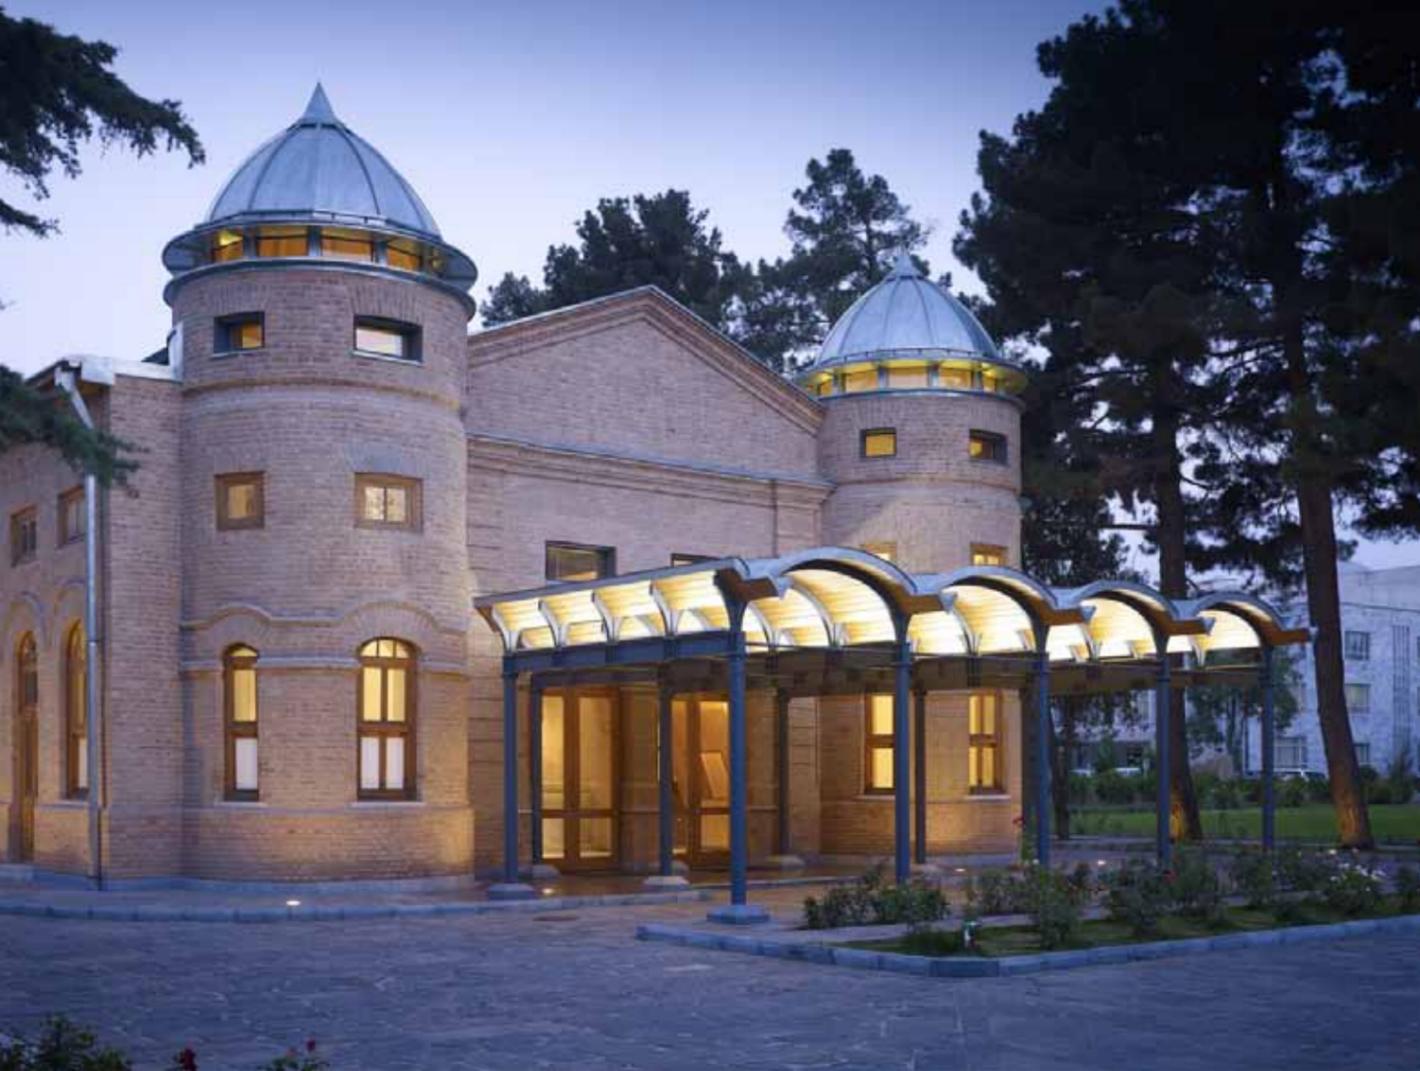
Above, a canopy was constructed over the entrance into the main reception hall in an area of the building that had been expanded in the mid-20th century.

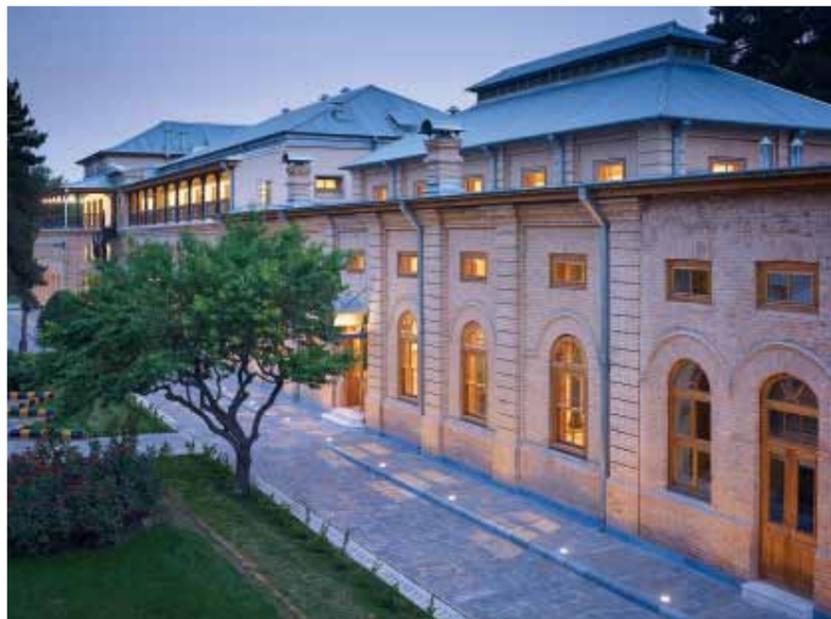
Below, designed to link a series of multifunctional spaces, the palace extends more than ninety metres in length.

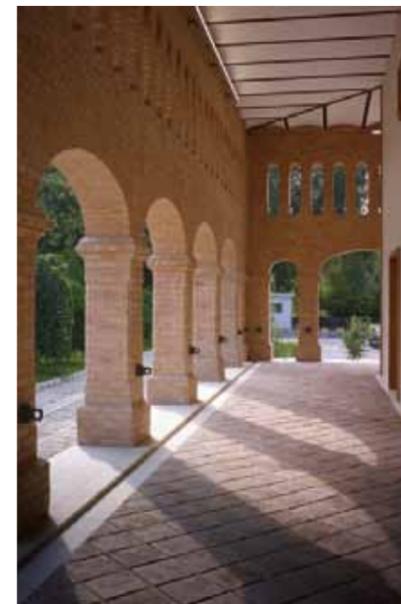
Left, main spaces are surrounded by a deep, shaded colonnade that prevents direct heat gain in warmer months.

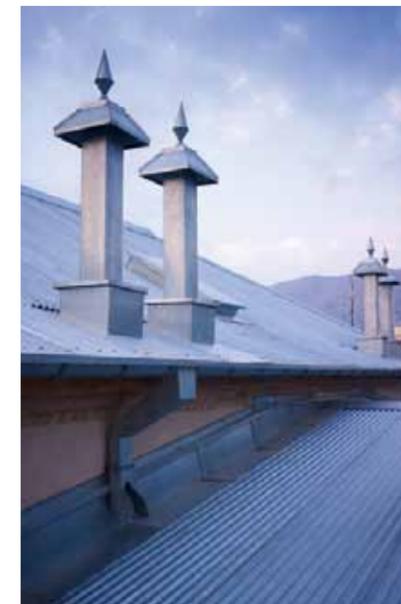
Right, the roofscape of the building reflects its multiple phases of expansion and had to be extensively reconstructed as part of rehabilitation work.

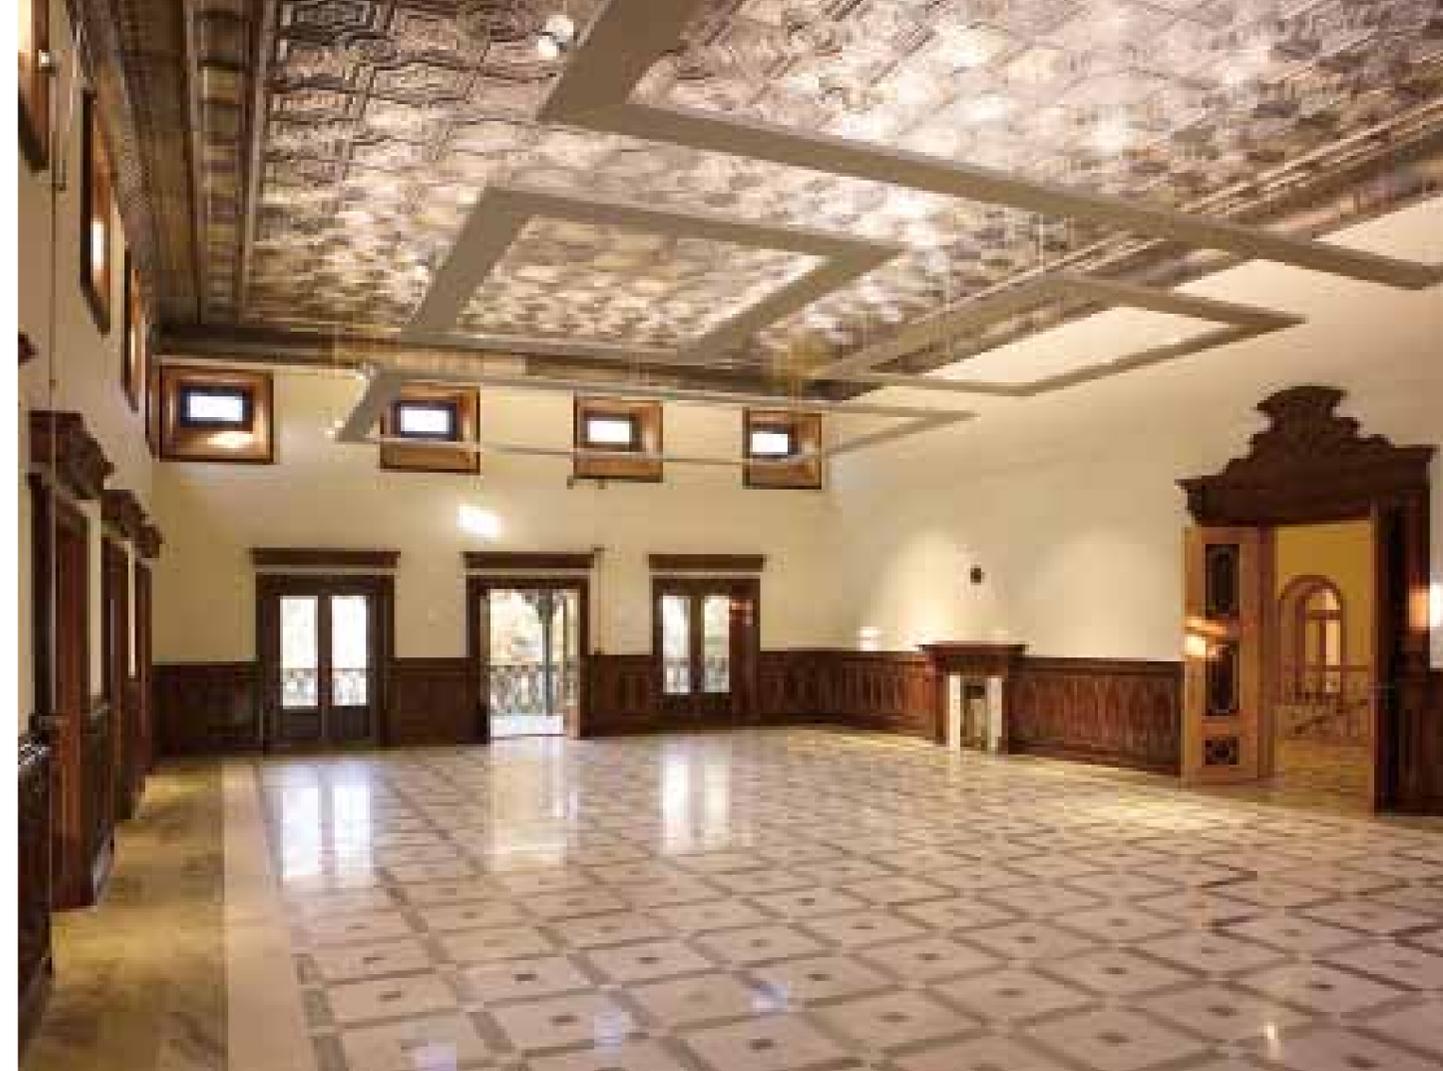
Above, layers of modern paint were removed from the surface of embossed metal ceilings, restoring their original finish.

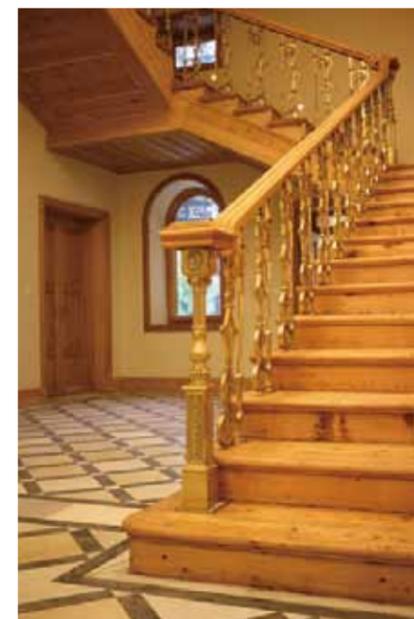
Left, oxidized brass railings were restored to reflect the original character of the building.

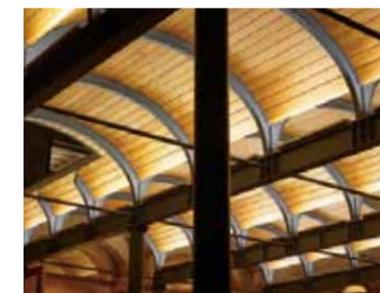
Right, above, steel elements used to construct a new entrance canopy were fabricated locally.

Right, below, the design of the entrance canopy reflected the arched openings of the palace.

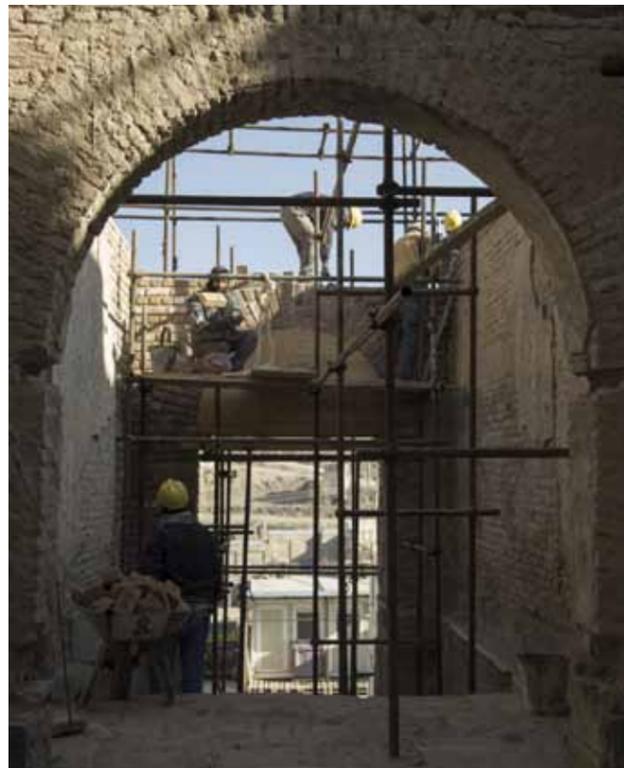
**Left, destroyed sections of the palace being repaired by masons as part of ongoing rehabilitation work.**

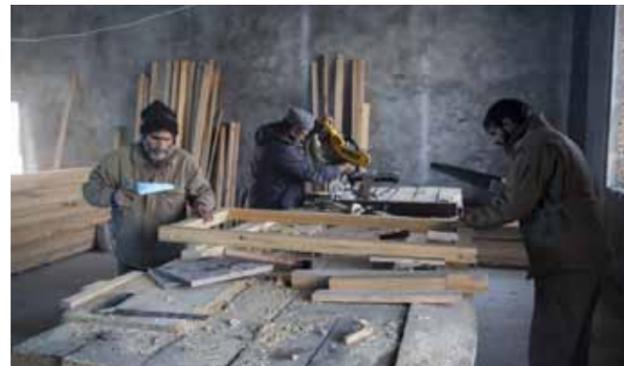
**Right, above, carpenters preparing timber-frame doors and windows, which will be installed in existing and newly constructed buildings.**

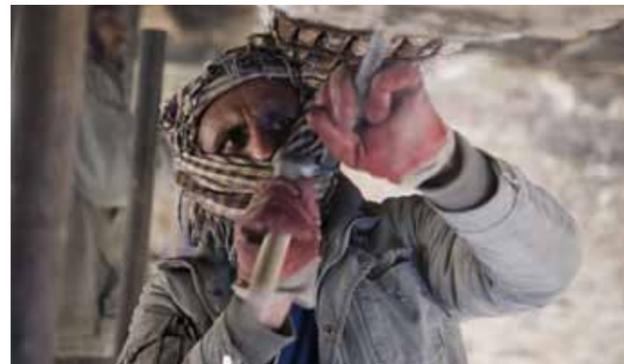
**Right, below, a worker prepares existing surfaces for structural retrofitting and repair.**

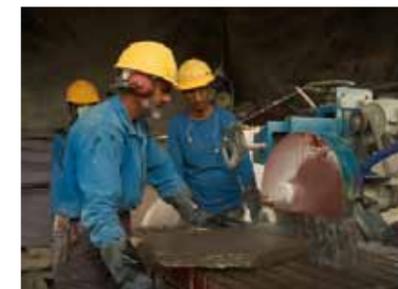
Below, left, local stone being prepared for use in pathways and as cladding on buildings.

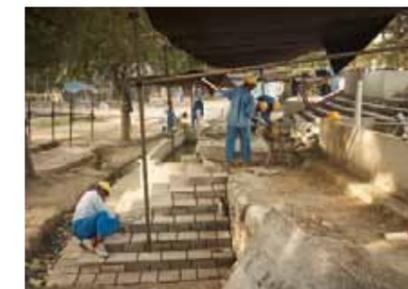
Below, right, masons laying dressed stone near the amphitheatre.

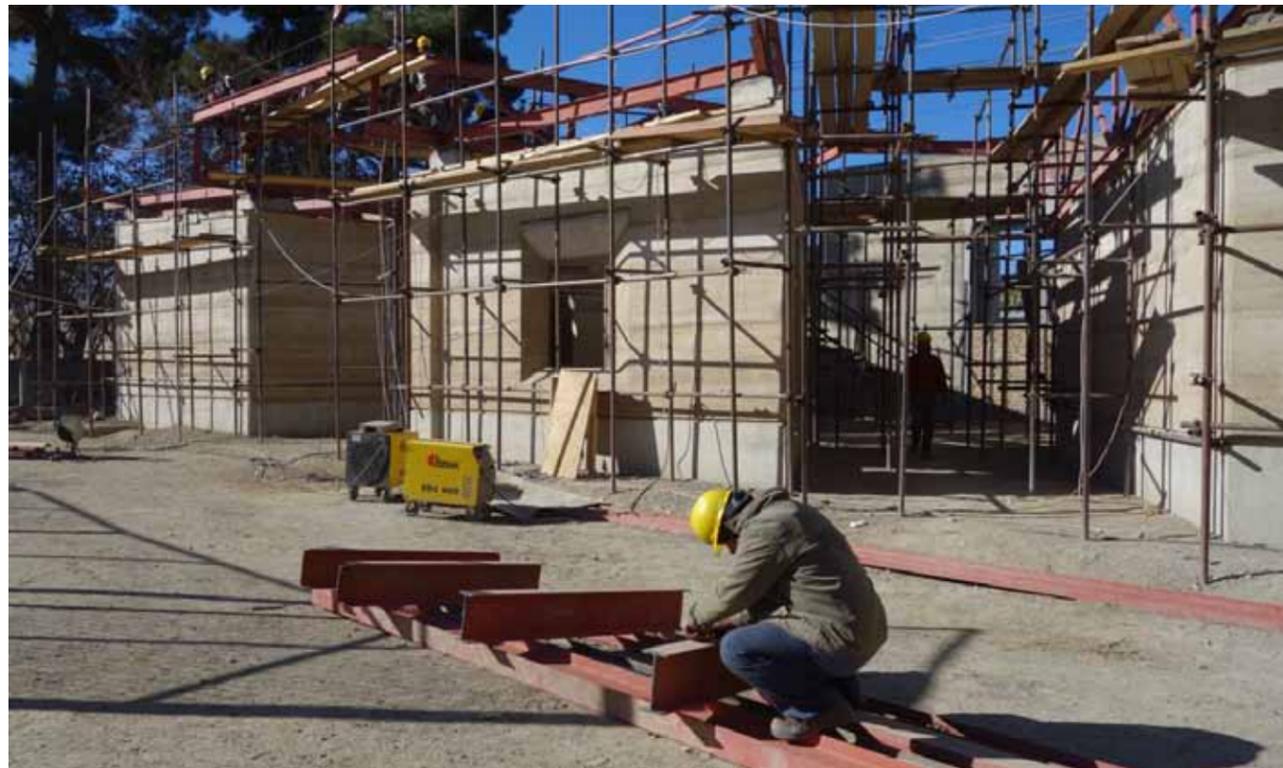
Assembly of lightweight, steel-frame roofing structure.

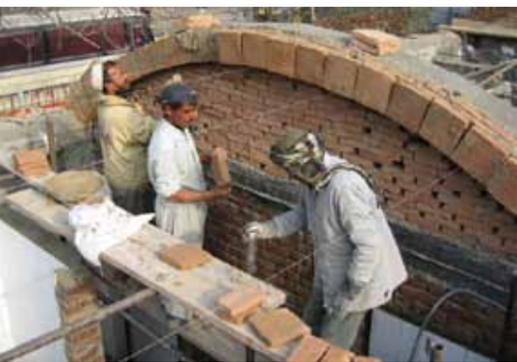
Above, masons prepare fixings for installation of decorative brickwork on the mosque located adjacent to the mausoleum.

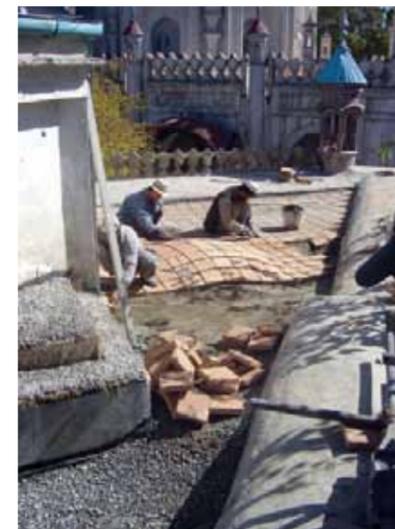
Left, a durable baked-brick surface was laid over a waterproof layer of lime concrete on the roof of the mosque.

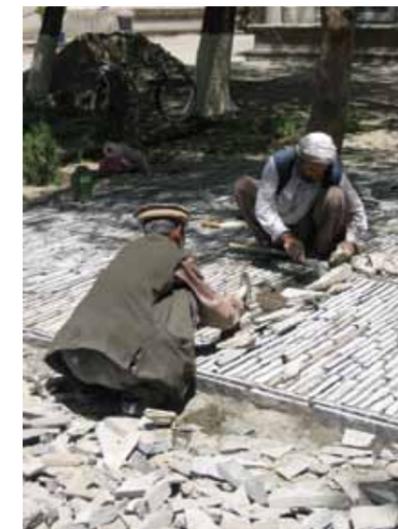
Right, local stones laid on edge were used to construct a durable pathway within the park.

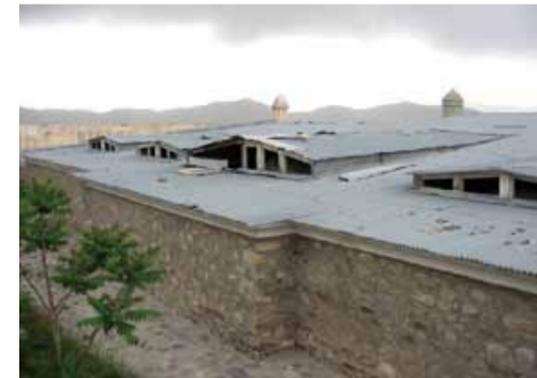
Above, galvanized iron roofing erected over the mosque had been damaged, resulting in the collapse of one of the mosque's domes due to water seepage.

In order to prevent further damage to internal spaces, the first stage of work focused on repairing the galvanized metal roof of the mosque. The previous corrugated sheeting — much of which had fallen into disrepair, due to poor fixing and lack of maintenance — was stripped in phases, in order to enable a detailed examination of the uncut timber joists beneath. Repairs were carried out to strengthen the wooden substructure, over which new timber boarding was fixed and sections of existing and new corrugated metal roofing was reattached. Lengths of coping and corner edges around the metal roofing were redesigned to prevent penetration of water and to allow for run-off into fixed points linked to surface channels on the ground.

Once the roof of the building had been repaired, internal conservation work was carried out on the partially collapsed dome that was rebuilt with mud bricks produced

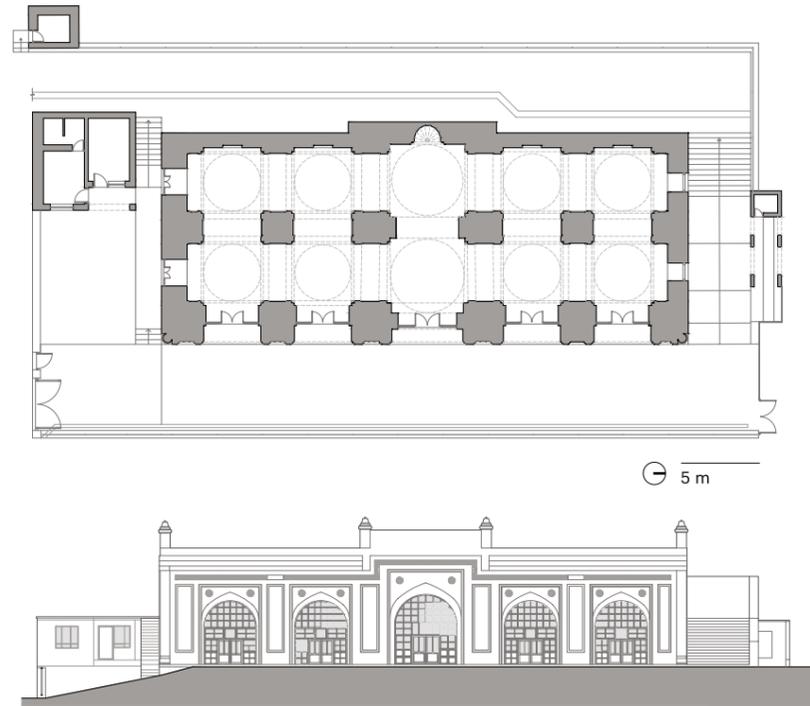
Top, ground-floor plan and main elevation.

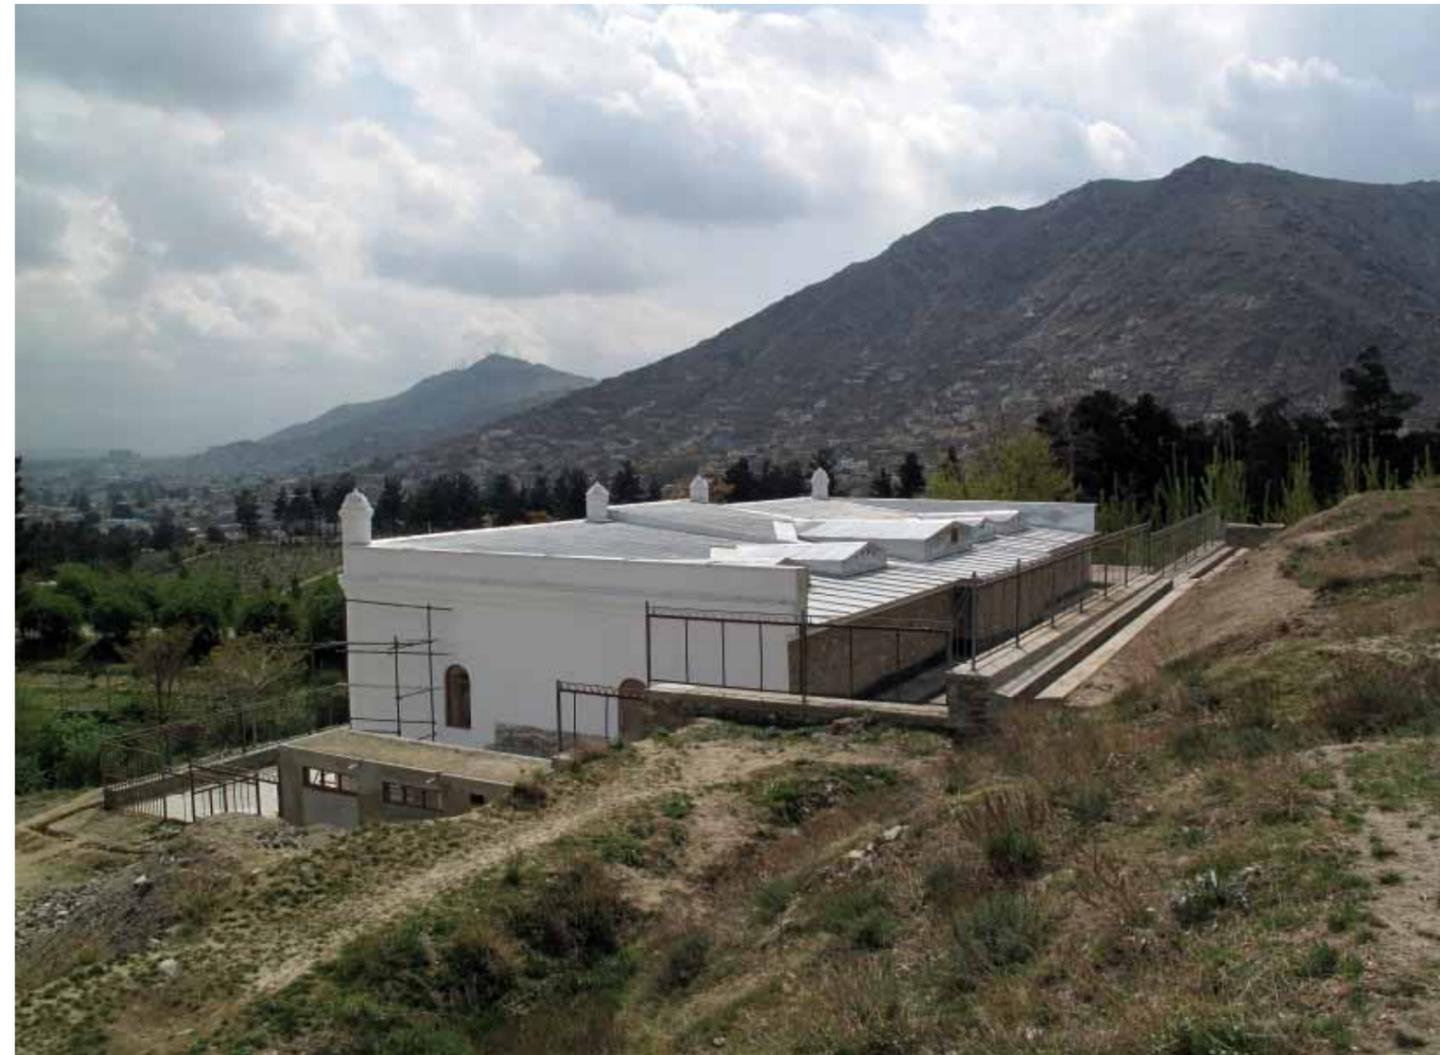
Above, situated on a terraced platform along a steep site, work entailed the construction of water diversion drains for flash floods.

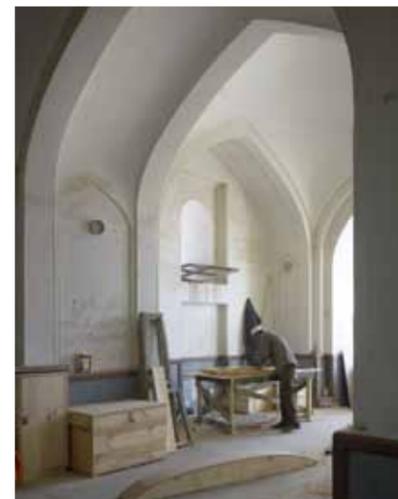
Left, a craftsman at work inside the mosque repairing timber woodwork.

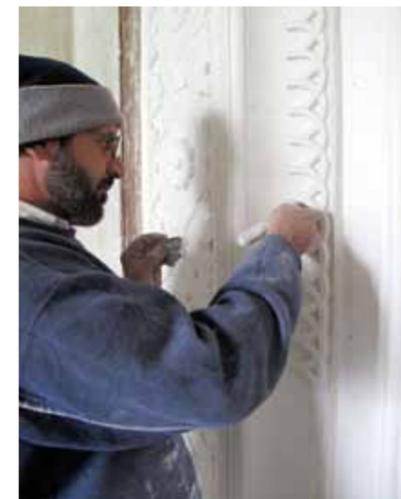
Right, sections of decorative plaster damaged by rainwater were repaired.

on site using soil collected during clearance work. Areas of damaged decorative plasterwork around the *mihrab* and on the main elevations of the building were carefully consolidated and repaired. Damp sections of undecorated plaster that had separated from the *qibla* wall were stripped and the area left to dry, before new plaster finishes were applied. The timber fenestration of the mosque was carefully cleaned and repaired followed by the application of a final layer of whitewash on internal and external elevations. In order to prevent future seepage of water into masonry walls at the back of the mosque, the area was paved using flat stones and a drainage channel was added to divert water away from the building.

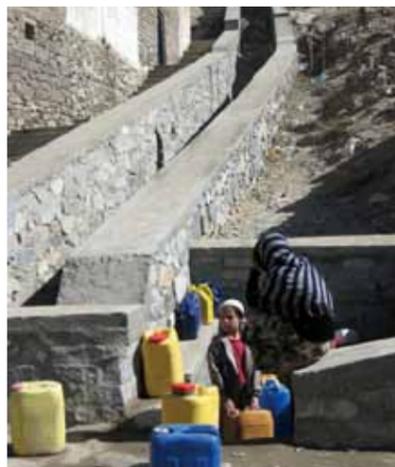
Left, construction of storm-water drainage around Babur's Garden led to a significant reduction in the destruction of hillside settlements.

In the residential area surrounding Babur's Garden, where sustained conflict had caused widespread damage to the housing stock, more than 9.5 kilometres of storm-water drainage have been created and two kilometres of access improvements have been made, including the construction of hillside staircases that allow communities access to water and other services. Investments made by AKTC in upgrading and improving public infrastructure have encouraged homeowners to rebuild or improve their properties. With a significant rise in property prices in recent years, further affected by the proximity of residences to the restored Babur's Garden, the socio-economic status of communities living around the garden has greatly improved.

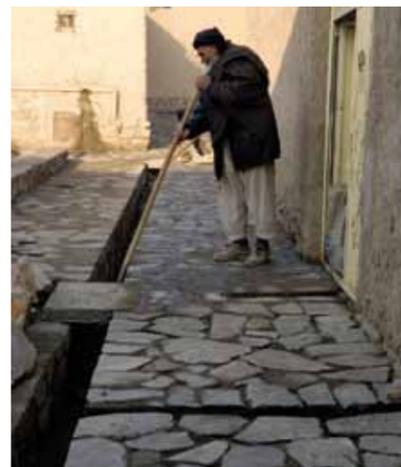
Right, construction of suitable drainage and alleyways and installation of potable water pumps have contributed to an improvement in living conditions for many in the Old City.

In order to address the abject living conditions facing the majority of residents in these areas, since 2002 AKTC has invested in repairs or construction of drains, paving of alleyways and streets, and provision of safer water supplies, benefiting nearly 25,000 inhabitants. These interventions have generated significant employment within the resident communities, which have also benefited from a range of measures aimed at promoting small-scale economic activity, especially among women. Together with the jobs created through conservation projects, these investments have contributed to the process of recovery across these quarters, where self-built repair and infill construction is on the increase.

As part of efforts to improve living conditions for the residents, nearly six kilometres of underground and surface drains have been repaired or rebuilt, while an area of more than 22,000 square metres of pedestrian alleyways and streets has been paved within the historic fabric of the Old City.
