# BADAKHSHAN

INTRODUCTION		304
PHYSICAL CONSERVATION AND RESTORATION		312
	RELIGIOUS BUILDINGS	
	Nasir Khusrau Shrine 312, Mullah Barat Mosque 320, Mir Yar Beg Shrine and Garden 322	
	326	OTHER BUILDINGS
		Hamam-e Kohna 326
	328	NATURAL LANDSCAPES
		Wakhan Heritage Inventory 328
THE CHALLENGE OF PLANNING		336

## Nasir Khusrau Shrine

# Mullah Barat Mosque

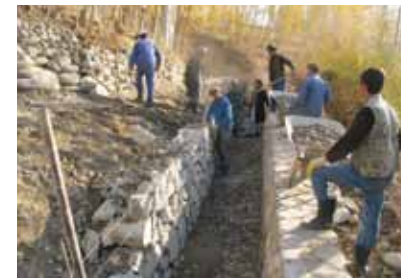
Above, geotechnical analysis of the site revealed that the loose conglomerate outcrop, upon which the shrine was built, required urgent structural consolidation.

Below, hillside water channels were constructed as part of preventative measures taken to stop the seepage of water into the foundations of the shrine.

Detailed physical surveys of the shrine were conducted in 2011, followed by a geo-technical study of the site that identified key areas requiring urgent structural consolidation and conservation. The most critical area of concern centred on the condition of the coarsely grained conglomerate stone outcrop on which the shrine is built. The base of the outcrop was found to have been extensively damaged by erosion and water penetration, resulting in the formation of fissures and cavities that had caused large sections of the loose conglomerate to become detached. Given the history of significant seismic activity in the region, the eroded state of the outcrop represented the most significant long-term threat to the shrine. In order to address this concern, an extensive network of stone breast walls, reinforced by treated timber posts, was constructed on three sides at the base of the outcrop. Large surface cavities were consolidated using hydraulic lime, applied together with a loose conglomerate in order to match the texture and colour of the outcrop. Lastly, a special mixture of hydraulic lime was injected into large cracks that had formed on the western surface of the outcrop, helping reattach loose sections of the conglomerate and seal its surface against future damage caused by water penetration. In order to protect the upper surfaces of the outcrop from erosion, the existing walkway surrounding the perimeter of the shrine was rebuilt and a wooden handrail was provided to ensure safe access for the maintenance of the roof and elevations of the shrine.

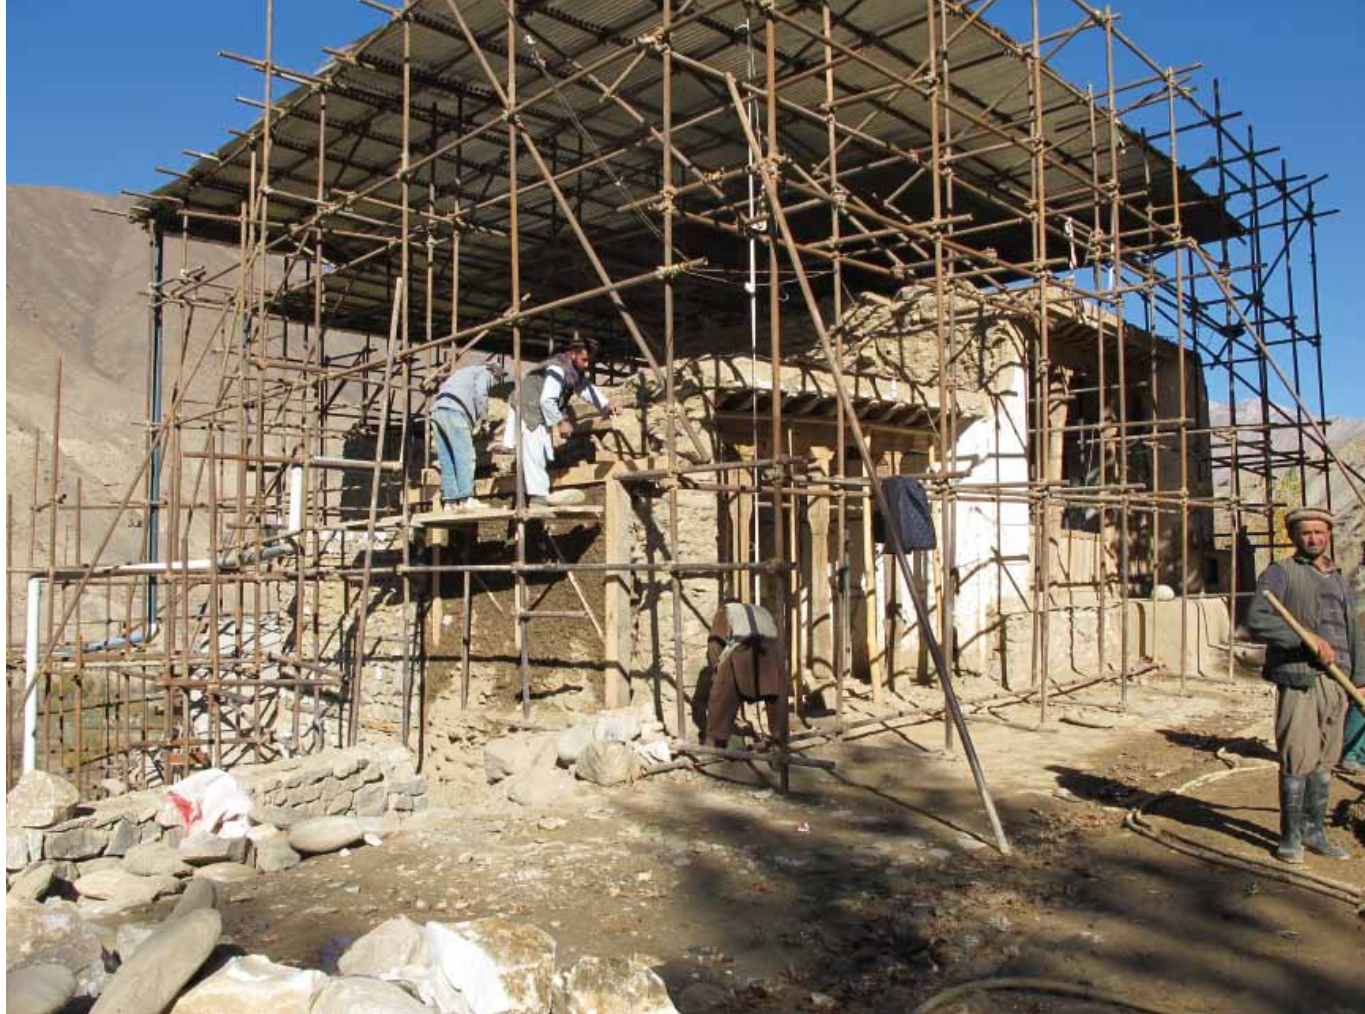
Conservation work entailed the removal of debris and re-roofing of the shrine, a delicate measure considering the highly decorated woodwork used to construct its ceiling.

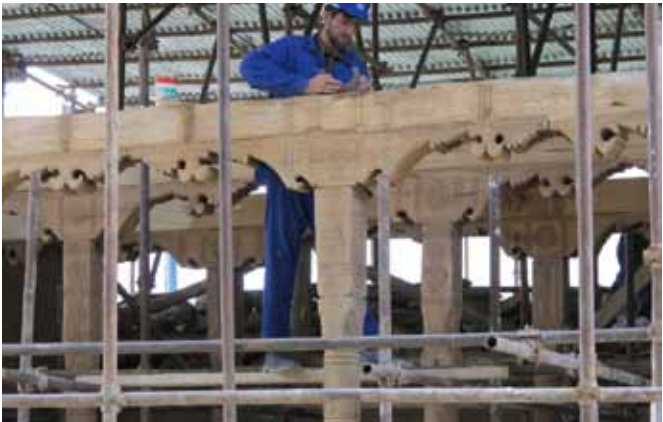
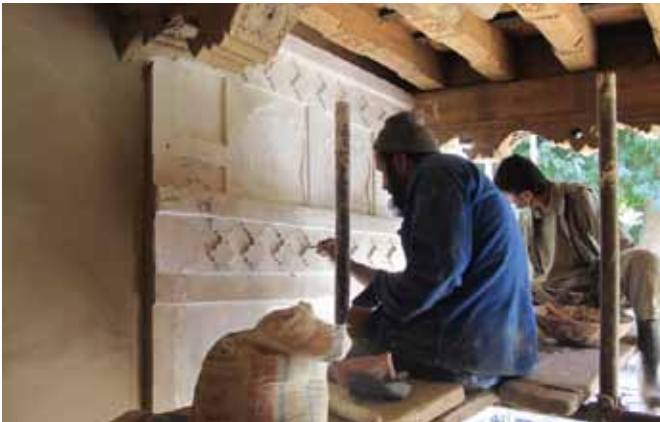
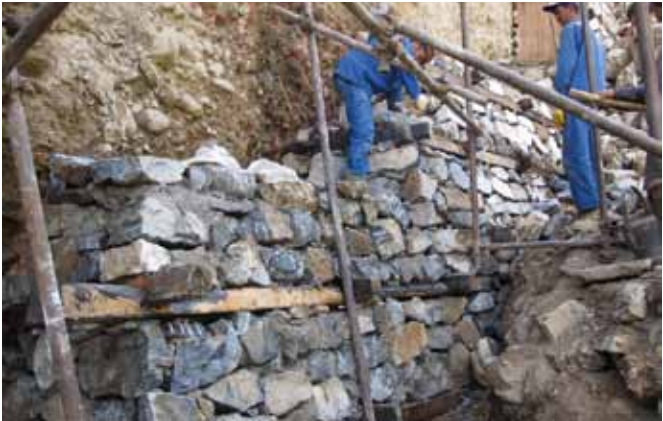
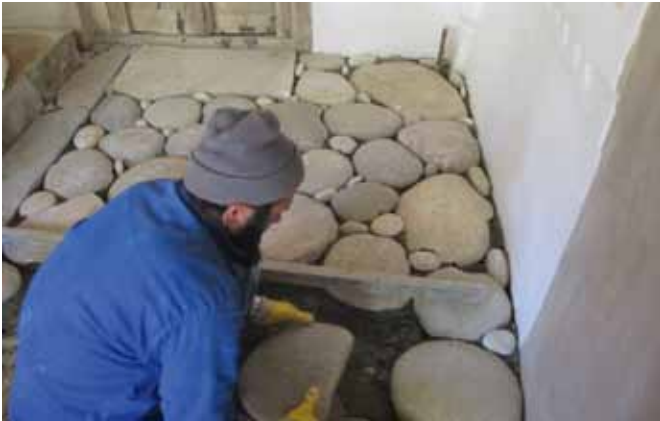
Top left, carpenters from the local community were engaged and trained in carrying out repairs to timber columns and rafters.

Top right, plasterers working to restore late-17th-century decoration added to the main vestibule of the building.

Bottom left, a timber-reinforced breast wall was designed and constructed adjacent to eroded sections of the conglomerate stone at the base of the outcrop.

Bottom right, river stone paving was laid in the open vestibules, as is customary in buildings of the region.

While the structure of the shrine remained largely intact, rising damp and the erosion of conglomerate foundations had caused significant settlement in the northern exterior wall. As large sections of the exterior walls were built using river stones set in mud mortar, the structure was particularly susceptible to rising damp. Analysis of the walls showed that older sections of the shrine around the *mazar*, where timber-frame ties had been used to strengthen the construction, remained intact while other areas constructed without timber inserts had become damaged. In order to stabilize the building it was decided that key sections of the northern and southern elevations, adjacent to the vestibules, would be strengthened by retrofitted structural wood-frame elements — similar to traditional techniques used in older sections of the building. Limited sections of the fragile stone masonry were carefully removed, before treated wood-frame sections were reinserted into the wall and attached to similar elements retrofitted into the walls from the interior of the vestibules. The retrofitting was carried out in one-metre segments, while hand-operated jacks were installed to bear part of the weight of the roof in the vestibules. Once the perimeter walls had been stabilized, a similar technique was employed to stabilize the internal partition wall between the small and large vestibules. Following the structural consolidation of load-bearing walls, it was decided to replace the external painted finish of the shrine with a traditional mud-straw-based plaster.

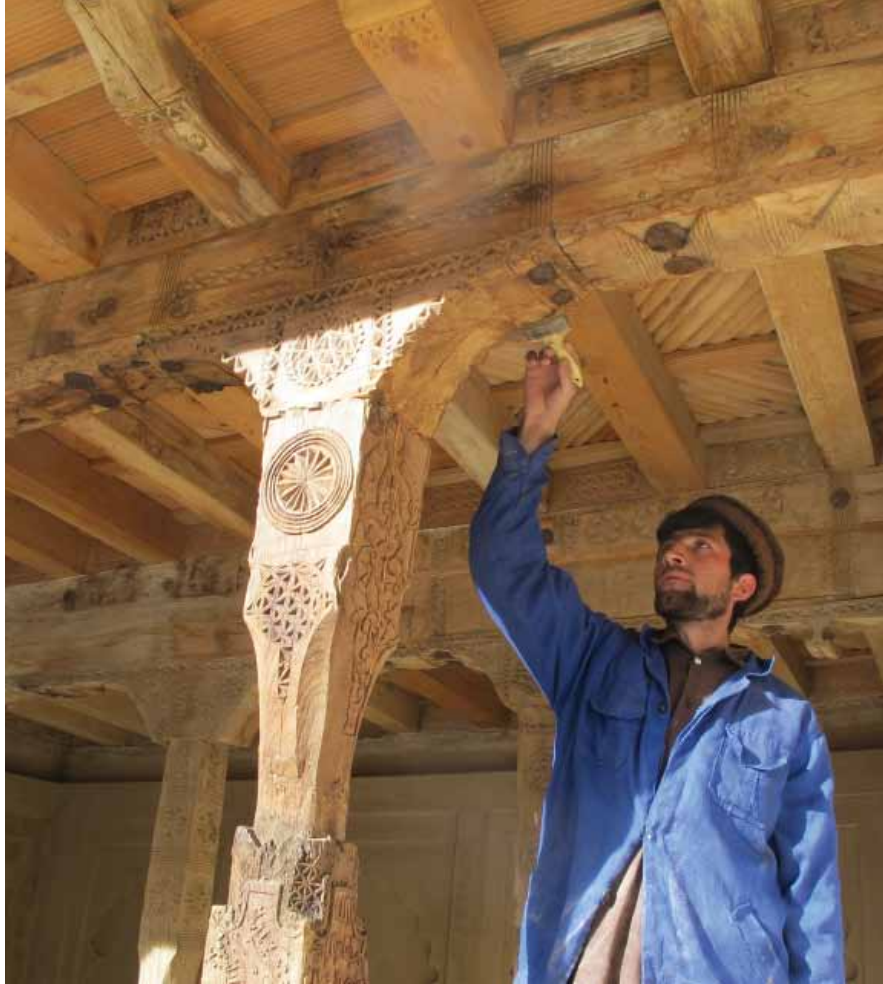
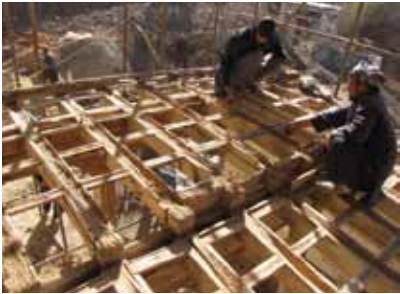
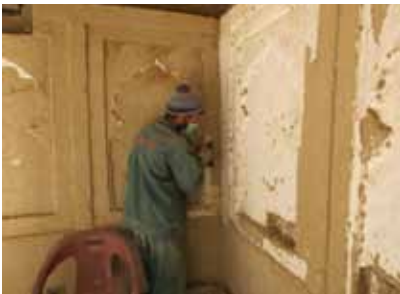
Right, linseed oil was applied to areas of  
woodwork to prevent damage from moisture.

Middle, carpenters work to repair and  
strengthen timber rafters damaged by pene-  
tration of moisture from the roof.

Bottom, recently applied paint was removed  
to provide access for conservation of mud-  
plaster decoration.

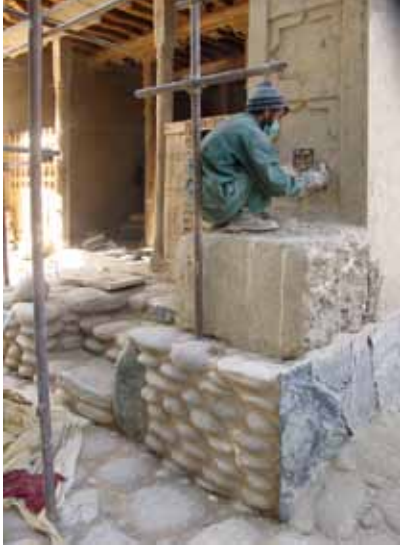
Above, external elevations were cleaned and  
repaired, before being finished with a mixture  
of mud-gypsum plaster.

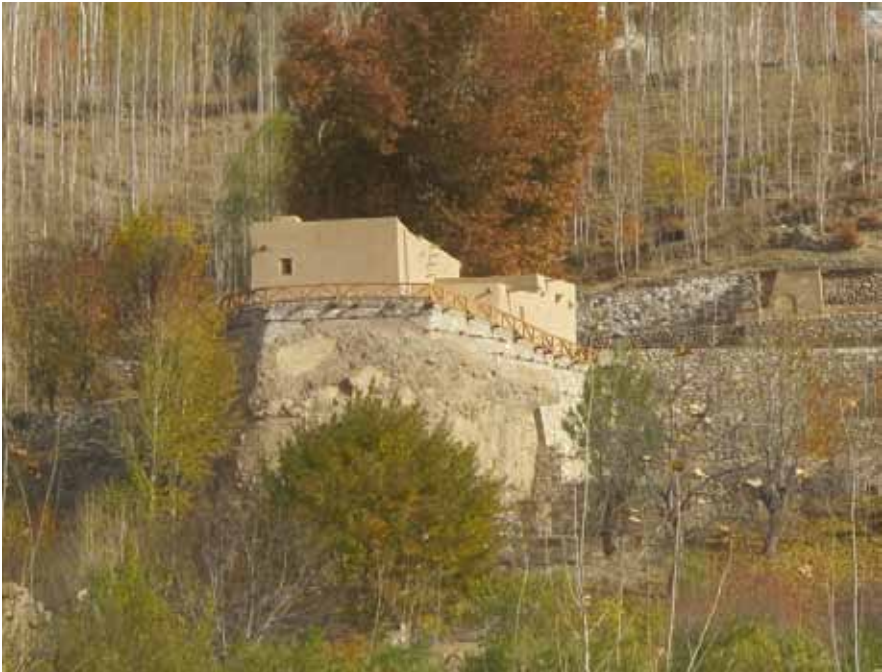
Left, the restored shrine and consolidated  
stone outcrop, as seen from the village below.

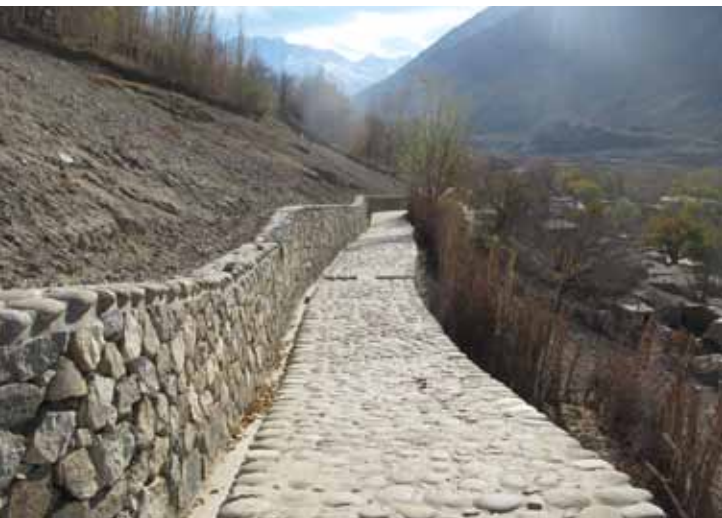
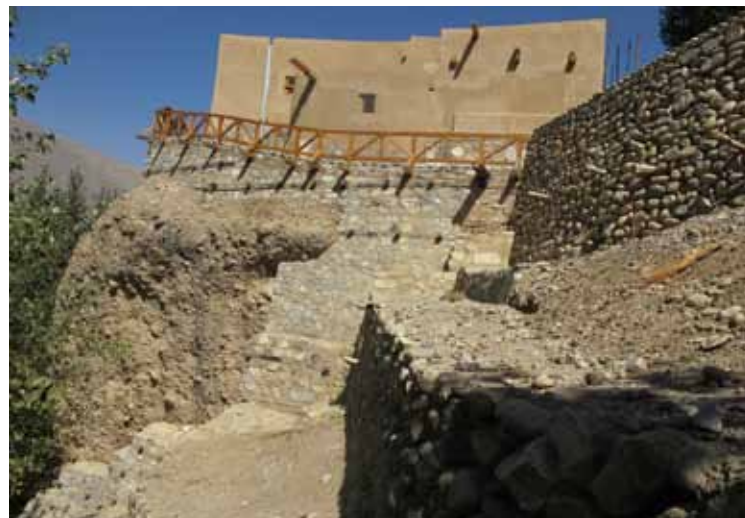
Above, left, a precarious trail leading to the shrine was replaced by a pathway paved with river stones and protected by a low retaining wall.

Right, timber railings were constructed along a pathway behind the shrine used for maintenance of the building.

Visitors to the shrine previously had to walk along narrow, unpaved and precipitous pathways that were regularly affected by landslides and other weather-related damage that rendered access to the site unsafe. As part of the physical conservation work, an unpaved pathway leading to the first gate of the shrine from the perimeter of the Hazrat-e Sayyed village was upgraded. Work included the construction of extensive areas of retaining walls required both for the delineation of the pathway and, in some areas, for the protection of the route from rocks falling from the steep slopes above. The whole length of the pathway was paved using river stone and a surface drain was provided in order to redirect water away from the walking surfaces.

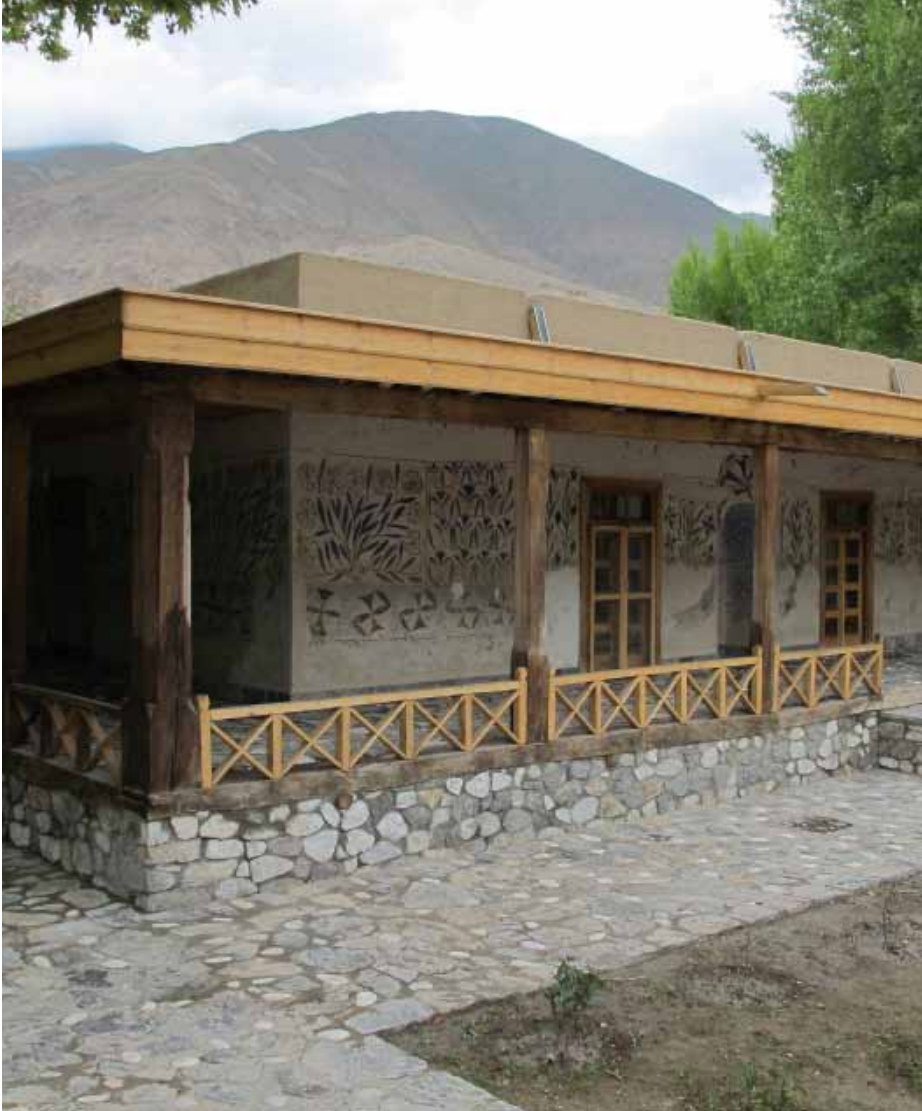
Top left, the restored mosque continues to be used for communal gatherings.

Top right, structural repairs were carried out to the timber roof structure prior to re-roofing the building using traditional techniques.

Above, durable stone paving being laid at the entrance veranda.

Conservation work was undertaken over a three-month period in 2011, commencing with structural repairs of damaged sections in the stone foundations of the western *qibla* wall. Once the foundations and walls of the mosque had been stabilized, the repairs were carried out on the roof of the building. Timber joists damaged by the build-up of moisture were replaced before wooden boards were installed, covered with compacted-mud insulation, and the roof protected using *kahgil* plaster. Teams of carpenters worked simultaneously to repair and clean the original timber door-frames and windows. In order to preserve the painted floral decoration, sections of the gypsum plaster base that had become detached from the walls were carefully consolidated using traditional techniques. Additional work was undertaken to reconstruct the service rooms to the north of the mosque, rendering the mosque usable by the local community. In order to improve access to the mosque, the veranda and

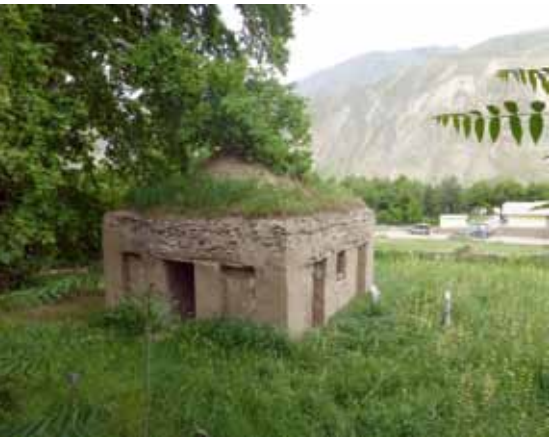
The Mir Yar Beg Shrine was in a poor state of repair and its surrounding landscape inaccessible to the community.

The shrine is located under a large plane tree on a raised platform area, accessed via an informal pathway from the street. Carved marble gravestones in the vicinity of the shrine identify additional burial sites, which may contain the remains of relatives of Mir Yar Beg or important figures in the area. Entry to the shrine is from the east, through narrow steps descending into a partially submerged room with small openings in its walls covered with traditional timber screens. Believed to have been built shortly after Mir Yar Beg’s death, the shrine has had ad hoc repairs on at least two previous occasions, which entailed the use of loose debris applied with mud mortar on the upper sections of walls. As a result, the shrine has had extensive structural damage, including the formation of a large fracture in its masonry dome, caused by settlement in foundations and seepage of water into areas of backfill above the wall.

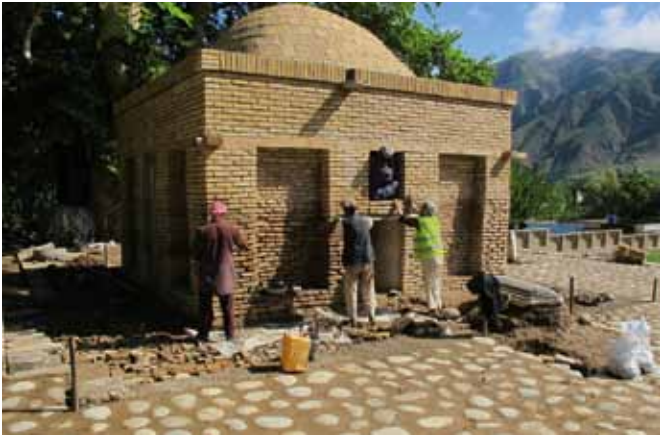
Below, masons work to repair and repoint the external load-bearing walls.

Square fired bricks were fabricated to match the quality and size of the original bricks used in both the walls and dome of the shrine. Applied with lime mortar, these bricks were used to reconstruct large sections of the external walls (as had been done in the original construction), with each layer of new brickwork carefully 'woven' with remaining sections of the original brickwork. At the uppermost sections of the walls, where the circular dome 'springs' from square building walls, traditional wood reinforcements (*katiba*) were installed to structurally 'tie' walls together and provide a stable base for the transfer of lateral loads. Once the structural consolidation of the dome and walls were complete, lime concrete was applied to the roof to prevent penetration of water and finished with a durable layer of brick paving. The external elevations of the shrine, a combination of original brickwork and newly laid bricks, were left exposed and repointed with lime mortar.

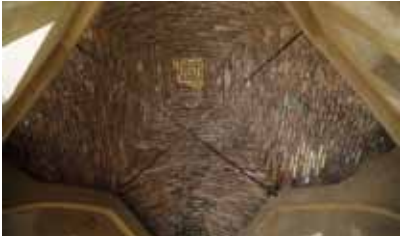
Middle, the brick-masonry dome of the shrine was repaired and metal-rod ties were installed to prevent further damage.

The first stage of conservation work on the shrine focused on the stabilization of its brick-masonry dome and load-bearing walls. Thick layers of mud-plaster backfill on the roof, applied by locals in order to prevent leaks, had compounded structural failures and were carefully removed. Together with the dismantling of previous areas of repair, the masonry dome was uncovered and structural repair work focused on stitching vertical fractures that had formed near the ‘squinsches’ of the dome, using newly produced traditional square bricks. Temporary supports were constructed

within the shrine, holding the dome in place, while teams of masons worked to repair its masonry structure. Before repairs on the dome could be completed, vertical fractures in the load-bearing walls needed to be consolidated.

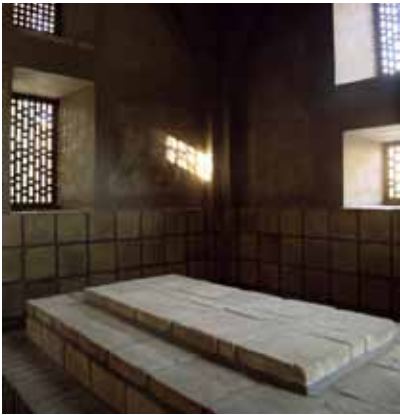
Bottom, interior view of the shrine with Mir Yar Beg's grave located at the centre of the space enclosed by plastered masonry wall and timber screens.

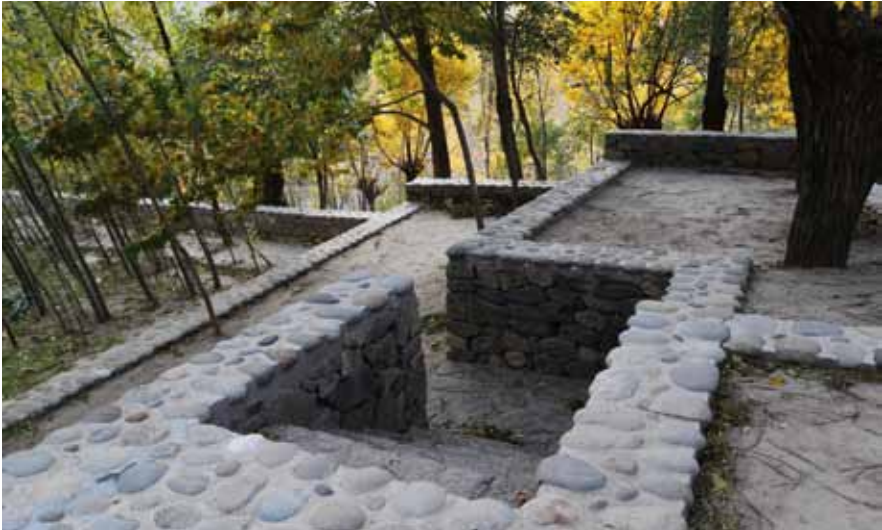
Below, the garden surrounding the shrine has been terraced and pathways paved in stone to allow safe public access.

With conservation work complete, the focus turned to transforming the external area into a public garden. In order to provide safe access to the site and incorporate the shrine as a key element of the park, the sloping landscape was terraced through the construction of low retaining walls incorporating ramps and stairs. Water from an existing channel to the south of the site was diverted into the park and linked to newly constructed channels and tanks, providing gravity-fed irrigation to more than seven hundred trees and flowers planted on the various terraces. A network of stone-paved pathways was created, linking the main entrance near the street with the upper sections of the park. In order to secure the site and prevent encroachment, a low perimeter wall was built around the entire site using stone and brick masonry. Landscaping work employed traditional planting techniques, sourcing indigenous species of plants and trees, ensuring that its upkeep and maintenance can be carried out by local custodians according to established landscaping traditions and gardening methods.

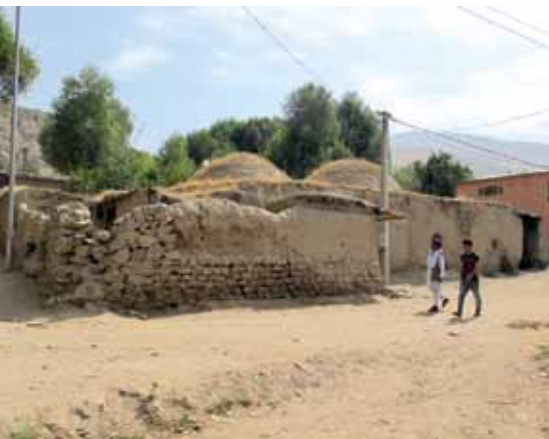
The Hammam-e Kohna was used as a site for dumping household waste prior to restoration.

At the onset of stabilization work, accumulated waste and infill was removed from the roof and the perimeter of the building in order to reveal the masonry stone and brick structure of the hammam. Stable parts of the existing masonry were consolidated, while ancillary spaces that were destroyed over the course of the past half century were rebuilt in a traditional manner. With the structure of the building consolidated, work commenced on the restoration of internal areas. The flooring of the hammam was removed and the hypocaust system was rebuilt using fired brick and lime mortar. Large sheets of stone were laid above the hypocaust cavity and internal paved areas were reconstructed using new and original marble tiles.

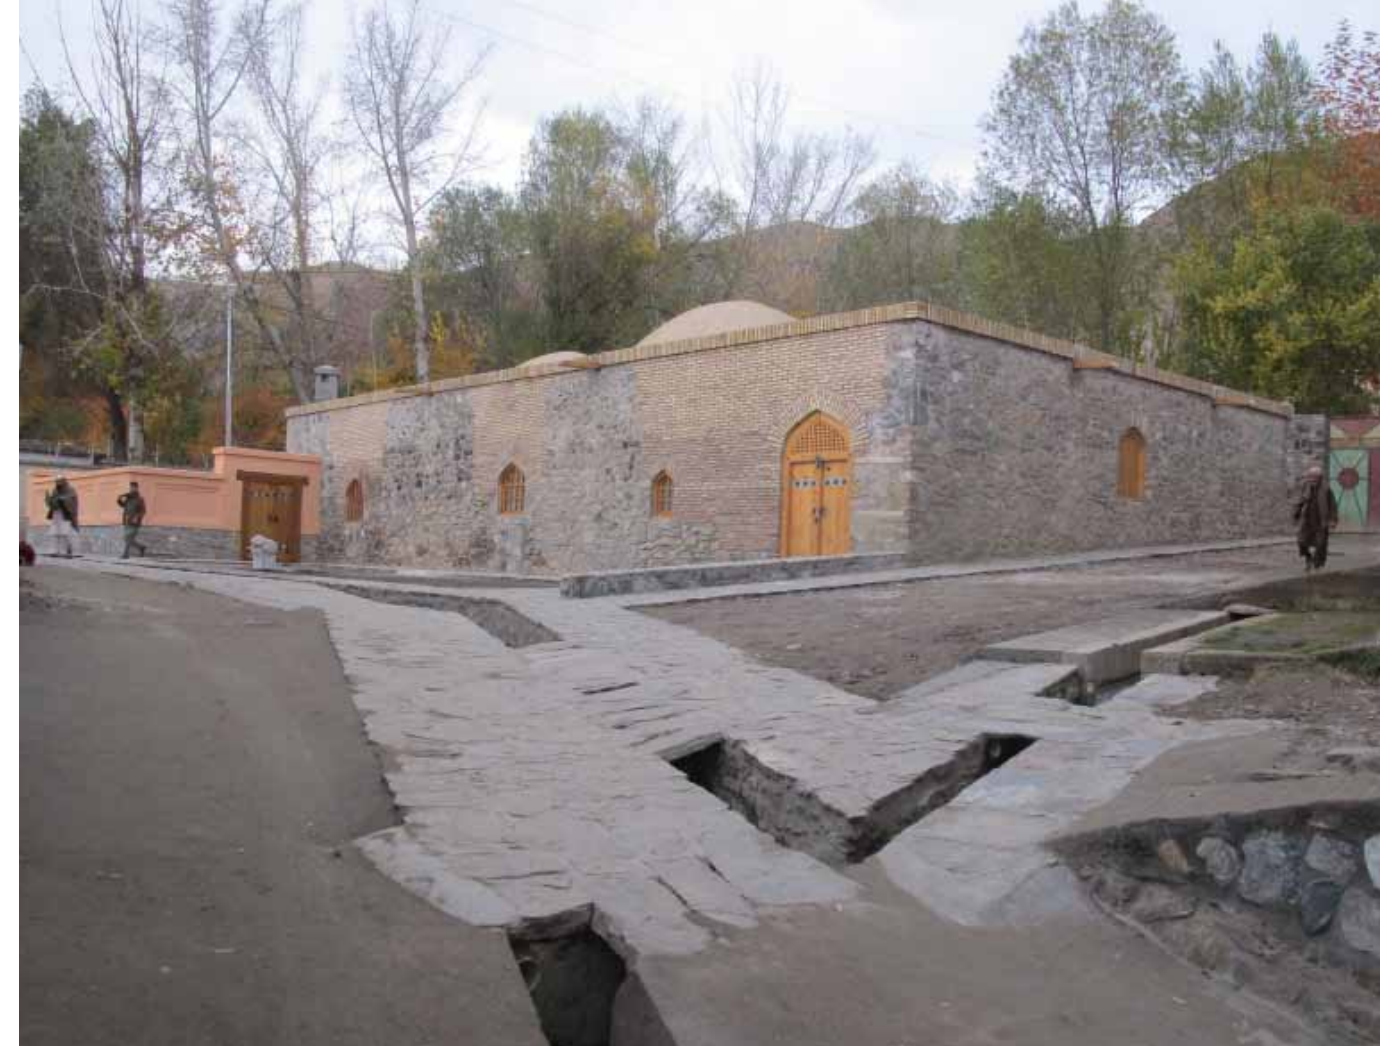
Above, the restored hammam provides an essential service to the local community, where many homes do not have proper bathing facilities.

The outflow of wastewater was connected to a newly built drainage channel and a fresh water supply was provided through the construction of a deep well. Prior to undertaking restoration work, an agreement with the private owners of the hammam stipulated that the building would be managed and operated as a public facility.

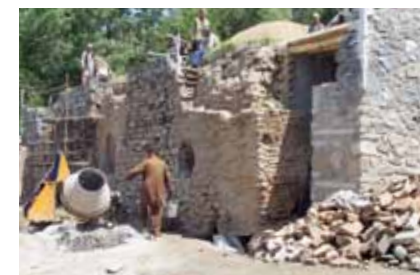
Left, constructed using brick and stone masonry, extensive repairs were undertaken on the dome and walls of the building.

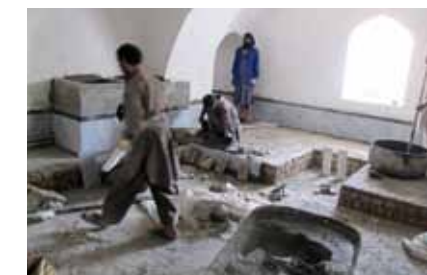
Right, marble being laid over a traditional hypocaust heating system.

On completion of the external building work, the hypocaust flooring, chimneys and vents were rebuilt and the hammam was made operational. Regular use of the historic hammam has sustainably revived a local business, while providing a much-needed service for the surrounding community.

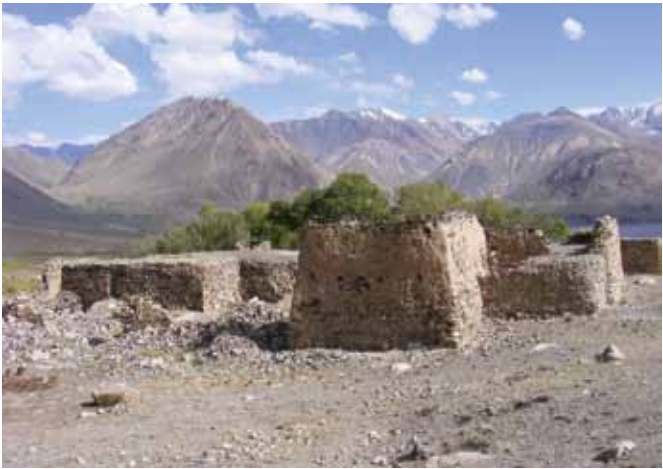
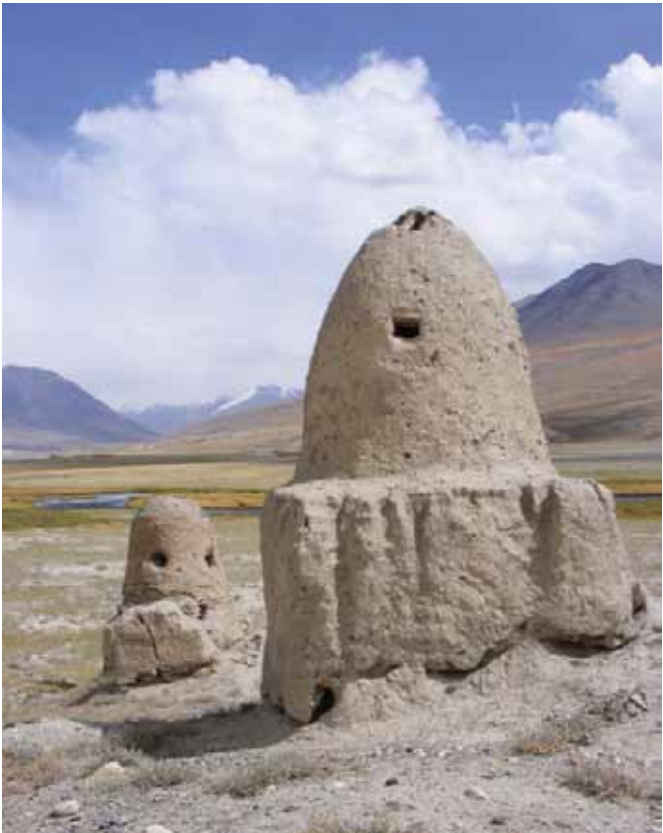
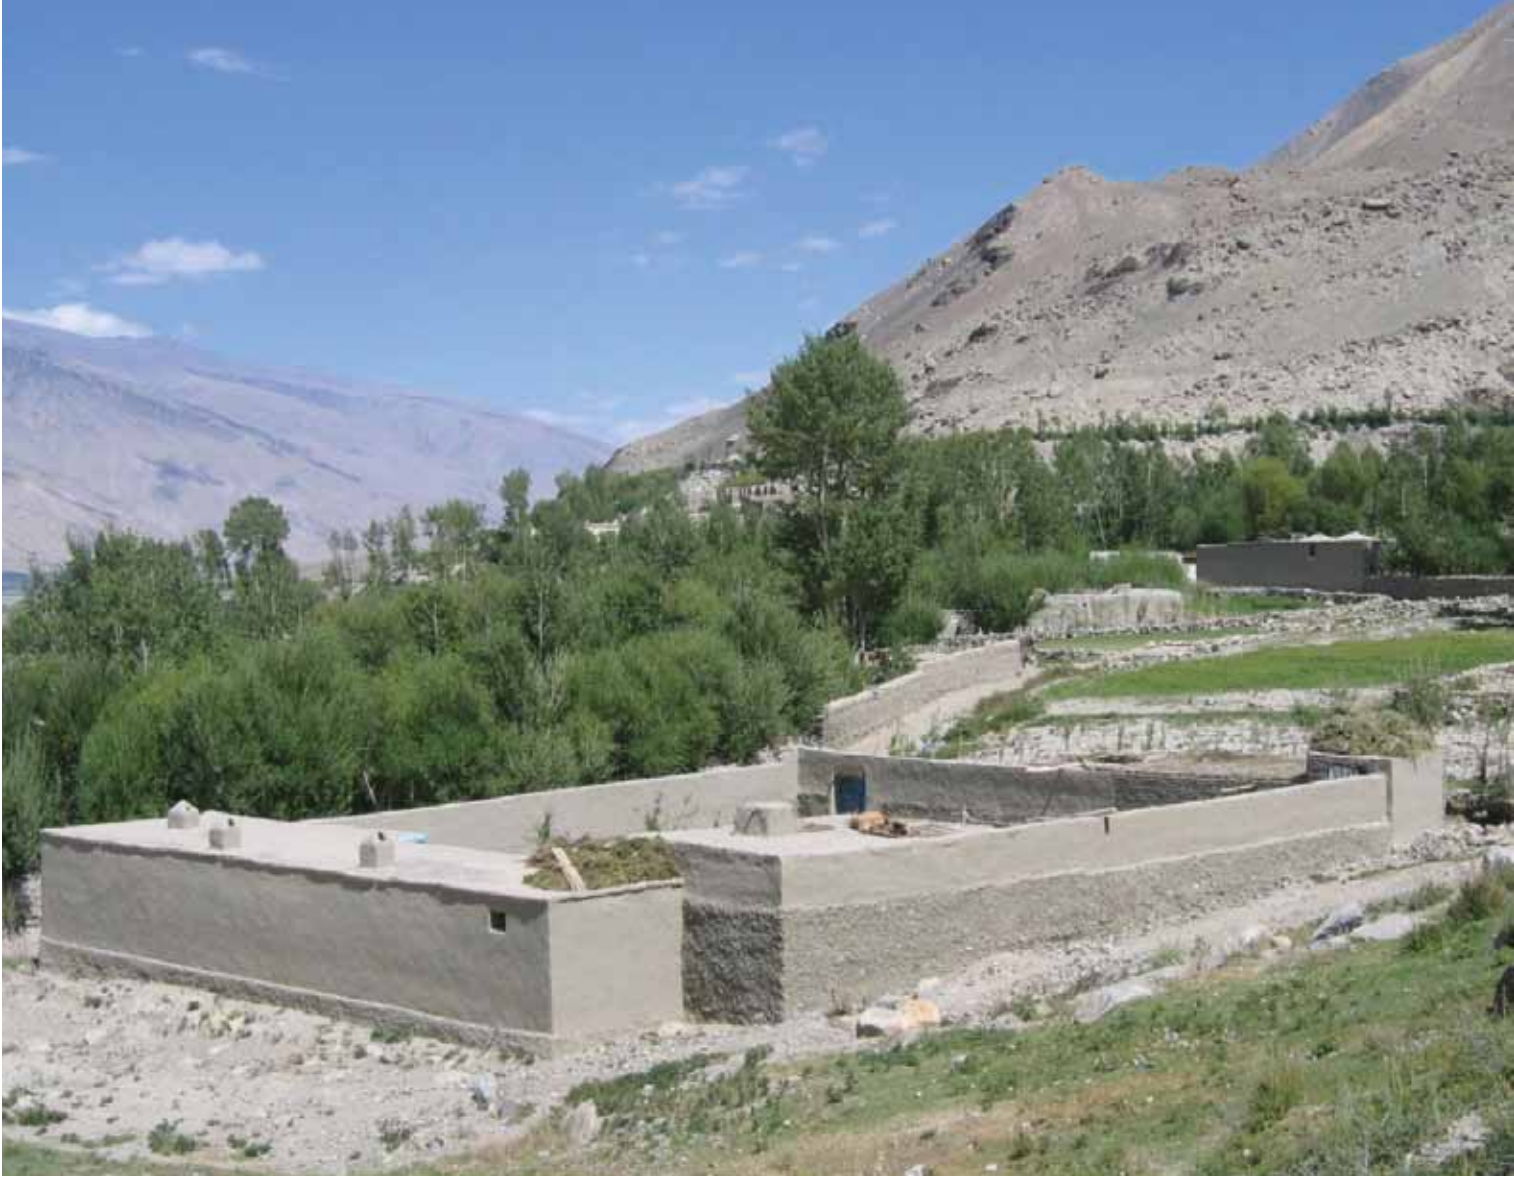
Below, left, stone dwelling in Sarhad-e Broghil.

Right, prominent conical ‘burial domes’ at Bozai Gumbaz facing south towards the Wakhjir River valley.

One of the more unusual burial complexes is Bozai Gunbad, or “domes of the elders”. Situated beside the Wakhan River on the route to Lake Chaqmaqtiin, the site comprises fourteen, one-room, domed mausolea, constructed from mud bricks, in an extensive graveyard. Traces of more than eleven collapsed structures can still be made out on the site. While mud-brick domed structures are not uncommon in the region, the conical shape of the domes seems to be unique to Bozai Gunbad. Visited, among others, by Lieutenant J. Wood in 1838, little is known about the precise history

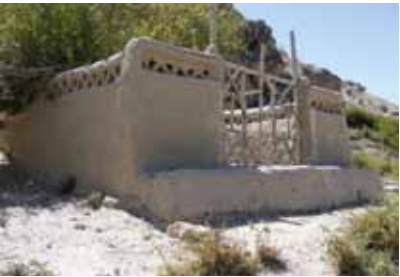
Above, stone and compacted-mud courtyard houses in Khandud.

Below, multiple tombs located within a mud enclosure in Khandud.

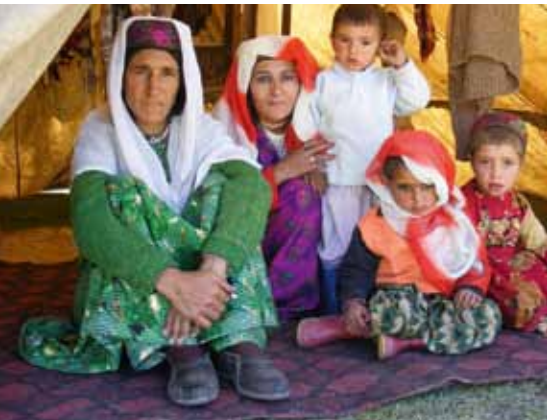
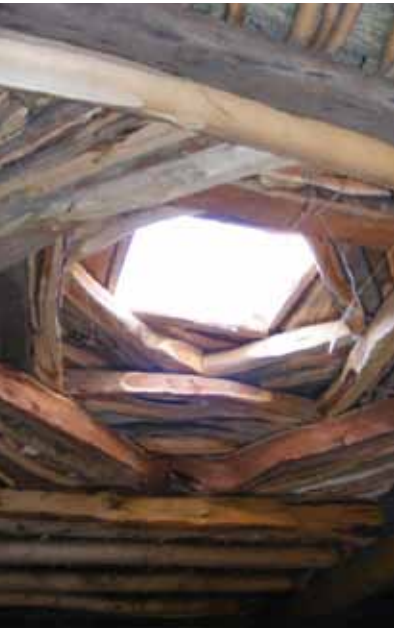
Bottom, left, Kyrgyz yurt with a low profile and wide roof ring (*tanuk*) in Kasch Goz, Little Pamir.

Right, traditional skylight and vent (*riczn*) located above living quarters in Chihil Qand.

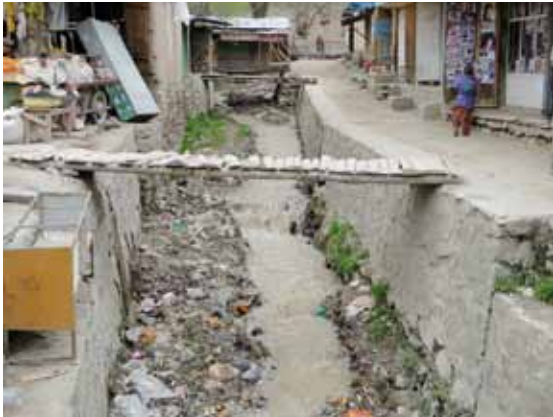
Storm-water drains in the old town are poorly maintained and often become blocked due to dumping of commercial waste.
