2013 On Site Review Report

Rehabilitation of Nagaur Fort

Nagaur, Rajasthan, India

Architect

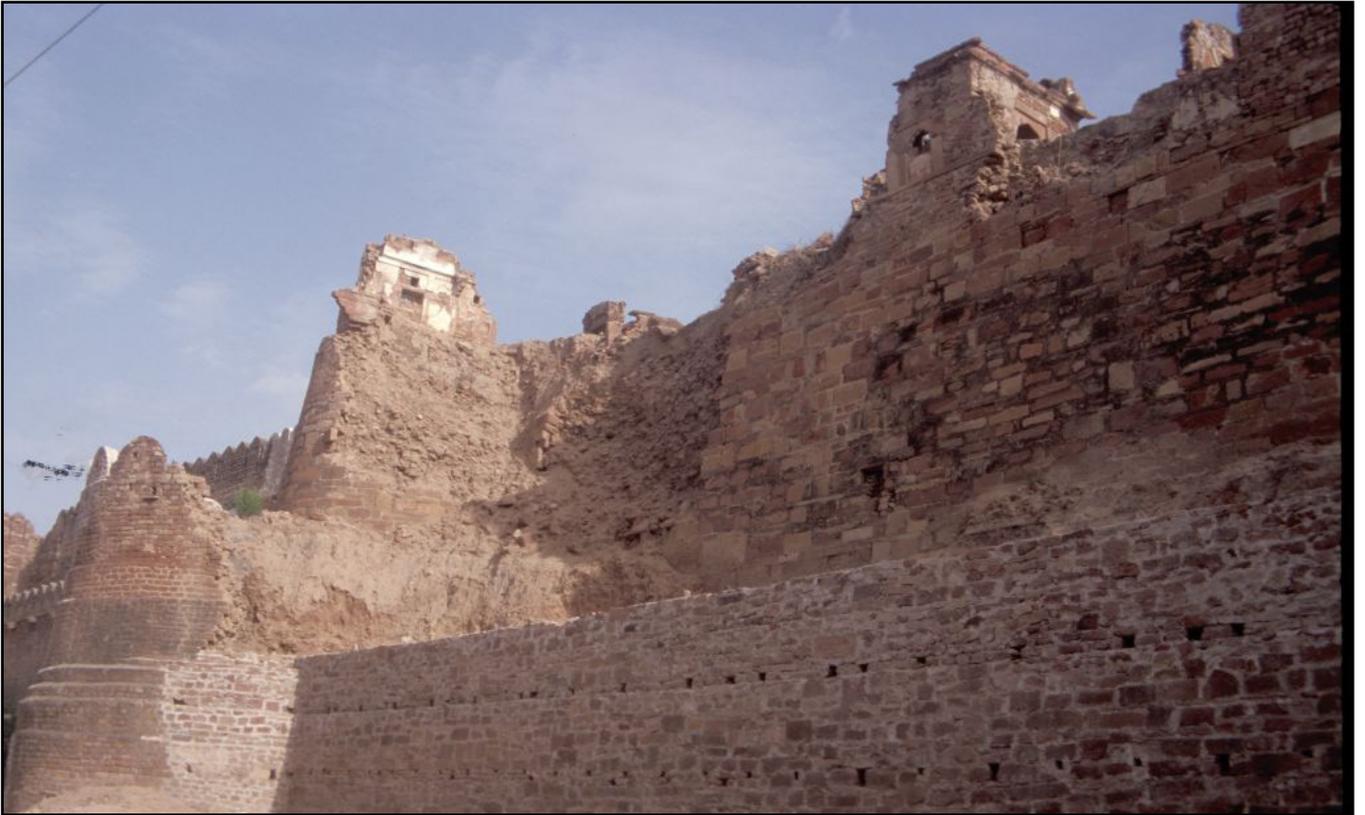
External fort wall before restoration.

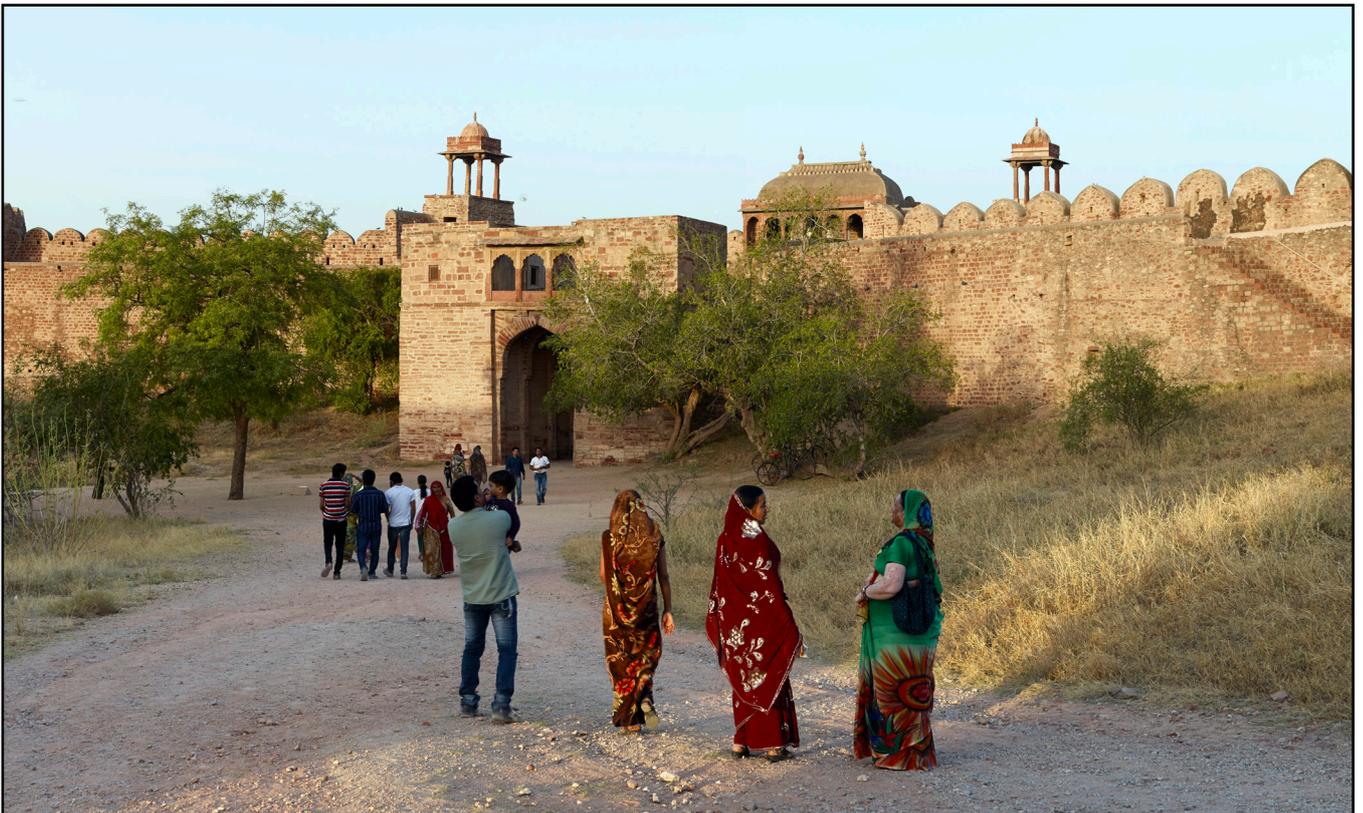
Bhakt Singh Mahal before conservation. After an appraisal of the complex, the buildings and fortifications were then documented in detail, showing the site condition and allowing conservation measures to be drawn up.

Following this, the stone roofs were repaired by strengthening the substructure, repairing cracks and refinishing the surfaces with lime concrete. The wooden ceilings, damaged by water ingress and subsequent termite attacks, were repaired, resealed and treated against termites. The ornate ceiling paintings were saved.

It was suspected that uneven settlement of the foundations had led to the formation of wall cracks and the displacement of arch brackets. In some cases, the walls were dismantled, and the foundations were given a proper base after removing loose soil and underlying vegetation and roots. In other cases, the ground was dug up in alternating 70-centimetre sections, and the foundation base and trenches were filled in with lime concrete.

Cracks were then filled, grouted, pointed and plastered. The arch brackets were repaired through the insertion of new stainless-steel U-shaped rods at the apex. All exterior plastered surfaces were merely stabilised; new plaster was applied only in the interiors. In addition, the lime flooring was repaired and doors, screens and windows in the original style and materials were installed.

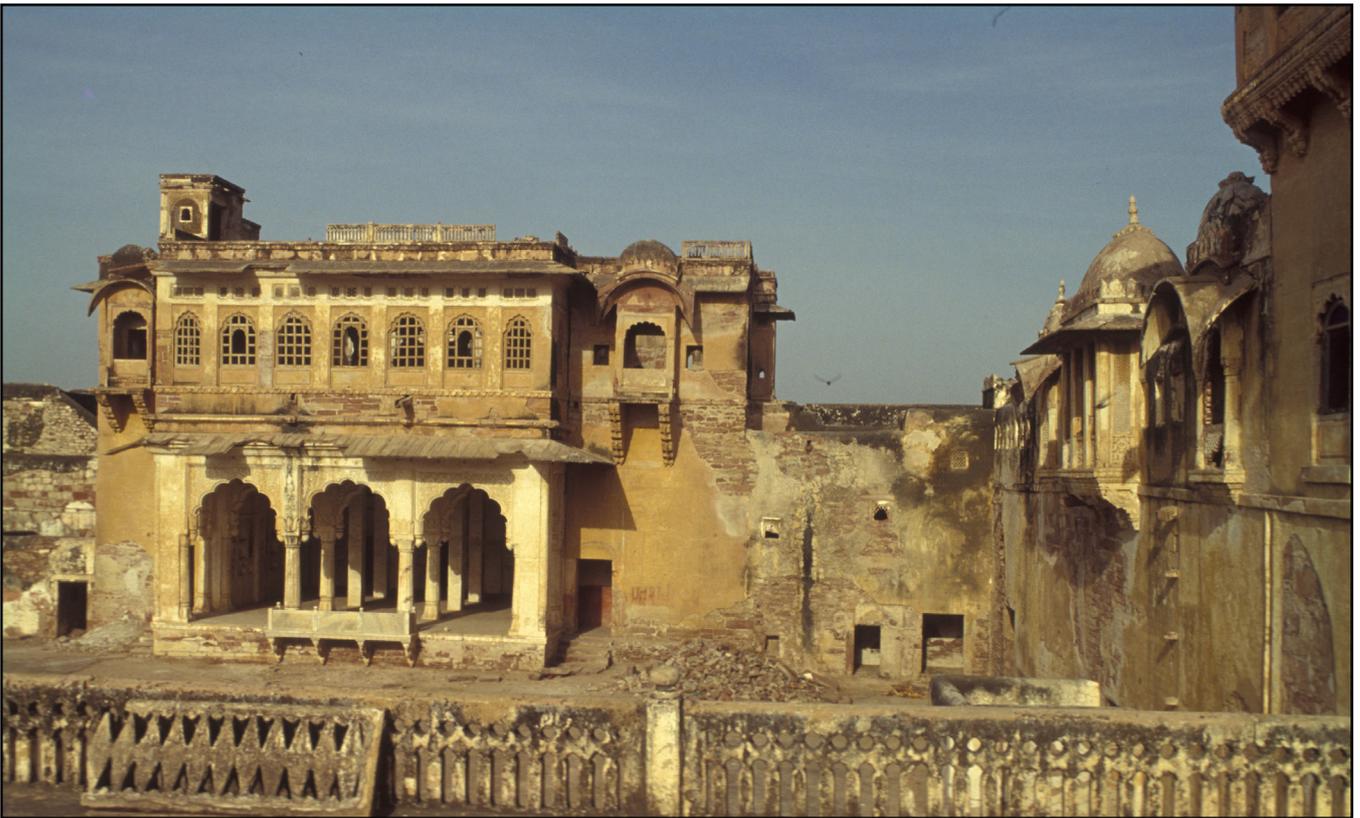
Bakht Singh Mahal after restoration. This consists of the Shees Mahal, an entrance pavilion, a Muslim prayer space and a hammam, all of which were built to host Akbar during his visit to the Fort around 1570.

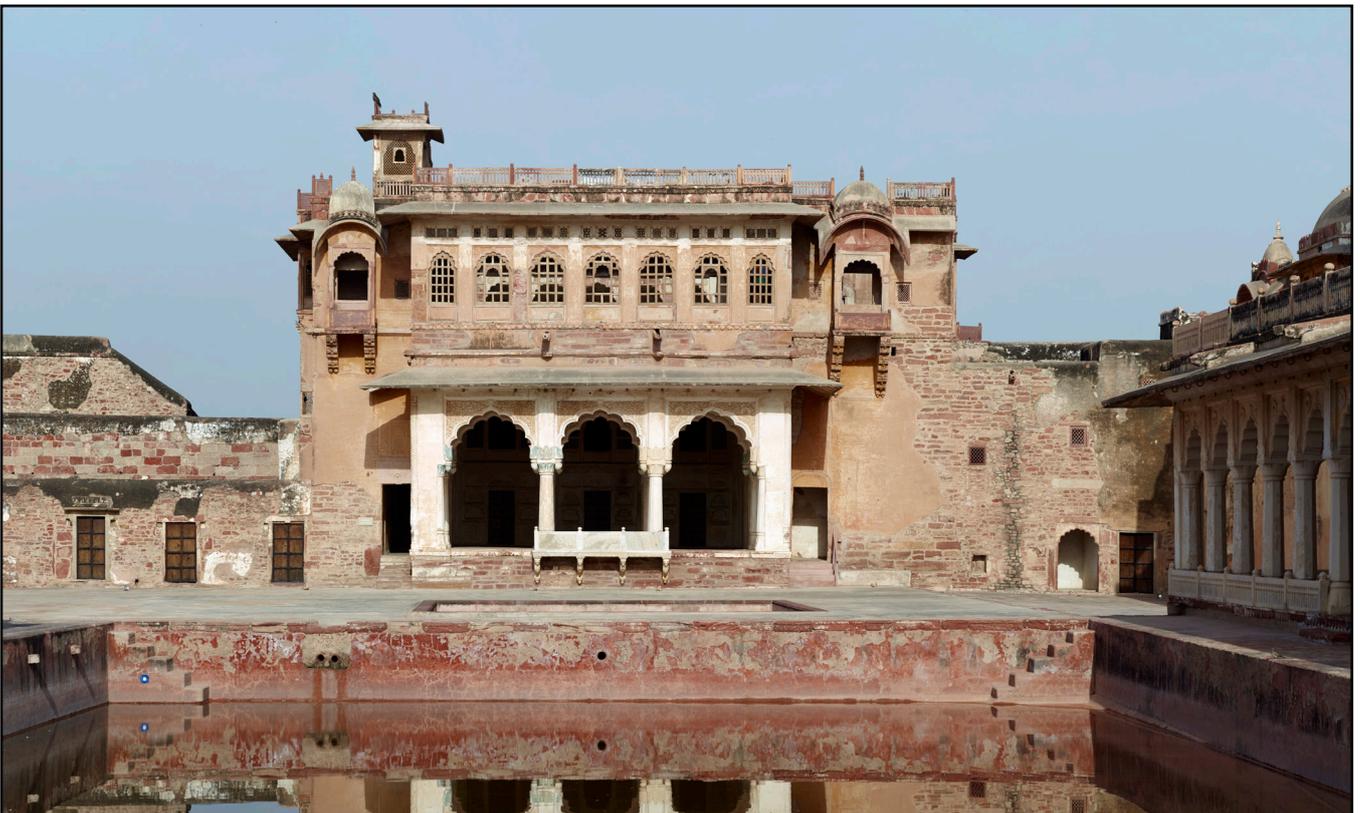
The Hadi Rani Mahal before conservation.

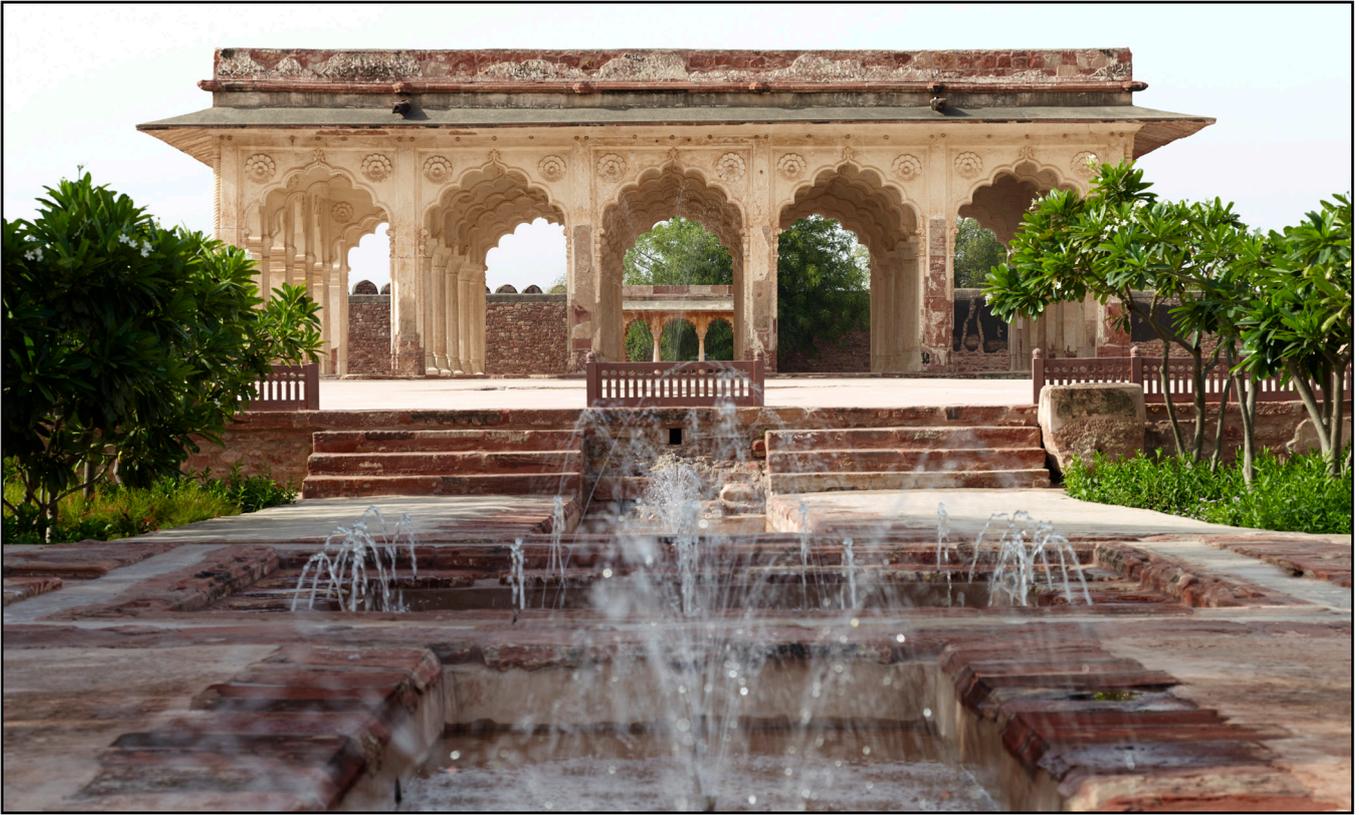
The uncovering and restoration of an intricate and ingenious water retention system that had fallen into disrepair and been buried has brought back to life a series of fountains and pools that help to moderate the microclimate of the various spaces within the Fort complex.

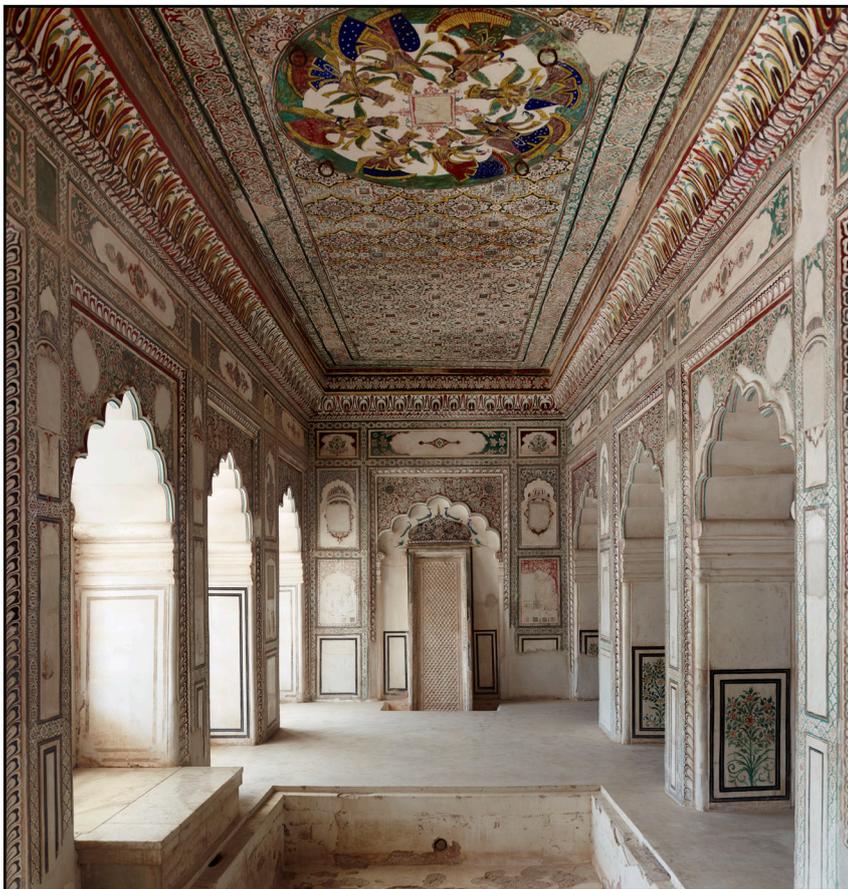
Water travels to the terraces of AbhaMahal, and is brought down through two vertical chadders, than gets connected to a basin with fountain, finally over flowing in to the horizontal passage.

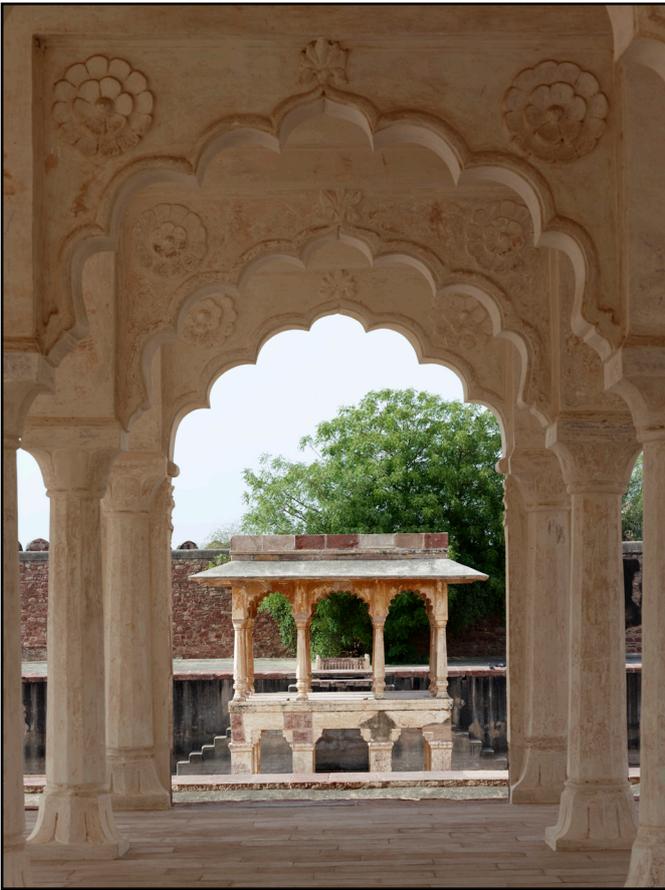
A variety of bracketed openings appear like constructed arches. Carved stone elements such as jalis, takias and brackets, lighten the appearance on the monolithic, outer stone facades, while fine paintings and mirrors embellish and distinguish the interiors.
