ERTEGÜN HOUSE  
BODRUM, TURKEY  
COMPLETED OCTOBER, 1973

ERTEGÜN HOUSE. Clients: Ahmet and Mica Ertegin; Architect: Turgut Cansever; Carpenter: Cemil Ormanlar.<sup>1</sup>

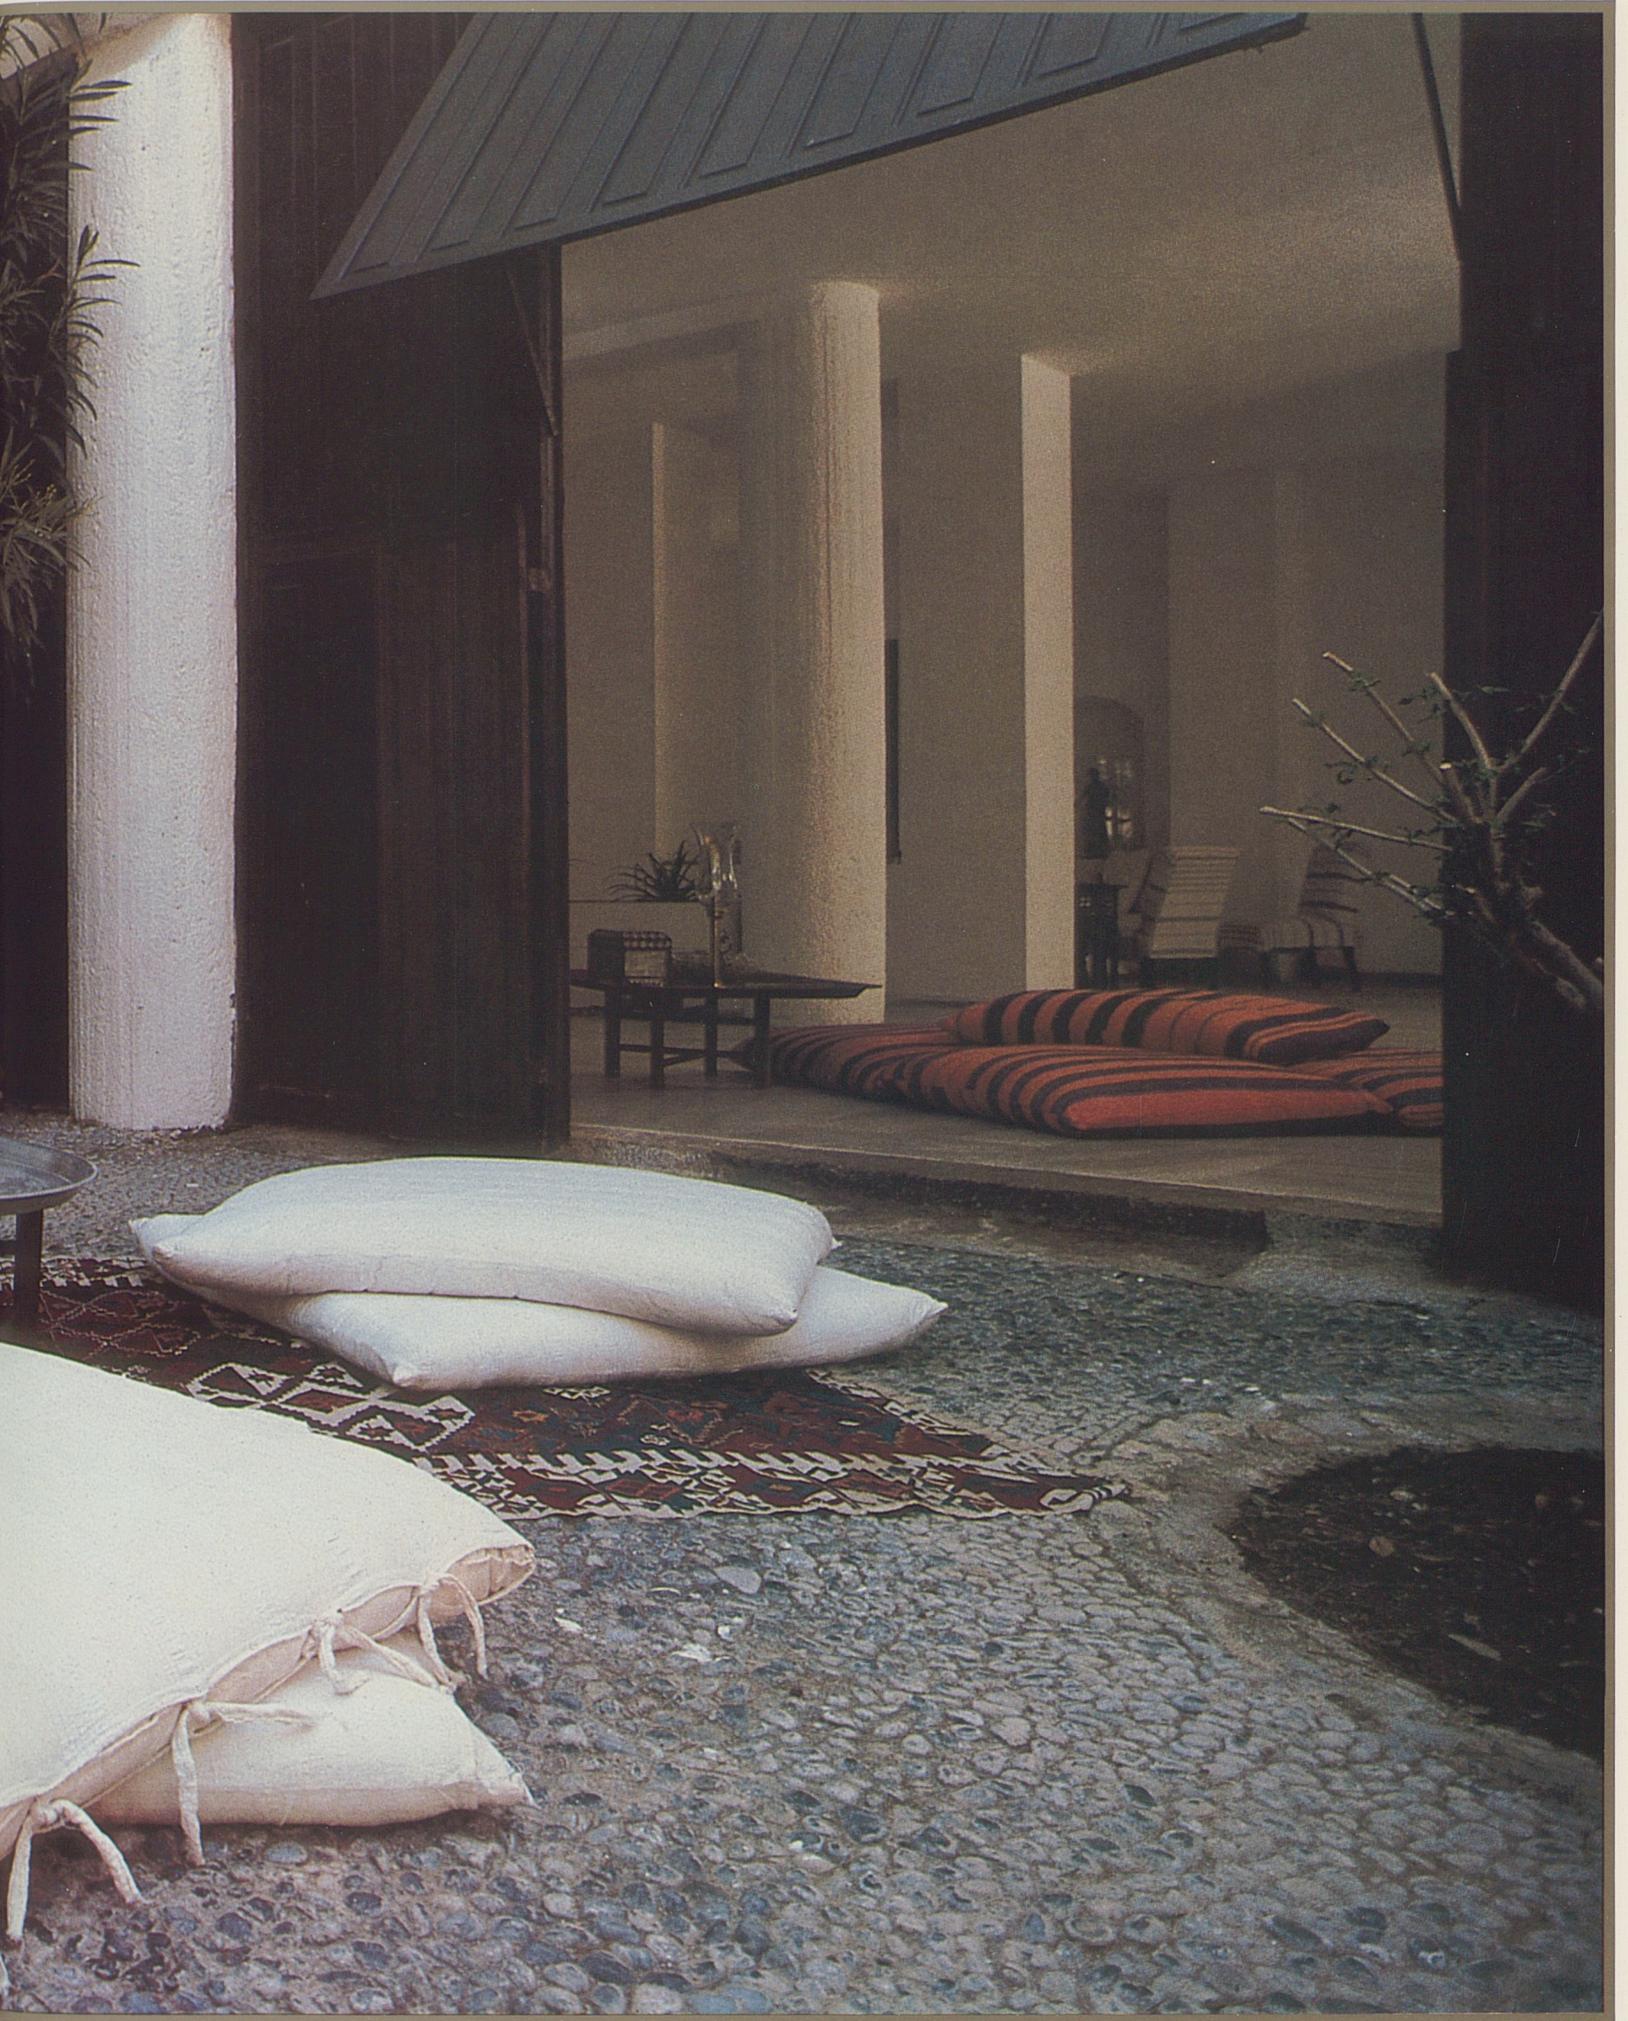
Patio with the newly added living room beyond.

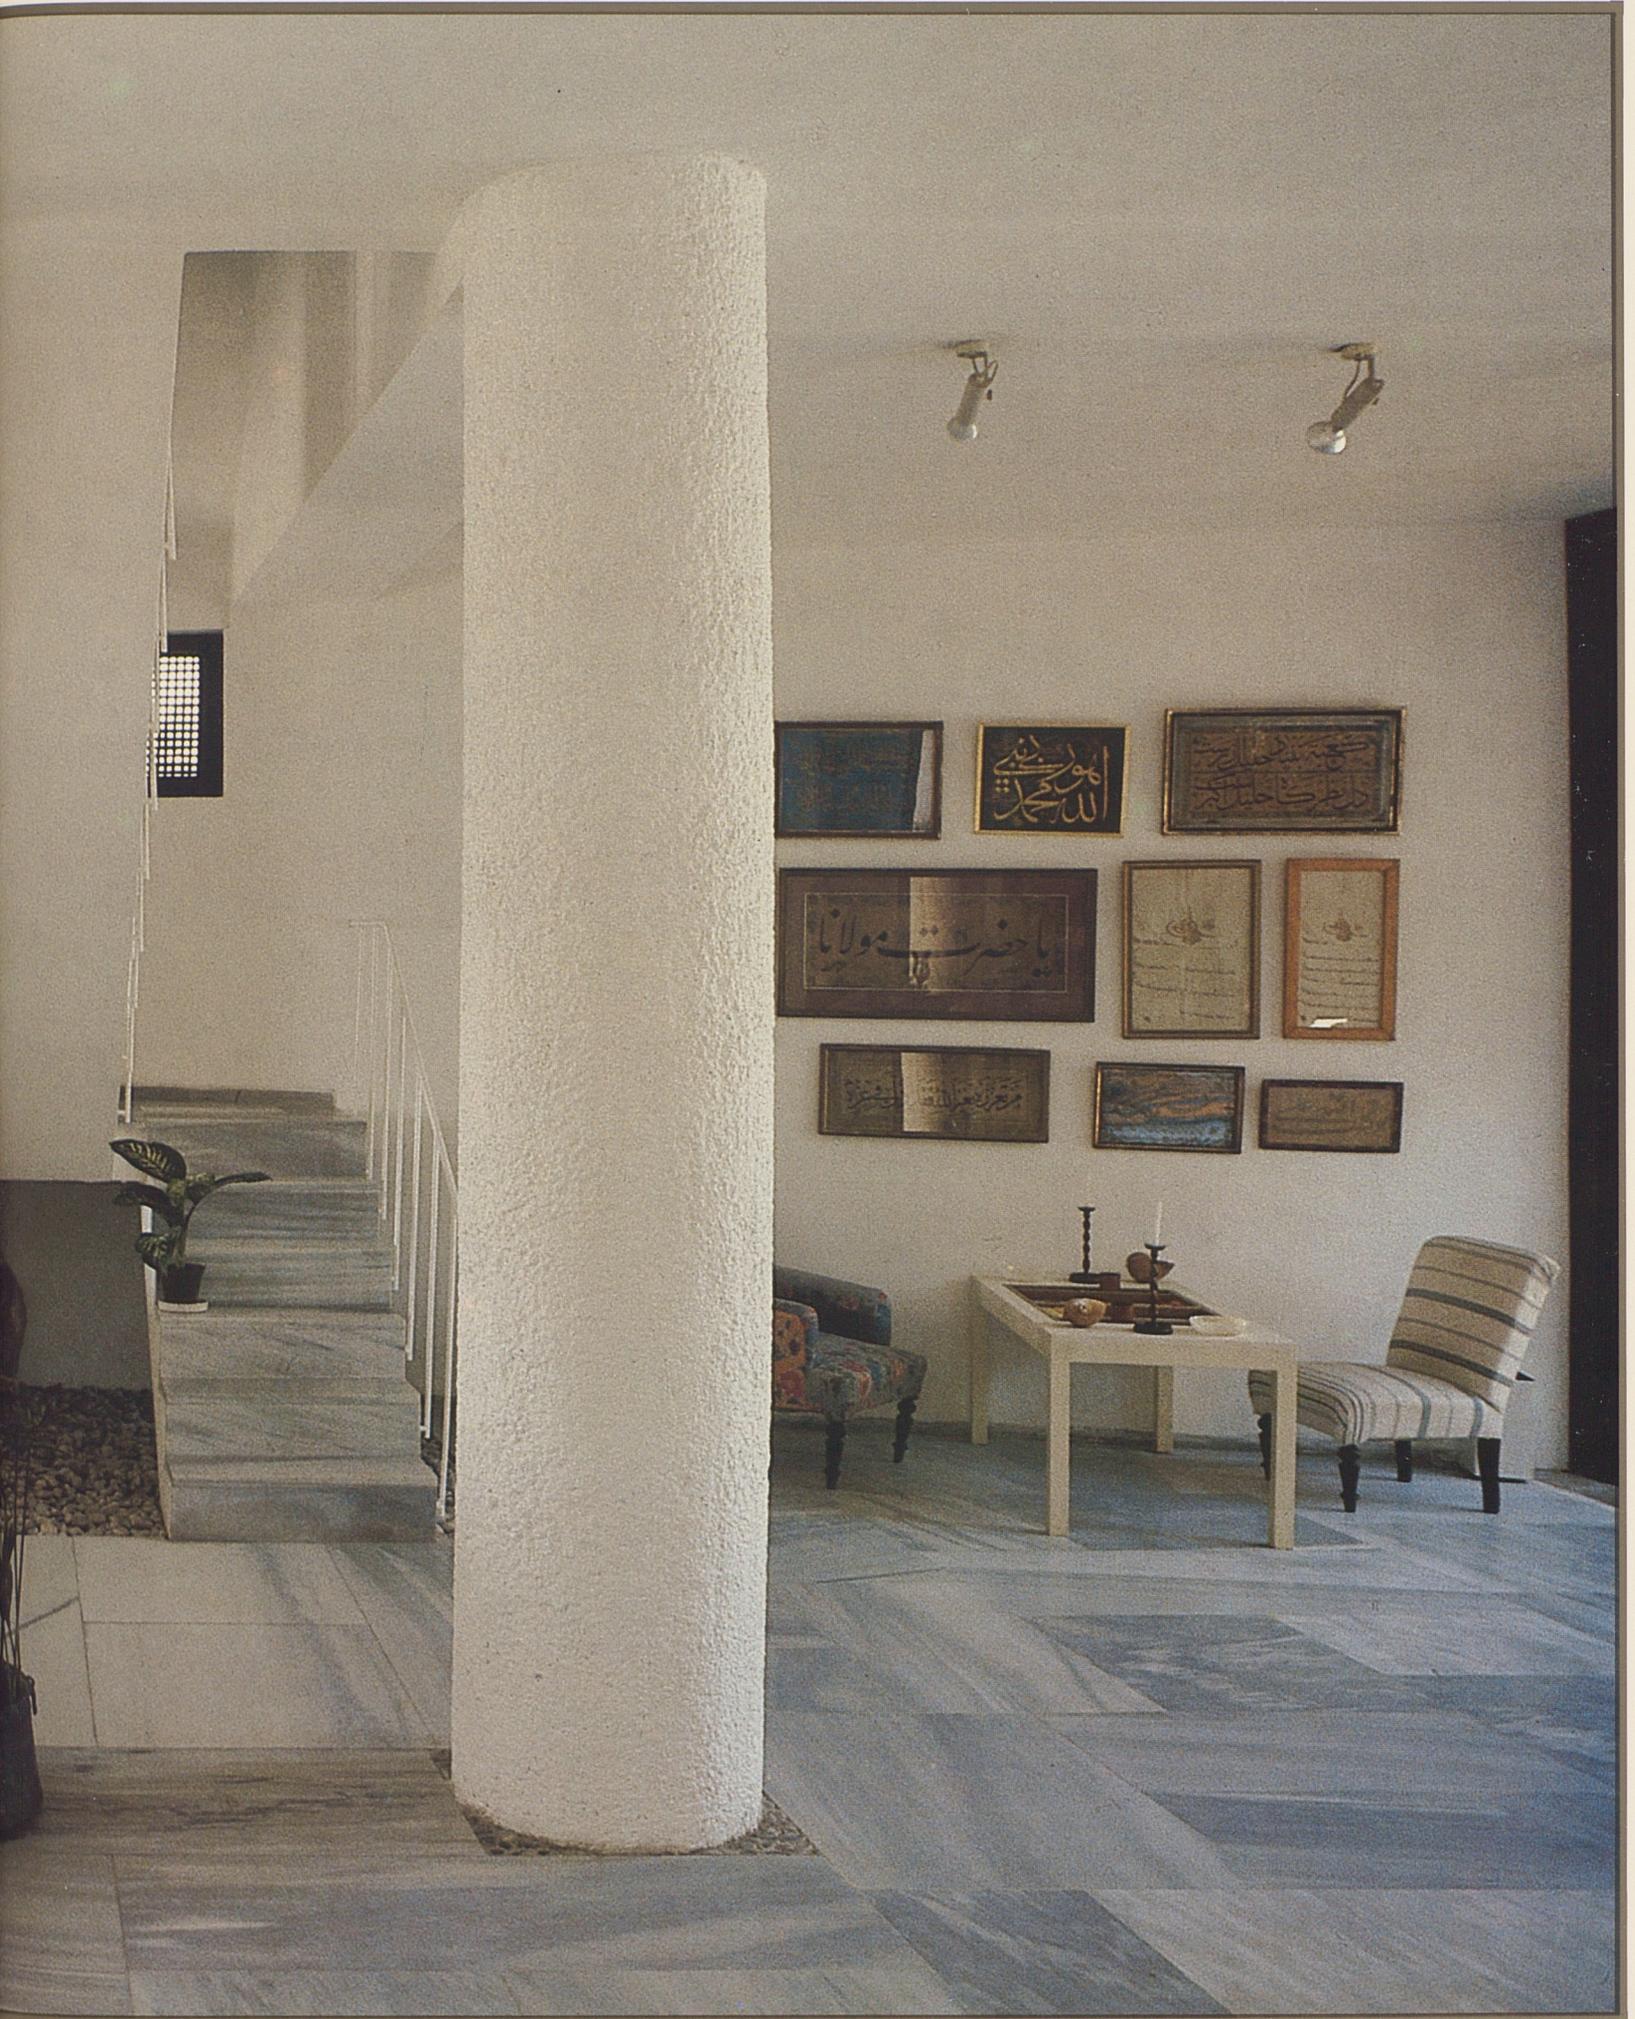
Living room. The old *selamlık* with its fireplace, stylistically typical to the region, has been integrated into the new living room.

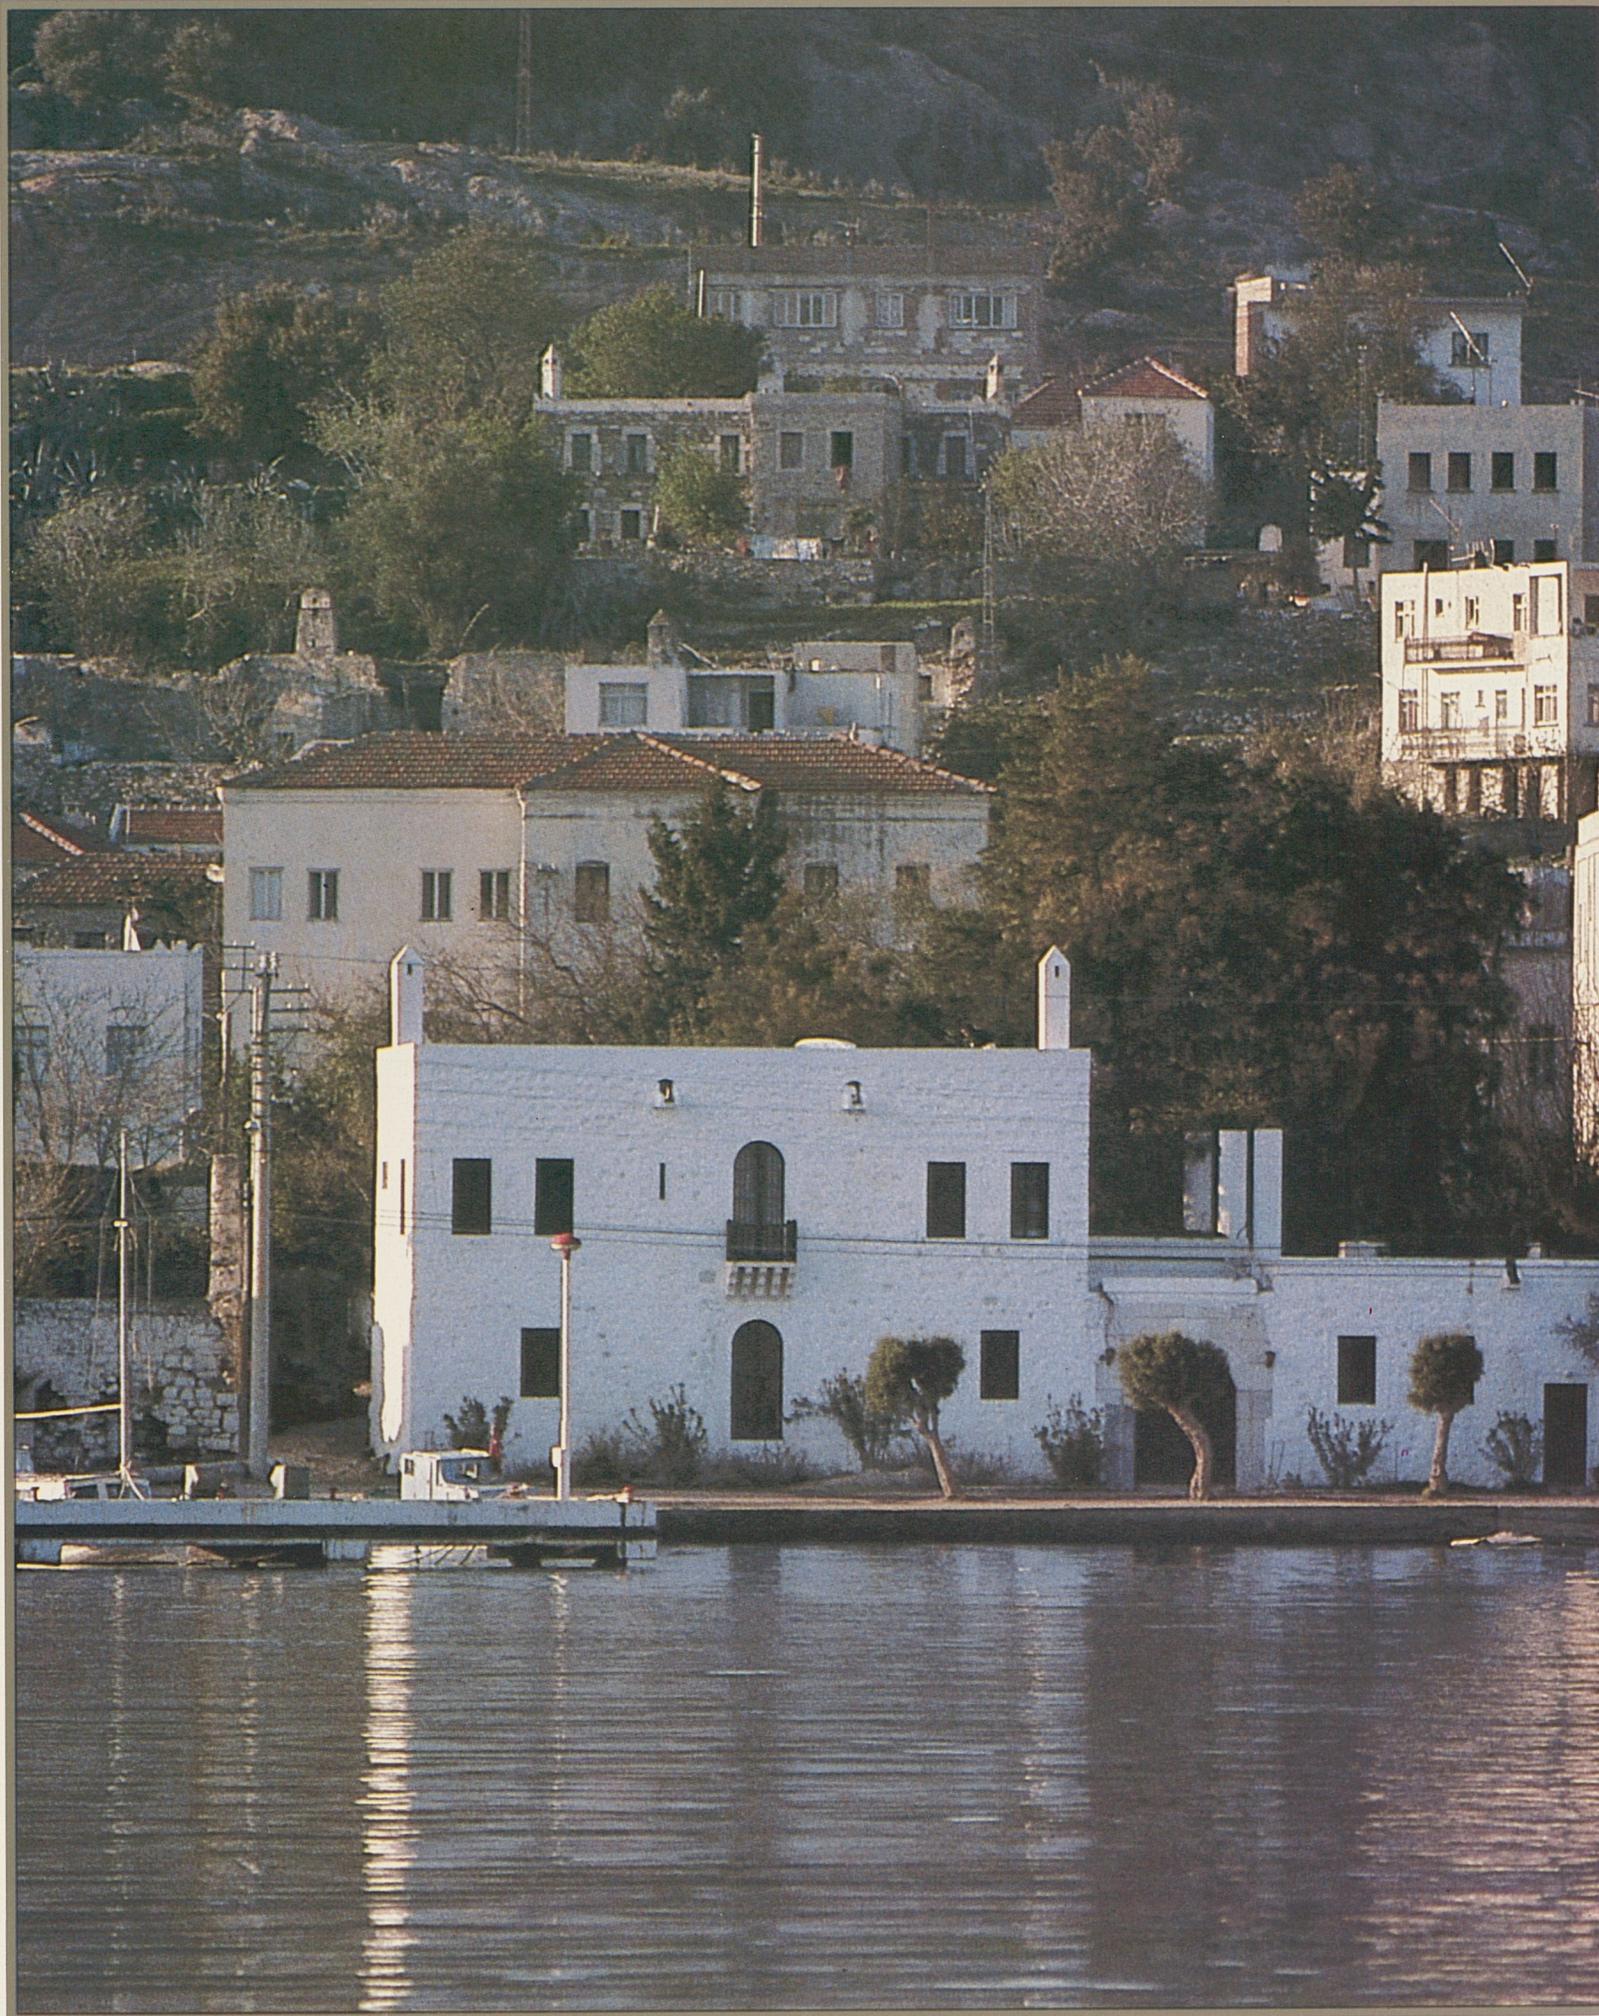
Harbour elevation. The street facades of the nineteenth century Salih Efendi Konak were retained in the 1973 restoration.

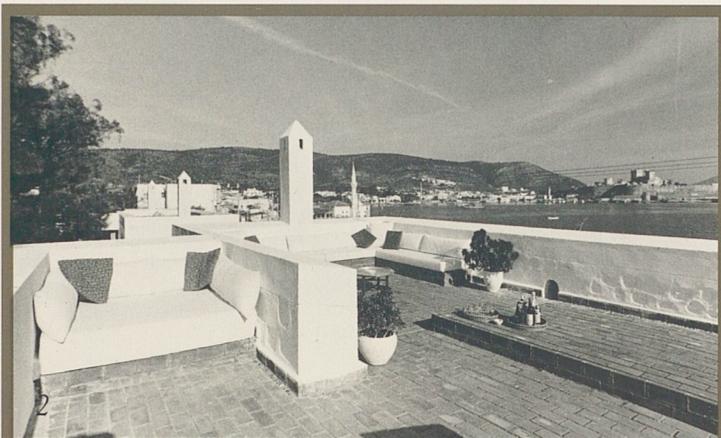
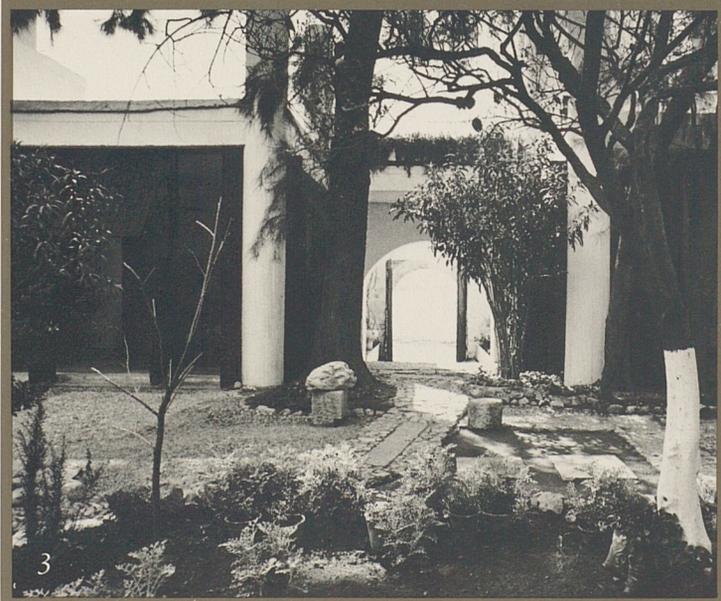
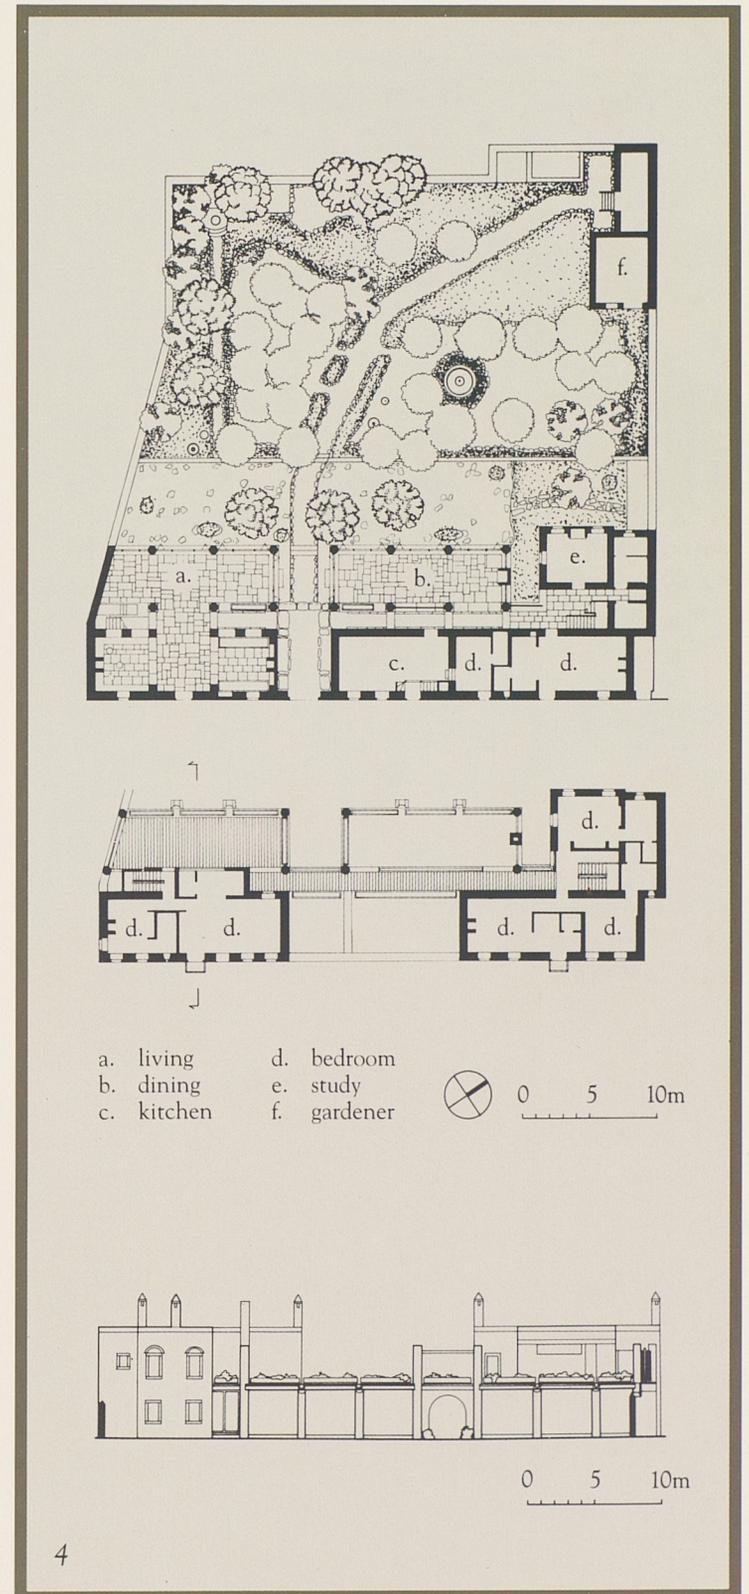
4. *Plan of house and garden, garden elevation.* The large private garden, surrounded by a high masonry wall, was once an orchard. It is dense with orange, lemon, and pine trees, flowering oleander and potted geraniums.

The plan is organised into three linear bands: the two wings of the existing house stretching along the street; the single-storey addition, which joins the two wings along the garden side; and the large garden with its surrounding masonry wall. The addition is clearly distinguished from the existing house by its structure. The reconstructed portions are of thick masonry bearing walls with small openings; the new structure is a concrete frame, with round columns and wood infill. While shunning mere imitation, the new structure parallels the old, and there is a consistent simplicity of spatial organisation and a concern for craft.

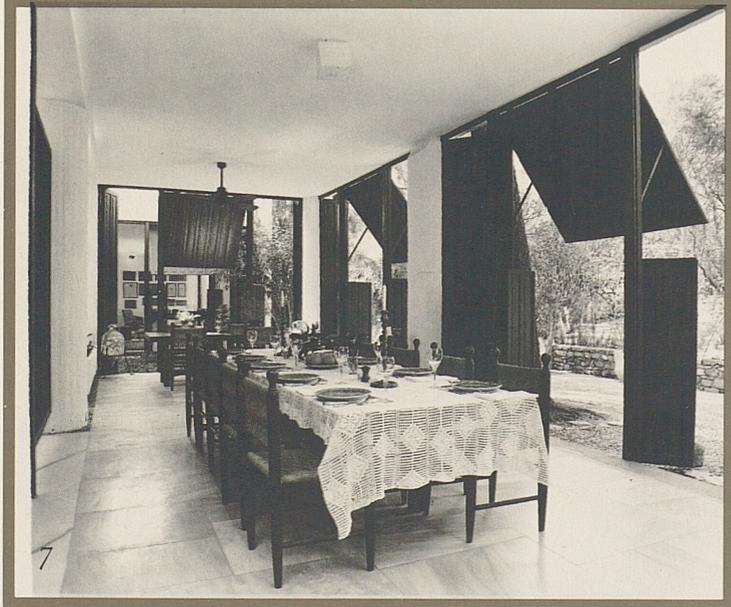
7. Dining area. The high standard of available craftsmanship was appreciated by the architect in designing “sail-like” oak shutters, crafted by carpenter Cemil Ormanlar. The shutters open and close to adjust the light and movement of air. When open, they visually extend the interior into the garden.
