AT THE ROOF OF THE WORLD

◆◆
THE
BALTIT
FORT

TEXT AND PHOTOGRAPHS BY
RICHARD HUGHES AND DIDIER LEFORT
DRAWINGS BY LUC VAICHÈRE

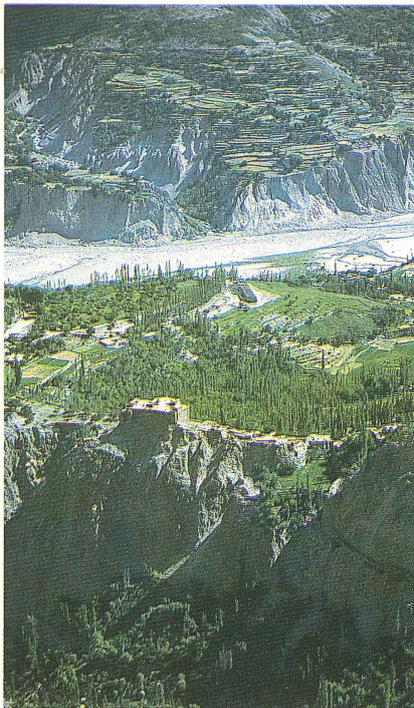
The Baltit Fort seen from the east.

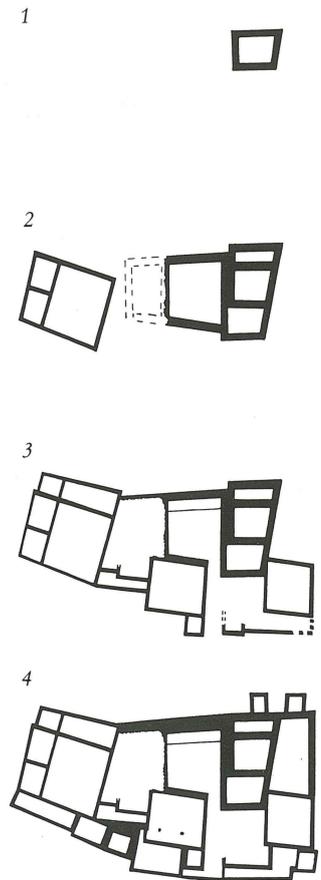
Above: The Fort developed from a nucleus of one, two or three Shingri towers which were gradually connected by a series of rooms to form the building as it stands today.

It is clear from our detailed survey of the Fort, both inside and outside, that it is slowly developed from a nucleus of one, two or three *Shingri* towers. Such free standing towers and surrounding single storey living rooms are still to be seen close by in the village of Ganesh. Until recently such forms of defensive towers

were common throughout the Northern Areas of Pakistan. They are now only used and still being built in the more remote valleys south of Gilgit. The towers were gradually joined together by a series of rooms. This agglomeration was then wrapped around by a series of defensive walls and guard rooms. During this period a series of rooms were also added to form a second storey and elements of a third storey. Many such phases of construction have now been defined.

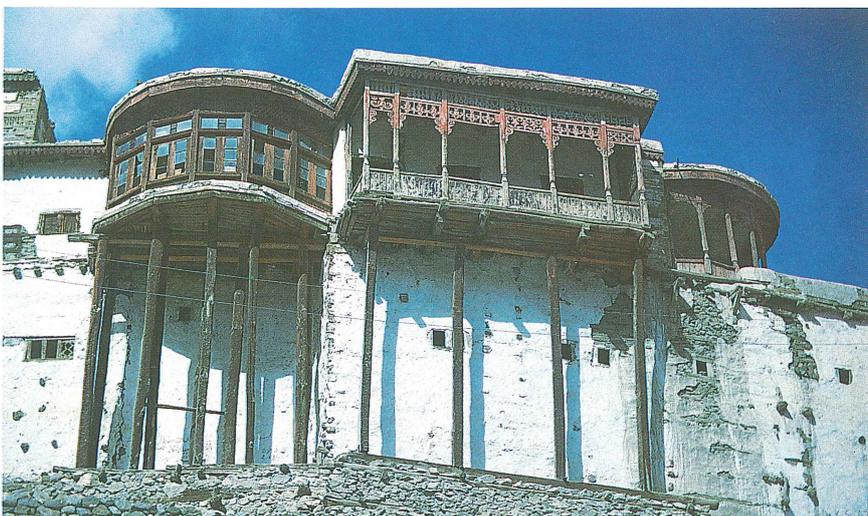
Left: The wooden semi-circular dais and verandah were added in the beginning of the 20th century to form the second storey.

ticeably the main facade was rendered and whitewashed in the beginning of the 20th century. At this time the semi-circular royal dais and verandah were added in imitation of certain administrative bungalows.

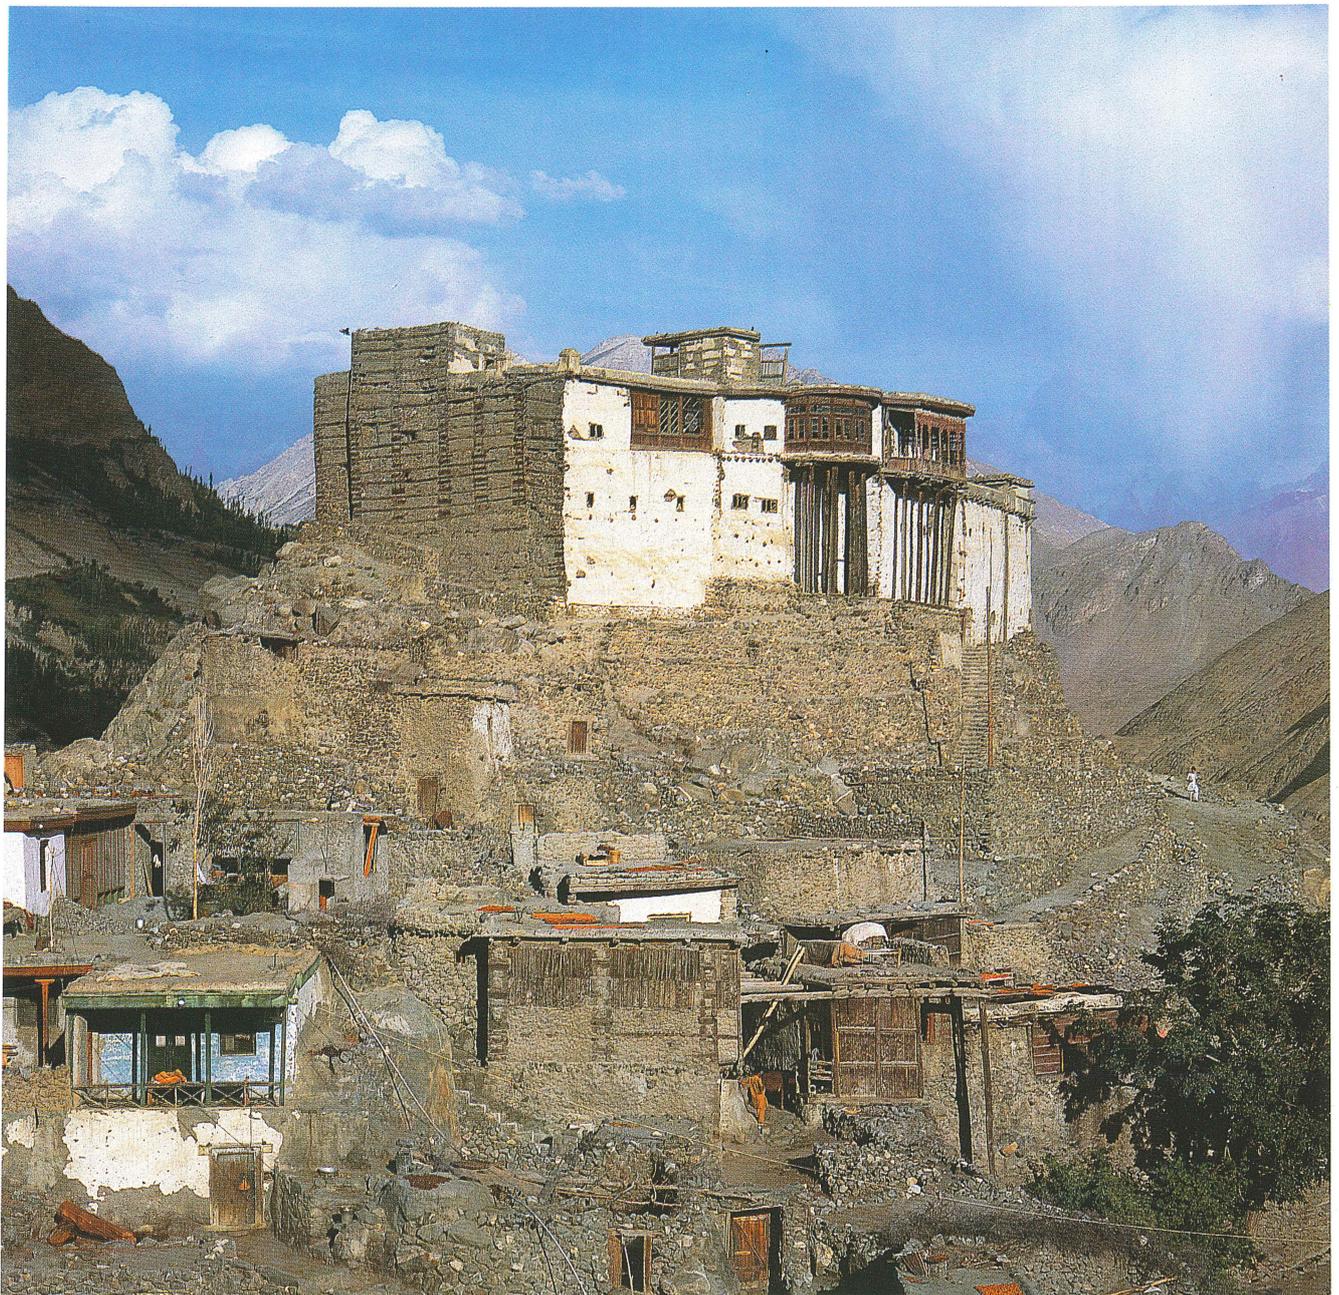
The changes in the fort are illustrated by the photographs taken from the same angle — one hundred years apart. The first (left) was taken in 1891 by Knight and the second (below) in 1985 by Ian Charles Stewart.

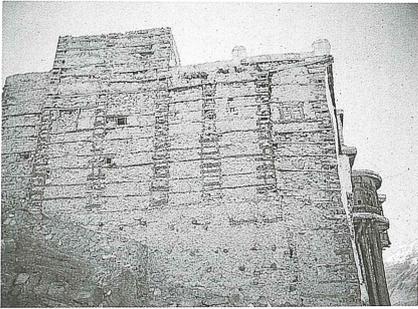
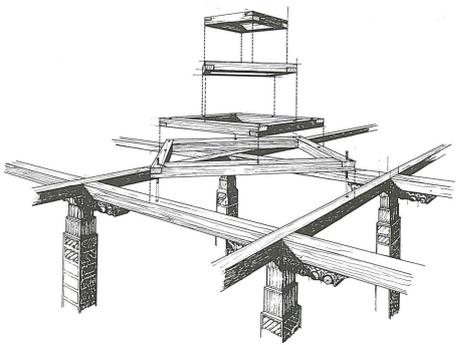
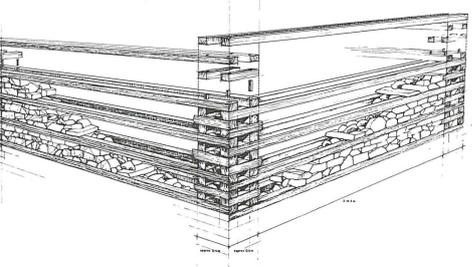
Top: Longitudinal squared timber tie beams are seen both on the outside and inside of the wall.
Centre, and above: Details of the main structural element showing the seismic-proof construction.

The main structural element consists of a pegged timber frame. Along the wall face on both the outside and inside are longitudinal squared timber tie beams. These are approximately 120 millimetres square, up to 8 metres long and are at 0.4 to 0.9 metres vertical intervals. Where such a timber does not span the required length it is scarf jointed, designed to resist tensile strains.

At corner points and where internal cross walls form a "T" junction with the external wall, timber "cribbage" work is found. Here, square timbers up to 0.75

metres long and 120 millimetres square are built up as columns up the full height of the wall and are pegged together.

In such tall structural elements the frame may have been raised in several "lifts". The inside of the timber frame is infilled with soil and small stone, loosely placed or poured in as a stiff slurry from a place higher up in the wall. In between the longitudinal timbers both externally and inside the wall faces are constructed in coursed random stone work or soil brickwork, these materials using a soil mortar. The timber building technique is intimately related to seismic zones stretching from Greece to India. It is proposed that through oral transfer or by a series of independent architectural Darwinistic processes timber became incorporated into stone or adobe walls specifically to strengthen the walls against earthquake induced ground movements. Its main advantage is in giving a wall the ability to withstand tensional forces along the plane of the wall and also across it. It is also an excellent system for allowing considerable differential vertical movements to occur in materials normally only able to resist compressional stresses. This is why perhaps, all the openings, doors, windows and skylights are small yet made with massive timbers.

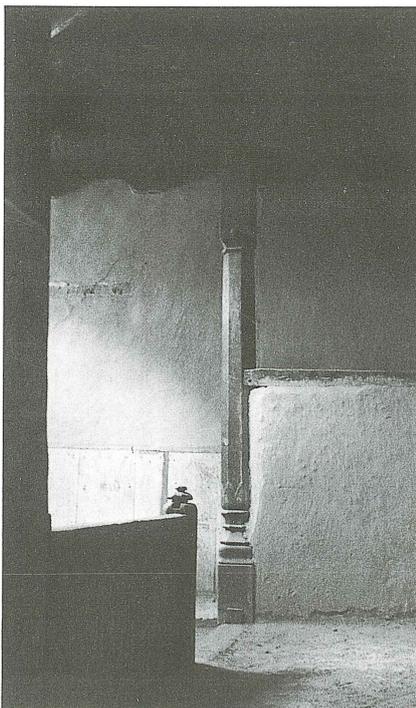
Below: A special area in front of the fire for guests. Below, right: The smoke vent, made of a wooden frame structure, is directly above the fireplace; it gives the room a central dome inside.

This hole in the roof structure is a clever device made of a complex wooden frame so arranged to give the room a central dome inside and a drainage slope above. For both climatic (protection against the cold and strong winds) and anti-seismic reasons the number of openings and their size is limited. At most a typical house would have one entrance and skylight and an occasional small window. Baltit Fort is simply just a complex arrangement of many such structures — a type of “nucleated village”. Only its size and decorative details make it functionally different from other housing.

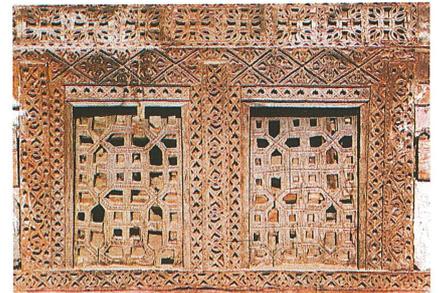
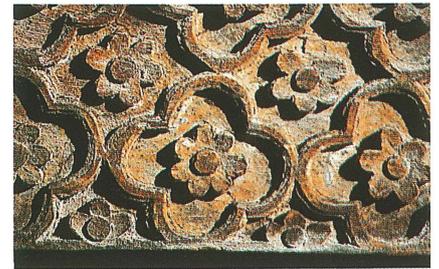
Top: The window frames, doors and columns are elaborately carved; timber is used for all the openings.

Above: Detail of wood carving.

Only the houses of wealthy people and the old mosques have architectural elements with refined decoration. These are mainly concentrated on wooden structural elements which is the expensive part of the construction (columns, doors, and window frames). The infill of stone rubble or adobe was always roughly done and frequently replaced whereas the

ornate wood is reused over many centuries. In Baltit Fort only the older rooms have this elaborate wood carving and it seems that this remarkable work was done by carpenters from Baltistan and Shrinagar, hence the influence of styles of patterns. Nowadays this kind of craftsmanship exists only in the Kalash Valley near Chitral. The lantern tower, added as late as the 1930’s has a Chinese or Tibetan influence.

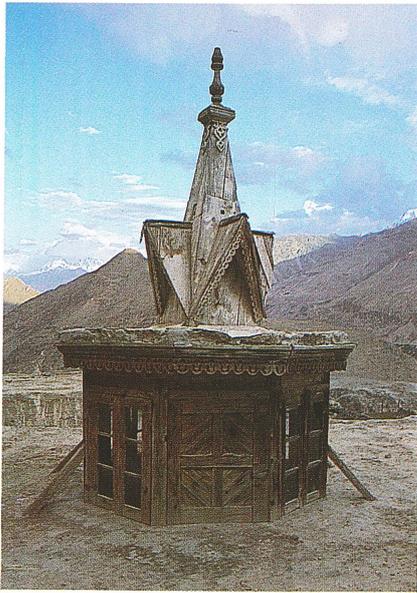
Above: A smoke vent, this wooden frame roof structure also provides natural lighting.

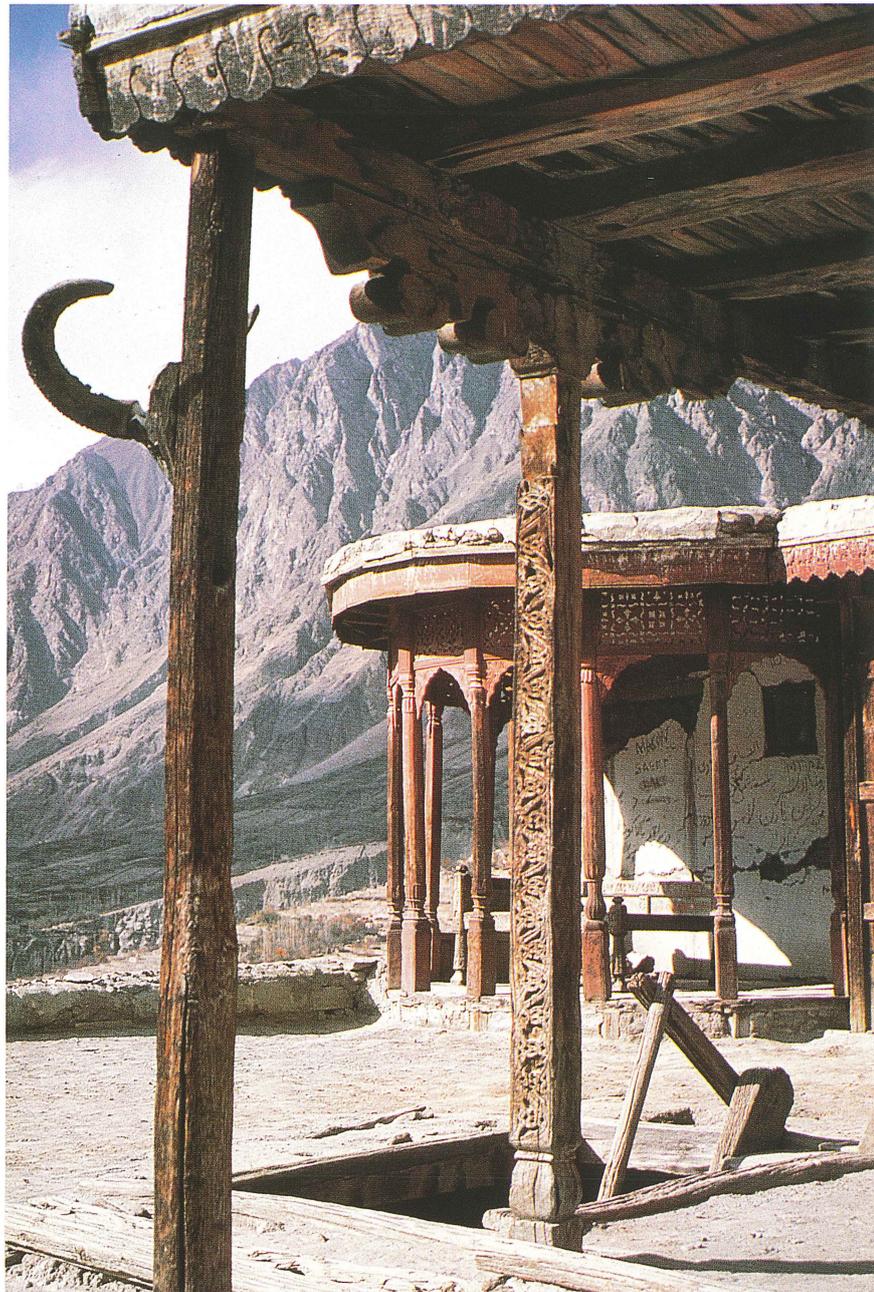
Right: The lantern tower with its carved wooden columns. Photograph: Elizabeth G. Darling.
