# Conference of Heritage and Urban Development Cairo

## "Rehabilitation with people participation"

Presented by:  
Dr. Salah Zaky Said

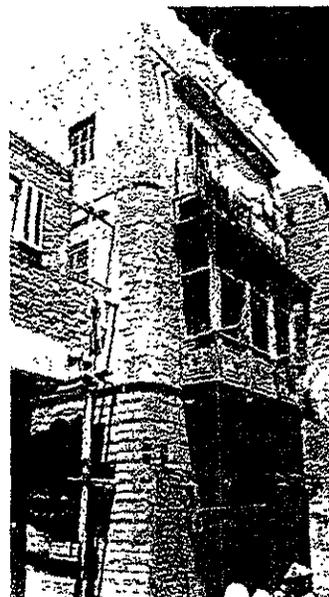
Bayt Sokkar before rehabilitation

Bayt Sokkar after rehabilitation

The most important elements that were replaced and renewed or changed in this process were: -

1 - The Decayed and almost failing parts of the walls, especially in the ground floor, these were replaced as of original, with good quality limestone from Mokatam Hills. The walls closer to water network were the most vulnerable ones and in some cases also walls on the street, close to ground level.

2- The water and sewer network pipes and taps, which were the main reason for decay and dilapidation.

3- The sanitary units were always replaced with new ones. In some cases new units of bathrooms were added to improve the facilities of the house.

4- The stair and its handrail was either replaced completely or in some cases partially.

5- The woodwork of the bal-

conies and windows was either replaced or restored as of original.

6- The roofs of constructed wooden beams with the flooring of Ma'sarani stone tiles or cement tile, were part of the rehabilitation process. Where necessary particularly some wooden beams needed renewal and in few cases the whole roof was replaced totally by a new roof.

7- The exterior plasterwork was either redone completely or partially.

8- The wall cracks were dealt with by inserting wooded beams to overcome the cracks if the walls were not replaced totally.

9- The roof was insulated where necessary and new tiles were installed with water drainage.

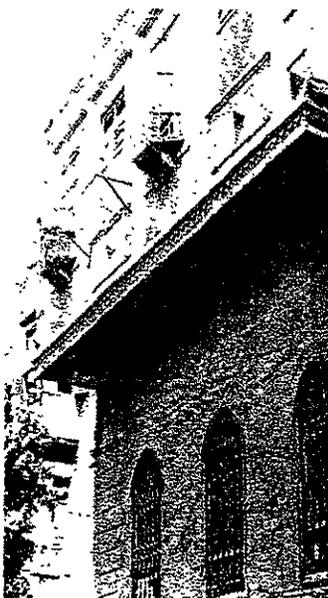
Bayt El-Sitt Awatef  
before rehabilitation

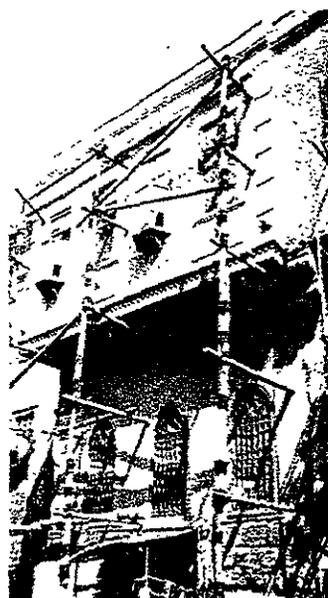
Bayt El-Sitt Awatef  
during rehabilitation
