9. The Restoration of Baltit Fort

RICHARD HUGHES

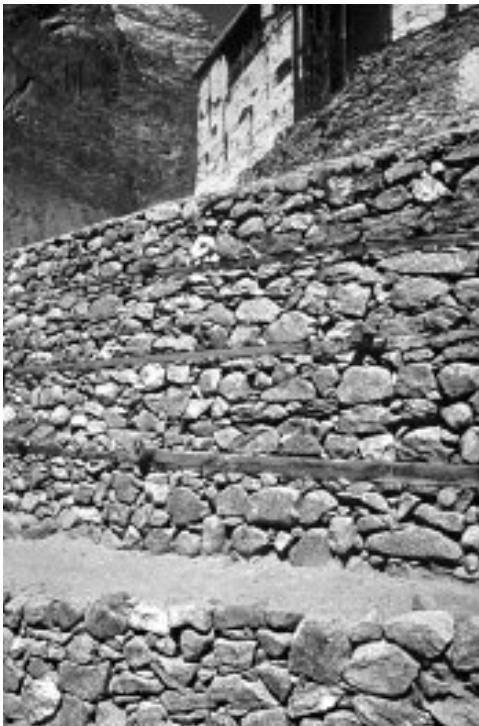
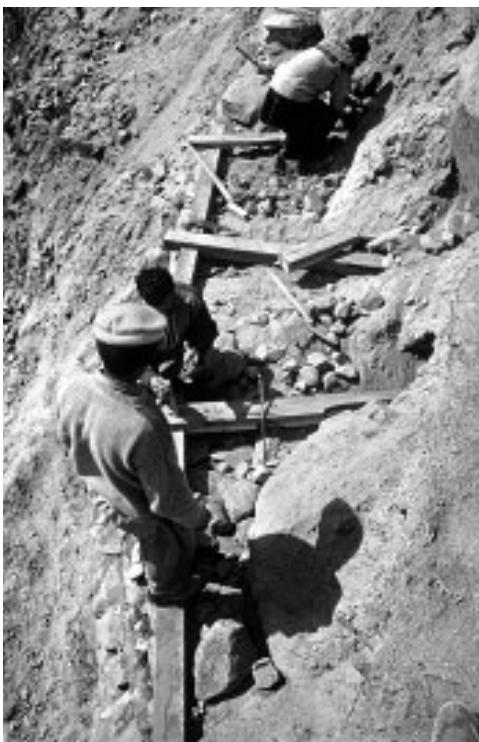
Figs. 182, 183. Repairing the terraces below the fort by placing 'cators' and anchors to consolidate the steep slope.

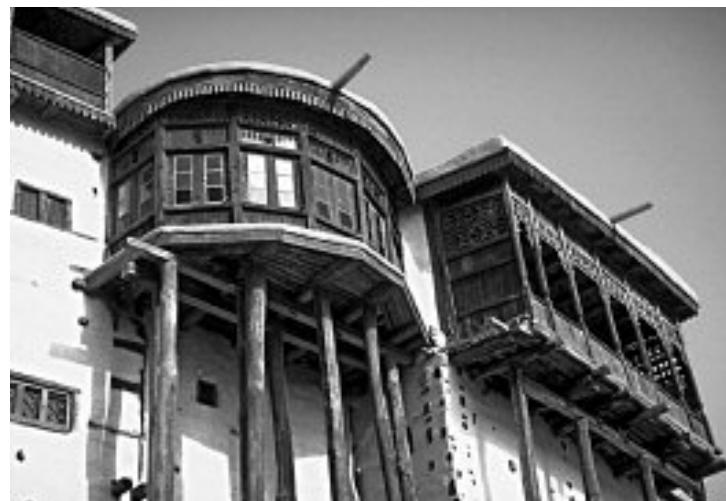
Fig. 186. The restored projecting bay window and veranda. The bay window is a 'colonial' addition from the 1920s.

das (figs. 186, 195) are more recent elements and add to the imposing image of a fort turned into a palace. As they cantilever considerably off the façade they had later to be supported by a series of tall posts.

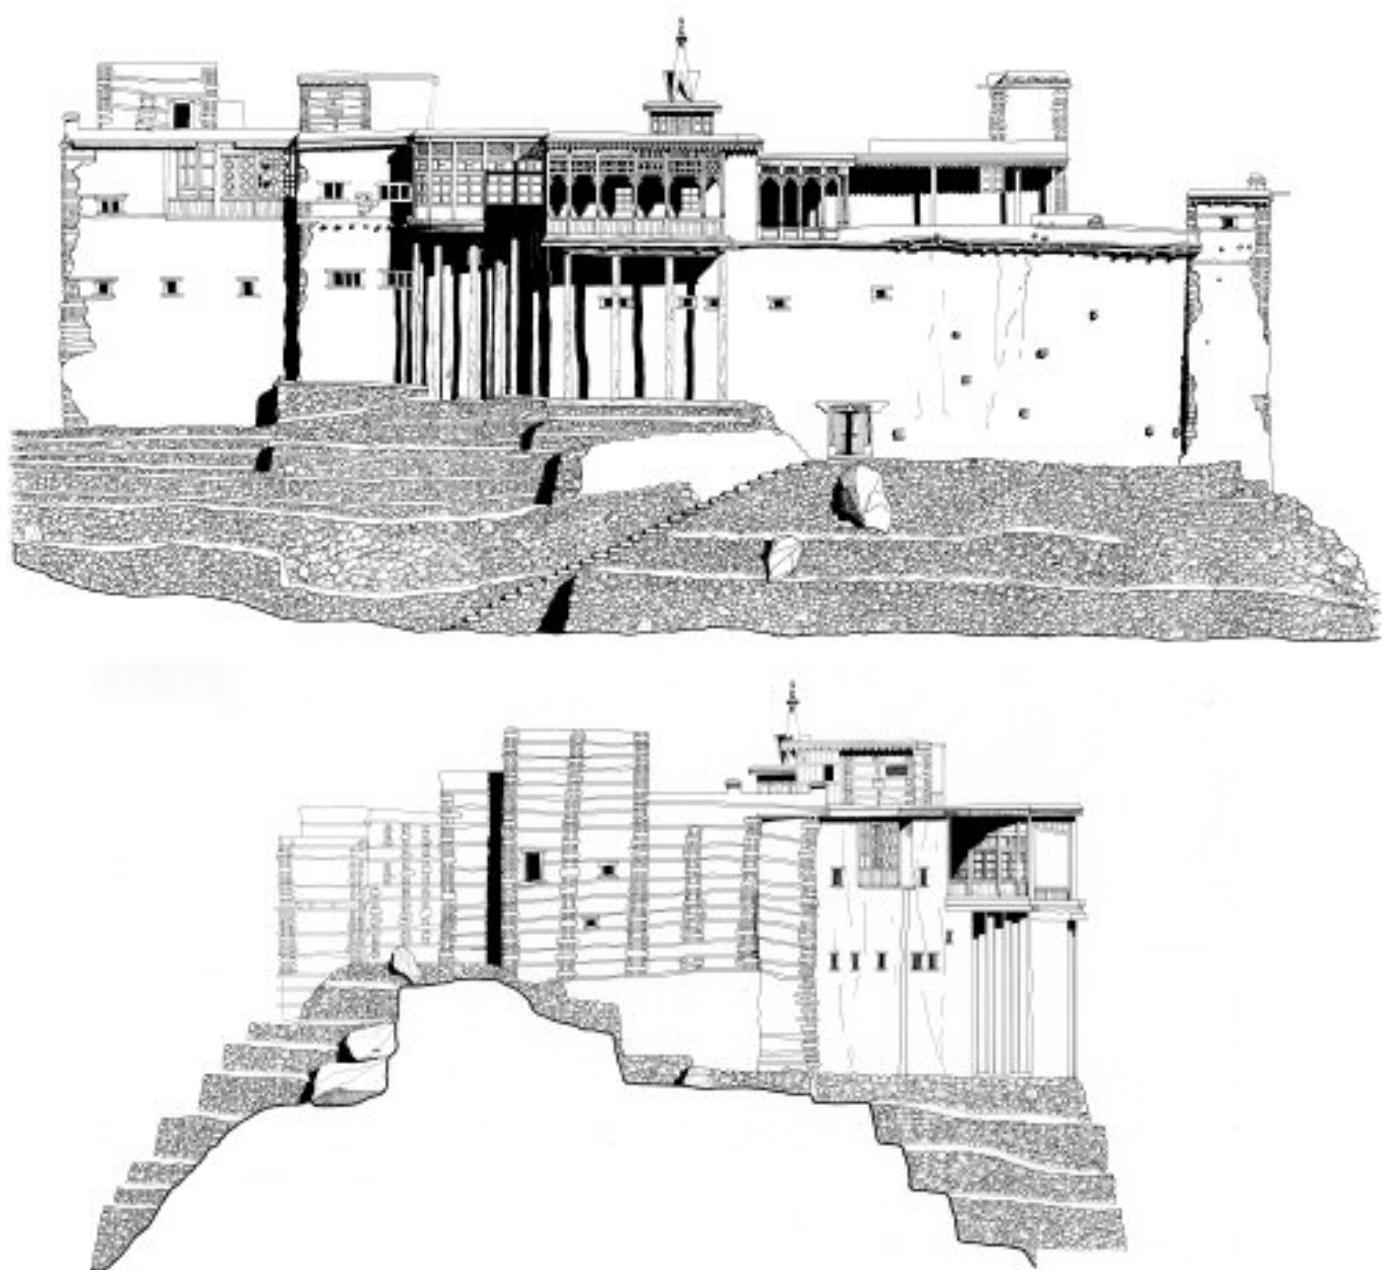
Figs. 187, 188. Above, the western elevation facing the village and the valley. Below, the northern elevation showing the tip of the precarious hill on which Baltit fort is sitting.

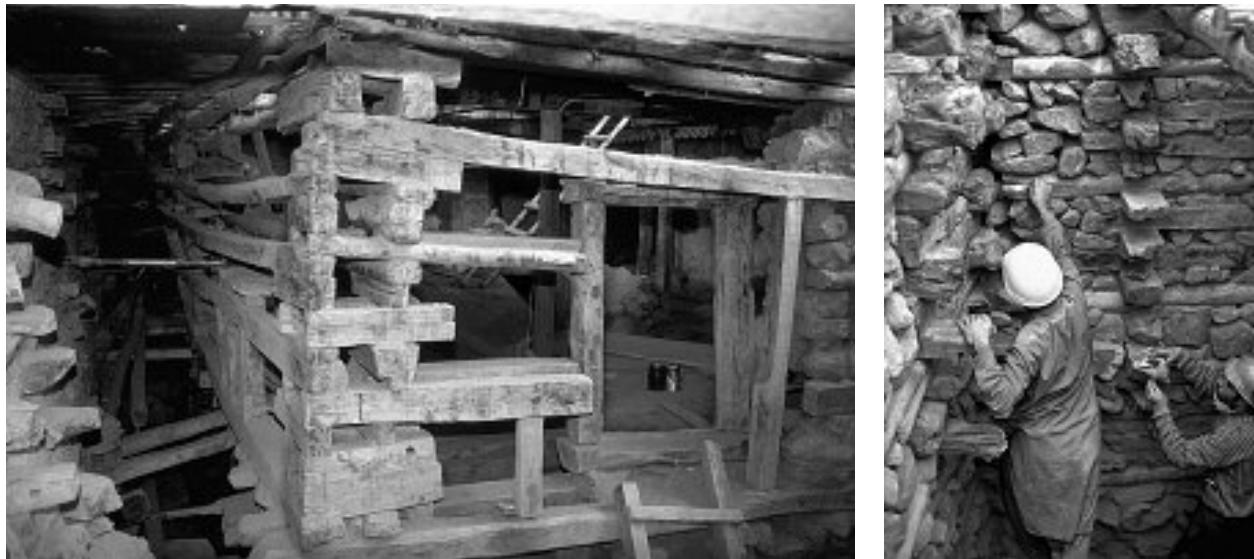
Figs. 189, 190. Left, the original 'cage' construction of two subsequent layers of outer walls being stripped of defective stone and mud infill to be restored in the traditional manner. In the background a tensile cable tying the leaning walls together can be seen. Right, workers monitoring structural movements during the restoration process.

Within the entrance of the fort, an older defensive wall can be seen, as well as the distance between it and the subsequent latest enclosure (fig. 189). This gap was the fort's weakest area, to be watched over by the garrison. The stairs then lead up to the main reception area (fig. 184). Turning to the right, the arrangement of spaces illustrates the strategy adopted for defence against attackers. Turning to the left, one can see the oldest part of the fort, a base room of a once three- or four-storey *shikari* tower – but then chopped off, as at some point it had dramatically tilted to the south (fig. 87). A later tower used for storing armaments is located just beyond the top of the stairs, and next to this is a suite of rooms used by guests in the summer (now the library) (fig. 199). Off the reception area is the fort's kitchen and one of the oldest winter rooms, surviving with all its highly ornate columns and capitals.

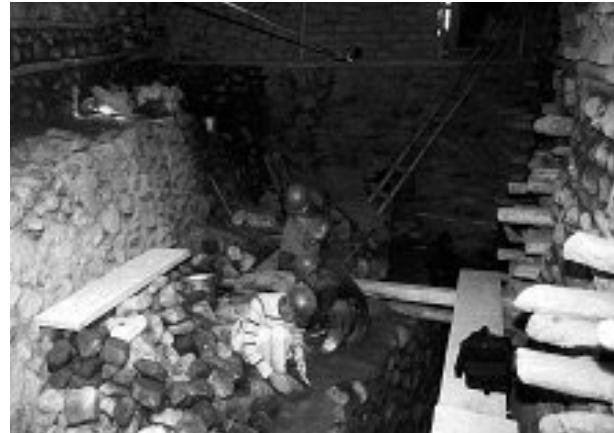
Fig. 191. Repairing the foundations after emptying the basement of rubble from collapsed older structures.

The major engineering works were along the front façade, especially around the south end. Here, the stabilisation of the foundations (fig. 191) and structural frame took nearly three years, requiring sophisticated engineering designs and construction techniques. During this work, older archaeological remains were found and successfully incorporated into the conservation project. This had to be done first, as it was essential to guarantee foundation stability before repairing the walls and then the roof. At each work station, the structural unit was thus repaired from the bottom upwards, with the overall roof and wall finishes completing the conservation sequence.

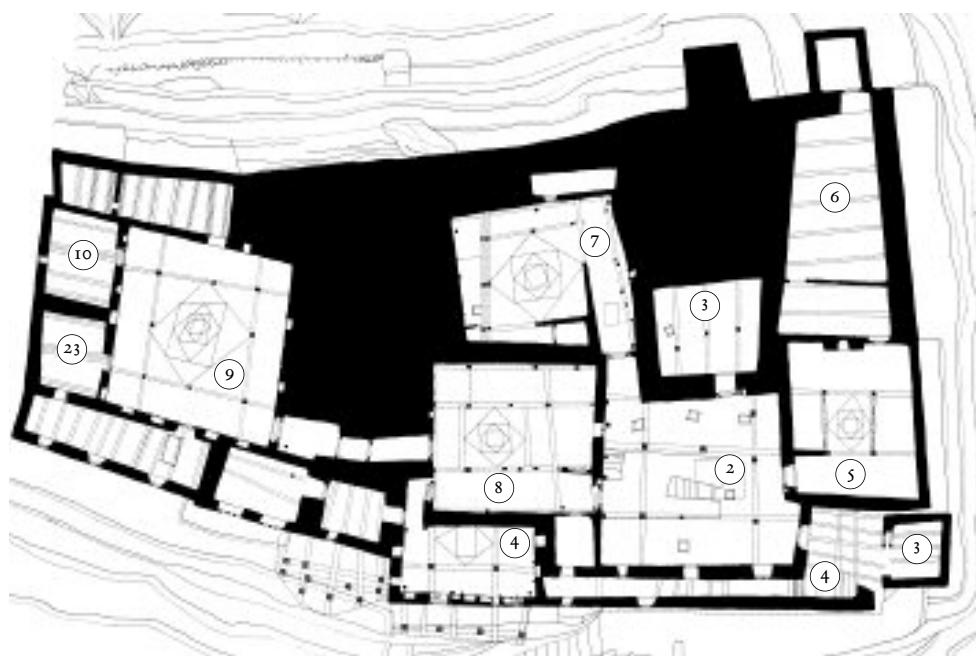
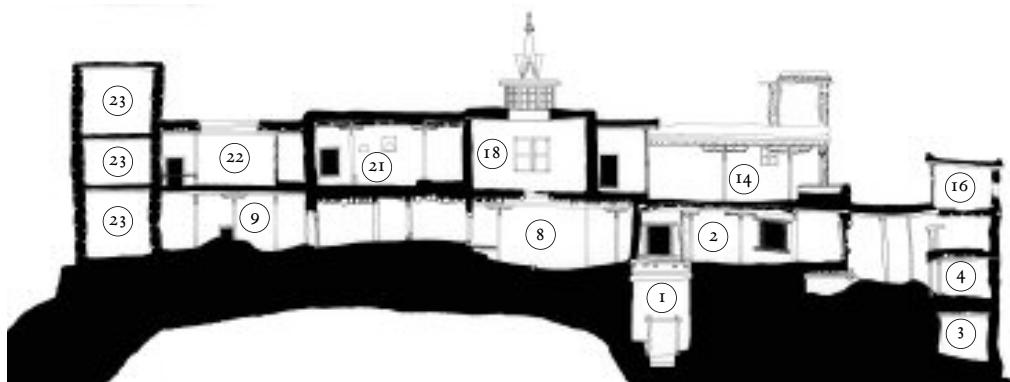
Figs. 192-194. Plans of the second upper floor (above) and the first floor (below), as well as the longitudinal north-south section.

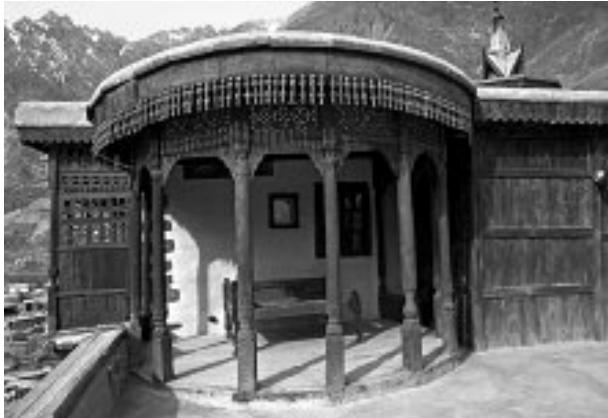
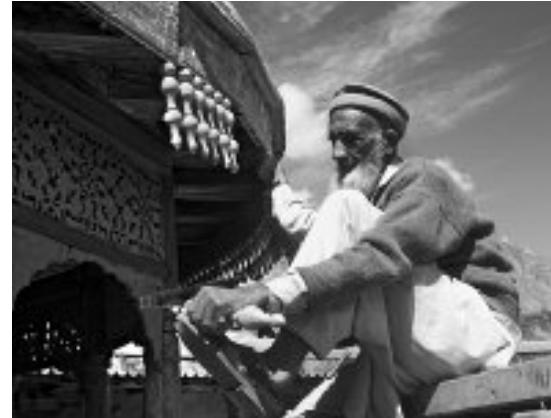
Figs. 202, 203. The restored dais on the main upper floor, and a local craftsman completing the missing ornamental timber features.

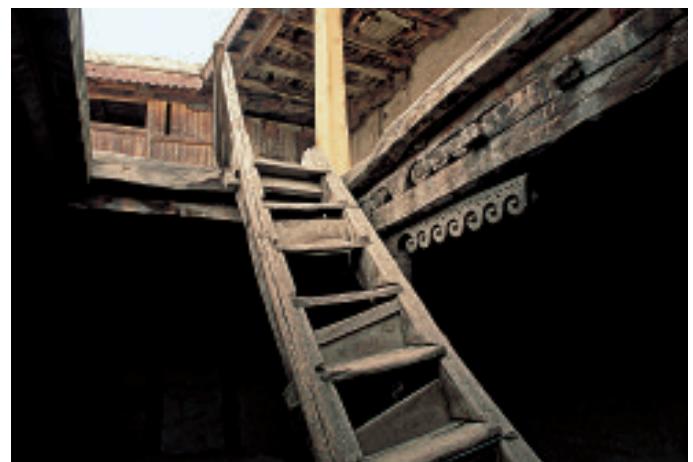
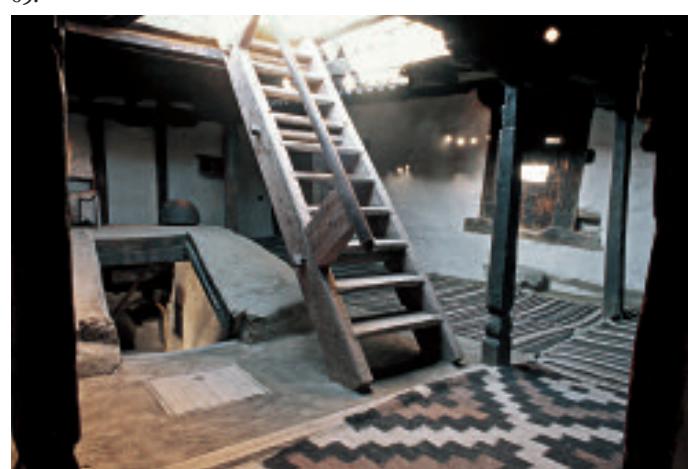
69, 70. The first floor entry hall with the stair leading to the upper terrace (figs. 192, 193) before and after restoration.

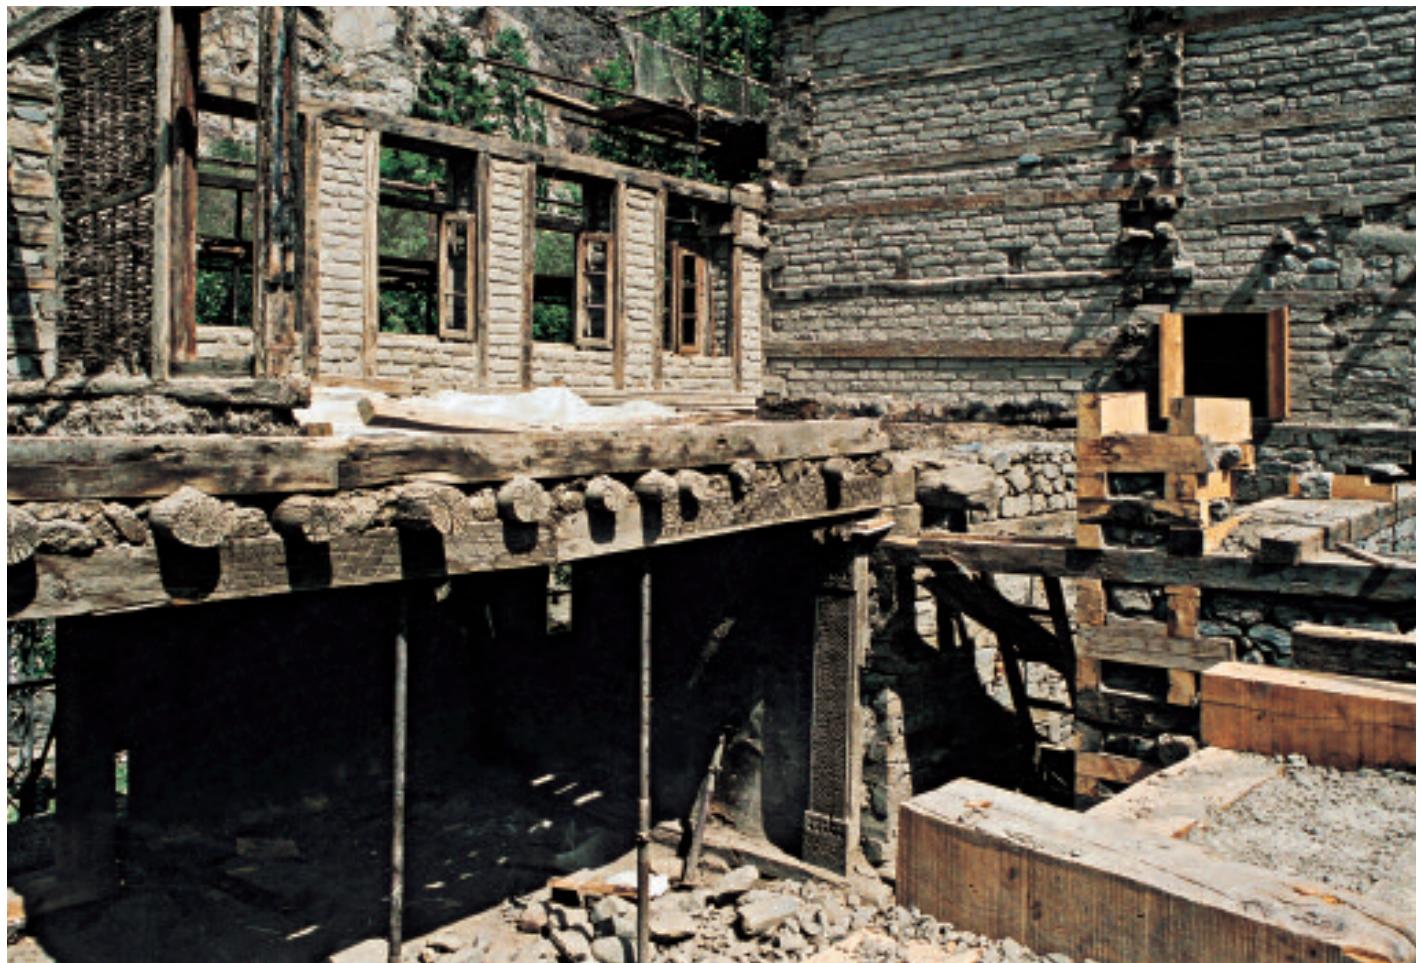
82. The courtyard of the fort on the raised platform during works, after stripping all dilapidated structures and before restoring missing elements (compare with pl. 88). On the left side, the remains of Module I, with the fragmented audience hall on the ground floor.

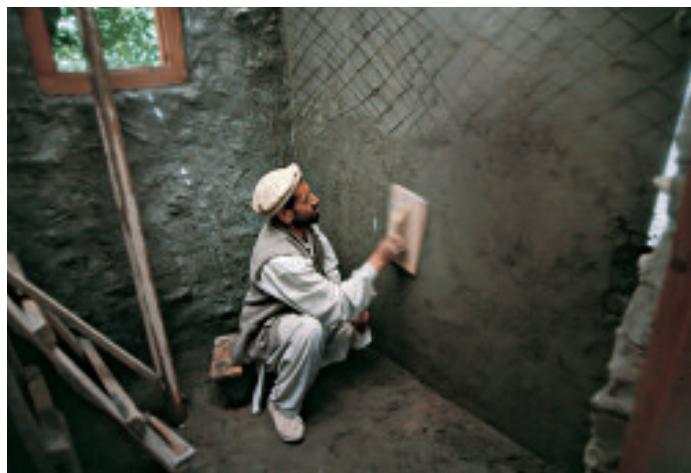
83. Rendering interior walls with stabilised soil plaster.

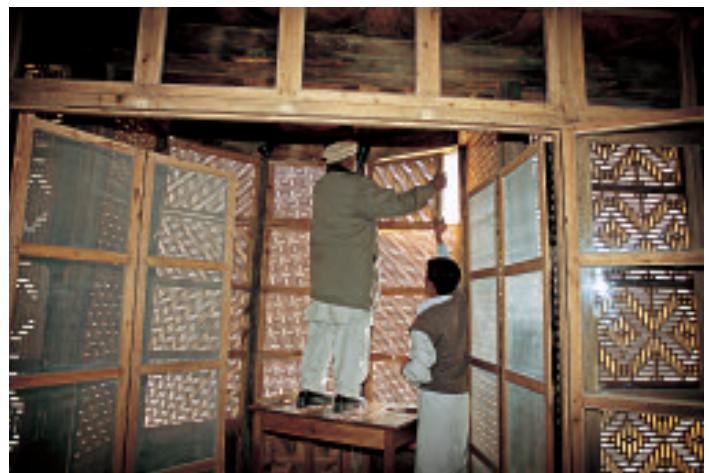
84. Mounting new *jali* screens on the restored bay window of the *rāja's* room on the second floor.

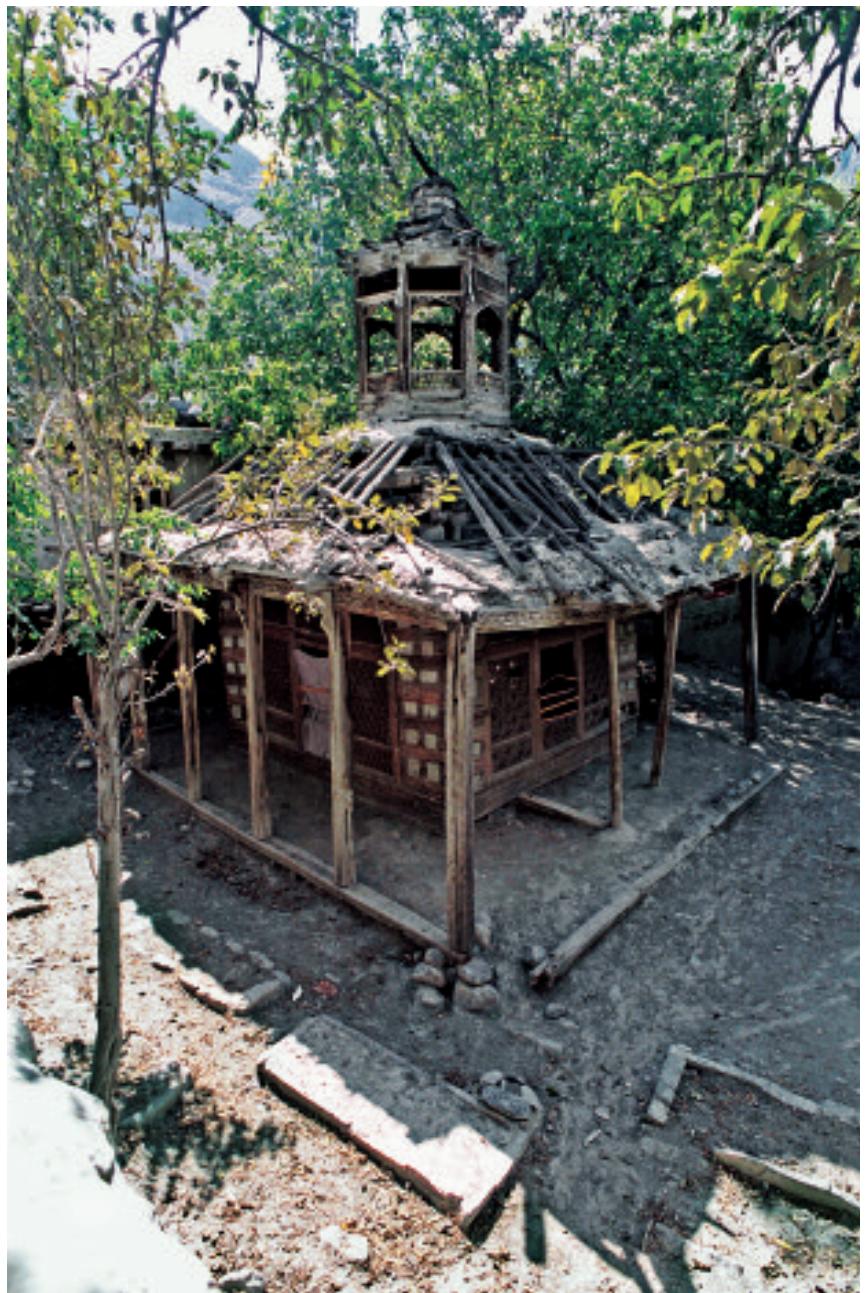
99. The Sayyed Mohammad shrine and tomb (*astana*) in Khaplu before restoration. It had to be completely dismantled and rebuilt by using as much as possible of the old timber components (see also fig. 294).
