# Ansari Shrine Complex

HERAT, AFGHANISTAN

The restoration of the Shrine complex at Guzargah involved structural analysis, detailed surveys, roof repairs and landscaping, together with reconstruction and restoration to better enable pilgrim visiting and document the surviving Timurid decoration.

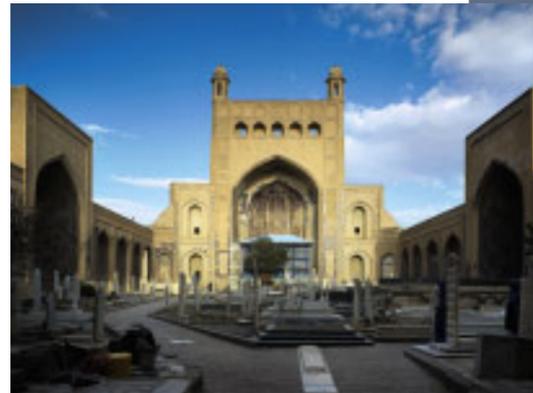
Abdullah Ansari's tomb is under restoration in the complex courtyard and the historic gravestones have been documented.

In order to facilitate the visits of pilgrims, original sections of marble paving were relaid at the main entrance. Incongruous aluminium doors were replaced with traditional wood, along with other doors leading on to the courtyard. To establish improved records, the historic gravestones that now fill this courtyard were methodically documented, prior to repairs and consolidation of the most vulnerable graves. Brick paving was also laid in key areas, to enable access and

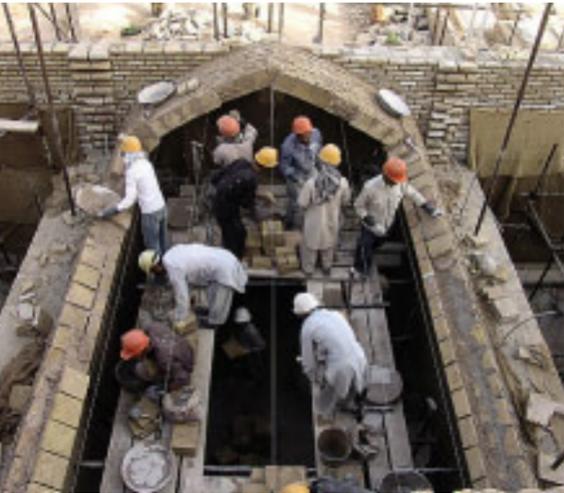
Left, work is being done on reconstructing the Haft Qalam room. The *haft-qalam* (seven pens) is a black marble gravestone marking the grave of one of Sultan Hussain Baiqara's sons. It refers to the seven styles employed in the decoration and design of the gravestone.

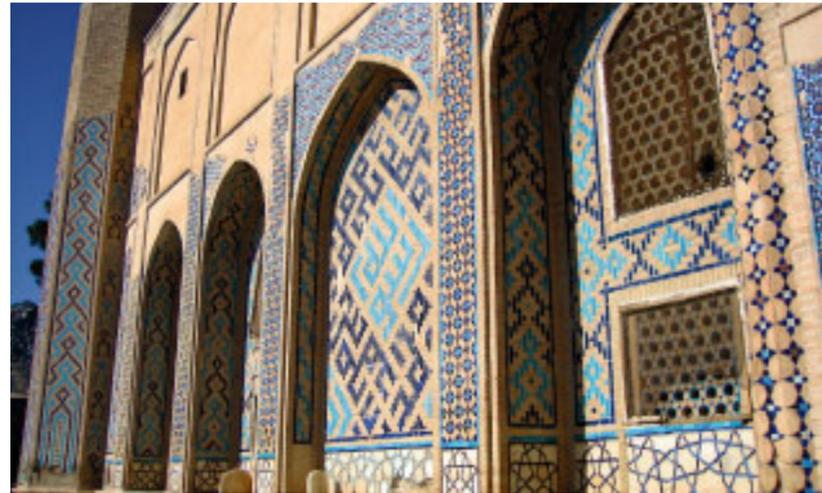
Above right, the fine detail of tile-work on the facade of the Shrine can be seen.

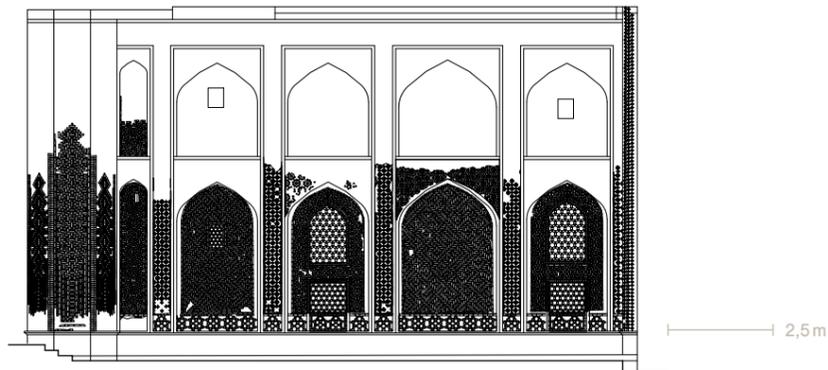
Right, a drawing of the tile-work.

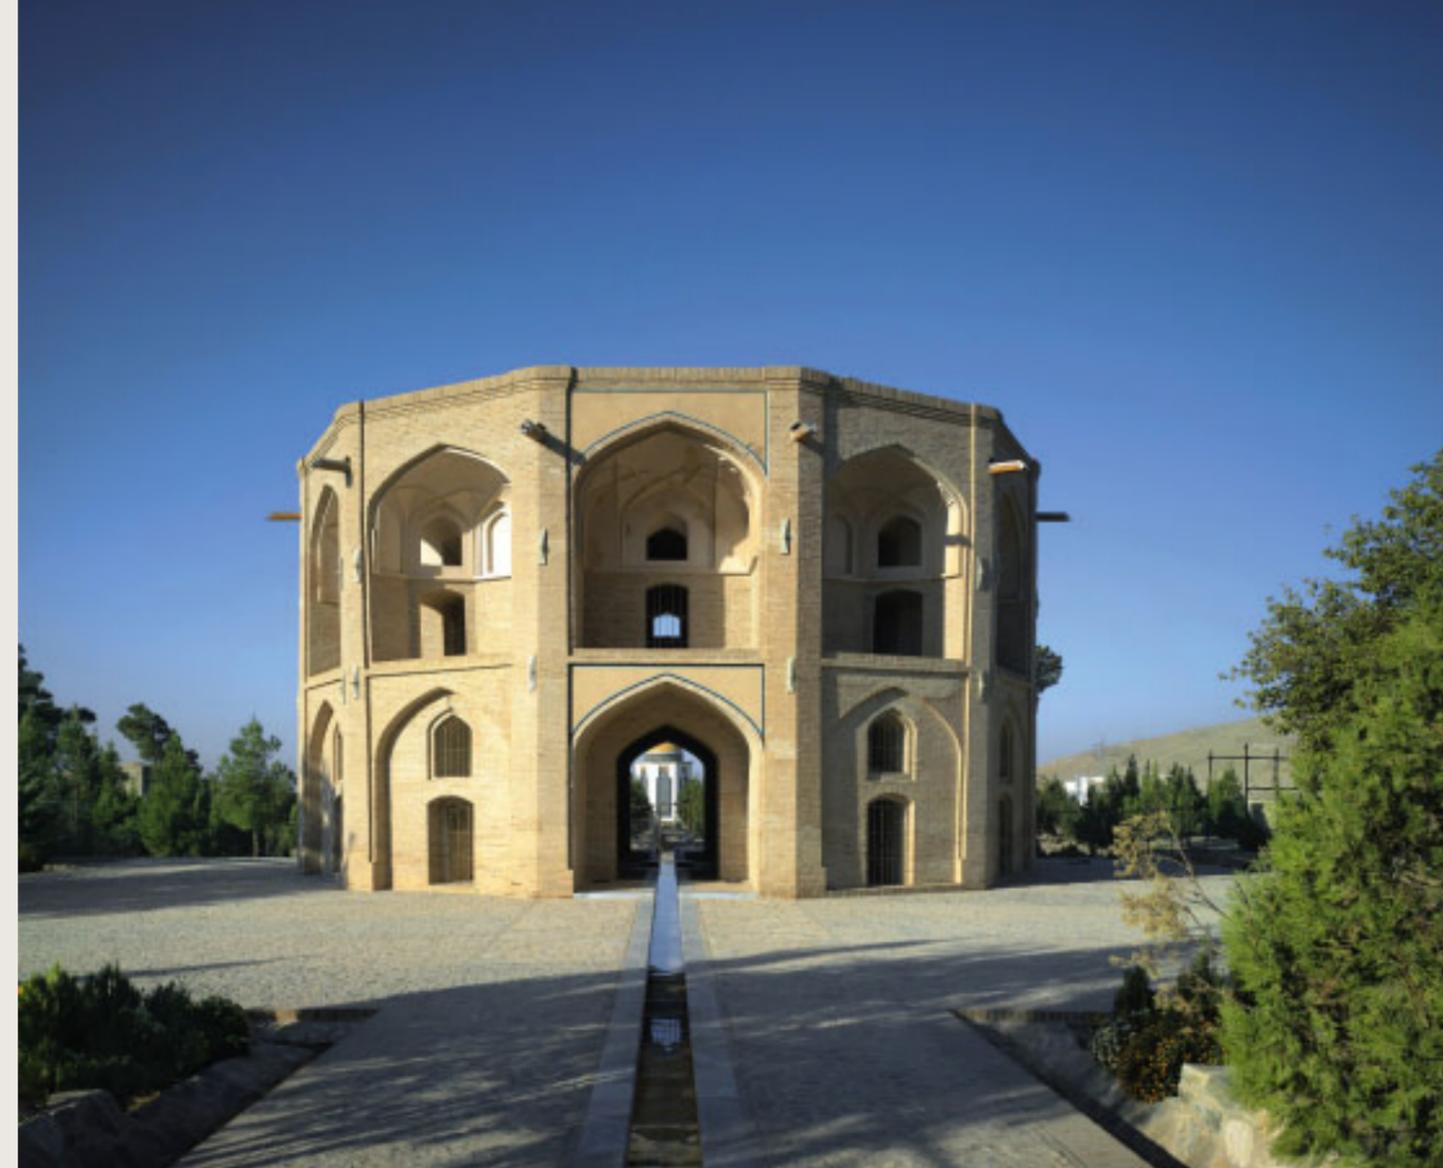
Opposite page:  
The restored Namakdan Pavilion once again represents the structure its Timurid builders had intended and work is now being undertaken on landscaping a formal garden around it.

Following a detailed survey of the existing structure, restoration work on the Namakdan Pavilion, which dates from the fifteenth century, was initiated in late 2005. The two-storey, twelve-sided brick structure, built around an octagonal central space, had been much altered and was found to be in a poor state of repair. Following repairs to the ribbed dome, a modern intermediate floor was removed, restoring the original double-height central space, where traces were found of a water pool and channel, which were subsequently reconstructed. In order to ensure the stability of the brick superstructure, a system of horizontal steel reinforcement was introduced at several levels of the Pavilion, in some places using the apertures that had originally housed timber ties. During the course of removal of modern plaster, traces of glazed-tile decoration were found on two external elevations, and have been restored. After more than four years of painstaking conservation, the Namakdan Pavilion again resembles the structure that its Timurid builders intended, while work continues on landscaping the surrounding area.
