Djingareyber Mosque

TIMBUKTU, MALI

Project Scope/Objectives

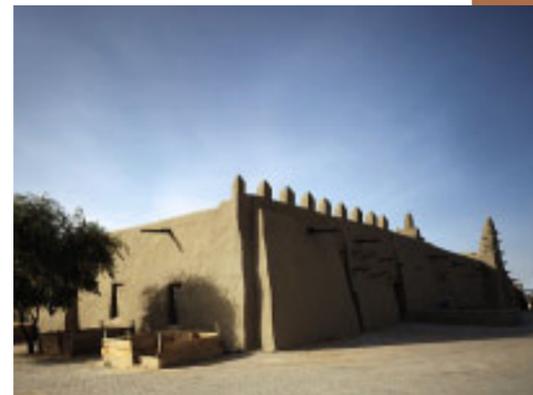
The corner elevation of Djingareyber Mosque.

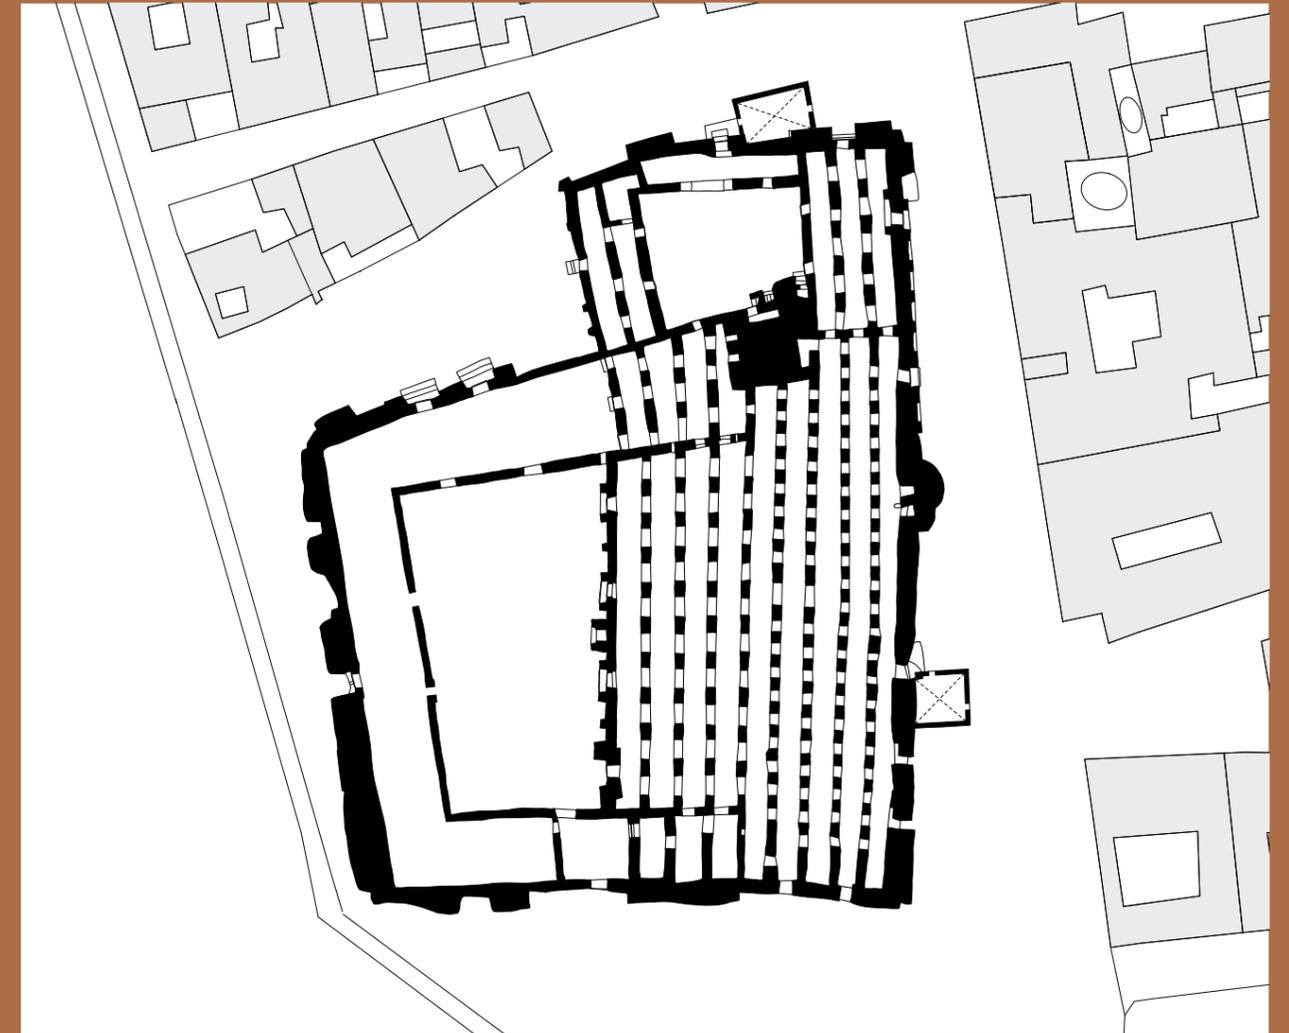
N
▲ |—————| 10m

Opposite page:
The east elevation and longitudinal section of the Mosque.

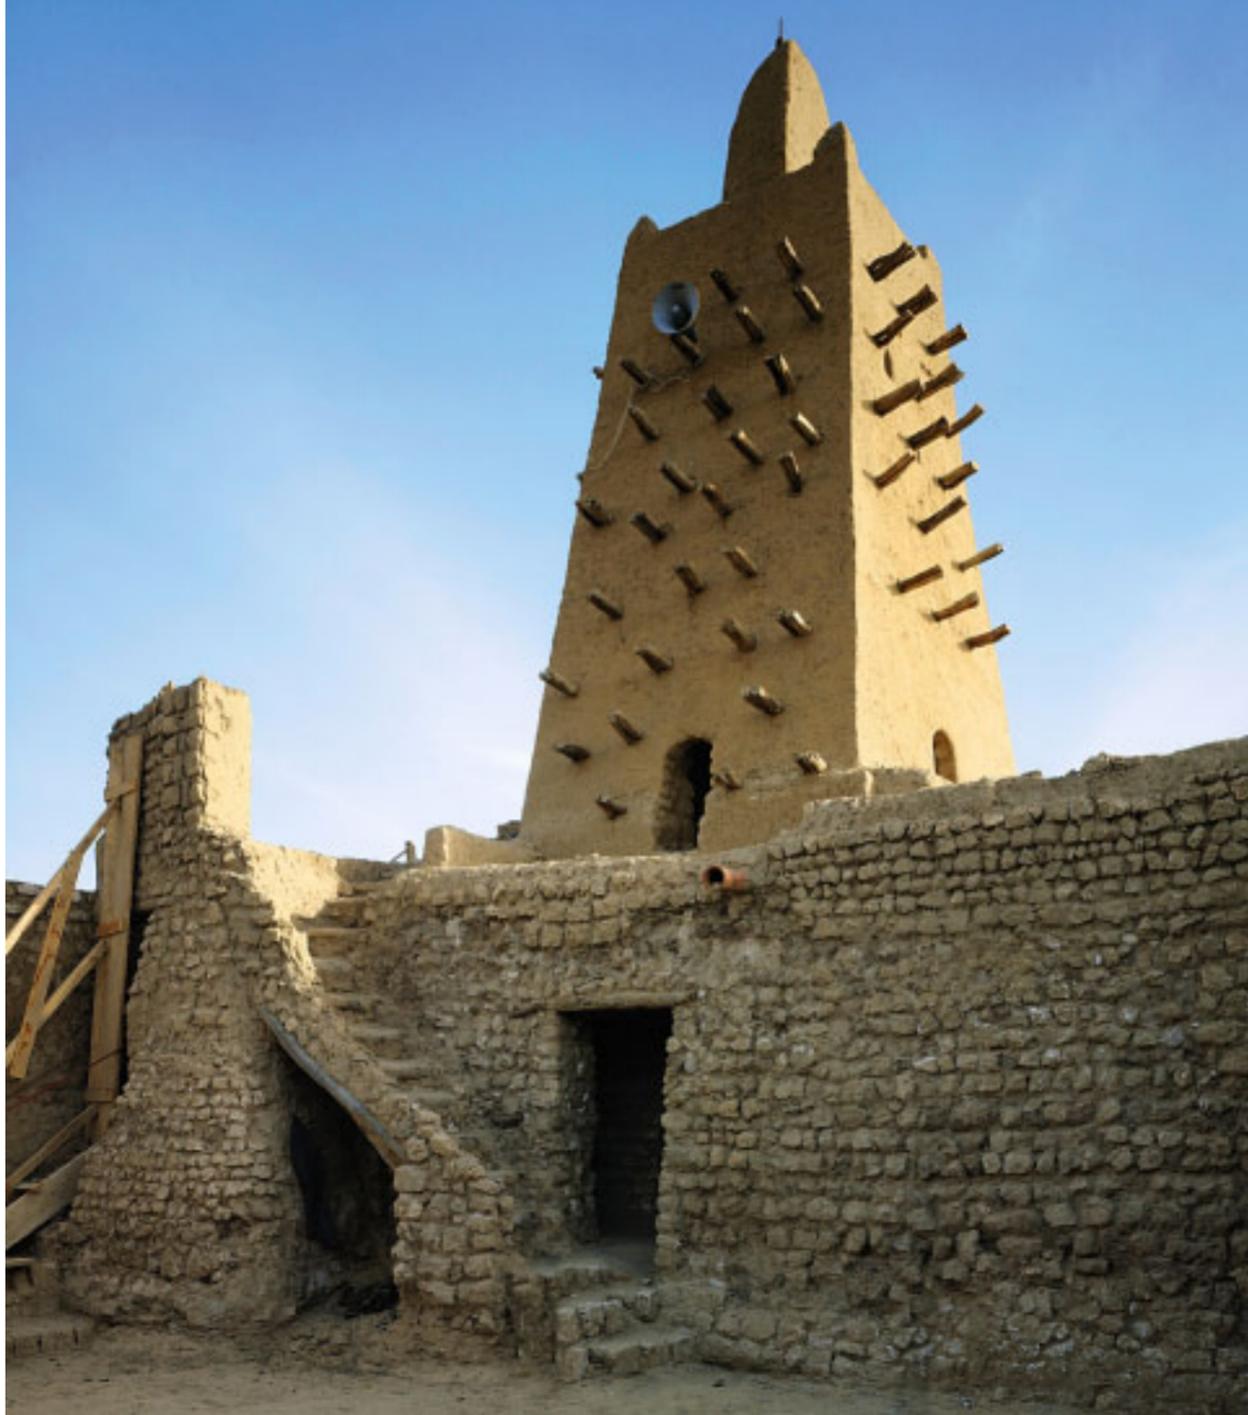
A minaret of Djingareyber Mosque after restoration. The Mosque was built in mud and tuff stone, evident in the foreground of the shot.
