The Aga Khan Historic Cities Programme

STRATEGIES FOR
URBAN REGENERATION

EARTHEN ARCHITECTURE PROGRAMME

MALI

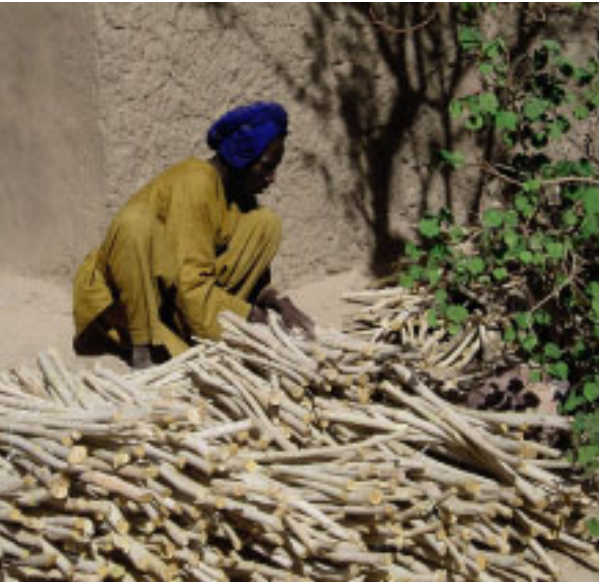
Left, at Djingareyber Mosque *golettes* (pieces of wood placed between beams) are used for the roof of the Mosque.

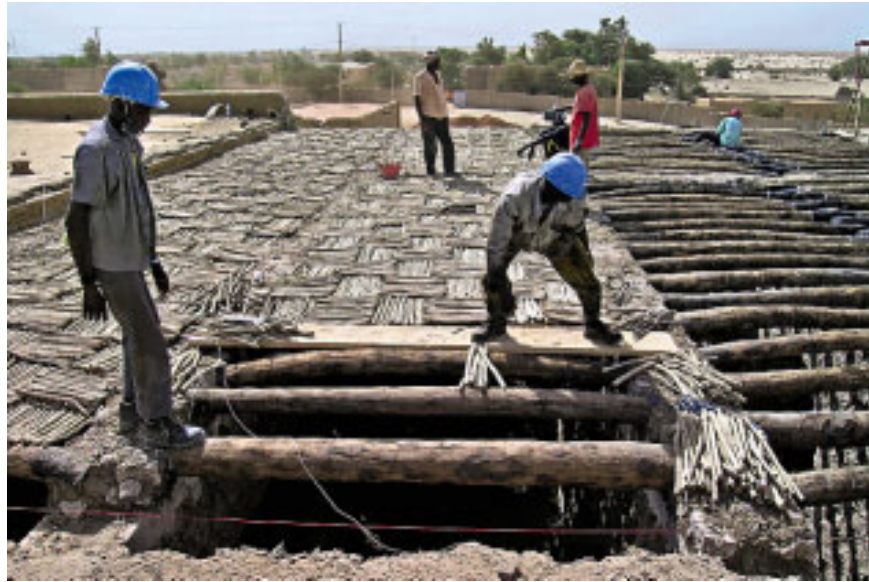
Right, the *golettes* are being put into place.

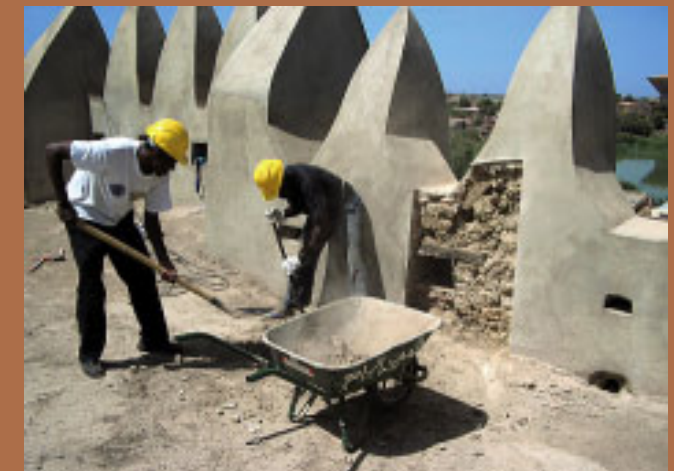
The Mosque elevation showing the cement render that had to be removed.

The first phase of the work on this important landmark focused on repairing the roof and stabilizing the upper part of the building, which had been damaged by the use of cement in 1978. Because cement adds additional loads to the structure and integrates poorly with the traditional materials, earthen buildings clad with cement often suffer water infiltration and structural damage over time – a process which, in this case, had weakened and seriously compromised the stability of the monument. Fissures in the cement cladding had been infiltrated by water, which had led to structural damage.

Starting in 2004, local masons worked to remove the cement layer and replace damaged areas with traditional mortar and bricks, which are made by mixing earth with rice. Roofing timbers and other structural and aesthetic elements made of wood were replaced. Then a fresh application of the traditional earthen plaster returned the building to its historic condition. To ensure that the Mosque remains structurally sound and that it is properly maintained well into the future, training courses were offered in traditional building crafts – skills that risked being forgotten in the region – and contemporary conservation methods

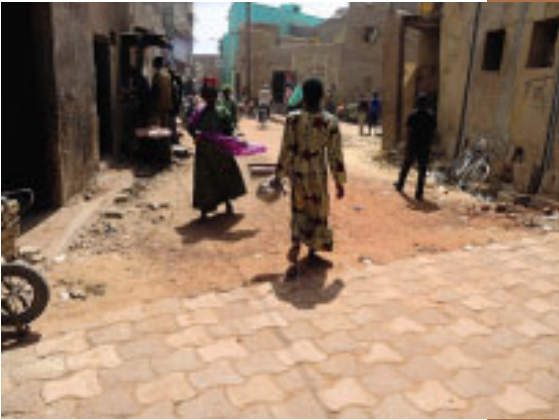
The streets are being paved with bricks made from recycled local refuse, such as plastic bags.

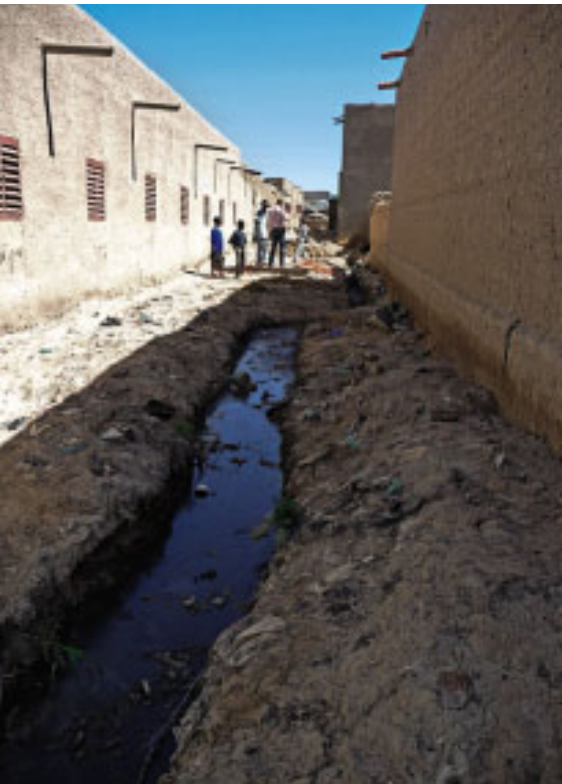
Open sewers and poor drainage were serious health hazards in Komoguel.

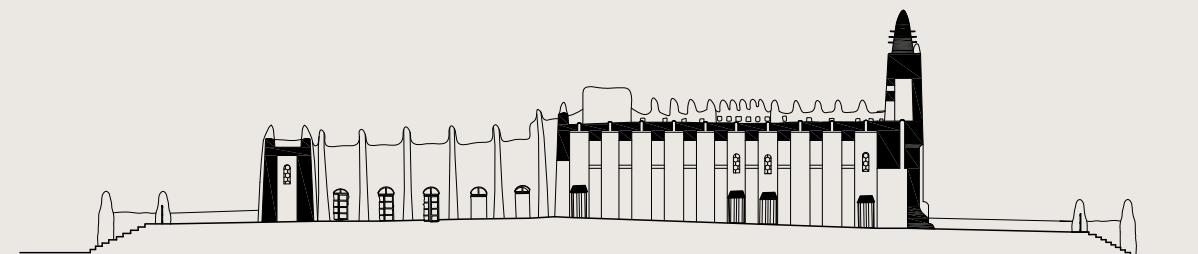
Above, the north-south section of the Great Mosque in Djenné showing the main prayer hall and the courtyard.

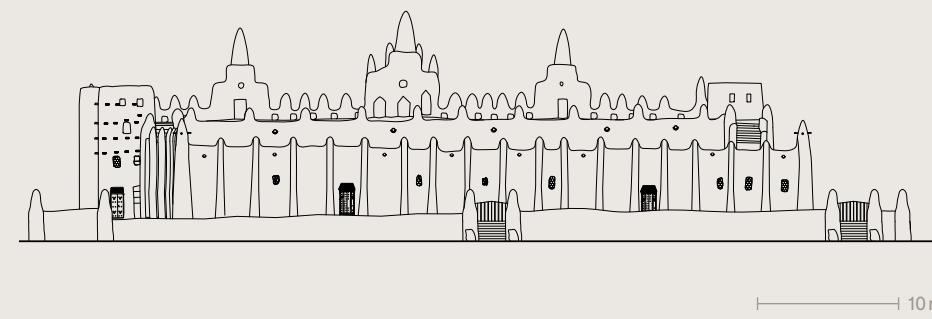
Below: the west elevation of the Mosque.

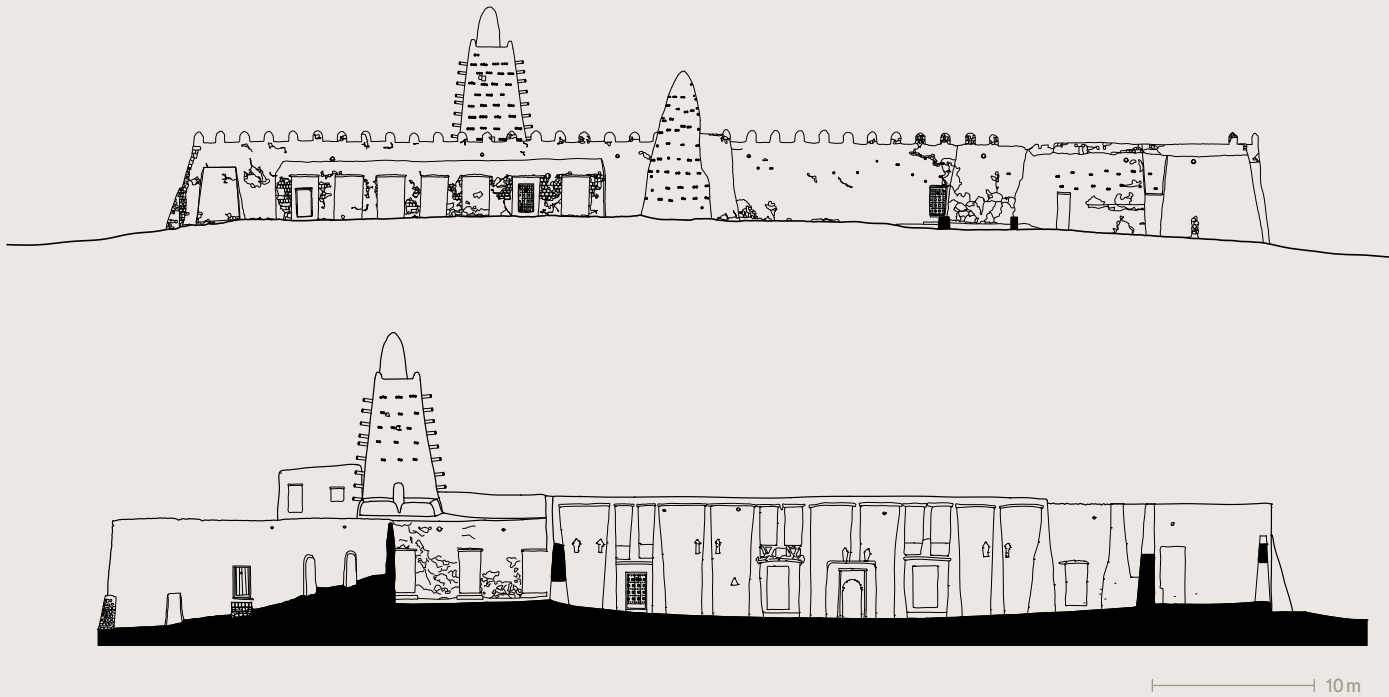
Opposite page:
The east elevation and longitudinal section of the Mosque.
