## BEYOND THE APPEARANCE OF HERITAGE: Reconstruction of Historic Areas Affected by Earthquakes in Chile

### Abstract

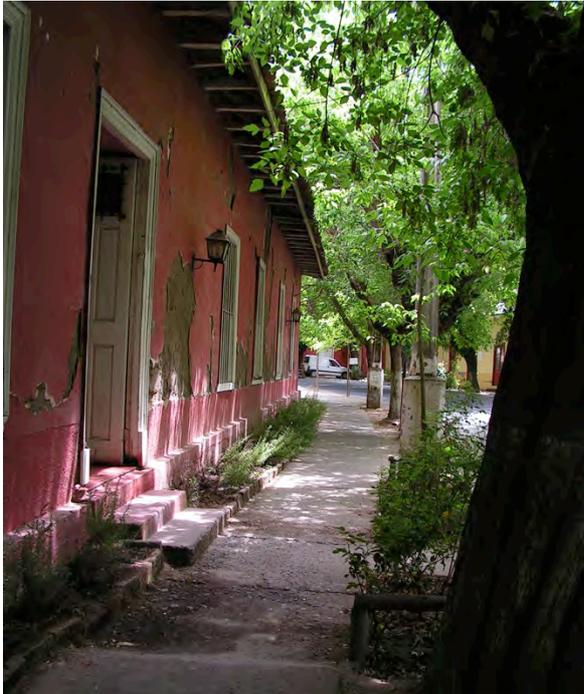
Figure 1: Continuous façade in *Zúñiga*, Chile, 2011  
(Source: Author).

This study looks beyond the widely addressed topic of monumental heritage, to consider housing in heritage settlements. In Chile, dwellings in historic areas are characterised as sustainable answers to climate and environmental conditions, using vernacular building techniques. They are economically efficient in their use of resources, giving place to their inhabitants' way of living and embodying their cultural expressions. They comprise a representative set of anonymous constructions, which are generally related to public spaces through porticos and continuous facades (Fig. 1 & 2). Some authors have described them as a:

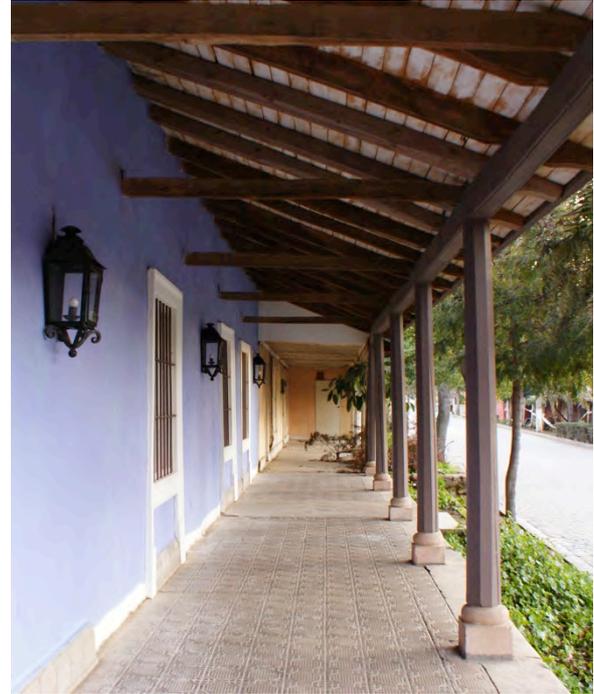
Figure 2: Use of porticos in *Lolol*, Chile, 2011

Certain elements, such as porticos are being maintained as architectonic elements in the new houses. One could argue that there is no need to replicate porticos if the new house is rebuilt with contemporary building techniques, as the function of protecting *adobe* from the rain and its structural stabilization is no longer necessary. However, these elements are seen as representative of this kind of heritage and are consequently repeated in reconstruction projects regardless of the structural system they have, which is very popular with inhabitants if they used to have them. Indeed, from the interviews taken in January 2013 almost three years after the earthquake, all interviewed inhabitants are in favour of new houses that include porticos, because they think they improve the appearance of the dwellings and help to preserve the tradition of the place. Besides, the porticos also offer a shaded intermediate situation connected to the public space, used by people during the warm seasons.

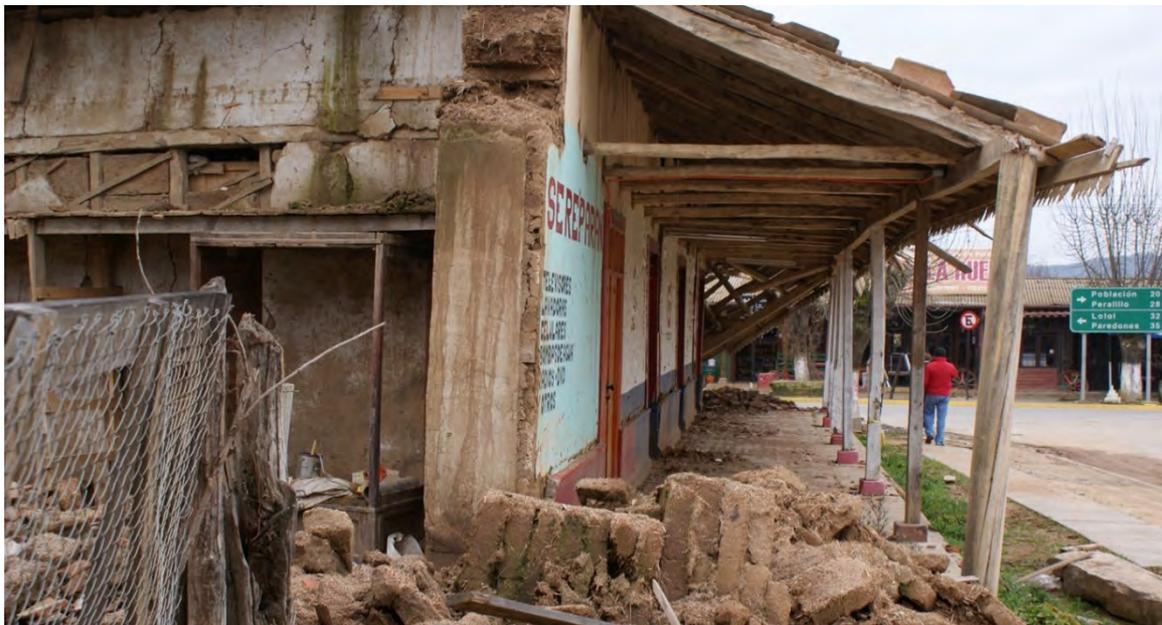
Figure 4: Dwelling severely affected by the 2010 Maule earthquake in Chile. *Pumanque*, Chile. April 2010 (Source: Author).

*Pumanque* (Fig. 4) and *Peralillo*, last of which was particularly damaged by indiscriminate demolition in the aftermath.

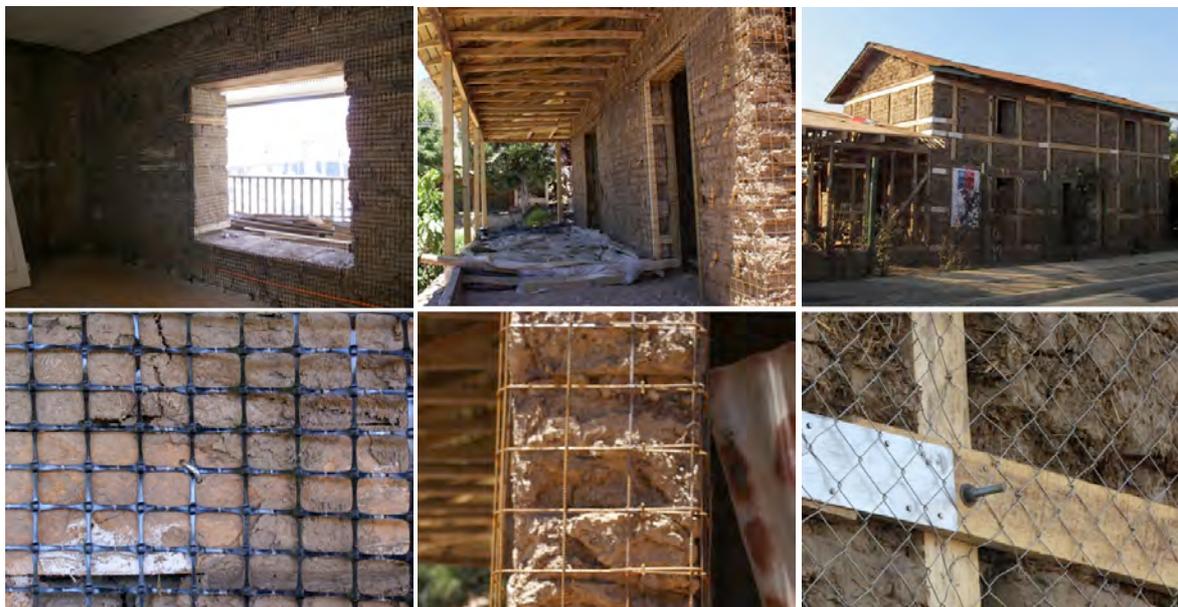
Figure 5: Reinforcements techniques. From left to right: a) *geomesh* used in *Almahue* (Source: author); b) metallic mesh in *Lolol* (Source: author); and c) timber reinforcements in *Olivar* (Source: F. Pérez, MINVU).

Structural meshes and timber reinforcements are currently used to repair affected houses. After uncovering the plaster in adobe walls and taking out doors and windows, the walls are repaired with clay mortar and reinforced using *geomesh* (plastic structural mesh) (Fig. 5a), which add flexibility to the adobe walls (Torrealva, 2009). With the same principle, walls are being reinforced using metallic structural mesh (Fig. 5b). Both systems should be applied in each side of the wall and then connected with steel or timber pieces, and the mesh should be completely covered by clay plaster in order to reach its full resistive capacity. Other method involves carving the walls to insert timber reinforcements in both vertical and horizontal ways, which should be connected by steel pieces, after which a mesh is applied (Fig.5c). Roofing and ceiling structure is reinforced with timber elements when needed, although it is mostly recycled from before. Tiles are usually installed using traditional weaving techniques, which are safer during seismic events as they would not fall and injure people. In some cases, a concrete beam is also installed in the interior of the dwelling, added to the inner part of the wall in order to reinforce the foundations.

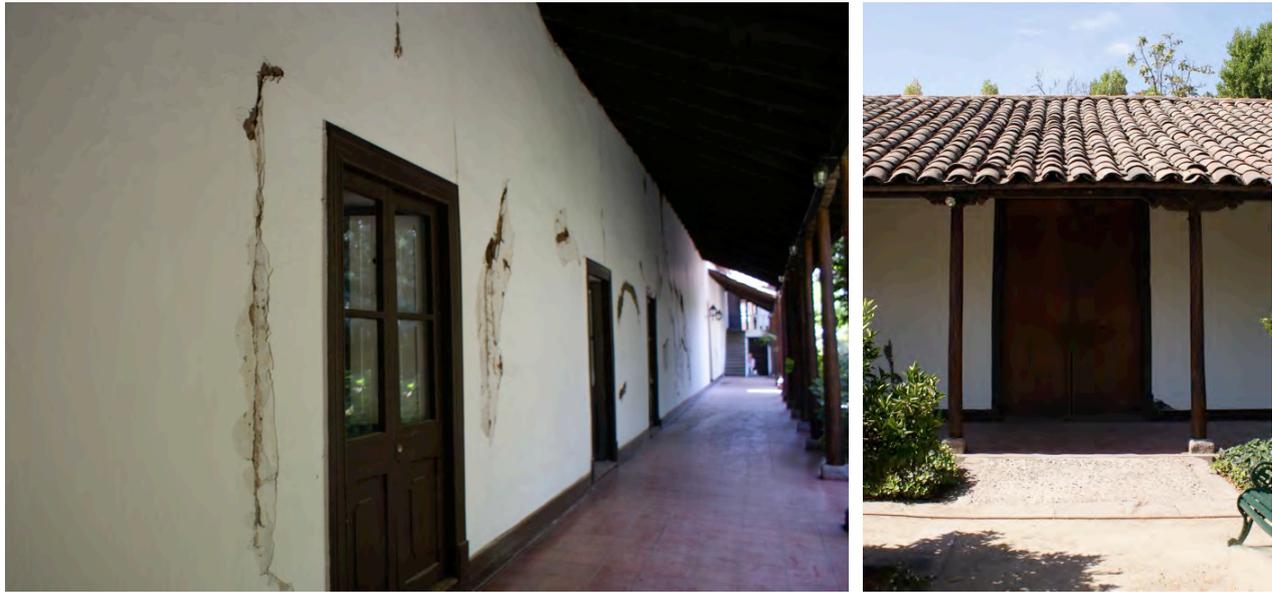
Figure 6 & 7: *Casona Lo Contador*, currently used as the School of Architecture of the Pontifical Catholic University of Chile. Photos taken one day after the 2010 earthquake, in which only superficial cracks can be seen.  
 (Source: Author).

Yet, it is important to remark that most of the historic buildings would have experienced less damage if they had been correctly retrofitted and maintained throughout time. For example, there are several monumental *adobe* buildings, which resisted structural damage, such as *San Pedro de Alcántara's* Church, retrofitted just before the 2010 earthquake, or the *Casona Lo Contador*, a 17<sup>th</sup> Century building in good condition as it has been well maintained over time (Fig. 6 & 7).

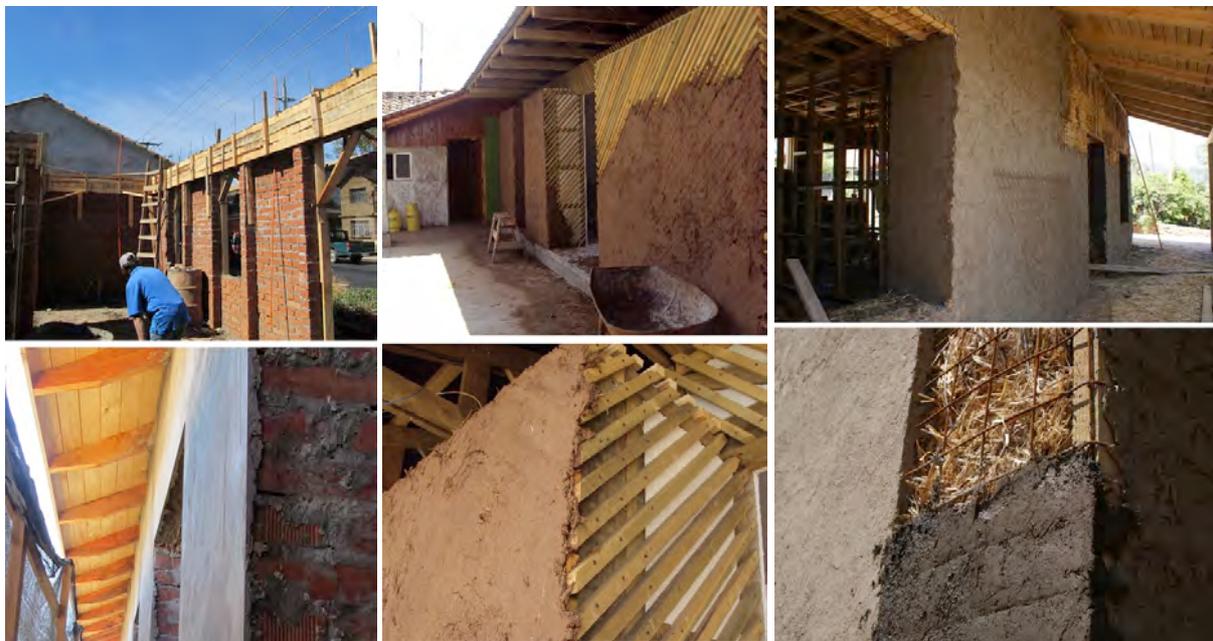
Figure 8: Building techniques used in housing reconstruction for heritage areas. From left to right: a) reinforced brick masonry; b) timber structure with clay plaster; and c) timber structure with straw bales in the façade and wood panels with clay in the rest of the walls. (Source: Author).

For new houses in the reconstruction process, it is possible to group applied building techniques into three categories. The first corresponds to reinforced brick masonry with timber roofing structure, covered with clay tiles, in some cases recycled and in some cases using new industrialised tiles. This is one of the most common building techniques used in general in Chile in new dwellings (Fig. 8a).

The second includes mixed techniques that incorporate earth and clay in the walls or as plaster. Some designers include the use of clay as a raw material as a way to address the value of building techniques in the previous dwellings, yet they do not use it in a structural or traditional way as the *adobe* construction. For example, earthen-made plasters on a timber structure filled with polystyrene as isolation are commonly used in reconstruction projects after the 2010 earthquake. However, they are not efficient from a thermal perspective in the central-southern area of Chile if they are not within thick walls necessary for isolation purposes. Whereas thermal

mass of adobe is perfect for the desert climate of the northern area, it is not useful as such in the central-southern zone, yet as insulation because of its thick walls. Thus, it is not enough for the required isolation of that Mediterranean climate to use only 10 cm. of isolation and clay within the wall structure. Moreover, some of those projects include shaping the walls in such a way that they would be recreating the thickness of the old adobe walls (Fig. 8b).

Finally, the third is based on a timber frame structure with two types of walls. The public façade of the house is filled with straw bales, giving good insulating properties. Their local availability and low cost also make them a sustainable alternative. However, as the other exterior walls, made of timber and clay, are thinner (10 cm), the insulating properties of the straw bales are not as effective (Fig. 8c).

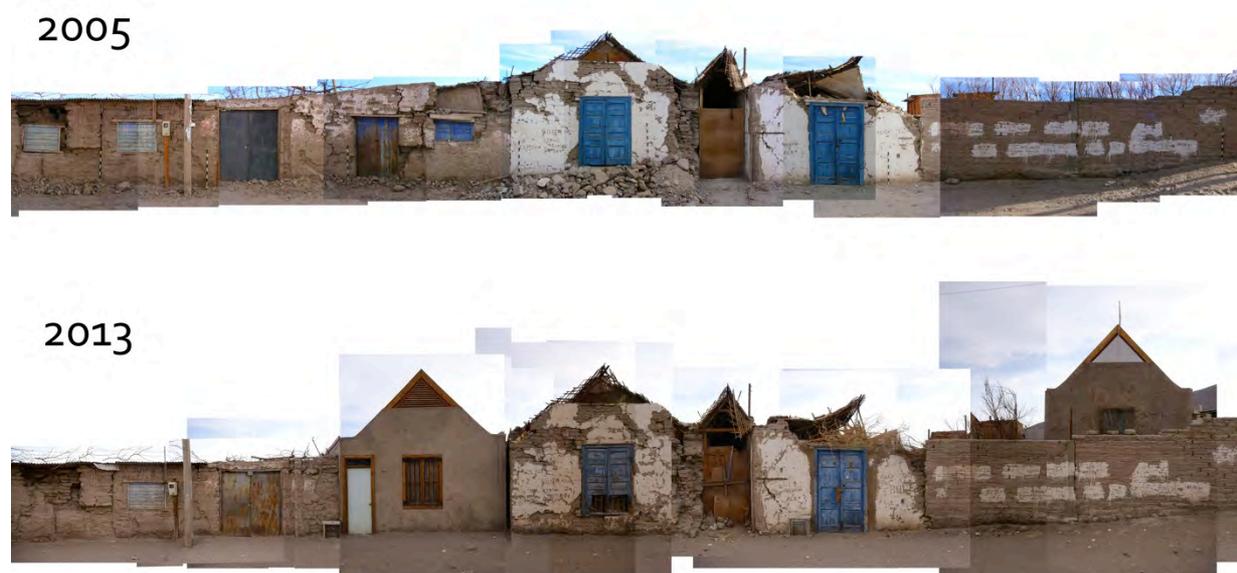
Figure 9: San Lorenzo de Tarapacá before and after reconstruction. Plane roofs were predominant before the reconstruction, which changed when gable-roofing dwellings were repeated many times.  
 (Source: Author).

This vision is not only for heritage reconstruction, but it is the commonly used approach in historic areas. Indeed, it has been used after other earthquakes in the country. For example, in San Lorenzo de Tarapacá, heritage area affected by the 2005 earthquake measuring 7.9 on the Richter scale, the governmental programme considered three models of 'heritage' dwellings, especially designed for that *Typical Zone*. They recreated the formal features of just three 'typical' types of dwellings existent in the village. Only two types were built, and one with a pronounced gable roof, repeated more times. This type of dwelling has increased with the reconstruction from only 6% of the total dwellings in the village before the earthquake to approximately 40%. These new houses have a special shape in the connection between the wall and the roof, which again intends to recreate the thickness of the old *adobe* walls and, ironically causes leaks to the interior of the dwelling when raining (Fig. 9).

These houses in Tarapacá are an example of what can happen if designers strive for an appearance of heritage rather than for a more sustainable construction. The building technique used, steel structure and concrete blocks as filling, with a plaster that includes 50% of clay, it is not appropriate for the dry/arid climate of the village, as thermal mass is needed to store the heat of the day and liberate it in the night when lowest temperatures are usually experienced, which is

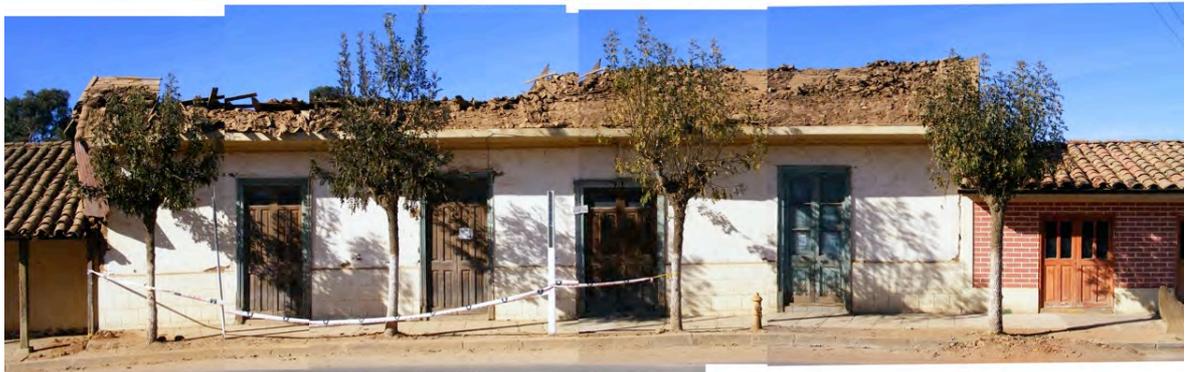
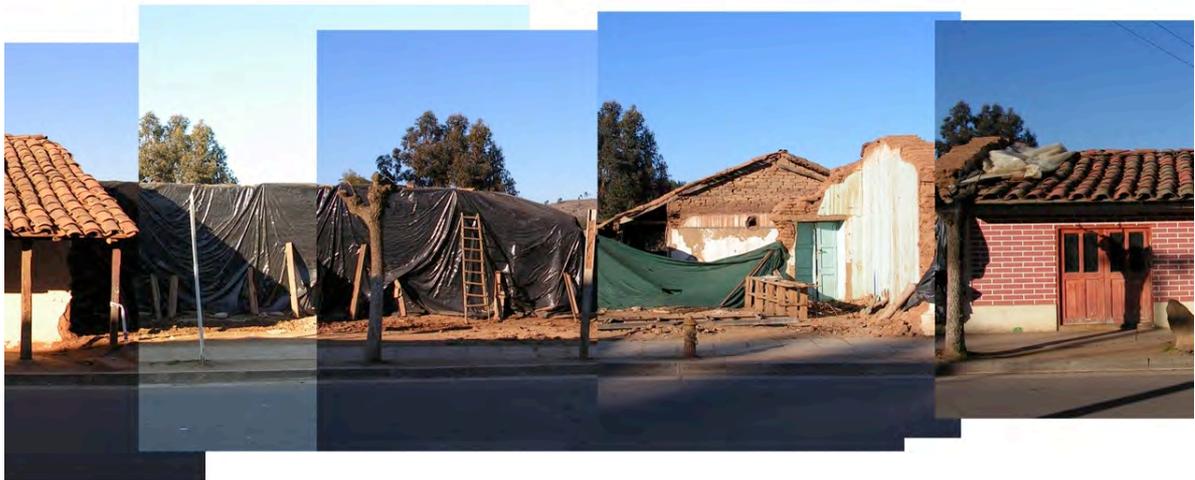
Figure 10: (above) Dwelling in Paredones after the 2010 earthquake. Above: before demolition.  
(Source: Muñoz, Alejandra).

Figure 11: (below): after demolition. The image above became the only record available of the dwelling before its demolition, thus the only input available for the design besides owner's experience.  
(Source: Author).

In such context, the role of the record of buildings before (and after) earthquakes and before demolition becomes fundamental. In post-earthquake situations, technical assessment for historic buildings and dwellings is usually done in a second stage, when several things have already changed, not only because of the earthquake but also because of the first emergency actions. This has also been the author's experience with the case studies following the 2005 and 2010 earthquakes. Therefore, the perception of affected historic areas is blurred with the destruction. Sometimes the only possibility to have an idea of the damage level is the existence of previous records that, although partial, can help professionals and researchers to understand the impact of the earthquake (Fig. 10 & 11).

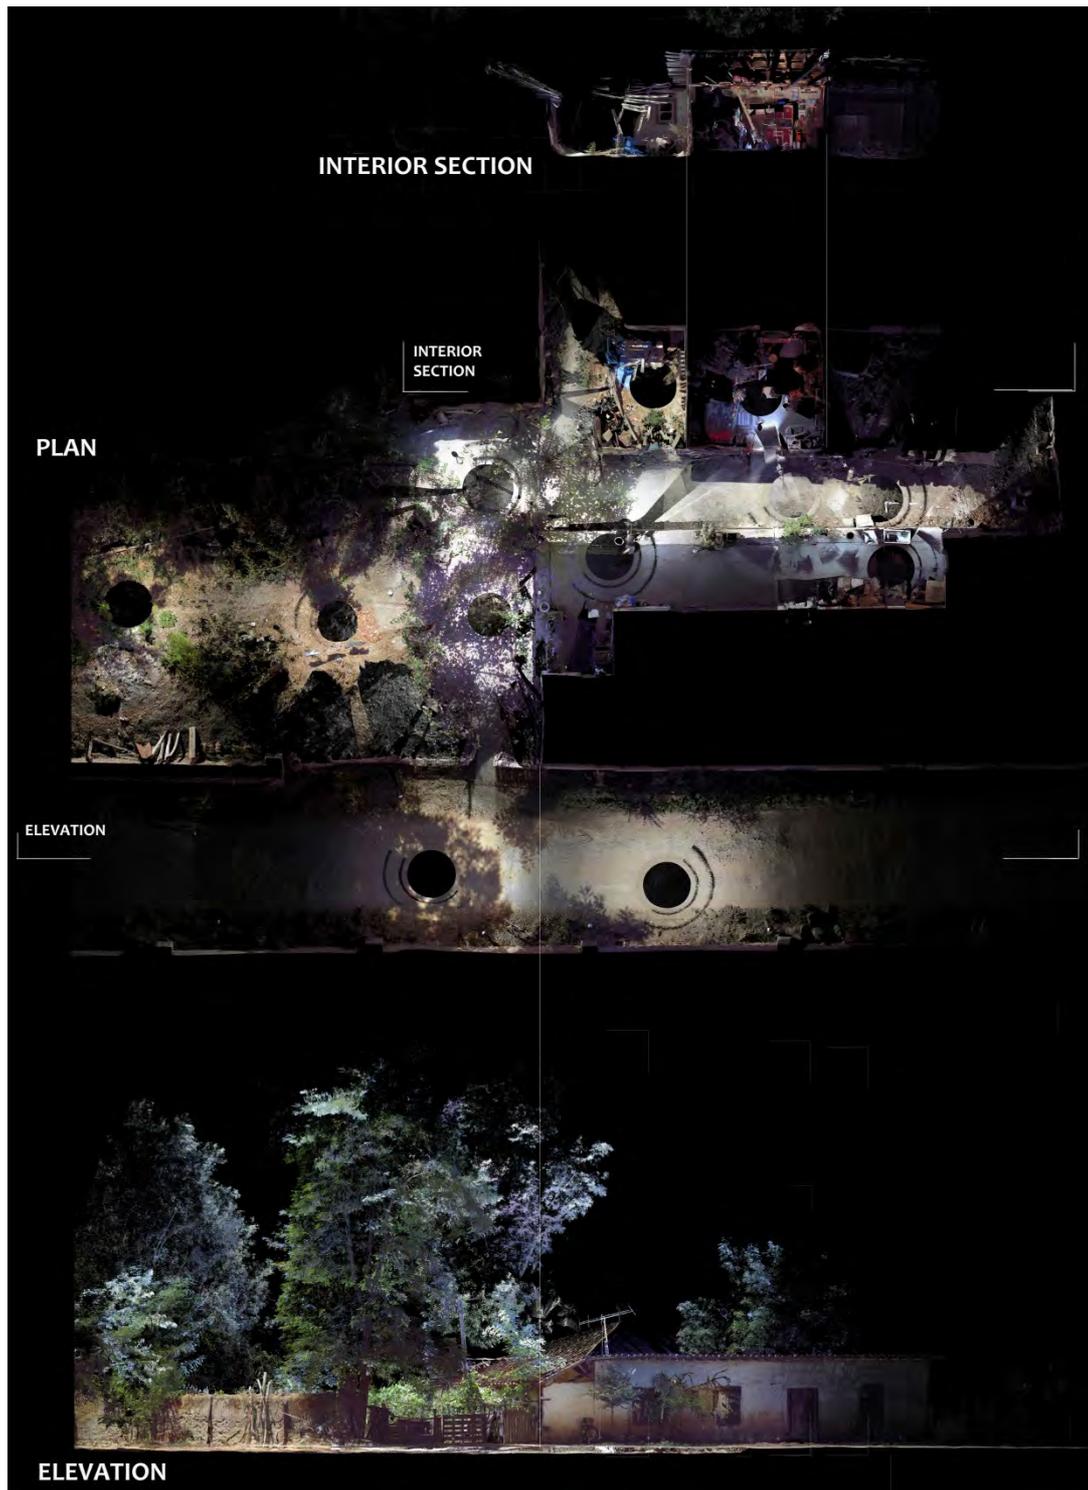
Figure 12: Section, plan and elevation of a dwelling in *Zúñiga* made using 3D digital model obtained through 3D scanning. The black circles show where the scan was positioned on site to survey (Source: Author).

3D scanning can provide a rigorous method of building information to be applied in the reconstruction projects, in order to avoid the interpretation or the creation of *average heritage* projects, as aforementioned. Related to this, it is important to mention that one of the issues that have made reconstruction of heritage areas such a slow process is the need for a survey of existing conditions in order to develop accurate designs of reparation and reconstruction of

dwelling, which usually takes a long time as is being done with traditional representation methods, such as hand and digital drawing, and photographic record. For example, to survey a dwelling with its interior, took only two hours on site (Fig 12).
