BLUEGRASS HOME INSPECTIONS LLC

BHI RESIDENTIAL INSPECTION

432 Maple Ave
Owensboro, KY 42301

05/08/2025

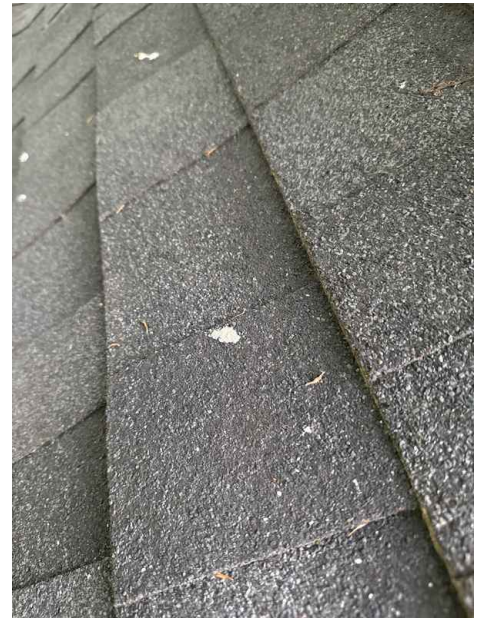
Coverings: Material

Asphalt, Fiberglass

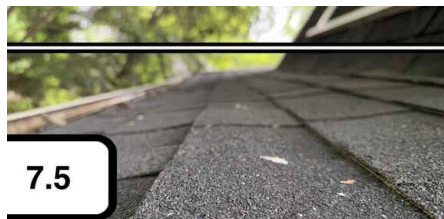
Coverings: Roof Pitch

Roof pitch varies. See picture(s) below.

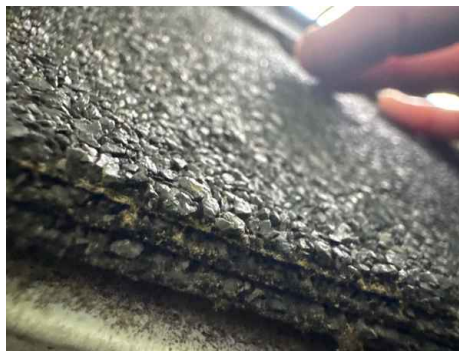
Coverings: Underlayment

Underlayment observed in one or more locations.

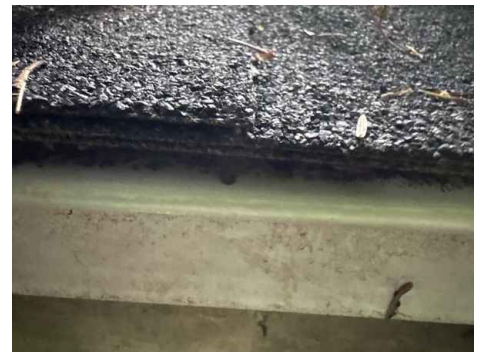
Coverings: Layers

1 Layer

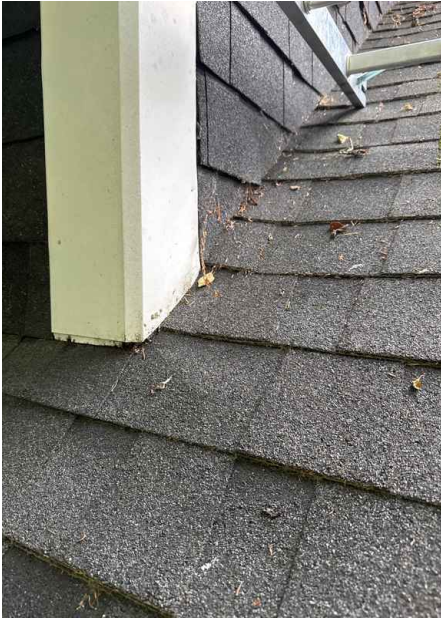
Coverings: Type of Valley

Open Valley

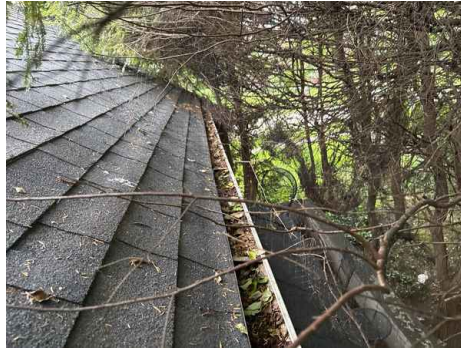
Roof Drainage Systems: Gutter

Material

Aluminum

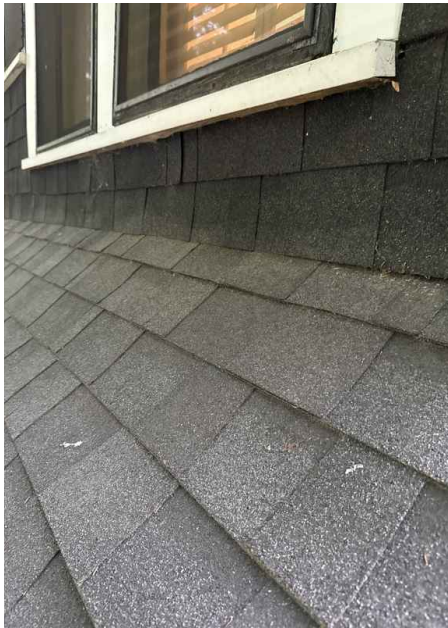
Coverings: Age

1-8 years old

Architectural shingles have a life expectancy of 20-25 years.

Three Tab shingles have a life expectancy of 15-20 years.

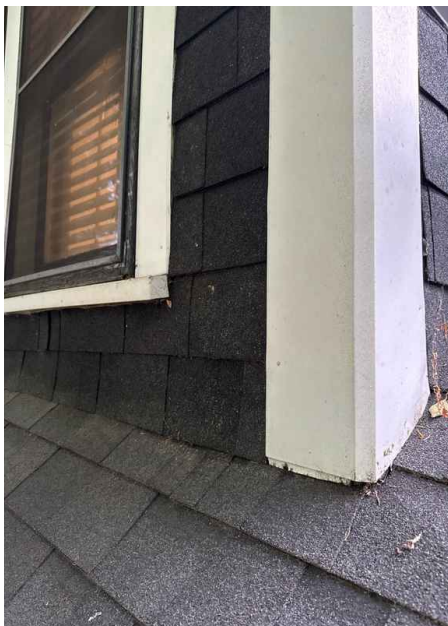
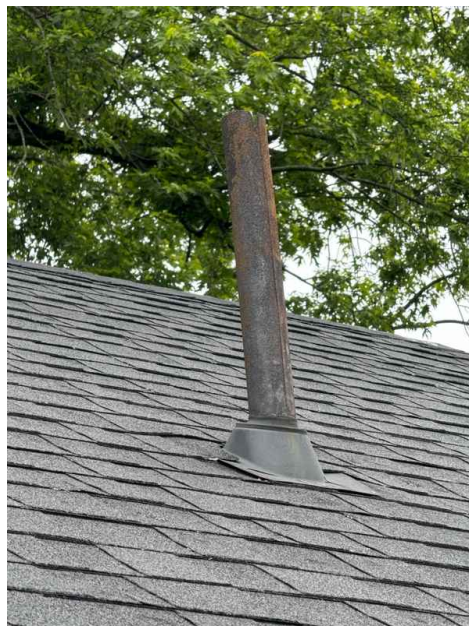
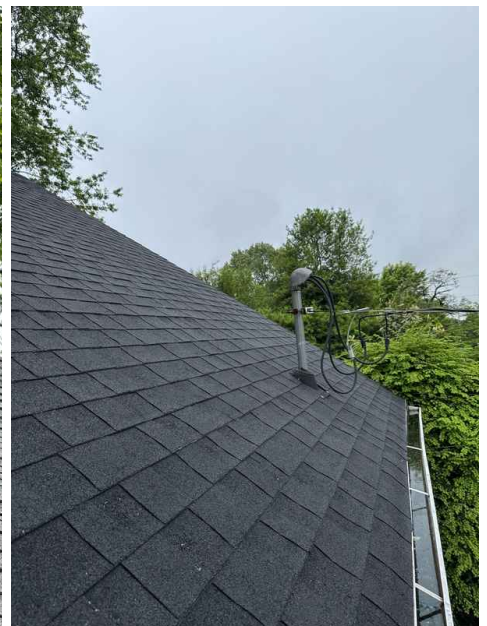
Flashings: Material

Aluminum, Silicone Sealant, Tar Sealant, Counter Flashing, Step Flashing, Metal, Cannot Confirm, Plastic

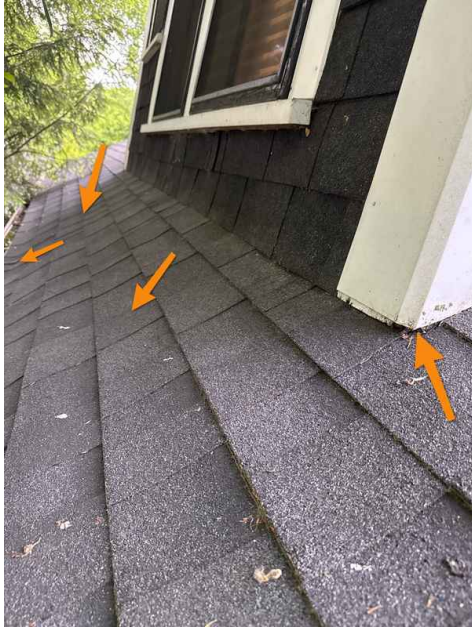
East

Evidence of water intrusion noted during the inspection. Recommend further evaluation by a qualified contractor.

Contact a qualified roofing professional.

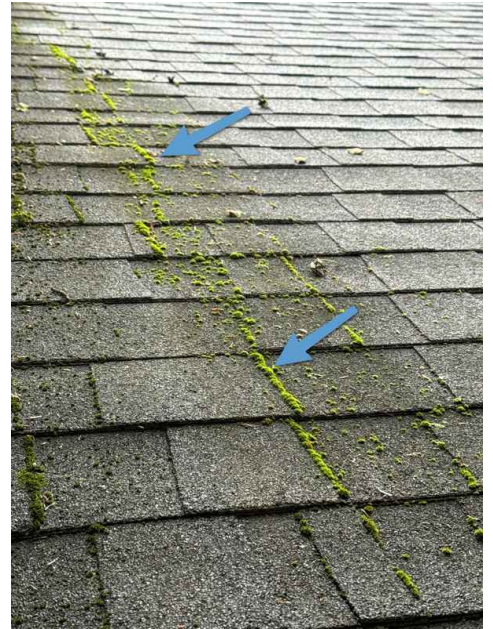
East

Moss/Mildew observed on roof during inspection. This is most commonly observed on the north or shaded side of the structure. One option is to use noninvasive cleaners to remove moss/mildew. Recommend further evaluation by qualified contractor.

Contact a qualified professional.

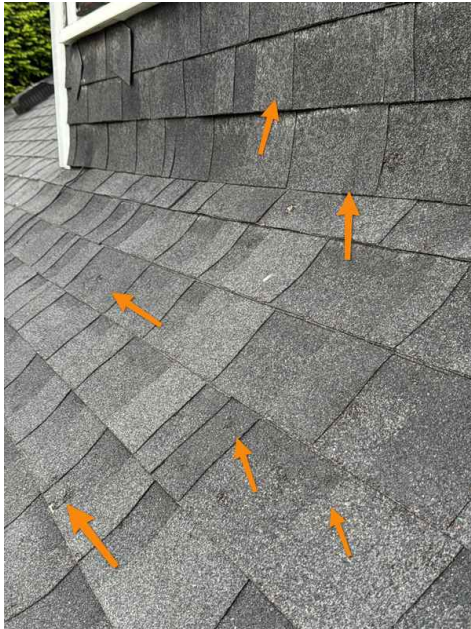
West

HAIL DAMAGE

Evidence of hail damage observed during the inspection. Recommend further evaluation by qualified roofing contractor.

Contact a qualified professional.

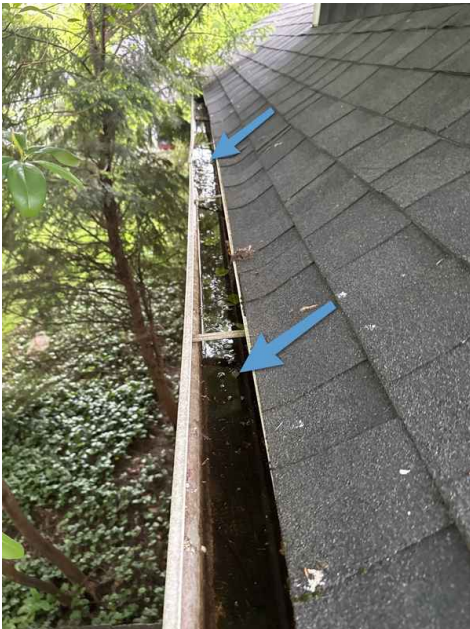
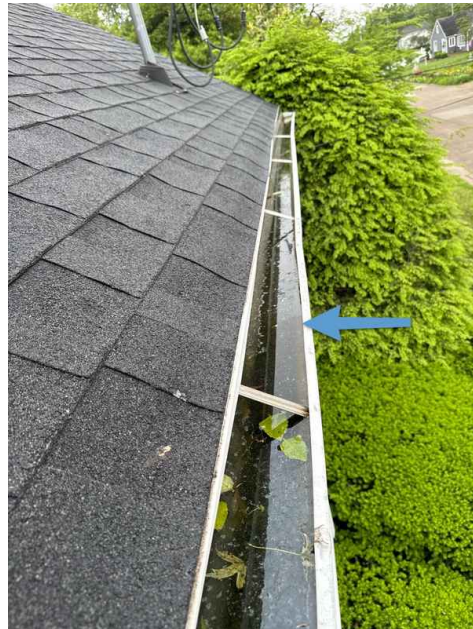
Debris accumulation observed in the gutters during the inspection. One option is to clean gutters to facilitate water flow. Recommend further evaluation by a qualified contractor.

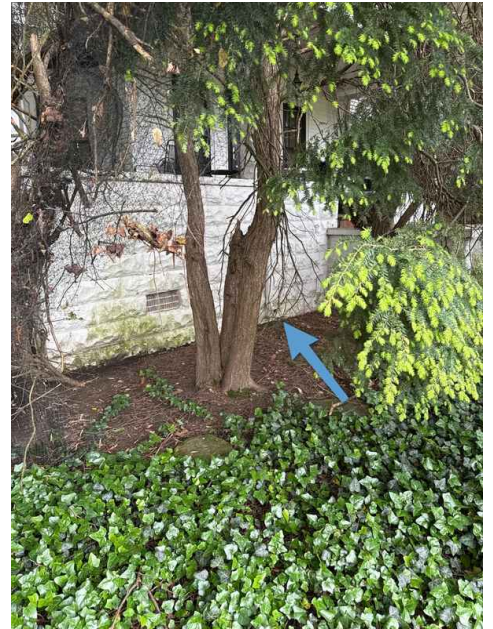
DOWNSPOUTS DRAIN NEAR STRUCTURE

One or more downspouts drain near the structure's foundation. This can result in excessive moisture in the soil at the foundation. One option is to adjust downspout extensions to drain at least 6 feet from the foundation. Recommend further evaluation by a qualified grading contractor.

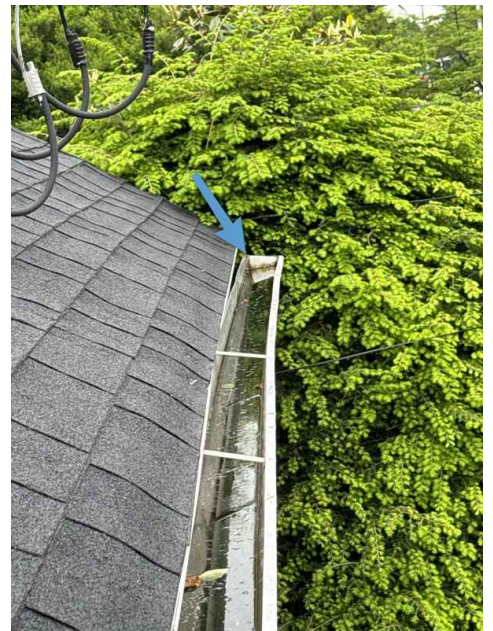
Southwest

GUTTER DAMAGED

Gutter damage noted during inspection. This can result in over capacity and excessive moisture in the soil at the foundation, which can lead to foundation/structural movement. Recommend a qualified contractor evaluate and repair.

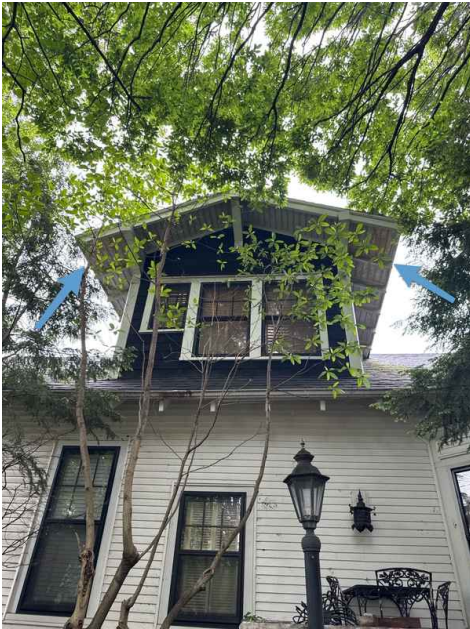
GUTTERS MISSING

There are gutters missing on the structure. Gutters are recommended because they collect rain water from the roof and direct it away from the building. Recommend further evaluation by a qualified contractor.

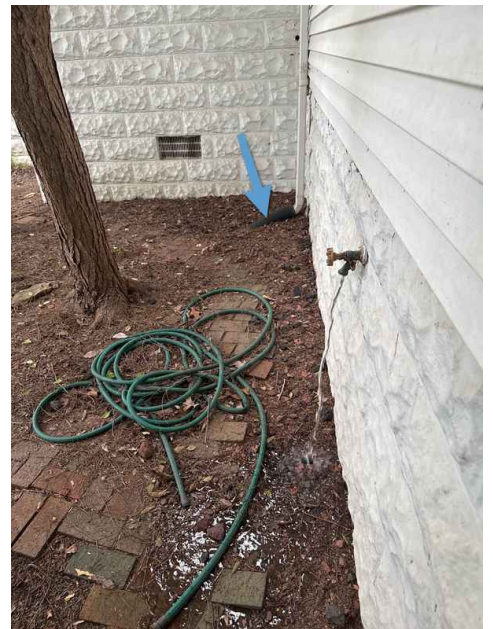
UNABLE TO CONFIRM DRAINAGE OUTLET

Unable to confirm drainage outlet at time of inspection. One option is to monitor during the next rain event. Recommend further evaluation by a qualified contractor.

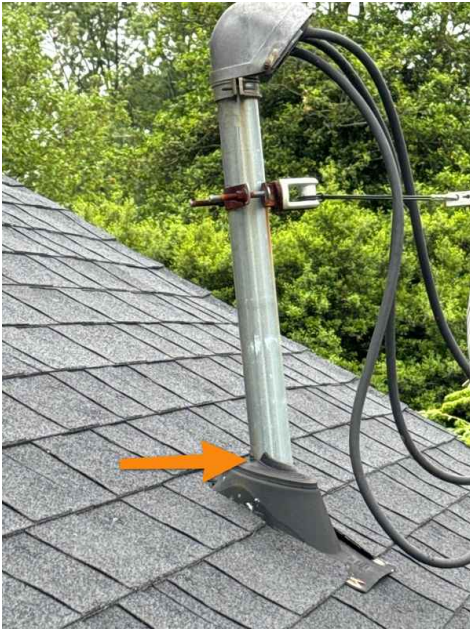
Southwest

LOOSE/SEPARATED

Loose/Separated flashings observed during the inspection. One option is to ensure flashings are properly mounted, sealed, and secured to prevent moisture intrusion. Recommend further evaluation by a qualified roofing contractor.

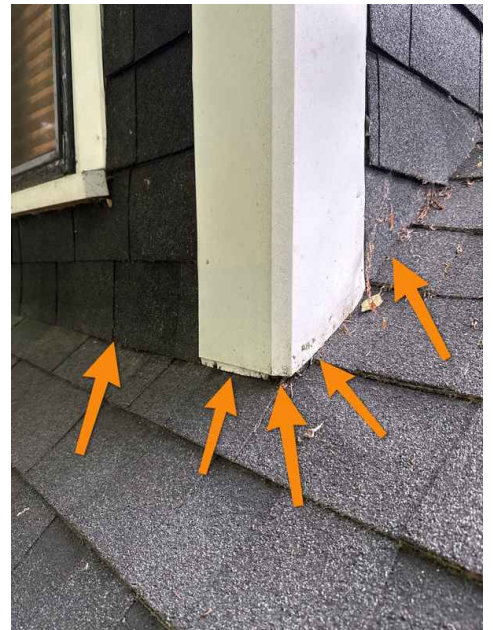
East

MISSING

Flashings were missing at time of inspection. Flashings provide protection against moisture intrusion. Recommend a qualified roofing contractor evaluate and remedy.

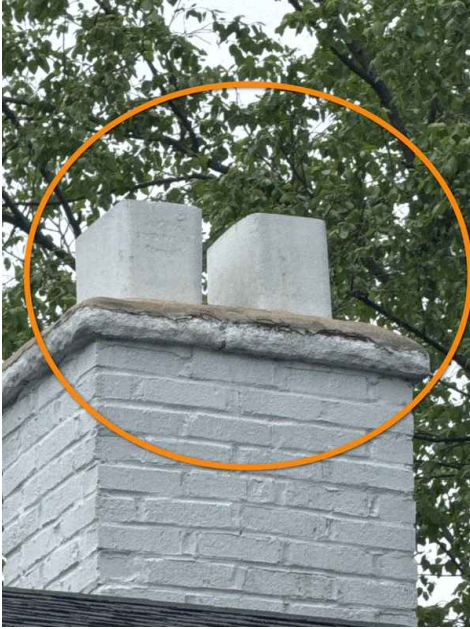
West

CHIMNEY CAP MISSING

No chimney cap was observed. This can protect from moisture intrusion and protect the chimney. Recommend a qualified roofer or chimney expert install.

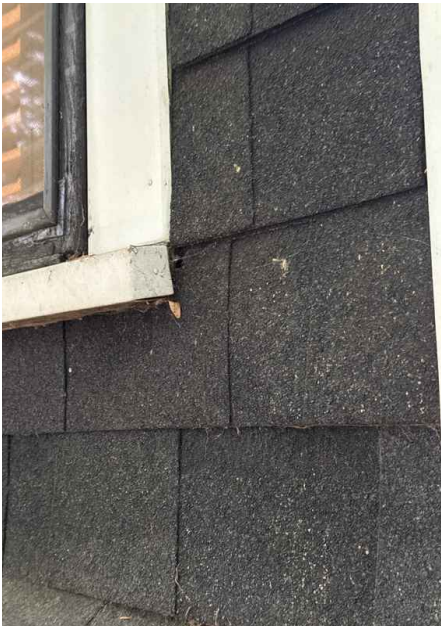
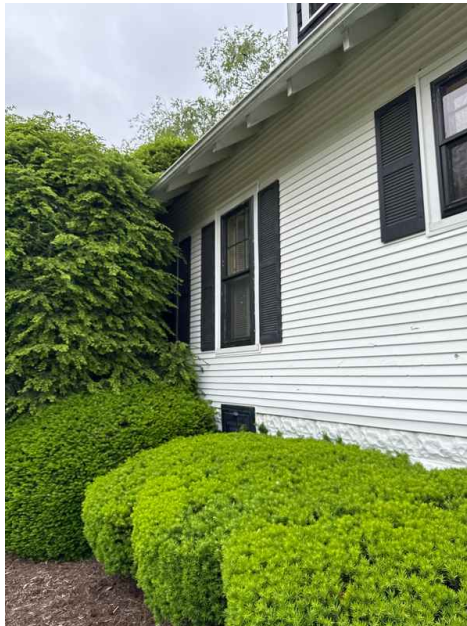
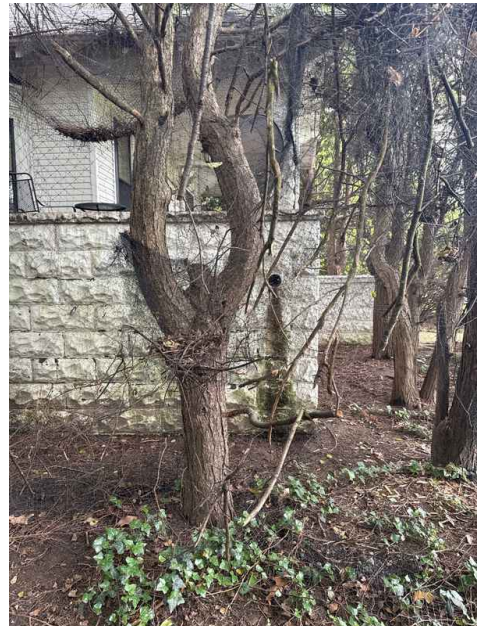
Siding, Flashing & Trim: Siding Material

Asphalt, Vinyl, Shingles, Masonry

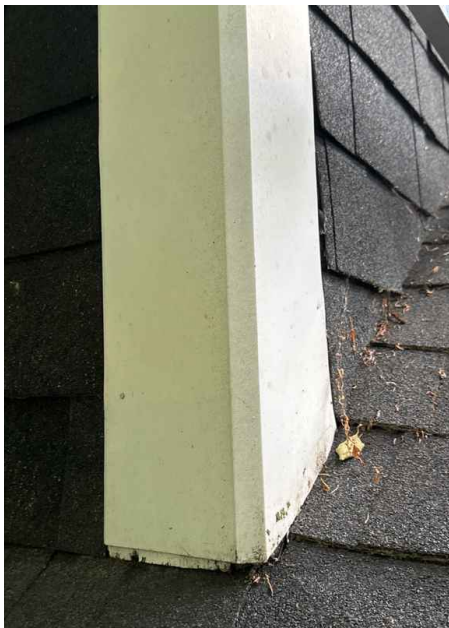
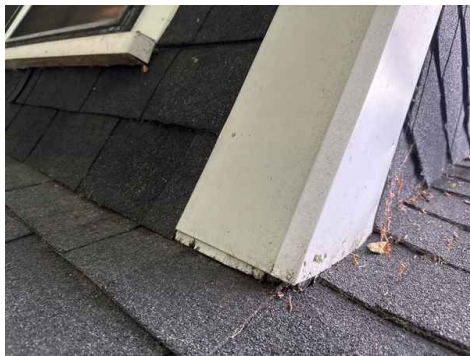
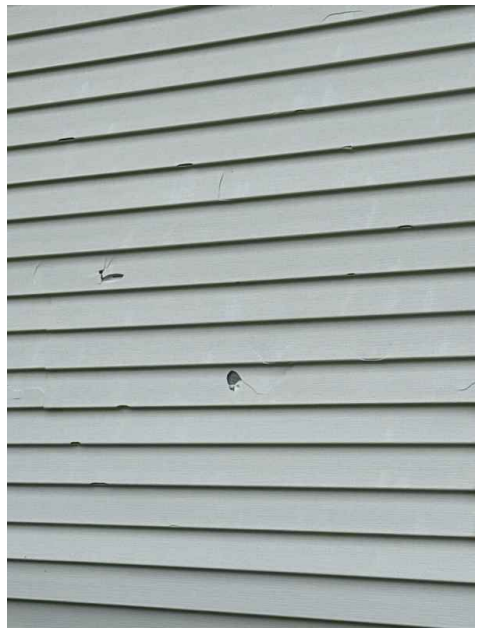
Siding, Flashing & Trim: Vapor Barrier

Not Present

The presence of vapor barrier is inspected in limited locations due to non-invasive testing.

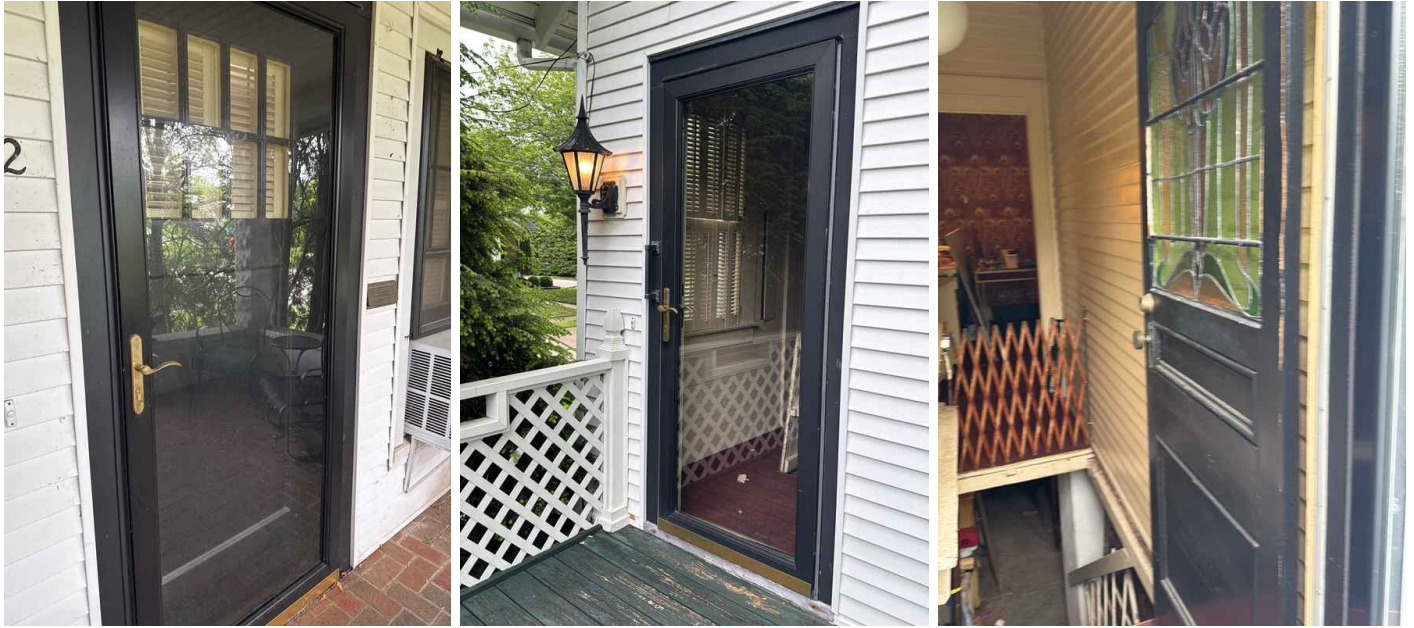
Exterior Doors: Exterior Entry Door

Glass, Wood, Storm

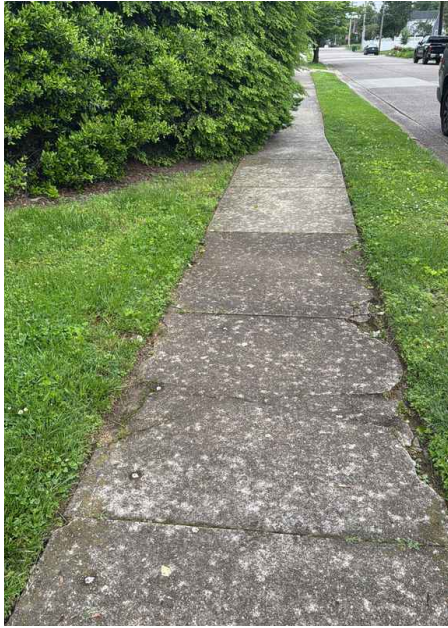
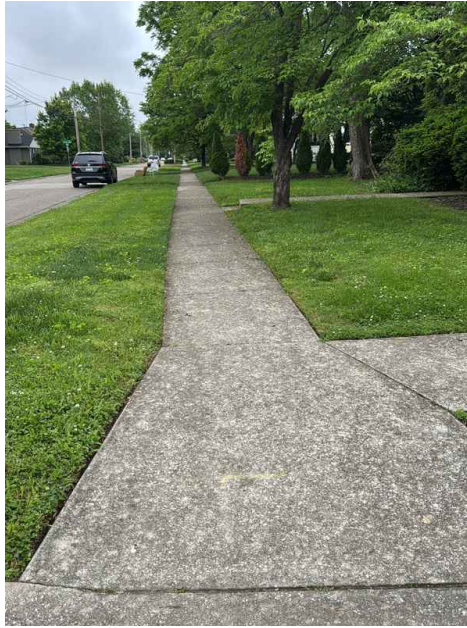
Walkways, Patios & Driveways: Hard-Scape

Concrete, Sidewalk, Decking, Wood, Brick

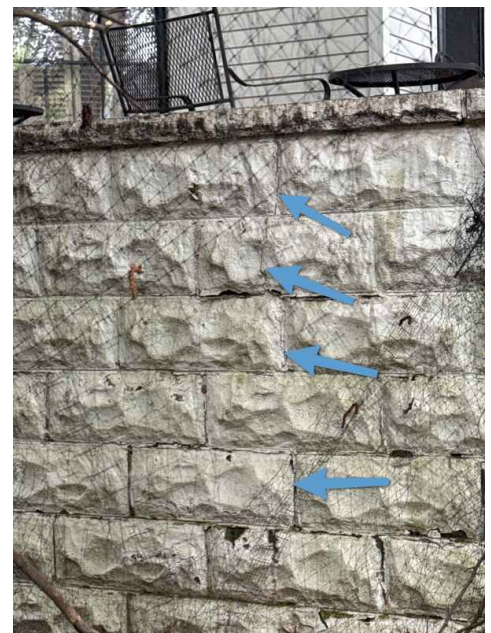
Northeast

CRACKING - MINOR

Masonry cracking observed in one or more places. This is often a result of temperature changes and/or poor drainage. This is also typical for structures with significant age. One option is to tuck-point new mortar. Recommend monitoring and/or further evaluation by a masonry contractor.

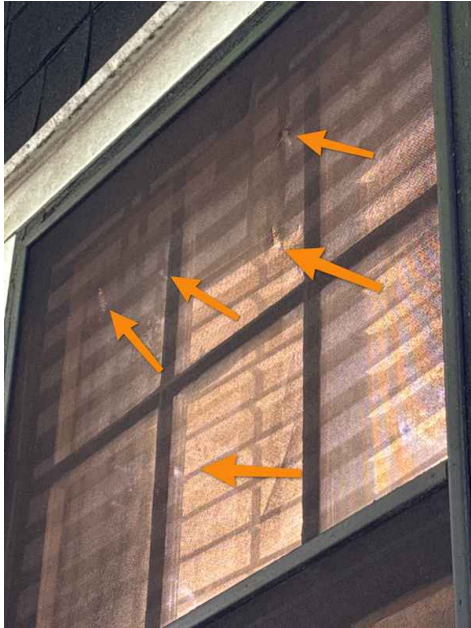
East 2nd Floor

HAIL DAMAGE

Hail damage observed during the inspection. Inquire with current owner/representative for past history. Recommend further evaluation by a qualified exterior contractor.

Contact a qualified siding specialist.

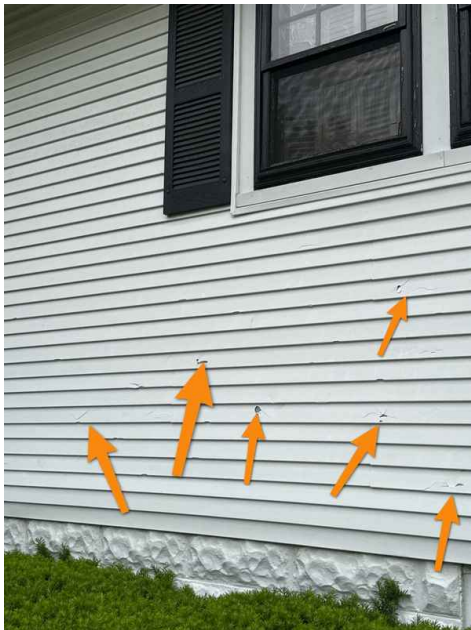
West

J-channel was used instead of a starter strip for the very bottom run of vinyl siding. This can trap water and cause moisture intrusion. Exterior siding manufacturers recommend drilling a 3/16" hole every 12 inches along the J-channel to allow drainage. Recommend further evaluation by a siding contractor.

Contact a qualified professional.

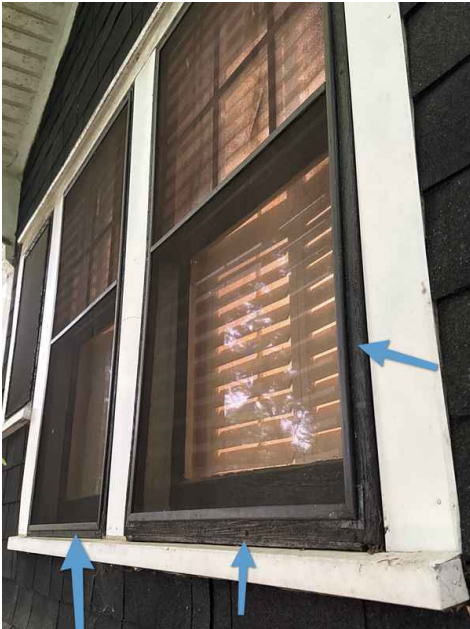
East 2nd Floor

Some materials in an exterior setting require more maintenance than other siding. One option is to Scrape, Caulk, and Paint (SCP) some exterior materials such as steel or wood to ensure full life expectancy. Recommend further evaluation by a painting contractor.

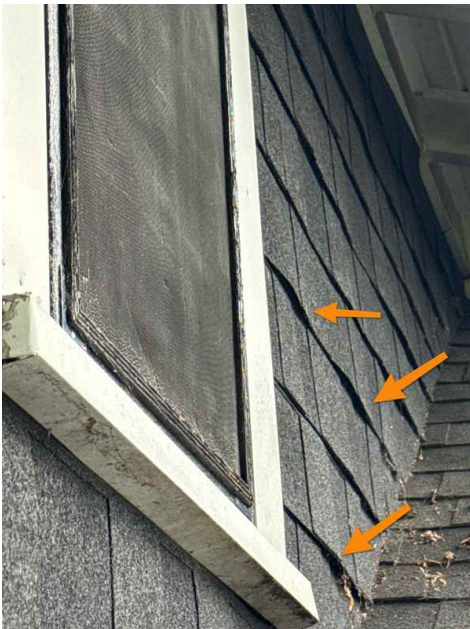
East 2nd Floor

Evidence of water intrusion noted during the inspection. One option is to repair exterior siding and/or flashing. Recommend further evaluation by a qualified contractor.

Contact a qualified professional.

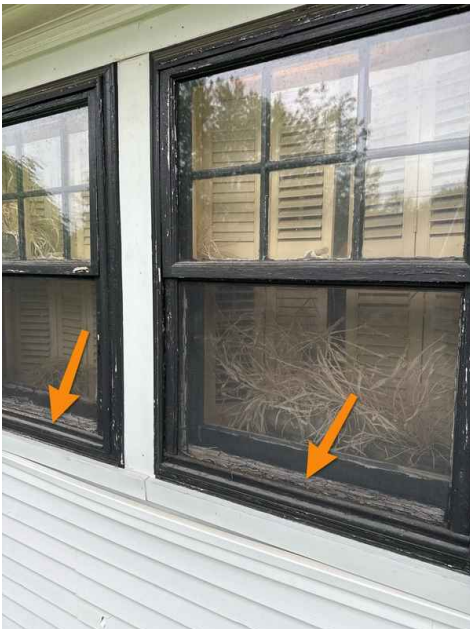
West

WOOD ROT

Wood rot noted during inspection. One option is to replace with a composite material that can withstand constant weathering. Recommend further evaluation by qualified carpenter.

Contact a qualified professional.

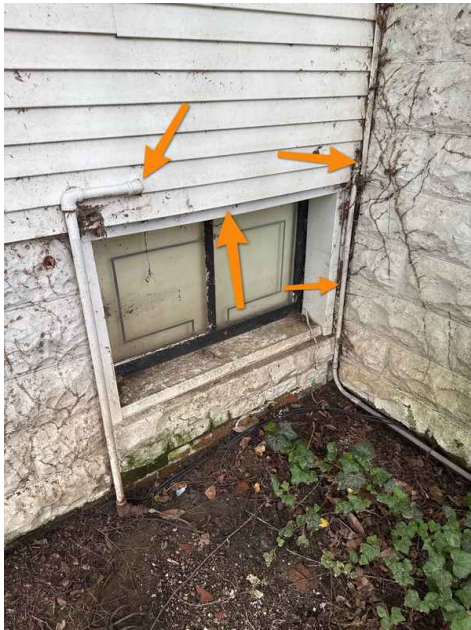
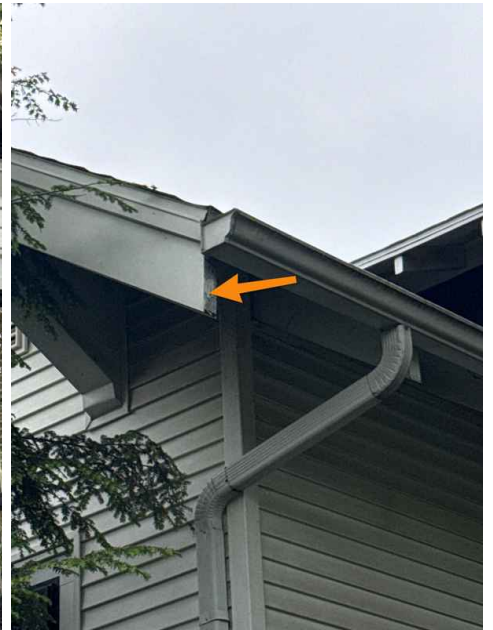
East

SEALANT/FLASHING RECOMMENDED

Sealant/Flashing recommended where two dissimilar exterior materials meet and/or change direction. One option would be to apply a tripolymer sealant and/or flashing. Recommend further evaluation by a qualified contractor.

Contact a qualified professional.

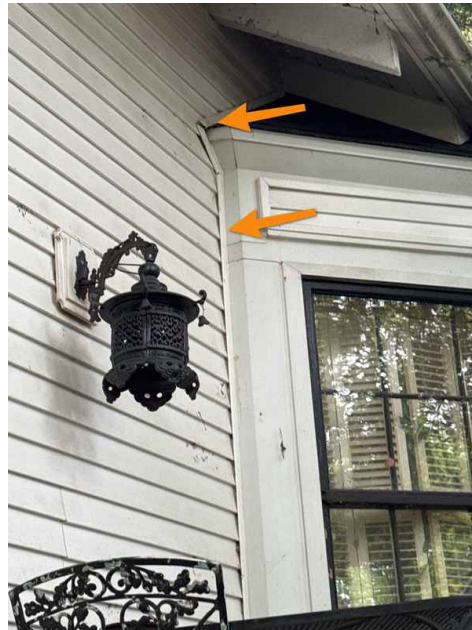
Exterior door trim damage noted at time of inspection. Recommend further evaluation by qualified contractor.

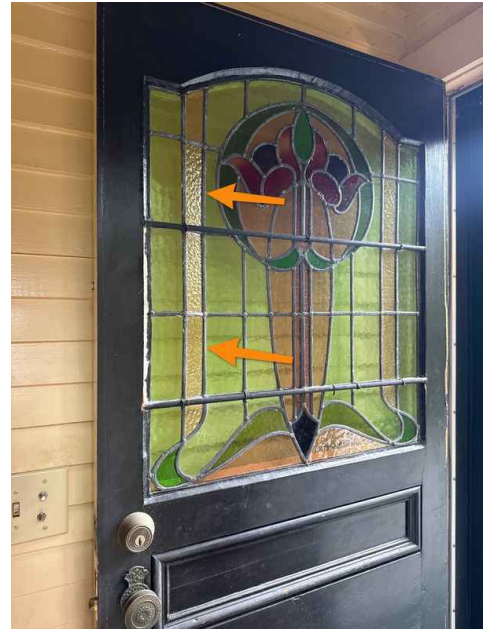
South

TRIM DAMAGE NOTED

Contact a qualified professional.

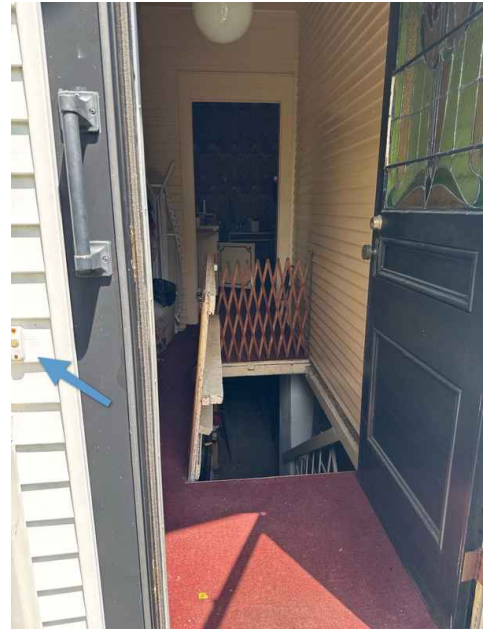
South

Doorbell not operational at time of inspection. One option is to repair/replace doorbell. Recommend further evaluation by a qualified contractor.

Contact a qualified professional.

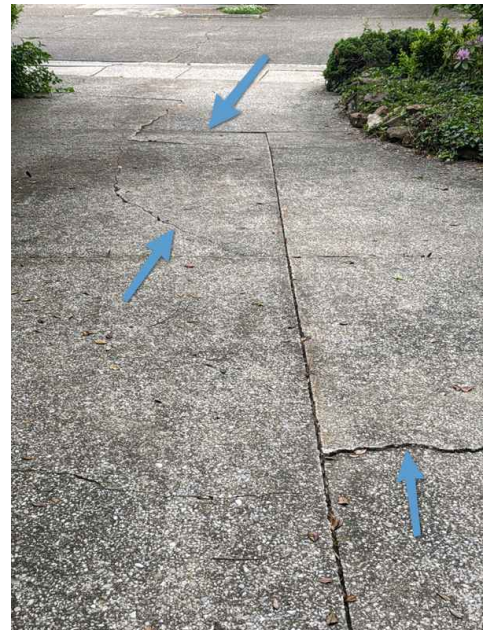
South

DRIVEWAY CRACKING - MINOR

Minor cosmetic cracks observed, usually associated with expansion/contraction due to temperature changes. One option is to patch/seal cracks. Recommend monitoring and/or further evaluation by a concrete contractor.

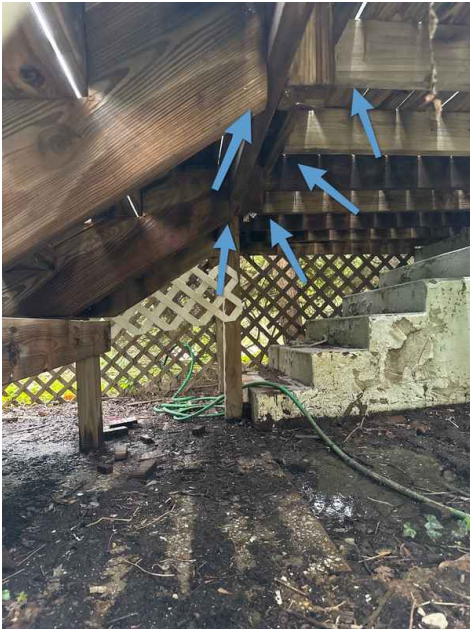
South

Joist hanger(s) are missing or improperly installed. Fasteners are not structural and are not permitted through veneers. This could cause the structure to fail. Recommend that joist hangers be properly installed by qualified contractor.

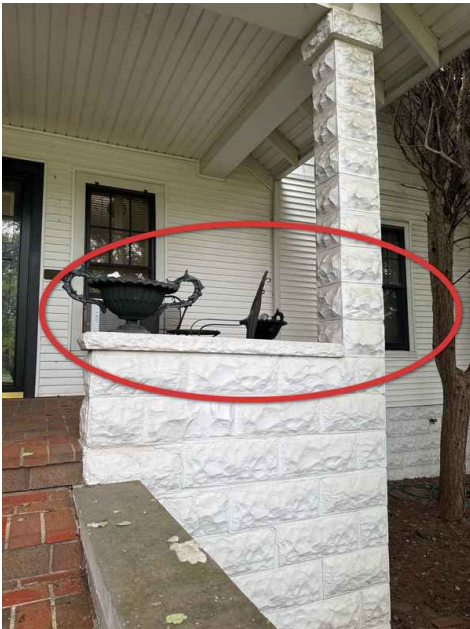
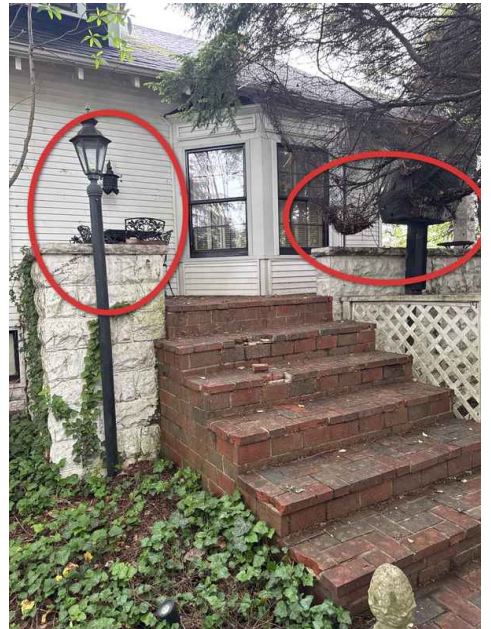
GUARDRAIL MISSING/DAMAGED

Guardrails are missing in one or more locations. Handrails/guardrails are required if there are four or more stair risers, OR 30" of vertical separation. One option is to provide positive separation between pedestrian routes and vertical separations greater than 30". Recommend further evaluation by a qualified contractor.

Contact a qualified professional.

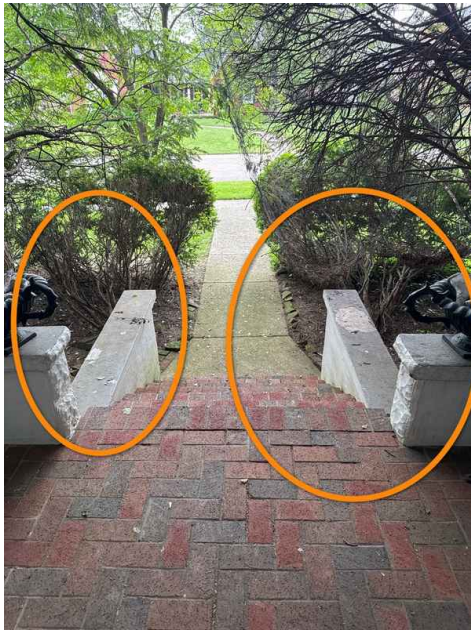
North

Any elevated surface greater than 30 inches or having four or more step risers require a graspable handrail. 2 x 4 and 2 x 6 dimensional lumber is not considered graspable. Recommend further evaluation by a qualified contractor.

Contact a qualified professional.

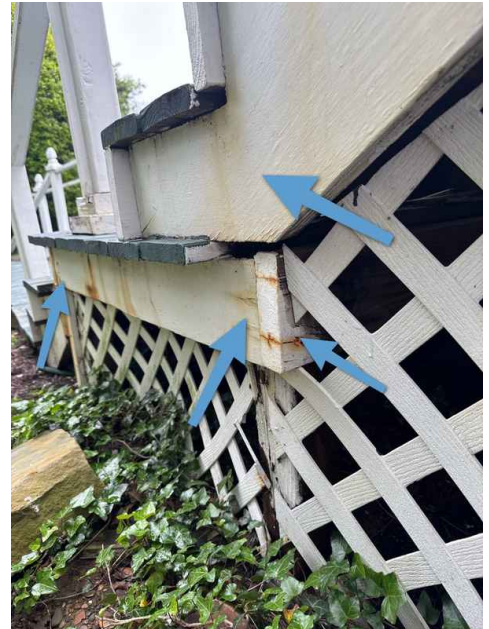
MISSING BOLTS

Bolts missing through boards. It is recommended to have bolts through the skirt/ledger boards and into the structural points. One option is to add bolts at beam/structural connections. Recommend further evaluation by qualified carpenter.

Contact a qualified professional.

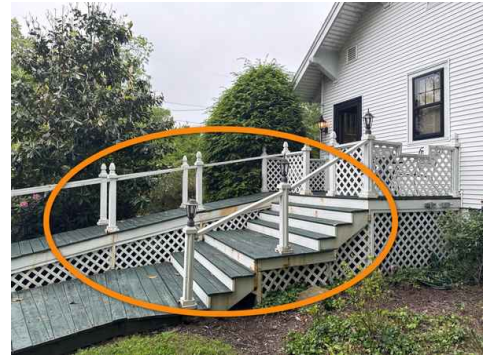
MISSING/DAMAGED SPINDLES

Missing/Damaged spindles observed during inspection. One option is to replace and or refasten spindles. Recommend further evaluation by a qualified contractor.

Contact a qualified professional.

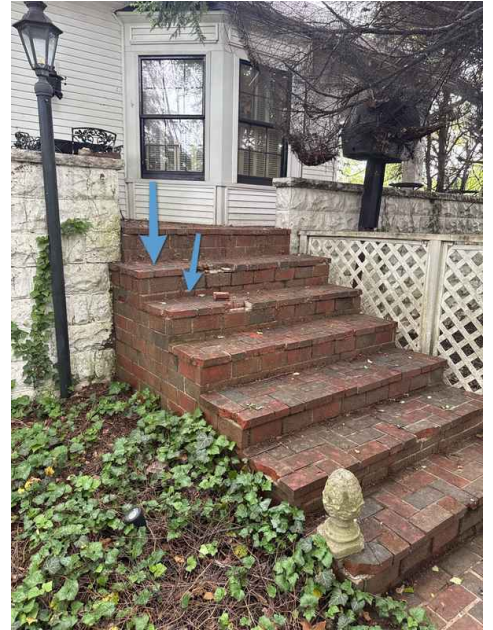
East

Minor concrete step/porch settlement observed during inspection. This is not abnormal to see on a structure of this age. Recommend further evaluation by qualified contractor.

Contact a qualified professional.

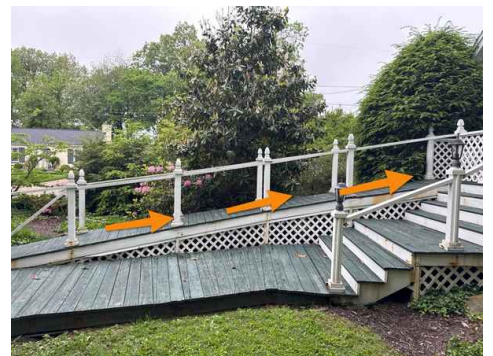
ADA ramp exceeds 8% slope. Americans with Disability Act, recommends a maximum slope not to exceed 1 inch of rise for every 12 inches horizontally, 8%. Recommend further evaluation by a qualified contractor.

Contact a qualified professional.

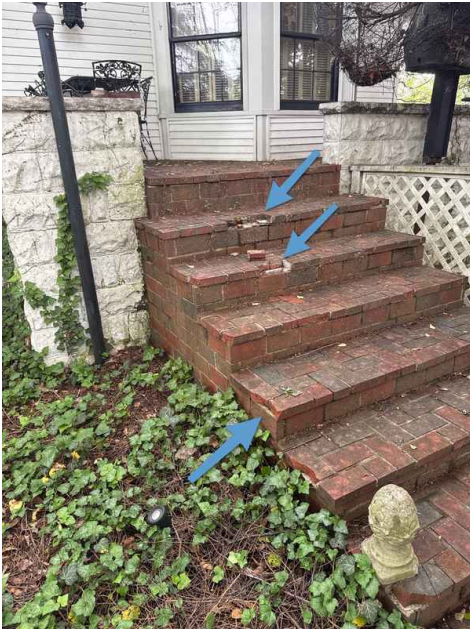
East

MASONRY/MORTAR/GROUT DETERIORATION

At the time of the inspection exterior areas were observed to have grout or mortar deterioration. Recommend further evaluation by qualified Mason.

Contact a qualified masonry professional.

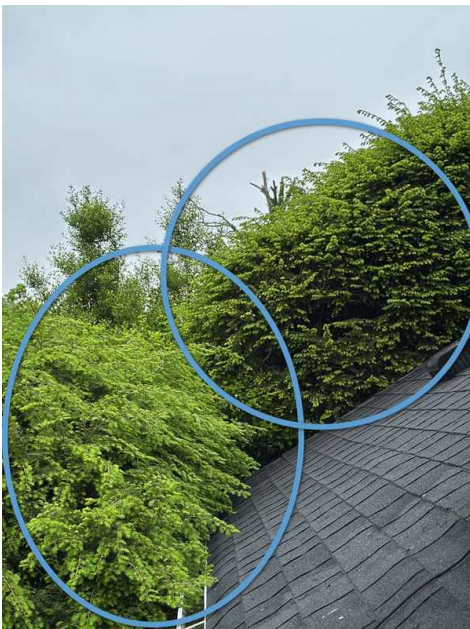
North

Excessive vegetation next to the structure without minimum required clearance. Recommend removal, or trimming of vegetation around the structure with a minimum clearance from tree/shrub limbs of 4 feet. Seek further evaluation by qualified contractor.

Contact a qualified professional.

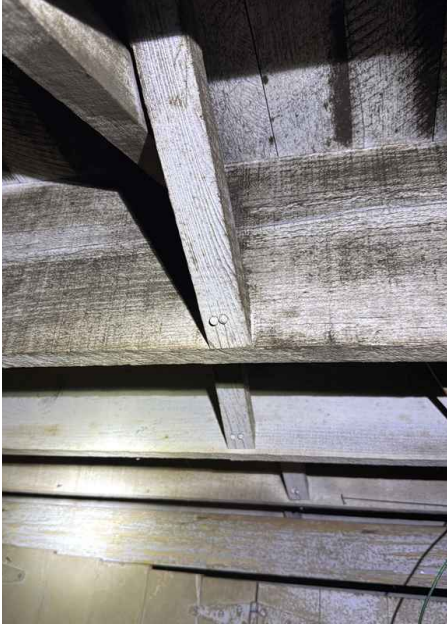
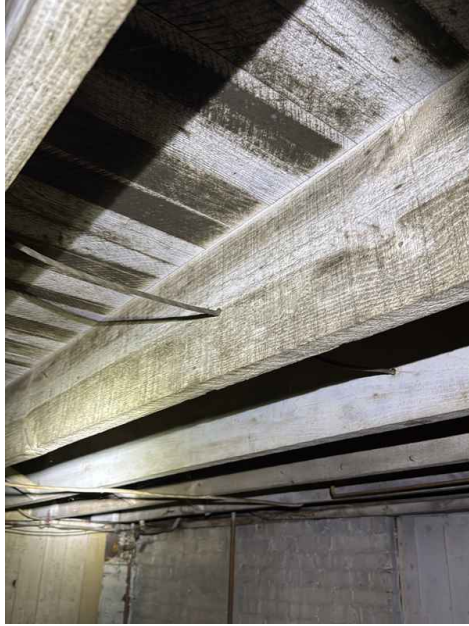
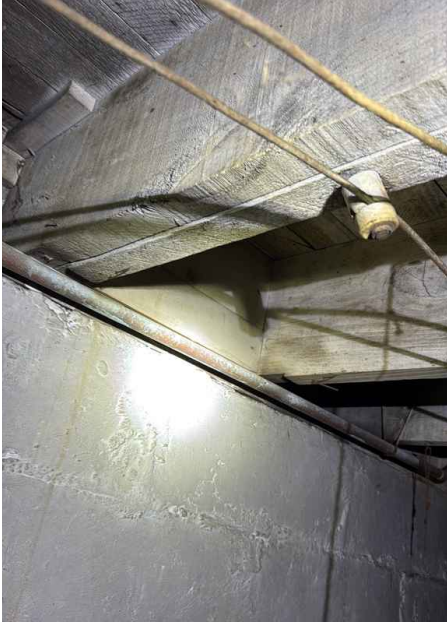
Floor Structure: Material

Steel H Beams, Wood Beams, Wood Joists

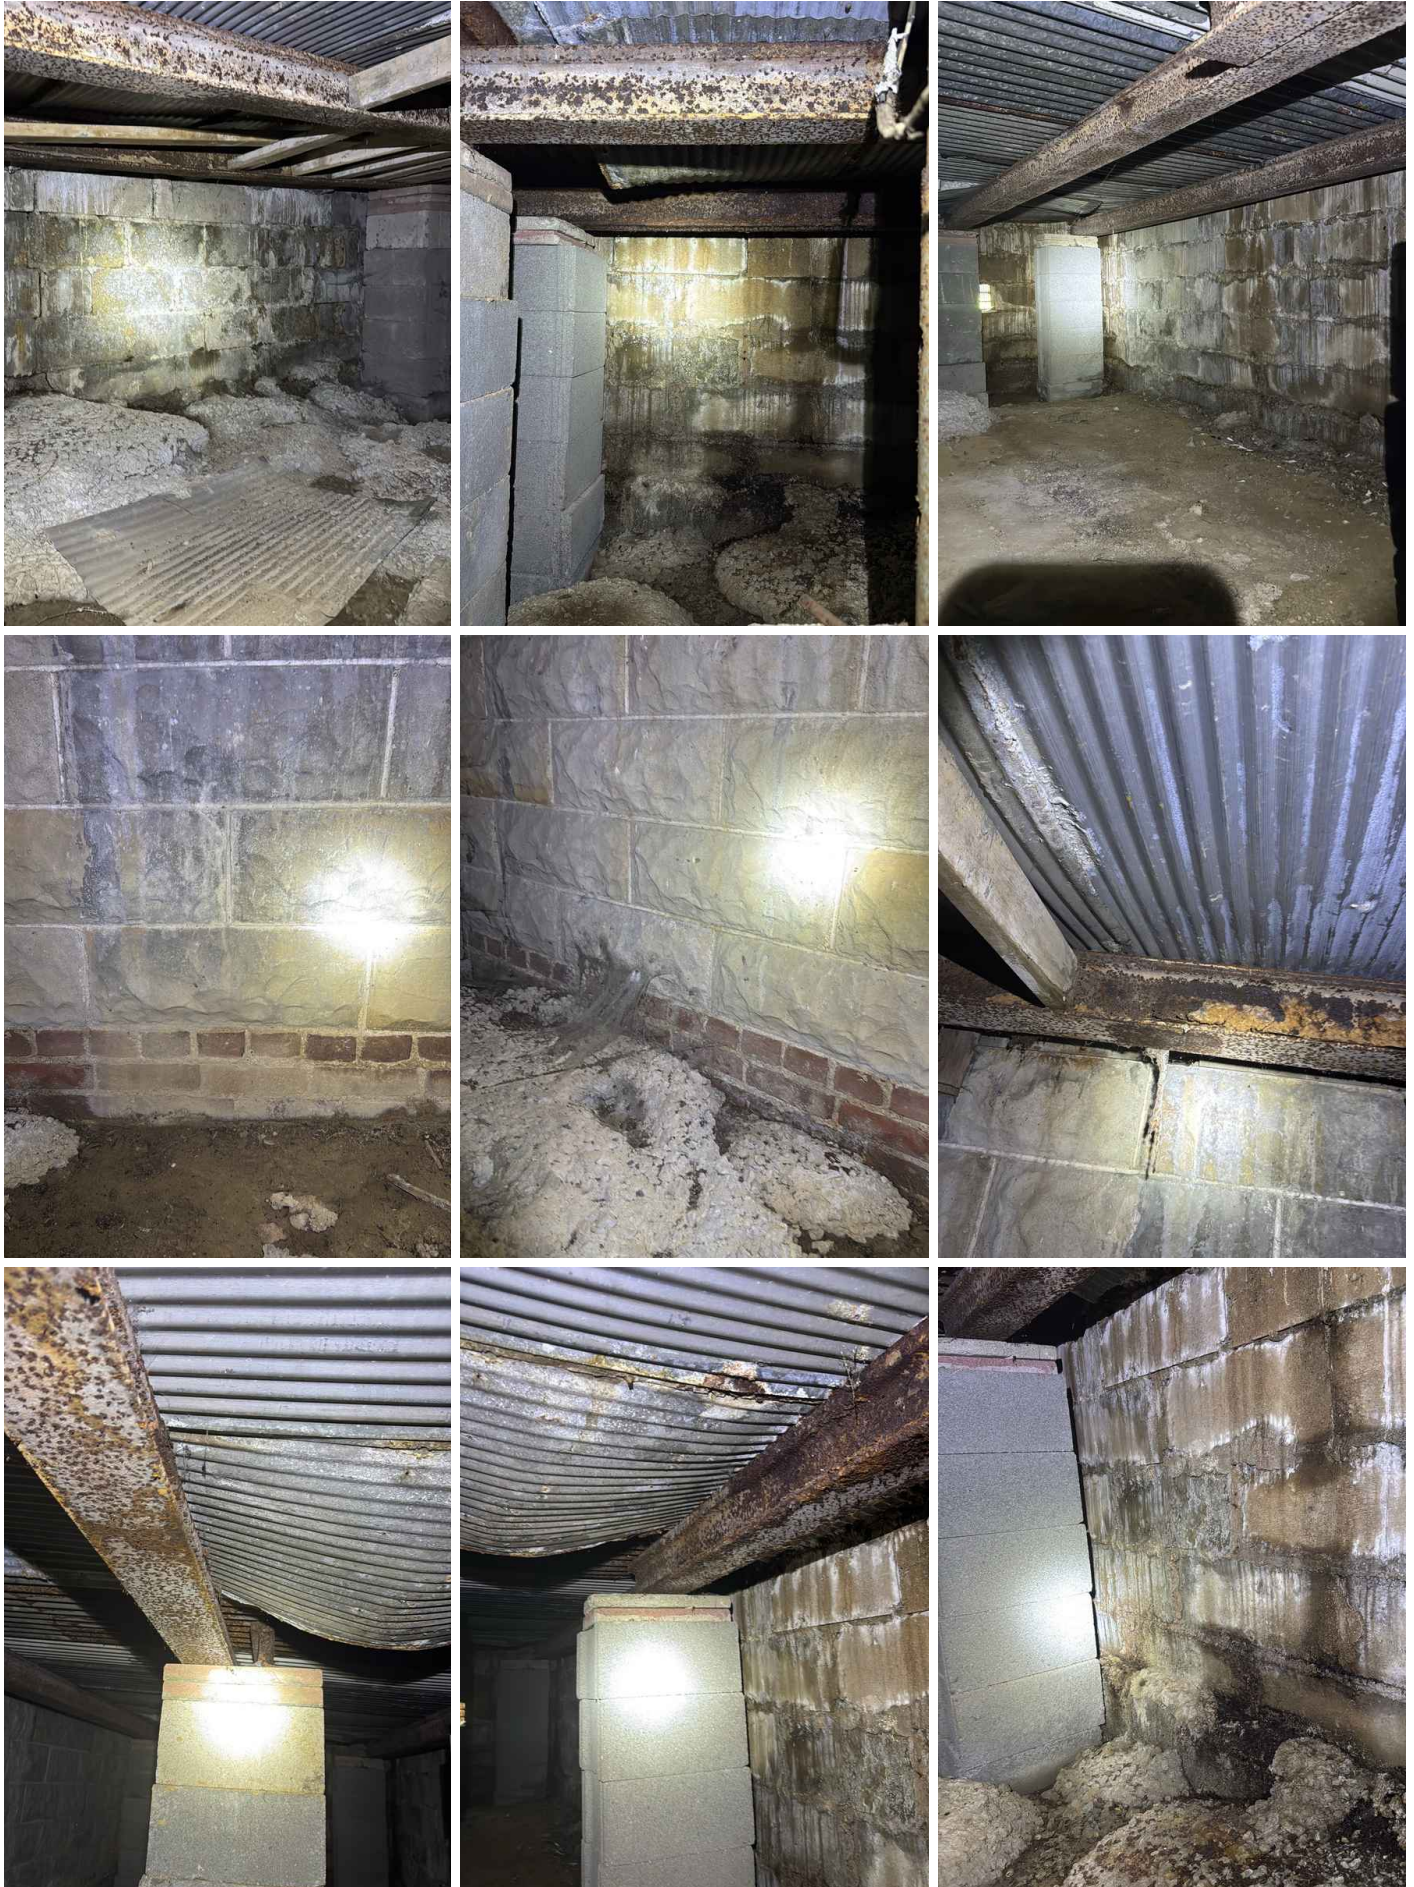
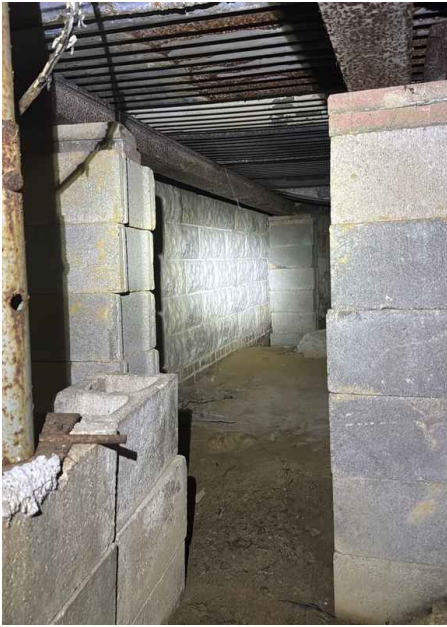
Wall Structure: Wall Structure

Masonry Block, Brick and Mortar, Masonry Brick

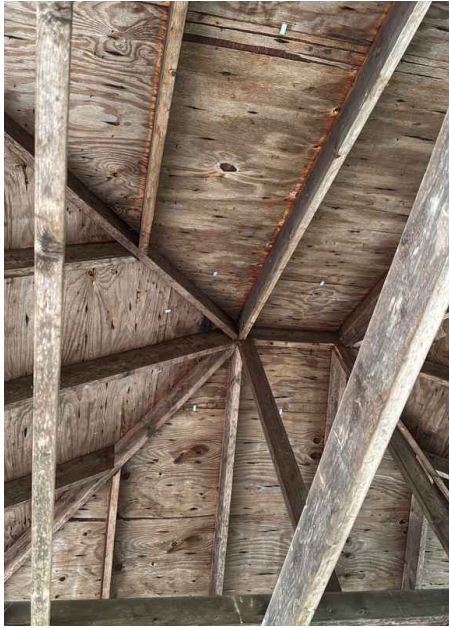
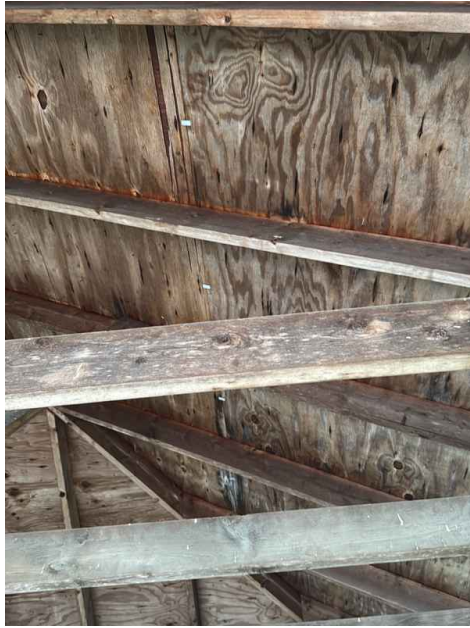
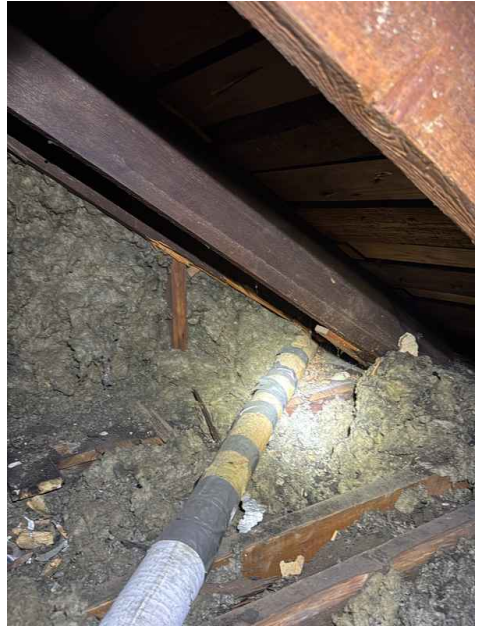
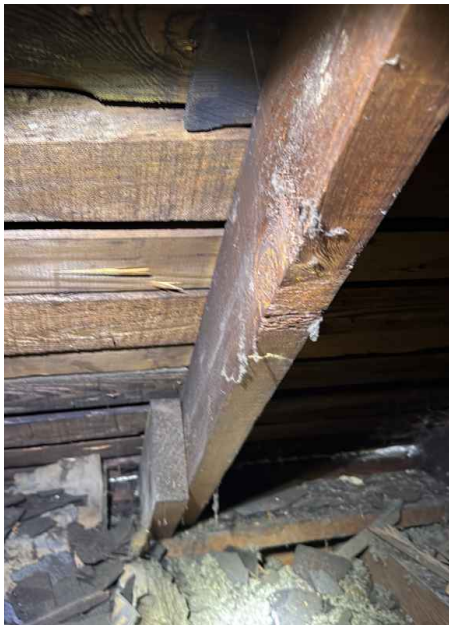
Ceiling Structure: Roof System

Stick Framing, Rafters, Ridge Board, Collar Ties, Not Accessible
