BLUEGRASS HOME INSPECTIONS LLC

BHI RESIDENTIAL INSPECTION

432 Maple Ave
Owensboro, KY 42301

05/08/2025

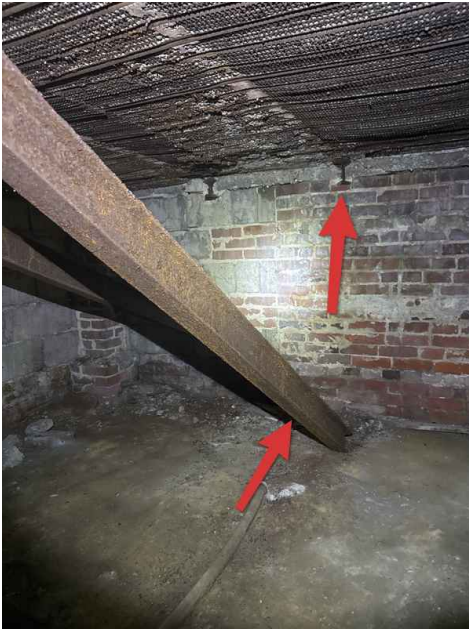
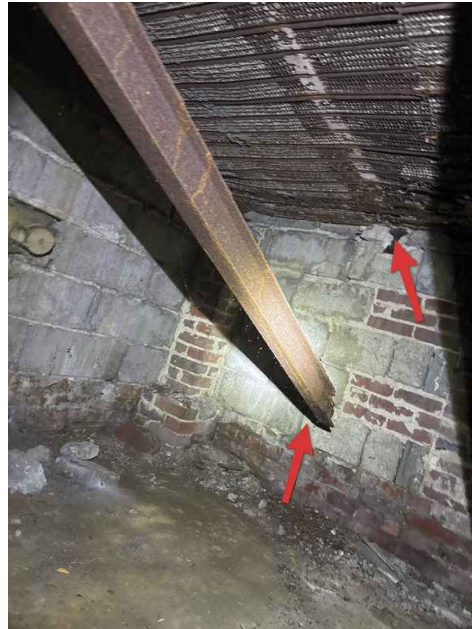
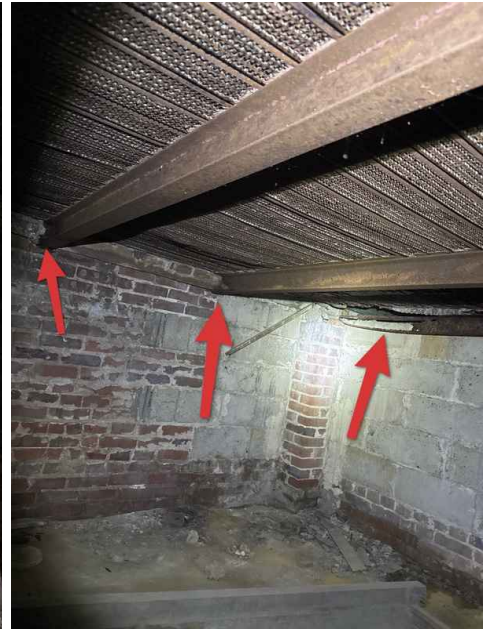
North Crawlspace

EVIDENCE OF STRUCTURAL DAMAGE

Structural damage was observed in the underlying floor structure. Recommend further evaluation by a qualified carpenter.

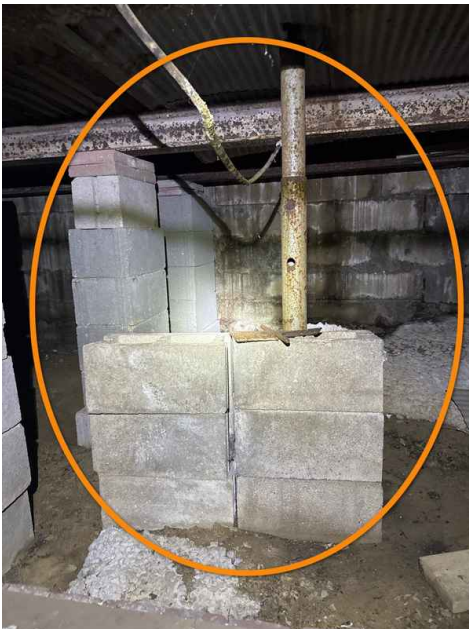
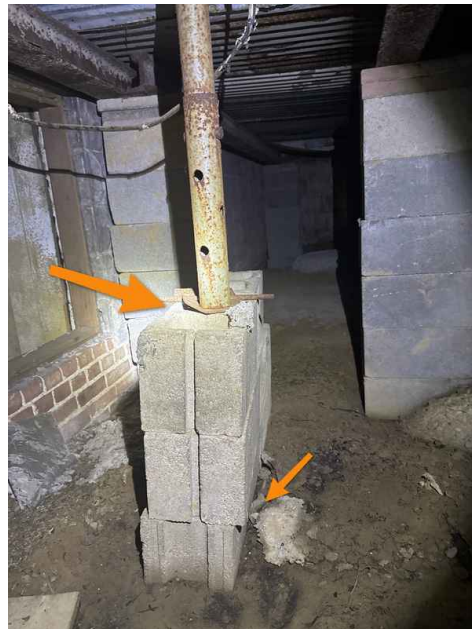
East Crawlspace

Pillar blocking is not on concrete. Soil conditions cause elevations to sag. Recommend further evaluation by qualified carpenter.

Contact a qualified professional.

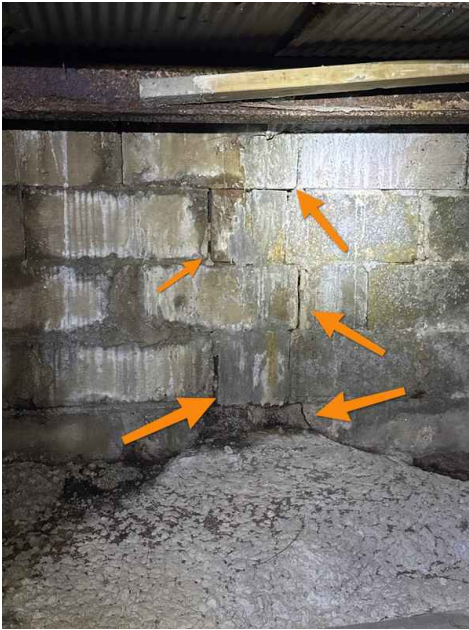
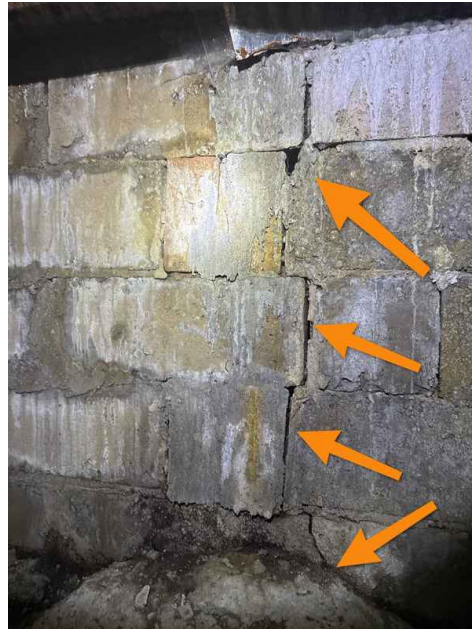
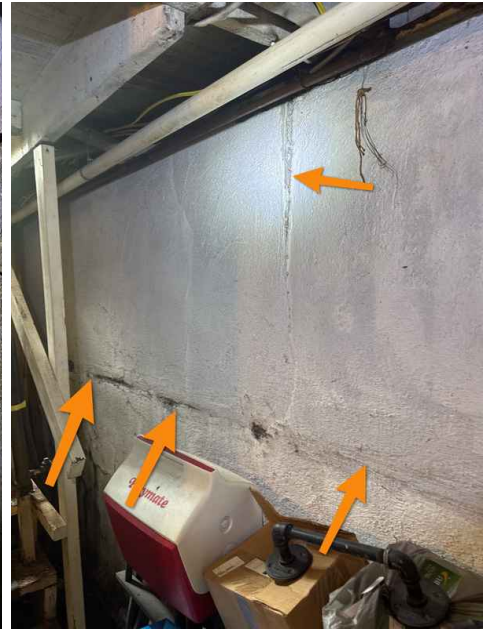
East Crawlspace

CRACKS - MAJOR

Major cracking observed in wall structure. This could be from moisture intrusion at the structure and/or extreme temperature fluctuation. Recommend further evaluation by a qualified contractor.

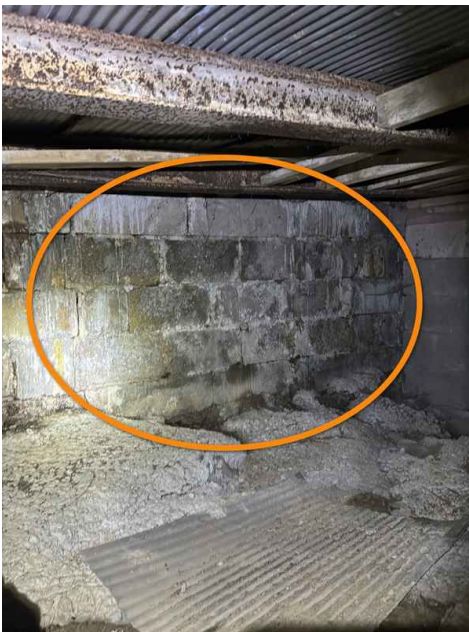
East Crawlspace

Evidence of water intrusion noted. One option is to ensure water is flowing away from the structure. Seek previous history from current owner and/or continue to monitor. Recommend further evaluation by a qualified contractor.

Contact a qualified professional.

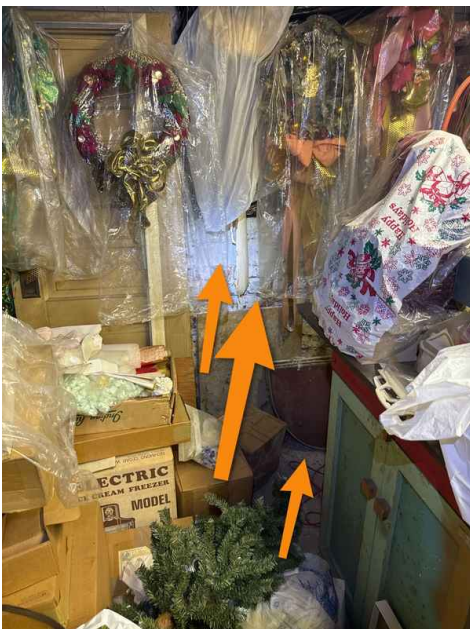
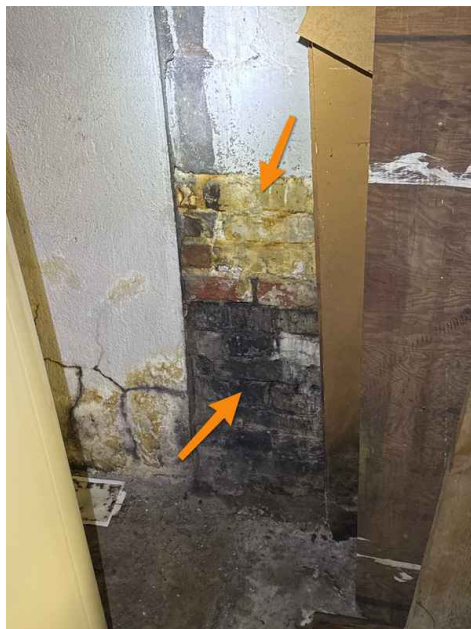
Evidence of possible lime mortar used in masonry. One option is to tuck-point cement mortar in deficient masonry areas. Recommend further evaluation by a qualified masonry contractor.

Contact a qualified professional.

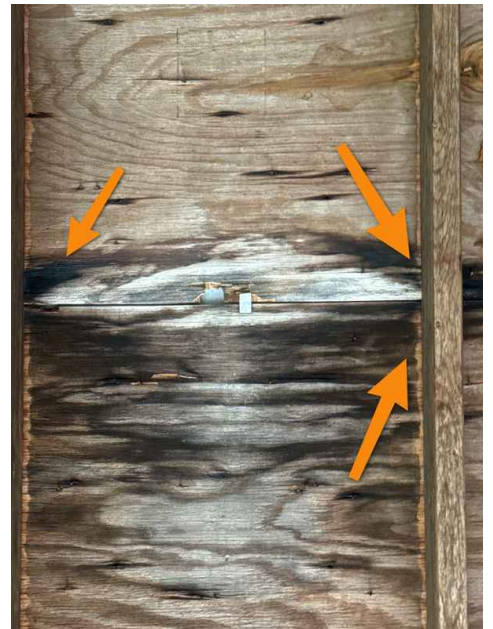
Garage

EVIDENCE OF WATER INTRUSION

Evidence of water intrusion observed during inspection. One option is to properly flash roof to prevent moisture intrusion. Recommend further evaluation by a qualified roofing contractor.

Contact a qualified professional.

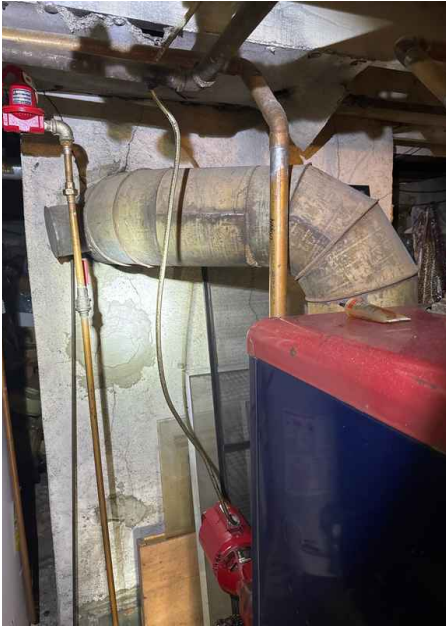
General: AFUE Rating

80

AFUE (Annual Fuel Utilization Efficiency) is used to measure furnace efficiency in converting fuel to energy. A higher AFUE rating means greater energy efficiency. 90% or higher meets the Department of Energy's Energy Star program standard.

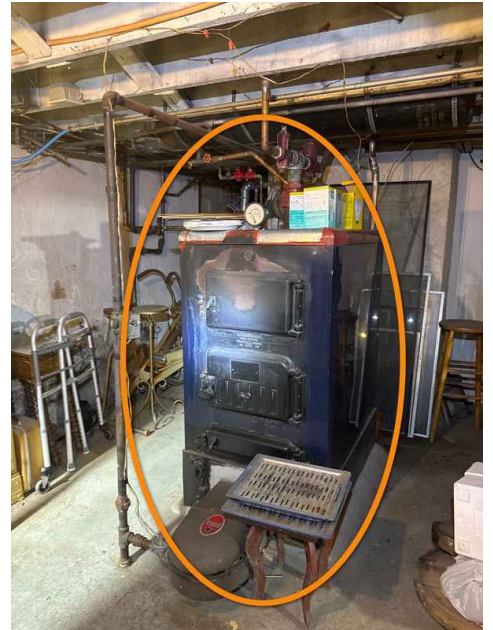
5.2.2 Equipment

Unit is near the end of its service life. Unit is operational during inspection, and generally has a life expectancy between 15-20 years of age. Recommend further evaluation by qualified, HVAC technician.

Contact a qualified HVAC professional.

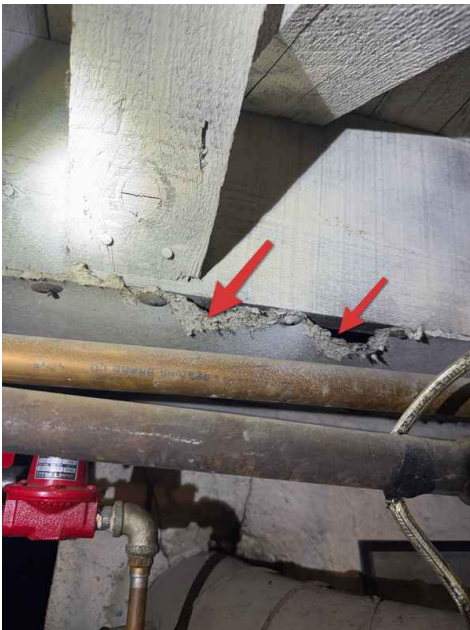
5.4.1 Distribution Systems

Unknown material observed in isolated areas. One option is to have it tested for asbestos like materials. Recommend further evaluation by qualified contractor.

Contact a qualified professional.

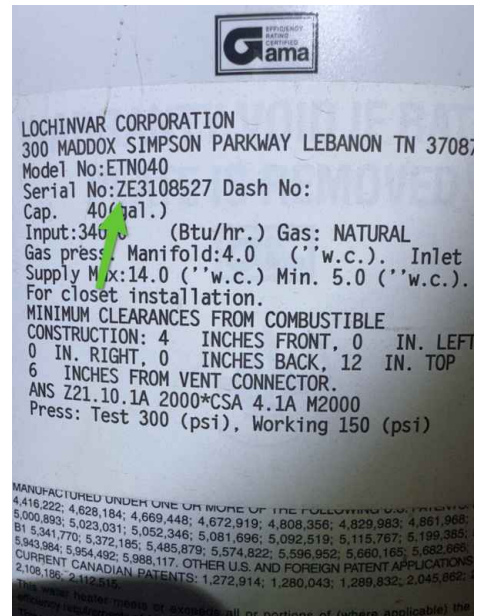
Hot Water Systems, Controls, Flues & Vents: Manufactured Date
Unit was manufactured in 2003.

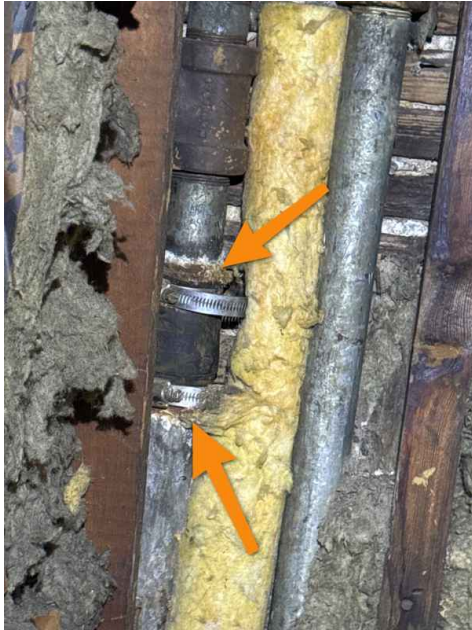
Southeast Attic

EVIDENCE OF A LEAK

Evidence of a leak observed during the inspection. One option is to repair plumbing to prevent moisture damage. Recommend further evaluation by a qualified plumber.

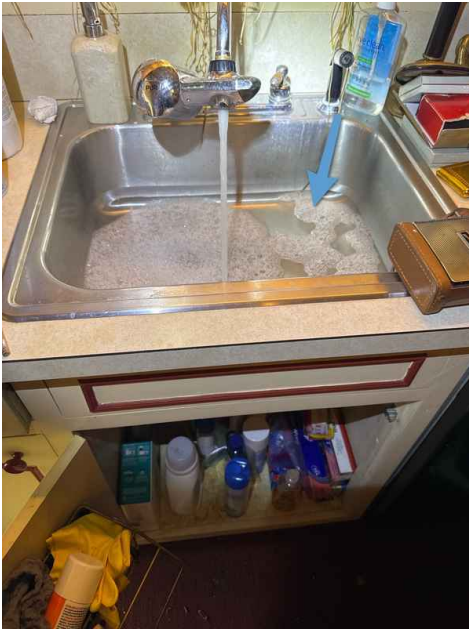
Kitchen

Sink had slow/poor drainage during the inspection. One option is to clean drain of possible obstructions. Recommend further evaluation by a qualified plumber.

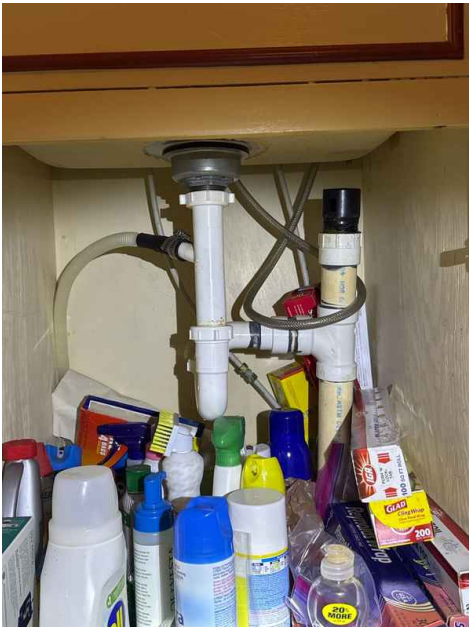
Basement Laundry Room

At the time of inspection, one or more air admittance valves were Observed to be installed below the 4 inch minimum required above the horizontal branch drain. One option would be to raise the location of the air admittance valve so that it is above the 4 inch required minimum. Recommend further evaluation by a licensed plumber.

Contact a qualified professional.

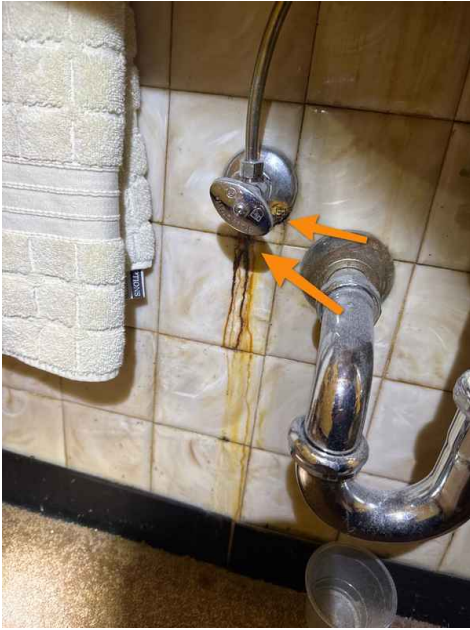
2nd Floor Bathroom

**DISTRIBUTION PIPE LEAKING**

Distribution pipe leak observed during the inspection. One option is to repair damaged connections and/or pipe material. Recommend further evaluation by a qualified plumber.

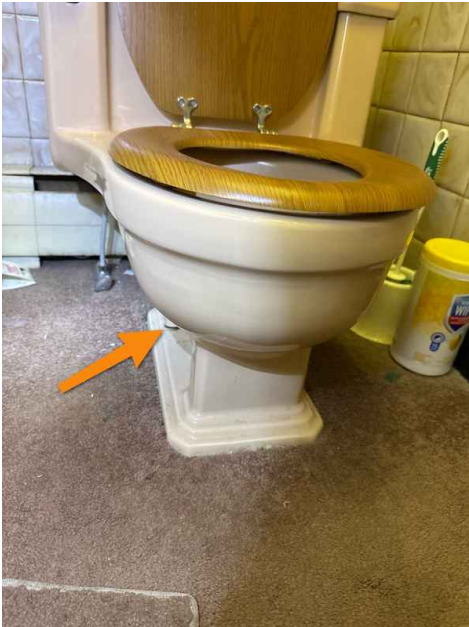
2nd Floor Bathroom

TOILET LOOSE

Toilet is loose and/or leaking at the base. One option is to tighten anchor points and monitor. Recommend a qualified plumber evaluate and repair.

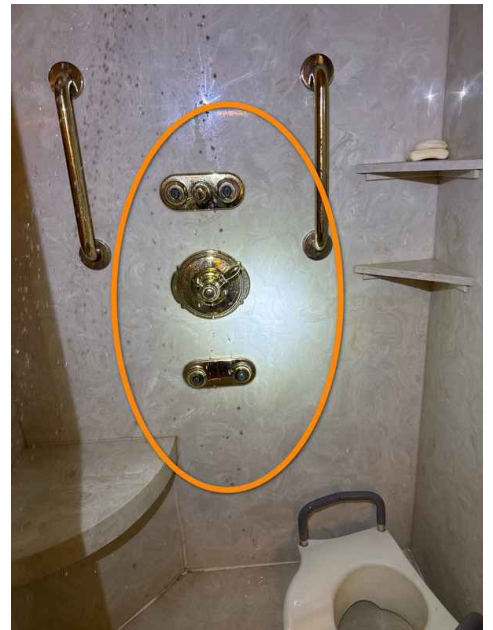
LOOSE/DAMAGED FIXTURE

Loose/damaged fixture components noted during the inspection. Recommend further evaluation by a qualified plumber.

Contact a qualified professional.

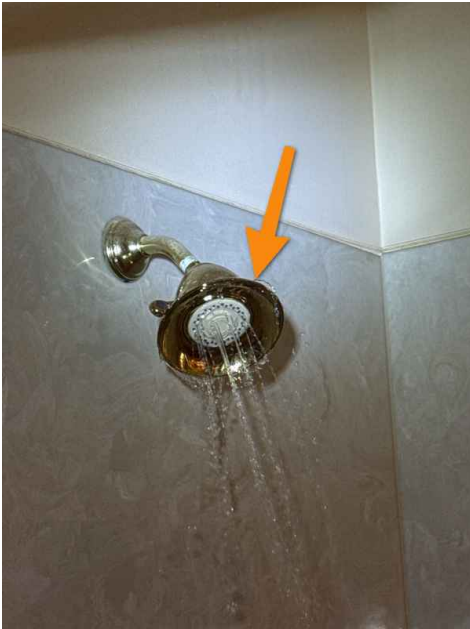
1st Floor South Bathroom

FIXTURE LEAKING

Fixture leaking at the time of inspection. One option would be to properly mount and secure the fixture connections. Recommend further evaluation by a qualified plumber.

Contact a qualified professional.

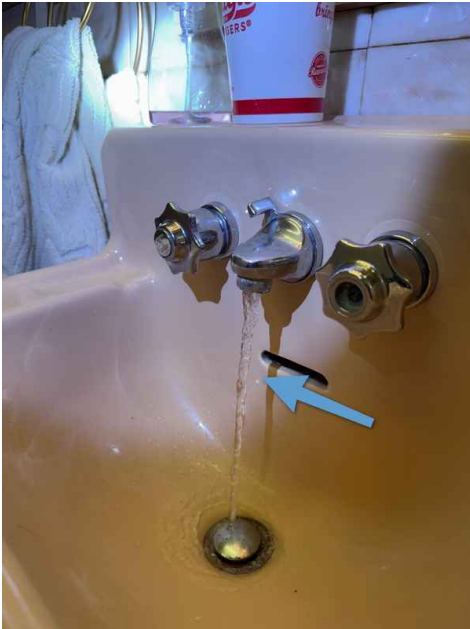
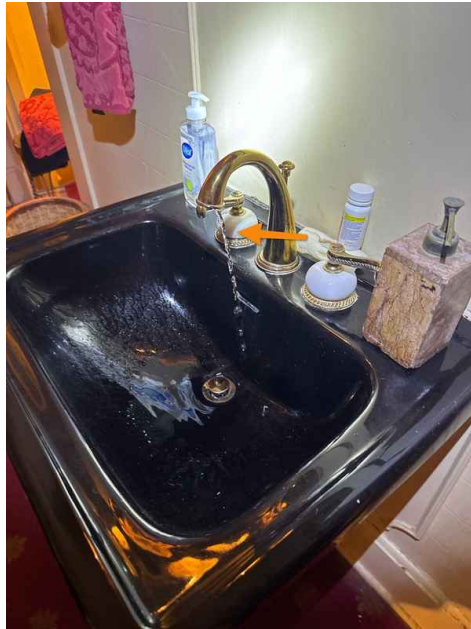
Low water pressure noted for during inspection. One option is to have the local water company check the pressure at the meter. Recommend further evaluation by a qualified contractor.

Contact a qualified professional.

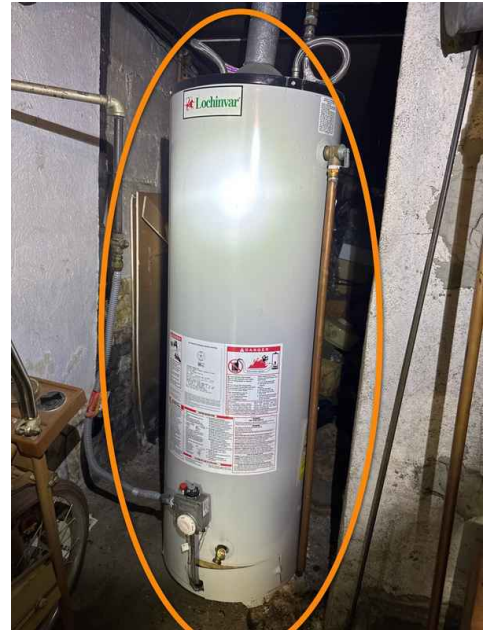
22 yrs. Old.

NEAR END OF LIFE EXPECTANCY

Water heater showed normal signs of wear and tear. Though the hot water heater is properly working under normal operating conditions, hot water heaters have a life expectancy between 20 and 25 years. Recommend monitoring it's effectiveness and replacing in the future.

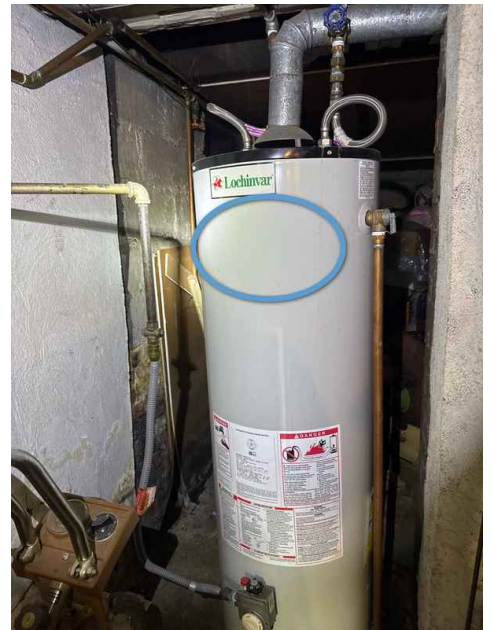
Basement

MISSING STATE (AHJ) INSPECTION STICKER

Missing inspection tag from Authorities Having Jurisdiction(AHJ) providing documentation the unit was inspected by local code enforcement. One option is to inquire with current owner for past documentation of inspection/installation. Recommend further evaluation by a qualified professional.

Contact a qualified professional.

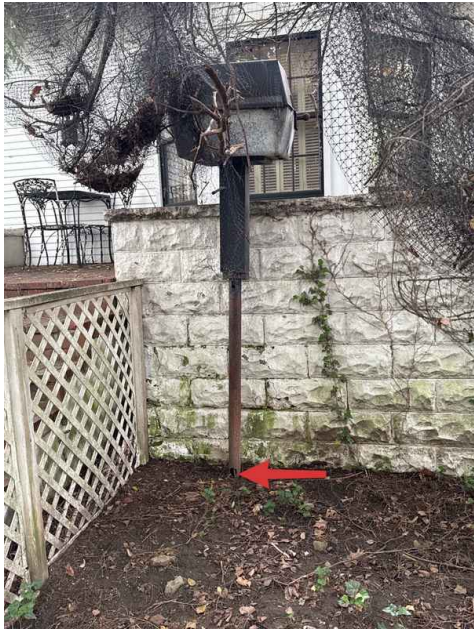
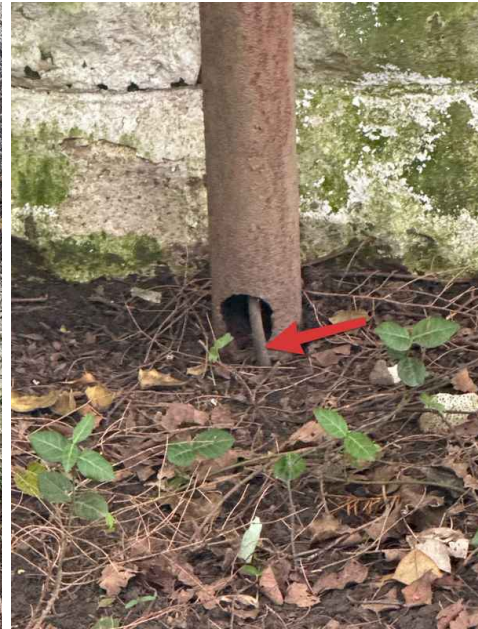
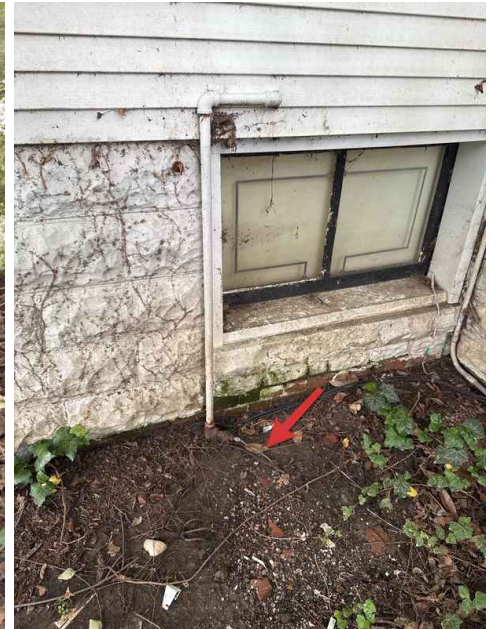
Copper gas line exposed and susceptible to damage by yard maintenance equipment. Recommend further evaluation by a qualified contractor.

Contact a qualified professional.

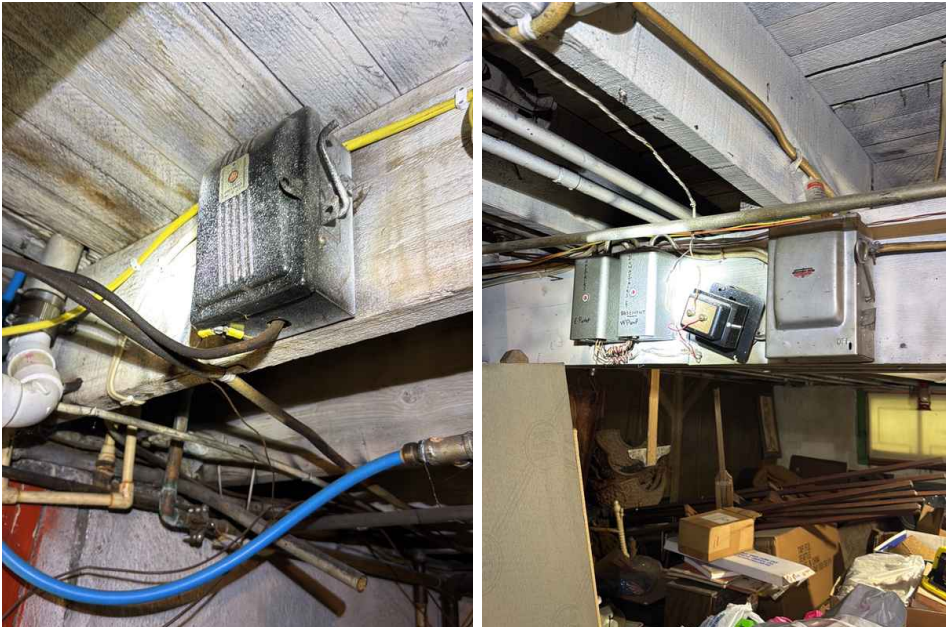
8.4.1 Branch Wiring Circuits, Breakers & Fuses

ALUMINUM BRANCH CIRCUITS

Aluminum wire appears to be installed on branch electrical circuits in the subject premises. These single strand, branch circuit aluminum wires were used widely in houses during the mid 1960s and 1970s. According to the U.S. Consumer Product Safety Commission, problems due to expansion can cause overheating at connections between the wire and devices (switches and outlets) or at splices. For further information on aluminum wiring contact the U.S. Consumer Product Safety Commission via the Internet at <http://www.cpsc.gov/> . One option is to update wiring when performing upgrades within the structure. It is recommended that the electrical system be evaluated by a licensed electrician.

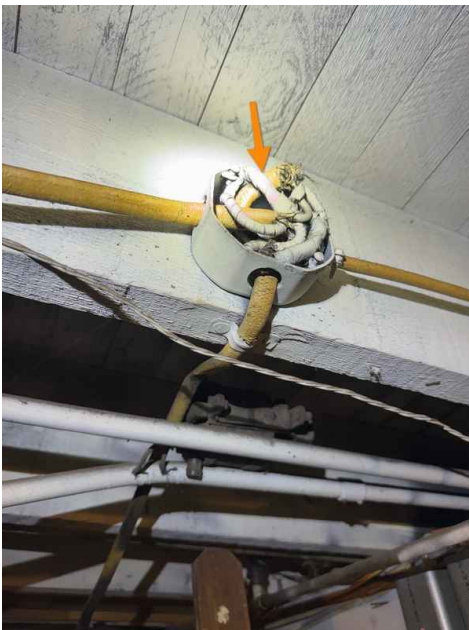
Basement

Branch wiring splice/termination observed outside of junction box in one, or more locations. One option is to properly secure and terminate branch wiring inside a readily accessible junction box. Recommend further evaluation by a qualified electrical contractor.

Contact a qualified professional.

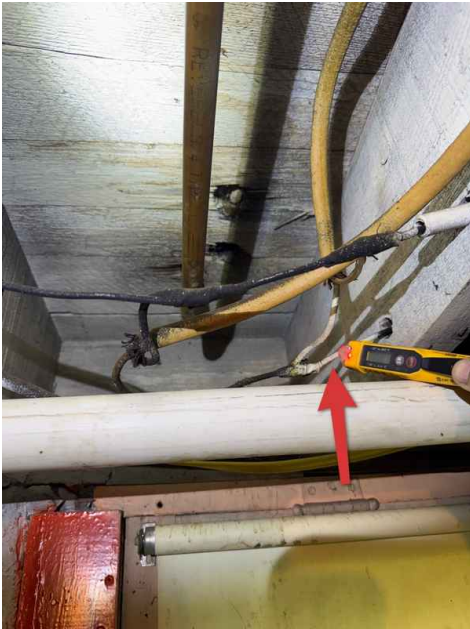
Basement

"Knob and Tube" (K&T) wiring observed during the inspection in one or more locations. K&T wiring is designed to dissipate heat into free air, and insulation will disturb this process. Insulation around K&T wires will cause heat to build up, preventing heat dissipation. K&T wiring also utilizes a cloth material as wire sheathing. Cloth sheathing generally is nearing the end of its life expectancy and can cause live wiring exposure. The 2008 National Electrical Code (NEC) requires that this wiring system not be covered by insulation. Specifically, it states that this wiring system should not be in hollow spaces of walls, ceilings and attics where such spaces are insulated by loose, rolled, or foamed-in-place insulating material that envelops the conductors. One option is to upgrade wiring. Recommend further evaluation by a licensed electrician.

Contact a qualified professional.

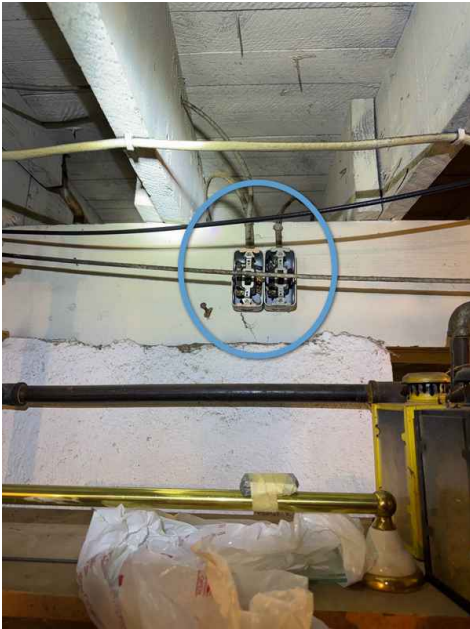
One or more receptacles/junction boxes are missing a cover plate/hardware. This promotes an electrical short and /or shock risk. One option is to install the correct cover plates. Recommend further evaluation by a qualified contractor.

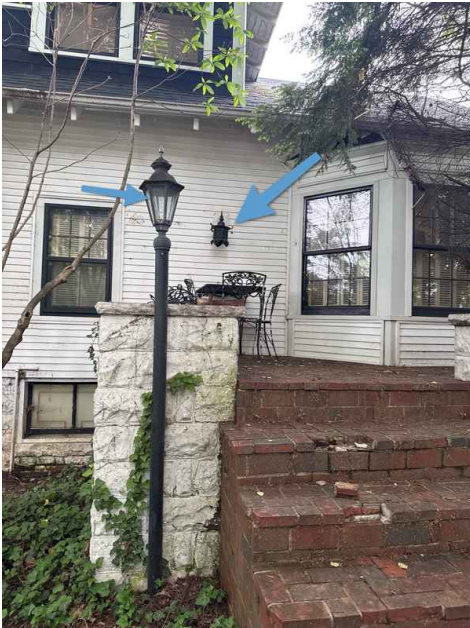
East

LIGHT INOPERABLE

One or more lights are not operating. New bulb/diode possibly needed. Recommend further evaluation by a qualified contractor.

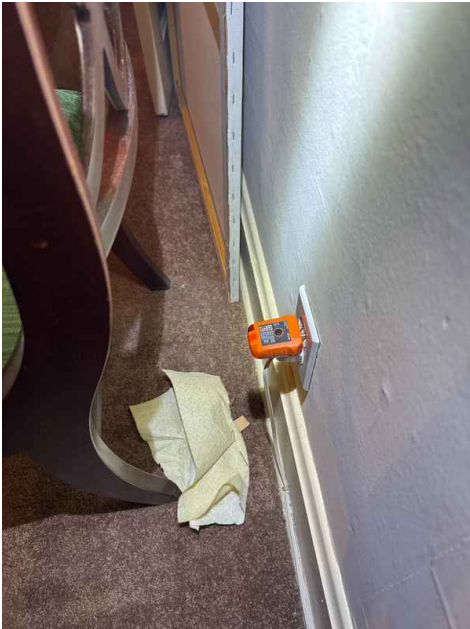
1st Floor 2nd Floor Basement

Ungrounded receptacle(s) observed during the inspection. As you perform upgrades, consider installing GFCI receptacles and/or ground connections. Recommend further evaluation by a qualified electrician.

Contact a qualified electrical contractor.

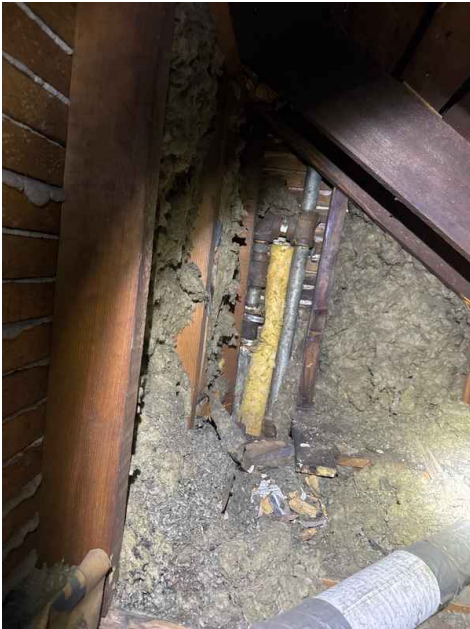
Insufficient insulation observed during the inspection. One option is to install additional insulation when performing upgrades.

Recommend further evaluation by a qualified insulation contractor.

Contact a qualified insulation contractor.

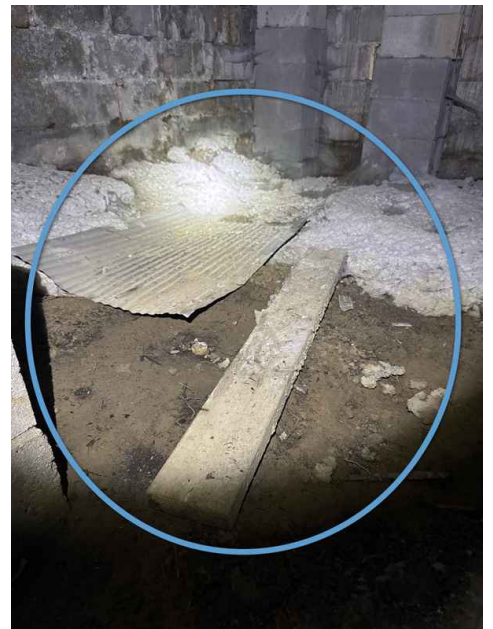
NO VAPOR BARRIER

There is no vapor barrier beneath the flooring in one or more areas of the crawlspace . This can result in unwanted moisture. Recommend further evaluation by a qualified professional.

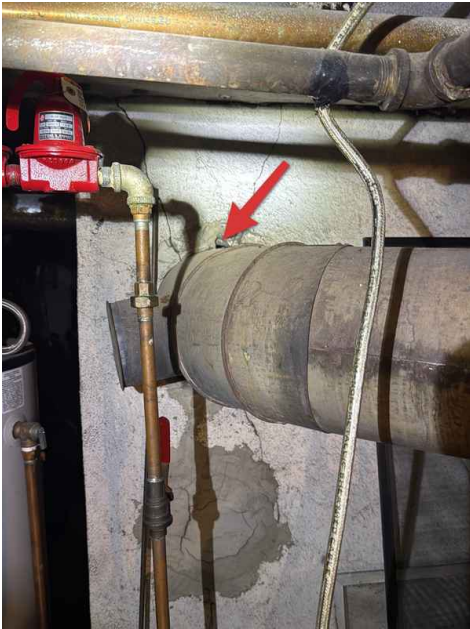
Basement

IMPROPER COMBUSTION EXHAUST TERMINATION

Combustion exhaust flue does not terminate to the exterior. This can cause over exposure to combustion exhaust fumes. One option is to terminate combustion exhaust flue to the exterior with the proper clearance. Recommend further evaluation by a qualified contractor.

Contact a qualified professional.

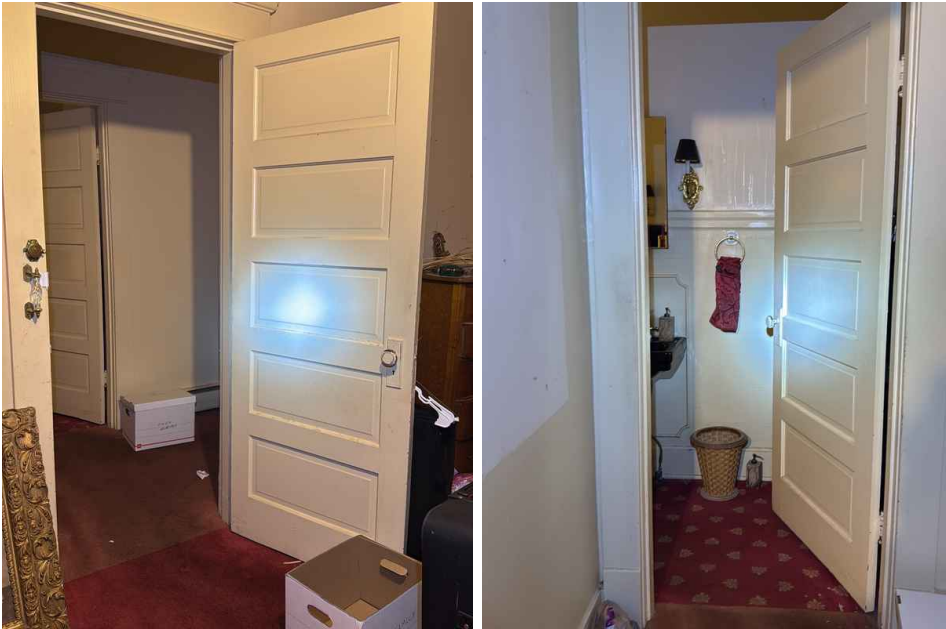
One or more interior doors need adjustments to close and function properly. Recommend further evaluation by a qualified carpenter.

Contact a qualified professional.

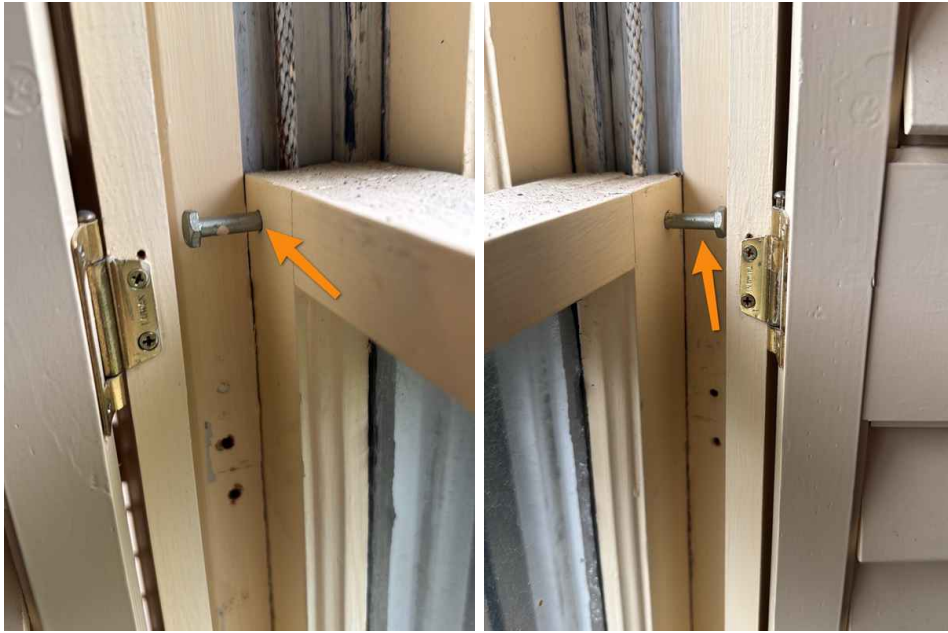
Unable to open window under normal operating conditions. Recommend further evaluation by a qualified carpenter.

Contact a qualified professional.

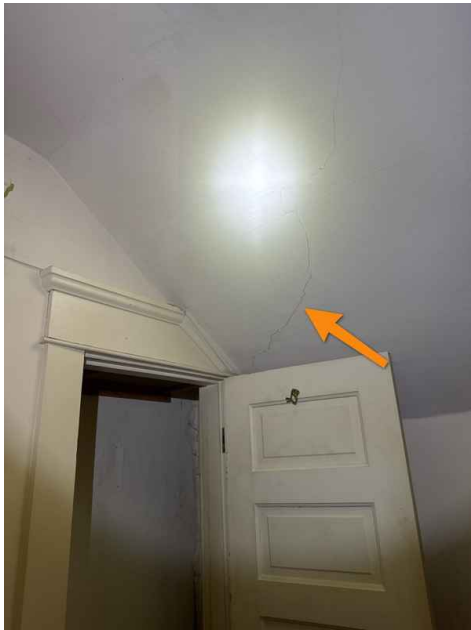
2nd Floor

Cracking visible at the corners of doors and windows. Recommend further evaluation by a qualified contractor.

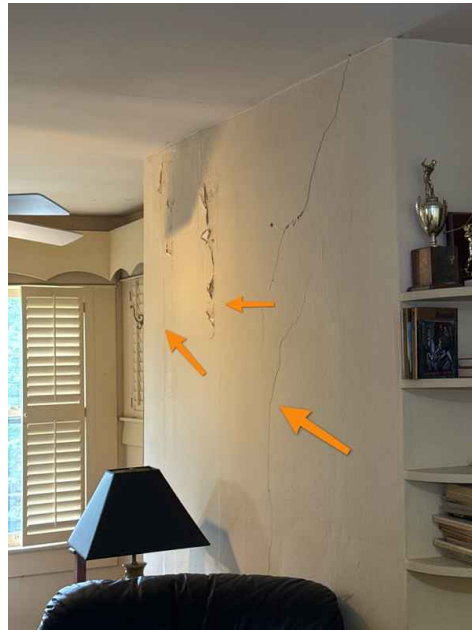
2nd Floor

10.5.2 Walls

MOISTURE INTRUSION EVIDENCE

Moisture intrusion observed at time of inspection along one or more locations. Recommend further evaluation by a qualified contractor.

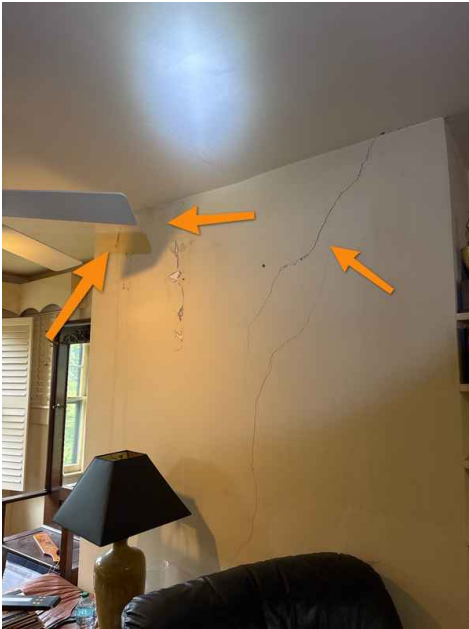
2nd Floor

ROOF/EXTERIOR/PLUMBING LEAK DAMAGE

Stains on the interior appear to be the result of roof/interior/plumbing leaks. The source of leakage should be identified and corrected. Recommend further evaluation by a qualified contractor.

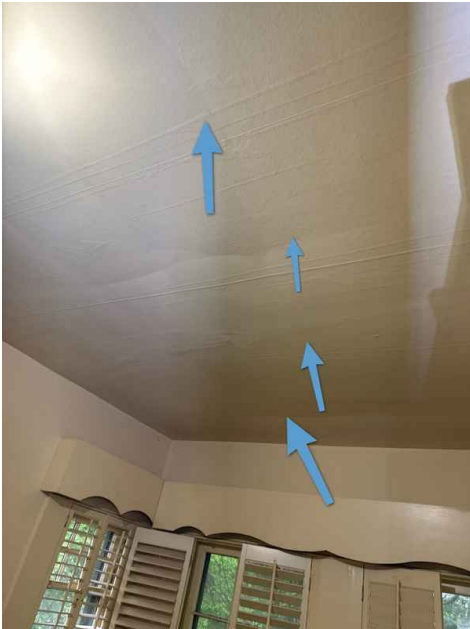
2nd Floor

Exposed tape joint/corner bead noted during inspection. This is not abnormal to see in a structure of this age. Recommend further evaluation by a qualified contractor.

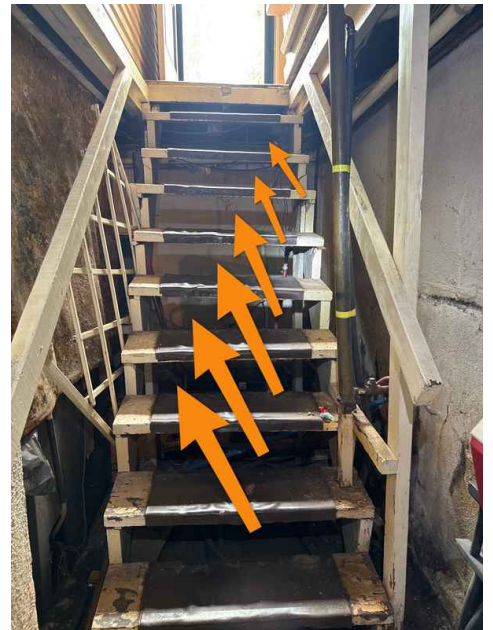
10.7.1 Steps, Stairways & Railings

MISSING/DAMAGED RISERS

Missing/Damaged risers observed during inspection. One option would be to install missing or damaged risers. Recommend further evaluation by a qualified carpenter.

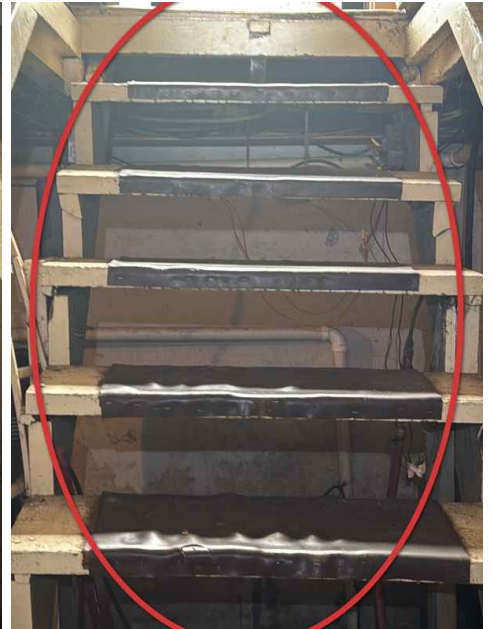
10.7.2 Steps, Stairways & Railings

DAMAGED STAIR SUPPORTS

Damaged stair supports/components observed during inspection. One option is to correct damaged areas. Recommend further evaluation by qualified Carpenter.

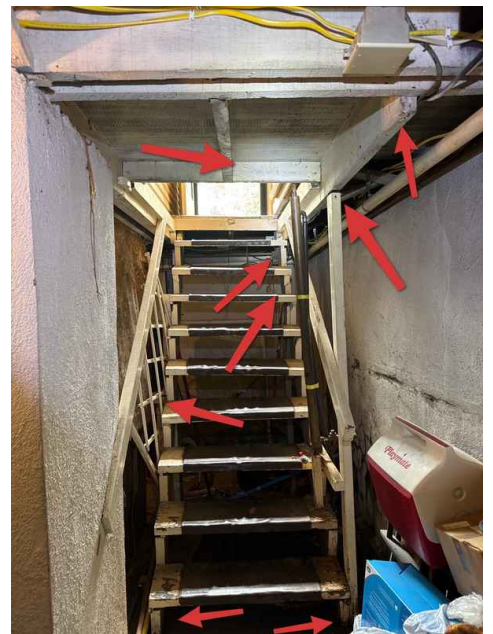
Basement

10.7.3 Steps, Stairways & Railings

UNSAFE STAIRWAY

A stairway was observed to have many general defects leading to it being unsafe for use. Recommend further evaluation by a qualified carpenter.

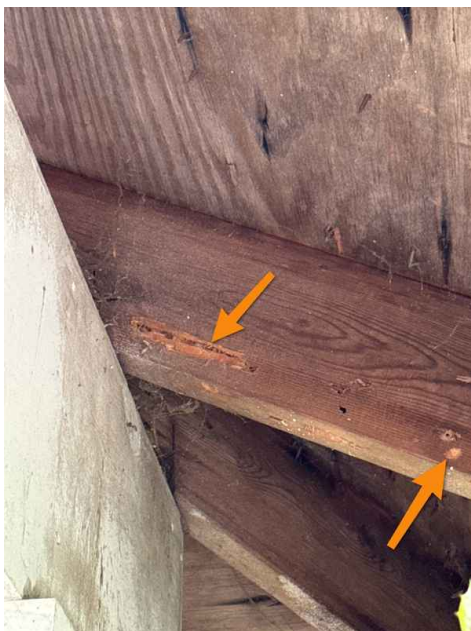
Garage

Evidence of wood destroying insects observed during the inspection. One option is to seek past history from current owner, and/or inquire with a Pest Management Company about an effective treatment plan for wood destroying insects. Recommend further evaluation by a qualified pest management/treatment contractor.

Contact a qualified pest control specialist.

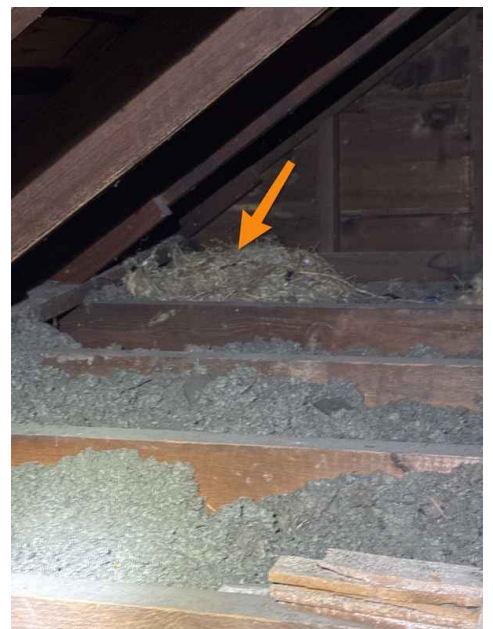
Southeast Attic

Evidence of current/past animal presence observed during inspection. Recommend further evaluation by pest management company.
