**AMERICORPS  
USDA  
NATURAL RESOURCES CONSERVATION SERVICE  
Lancaster Field Office  
44811 N. Date Ave Suite G  
Lancaster, CA 93534  
(805) 945-2604**

**AMERICORPS ACTIVITIES**

SUMMARY OF 1993-94 FLOOD PREVENTION  
AND  
RECOMMENDATIONS FOR 1994-95 RAINY SEASON  
Altadena / Kinneloa Fires

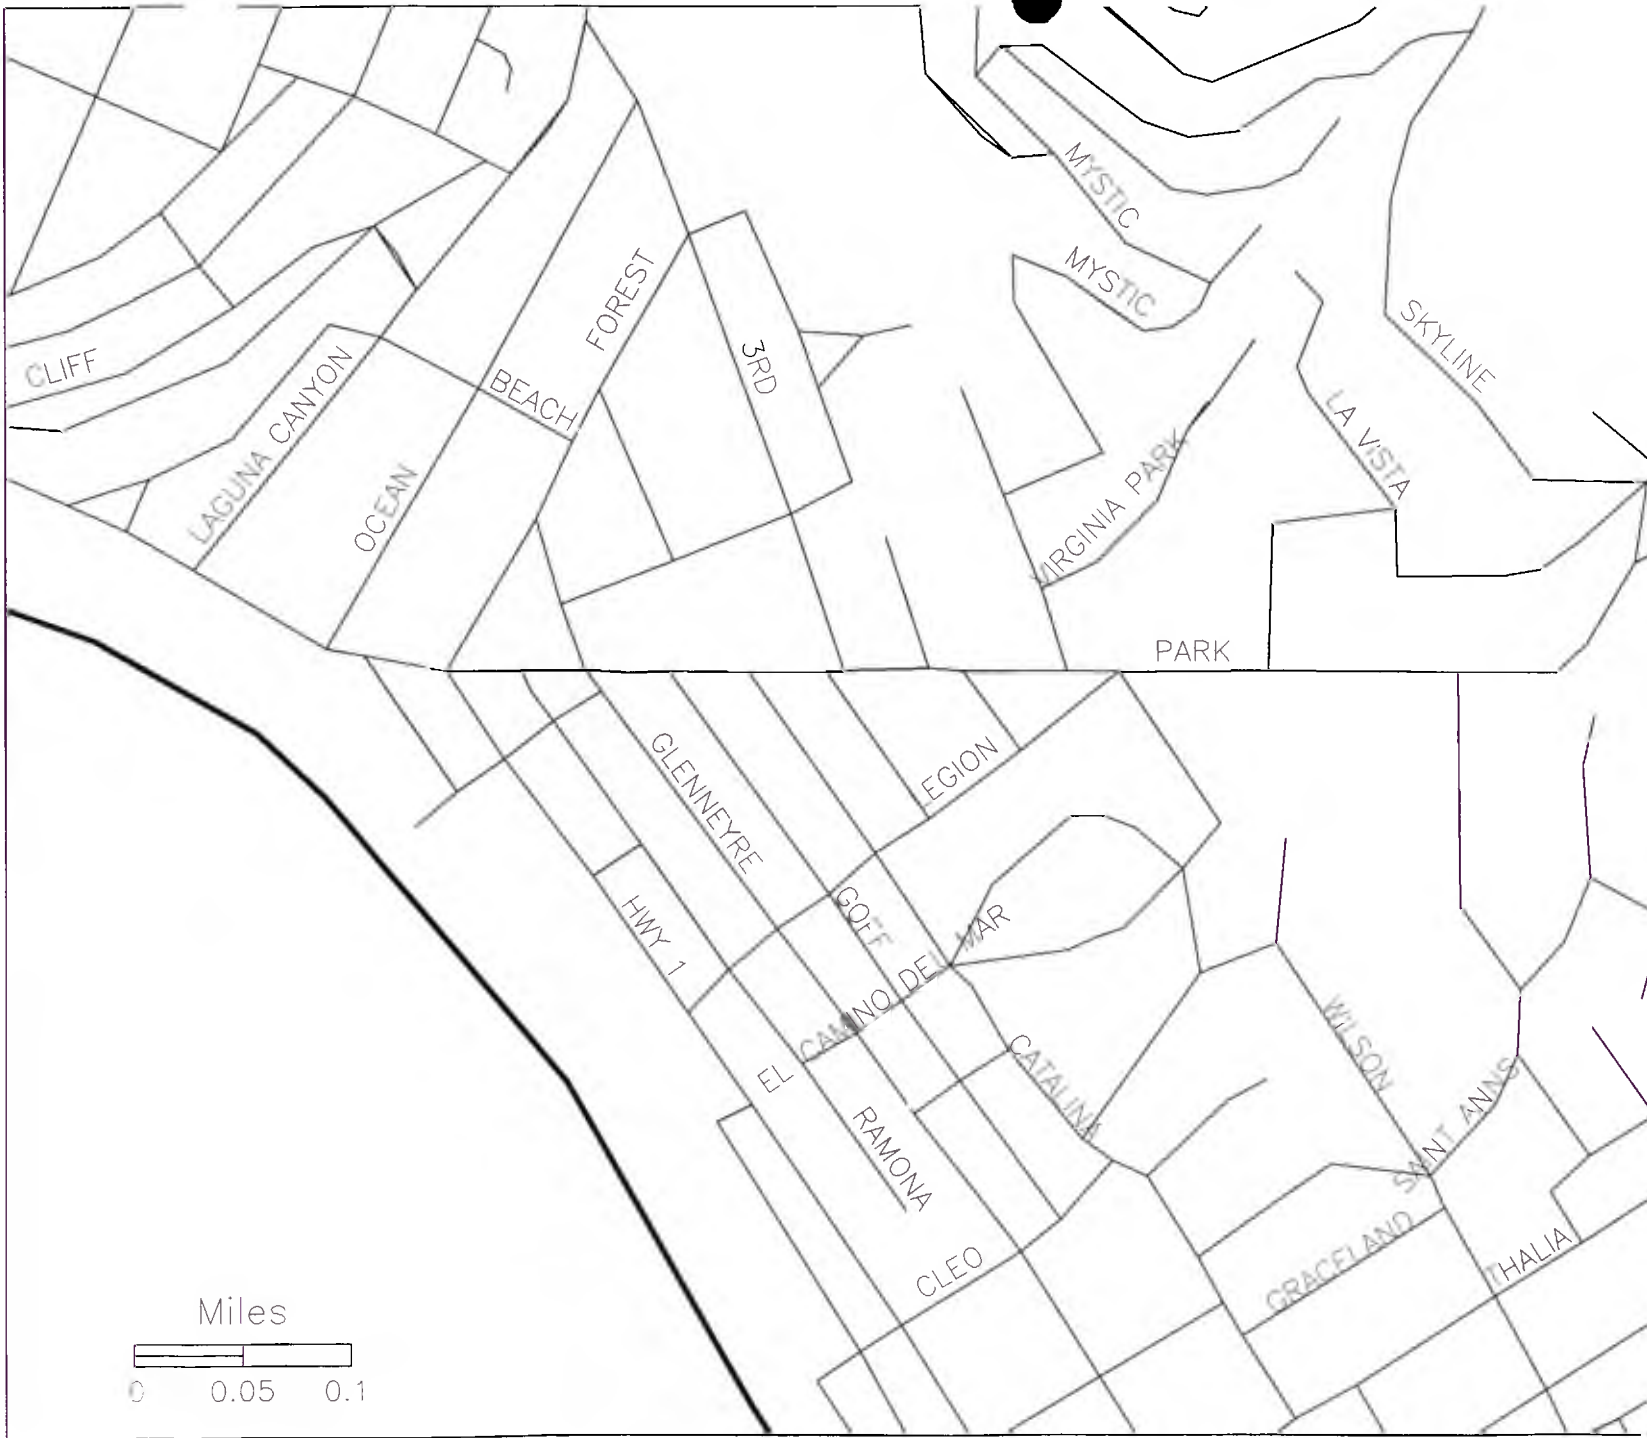
**9**

Park Avenue/Browncroft Burned Area - Maps A, 8, & 9

Coral Drive and Park Avenue - Remove all sandbags on slope between these roads. Sandbags are unstable and may cause a hazard to motorists.

Griffith Way - This street should have a permanent drainage system installed to direct and control flows that now travel along the roadway. All residential sandbags should be maintained or replaced with pipe and plywood deflector walls along the edge of the roadway. A two foot tall headwall should be installed behind 605 and 610 Griffith Way. An inlet structure located behind these homes is set at an elevation only slightly lower than that of the homes and may plug and cause flooding.

945 Park Avenue - Masonry or pipe and plywood deflector walls should be placed behind the residence on Park Avenue and the doorway should be sandbagged for additional protection. The flow path from the Park Avenue overflow is only three inches below the lower story glass doorway, and water flowing through may cause damage to the home.

Hidden Valley Canyon - All loose and unstable straw bales on the hillside should be removed, as they are a hazard to the residents below. Straw bales may be opened and the straw spread for mulch on site.

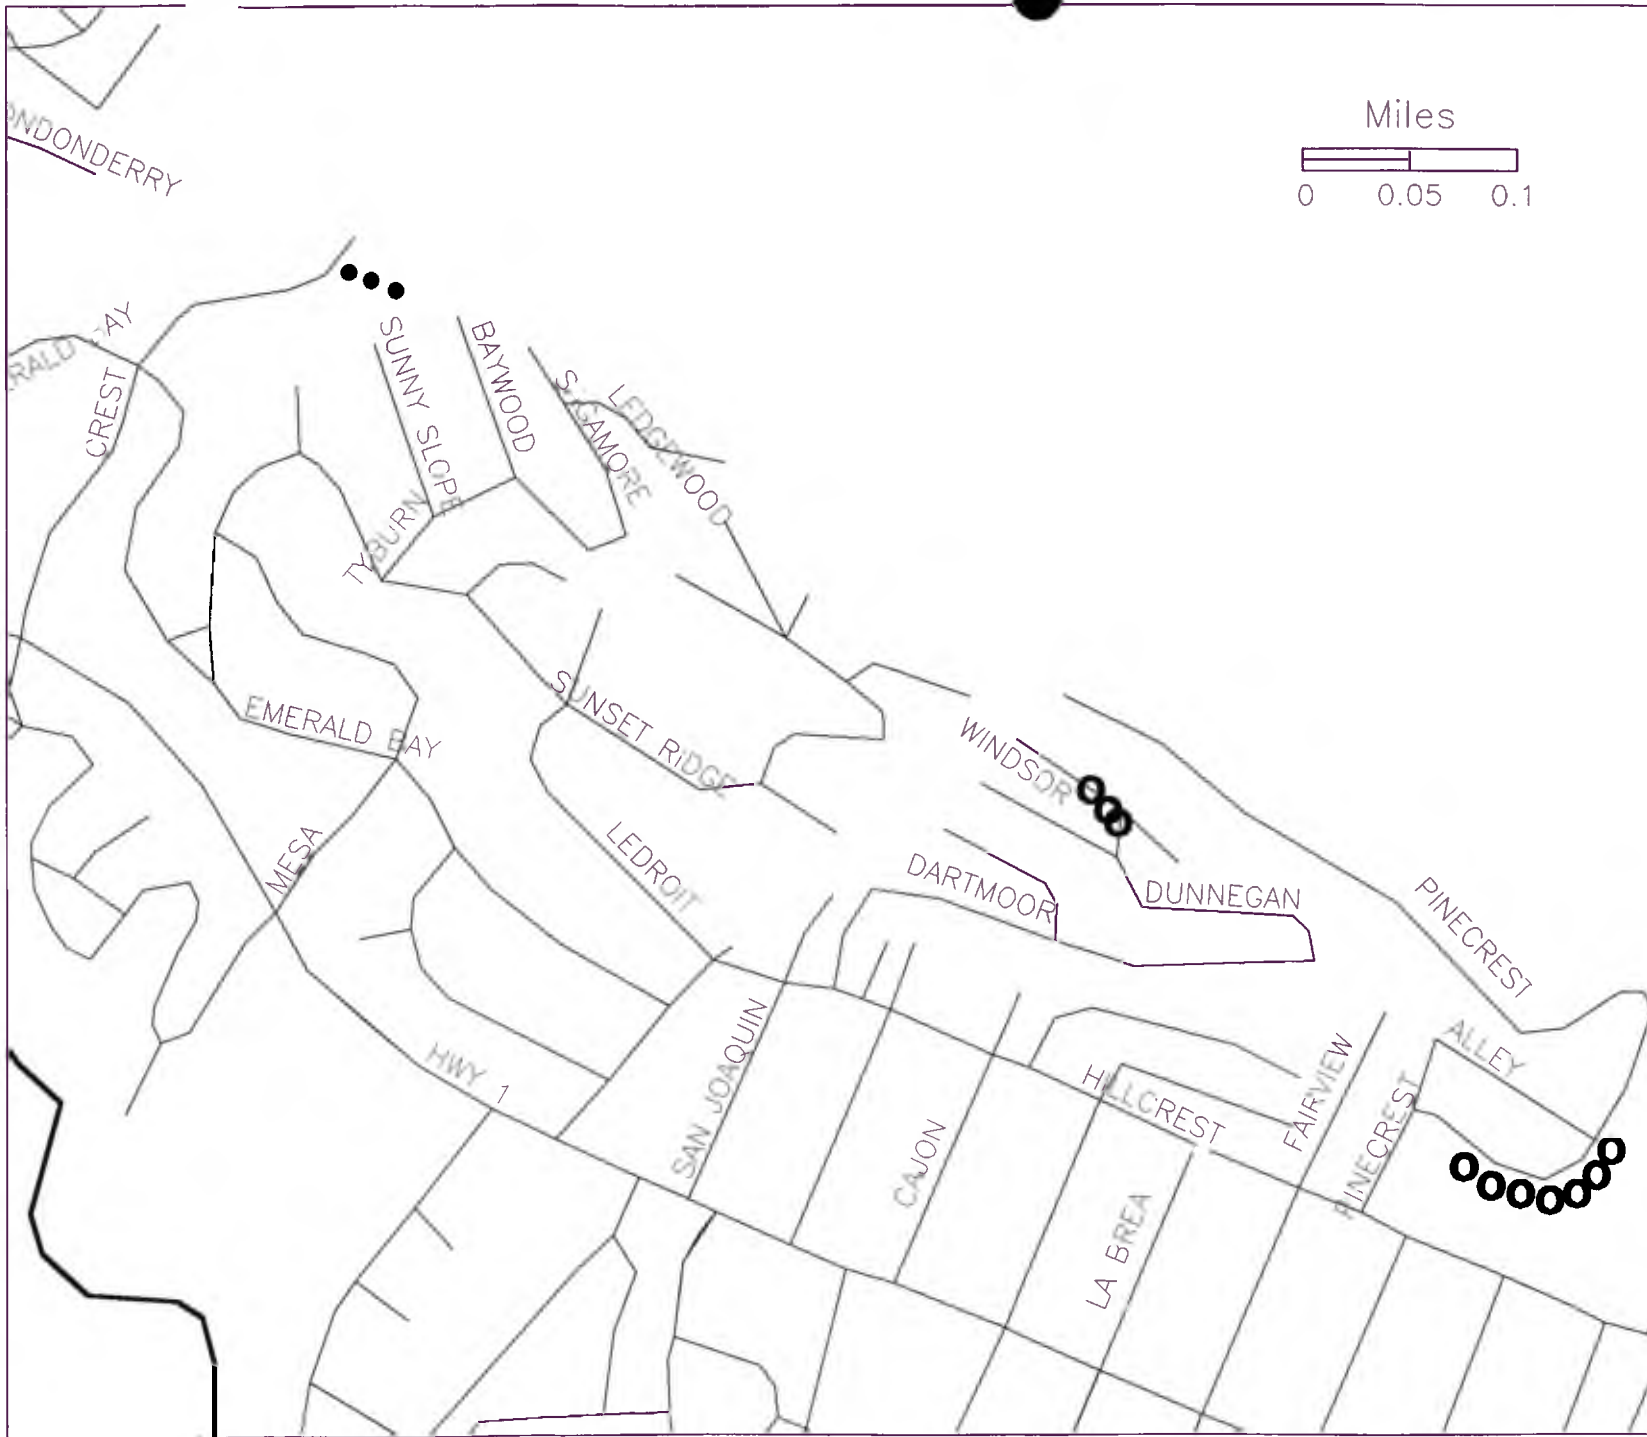
**12**

#### Lookout Drive Burned Area - Map 12

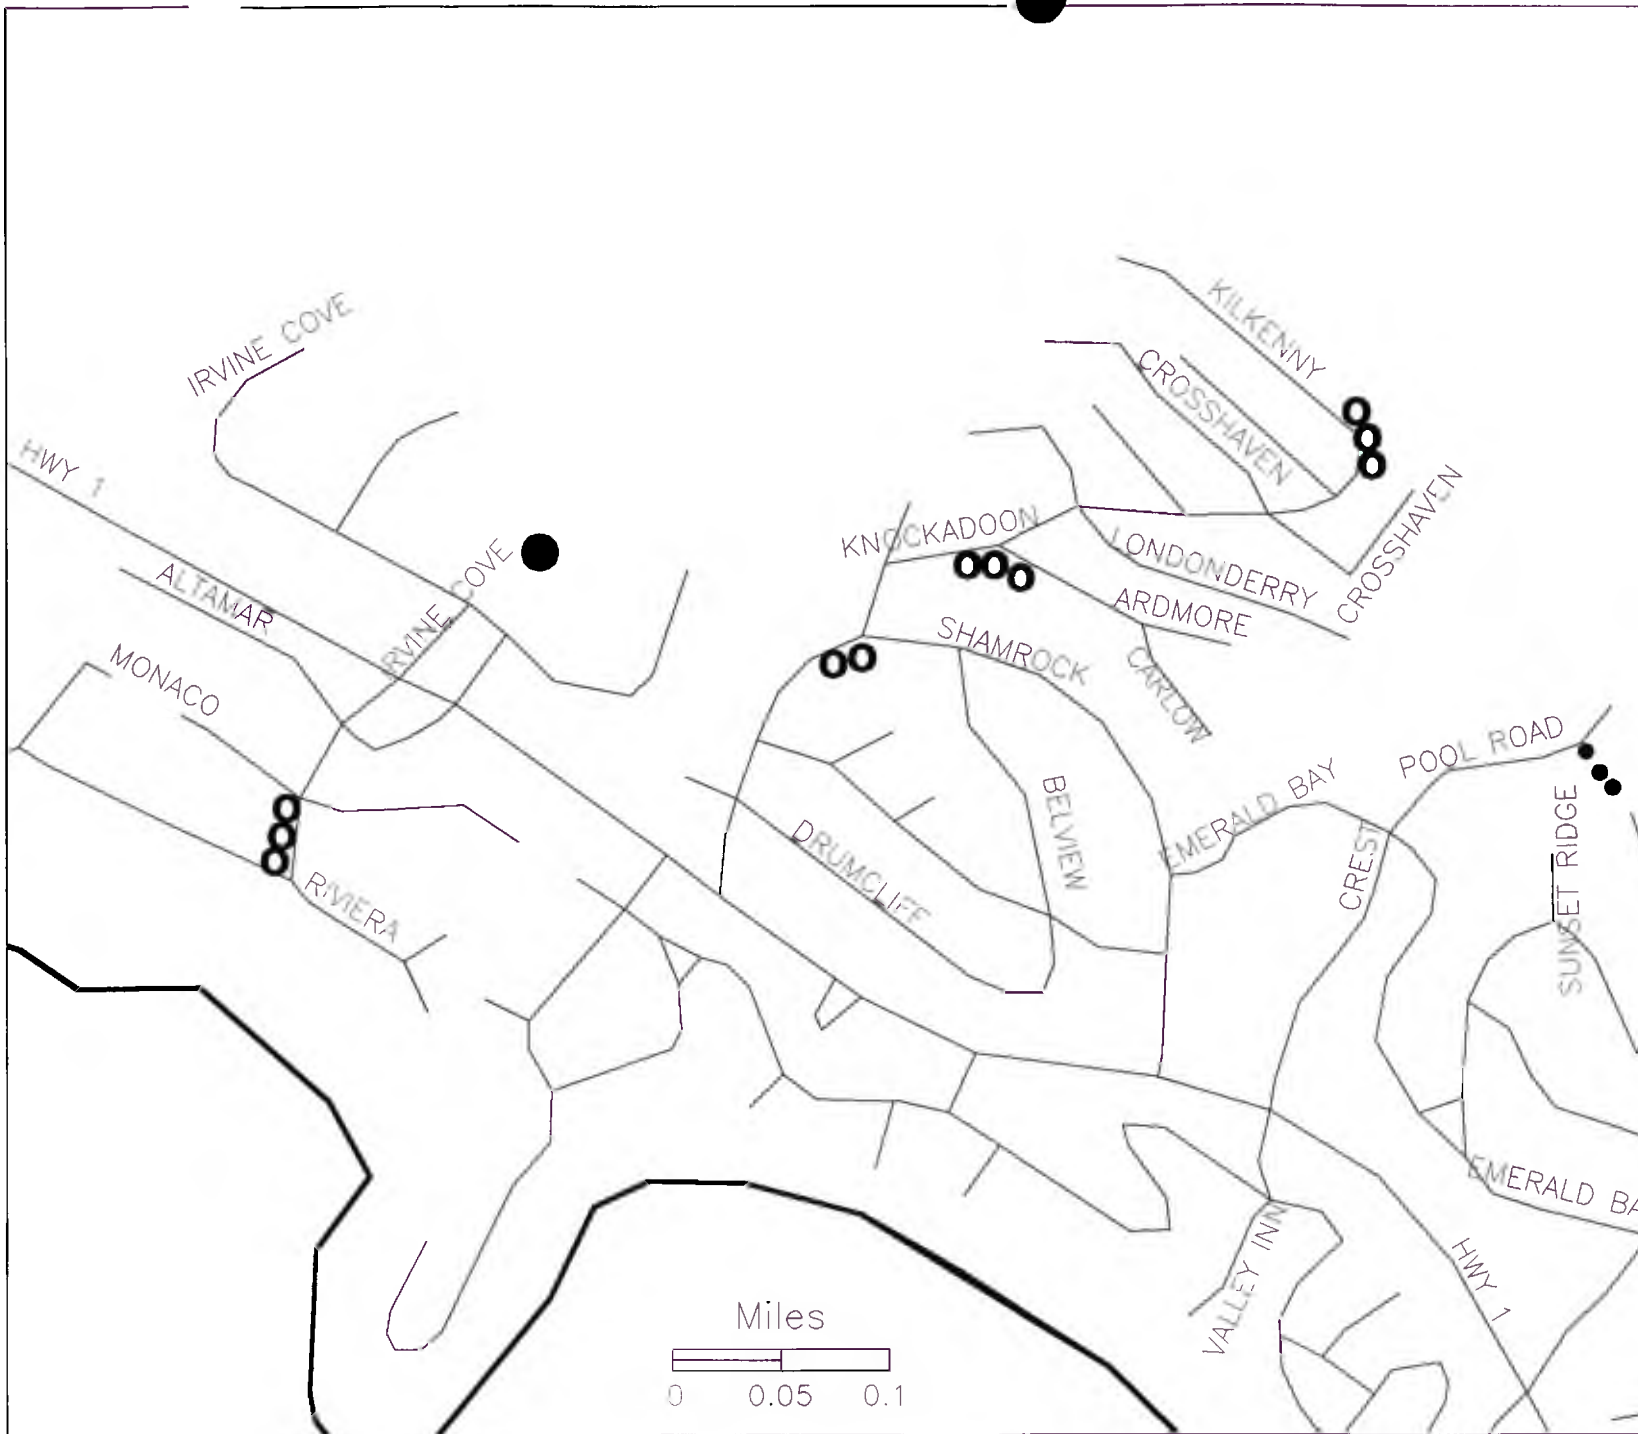
**14**

#### Irvine Cove Burned Area - Map 14

The silt fence installed at the northeast boundary of the residential area is in good condition and may remain in place. The fence should be inspected regularly and maintained as needed.

Irvine Cove Crest Road - The sediment basin located east of the road should be cleaned out, enlarged to the east and a grouted rock inlet structure added. The sandbags placed across the outlet structure should be removed. They are causing the drop structure to plug and they could fail in the event of heavy debris flows. Sandbags should be installed across driveways and curbs at homes west of Pacific Coast Hwy., downstream of canyon (102 Irvine Cove Dr. and 2501 Monaco). The series of straw bale/sandbag check dams located in the channel above the sediment basin should be removed. Some of these dams have failed while others have deteriorated and headcutting has occurred, increasing the chances of failure of the remaining dams.
