**EVALUATION OF WATERSHED CONDITIONS AND HAZARDS**  
**and**  
**RECOMMENDATIONS FOR ADDITIONAL PROTECTIVE**  
**MEASURES**

**for the**  
**LAGUNA FIRE AREA**  
Orange County, California

January, 1995

Prepared by:  
USDA, Natural Resources Conservation Service  
and  
AmeriCorps National Service  
Lancaster, California

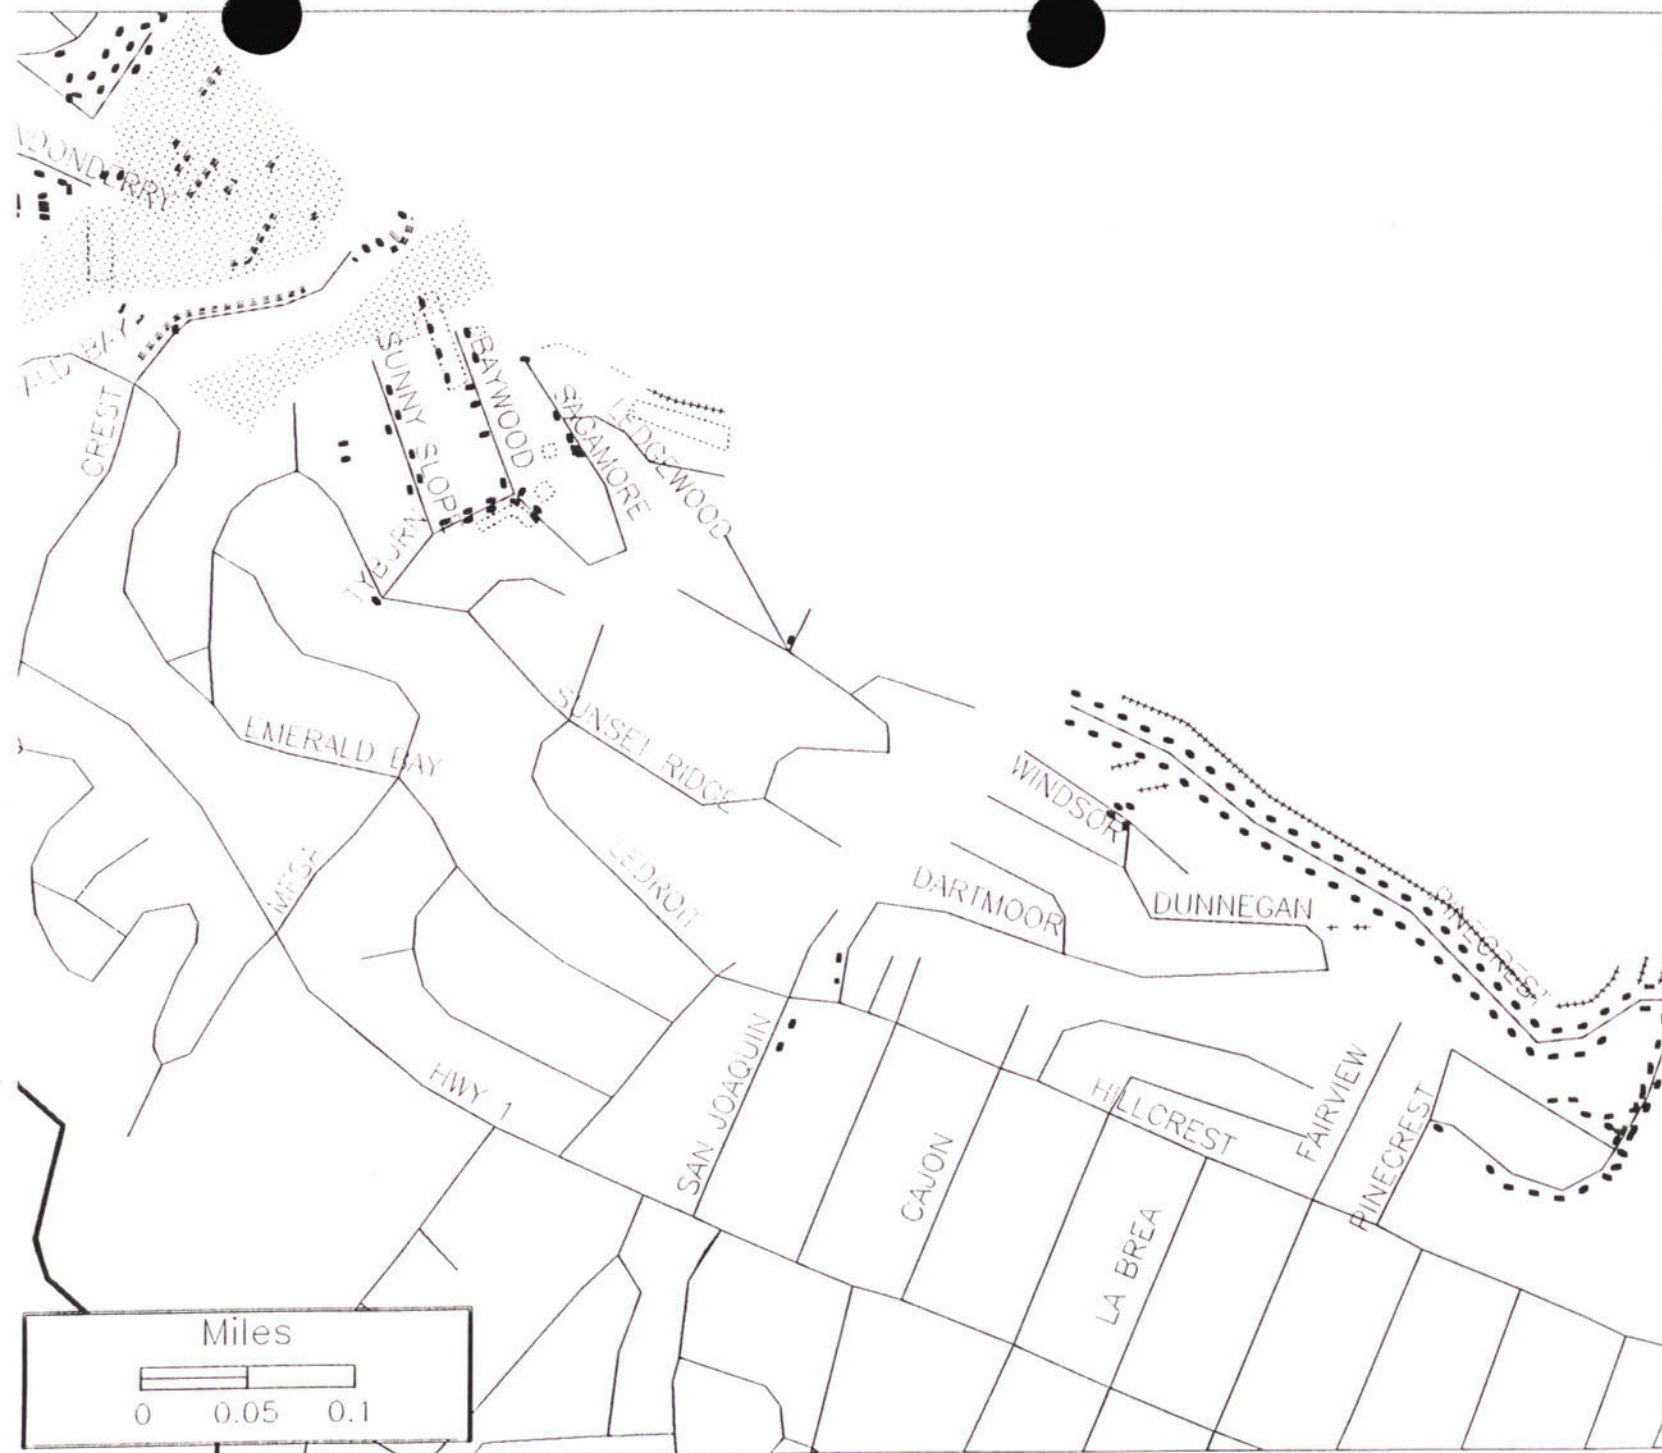
# 13

Emerald Canyon - The pipe and timber debris/sediment barrier installed in the Emerald Canyon drainage was damaged and buried in the January storms. The channel bottom has stabilized and there is no need for the structure to be repaired.

The chain link fence across the channel near the tennis courts should be removed. It has failed in the January storms and could plug a culvert located downstream. The fence was protecting the culvert that, if it plugs, would cause little damage that would be limited to clean up. The fence could be replaced with a pipe trash rack.

Emerald Bay, North - Sandbags should be replaced at the following residences to provide protection from flood waters: 911 Shamrock, 1423 to 1425 Knockadoon (2 bags high/1 wide), 1005 Knockadoon (2 bags high across driveway, 1 high across curb).

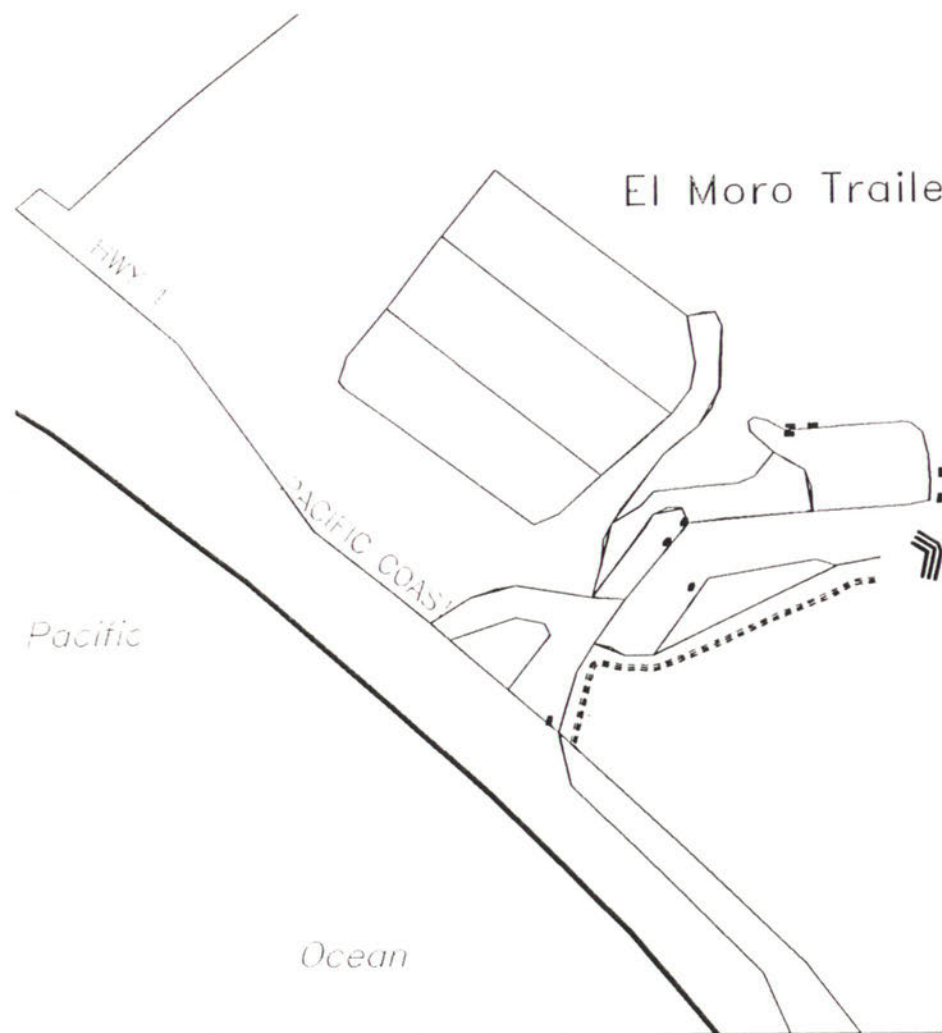
# 15

The temporary trash rack, installed in El Moro Canyon on California State Park land, failed in the January storms. A headcut developed at the Pacific Coast Highway crossing, eroding upstream to the structure in a wedge shape. The cut was up to ten feet deep at the structure, undermining the rack, and causing failure. The State Park agency has requested that the County remove the remains of the structure. Grade stabilization structures may be installed to prevent future headcutting in the channel but a hydraulic and hydrologic study should be conducted before anything is installed in the channel.

Straw bales originally placed adjacent to the stream corridor have been removed and new mobile homes have been installed. Straw bales need not be replaced.

Sandbags at the north and east ends of the trailer park should be replaced, to divert water flow away from homes.
