# Laser Engineered Net Shaping® for Repair and Hydrogen Compatibility

*LENS technology seems well suited for repair of overbored reclamation-type materials, but additional process development is required for other types of repairs*

BY P. S. KORINKO, T. M. ADAMS, S. H. MALENE, D. GILL, AND J. SMUGERESKY

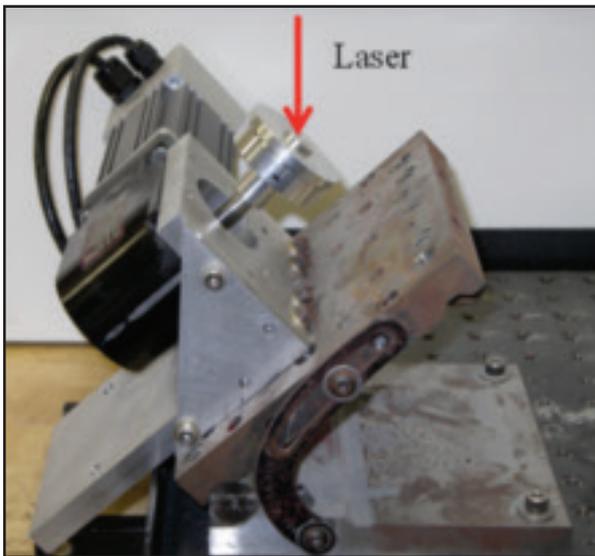
Fig. 3 — The reclamation weld bases were repaired using the 4th axis mounted in the LENS machine at 45 deg to horizontal.

The bore was filled utilizing a 4th axis unit mounted in the LENS machine with the axis of rotation at an angle of 45 deg from horizontal, as shown in Fig. 3. This approach was used to allow the laser to deposit material on the bottom of the bore as

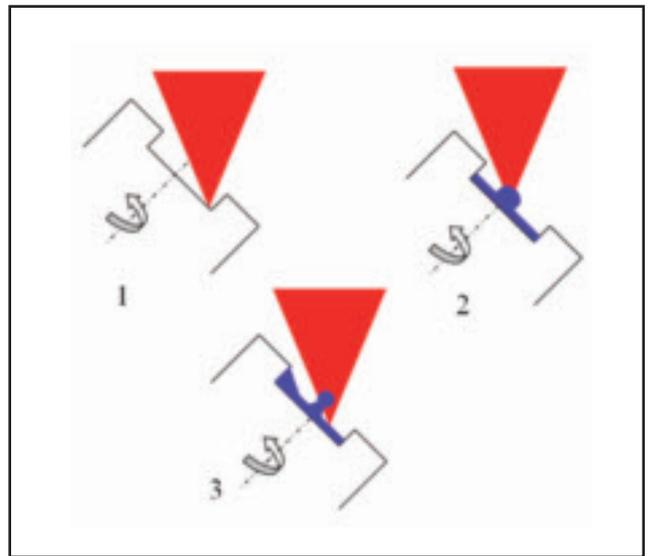
Fig. 4 — The repair proceeded from the outside to the center of the bore with the axis greatly increasing in rotational speed for each subsequent ring.

well as the walls. Concentric rings of material with decreasing radii were deposited on the bottom of the bore from the outside to the center. The laser then incremented up one layer and deposited the next layer from the outside to the center again. In this way, the bore was filled. In the initial efforts, the rotational speed of the weld base on the 4th axis was increased as the radius of deposit was decreased such that the apparent feed rate remained constant regardless of radius size. The method presented several challenges, however. As seen in Fig. 4, as the laser approached the center of the bore, the heat built up and caused excess powder to be entrained in the melt pool, thus creating a bump. By the second pass, the bump became tall enough to grow into the beam even when the laser was depositing at the outer edge. This caused the beam to be obscured at the outer edge and caused the bump to grow at a very high rate all the time. To address this issue, the rotational speed of the axis was increased near the center to considerably higher speeds than used previously. In addition, the very center of the part was not filled on the first several passes. This allowed high-quality material to be deposited on the walls of the part without obscuring the center. It did mean that the center material did not adequately fuse with the layer below it. This attribute was not important since the center of the hole is sacrificial material and would be removed as part of the RW preparation of the test bases. In fact, the center material was just provided to allow the hole to be drilled, if desired, rather than helically interpolated with a mill, which is a more time-consuming process.

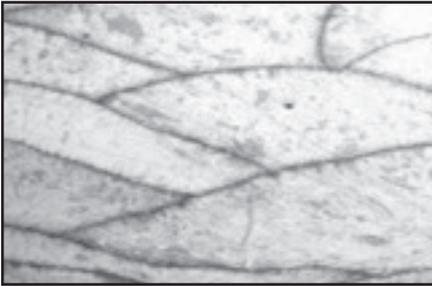
Fig. 10 — Representative microstructure of as-processed 304L LENS materials [polished and electrolytically etched (10% oxalic acid)].

and examined using light optical microscopy. The multilayered structure displayed in Fig. 10 is characteristic of LENS-deposited materials and depicts the nature of the multipass deposition technology with very fine grains and interpass and interlayer interfaces. Unfortunately, higher magnification images were not taken so the solidification morphology and primary solidification mode cannot be discerned.

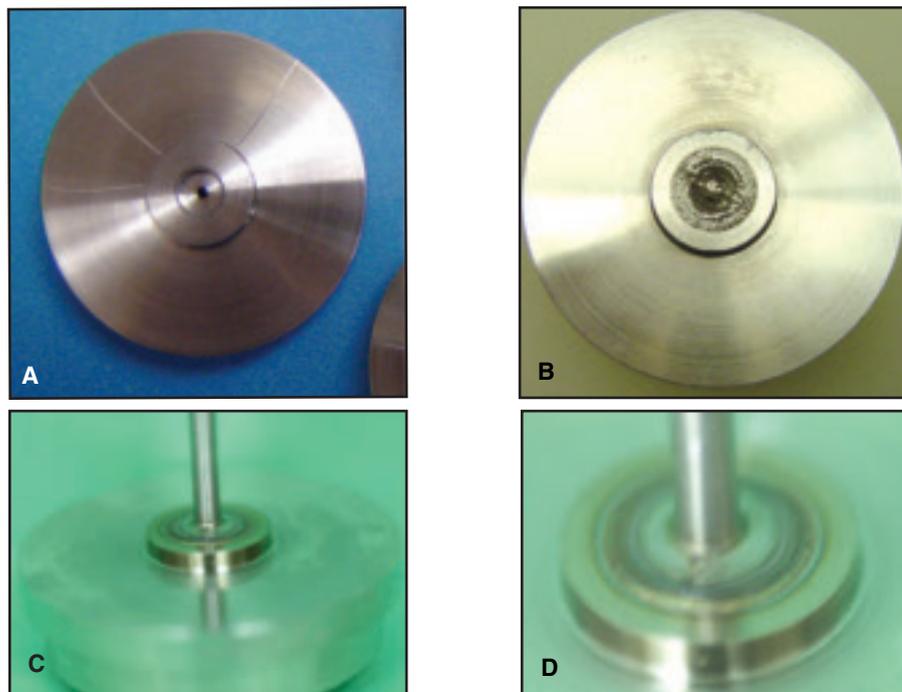
Reclamation welds were made using the nominal weld parameters for common production-type test bases fabricated from Type 304L stainless steel, i.e., 2250-lb (5.56-kN) loading force, 11,400-A welding current, and 25 weld cycles based on a 60-Hz weld process current. All of the welds were performed in a manner consistent with the production weld parameter range. Typical reclamation test bases in the as-machined, as-repaired, and as-welded conditions are shown in Fig. 13. There is a small amount of heat banding and some material extrusion around the weld; these features are typical of normal production reclamation welds.

Fig. 13 — LF-7 test base in the following conditions: A — As machined; B — as LENS repaired; C and D — as welded.

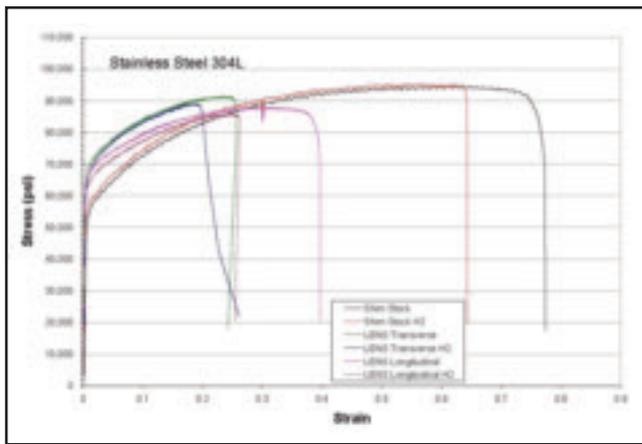
Fig. 15 — Tensile testing curves for 304L sheet stock and LENS materials in the hydrogen-charged and baseline conditions.

Typical results from the tensile testing and small sample punch testing of 304L LENS samples are shown in Figs. 15 and 16. The tensile curves in Fig. 15 show that for both the longitudinal and transverse sample directions (longitudinal and transverse to the build direction of the 8 cm<sup>3</sup> block), there is little difference in the yield strength (YS) and ultimate tensile strength (UTS) comparing identically oriented samples exposed to hydrogen to those not exposed. The largest difference between the unexposed and exposed samples occurs with respect to the percent elongation to failure (%EL). The %EL in both orientations decreased following exposure of the materials to hydrogen. This indicates the reduced ductility from hydrogen embrittlement, which would manifest itself potentially in reduced fracture toughness. Examination of literature data for 304L in both the unexposed and hydrogen-exposed conditions shows a similar trend — little change, to some strengthening — in the tensile properties of YS and UTS with greater change in the %EL upon exposure to hydrogen (Ref. 26). Further analysis of this literature fracture data for samples that exhibited reduced %EL upon exposure to hydrogen has shown a reduction in the ductile fracture toughness on the order of 25–40%.

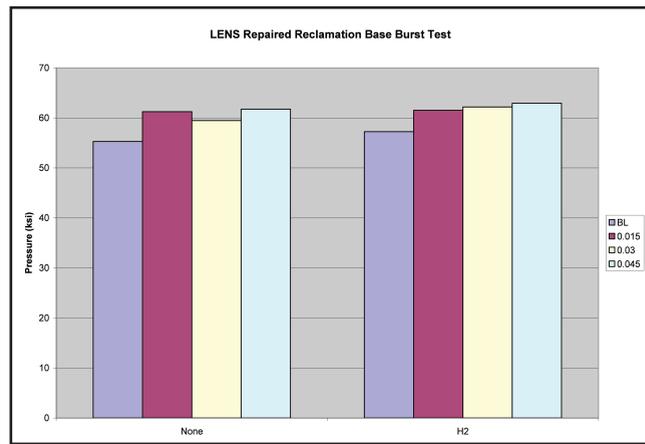
Fig. 17 — Hydroburst pressures for baseline, lens repaired, and hydrogen charged fill stems show that no adverse effects are indicated.

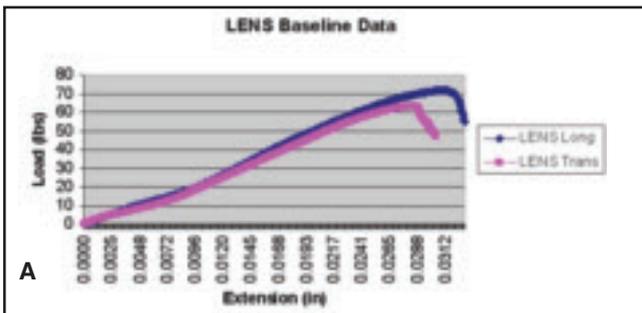
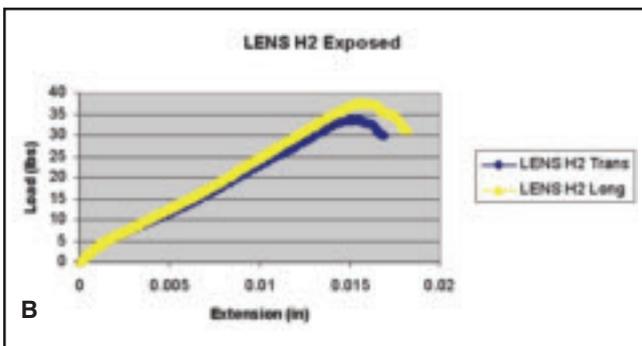
Fig. 16 — Small sample punch testing curves for Type 304L LENS materials in the following conditions: A — Baseline; B — hydrogen charged.

Analysis of the small sample punch test data in Fig. 16 to estimate the reduction in fracture toughness of the LENS process 304L material upon exposure to hydrogen has been performed. Calculation of the biaxial fracture strain  $\epsilon_{qf}$  using Equation 1,

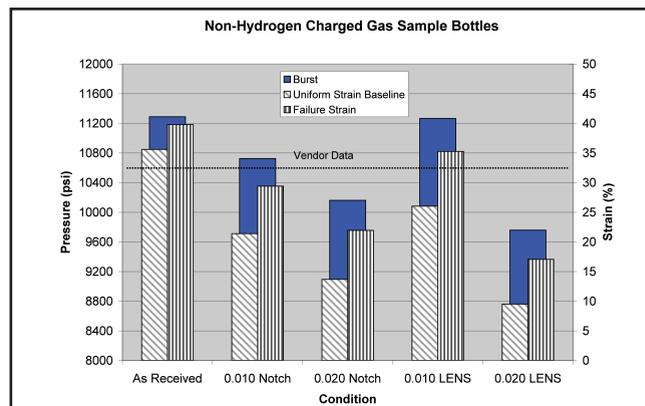
Fig. 19 — Effect of notches and LENS repair on burst properties of gas sample bottles.

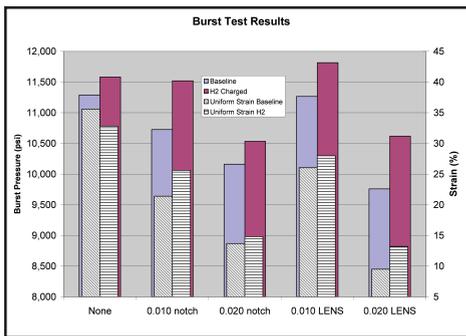
Fig. 20 — Effect of hydrogen on baseline and LENS-repaired samples.
