# ***FOUNDRY DEFECTS*** ***(Some Tips)***

Practical Causes, Observations and Remedies

**Prepared by: P. Arul Mozhi Devan**

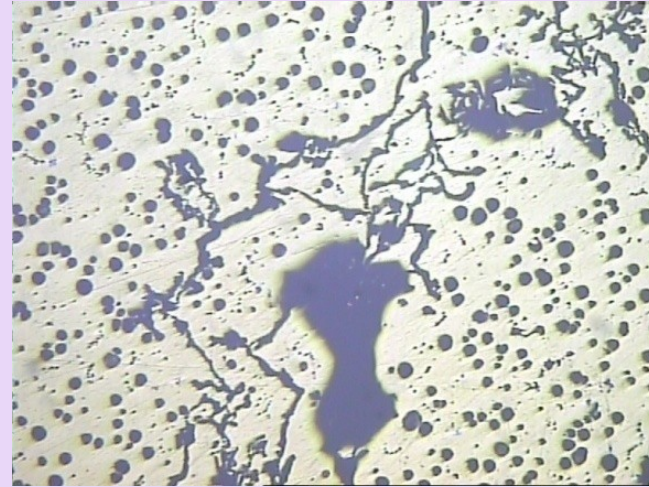
## Slag inclusion

In Using salt tube to break the heavy blockage of slag , agitated the mass slag into lose and then get entry into the mould

This is a combinatiion of MnS,MgS,MgO and MgSiO<sub>3</sub>

Avoid the salt tube inserting,launcing with oxygen.Slag off at every stages before transfer into press pour.

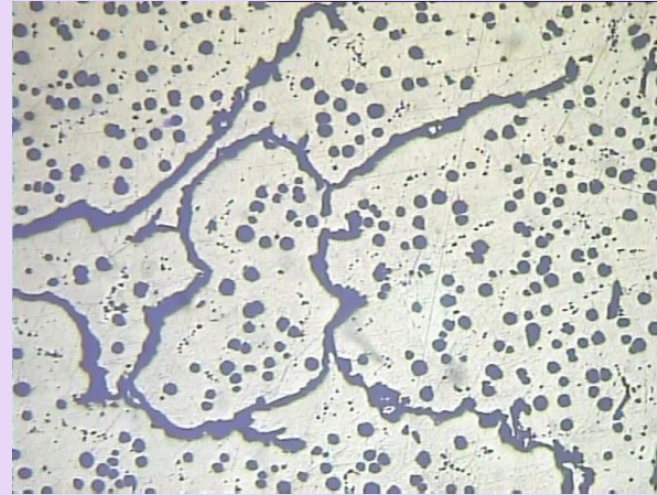
Magnesium Silicate inclusion. This layer type inclusion is  $\text{MgSiO}_3$ . As seen in the photo there was little or no chemical reaction between this compound and carbon, hence the absence of a gas envelope in the surroundings. The oxygen laden inclusions disturbed the spherical graphite structure very little. Indeed they seem to have acted as nuclei for a relatively large number of spheroids in the immediate neighborhood. In fact the majority of the inclusions exhibit a graphite layer next to itself indicating again a graphite nucleating effect. This is due to poor gating system leads

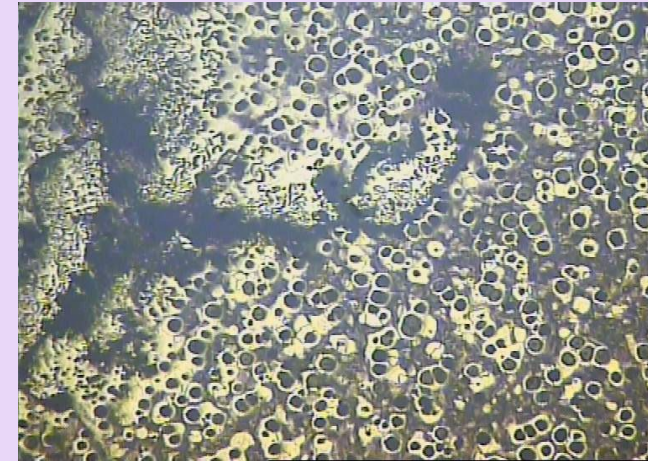
- conversion Grey iron to S.G.iron. That means high sulphur content iron in the press pour while conversion form MgS and MnS that may get entry into the cavity during pouring.

During conversion self items to be produced at least 3 treatment with 20 to 25% more Mg to dilute the Sulphur present in the metal and inside the ladle to saturate with MgO so as Mg. fading will be extended

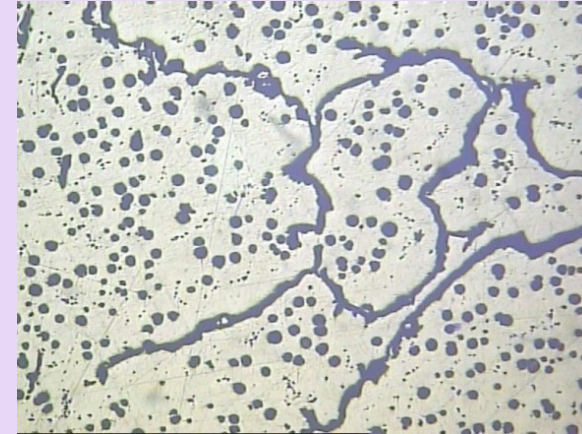
Slag Inclusion (Dross)

Convertor slag . Due to pure Mg. treatment ,the sulphur and the oxygen in the metal react with Mg. and form  $MgS$ ,  $MgO$ ,  $MgSiO_3$ . These are liquid slag and chances are there to get entry into the mould cavity irrespective to filter and gating system.

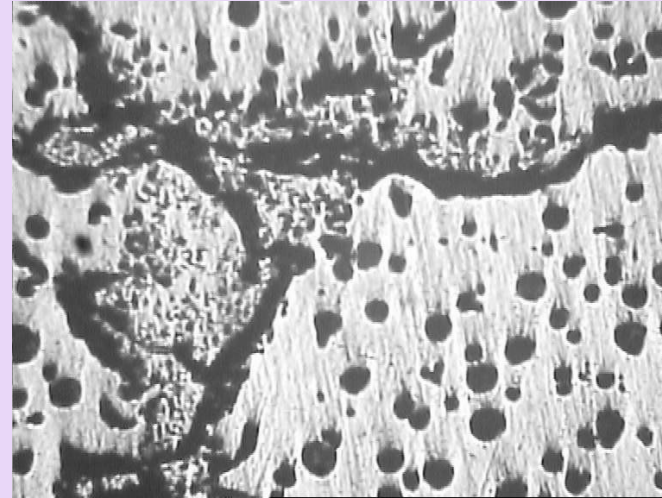
## Slag Inclusion

Conversion grey iron to sg iron .That means high sulphur content and Manganese content in the press pour while conversion form MgS and MnS that may get entry into the cavity during pouring. Poking with steel rod when spout gets blocked or lancing with oxygen generate MgO,MgSiO<sub>3</sub> slag.

During conversion self items or suitable parts to be produced at least 3 treatment with 20 to 25% more Mg to dilute the Sulphur ,chromium etc.

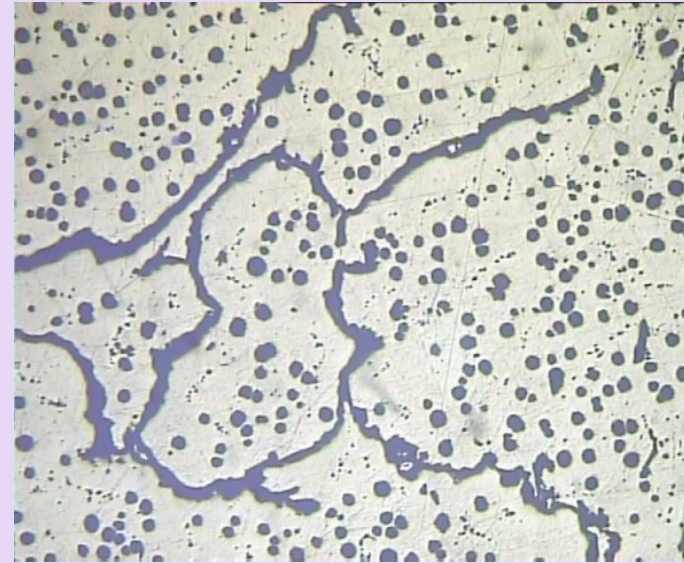
. Magnesium Silicate inclusion. This layer type inclusion is  $\text{MgSiO}_3$ . As seen in the photo there was little or no chemical reaction between this compound and carbon, hence the absence of a gas envelope in the surroundings. The oxygen laden inclusions disturbed the spheroidal graphite structure very little. Indeed they seem to have acted as nuclei for a relatively large number of spheroids in the immediate neighborhood. In fact the majority of the inclusions exhibits a graphite layer next to itself . Poor Gating system. Filling is not quite, More Turbulence .

Improve the gating system so as no turbulence, Control the Magnesium to max.0.05%.Ensure slag off before pouring into moulds.

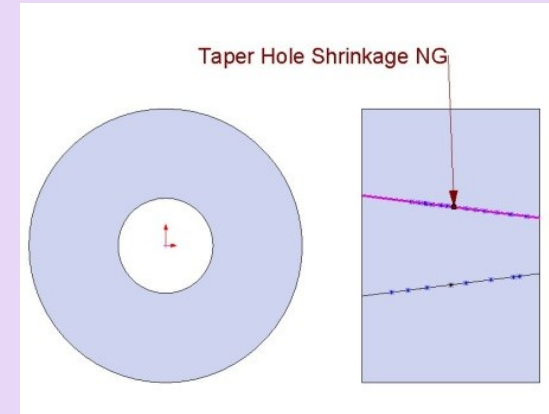
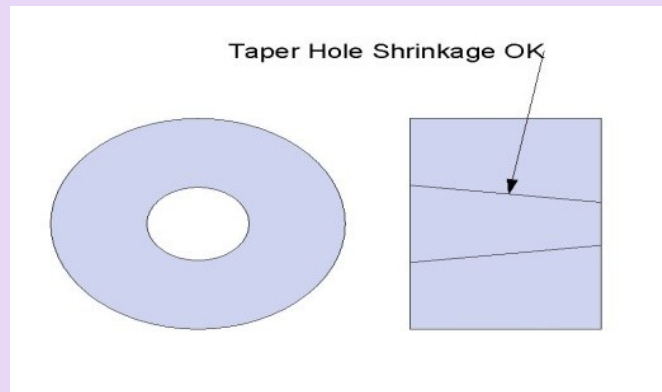
## Tapper Hole porosity

.Insufficient feeding or not uniform cooling due to isolated section.  
Heavy flash around the boss.

, Gating modified.  
Provision of hot or cold riser at  
the tie rod arm boss.

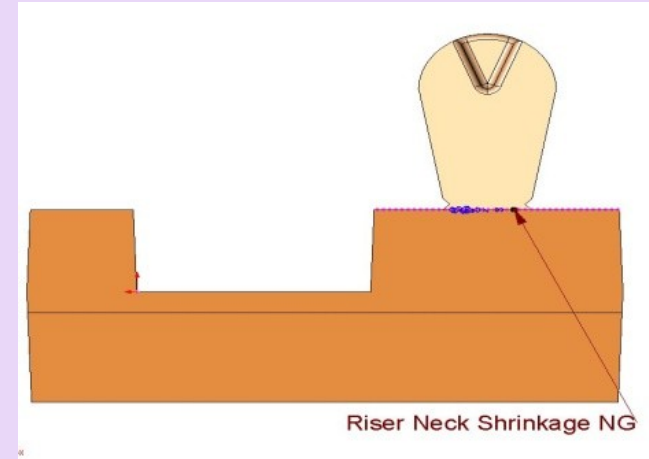
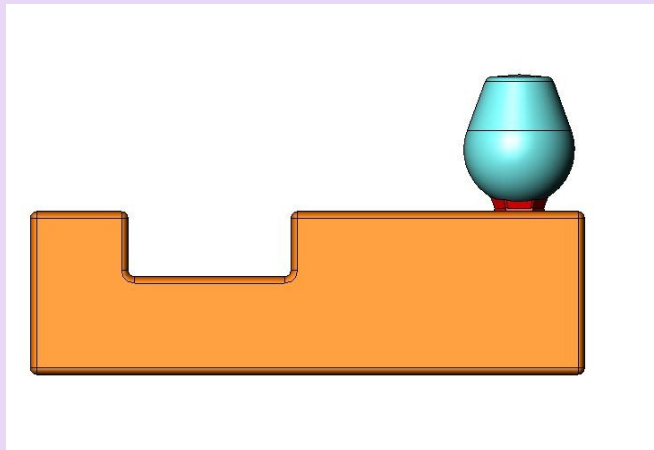
## Riser neck shrinkage

Too large riser neck than required. Soft ramming around the neck due to narrow pockets. Hot zone around the neck make neck solidification slow.

Riser neck AREA TO REDUCED to the process variation. Improve air vents around the neck for better ramming. Reduce hot zone around the neck.

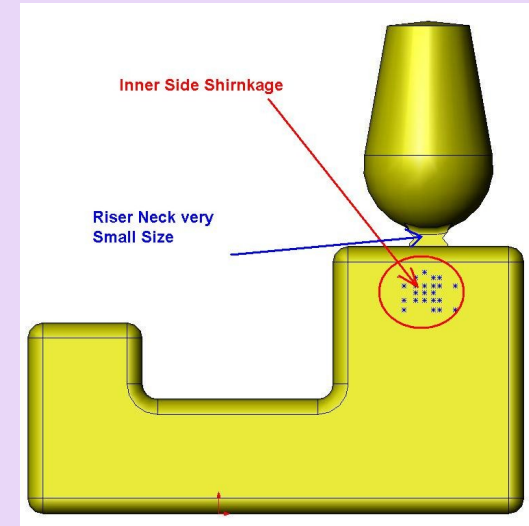
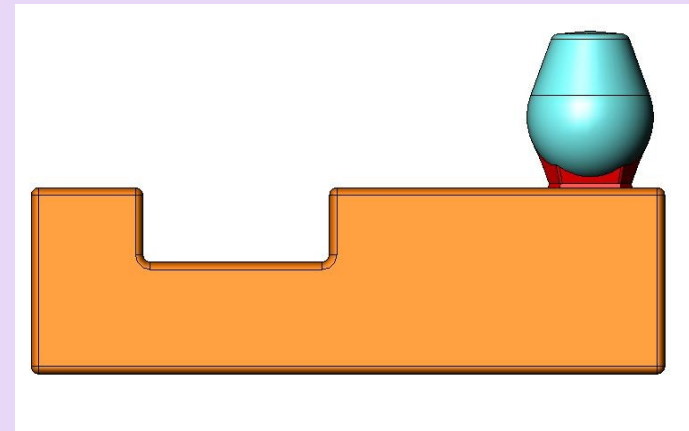
Internal shrinkage below riser neck

Too small riser neck.  
Low pouring temperature.  
Excess residual Mg.  
Low carbon equivalent

- Riser neck optimized.
- Control of residual Mg. and carbon equivalent

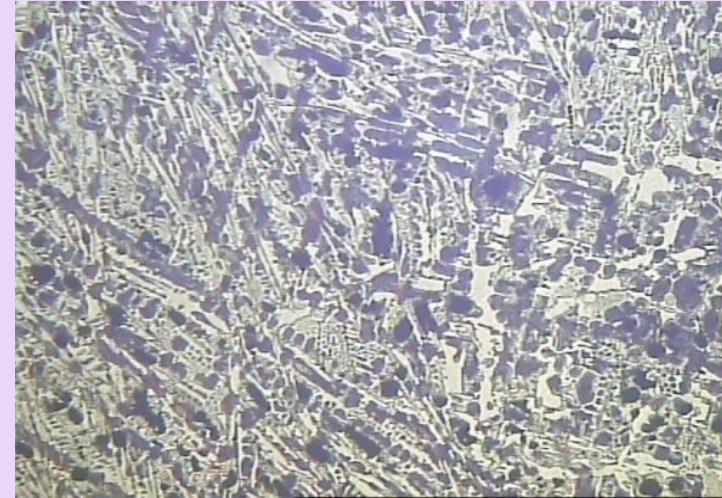
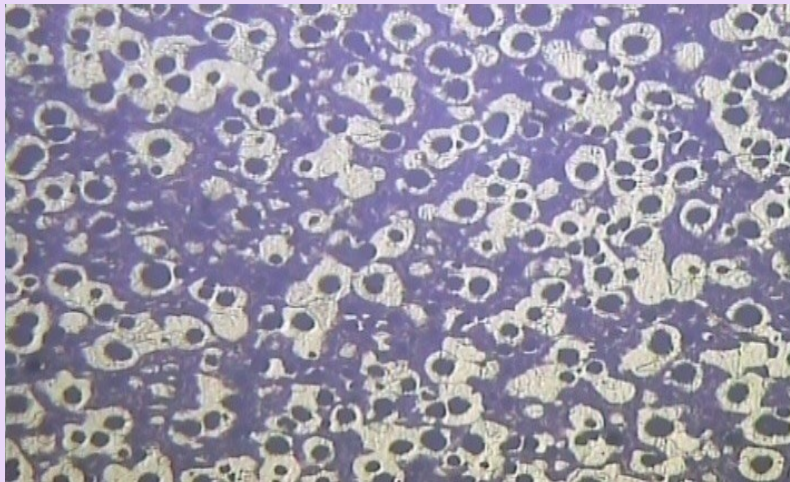
Fully carbide in the casting

Inoculant (Ferro-silicon powder) not responding to Nucleation due to low Aluminium content 0.01 to 0.05% (special grade for steel)

Normal grade Ferro-Silicon powder contains 1.0 to 1.2% Aluminium was used.

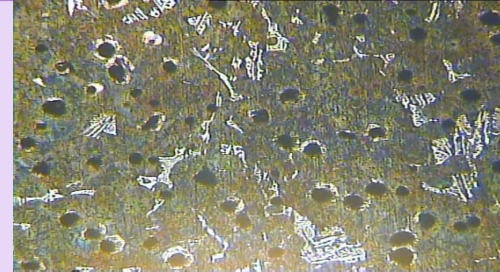
## Presence of carbides on the castings

Since stream inoculation synchronized with joystick which is used for opening the nozzle to pour liquid metal into moulds. Nozzle leak metal did not initiate the pouring or inoculation to the first metal.

Continuous inoculation and  
In mould Inoculation introduced

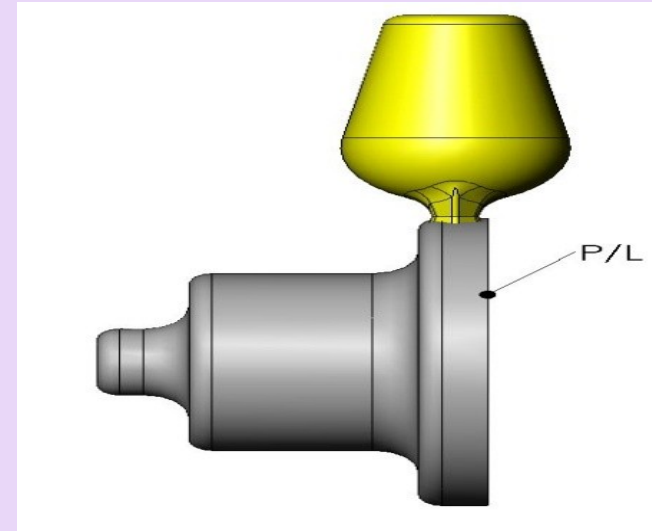
Presence of carbides in the speed of meter Hub I.D

That particular Hub I.D gets filled lastly with first entry metal (metals gets cold) and feeding distance is more from the feeder.

Fast pouring ensured by reducing the pouring time from( 10 to 11 Secs. ) to (7 to 8 Secs.).

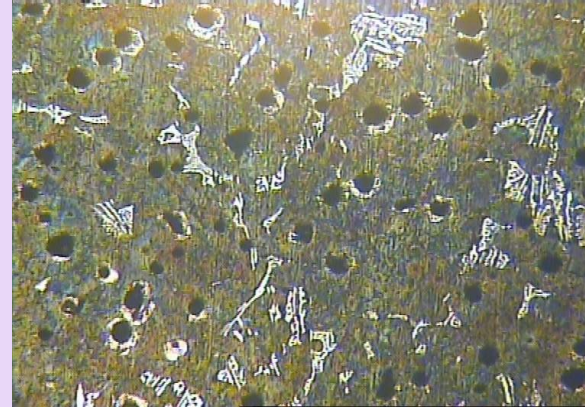
Presence of carbides on the castings Excess metal transferred into press pour filled the discharging spout and then filled the mould cavity without imitating pouring. and hence no inoculation.

- A small tank (3 to 5 Kgms capacity) on the mould introduced to collect the first metal

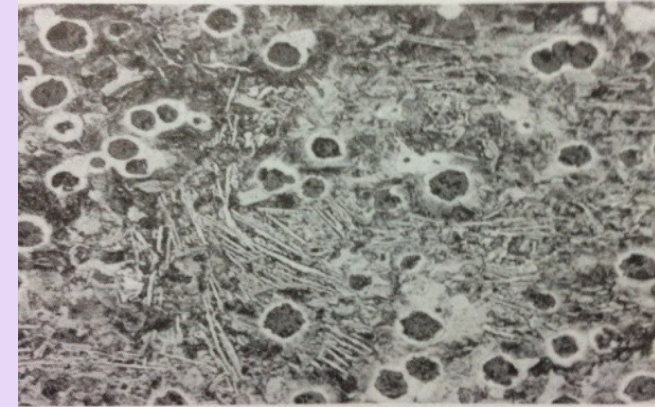
Excess Residual Magnesium or Manganese, Chromium, Vanadium etc. accompanied with high pouring Temperature more than  $1410^{\circ}\text{C}$  at the heavy sections.

Control of Residual Magnesium and Manganese, Chromium Vanadium etc. and pouring Temperature Max.  $1400^{\circ}\text{C}$  And improve the inoculation process & quality of inoculant.

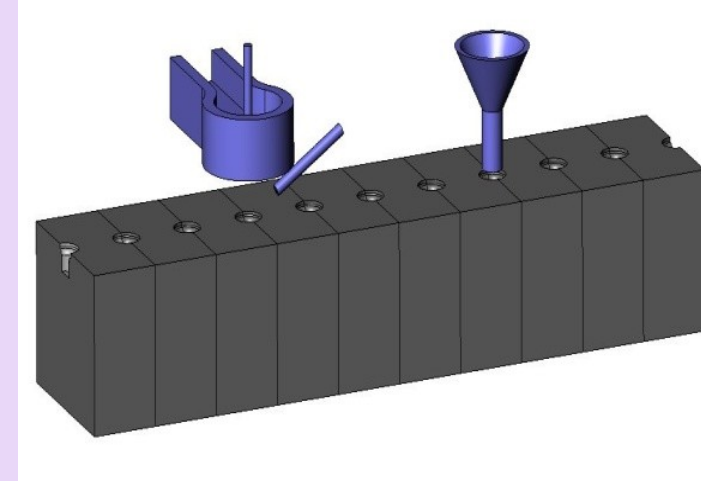
Presence of Carbides on the castings

Inoculation pipe blockage partially due to spill metal during pouring.

One Quality control person specifically assigned to monitor inoculation continuously in addition to the review of the pouring recording C.D.

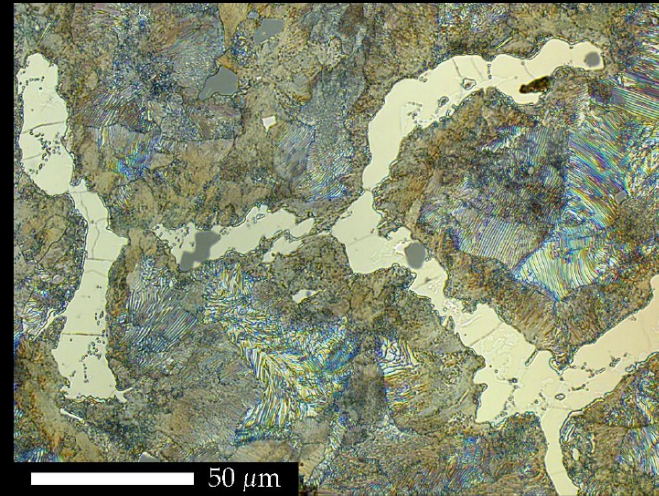
presence of carbides. Machinability problem  
Excess residual Magnesium, or Manganese or chromium and low silicon content

Converter chamber to be kept clean to avoid excess Mg consumption. Control of other carbide promoting elements like chromium, Manganese etc. And control of silicon content

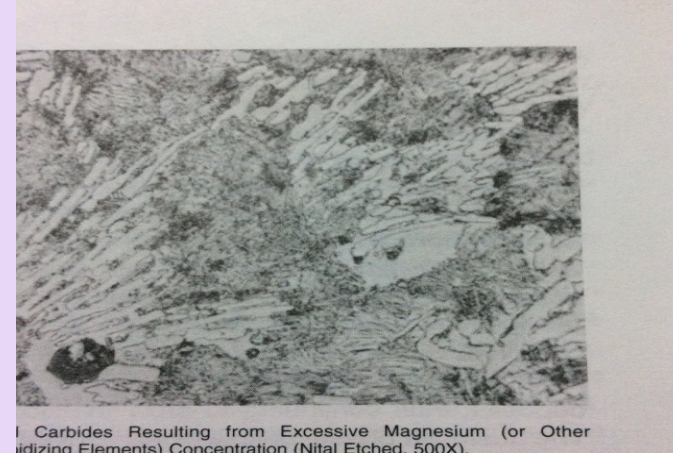
## Presence of carbides on the castings

Excess of residual Mg.due to transferred metal not mixing uniformly because of excess floating slag and / or very low level metal in the presspour unable to get average.

After transfer pressurizing and vent the metal so as to mix properly. Periodic vat cleaning or vat replacing will be planned

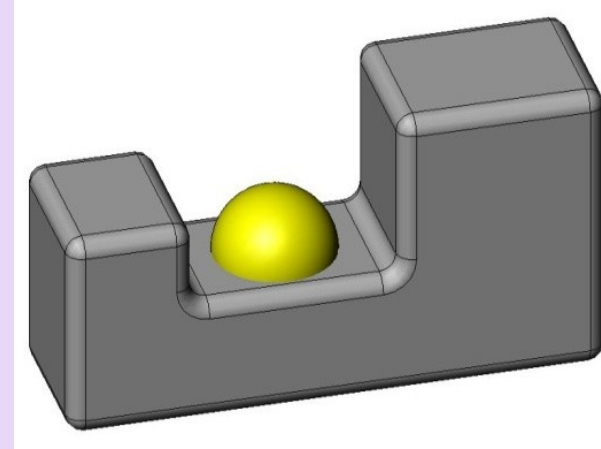
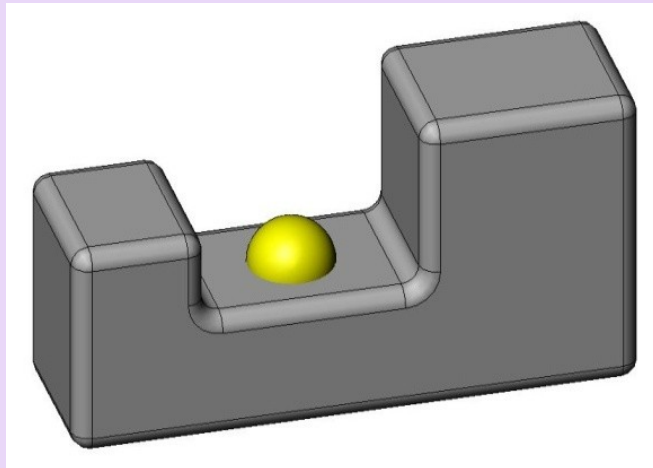
Wrong selection of bigger size ejection ball leaving less wall thickness of sand get sheared up quickly and eroded

Correct selection of ejection ball and enough sand thickness ensured to avoid quick heating and erosion.

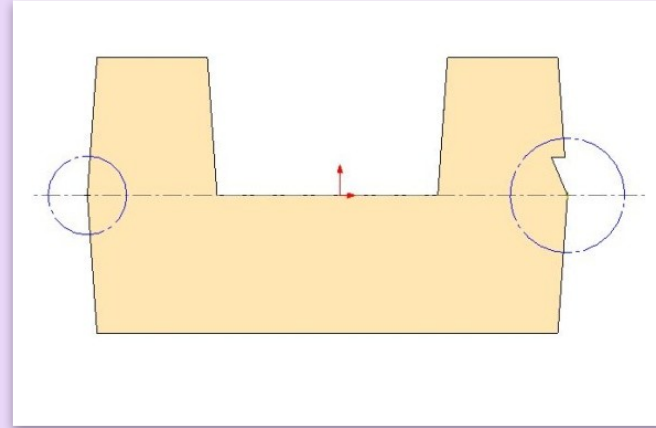
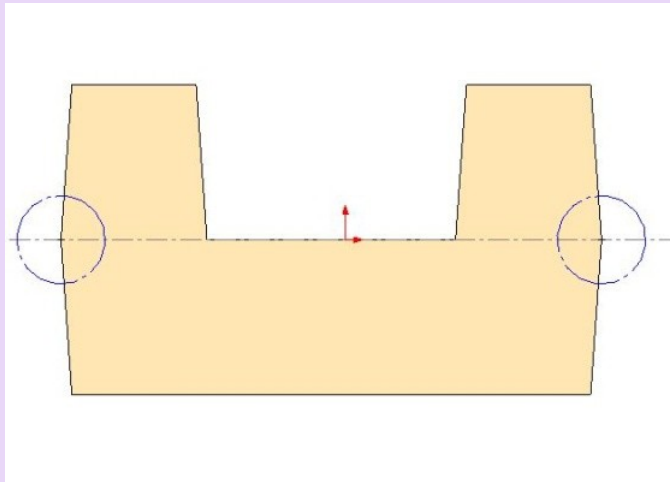
Sand inclusion due to tooling under cut .

Tooling under cut corrected

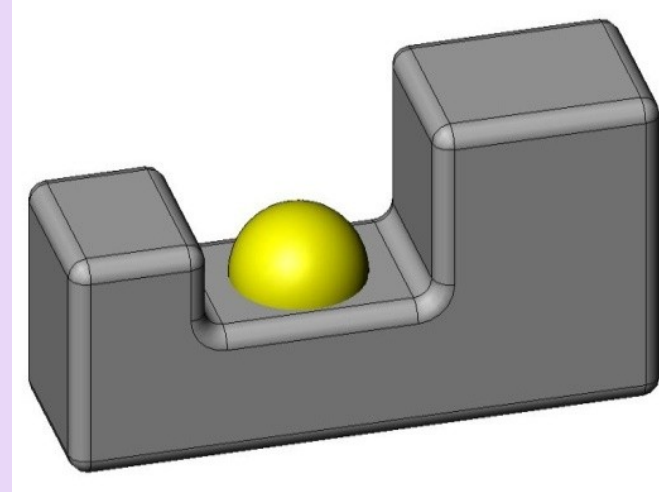
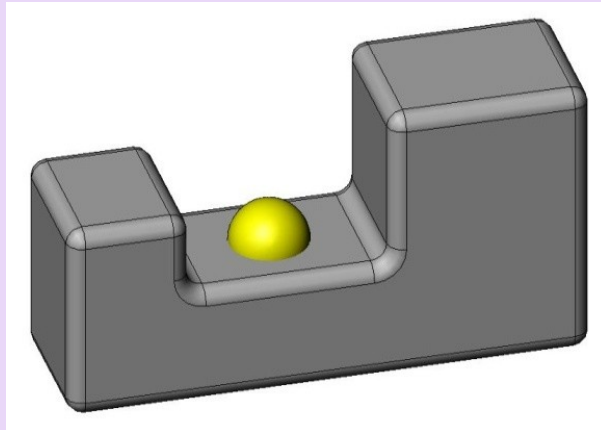
Wrong selection of bigger size ejection ball leaving less sand thickness

Correct selection of ejection ball  
leaving more sand thickness

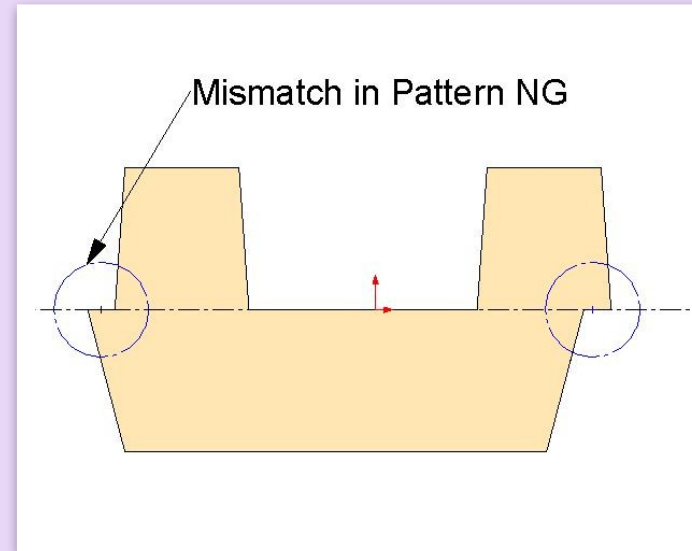
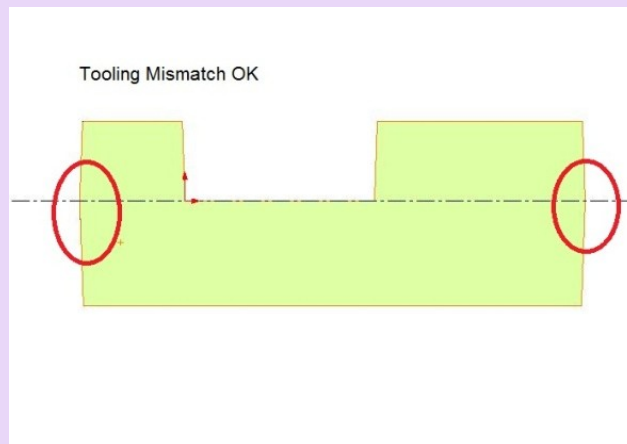
Mismatch on the tooling

Mismatch corrected

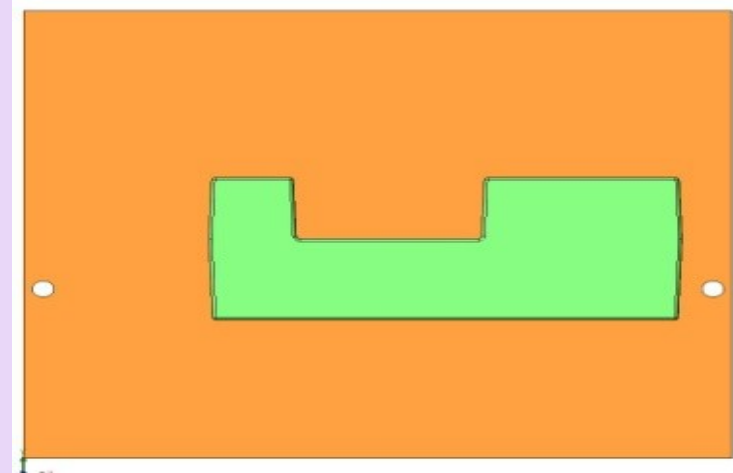
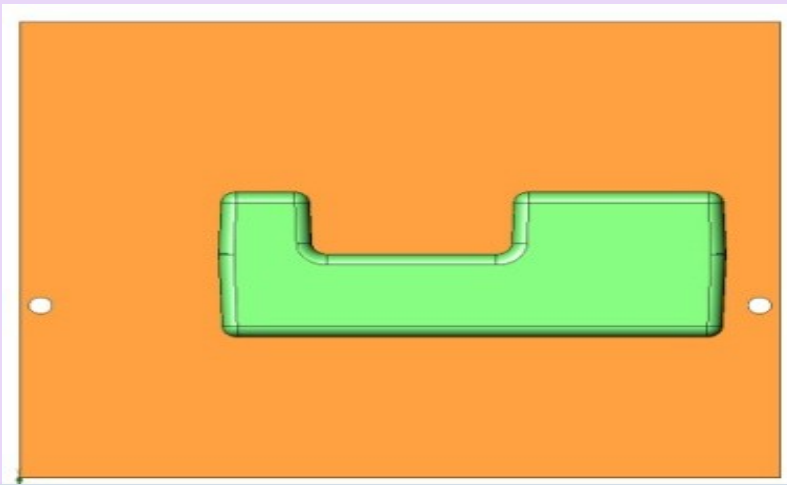
Insufficient fillet or corner radius at parting line.

Sufficient fillet or corner radius  
provided

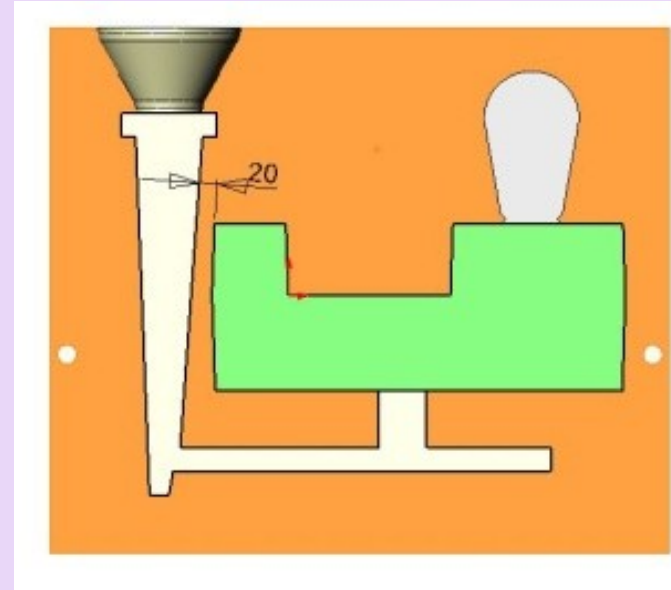
Narrow gap between part and runner

The gap widened and draft increased.

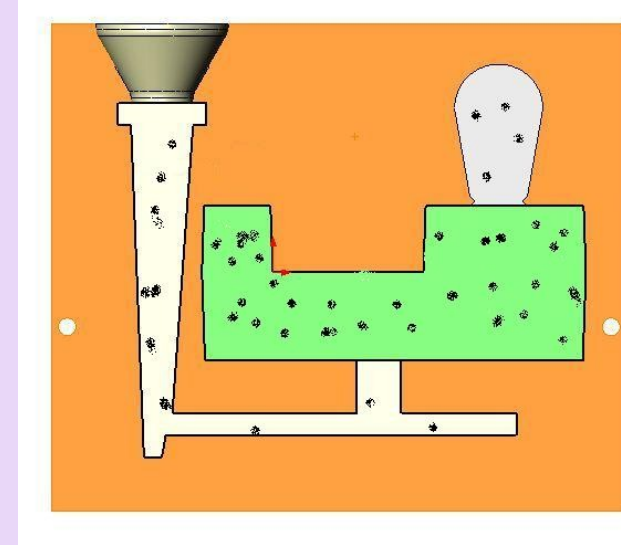
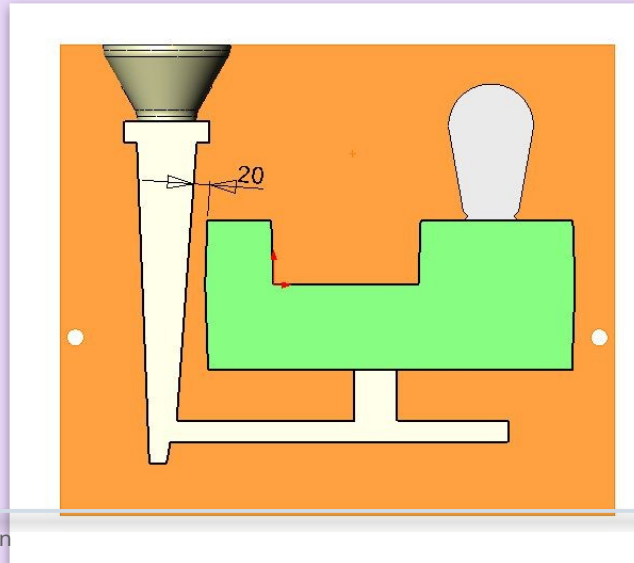
Fines' deposits on the excess oil sprayed on the tooling

Oil spray controlled. Sand sticking locations are smoothened

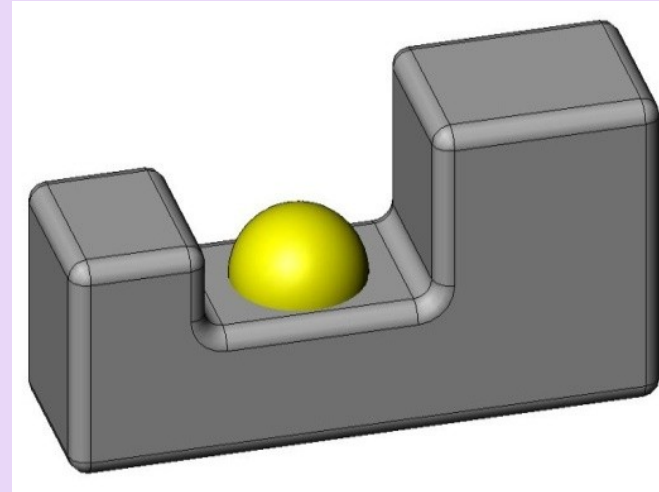
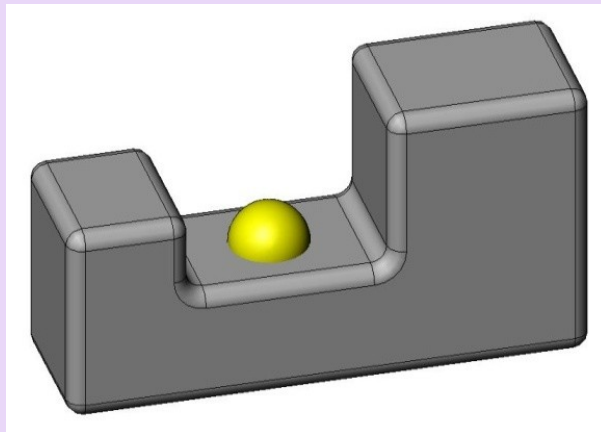
Ejection ball in the hub I.D., not properly fitted  
The gap between the ejection ball and the tooling very narrow

Ejection ball fitted properly without any undercut or sand sticking.  
Correct size of ejection ball to be fitted to ensure sufficient gap.

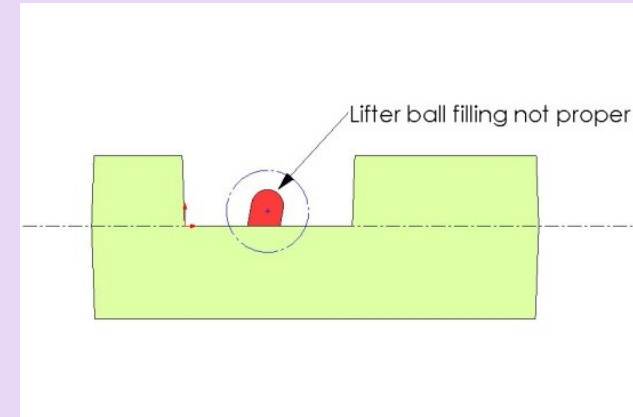
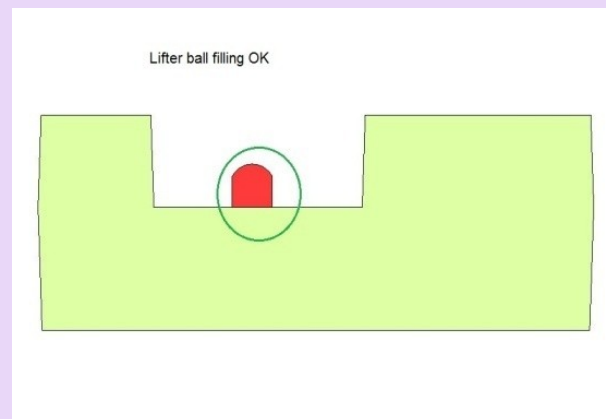
Ejection ball in the hub I.D., not properly fitted  
The gap between the ejection ball and the tooling very narrow

Ejection ball fitted properly without any undercut or sand sticking.  
Correct size of ejection ball to be fitted to ensure sufficient gap.

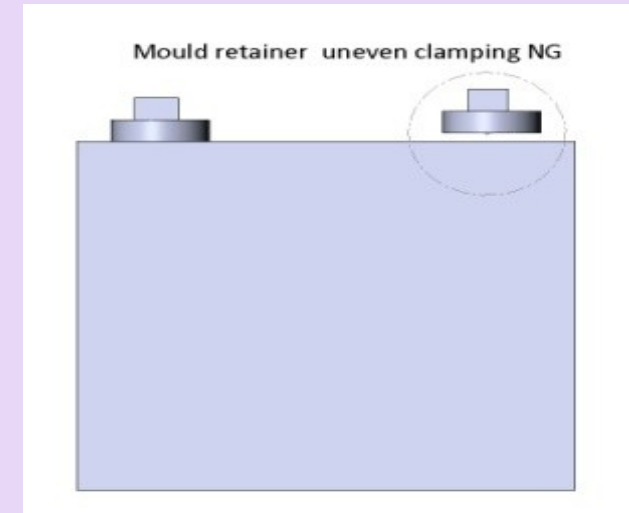
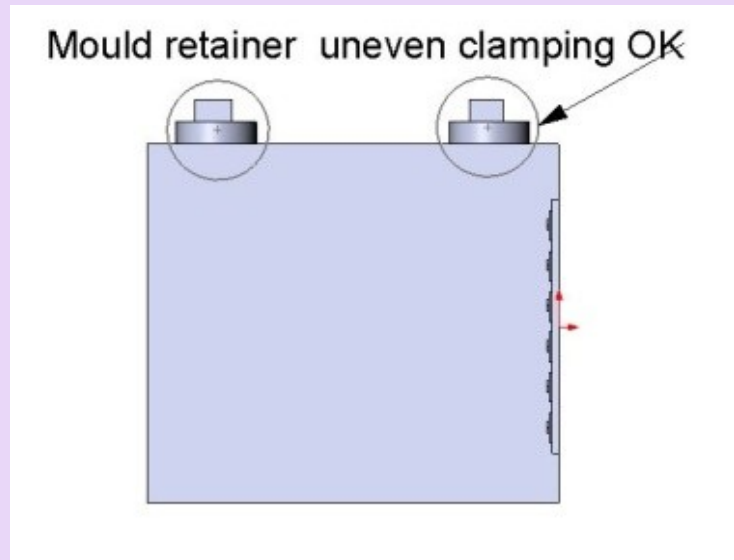
# SAND INCLUSIONS

Mould retainer uneven clamping

Correct the mould retainer for even clamping

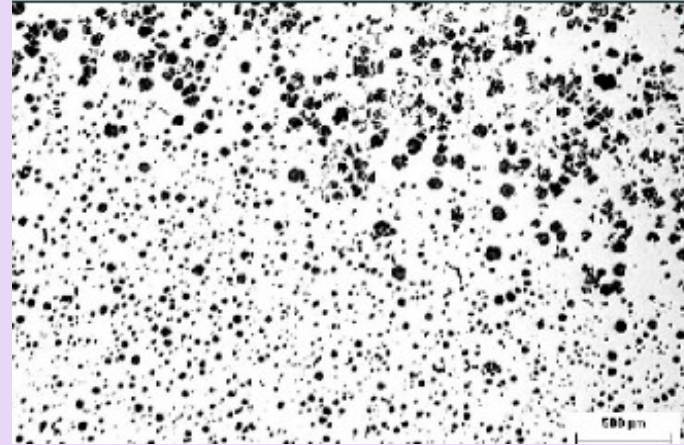
# METALLURGICAL DEFECTS

## Graphite Flotation

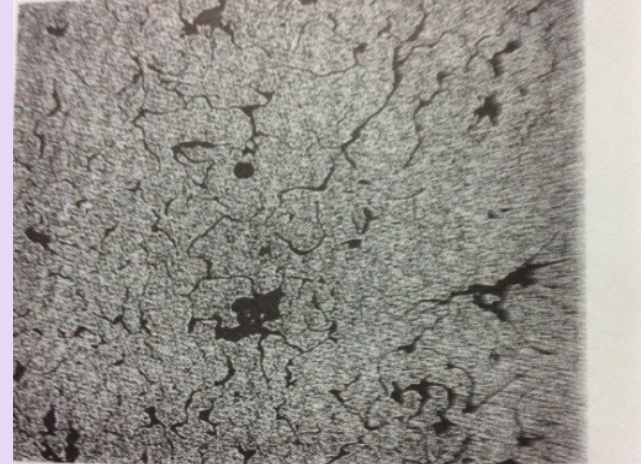
FIGURE 4.14 Flake Graphite Typical of Magnesium-Treated Iron Contaminated with Lead (0.0086%) and Antimony (0.0057%) (100x, Unetched).

Flake Graphite in Ductile Iron .

Metal contaminated with Lead and Antimony

Dilute the metal with mild steel scrap  
free from Lead,Antimony  
Incoming materials to be ensured free  
from contamination
