ANALYSIS OF TRADITIONAL BUILDING TECHNIQUES AND DAMAGE ASSESSMENT OF TRADITIONAL TURKISH HOUSE: The Study of Timber-framed Kula Houses

Mine Tanac Zeren, Ozgul Yilmaz Karaman

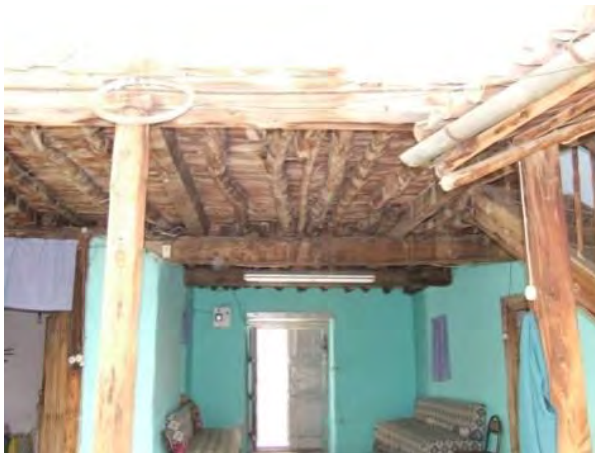
Figure 11. Floor Construction – Hayataltı Space (Source: Authors, 2008).

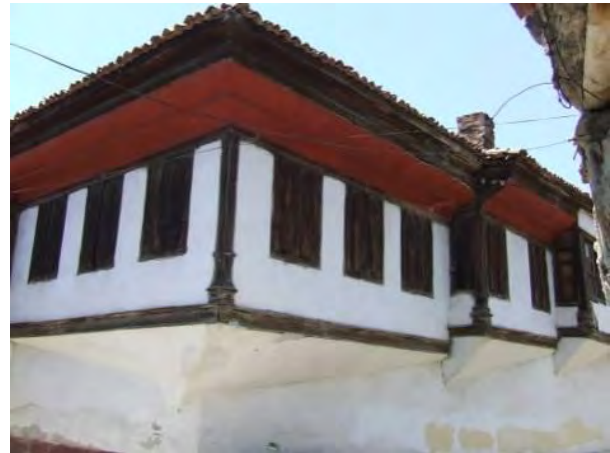
Figure 12. Projections of the house (Source: Authors, 2008).

Four rooms are located on the first floor and are all opened to Sofa space, one of them is overlooked to the main street and the other three are situated side by side and prolonged to the other side of the street by angled projections (see Figure 12). The rooms are decorated with unique wooden architectural elements such as cupboards, fireplaces.

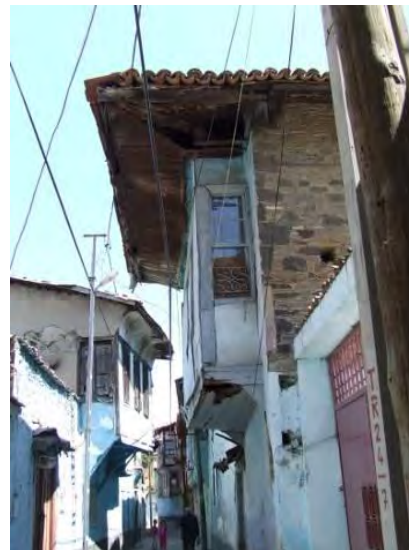
Figure 17. Case 02 the building and its surrounding (Source: Authors, 2008).

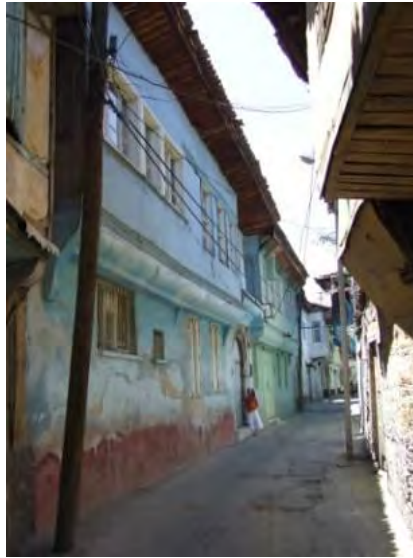
Figure 18. Case 03 The building and its surrounding
(Source: Authors, 2008).

The owners of the house live in a one storied new house which they have built in the courtyard of the building during the recent years. During this process, the building has also suffered from wrong repair attempts as well. The external sofa space is partly closed, the hayataltı space is closed with a concrete extension, and some new openings are added to the façade of the building. The atmospheric conditions caused to degradations as well such as the material loss and colour changes on the wooden eaves, ceiling coverings and floor coverings.

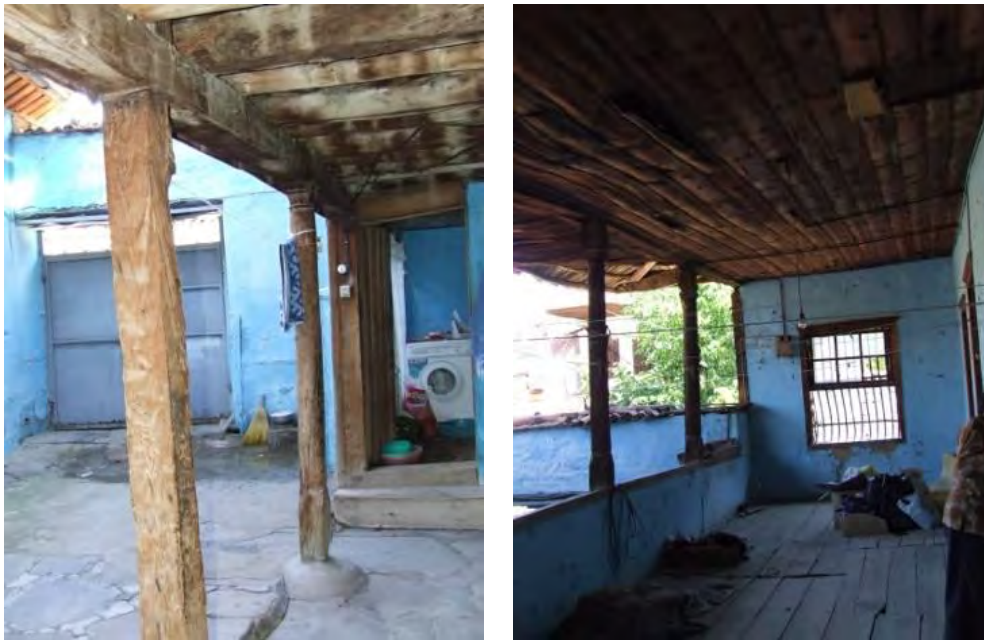
Figure 20. Case04 Sofa and Courtyard of the House (Source: Authors, 2008).

The deterioration types that have been identified can be listed as, fungi attacks, infestation, material loss, colour changes. There are fungi attacks, colour changes and infestation on the post elements carrying the Sofa. There are material losses and colour changes on the coverings of the eaves. There is deflection on the first floor carrying system, and some material losses and colour changes on the floor coverings.

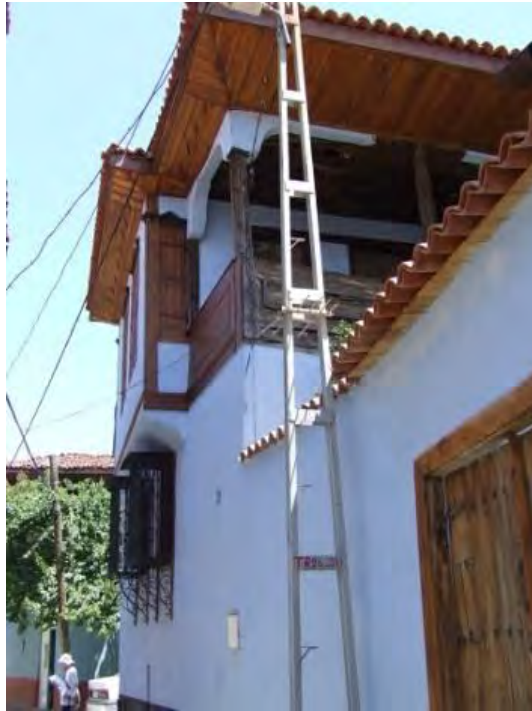
Figure 23. Case05 Exterior View of the House
(Source: Authors, 2008).

It can be seen that now that the building ensured the continuity of its building use and it is restored since the recent years, it is not possible to obtain any important deterioration problem within the structure system and the materials of the house. The restoration attempt of the building, replaced the deteriorated architectural elements with new elements by preserving the uniqueness of the building.

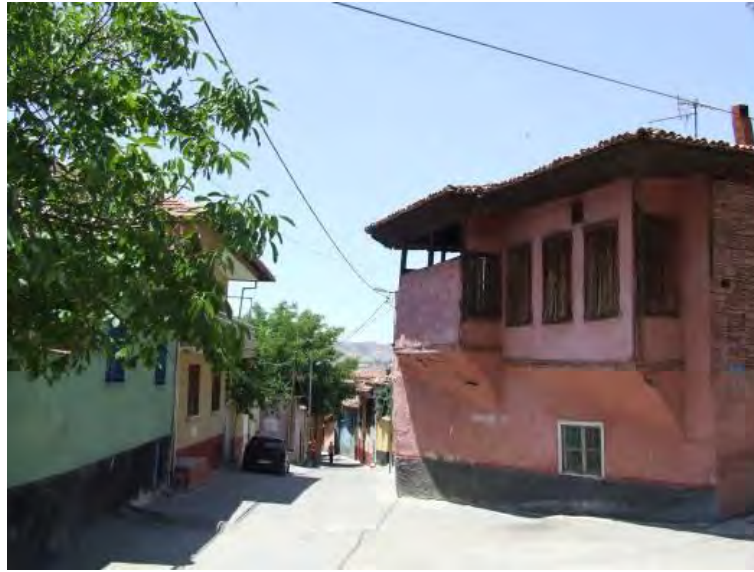
Figure 24. Case06 Exterior View of the House (Source: Authors, 2008).

The deterioration type that has been identified within this case is the colour changes mainly on the wooden elements. During the historical process; a one-storied building is built in the courtyard of the house as an extension. The original space organization of the ground floor is changed due to this extension spaces. This new addition space organization changed the façade organization as well with new openings on the masonry walls.

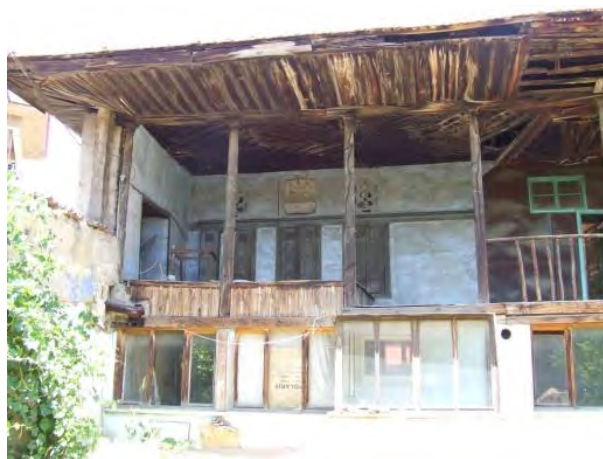
The main deterioration factor can be seen within the case is suffering from humidity. Humidity caused colour changes, fungi attacks on timber element. Different from other cases, insect invasion can be obtained in this case on the timber beam elements that support the masonry stone wall. The insect invasion fragmented and reduce the cross section dimension of timber elements.

Figure 27: Case09 Courtyard View of the building (Source: Authors, 2008).

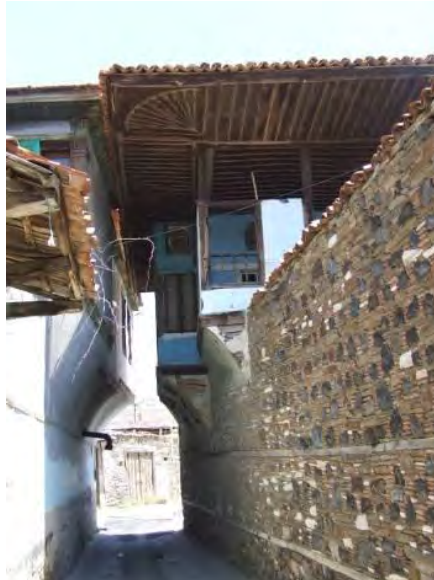
Figure 28. Exterior view- Long eaves of the house (Source: Authors, 2008).

Timber post elements carrying the Sofa space have 0.15*0.15 meters cross-section dimensions and are placed within 2.00 meters intervals on the courtyard direction. The house is in good condition in the general point of view. Deterioration can be seen within the building is some material loss on the eaves of the building. A second thing can be seen within the building is a wrong restoration attempt example which is a one storied space added under the sofa space of the building and this space demolishes the space organization of the ground floor.
