# CONSERVATION OF THE WAZIR KHAN MOSQUE LAHORE

PRELIMINARY REPORT ON CONDITION AND RISK ASSESSMENT

AGA KHAN TRUST FOR CULTURE AGA KHAN CULTURAL SERVICE - PAKISTAN

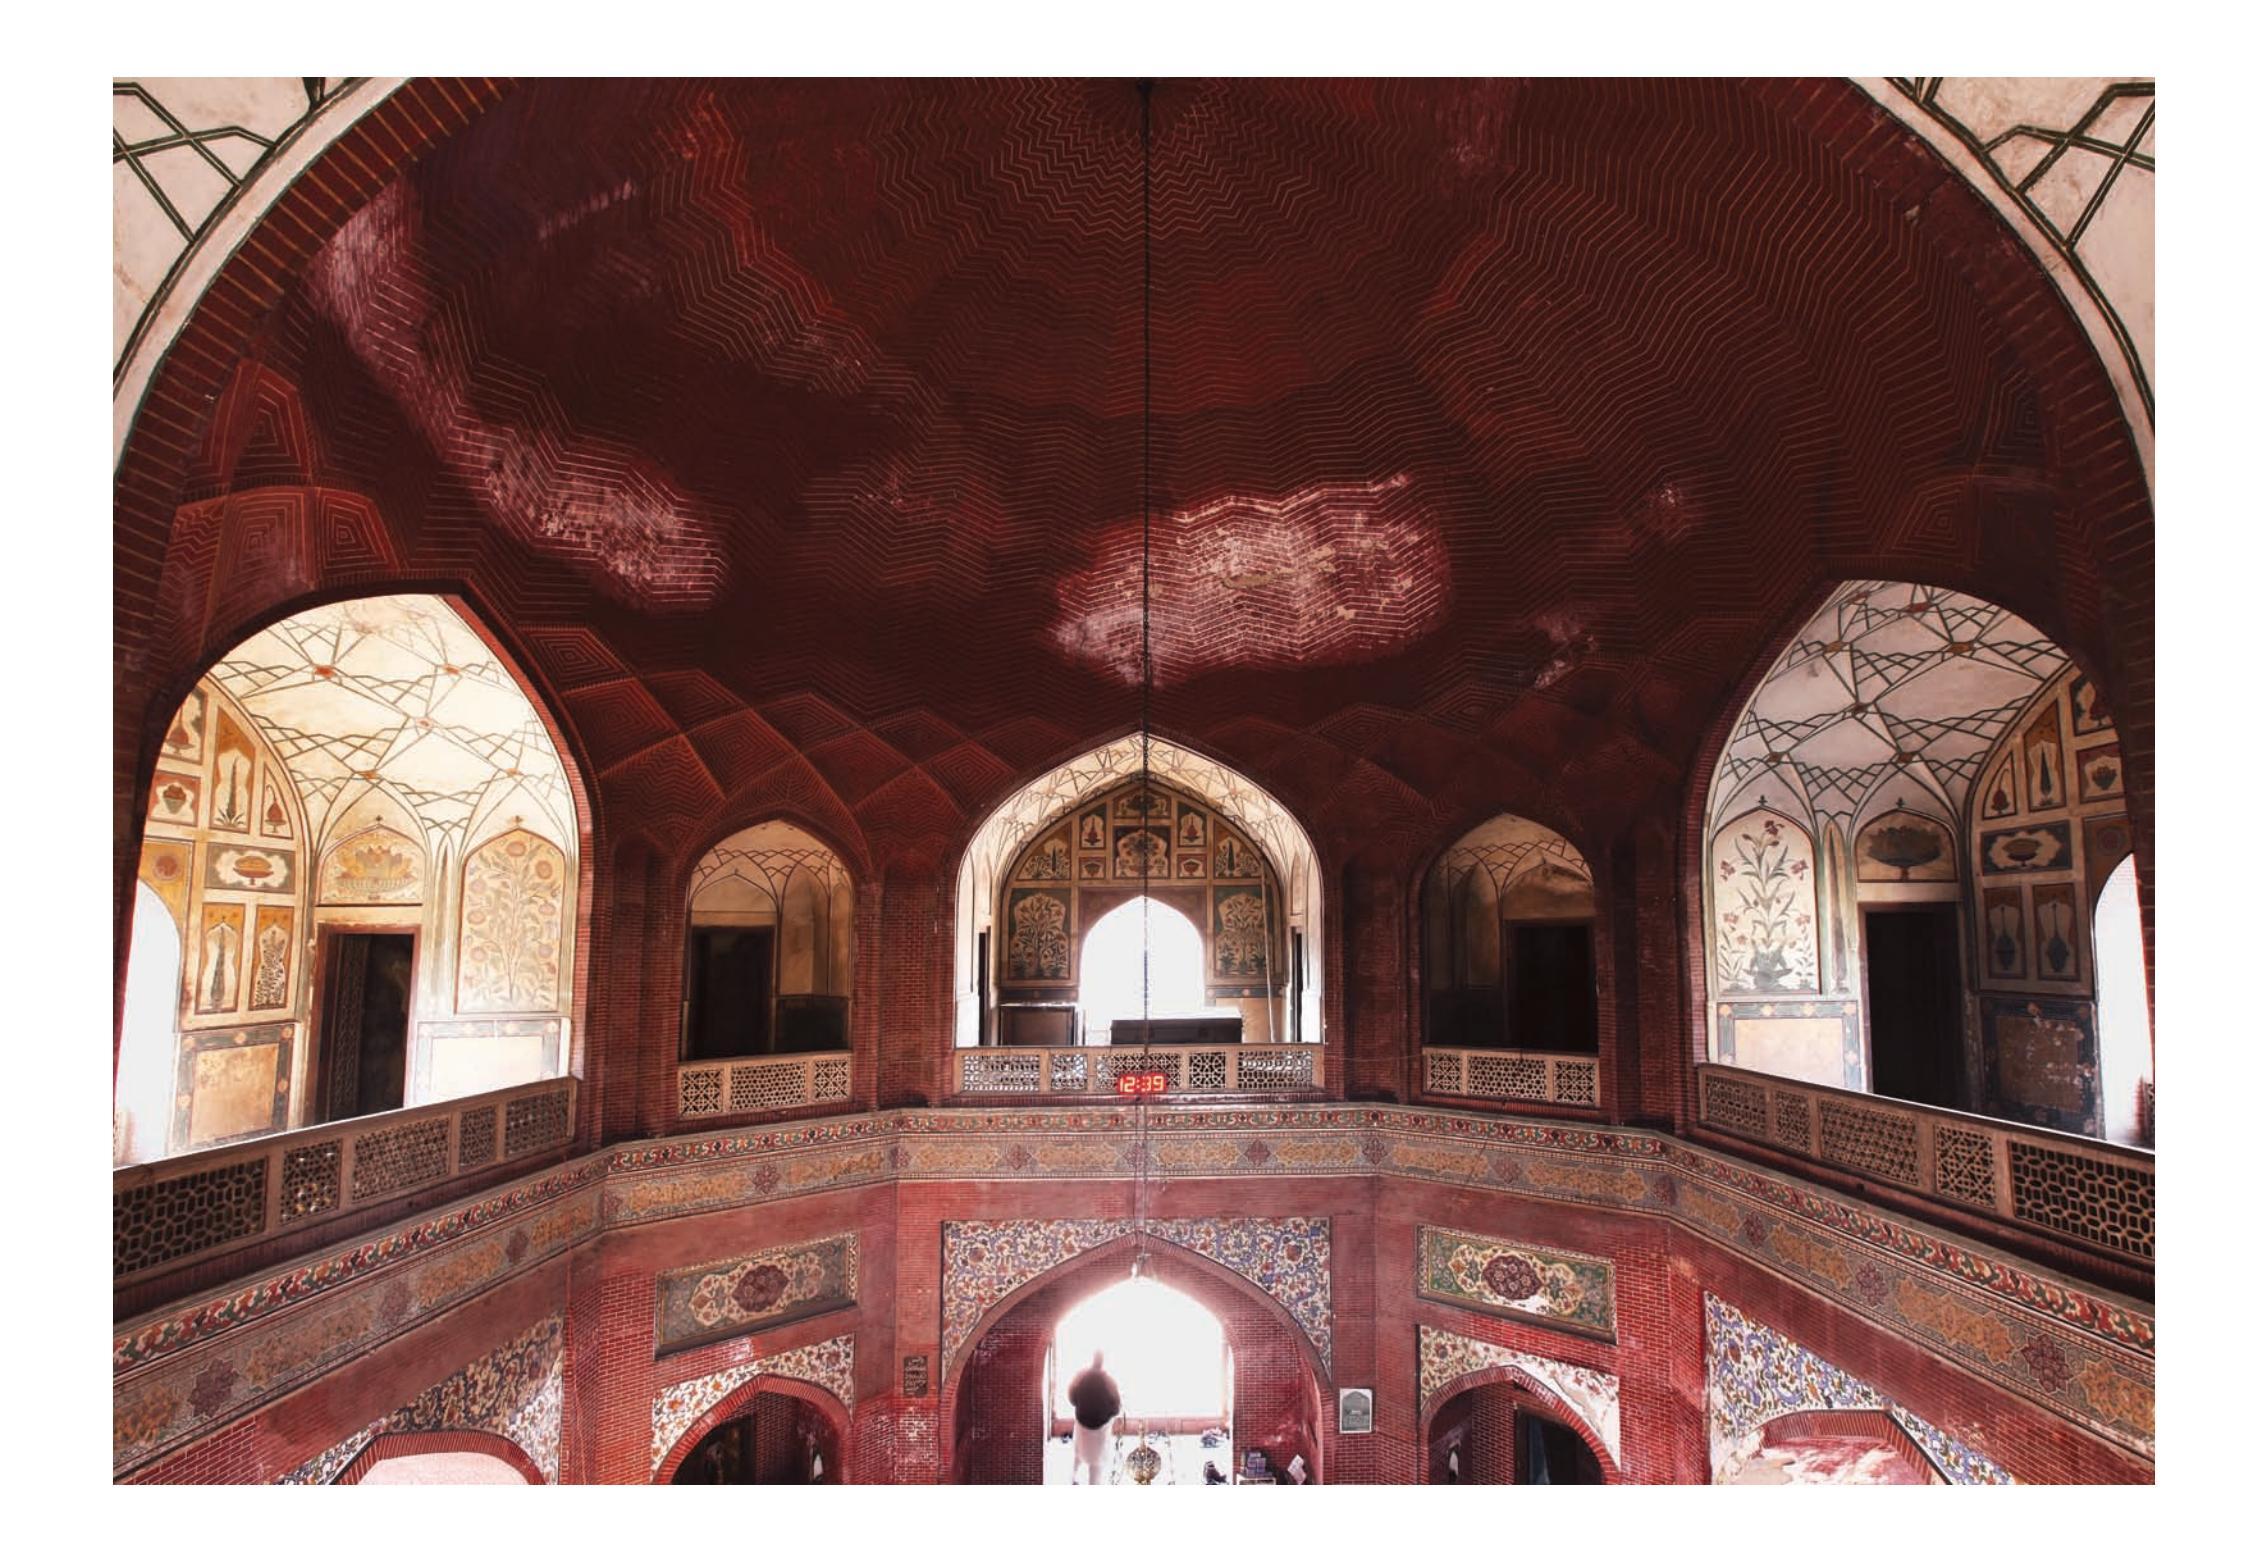
This page: Details of fresco work in the prayer chamber. Opposite: Tazakari work being executed during a previous restoration phase.

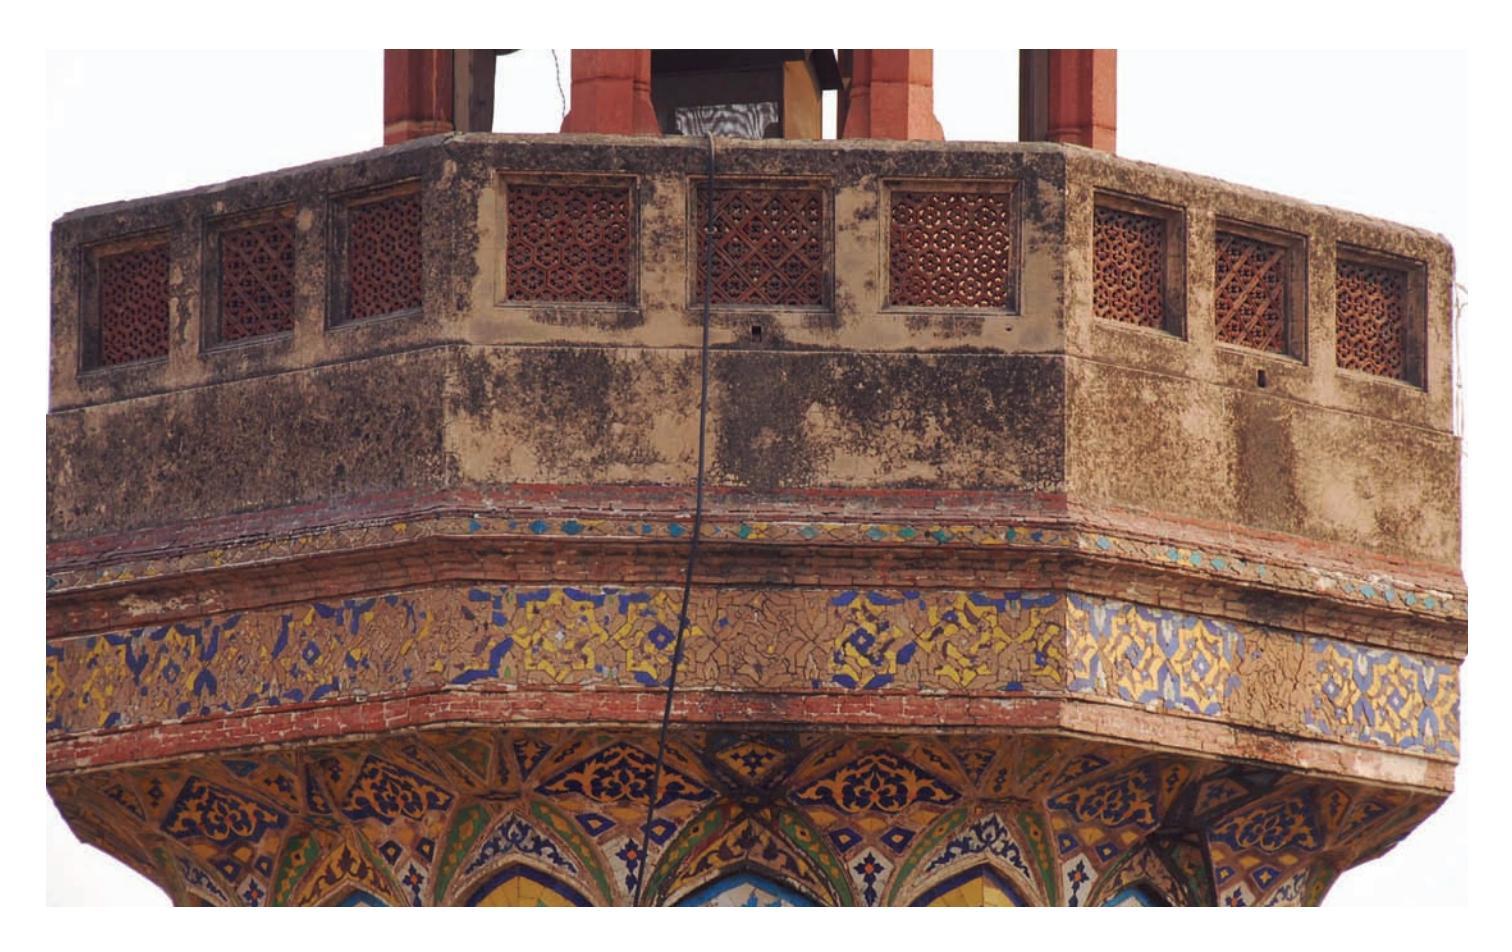
Right top: Terracotta jalli work in the balustrade surrounding the north-western minar's ambulatory.

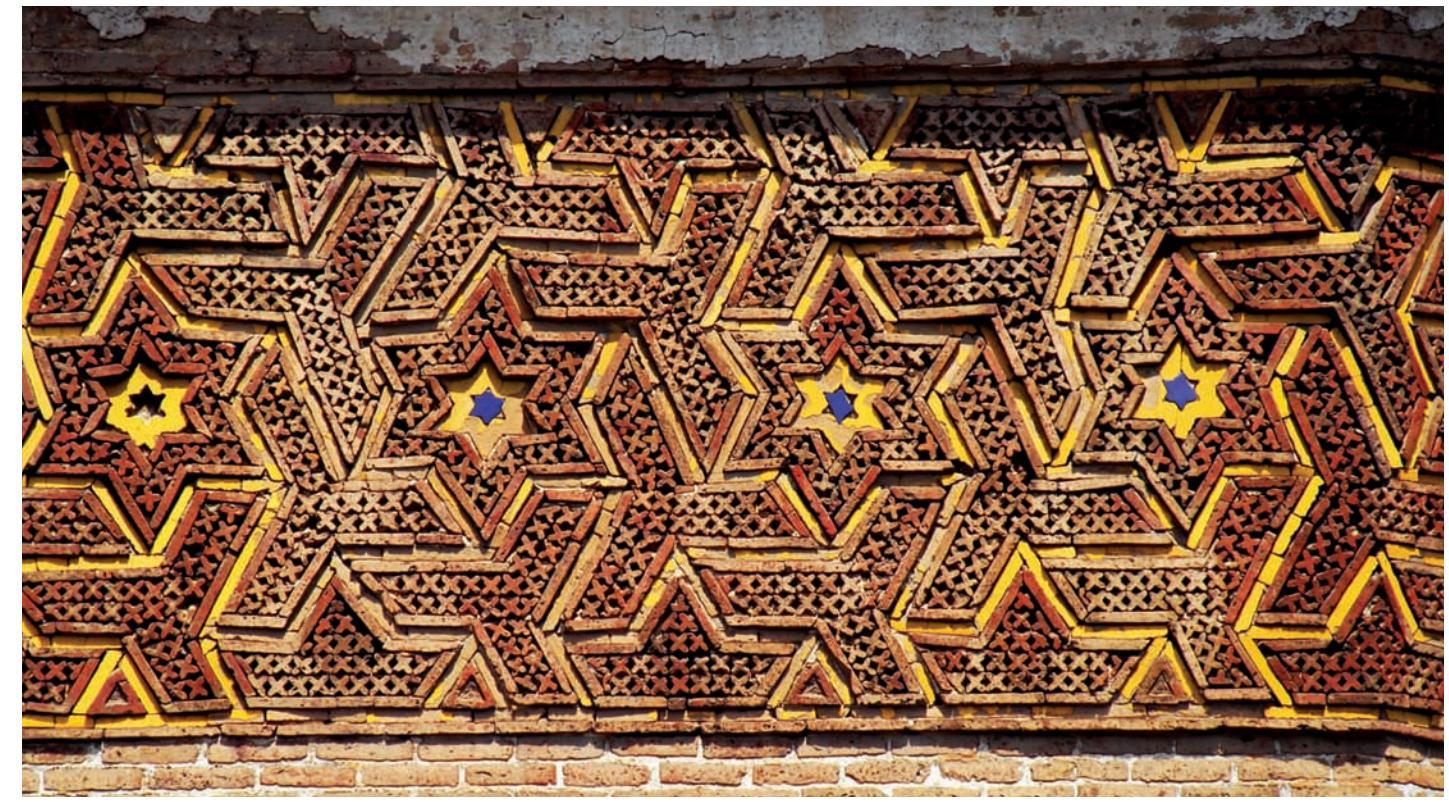
This special form of glazed tile terracotta decoration is to be found in panels on the northern façade of the northern axial pavilion, and in bands encircling the top most part of the shafts in all four *minars* before the shaft begins to cantilever out to form the ambulatory around the *minar chhatris*. In general considerable damage is found in this kind of treatment.

Right: Glazed tile work interlaced with unglazed terracotta lattices at the top of the south-eastern minar's shaft.

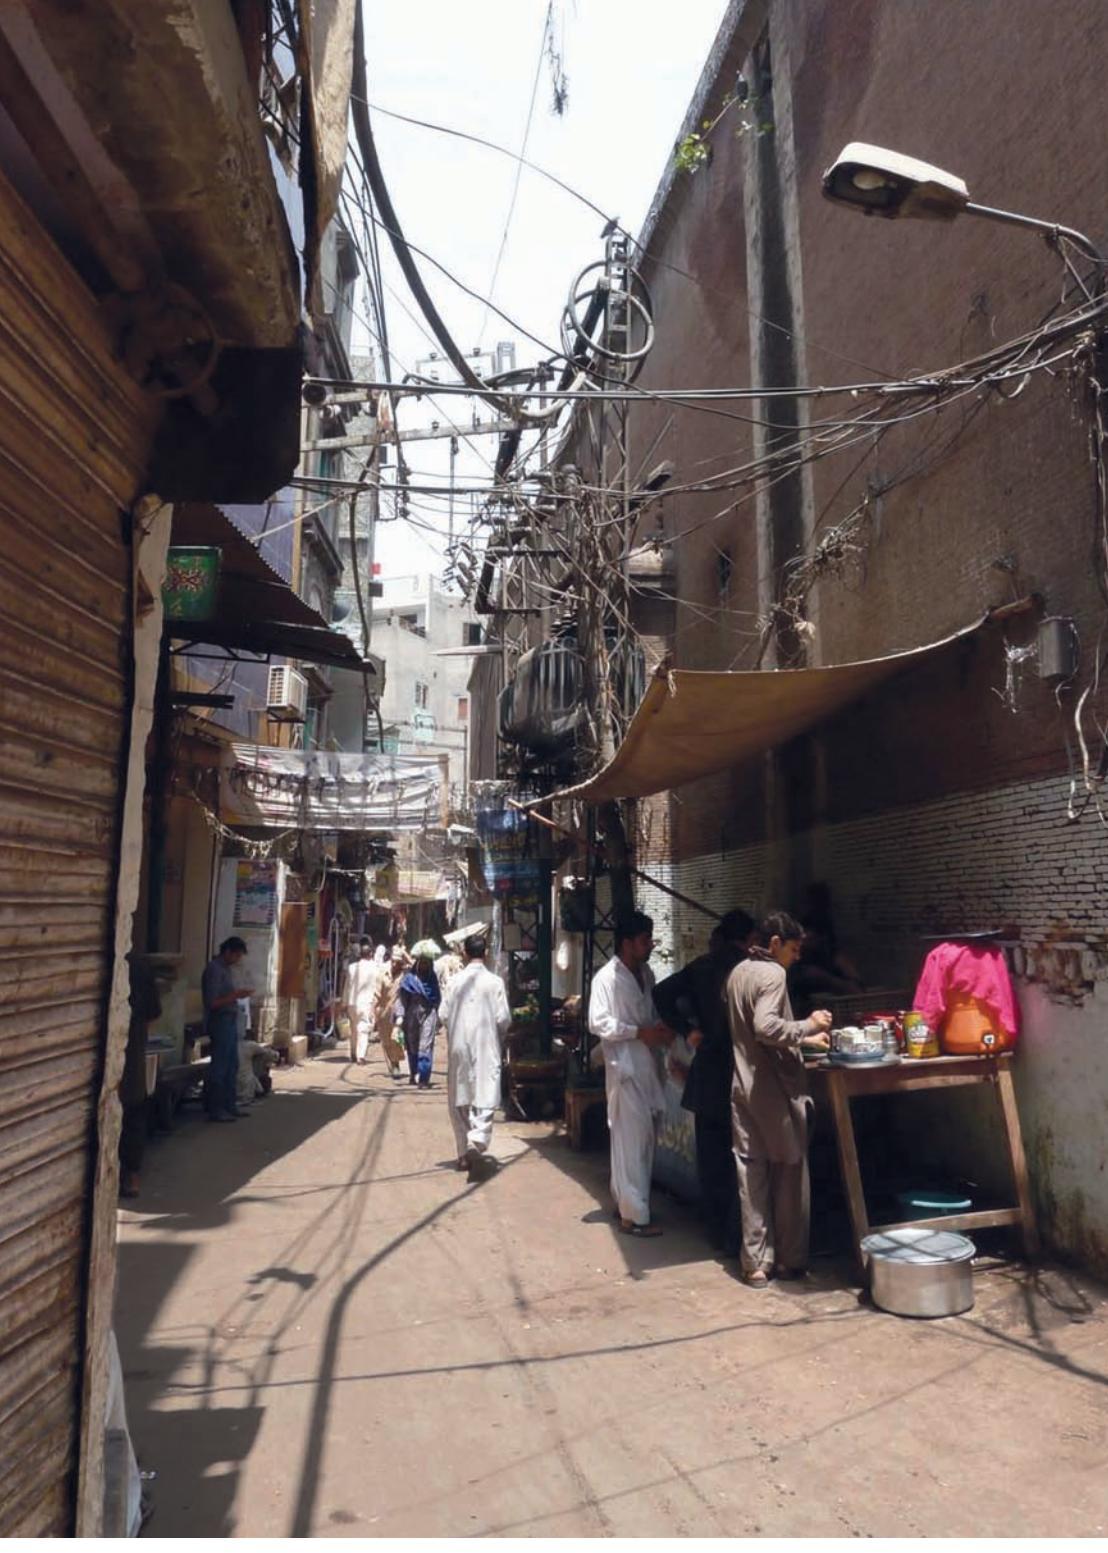
Above: There are no structures abutting the western façade of the mosque, with the exception of the southwestern corner where a residential building is using the mosque's walls for support. The remaining western façade is fully accessible from the gali immediately adjacent, which is occupied only by street hawkers, mobile food trolleys, and a conspicuous electricity transformer.

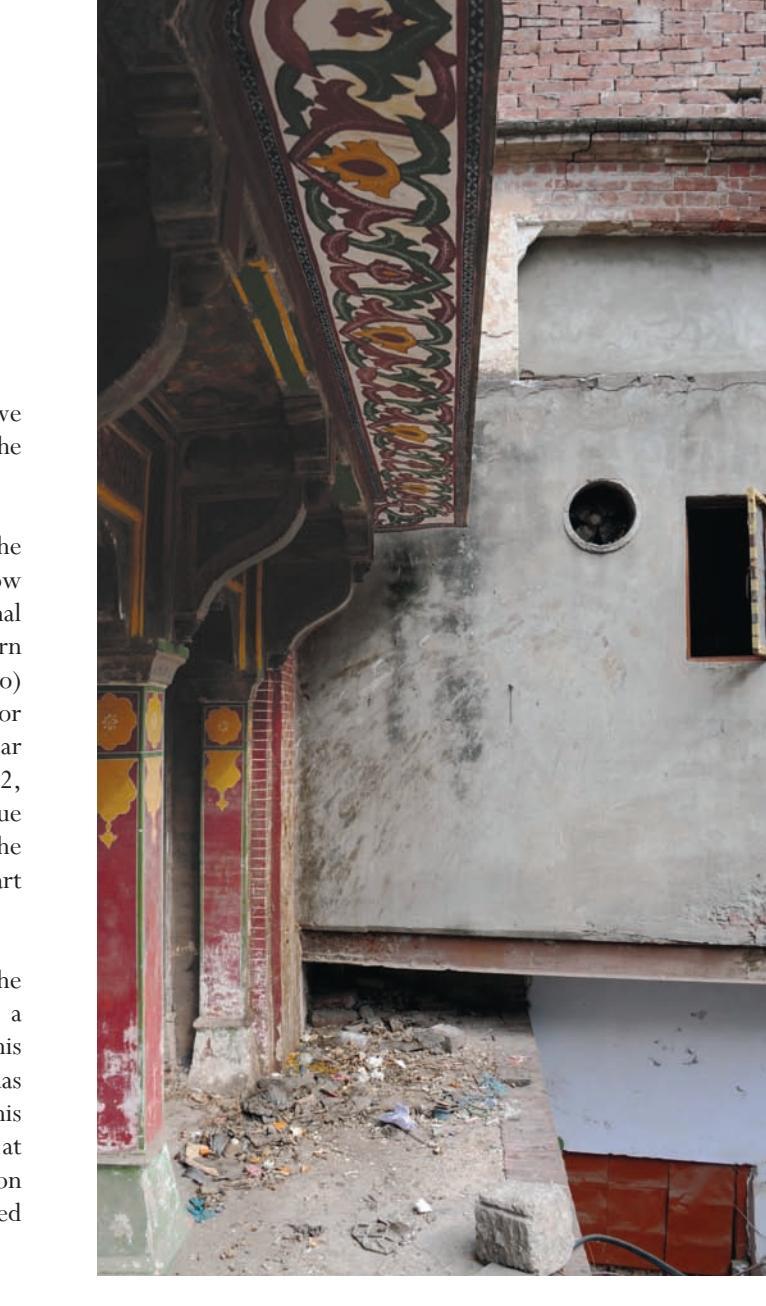
Opposite: Concrete slabs inserted into the mosque's fabric constitute the roofs of the extended shops on the north side.

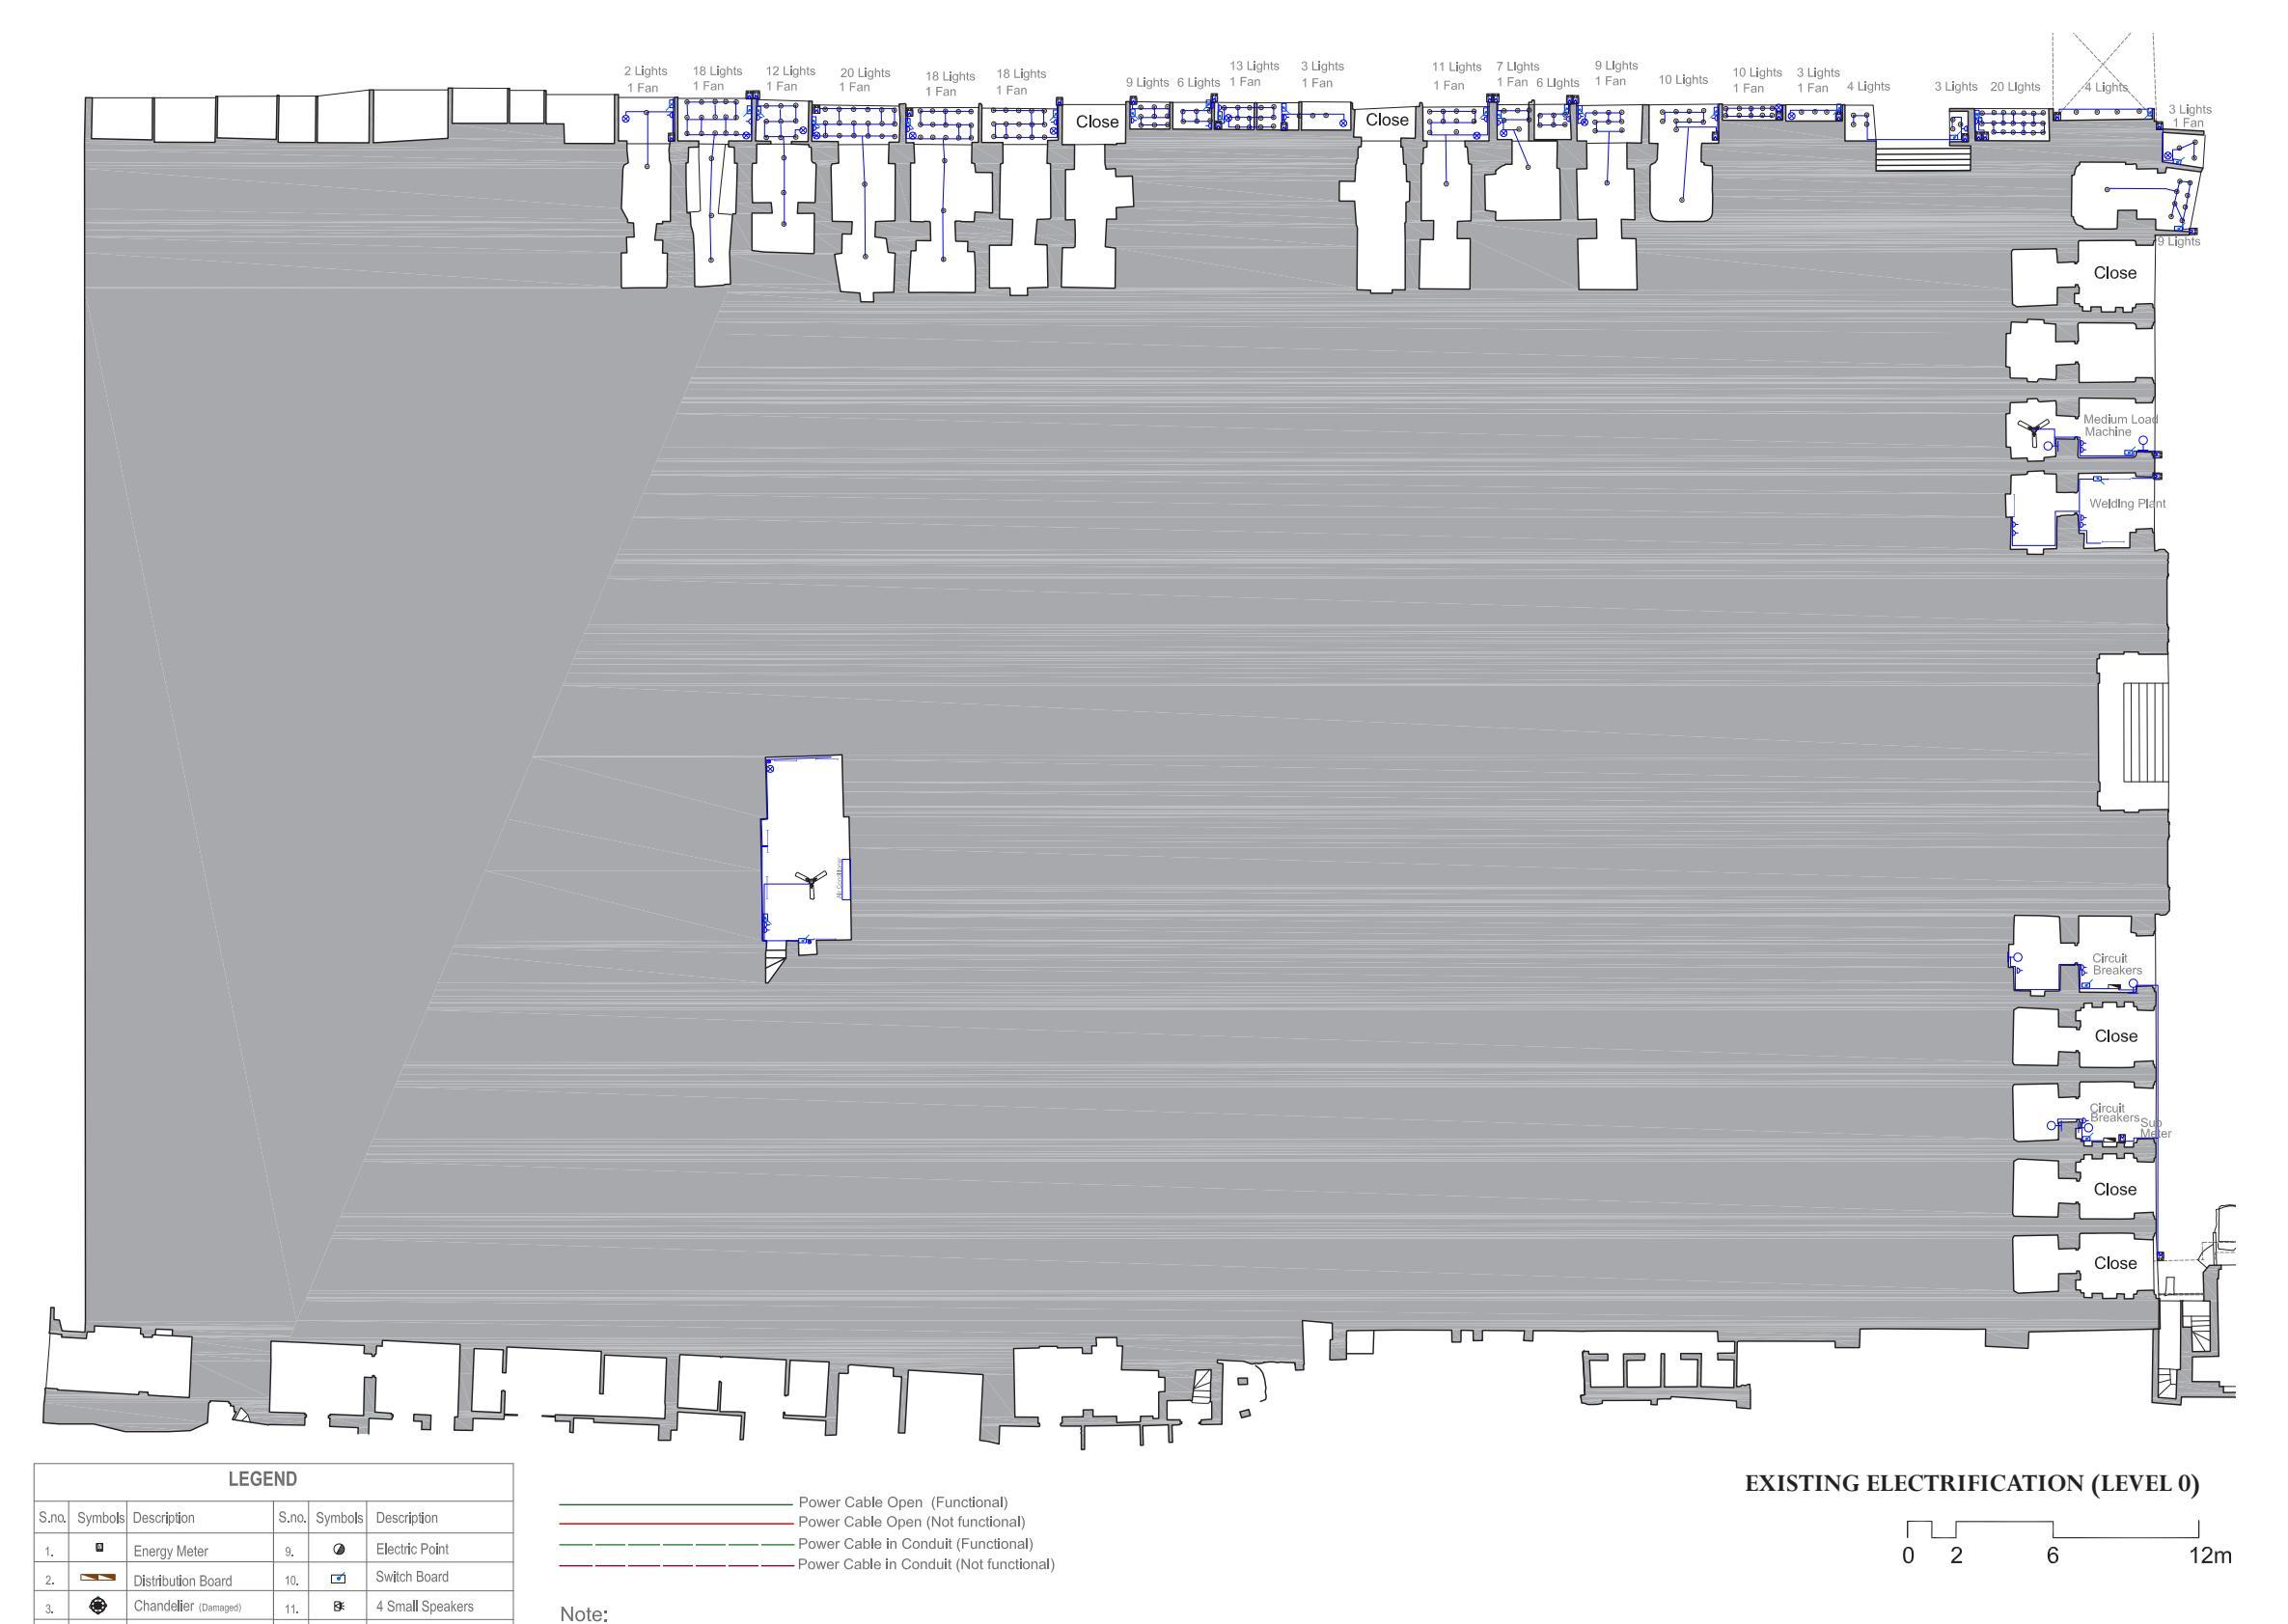
1. There are dangerous open connections of live wires

Insulation of electrical wires are damaged at a number of places
 High risk for short circuiting & fire

4. No water proofing of electrical installations located in the open

5. Most of the sockets are damaged

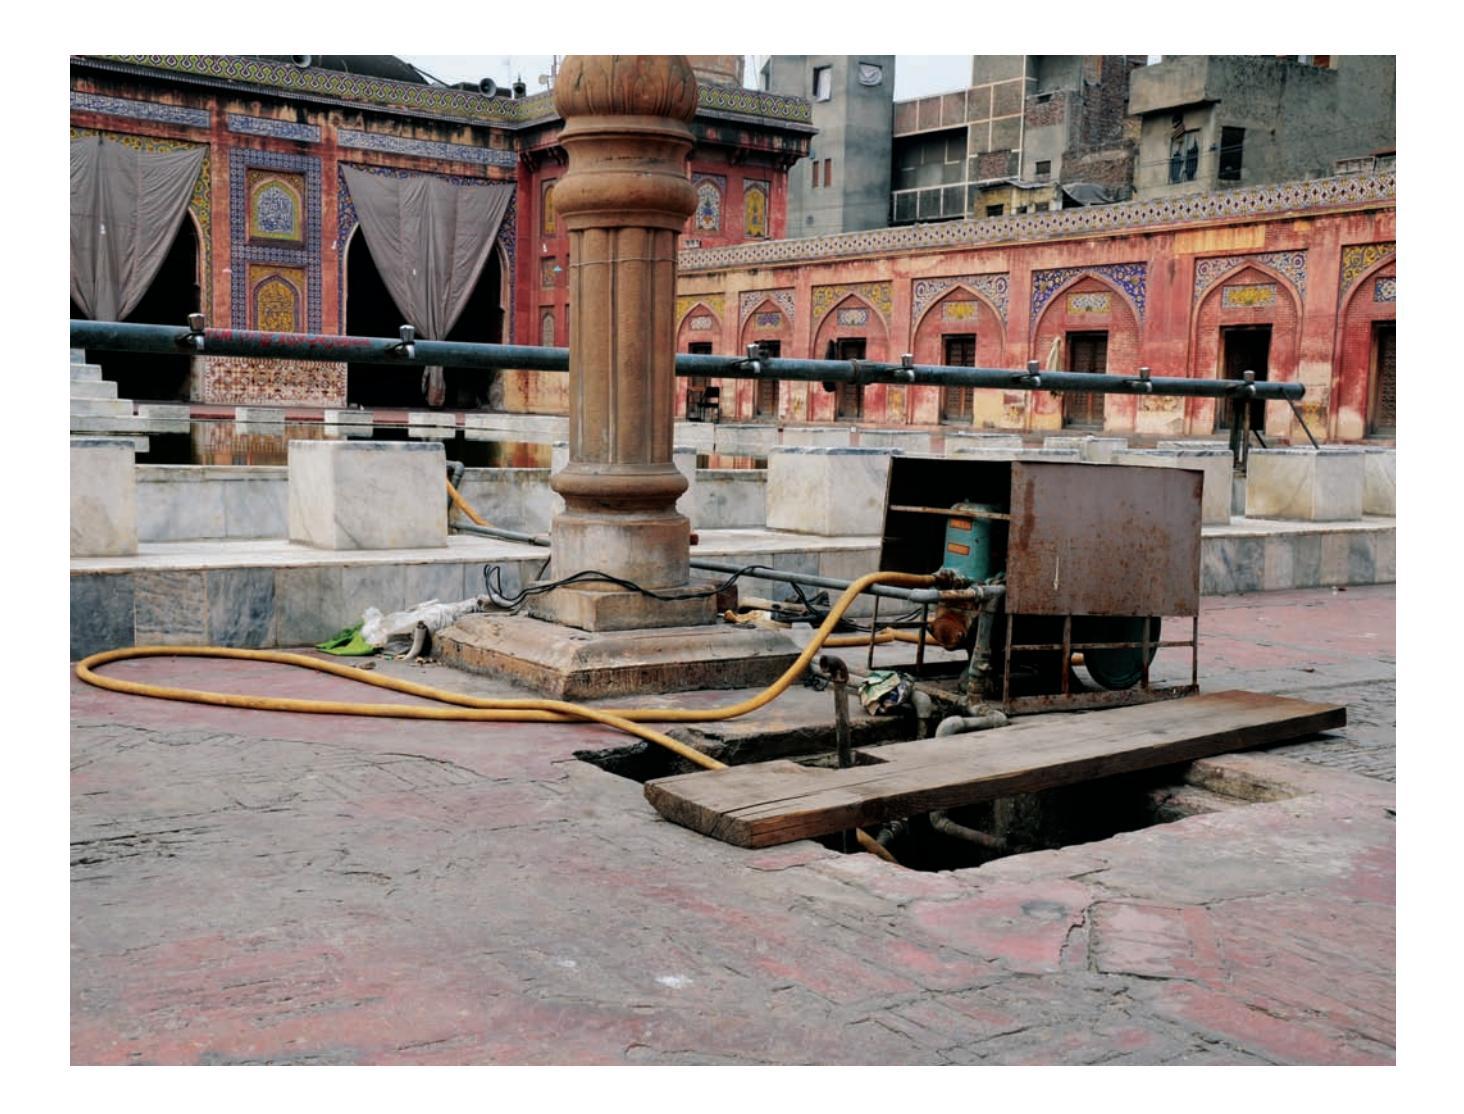
Above: Water supply pump positioned on the east side of the ablution pool - one of the first things visitors are confronted with on entering the courtyard from the entrance.

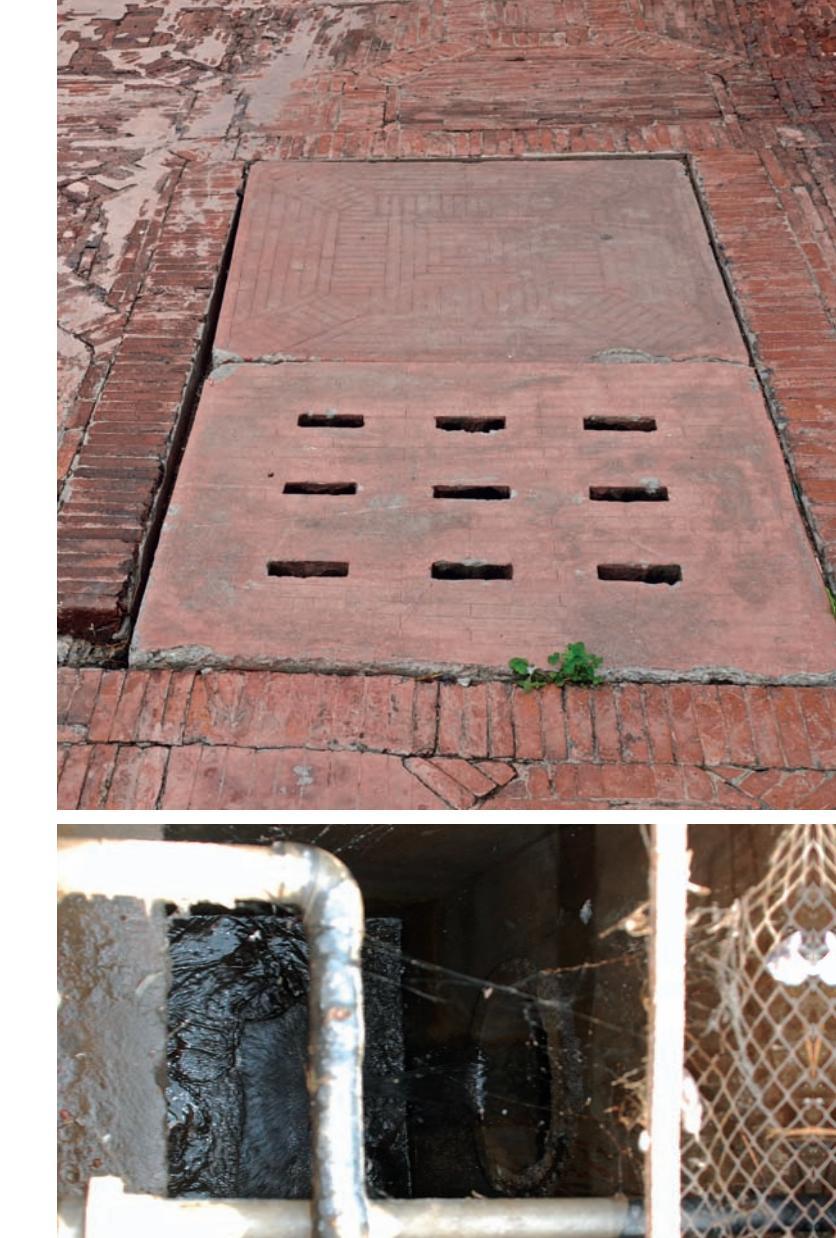
Top: Drainage grate at the level of the courtyard. Above: Cover is lifted to expose drain and water supply pipes.

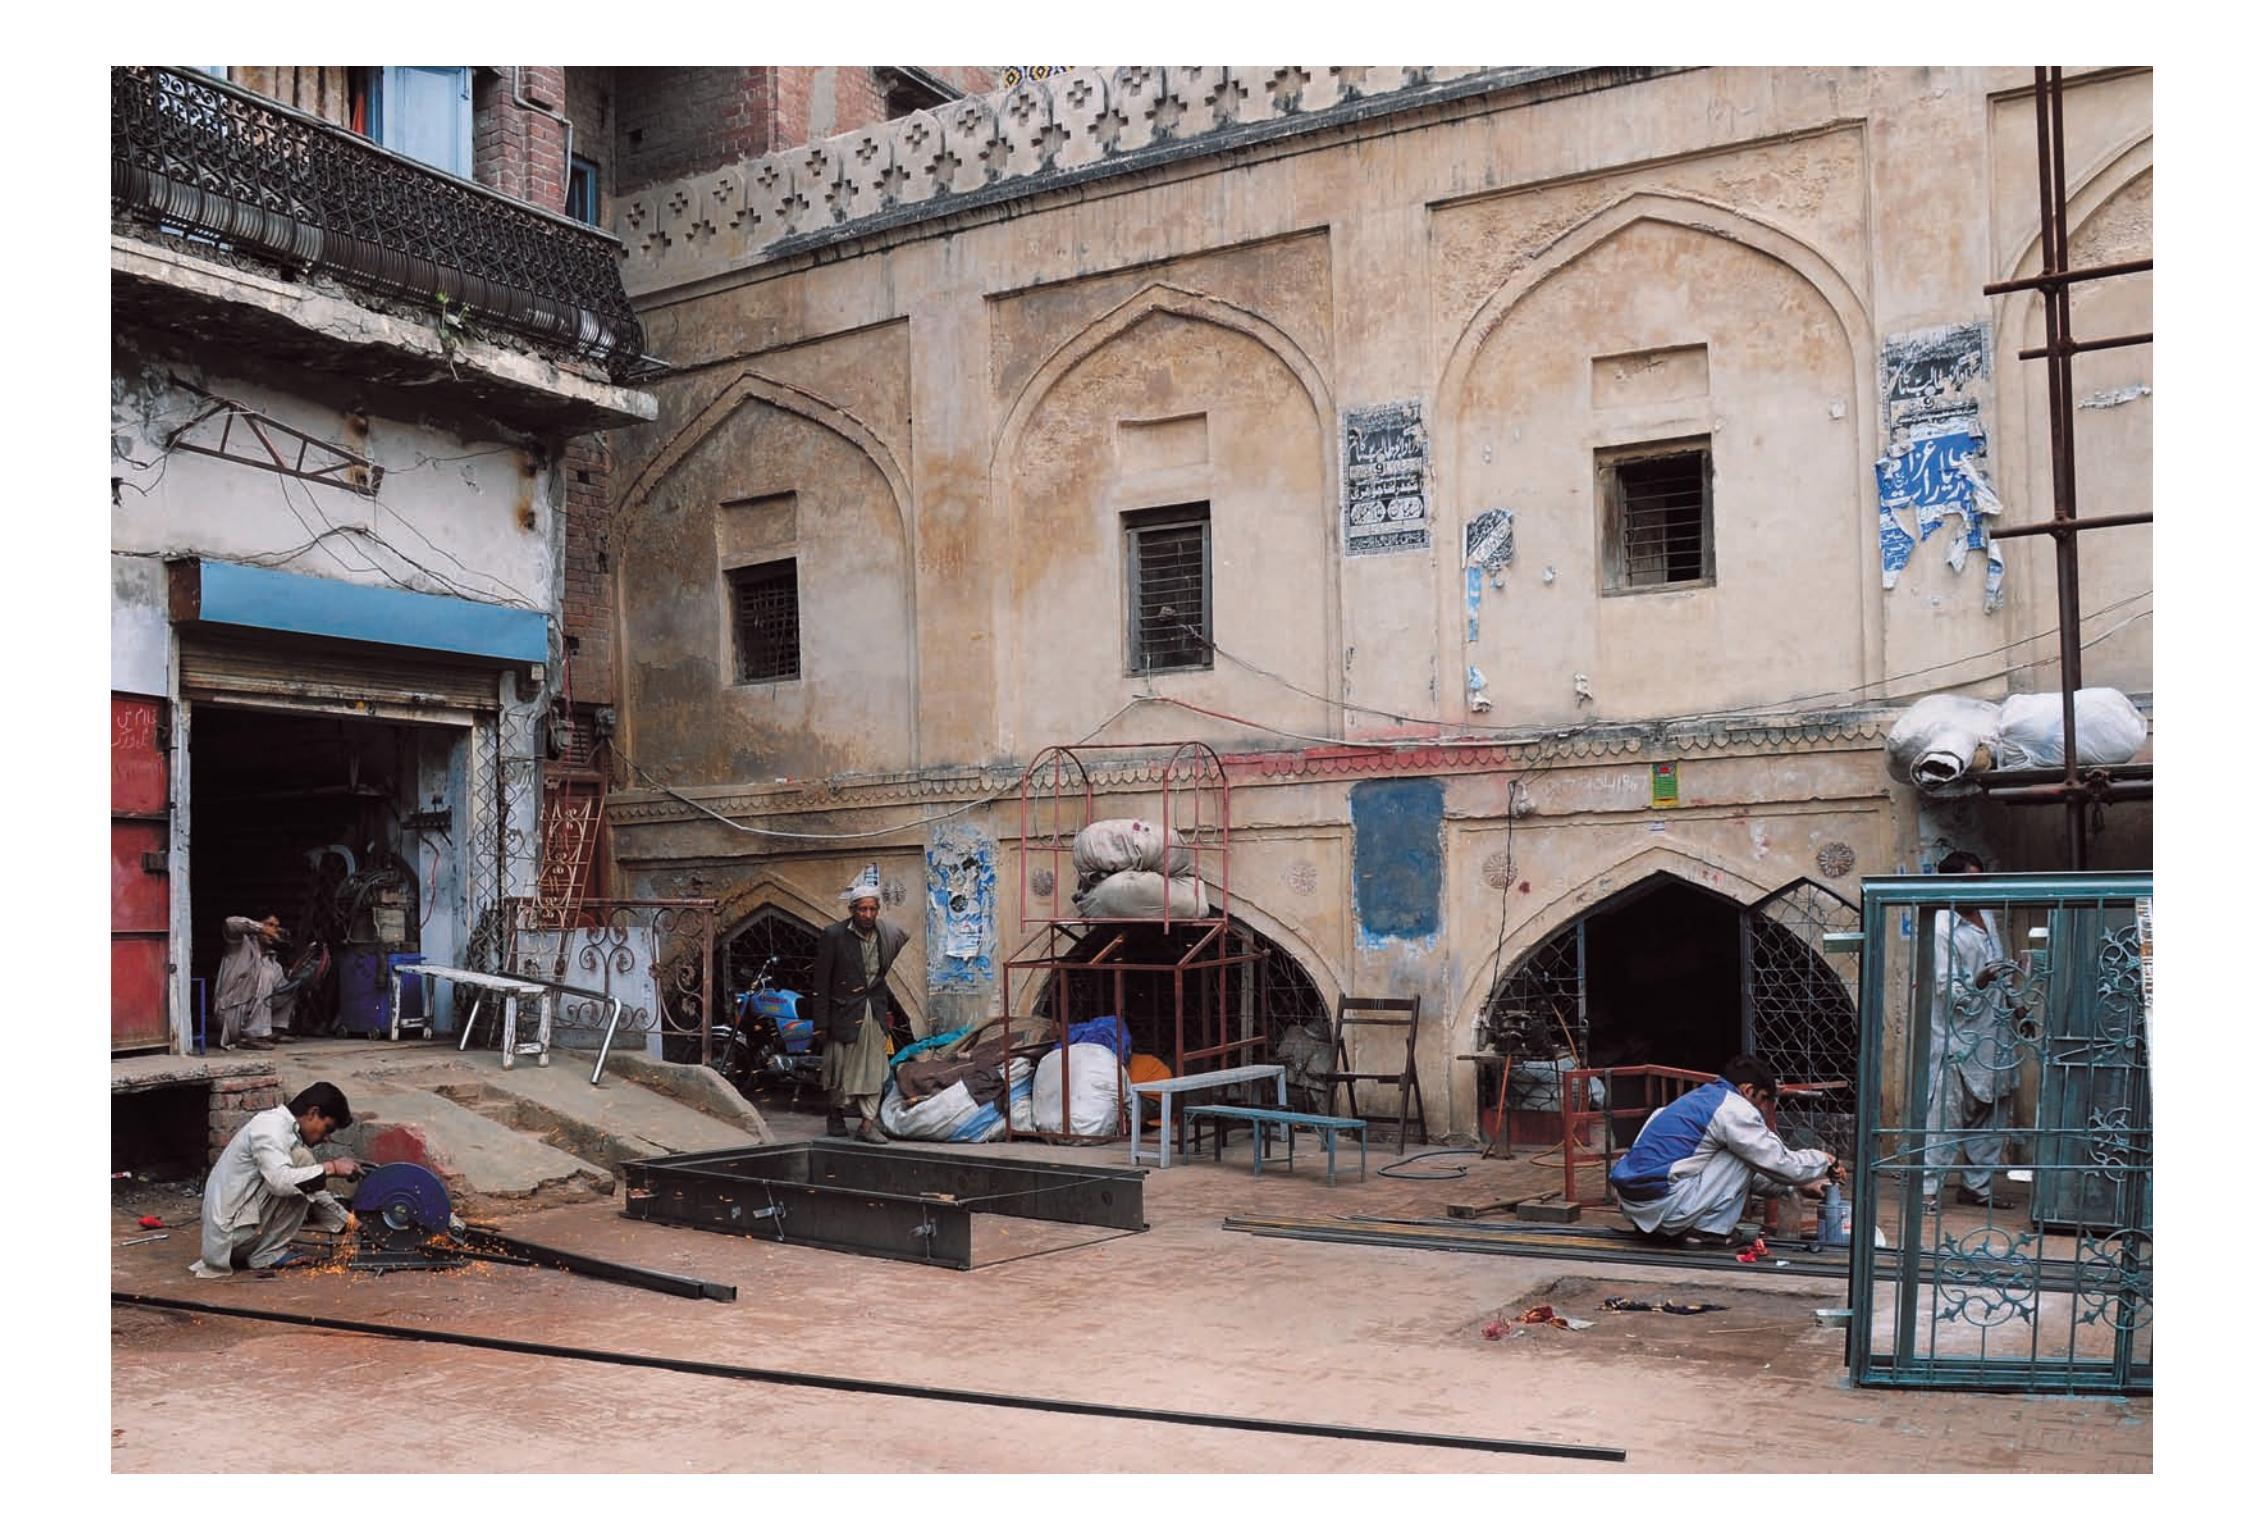
Above: Subsidence and floor repair in the north-west corner of the courtyard has created different levels with badly finished edges.

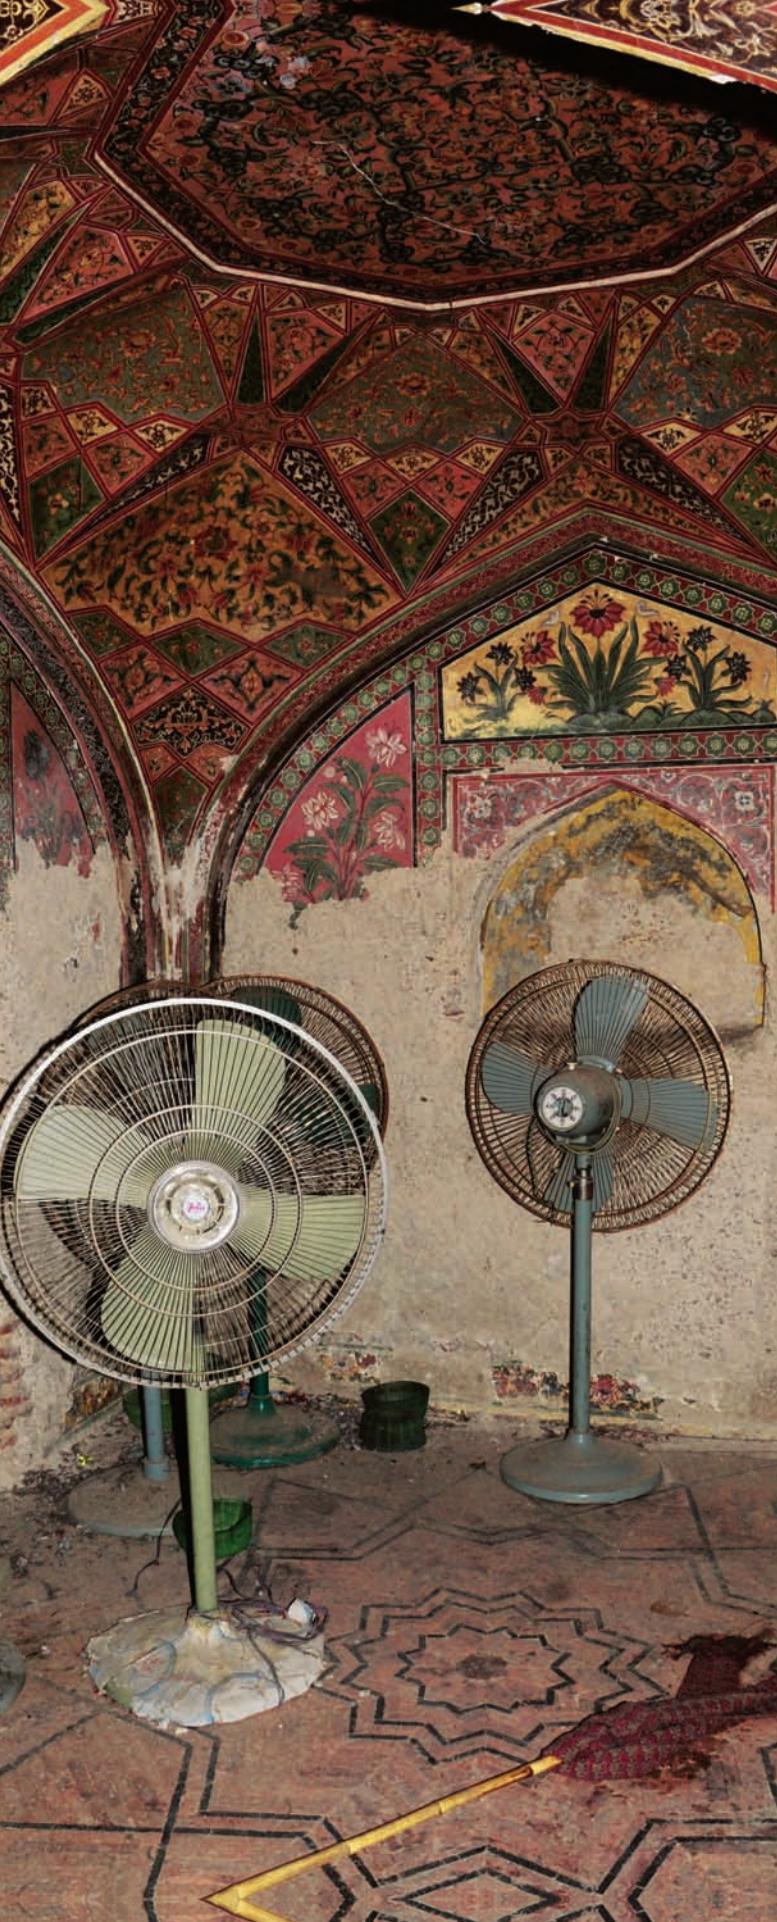
Far Right: The height of wall damage corresponds to the height of the pedestal fans being stored. In this instance, it is a small room on the southern side of the prayer chamber.
