# CONSERVATION OF THE WAZIR KHAN MOSQUE LAHORE

PRELIMINARY REPORT ON CONDITION AND RISK ASSESSMENT

AGA KHAN TRUST FOR CULTURE AGA KHAN CULTURAL SERVICE - PAKISTAN

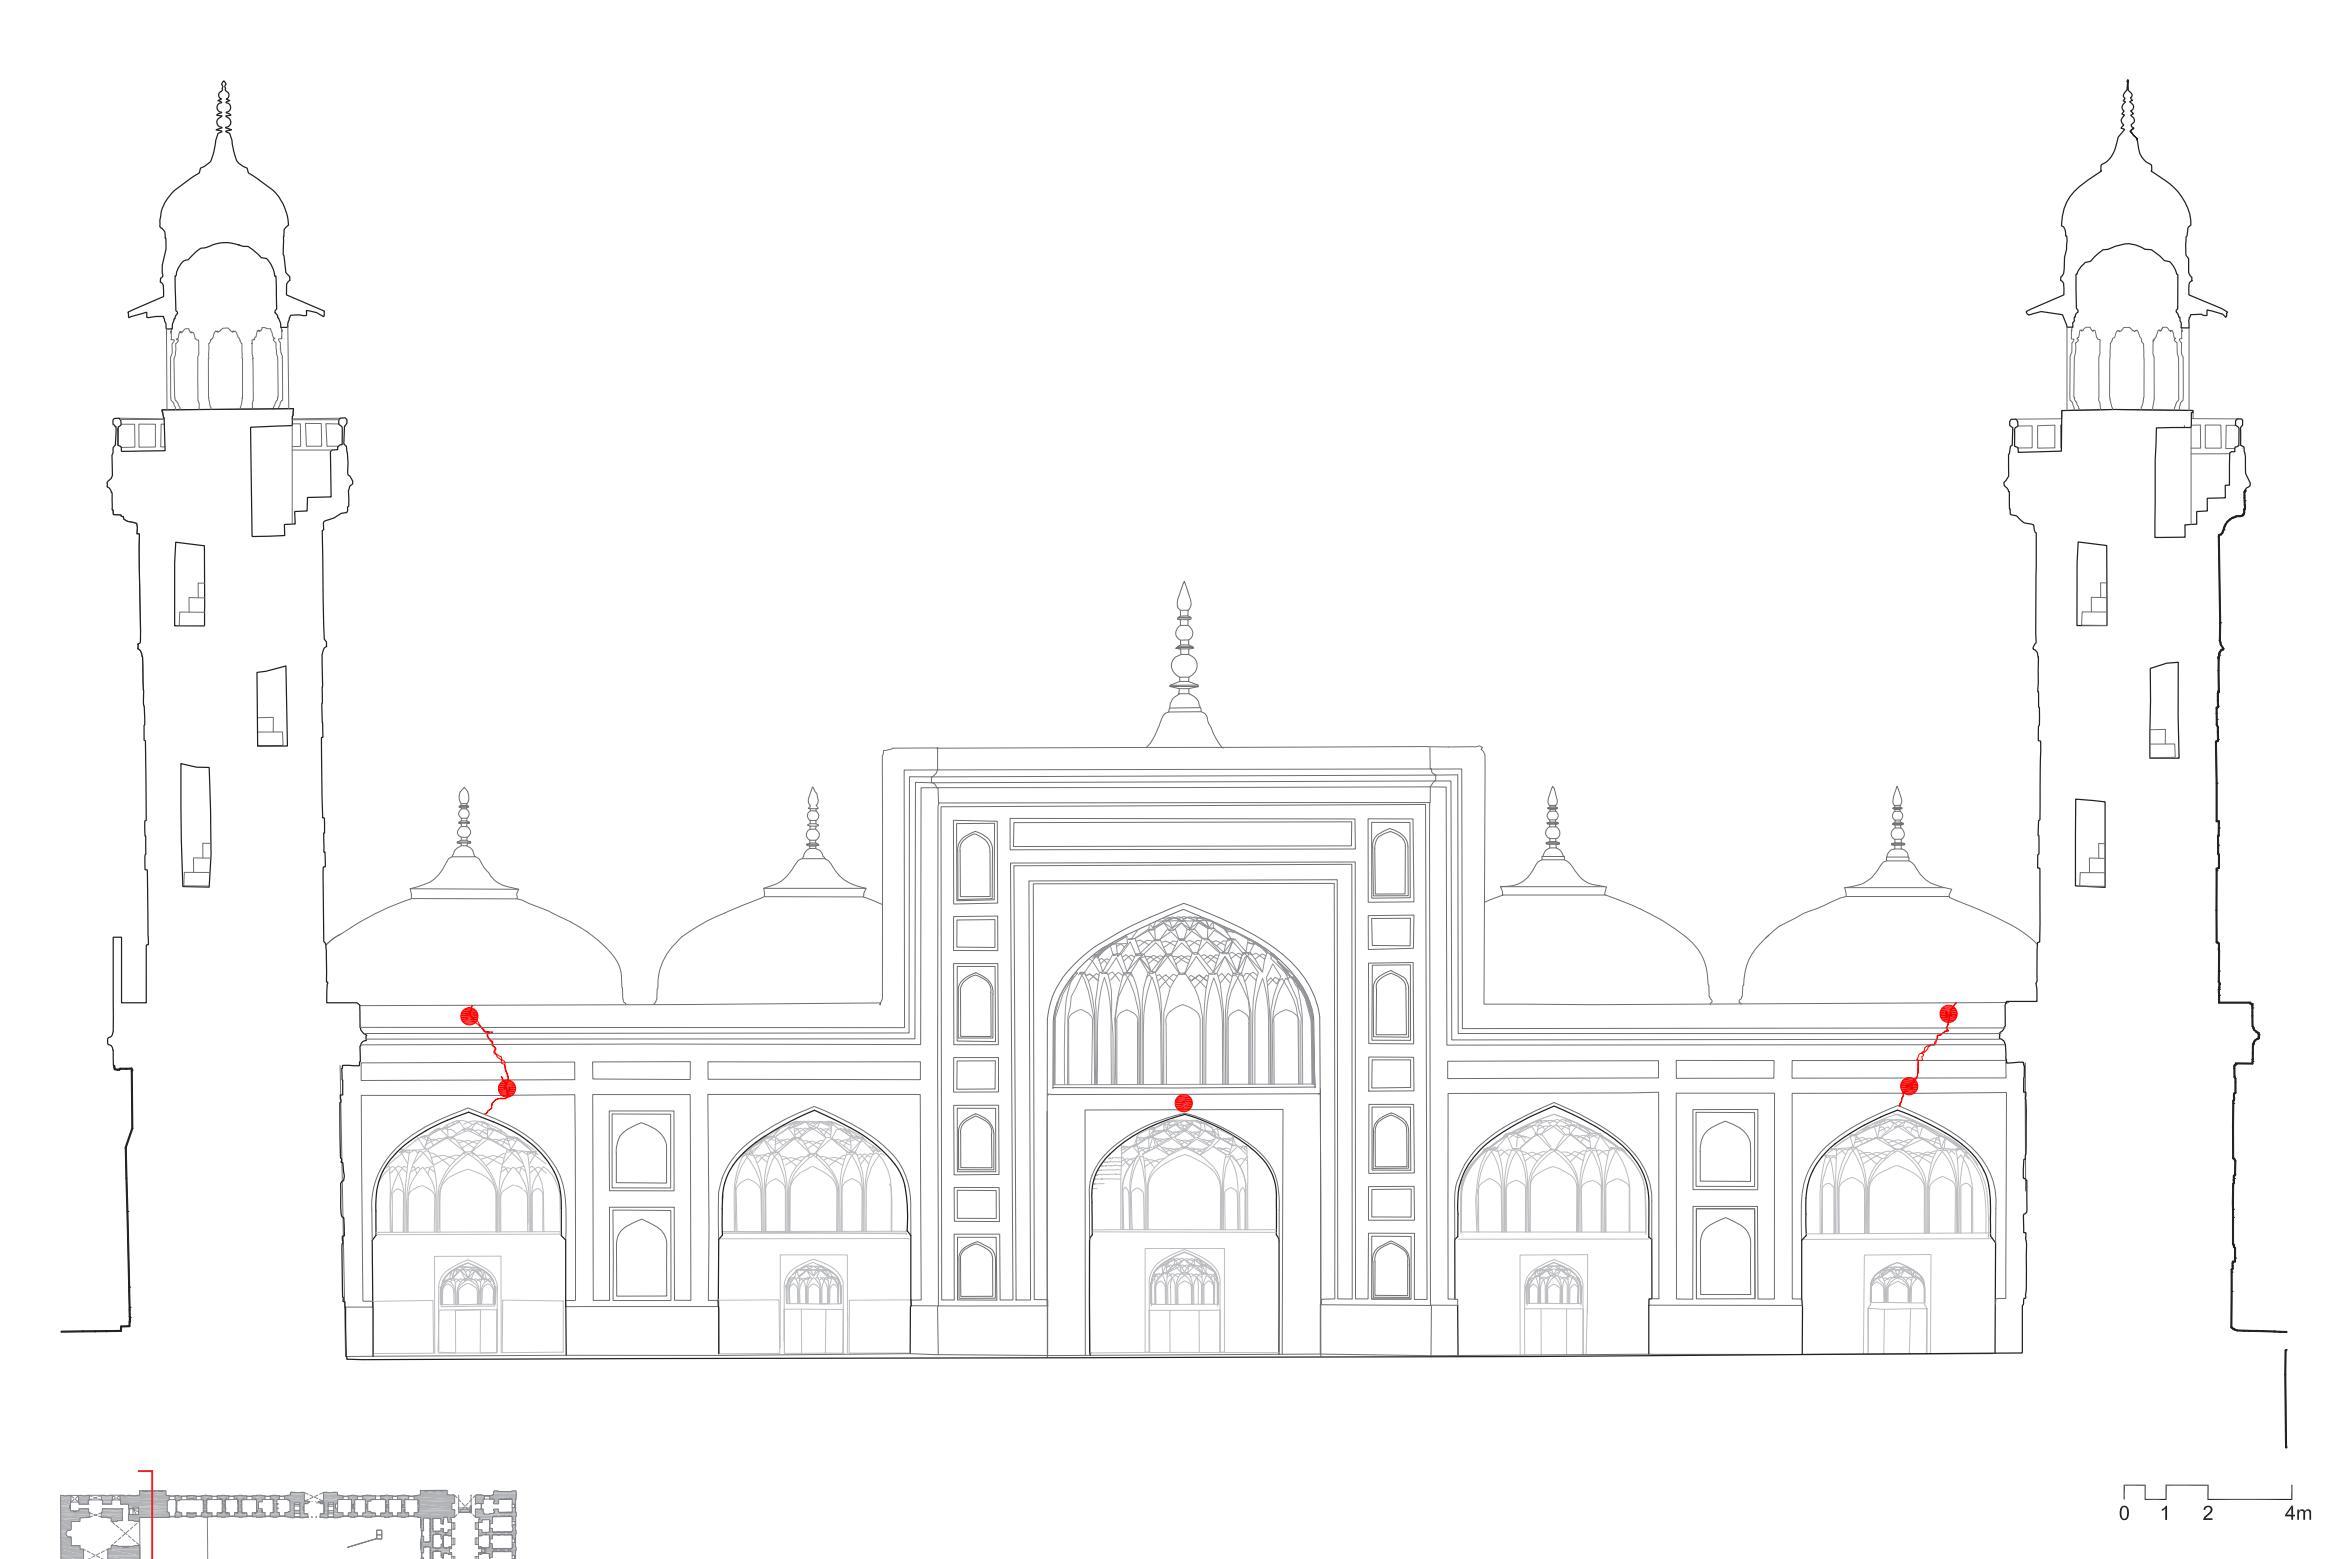
DOCUMENTATION OF CRACKS IN THE PRAYER CHAMBER - EAST ELEVATION

While in structural terms the mosque appears to be generally robust, there are certain grave structural threats that need to be immediately addressed. Glaring structural cracks exist in the prayer chamber, and in the south-eastern corner of the Calligraphers' Bazaar fronting on the courtyard. There is no historical record available for the cracks in the prayer chamber, and expert opinion<sup>44</sup> has related this to an earthquake in the early 20<sup>th</sup> century.<sup>45</sup>

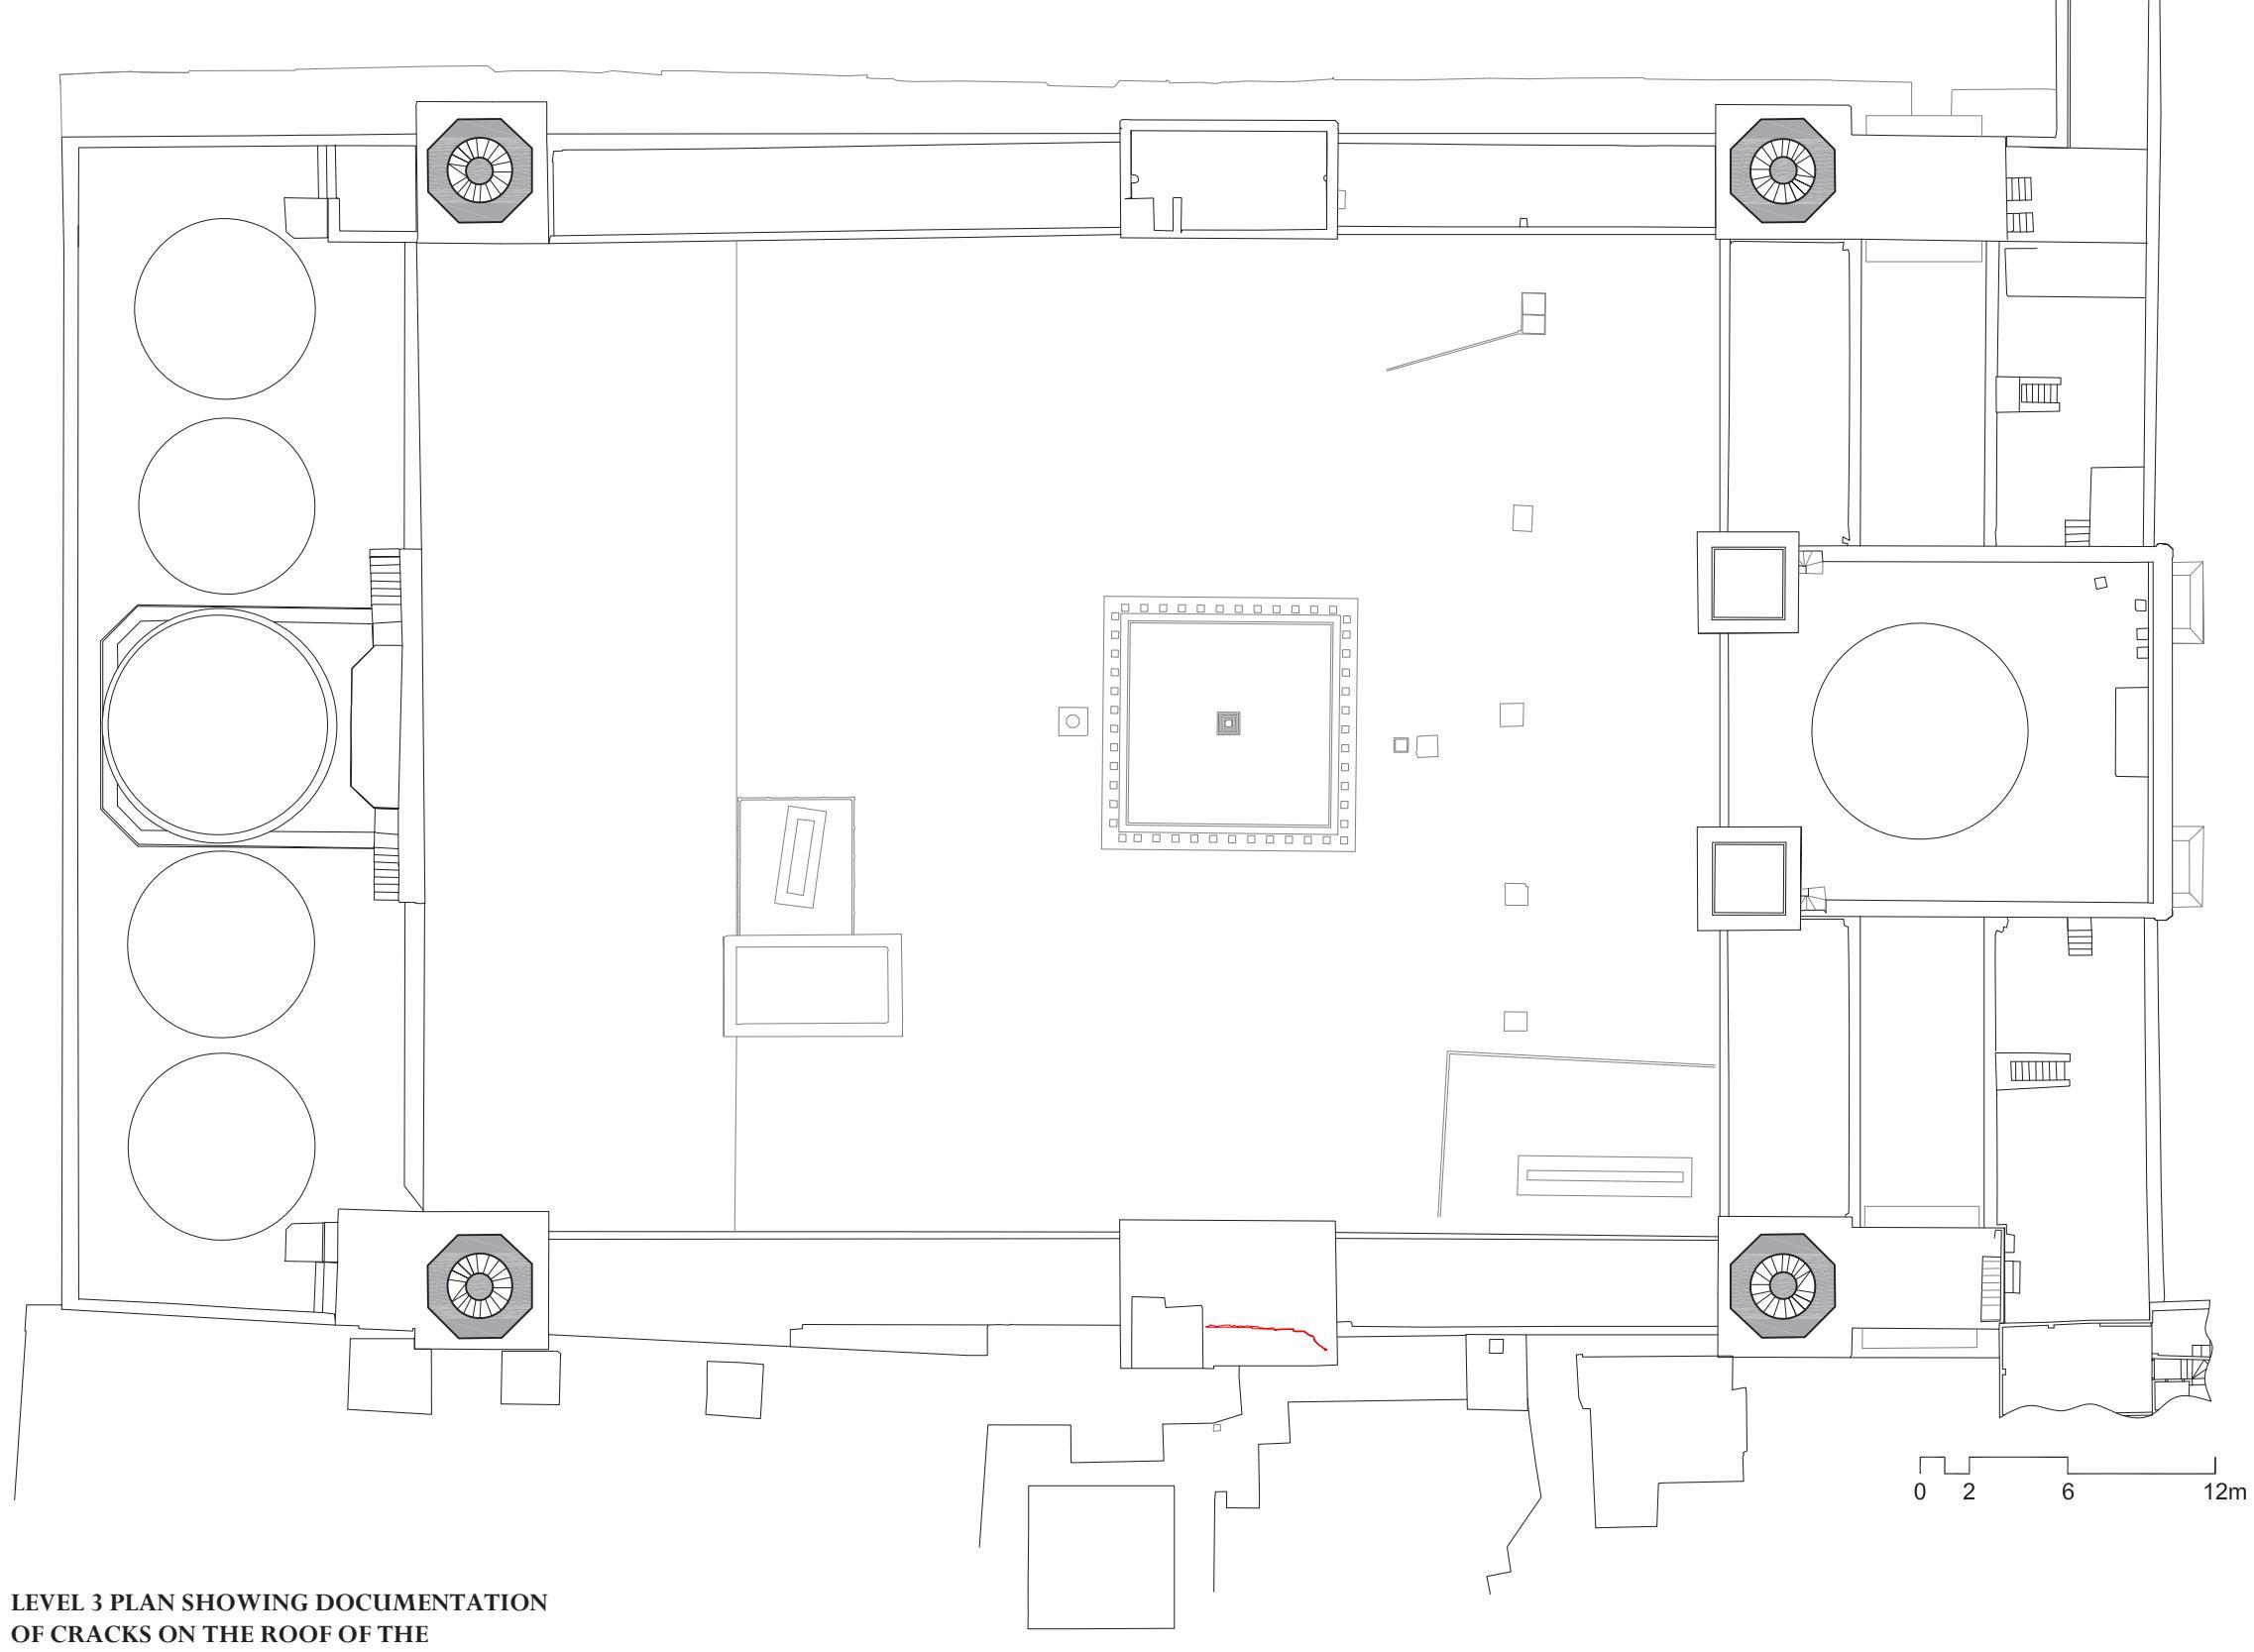
SOUTHERN AXIAL PAVILION

The roof of the pavilion at the centre of the southern array of *hujras* shows a large crack, probably due to the precarious condition of its southern wall.

The poor quality of drainage on the outside of the southern wing, as described above, has resulted in considerable damage to the structure of the southern pavilion and to the wings of *hujras* on its sides. The pavilion appears to have subsided in a major way, and apart from suffering serious structural damage itself, has caused the entire section of the *hujras* to its west to list downwards by 15 cm (6 inches) from the horizontal. A similar subsidence has also occurred on the row of *hujras* on the eastern side, measured at a maximum of 16.3 cm along the length of these *hujras*. Damage on the southern side of the pavilion has occurred in the form of major roof cracks, loss of historic masonry and surface deterioration.

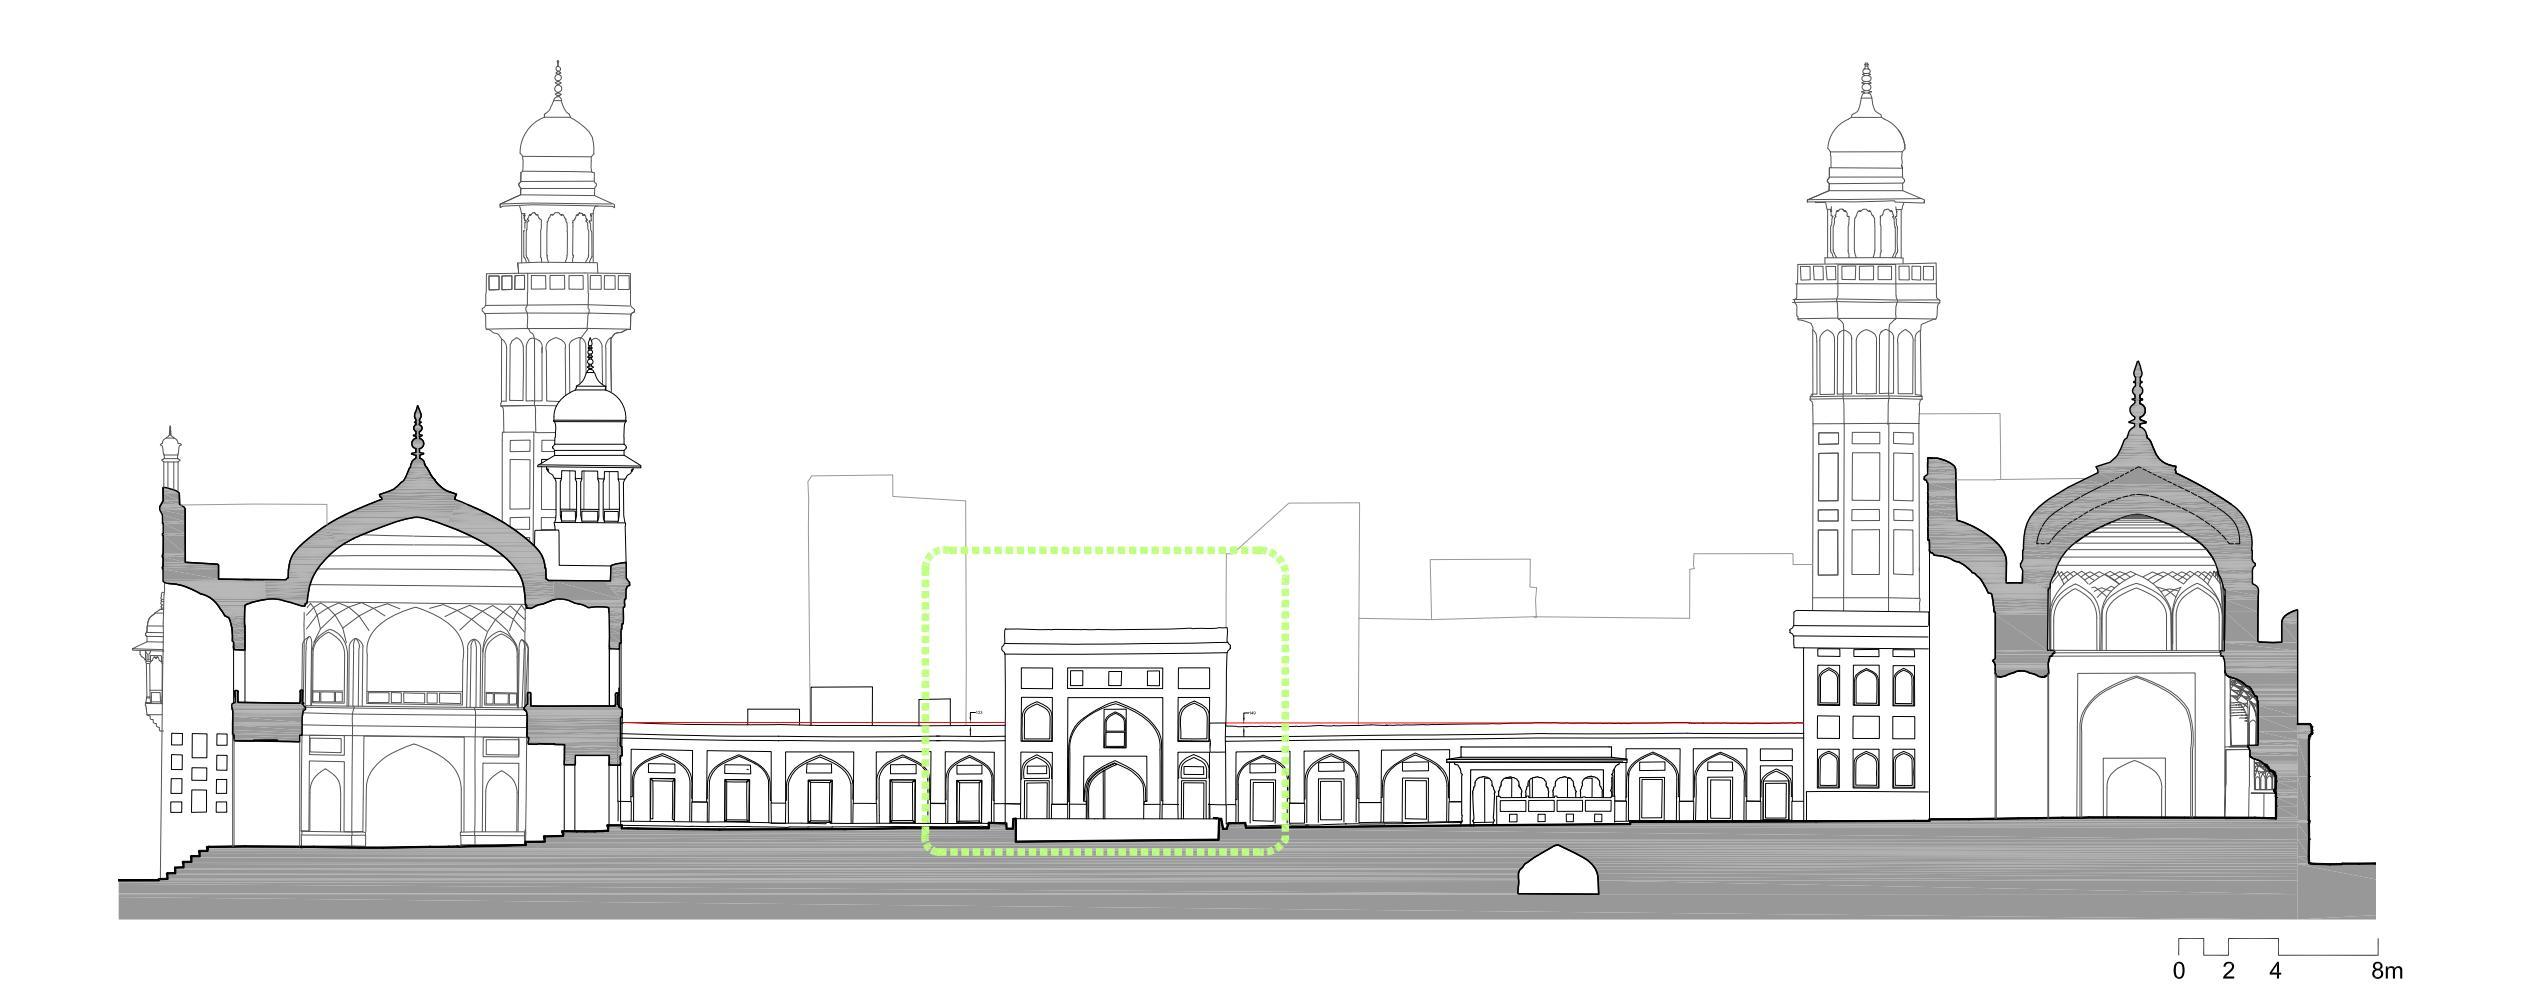
# SUBSIDENCE IN THE SOUTHERN ROW OF HUJRAS

Opposite page: detail of the southern hujras and the southern central pavilion. Note the subsidence experienced on this side. The two wings of the hujras on the south side of the courtyard have subsided as shown with respect to the central pavilion. Subsidence is shown in millimetres with reference to a horizontal line (in red) drawn from the point where the parapets end against the base of the south-east and south-west minars.

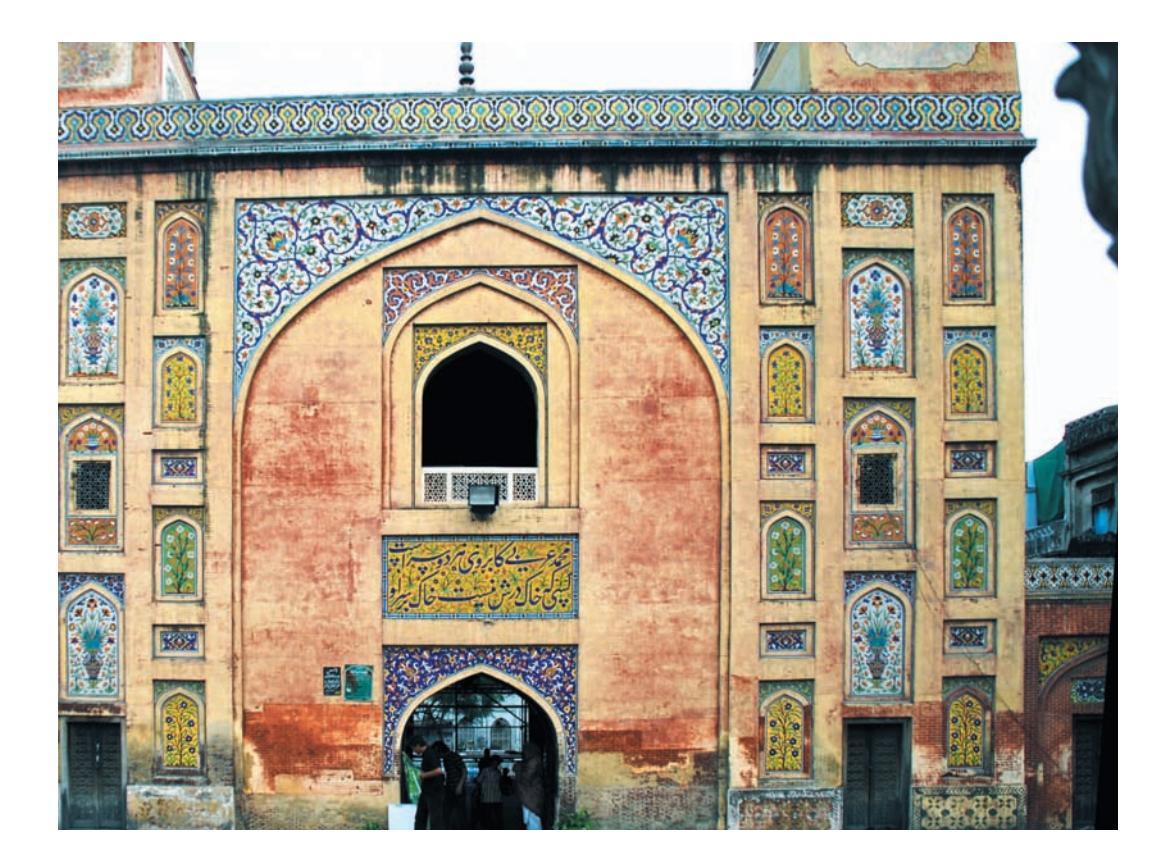
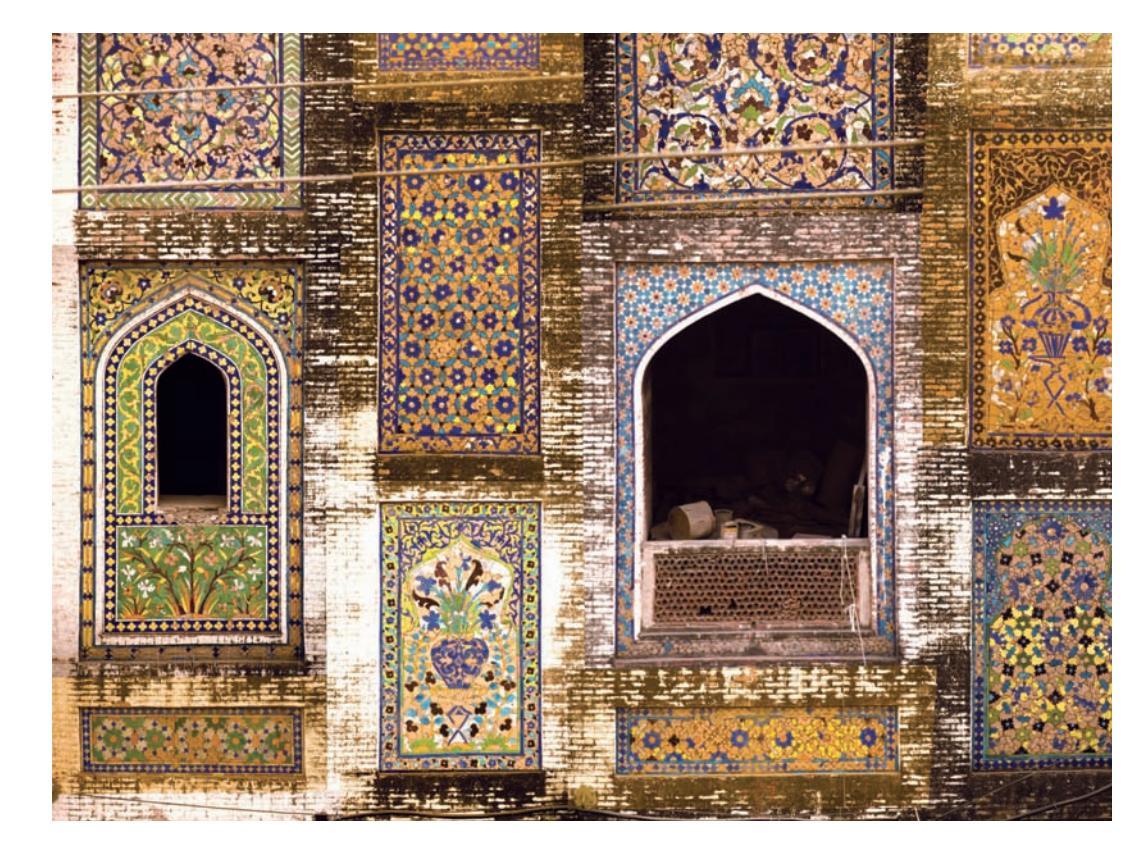
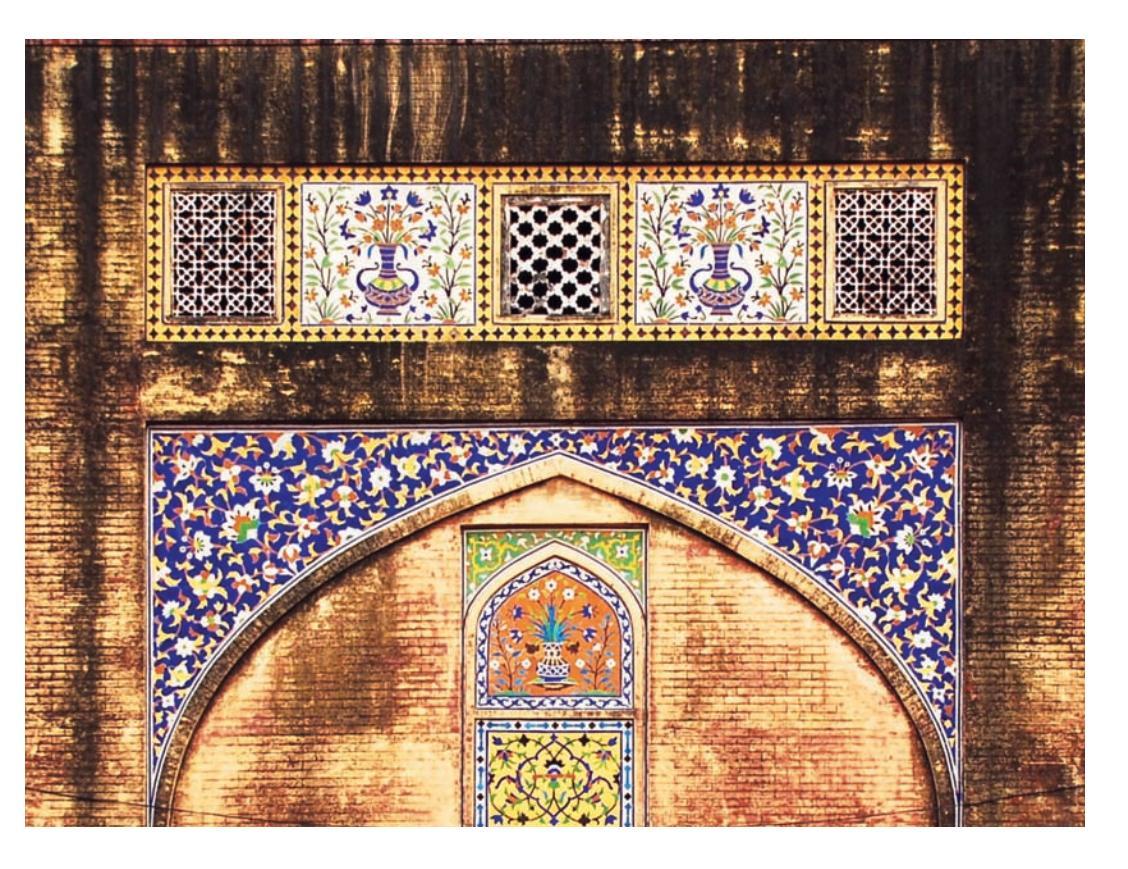
# DISCOLOURATION

Three examples of discolouration, biological deposits and dust on various surfaces of the exterior.

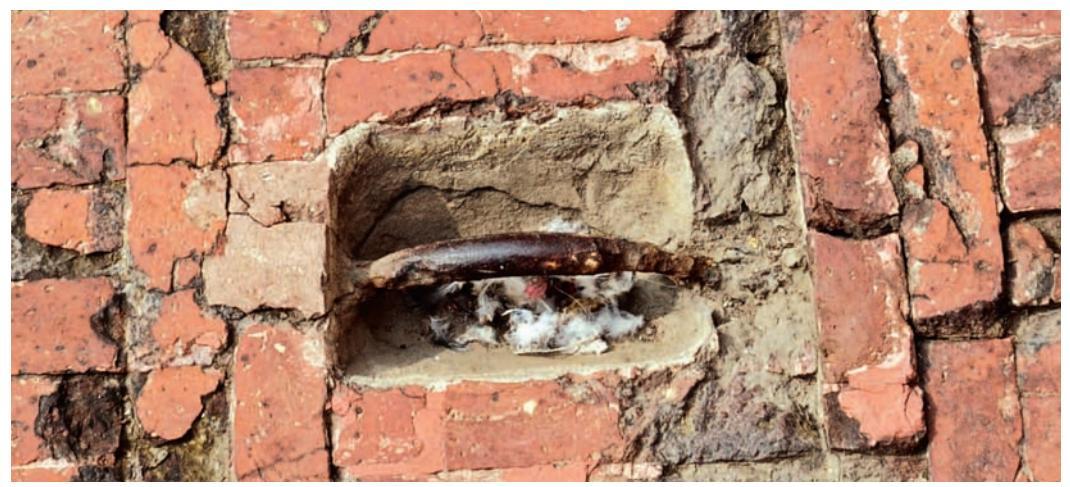
Puncturing of floor to accommodate fixtures such as metal hooks for tying shamiana ropes indicates the need for better and more appropriately located details.

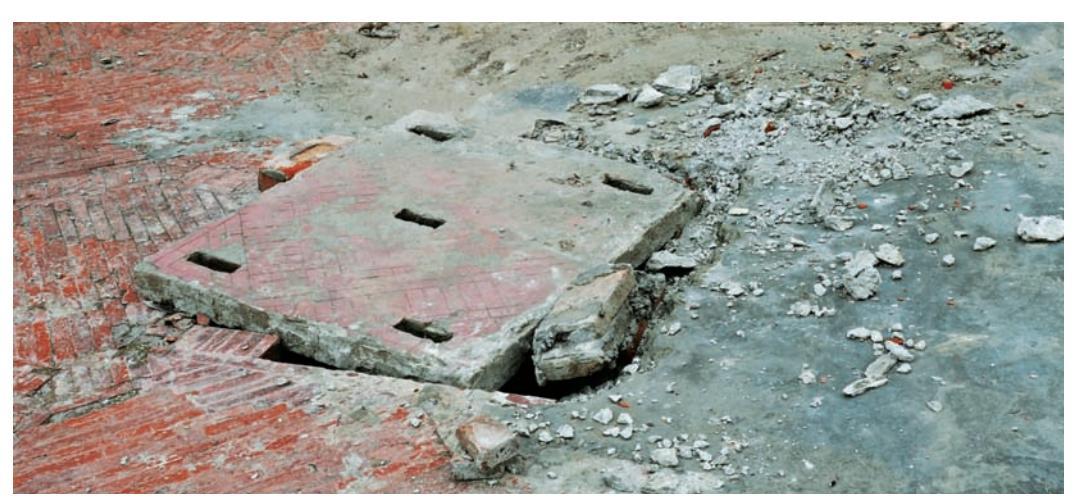
Poor detailing of waste and storm water disposal grating.

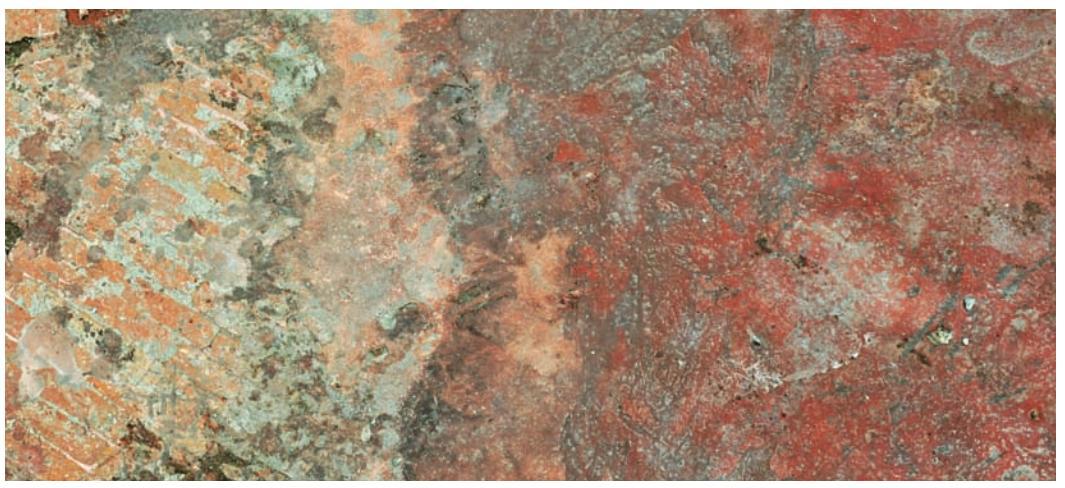
Inappropriate use of materials to repair floor - in this case coloured cement/sand or coloured lime render.

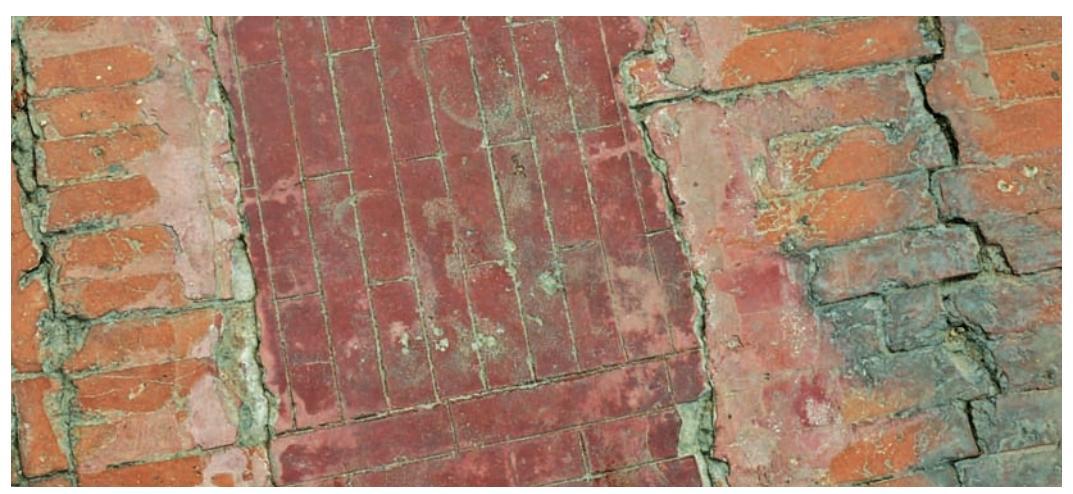
Brick and fake brick markings on cement/sand or lime/sand renders create an unsatisfactory appearance. Note the subsidence crack on the right of the photograph.

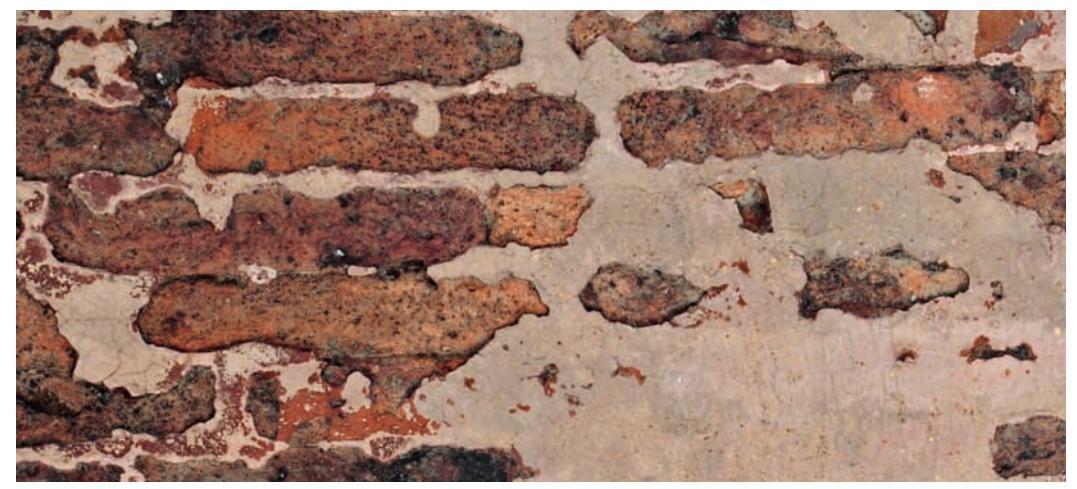
Inappropriate use of cement/sand renders and overgrouting between bricks.

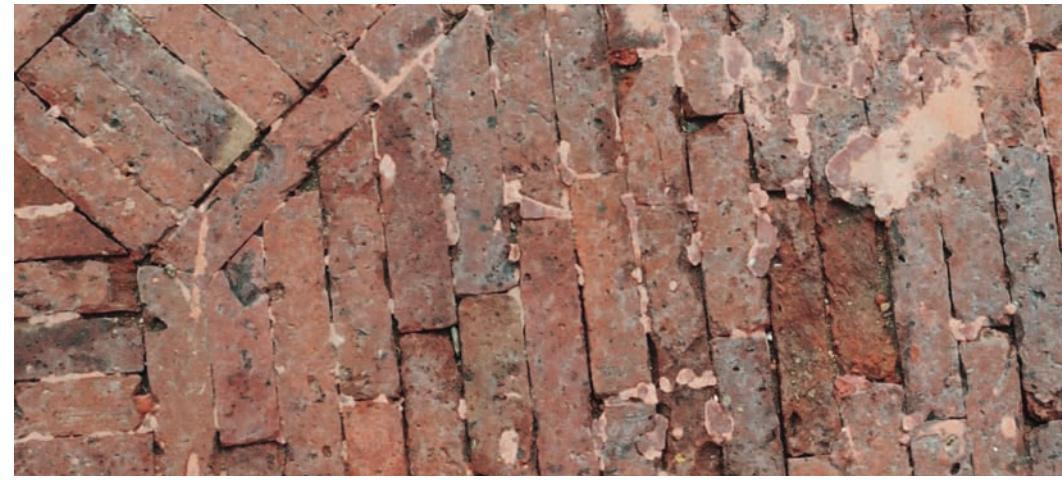
Erosion and disintegration of brick with surface wear.

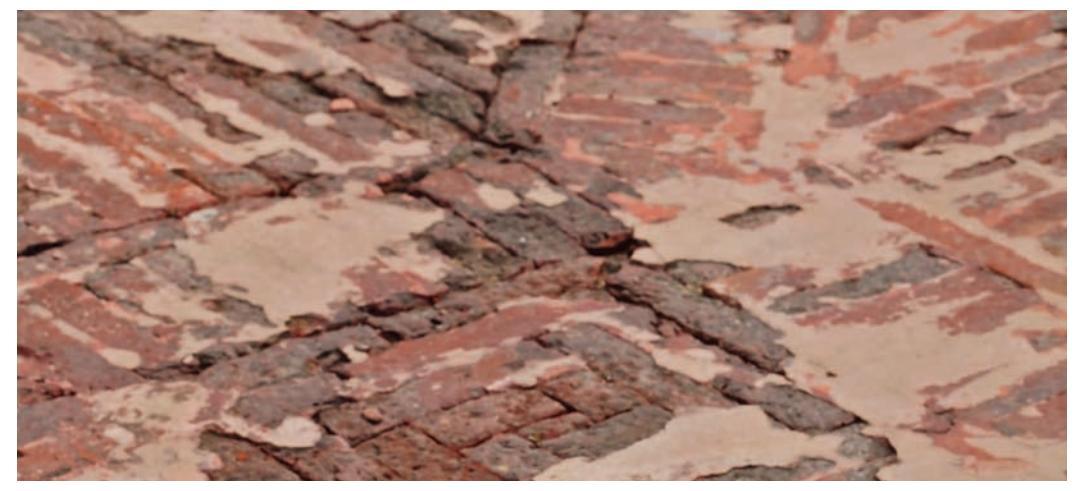
Faster rate of erosion of bricks with the inappropriate use of cement/sand renders used to achieve a water repellent surface.

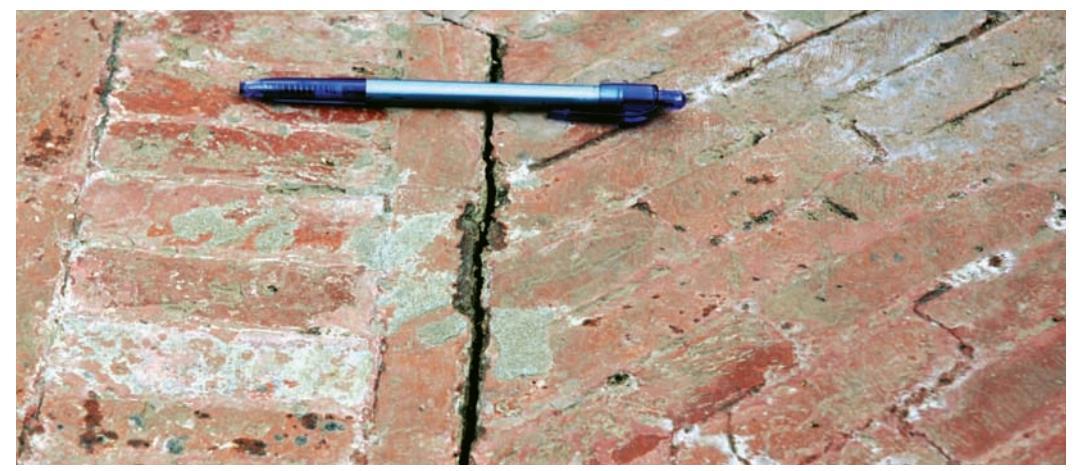
Major crack in the floor of the south-eastern part of the courtyard.

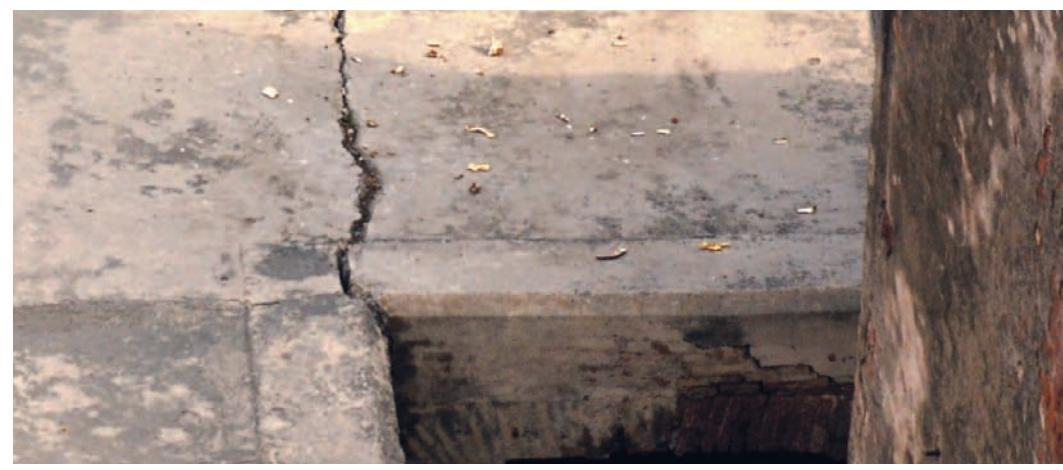
Major crack in the roof of the southern axial pavilion.

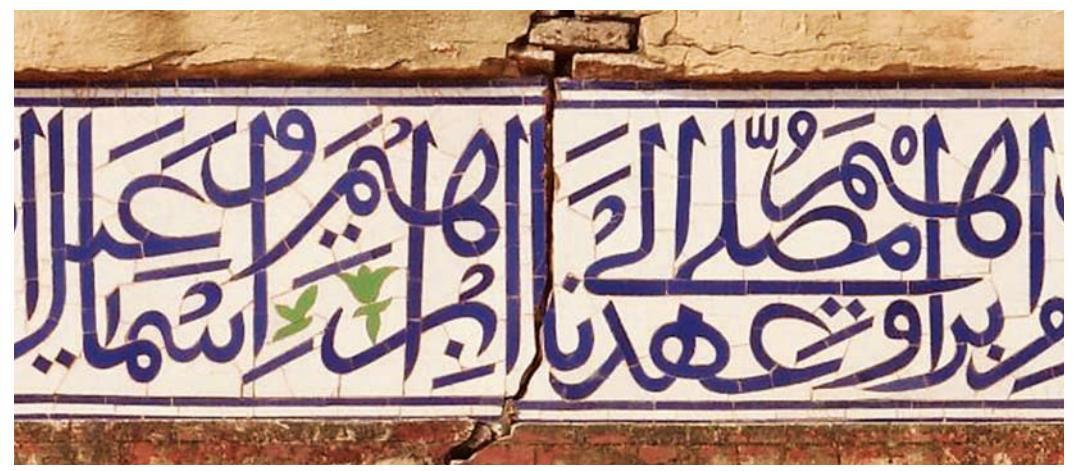
Major crack in the wall above the northern most archway of the prayer chamber.

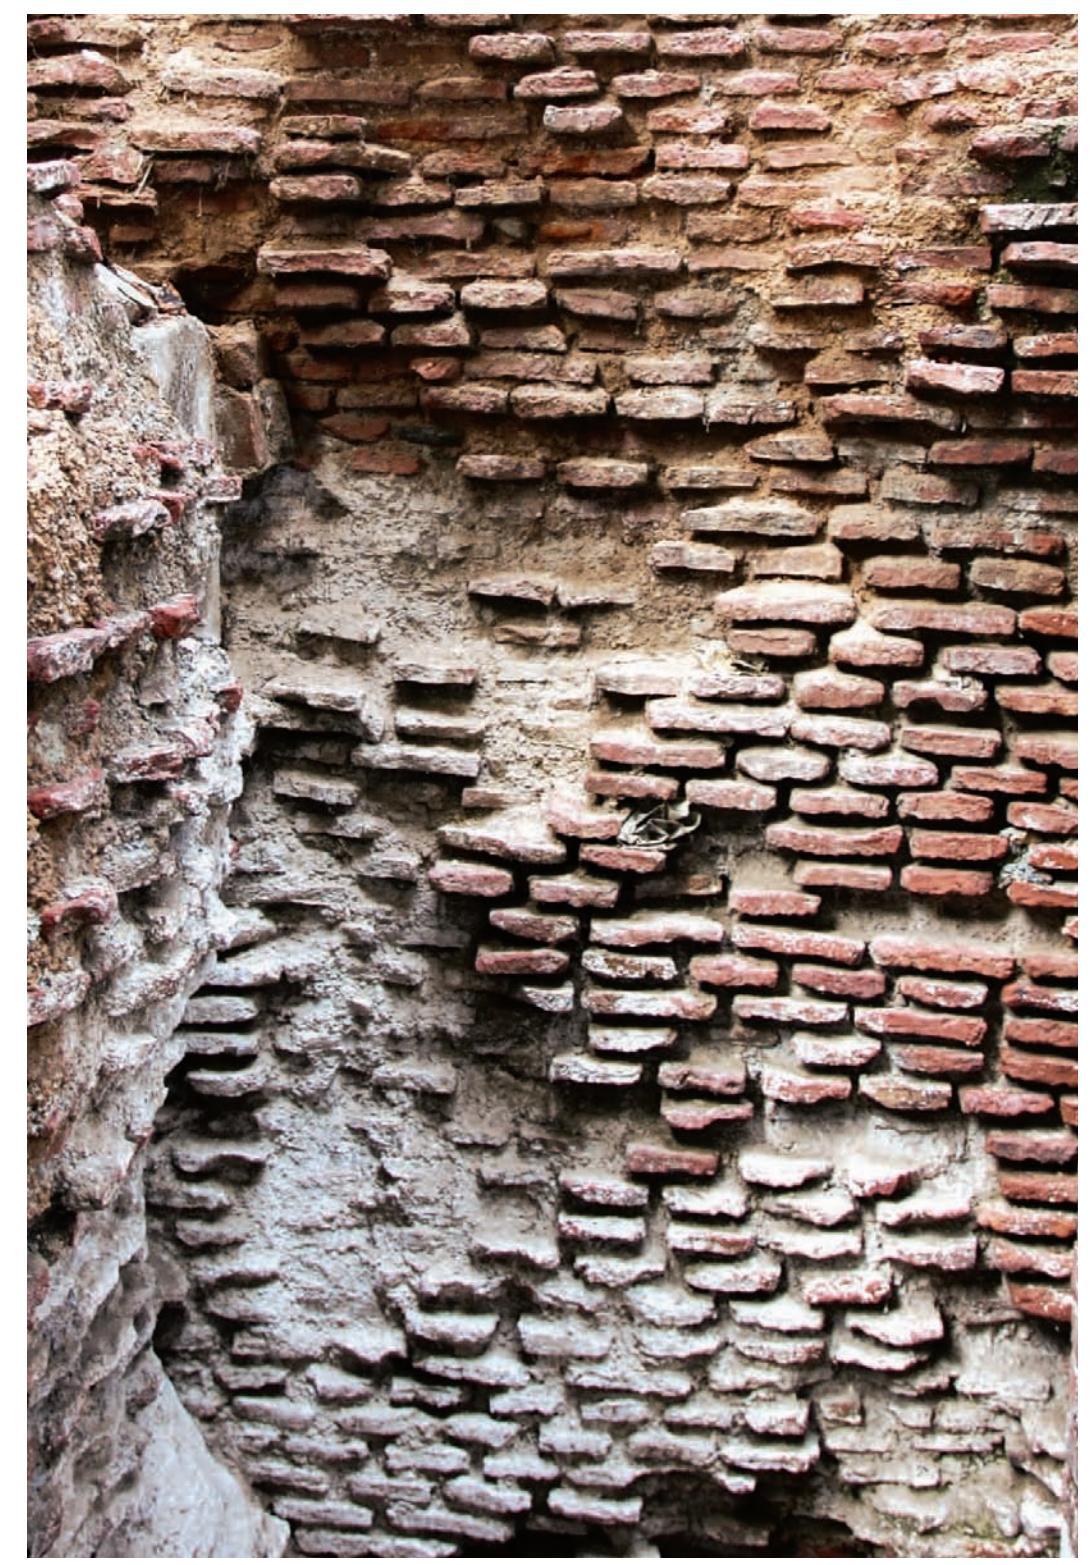
Sanding of mortar.

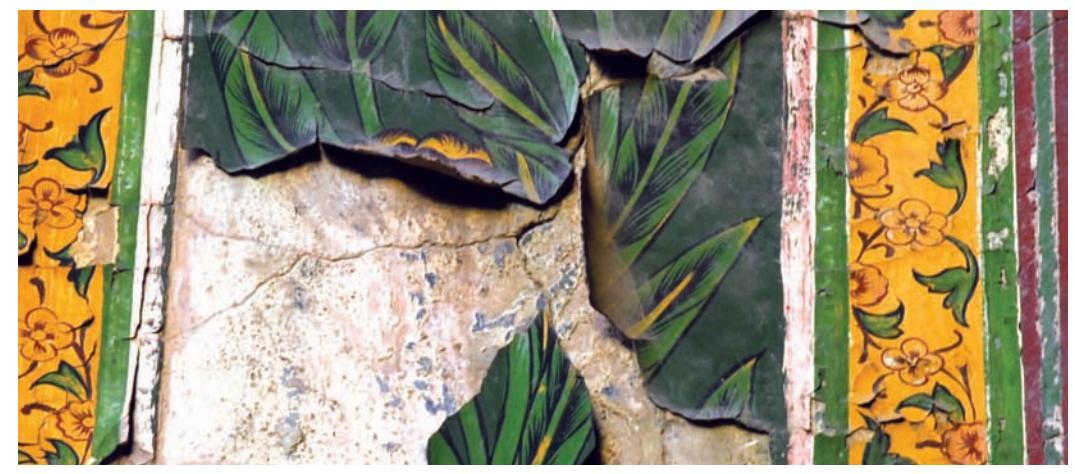
Peeling of upper coat of paint surface in the northern axial pavilion.

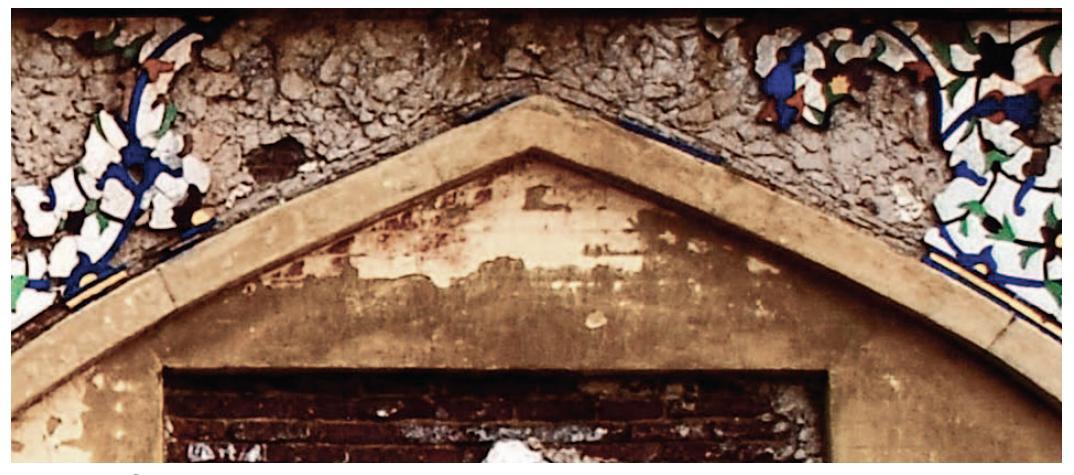
Partial loss of bond between tile and mortar.

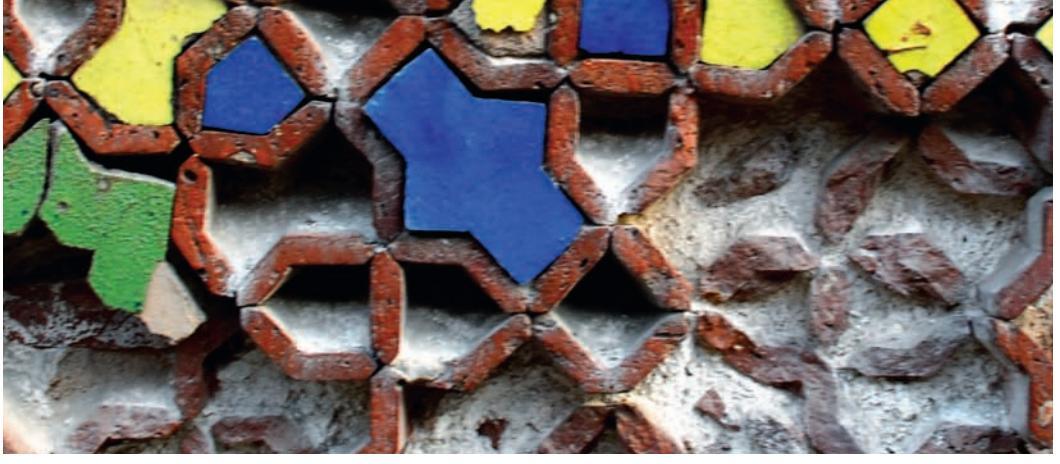
Breakout of tile embedded in unglazed terracotta lattice.

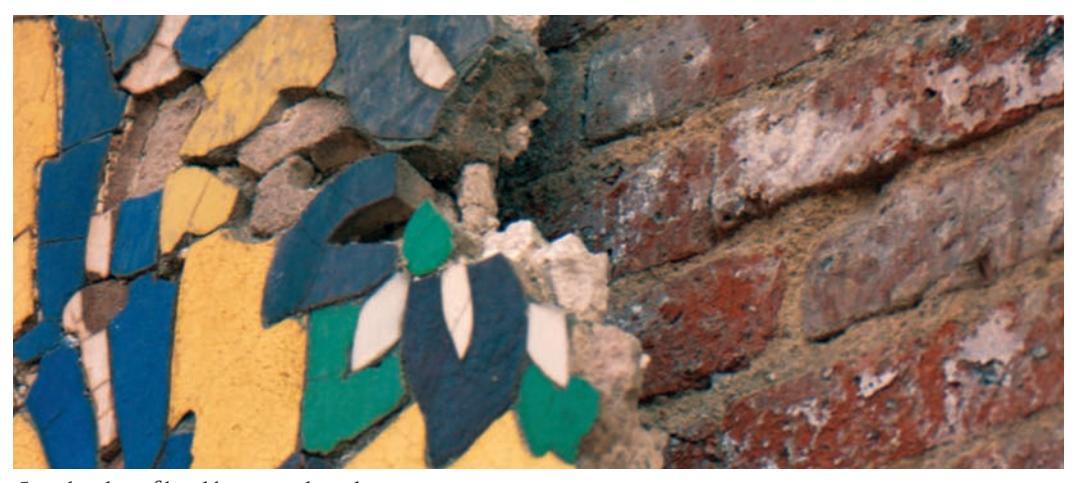
Complete loss of bond between tile and mortar.

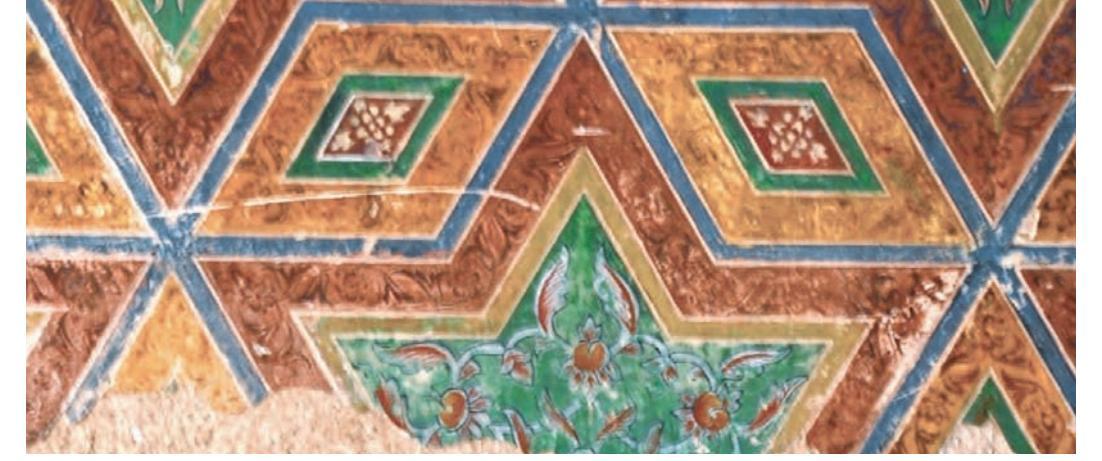
Peeling of the upper coat of surface render in the prayer chamber.
