# CONSERVATION OF THE WAZIR KHAN MOSQUE LAHORE

PRELIMINARY REPORT ON CONDITION AND RISK ASSESSMENT

AGA KHAN TRUST FOR CULTURE AGA KHAN CULTURAL SERVICE - PAKISTAN

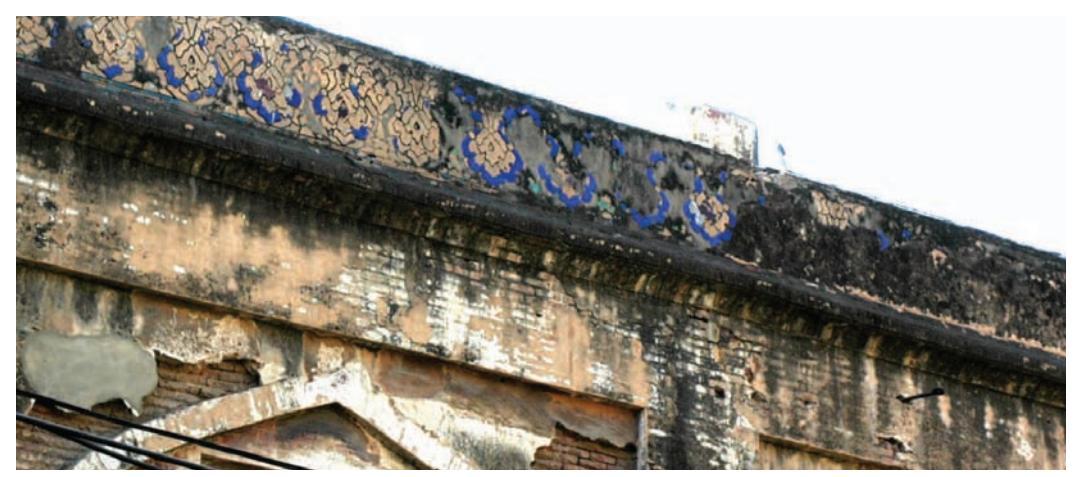
Advanced state of the deterioration of both mortar based external finishes such as faux brick and plain plaster render, as well as deterioration of crenellated tile work on the roof line of the north façade.

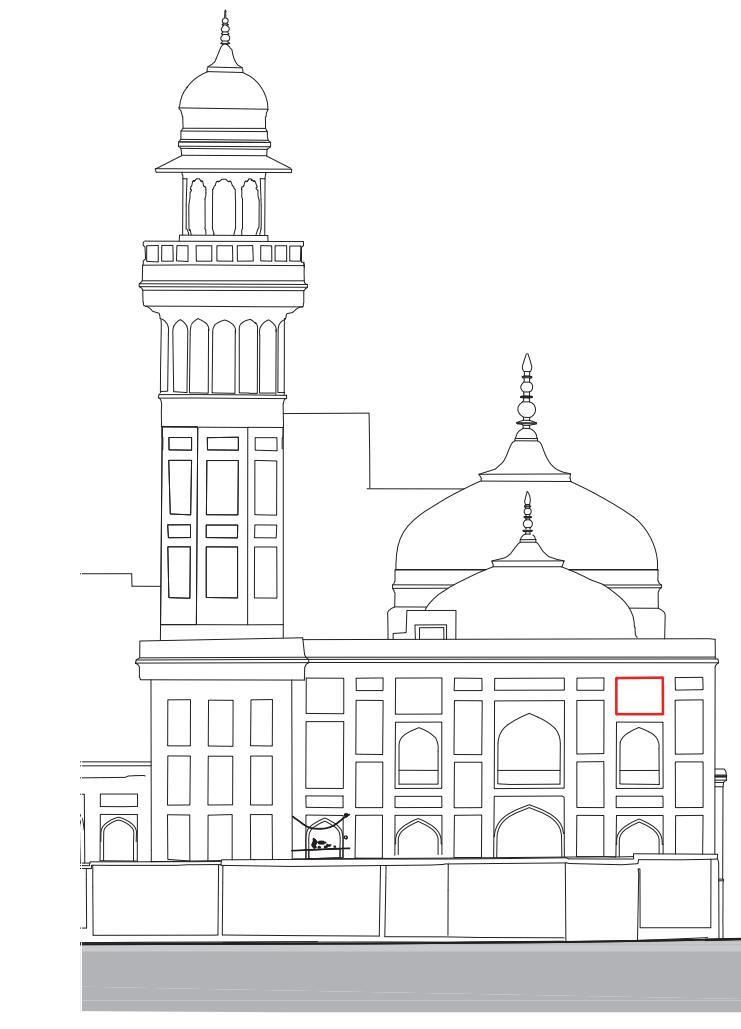
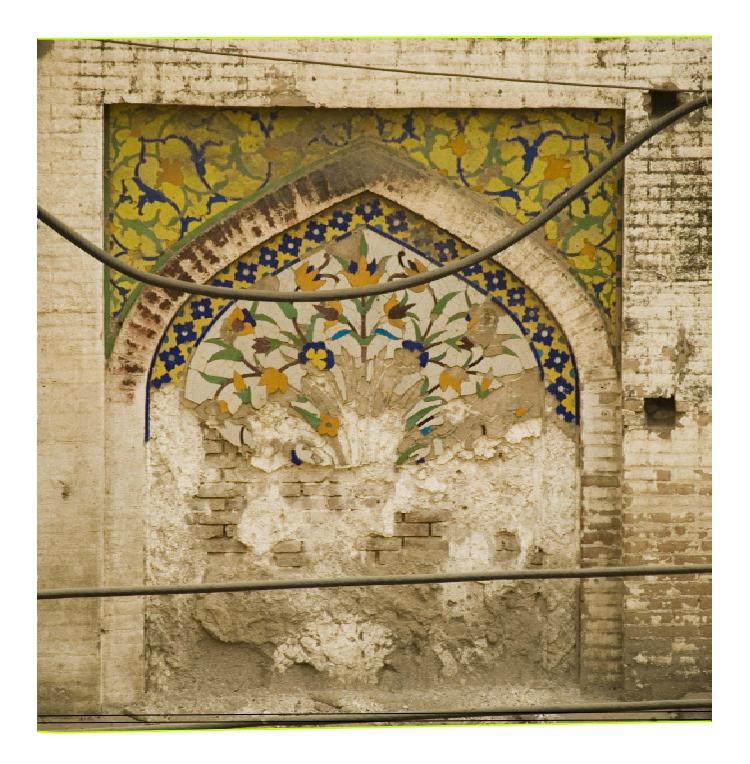
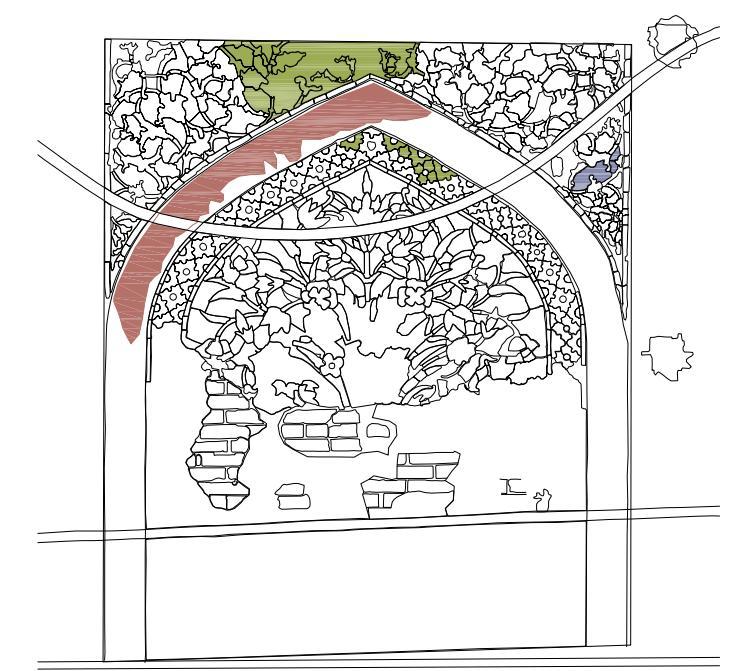
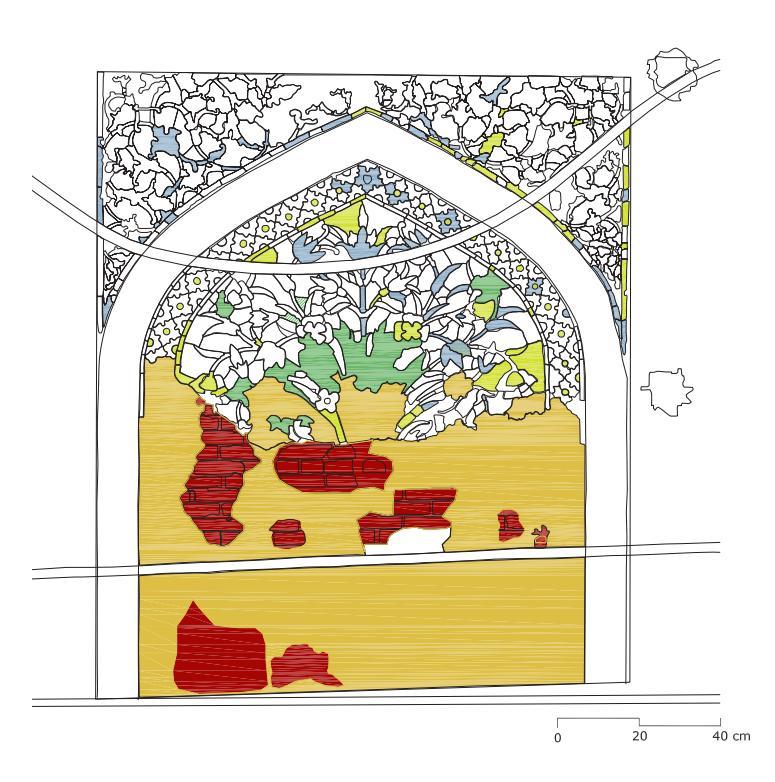
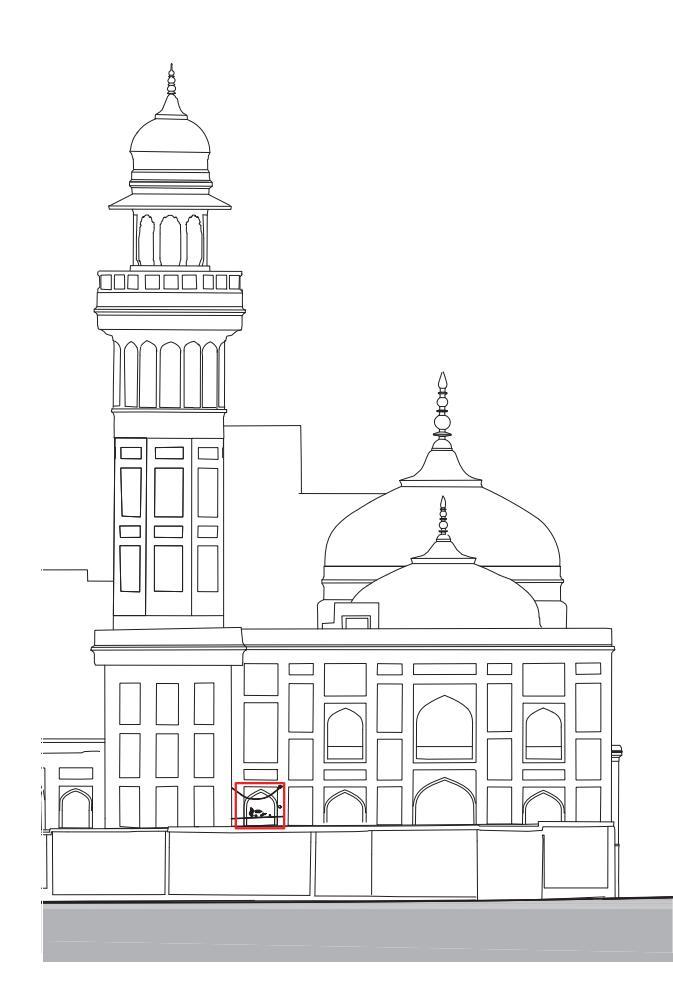
# DOCUMENTATION OF SURFACE CHANGES AND TILE DISINTEGRATION OF A PANEL ON THE NORTHERN FAÇADE OF THE PRAYER CHAMBER

This floral/geometric glazed tile panel on the north façade of the prayer chamber, is located above Kotwali Bazaar. It displays instances of discoloration of glaze, deposits, complete loss of tiles and base mortar, exfoliation of glaze from the terracotta body, complete loss of glaze from terracotta and spalling of tile body.

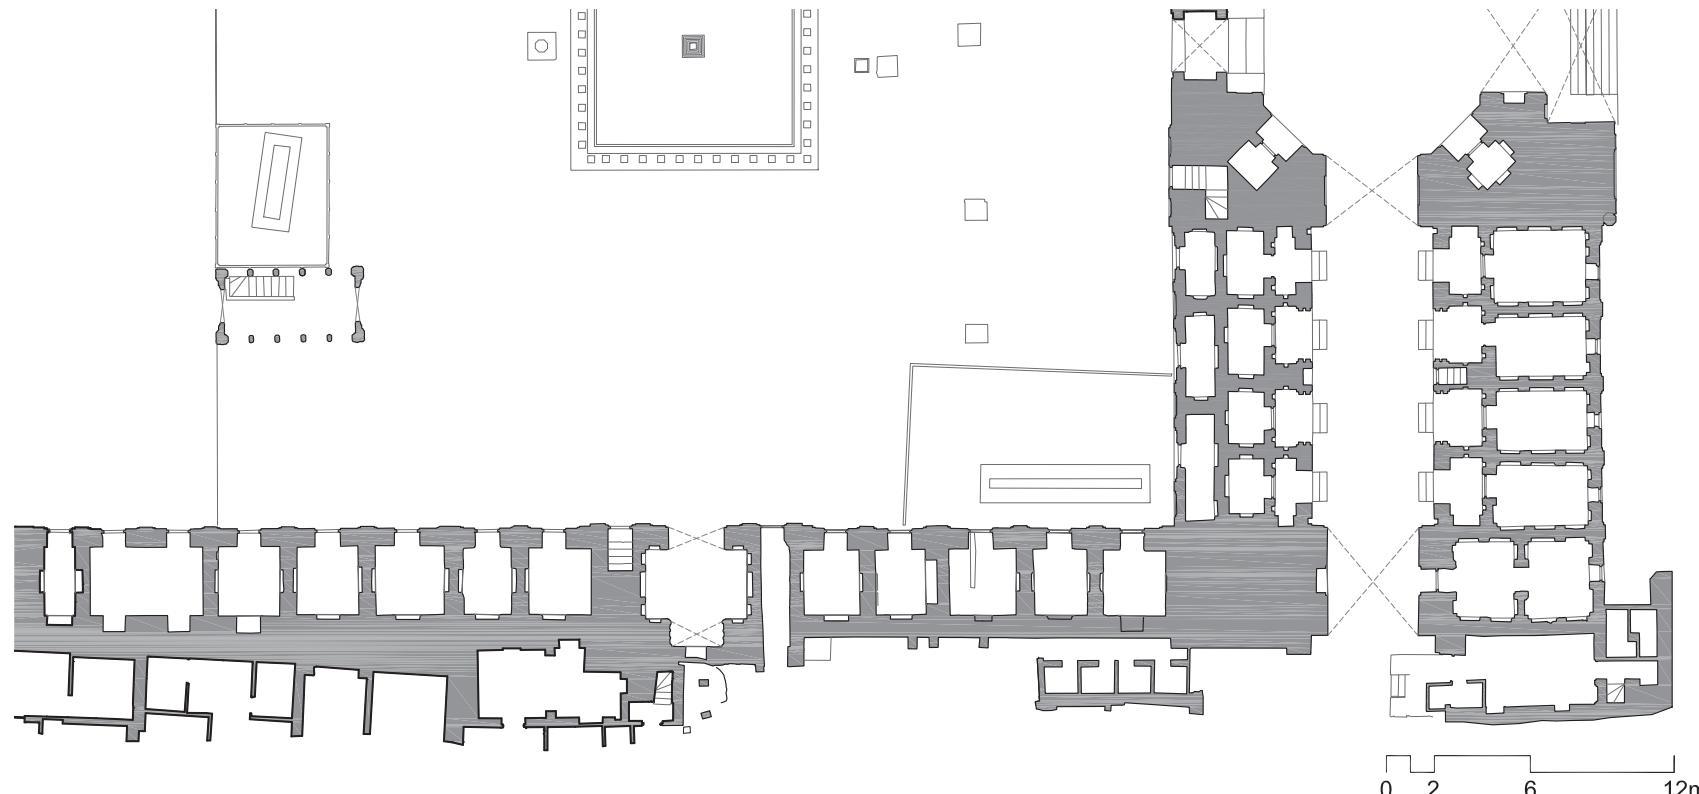
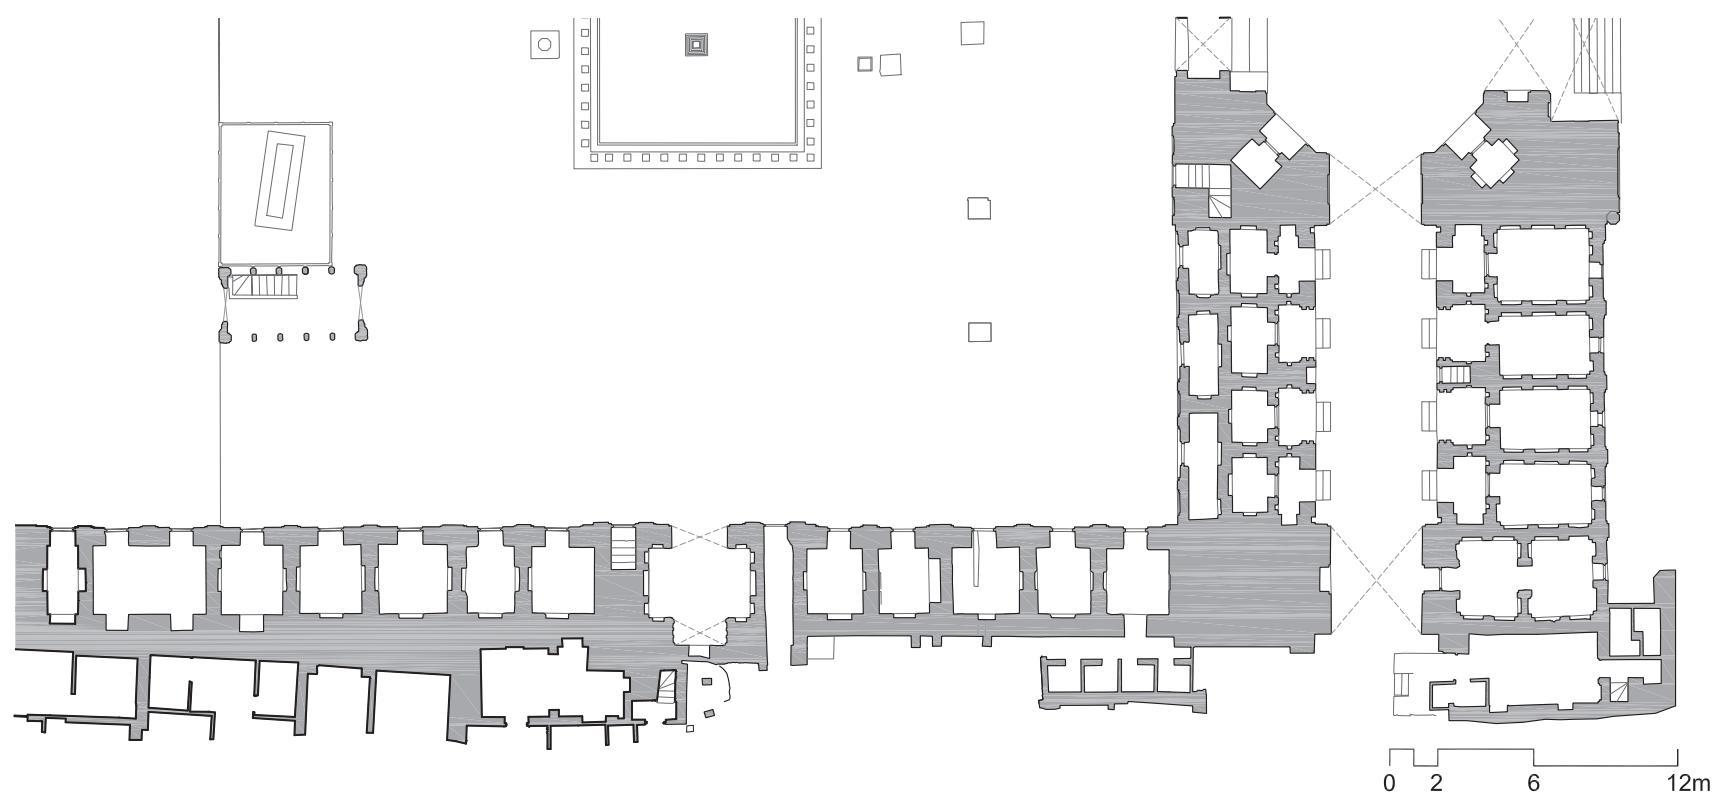
# PLANS SHOWING CHANGES IN THE SOUTH-EASTERN CORNER OF THE MOSQUE COURTYARD

Top: Showing the ablution facility in the southeastern corner, and the adjacent hujra (the first on the southern row) which at that time was still intact.

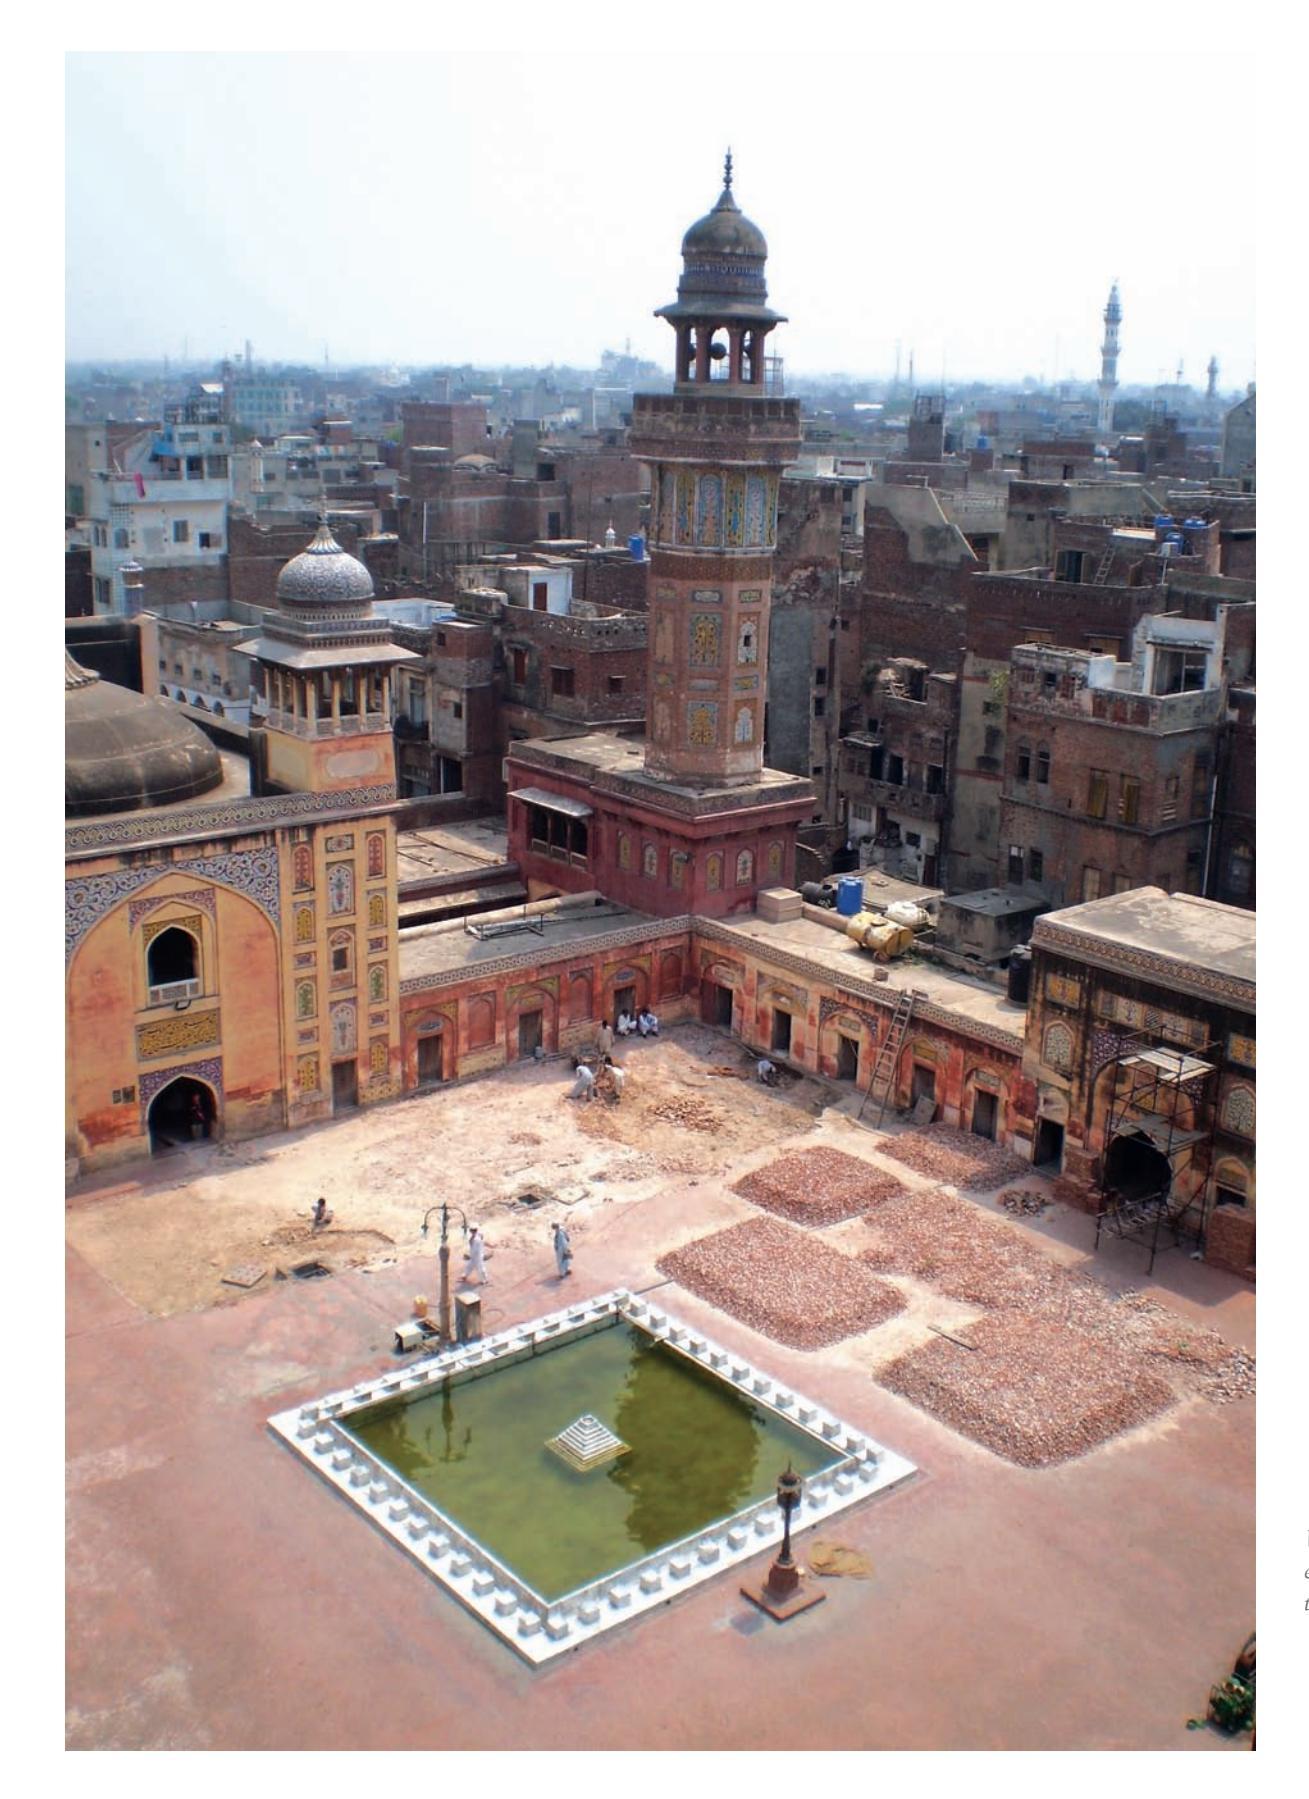
View from the north-west minar of the excavation work in the south-east corner of the courtyard.

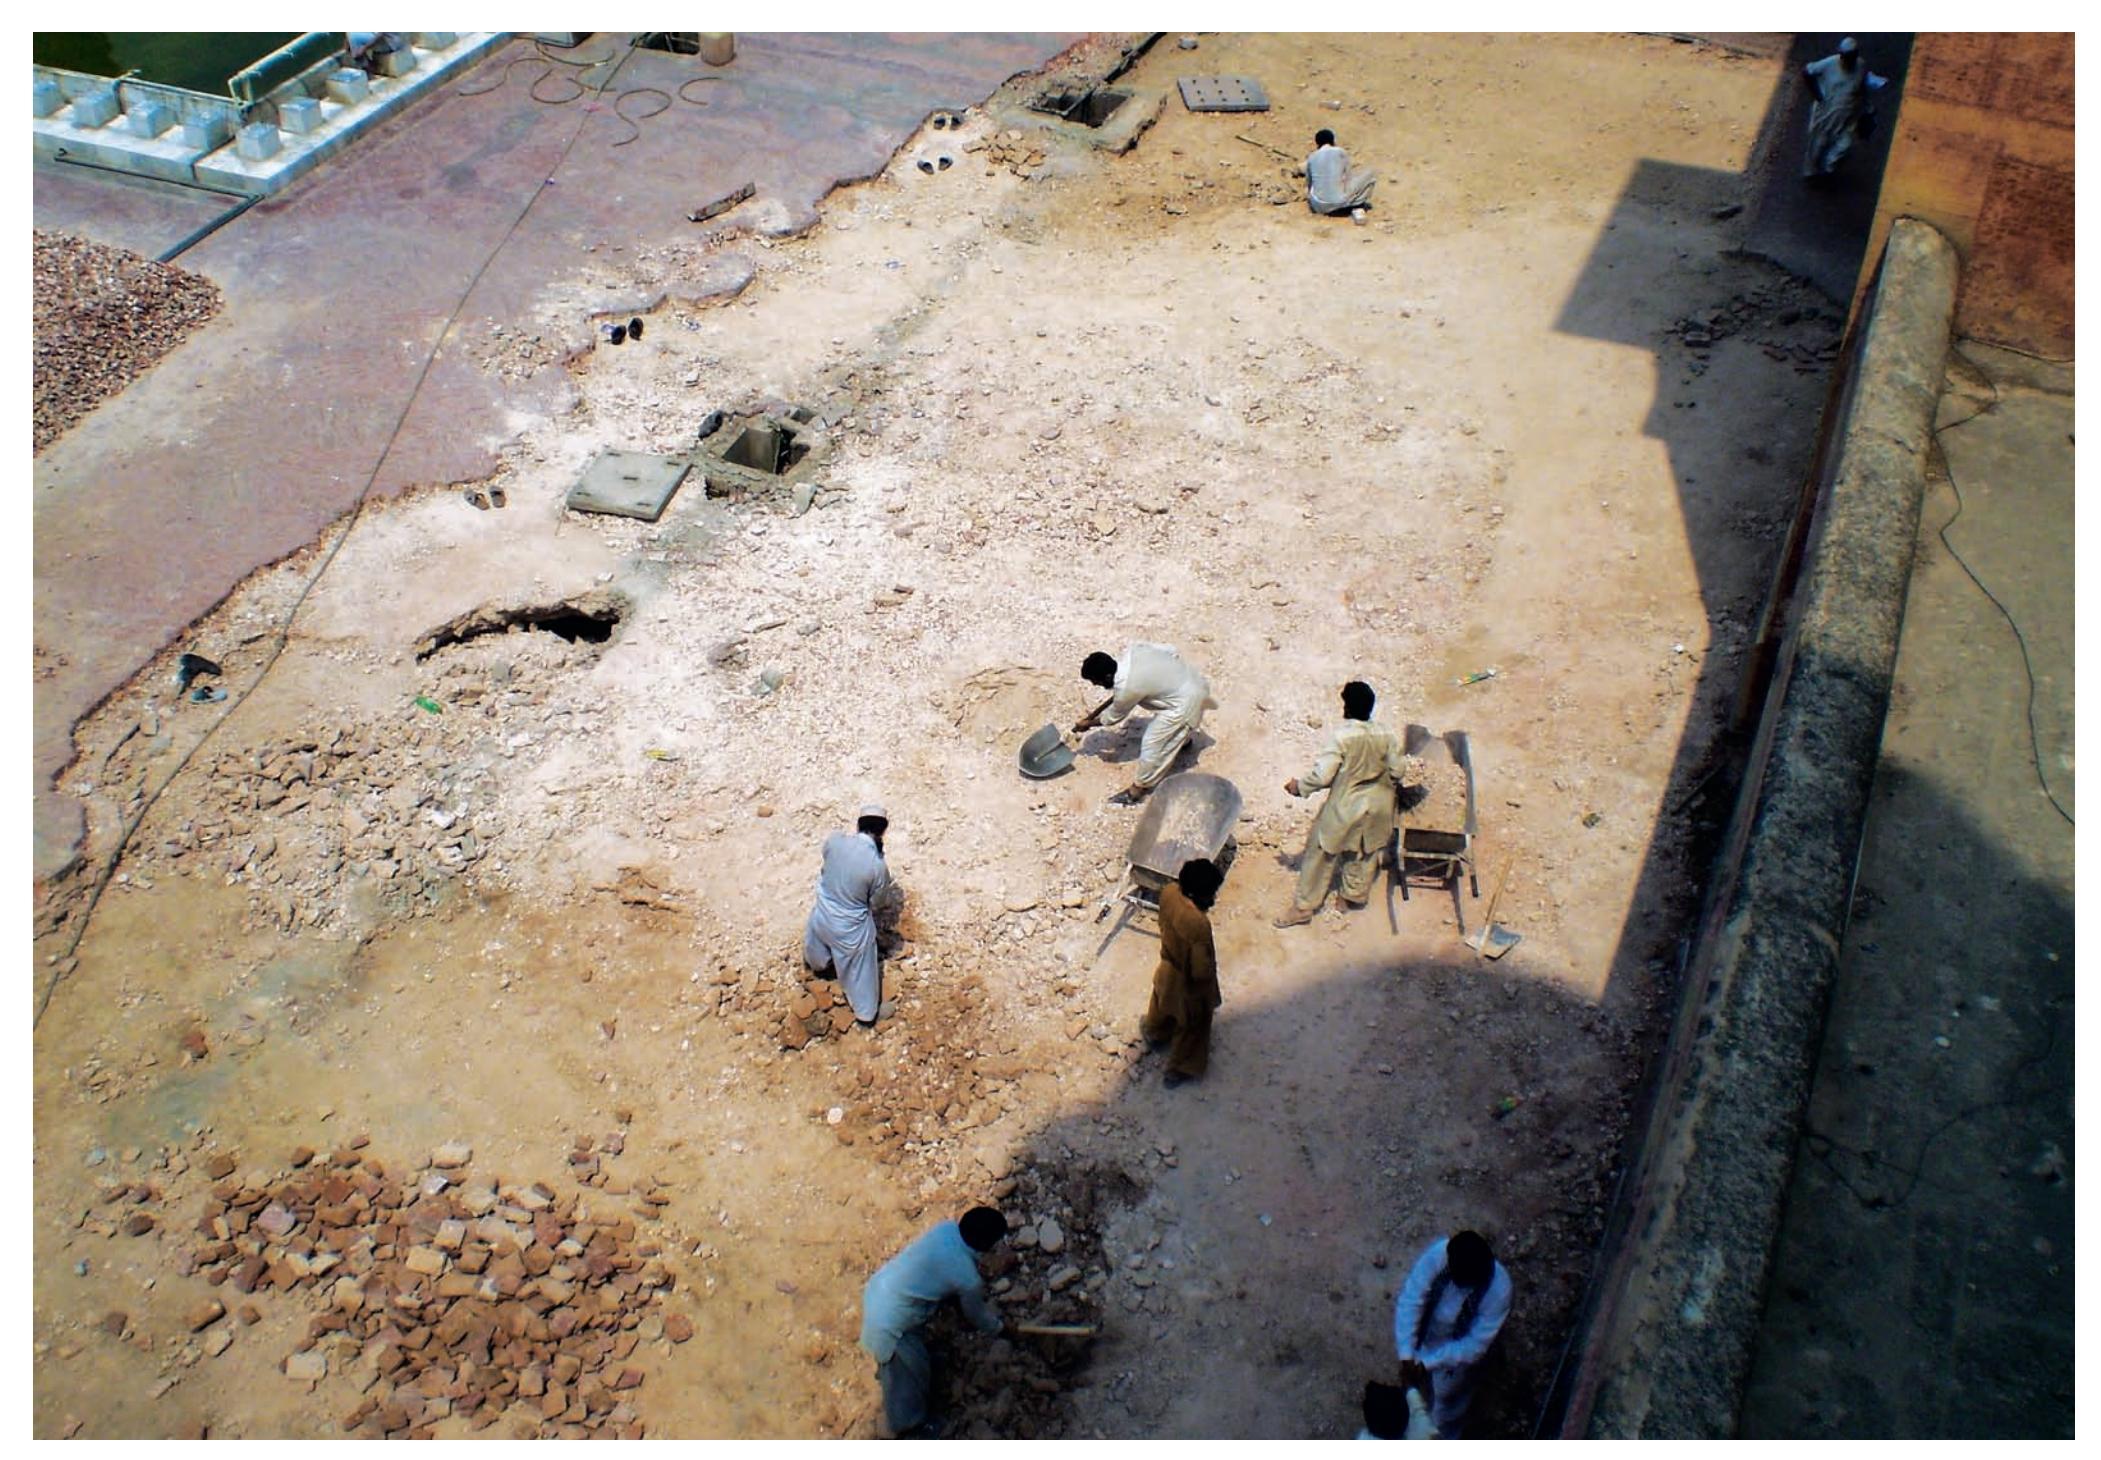
Close-up view of the excavation work.

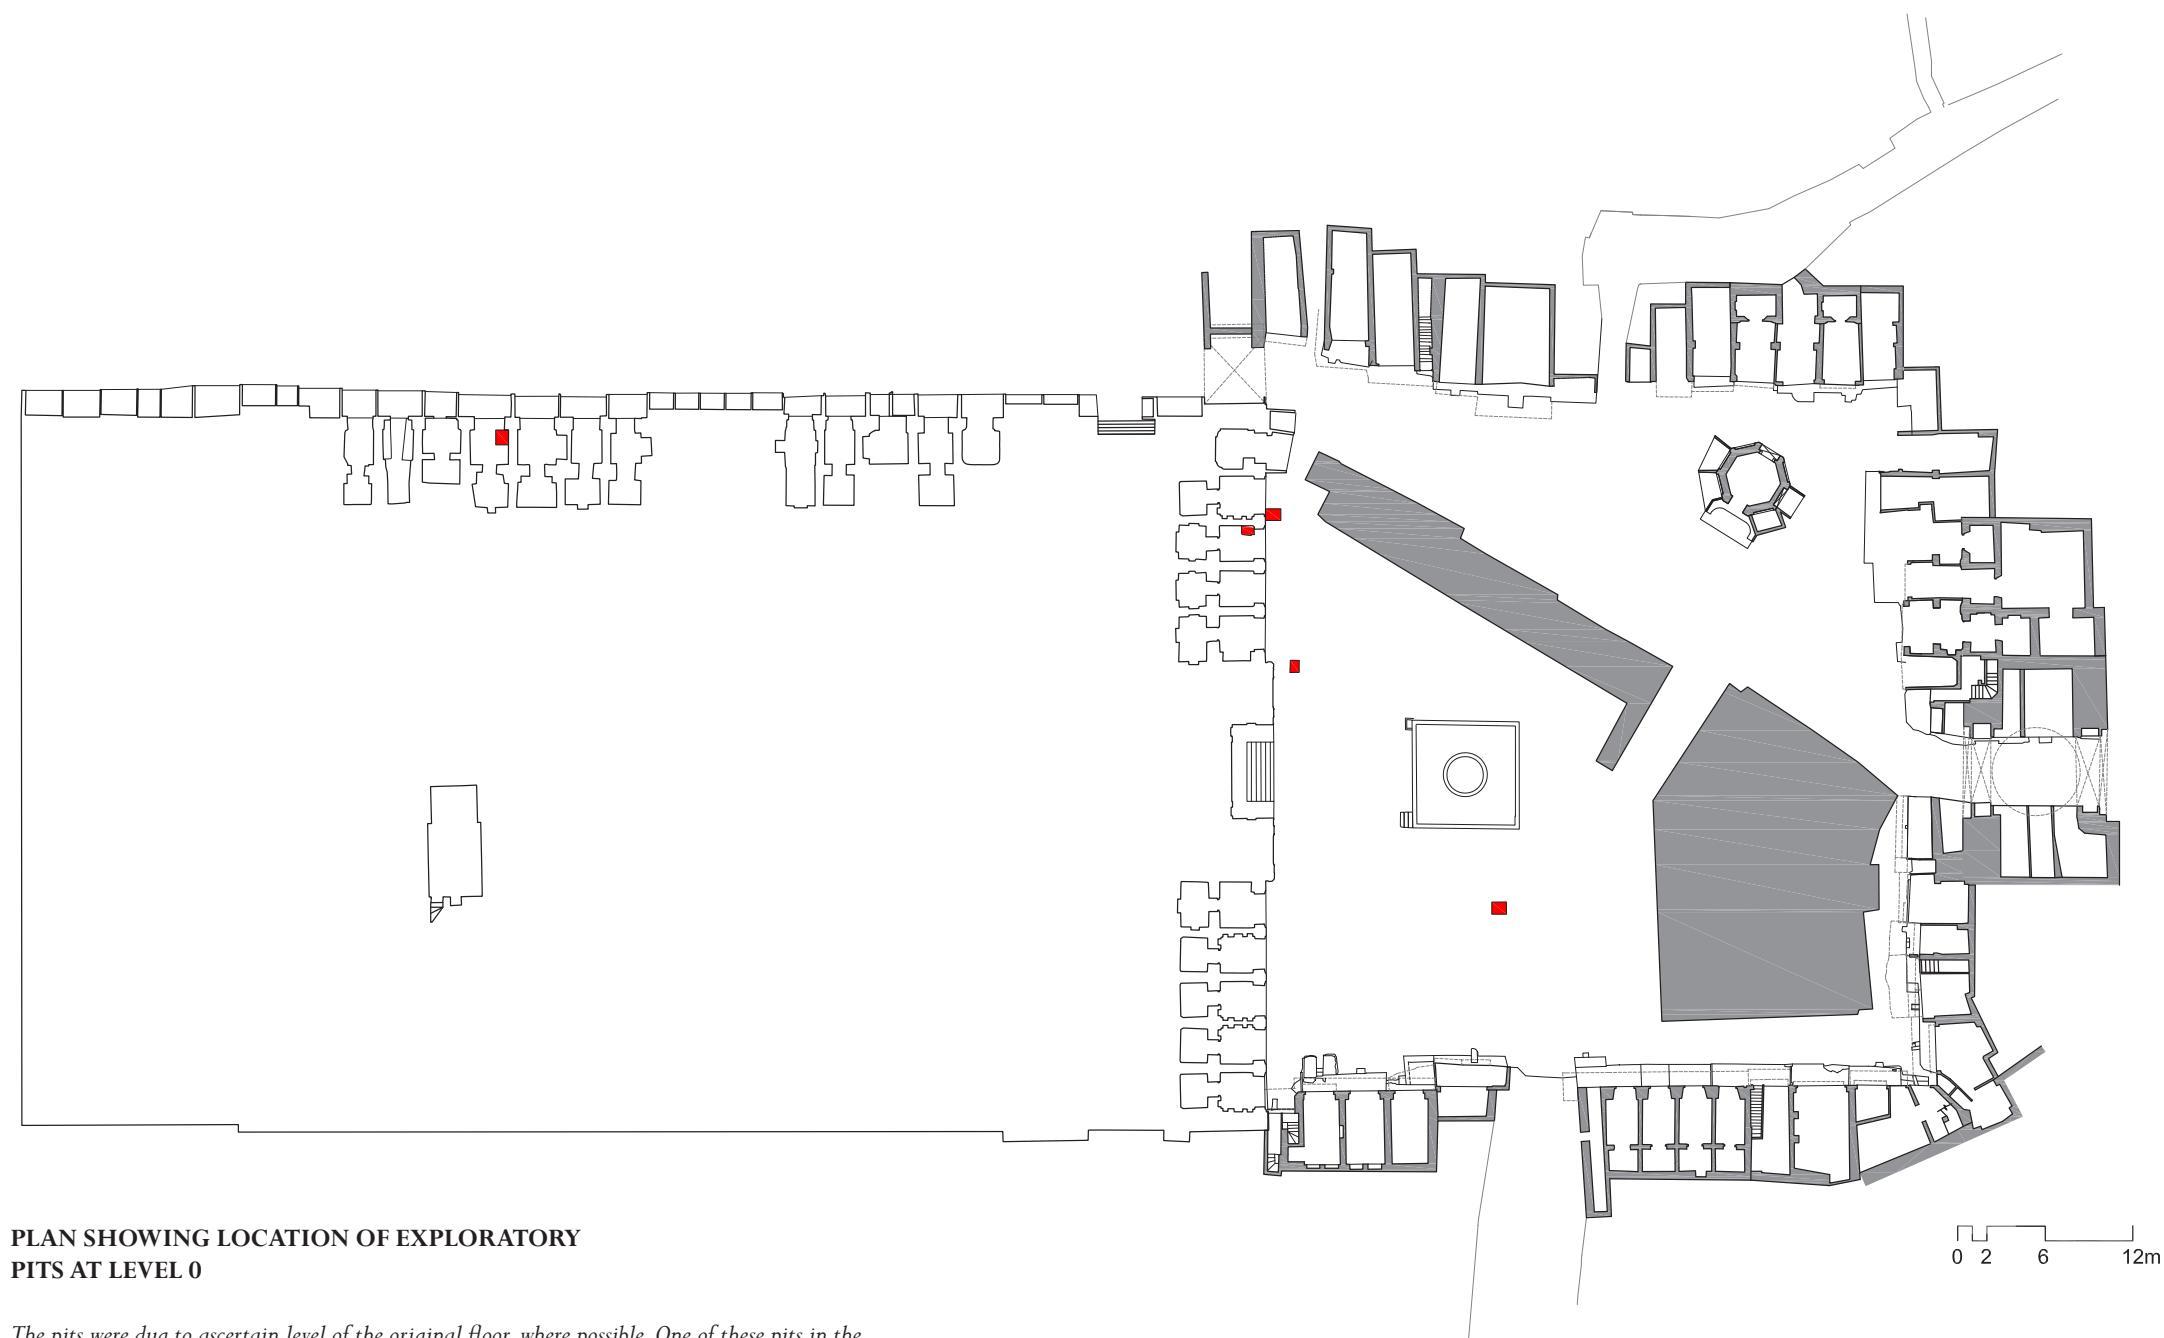
The pits were dug to ascertain level of the original floor, where possible. One of these pits in the Chowk led to the discovery of what appeared to be the original floor 1.2 metres below the present surface paving.

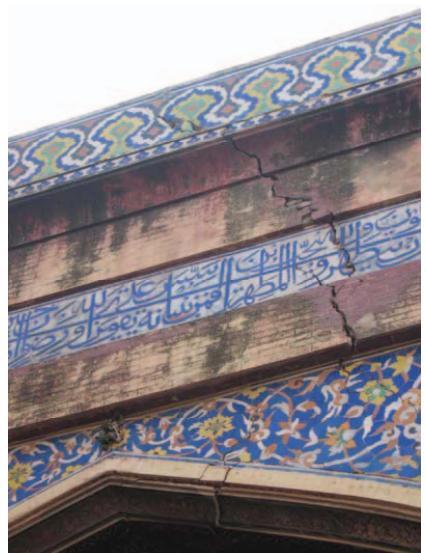
Parapet, southern end

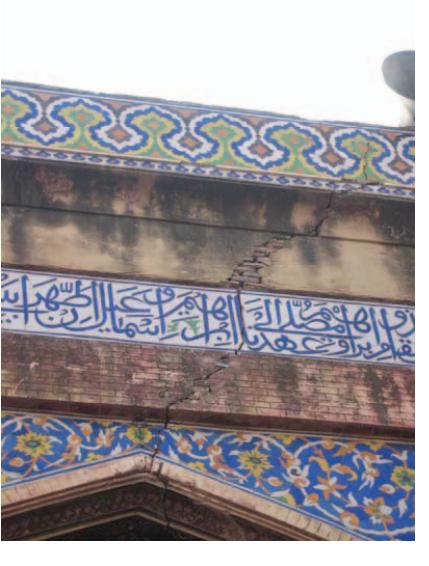
Parapet, northern end

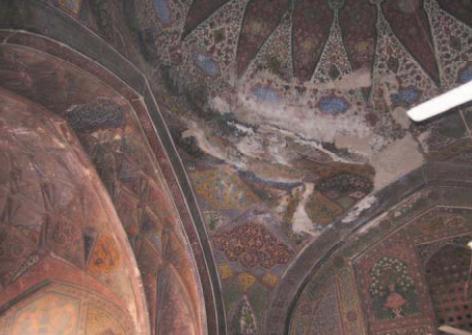
Cupola spandrel, south

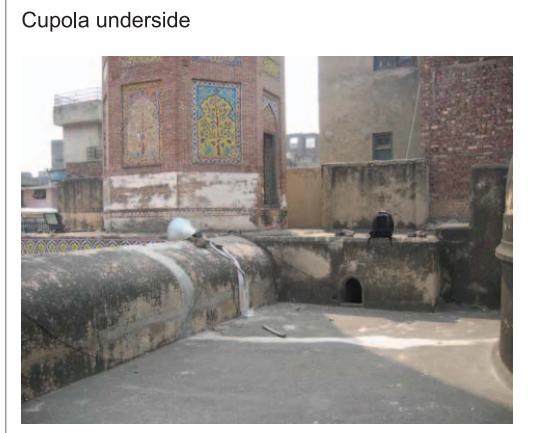
Roof, southern end

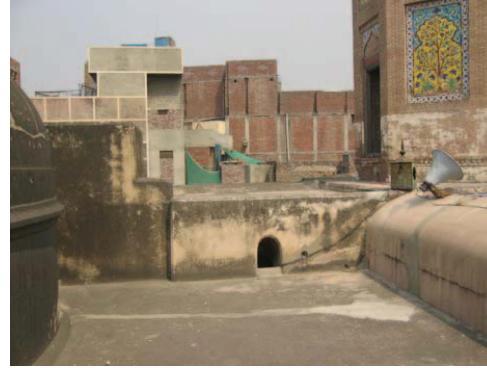
Roof, northern end

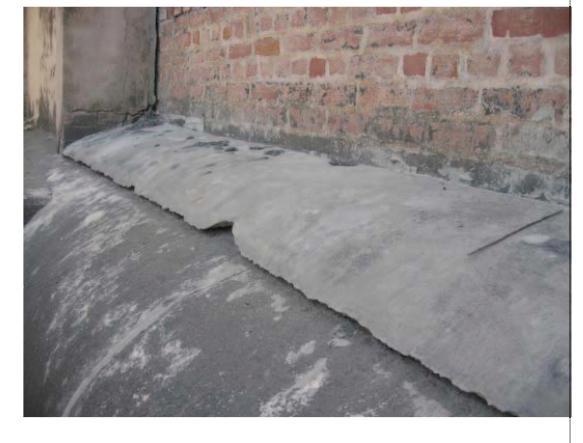
Gap and displacement between mosque and neighbouring building in Southwest

The gap between the mosque and the adjacent house in the South (Fig. 5) is similar to the gap further away in the South-West (Fig. 6), described in my Interim Report of 25 November 2009. Recommendation: Don't fill up the gaps with grout, leave them open, avoid seeping of rain water into them by closing their edges with compressible material.

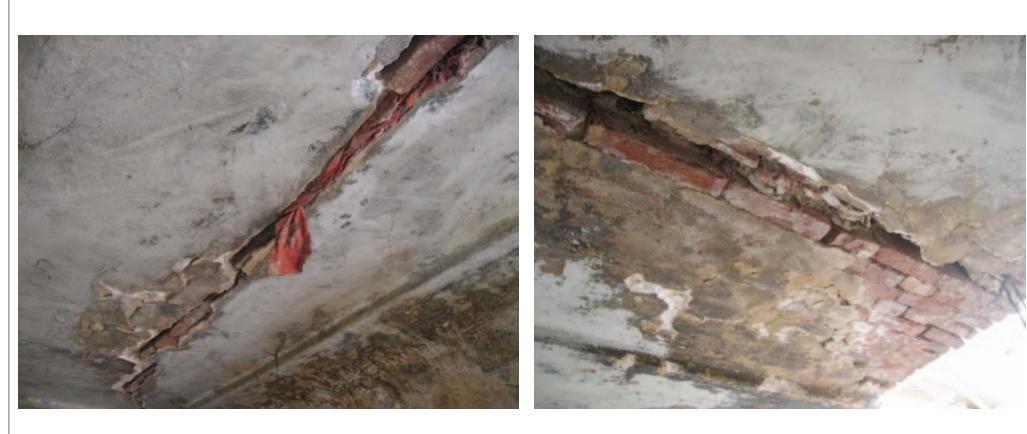
The thrust of the barrel vault pushed the upper part of the southern wall outwards and caused a wide gap in the crown of the vault. The gap runs through from the eastern to the western end of the vault (Fig. 1 and 2). The shift of the southern wall is visible at the eastern wall up in the corner (Fig. 3). The condition of the outer corner including bond and joints of both walls is insufficient as well (Fig. 4).

Fig. 1, 2 Gap in the crown of the southern barrel vault of Middle Pavilion South

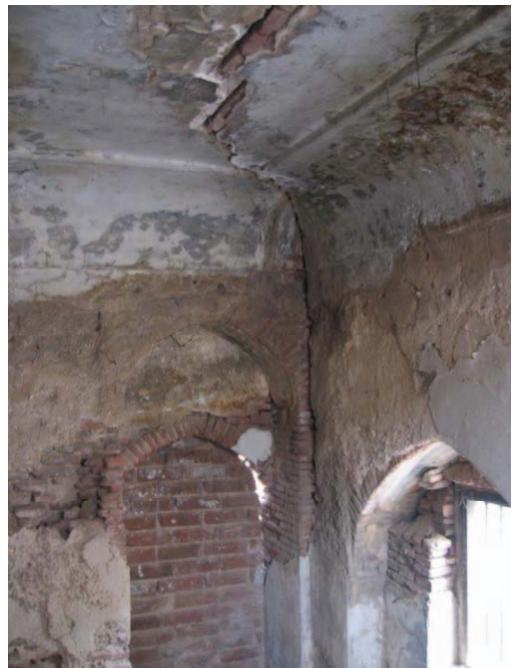
Fig. 3 Shift of the southern wall by thrust of the barrel vault (see upper corner) Fig. 4 Condition of the outer corner between southern and eastern wall

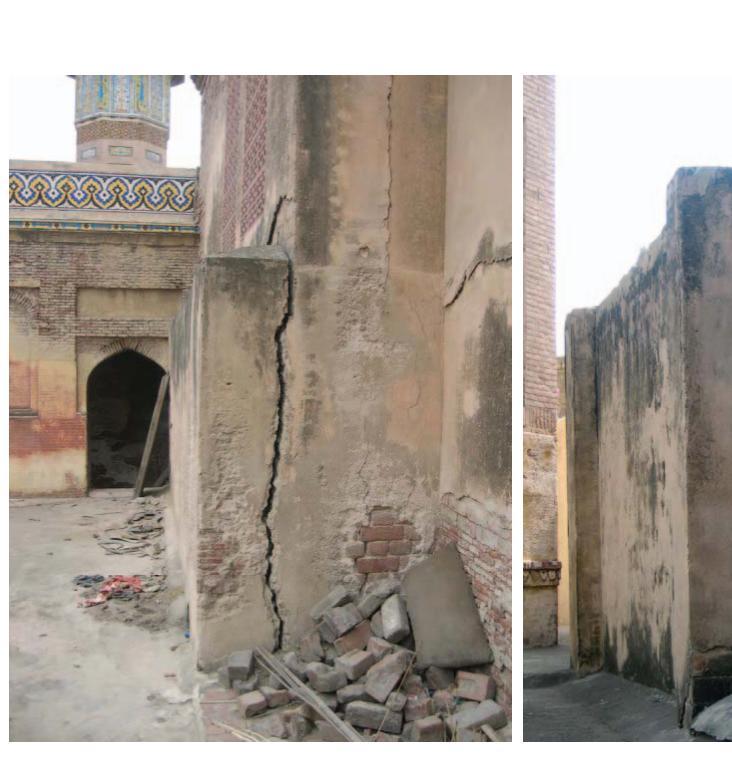
- Fig. 5 Gap between mosque and adjacent house in the South
- Fig. 6 Similar gap further away in the South-We area of the mosque

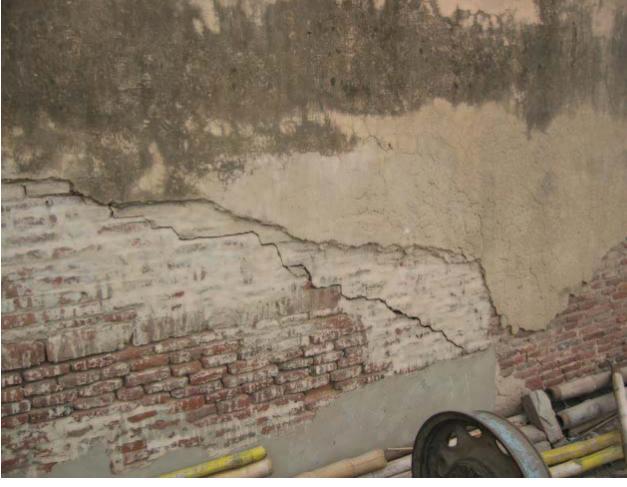
The neighbouring property in the South shows cracks in the wall adjoining the mosque (Fig. 7). An investigation of the inner structure and damage condition of the building is recommended, negative influence of a weak structure on the construction of the mosque should be assessable in good time.

- Crack in the wall of the neighbouring property in the South Fig.7
- Fig. 8 Round with the archaeologi

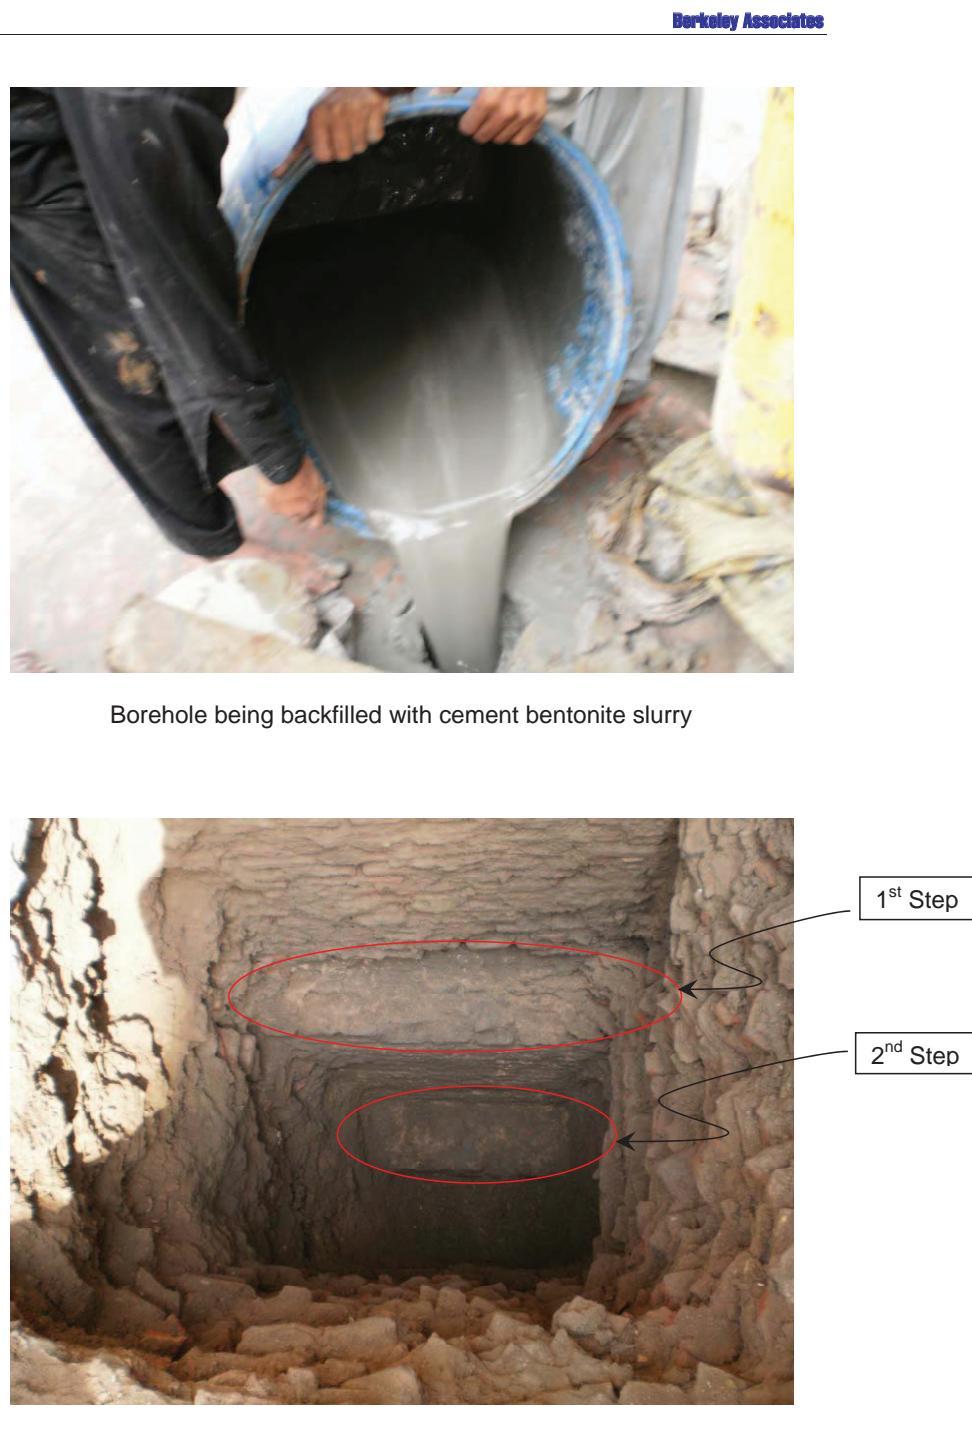
A view of excavated testpit showing steps of minaret foundation
