## TIMUR SHAH'S MAUSOLEUM AND THE AFGHAN FUNERARY BUILDING TRADITION

## THE ARCHITECTURE OF TIMUR SHAH'S MAUSOLEUM

## TECHNICAL APPROACHES IN CONSERVATION OF THE MAUSOLEUM

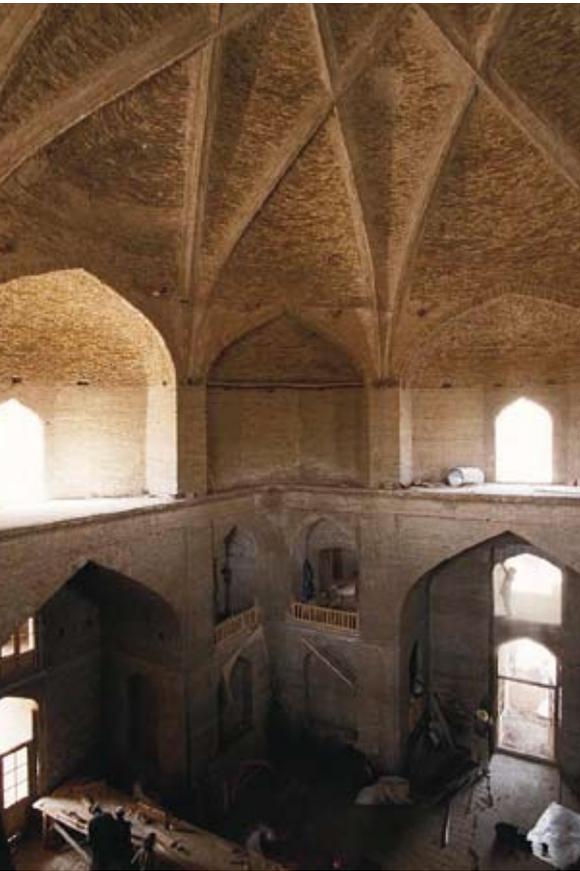
*Interior of the mausoleum during restoration, showing the ribbed inner dome, built in brick.*

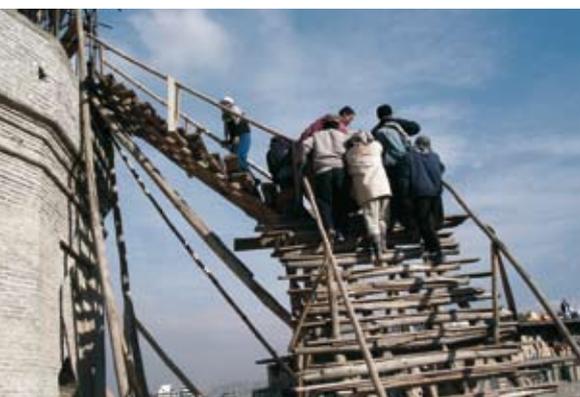
*Sections of the damaged upper dome were removed during conservation works. All materials were manually carried to the upper levels up a temporary timber stair.*

Based on an analysis of the structure, it was decided to remove the unstable edges of the damaged section of the upper dome and part of the masonry drum, and re-build these in a manner that as closely as possible matched the original. Newly made bricks of the same size (20 × 20 × 3.5 centimetres) as the originals, fired to a relatively low temperature (in order to match the strength of the surviving masonry) were laid in lime mortar prepared with putty from local sources that had been slaked for a minimum of eight weeks. The geometry of the new section also needed to match the existing masonry, which comprised of six layers of brickwork at the springing, reducing to two at the apex. The

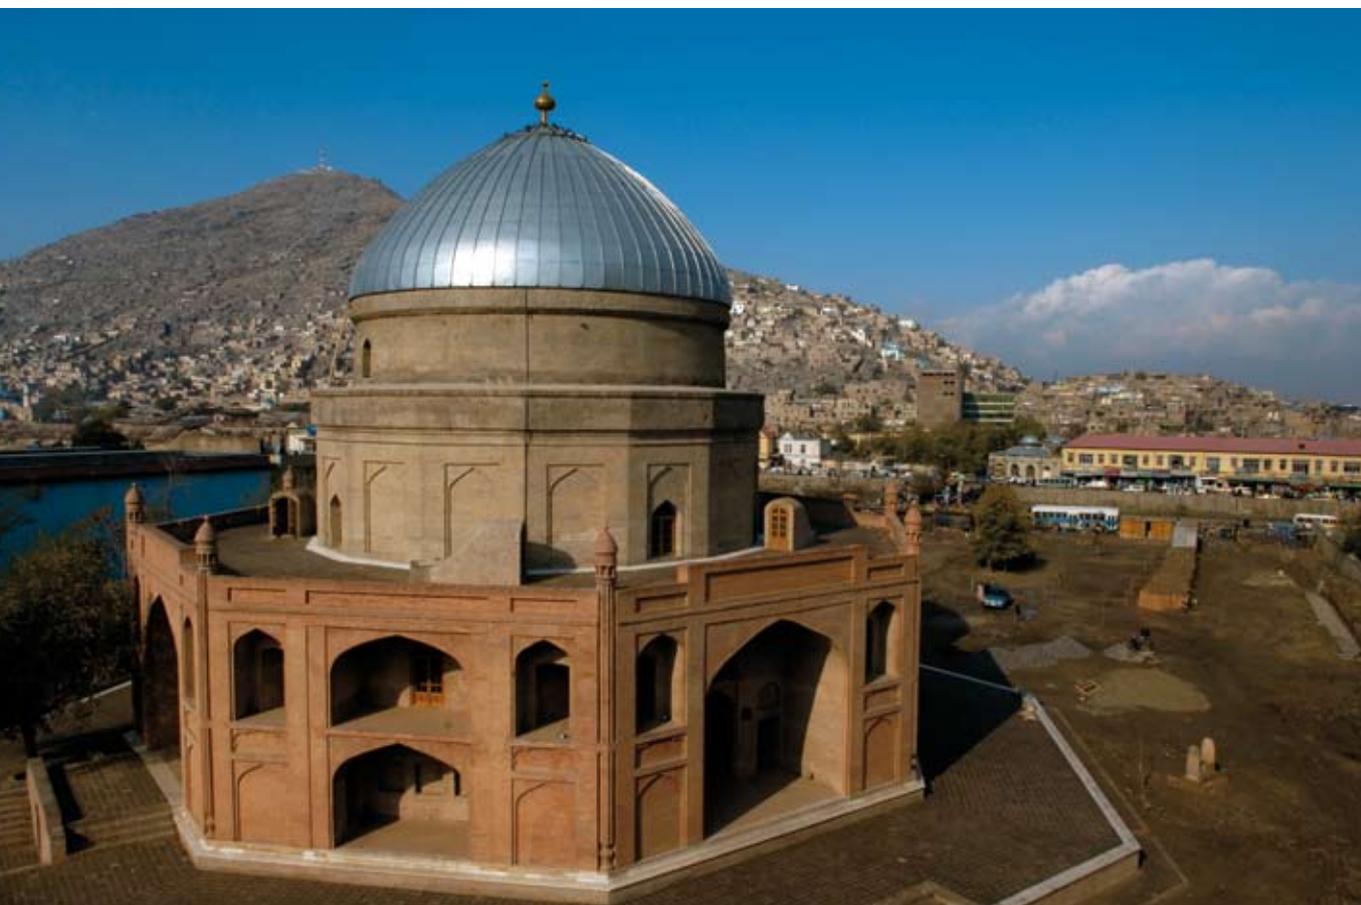
In parallel with repairs to the main dome, earth was removed from the flat section of the mausoleum roof, and the two masonry vaults that had begun to collapse as a result of moisture penetration were propped and repaired. The spaces between the vaults were re-filled with crushed bricks, stabilised with cement slurry, over which a layer of lime concrete topped with waterproof isolation was laid, before finishing with brick paviors laid to falls. The existing internal downpipes were repaired and lined with PVC pipe, leading under the new platform to the garden. The decorative brick finials that had been subsequently added to the

building were repaired, and a new parapet built of brick masonry, replacing damaged concrete elements that were added in the 1960s.

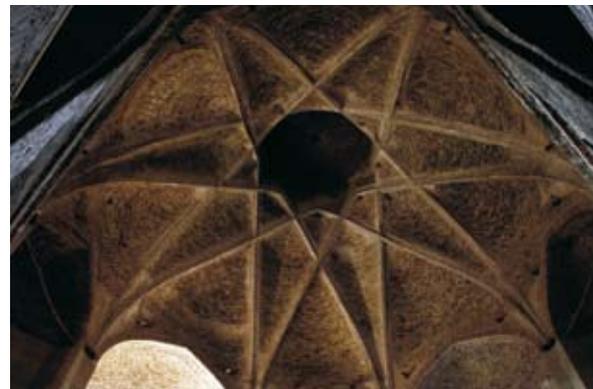
*The ribbed brickwork on the inner side of the lower dome.*

In recognition of the unfinished state of the interior of the mausoleum, repairs were restricted to conservation of the single small dome that showed traces of plastering, re-pointing of the soffits of masonry domes and vaults, and the brushing of accumulated dust from the wall surfaces. Internal floors were re-surfaced with brick paviors of similar dimensions to the originals.

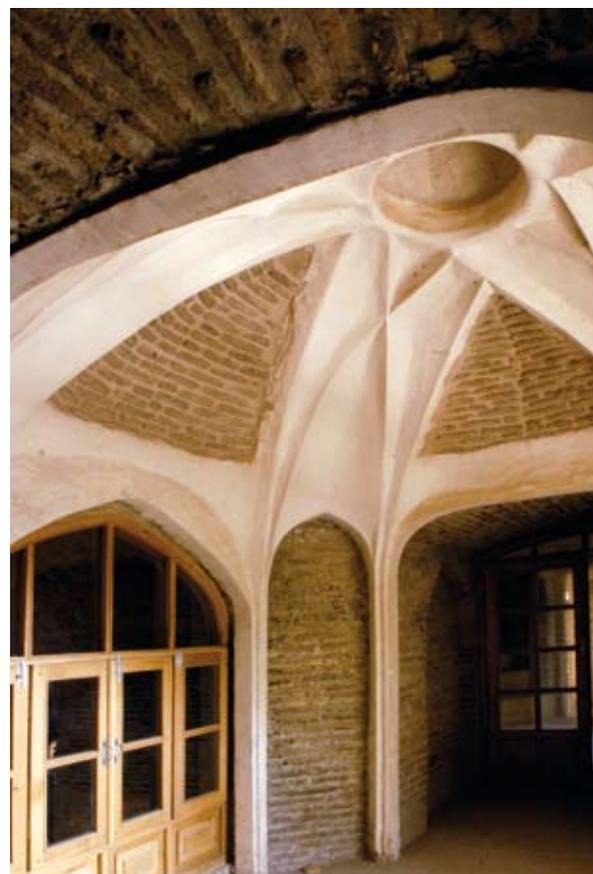
*Restored plasterwork in the first-floor ambulatory of the mausoleum.*
