AGA KHAN CULTURAL SERVICES - AFGHANISTAN

FINAL NARRATIVE REPORT

Restoration and Stabilization of the Khwaja Parsa Shrine, Balkh

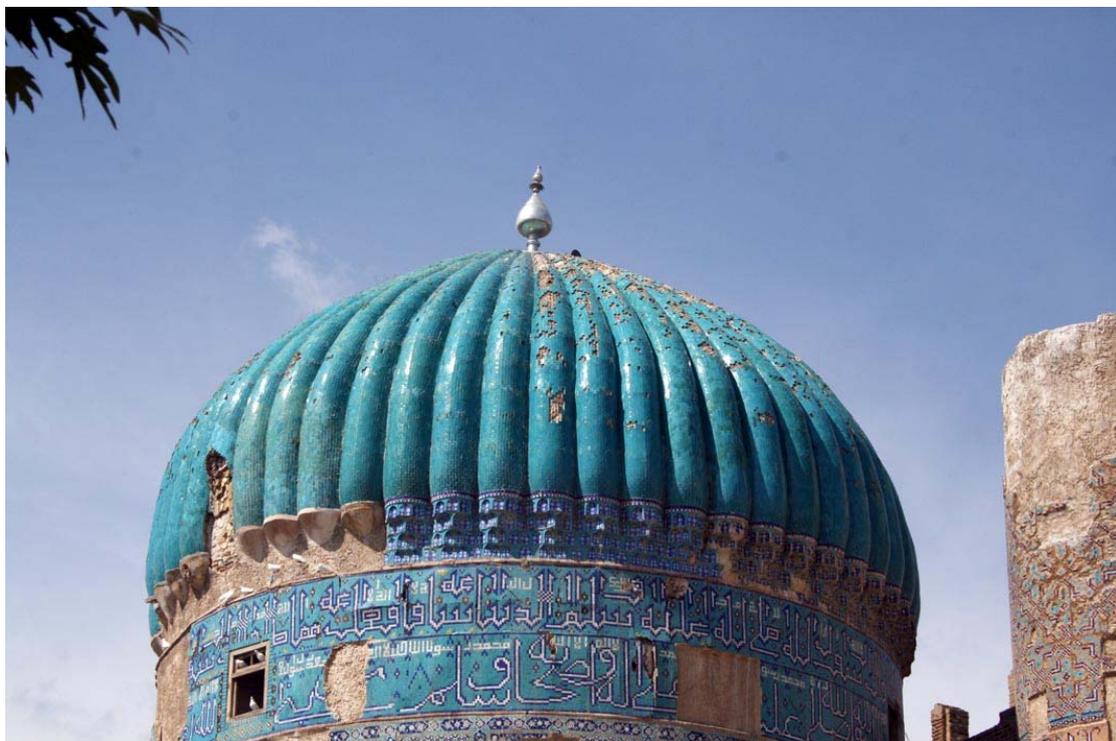
Although not all of the current structural concerns stem from previous conservation effort. The original construction also has several defects such as the fact that at its base the dome rests on a 26cm wide row of bricks. A construction of this size would today require at least a 39-52cm thick or 3-4 rows of brick masonry at its lower extremities. In addition to structural damage to the dome itself, inappropriate conservation techniques in the past have resulted in the use of sub-standard mortar material when applying the glazed tiles to the external surface of the dome. This has resulted in extensive cracking of the mortar and the dislodging of the tiles from the curved ribbed surfaces. When sections of the loose tiles were removed it became evident that previous retiling had taken place above existing tiles surfaces. In other words – like coats of paint added in layers over time, the tiles had been applied in several layers each time on top of the previous layer. This adds significant load to the already weakened dome structure. Removal of these tiles also revealed that the surface of the dome was flat – i.e. that the ribbing had simply been formed by shaping the mortar beneath the tiles into curved shapes.

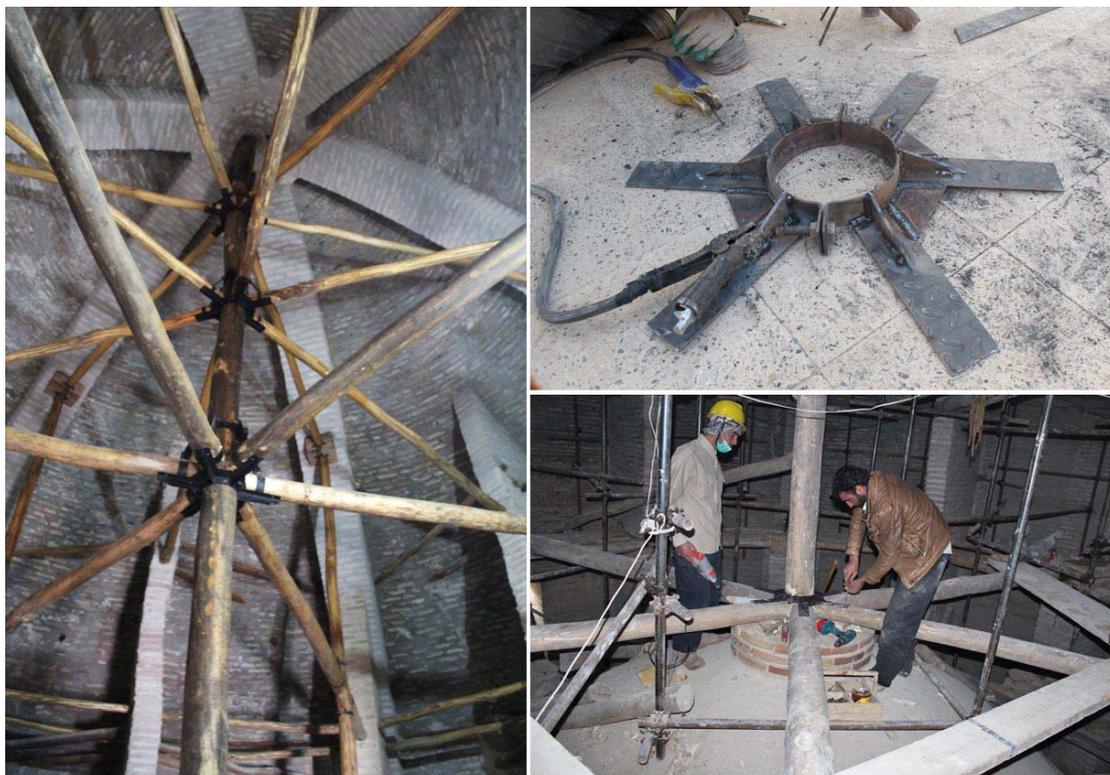
As described, physical documentation and analysis of the space directly beneath the main external tiled Dome of the Shrine, revealed that large sections of the historic wooden tensile supports beneath the Dome had been either removed intentionally or collapsed as a result of previous damage and were not reconstructed. Teams responsible for the previous reconstruction of the dome had either not been aware of the existence of this structure or had simply chose to ignore this during their work. By “covering” over indications of serious structural problems, such as re-pointing tension cracks caused by the deformed dome, without undertaking appropriate structural consolidation, these teams also made the task of monitoring the structure and identifying problems much more difficult.

When further investigations revealed that the structural condition of the large masonry Dome was tenuous, project personnel made the decision to reconstruct the wooden supports with the aim of strengthening the main Dome ahead of additional consolidation and retiling works.

Following the calculation of material loads and forces, designs were prepared for the construction of the wooden supports. Based on these, large timber poles, which would have been used in the previous structure, were sourced locally. A small metalworking workshop was built in order to produce bespoke metal ties and joints that would hold the timber structure together. (Provide Image) Skilled teams of carpenters, masons and metalworkers were employed to construct the support structure before consolidation works could be carried out on the masonry Dome itself.

Based on the existence of evidence indentifying the location of the base of the previous timber structure and areas where it had connected with the masonry dome, a central pole was constructed above the internal Dome, which was assessed to be in good condition, and tied through the azimuth of the outer shell. From this central “trunk”, like that of a large tree, two rings of radiating timber poles were extended systematically and linked to key locations of the external dome. This network of timber supports will ensure that loads from the Dome are transferred laterally to key areas of the Drum and should improve the performance of the structure during mild earthquakes.

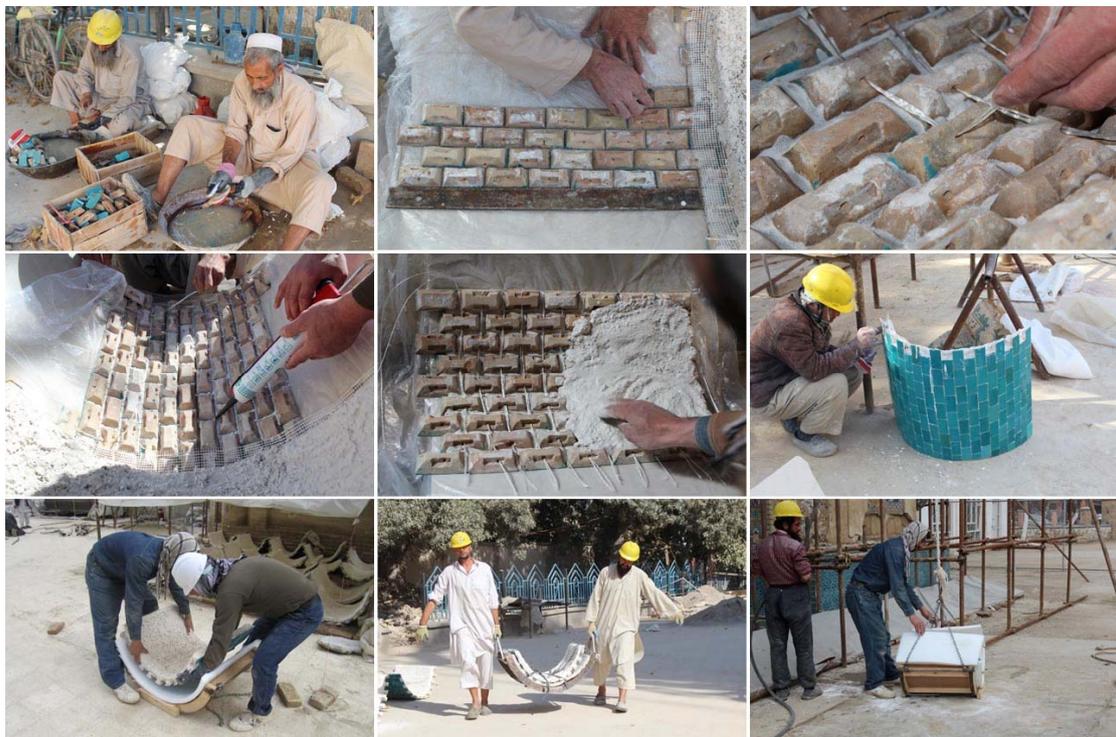
Durable colour glazed tiles were applied to the dome, originally in the 16th century, in order to embellish the important religious structure and to protect the baked brick masonry sub-structure from water penetration and weathering. A large percentage of the tiles that remained on the dome were produced during several inadequate restoration attempts in the late 1970’s and in early 2006. A vast majority of these were damaged and had become substantially loosened or had been detached from the dome. The base material (clay), the shape and design of the tiles, the chemical composition of glazes, the baking process and the installation techniques and mortar composition were found to be below acceptable standards. As a result, the penetration of water and ice had damaged the external glazed surface of the tile and forced the tiles to “pop” off the structure during extreme temperature fluctuations.

In total approximately 78,800 (400m²) of damaged tiles were carefully removed from the Dome. Previous retiling had made use of historic tiles together with new tiles that had been produced at that time. These tiles were sorted and original tiles in good condition were preserved. In total more than 35,000 historic tiles were salvaged and reused in the retiling of the dome. The process of preparing approximately 44,000

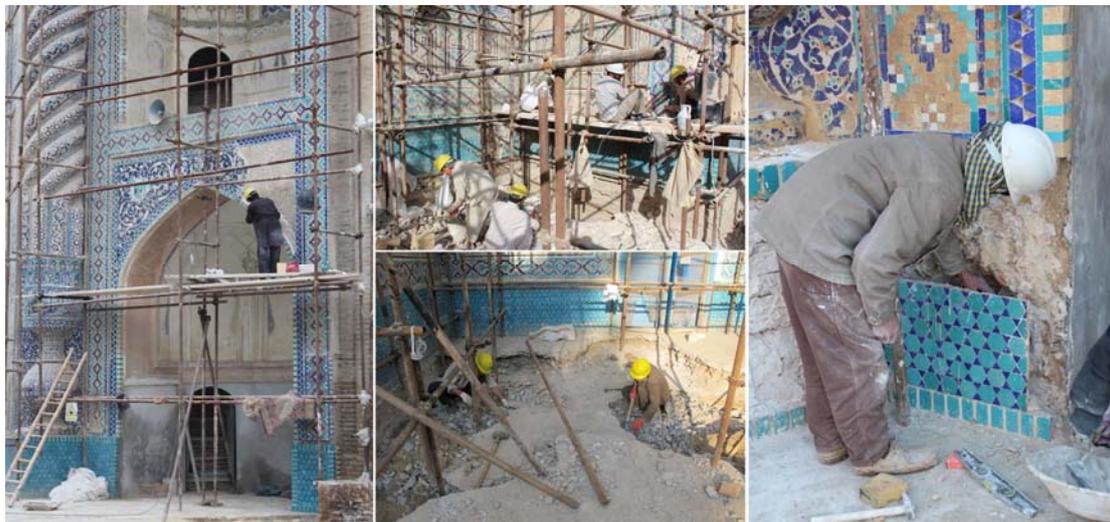
Iwan portal: The main Iwan portal is composed of several individual sections of design incorporating varying styles of colour glazed tiled decoration. The main external facing elevation and the cork-screw tiled columns are exposed to direct weathering and have suffered the most damage in recent years. The internal covered wall together with the arched soffit have been spared exposure to rain and ice, but large sections of tiled decoration in these areas have become detached from the masonry walls due to the penetration of water from areas above the Iwan structure. Due to raising damp at the base of the Iwan, a vertical band of 1-meter high original tile-work located directly above ground level had collapsed and been replaced with modern tiles during the construction works in 1975. Luckily, large areas of the original tiled decoration, including sections of Kufic inscriptions and mosaic tile-work on the

cork-screw columns had survived centuries of neglect and weathering. As the main entrance and one of the most visible features of the mosque, conservation activities were expanded to include consolidation and repair of the tiled decoration under an addendum to the existing grant. The first order of work involved the removal of newly produced tiles (1975) at the base of the Iwan area and the repair of the damp and eroded masonry walls on which the tiles had been installed. Damaged brick was removed and replaced with new masonry using lime mortar, followed by the reinstallation of the glazed tiles. In order to prevent raising damp in the future, the thick concrete flooring inside the Iwan area was removed and the level of the ground was lowered by 40 centimeters. It is expected that the removal of the concrete flooring and re-paving this area with baked bricks on edge will reduce the build-up of damp beneath the Iwan area.

All of the tiled decoration inside the Iwan portal, above the level of the base band, remains the original historic tile-work. Repair works on the perpendicular walls that extend upwards to join the arched soffit, which include sections of kufic inscriptions, involved the careful consolidation of areas of the decoration that had become detached from the masonry structure. In areas where the deformation (detachment) of the tiles were limited, hand operated jacks were used to stabilize the decoration and gypsum grout was poured to re-attach the tiles to the masonry walls. Where the deformation was significant, these sections of original tiles were carefully removed and reinstalled using traditional materials and techniques. A similar process was repeated carefully in all areas inside the *Iwan* where the original tile-work had become detached. Once sections of detached the original tiles inside the *Iwan* portal had been consolidated, the remaining surfaces were cleaned and re-pointed with gypsum plaster. The original mosaic tile-work found on the cork-screw columns were repaired and consolidated, as per the techniques described above.

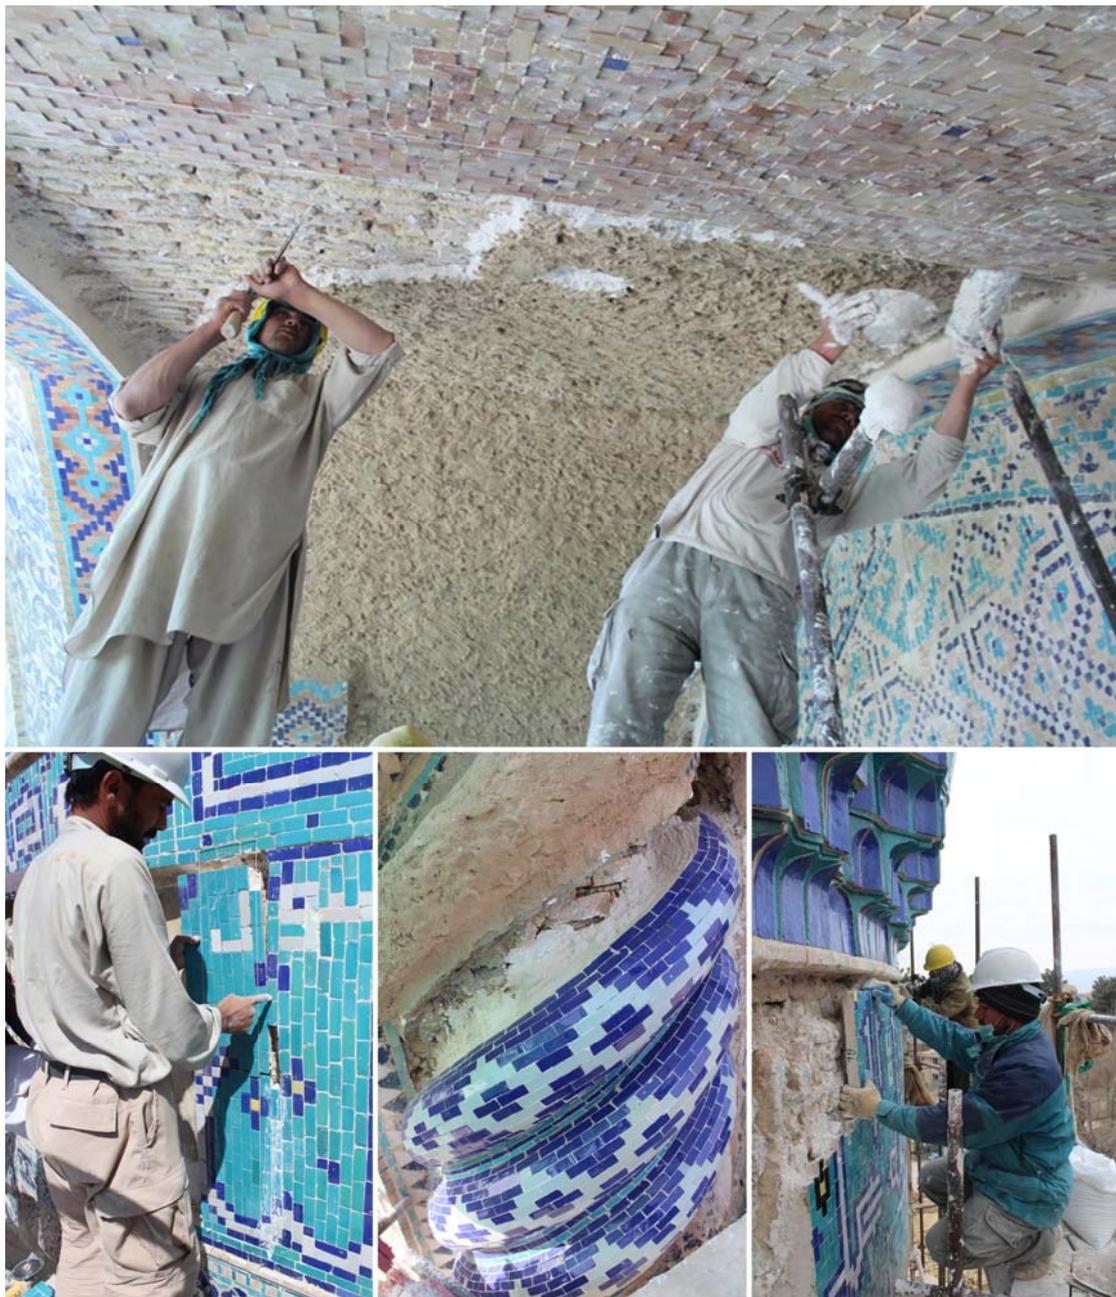
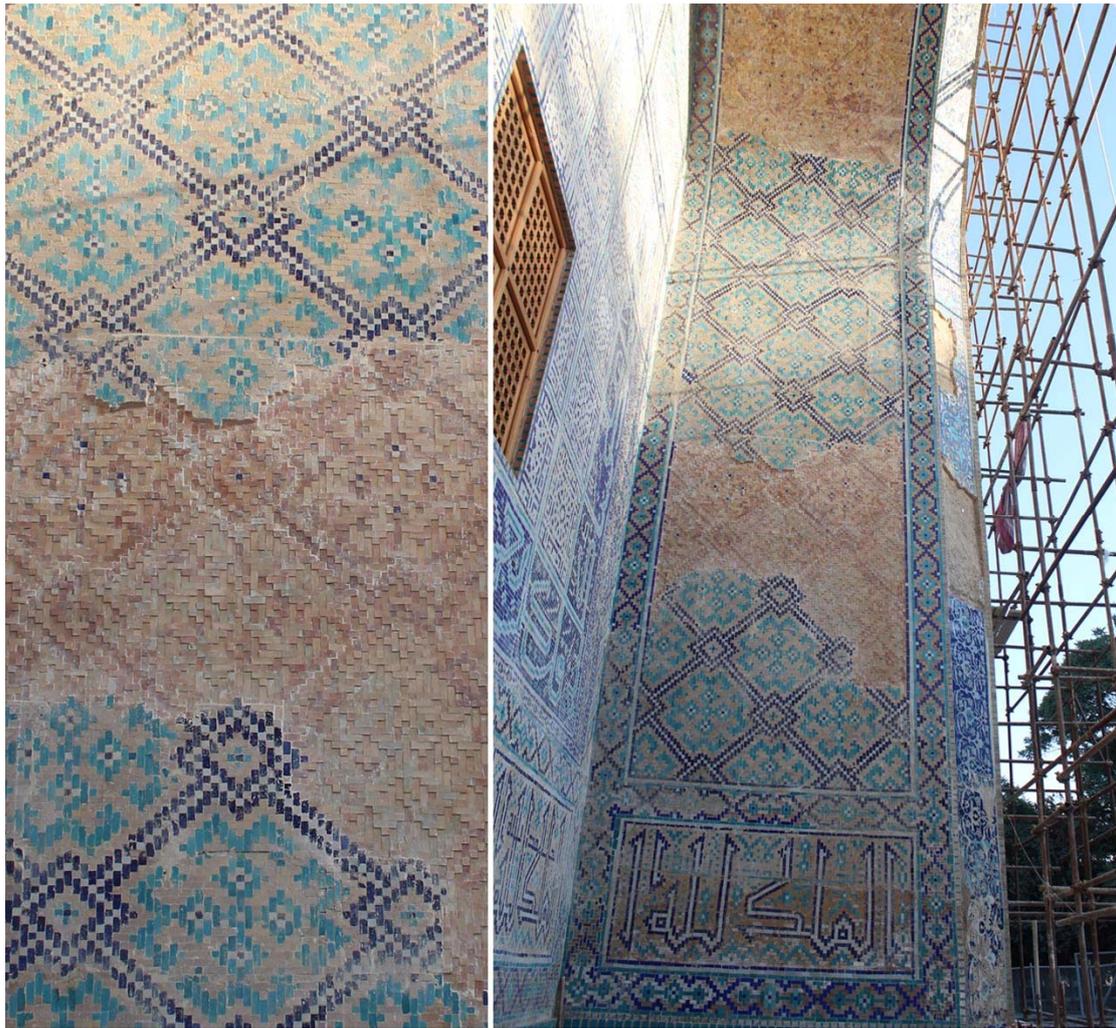
Drum (20m² new glazed tiles / 20m² new unglazed tiles / 34m² gypsum plaster)
Minarets (7m² new glazed tiles / 6m² new unglazed tiles / 7m² gypsum plaster) Iwan
(37 new glazed tiles / 60m² new unglazed tiles / 30 m² gypsum plaster)

In total more than 64 square meters of new glazed tiles and 86 square meters of unglazed tiles were produced and installed.

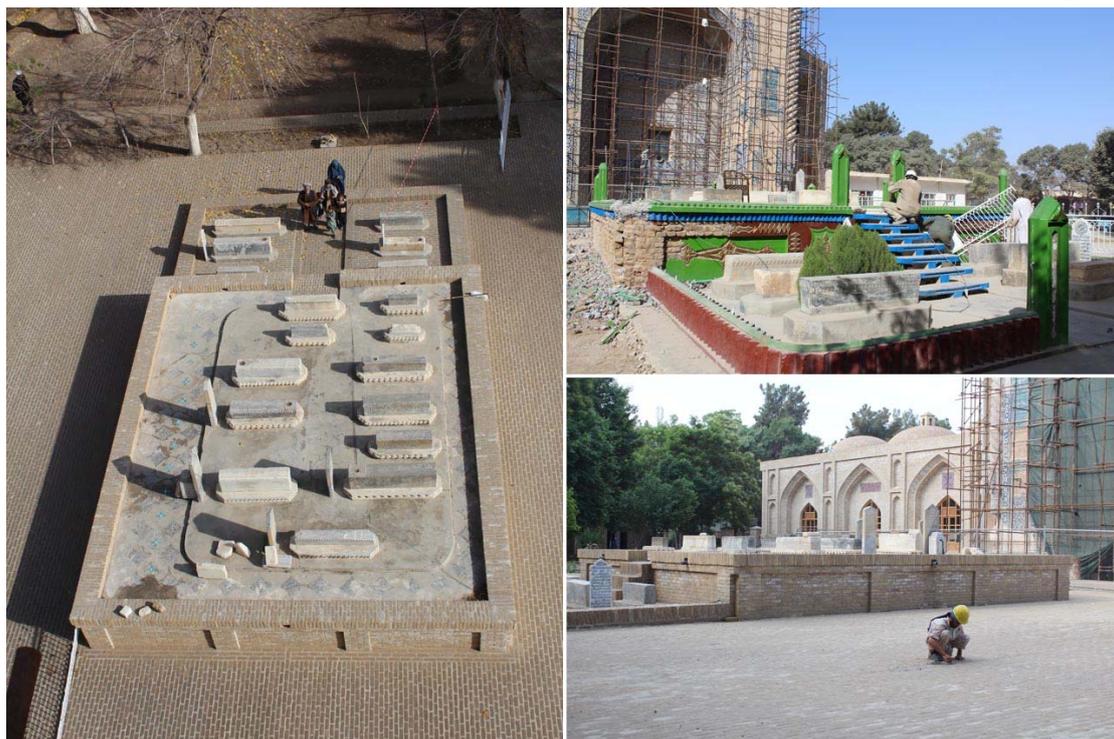
The platform had been repaired on several occasions, the most recent of which had included the addition of layers of concrete surfaces. In order to restore the platform using appropriate materials that match the technical and visual requirements of the project, skilled teams of mason's carefully removed sections of the recent intervention and encased the platform in a new baked brick masonry wall.

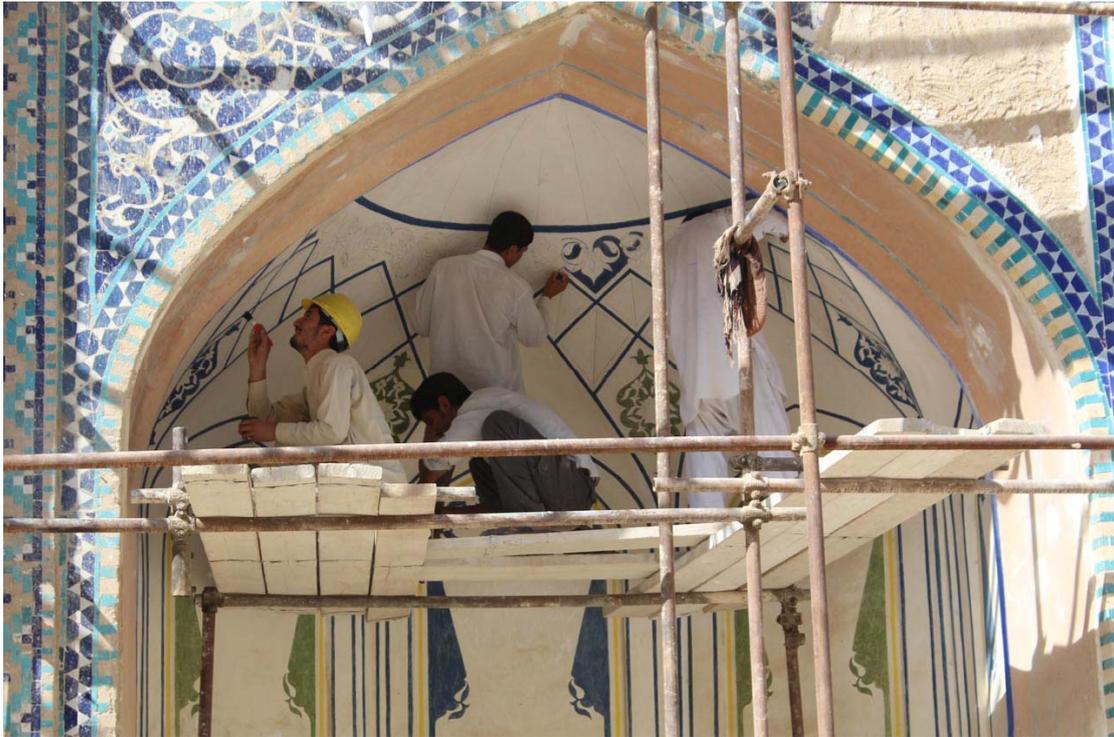
aspect of important embellishments of the shrine. In order to preserve these areas of decoration, the hand painted floral motif was carefully cleaned and fixed with a primal solution. Adjacent sections of deteriorating plaster work were also repaired. Recent graffiti added to the walls was removed using special solvents and by scraped with steel utensils.

As appropriate and in areas where the addition of painted decoration reflected and reinforced the original designs, teams of painters revived previous floral patterns using water based paints.

In total more than 65 square meters of hand painted decoration was cleaned and restored, which included 27 square meters of newly painted areas.

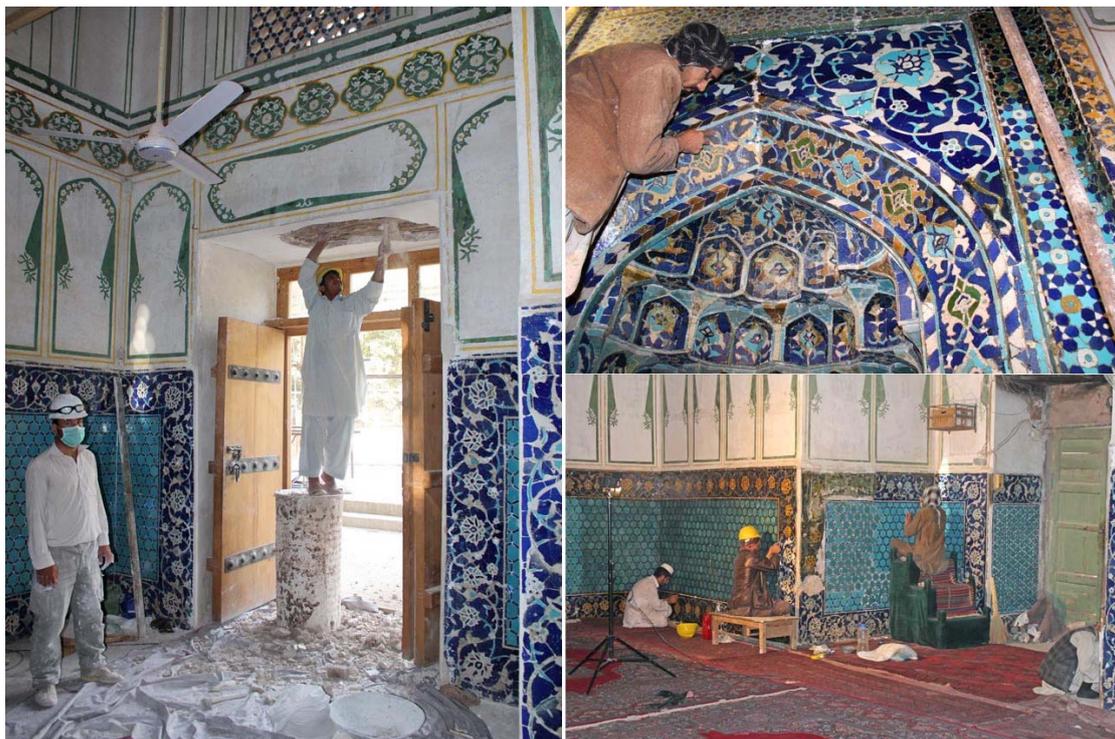
The design and production of *Moaraq* or Mosaic tiles requires the highest level of skill and creativity that a master tile maker can hope to achieve and the sections of this type of tile-work that remain within the Khwaja Parsa Shrine are the work of a master in the craft. After more than 4 Century's of wear and tear and the turbulent period of recent conflict in Balkh, it is surprising that large sections of this type of tiled decoration survived the neglect of maintenance and repair. The main reason for the survival of the tile decoration must thus be associated with the fact that the tiles are located within a place of worship and prayer.

Following documentation and study of the internal spaces of the mosque it was discovered that large areas of the decoration lay hidden under layers of plastic and water-based paint, probably commissioned through *Waqfs* (religious donations) made over the past 3 decades. The initial task of the conservation team was thus to carefully remove the paint, exposing and consolidating the mosaic tiles beneath. Special tools for the removal of the paint were produced in order to avoid scratching the surface of the glazed tiles. Chemical paint removers could not be used as they may have caused damage to the tiles or resulted in the discoloration of the plastered

mortar joints. It remained for teams of worker to painstakingly remove the paint by hand with no more than 30 centimeters square possible per day per person. Once the complete length of internal elevation of the mosque had been cleaned, it possible to take stock of the full design of the mosaic tile decoration. While large sections of the decoration had been removed or had collapsed and replaced with simple plaster and hand painted motifs, the areas of the mosaic decoration that survived constitutes one of the most important and significant remains of such craftsmanship in Balkh. In total more than 93 square meters of original tile work were cleaned.

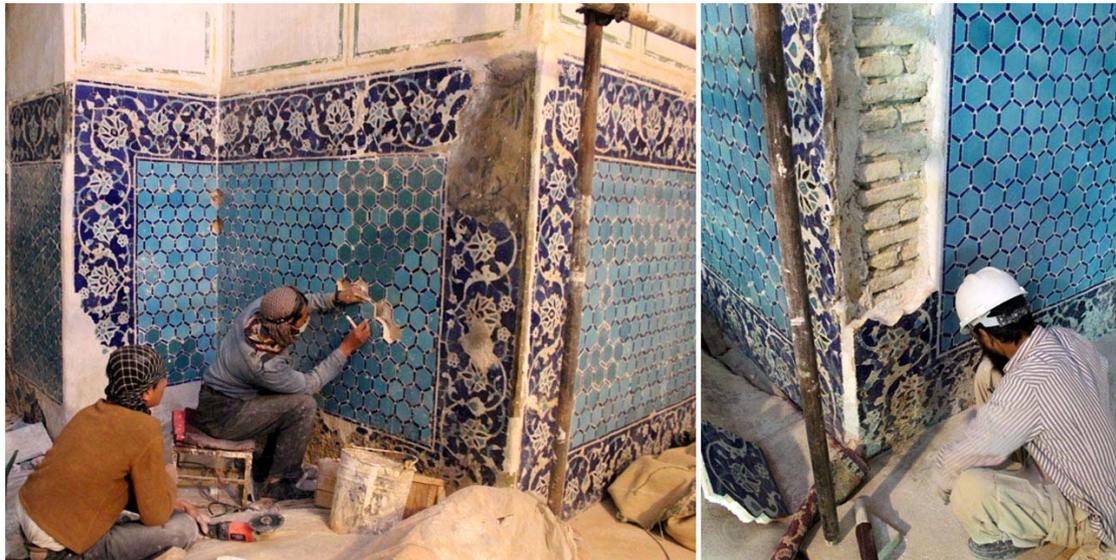
Following the cleaning of the mosaic tiles, the next task involved the repair of large sections of the historic tile work that had been damaged and the consolidation of areas that had become weakened or detached from the walls. This was done by carefully stabilizing the tile work in place and injecting a special plaster based mortar into the gaps and cracks behind the tiles. Once the mortar composite had dried, a layer of plaster was applied to the surface of the tiles in order to fill the gaps that had appeared between the mosaic. The surface of the tiles where then cleaned with warm water and cotton cloths and left to dry. With the full length of the historic mosaics tiles consolidated and repaired, the next task involved the retiling of sections of the decoration that had collapse or been removed. In total more than 90 square meters of original tile work was repaired and consolidated.

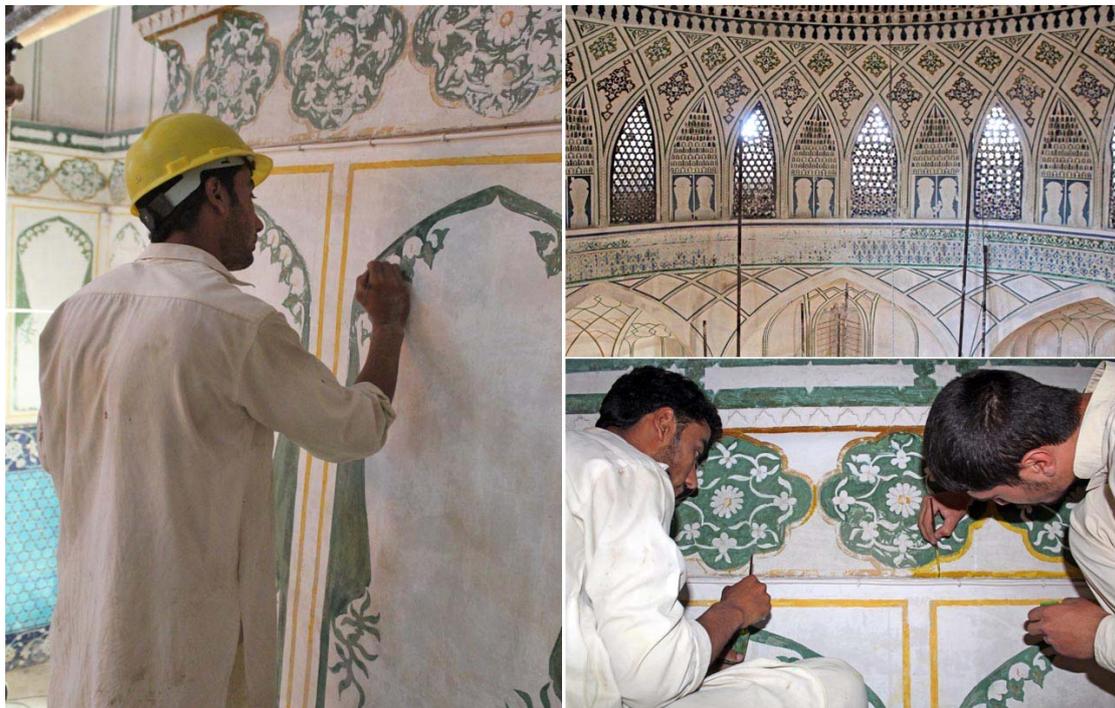
Several areas of the decoration where the mosaic tiles were missing were simply filled with plaster and crudely repainted by hand. In consultation with counterparts and as per standard conservation practice, it was decided that new *haft rangi* tiles would be produced as per the designs of the mosaic tiles and installed in areas where the original decoration was missing. The purpose of this work was to protect the remaining historic tiles while retaining the overall cohesion of the space and decoration. The *haft rangi* tiles are typically used in conservation where mosaic tiles are too difficult to replicate or require significant time to produce. These tiles are usually made in standard sizes – often rectangular or square – and the decorative

pattern required is painted on by hand and in multiple colours. In the context of the Khawaja Parsa mosque, craftsmen designed a standard 10cm x 10cm square tile upon which the historic floral pattern of the mosaic tiles were drawn and painted in similar colours. As part of standard conservation practice, new areas of tiled *haft rangi* decoration are distinct and distinguishable from original sections of the mosaic decoration yet contribute to the overall harmony of the space and effect of continuity. In this instance the areas retiled also protect and safeguard the mosaic tiles against deterioration and help prevent inappropriate interventions in the future by unskilled laborers.

In total more than 1.3 square meters of new '*haft range*' tile work was produced and installed.

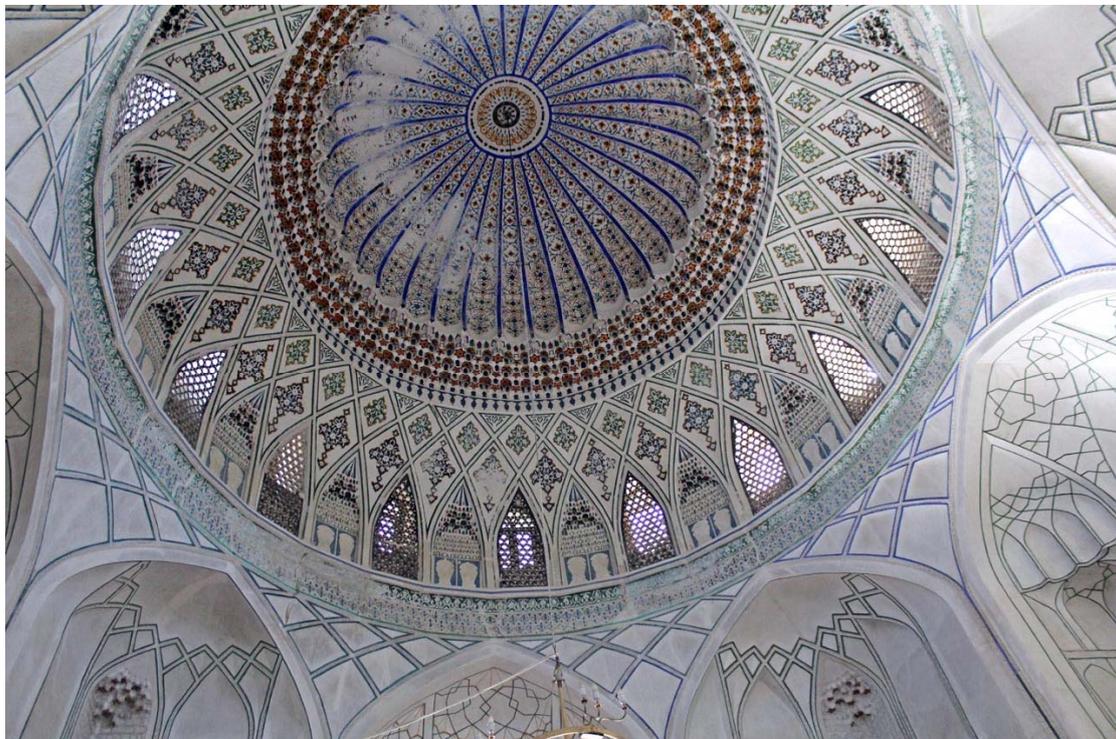
Damp that had penetrated the cavities between the historic mosque and the flanking concrete mosques had resulted in the sustained penetration of snow melt and rainwater into the upper areas of the historic masonry structure. Together with water saturation in the brick surface above the mosque, resulting from inappropriate falls in the paving, the seepage of moisture into the building had resulted in the slow deterioration of sections of the internal plaster finish. These areas of loose and damaged plaster were carefully removed, left to dry, and re-plastered using gypsum.

In total more than 18 square meters of gypsum was applied to the internal elevations of the mosque.
