SUMMARY

432 Maple Ave, Owensboro, KY 42301
Mary Bryan Hood Estate Tom Neal Executor
05/08/2025

David Johnson
KY#270106 IN#HI02100119 TN#2494
Bluegrass Home Inspections LLC
2702310825
bluegrasshomeinspectionsllc@gmail.com

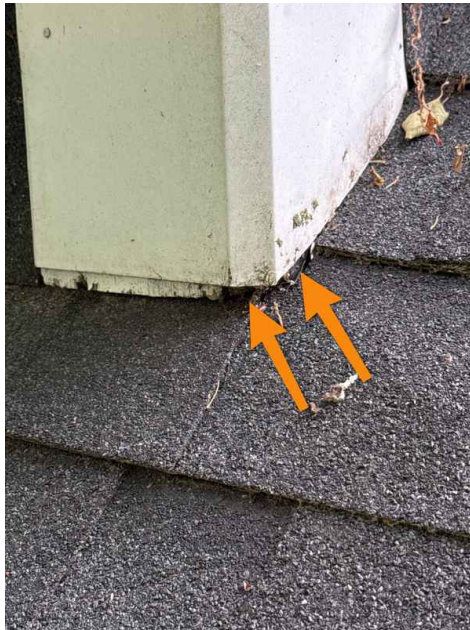
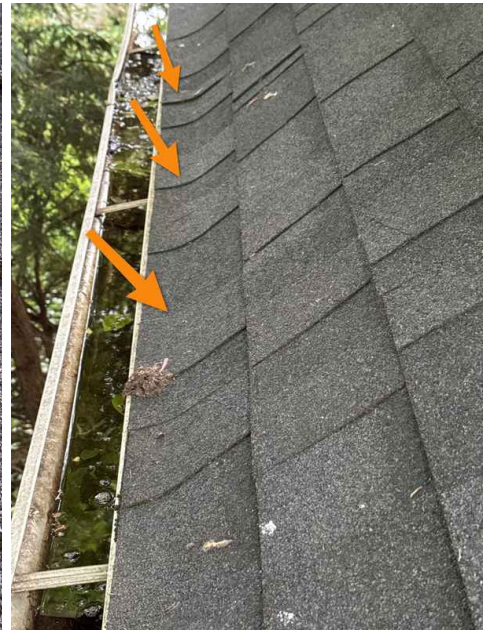
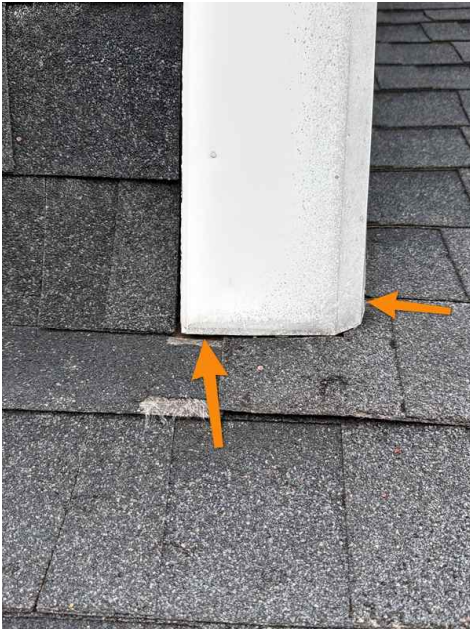
EVIDENCE OF WATER INTRUSION

Evidence of water intrusion noted during the inspection. Recommend further evaluation by a qualified contractor.

Contact a qualified roofing professional.

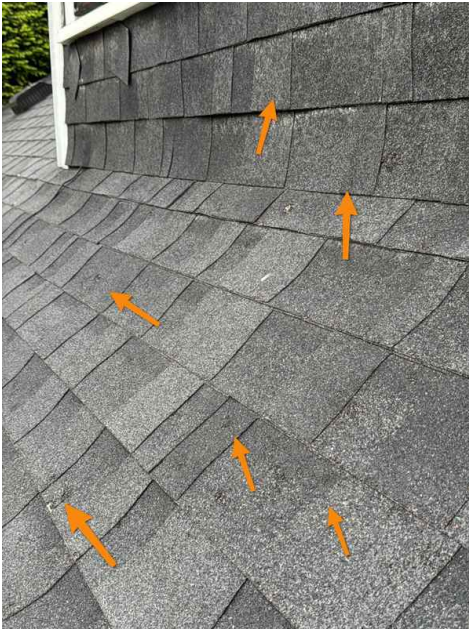
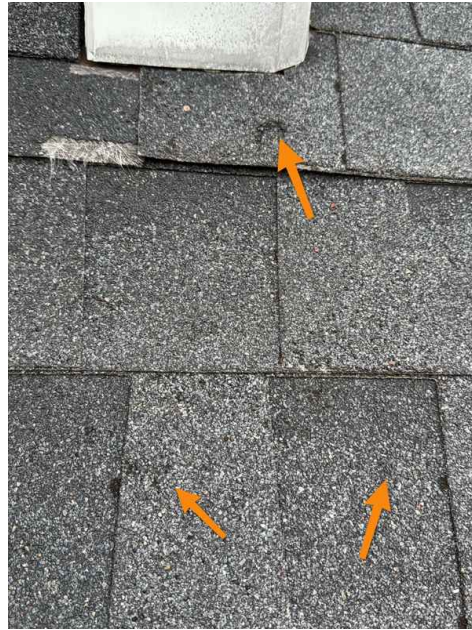
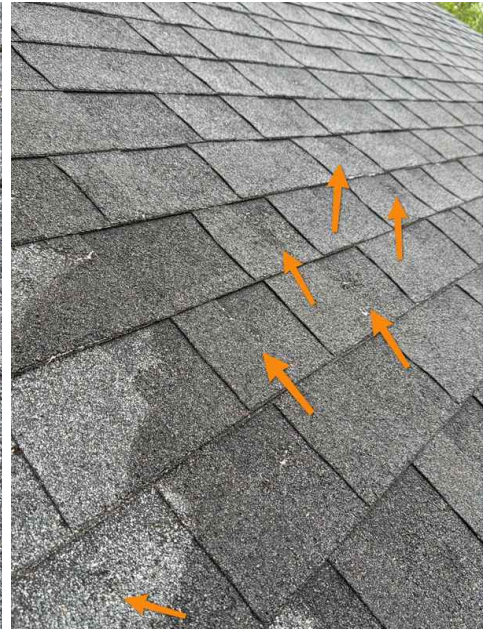
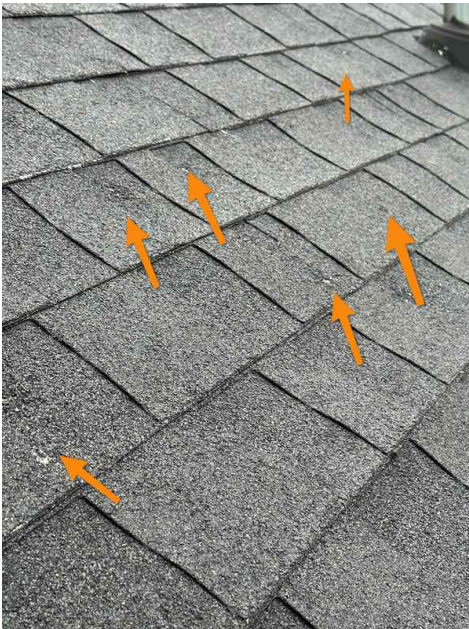
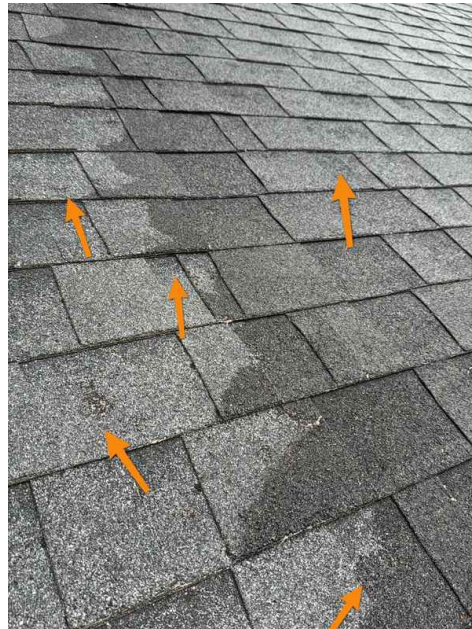
2.2.3 Coverings
HAIL DAMAGE

Evidence of hail damage observed during the inspection. Recommend further evaluation by qualified roofing contractor.

Recommendation
 Contact a qualified professional.

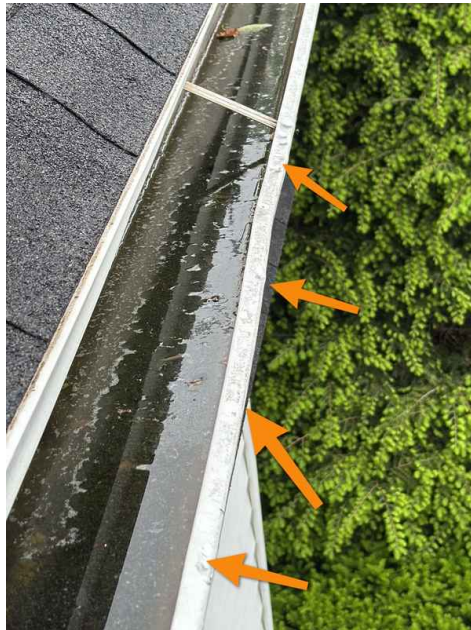
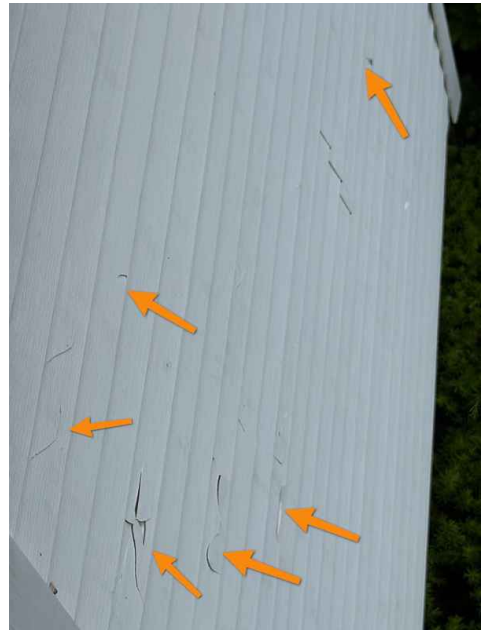
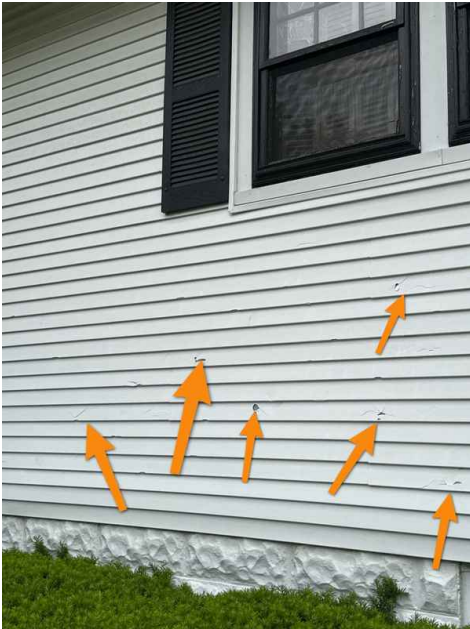
HAIL DAMAGE

Hail damage observed during the inspection. Inquire with current owner/representative for past history. Recommend further evaluation by a qualified exterior contractor.

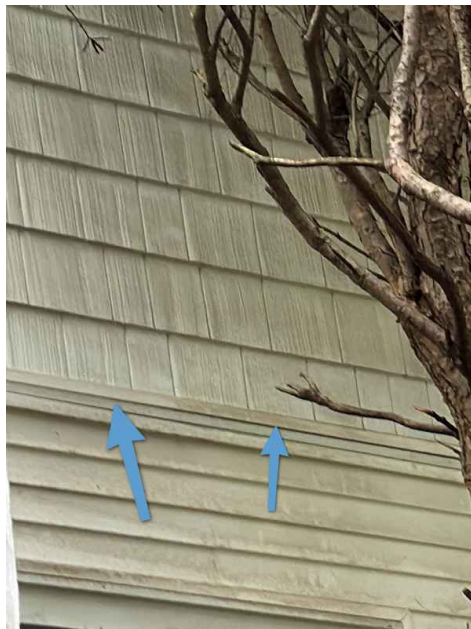
North

J-channel was used instead of a starter strip for the very bottom run of vinyl siding. This can trap water and cause moisture intrusion. Exterior siding manufacturers recommend drilling a 3/16" hole every 12 inches along the J-channel to allow drainage. Recommend further evaluation by a siding contractor.

Recommendation
Contact a qualified professional.

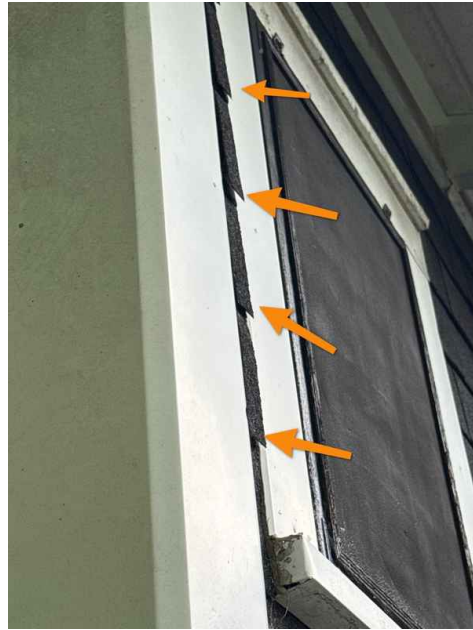
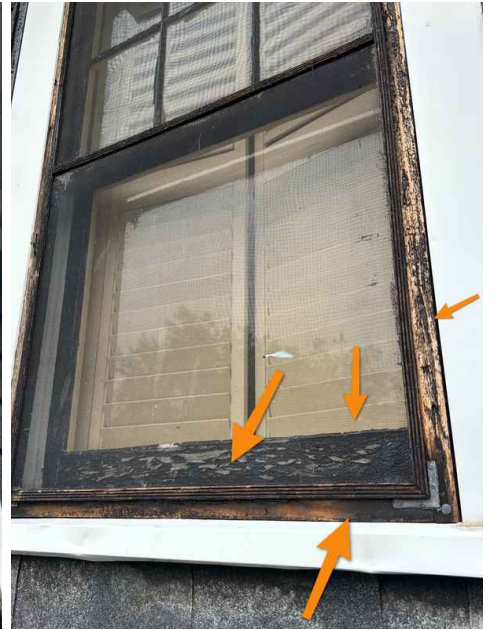
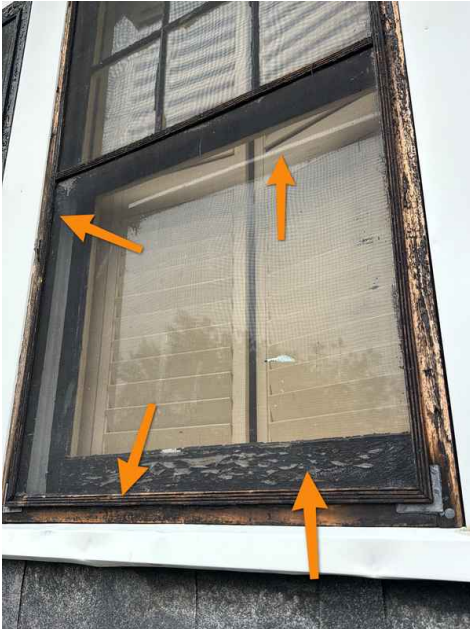
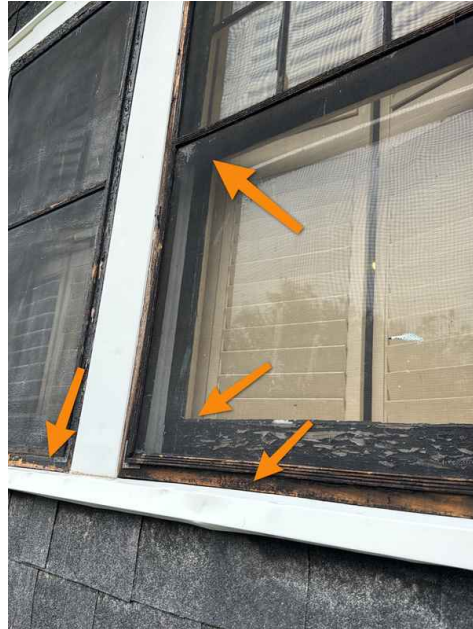
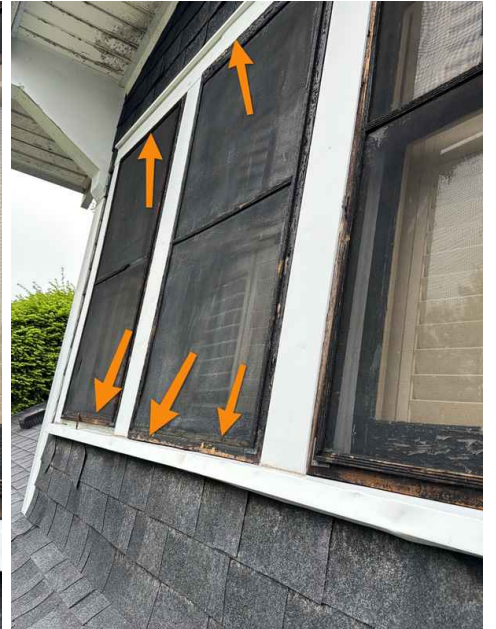
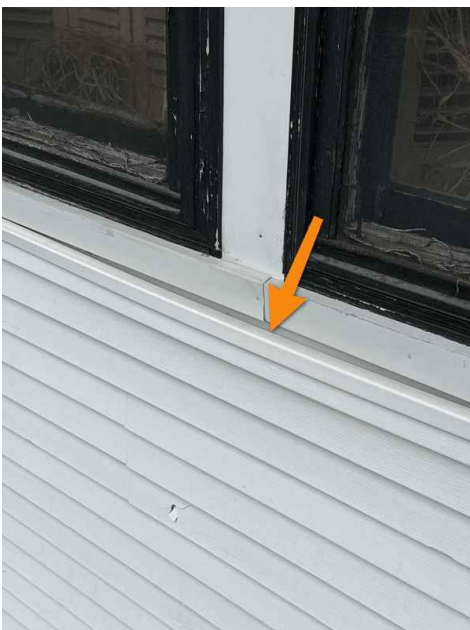
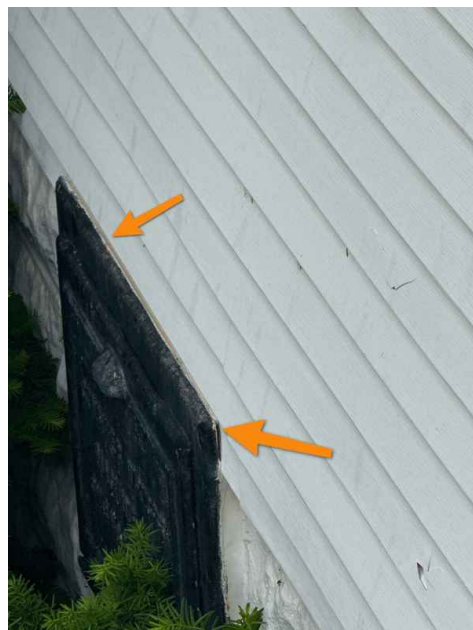
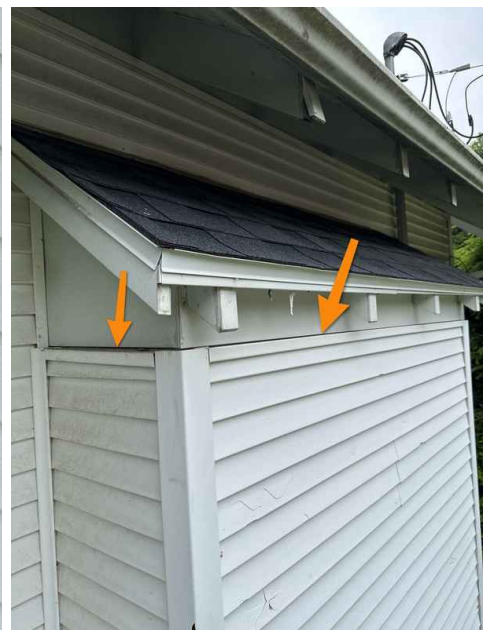
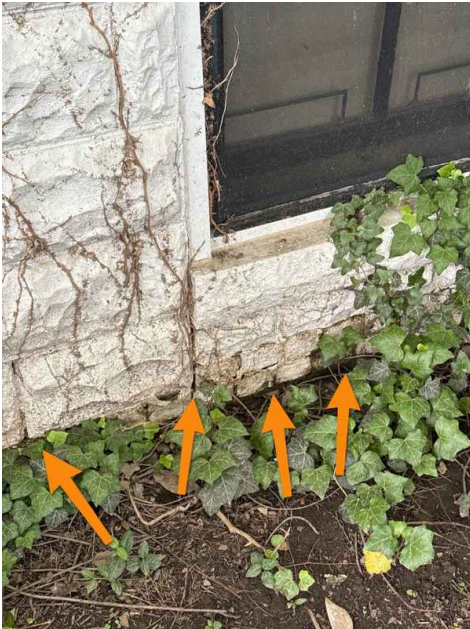
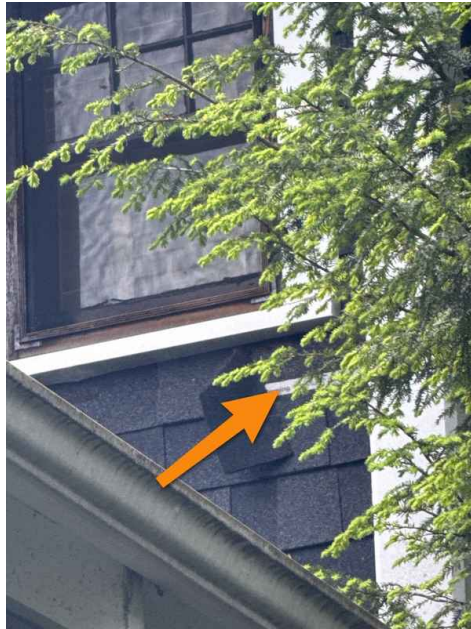
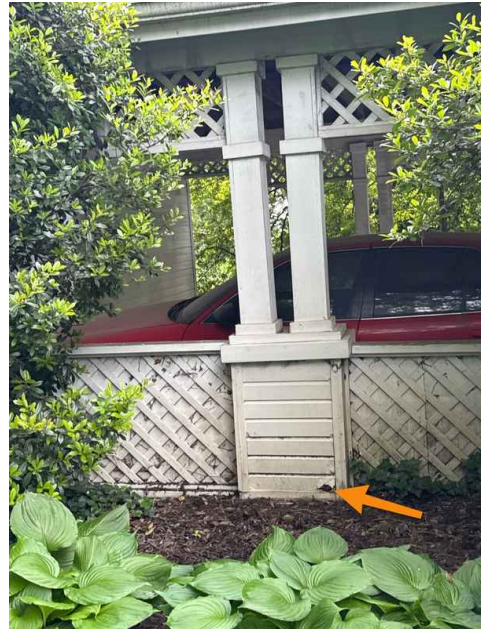
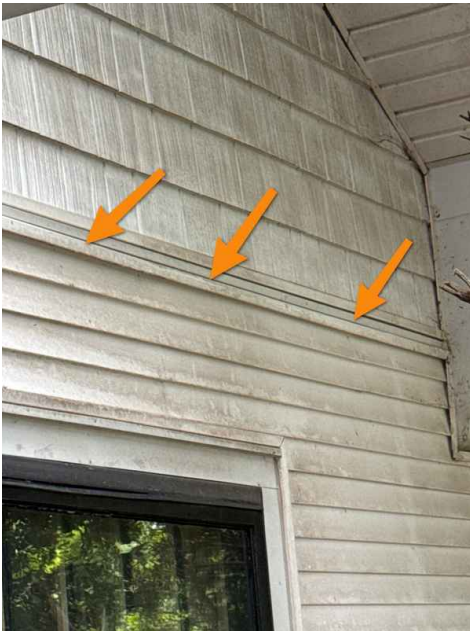
Evidence of water intrusion noted during the inspection. One option is to repair exterior siding and/or flashing. Recommend further evaluation by a qualified contractor.

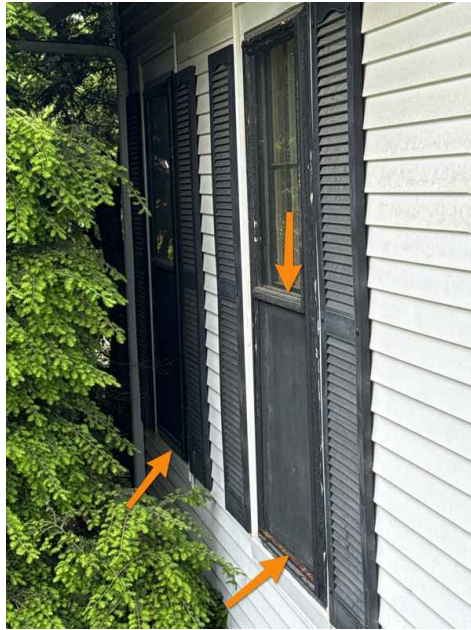
West

Wood rot noted during inspection. One option is to replace with a composite material that can withstand constant weathering. Recommend further evaluation by qualified carpenter.

Recommendation
Contact a qualified professional.

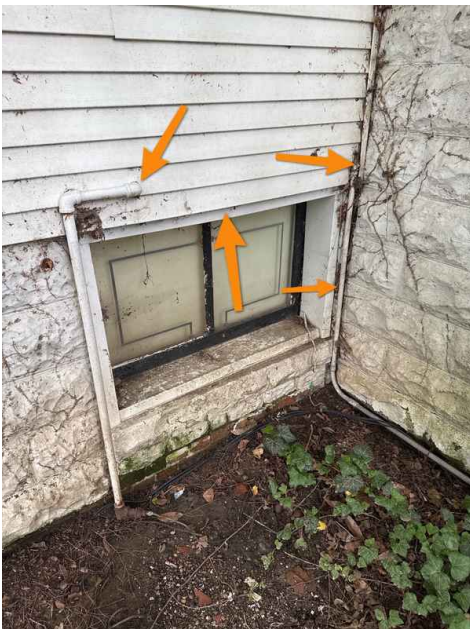
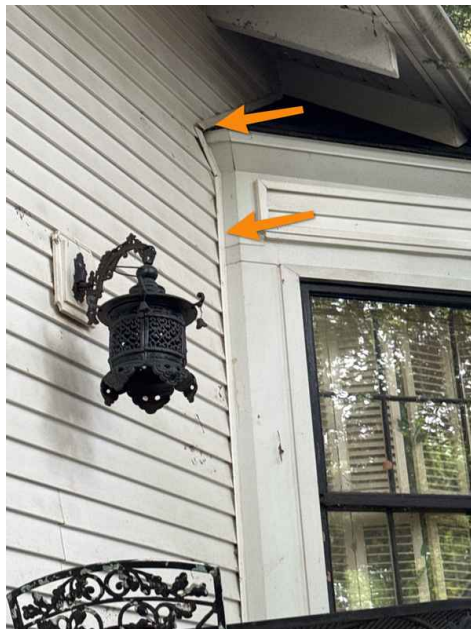
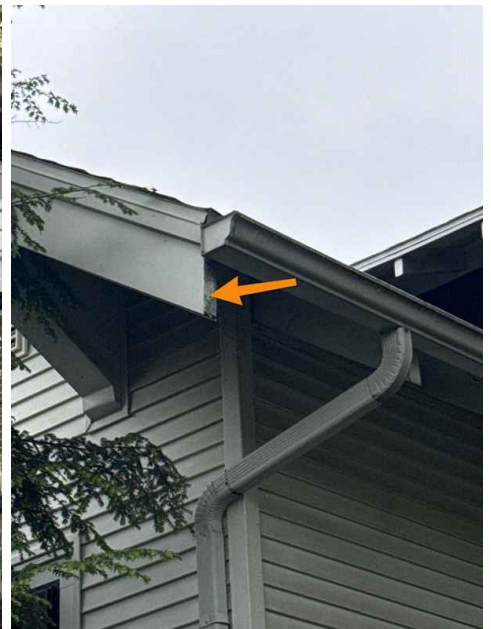
Sealant/Flashing recommended where two dissimilar exterior materials meet and/or change direction. One option would be to apply a tripolymer sealant and/or flashing. Recommend further evaluation by a qualified contractor.

Recommendation
Contact a qualified professional.

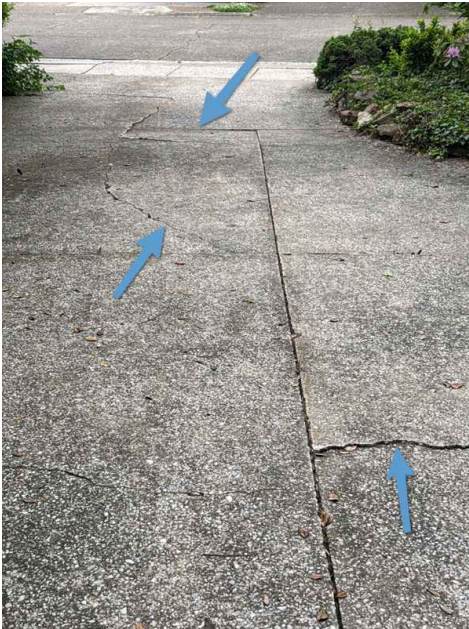
South

Minor cosmetic cracks observed, usually associated with expansion/contraction due to temperature changes. One option is to patch/seal cracks. Recommend monitoring and/or further evaluation by a concrete contractor.

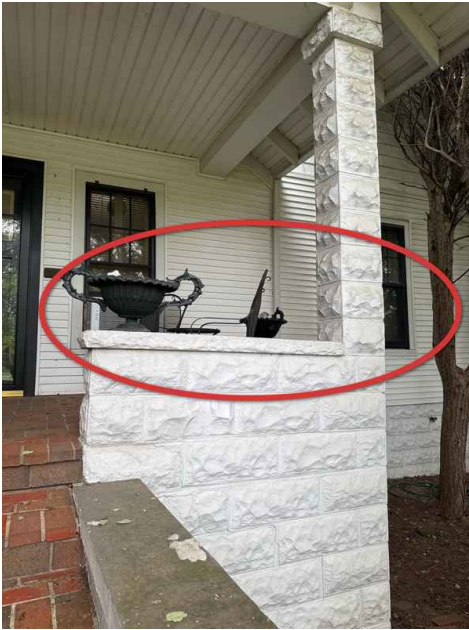
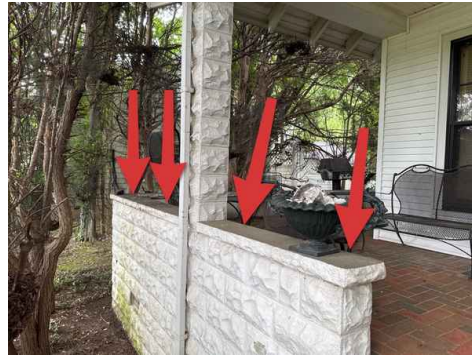
Guardrails are missing in one or more locations. Handrails/guardrails are required if there are four or more stair risers, OR 30" of vertical separation. One option is to provide positive separation between pedestrian routes and vertical separations greater than 30". Recommend further evaluation by a qualified contractor.

Recommendation
Contact a qualified professional.

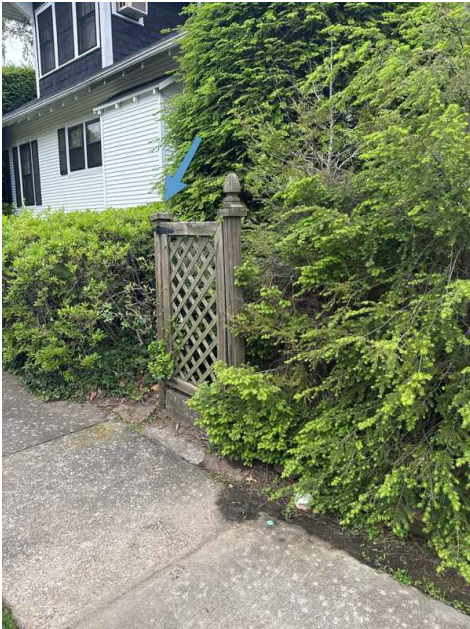
DETERIORATED POSTS/SLATS

One or more fence posts/slats were observed to be deteriorated. Recommend further evaluation by a fencing contractor.

Recommendation
Contact a qualified professional.

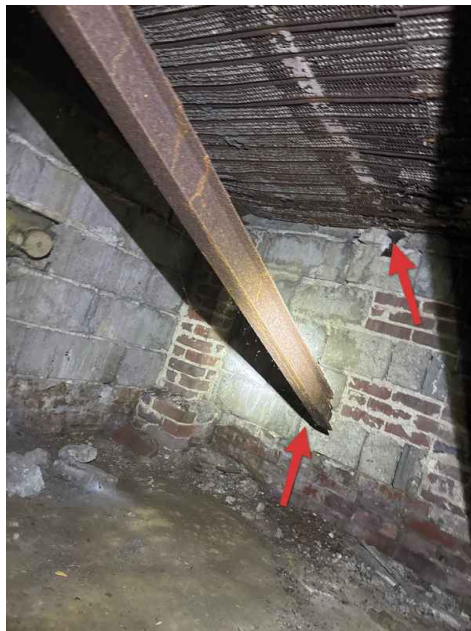
North Crawlspace

EVIDENCE OF STRUCTURAL DAMAGE

Structural damage was observed in the underlying floor structure. Recommend further evaluation by a qualified carpenter.

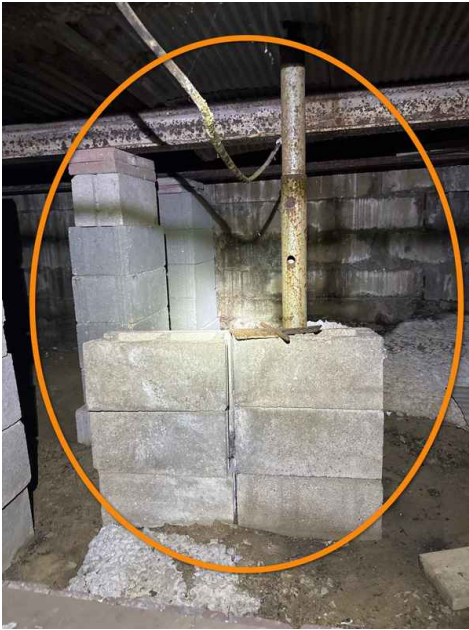
East Crawlspace

Pillar blocking is not on concrete. Soil conditions cause elevations to sag. Recommend further evaluation by qualified carpenter.

Recommendation
Contact a qualified professional.

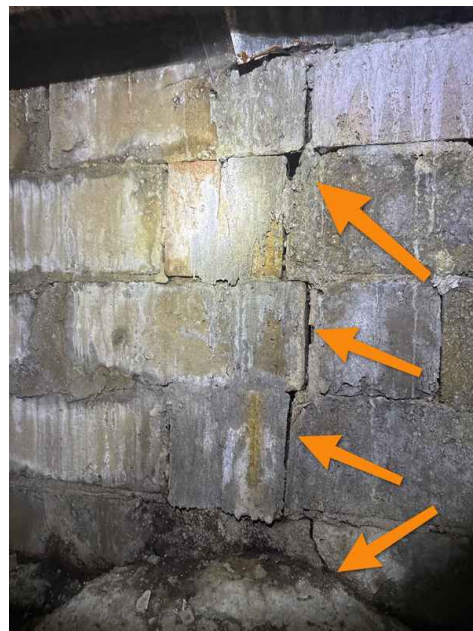
East Crawlspace

4.5.1 Wall Structure
CRACKS - MAJOR

Major cracking observed in wall structure. This could be from moisture intrusion at the structure and/or extreme temperature fluctuation. Recommend further evaluation by a qualified contractor.

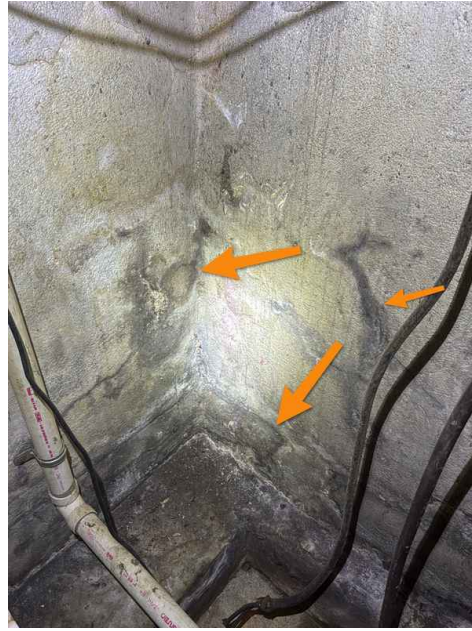
Basement

4.5.2 Wall Structure
EVIDENCE OF WATER INTRUSION

Evidence of water intrusion noted. One option is to ensure water is flowing away from the structure. Seek previous history from current owner and/or continue to monitor. Recommend further evaluation by a qualified contractor.

Recommendation
Contact a qualified professional.

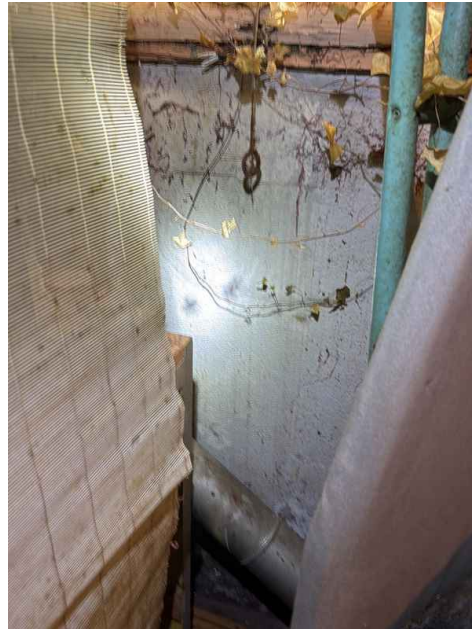
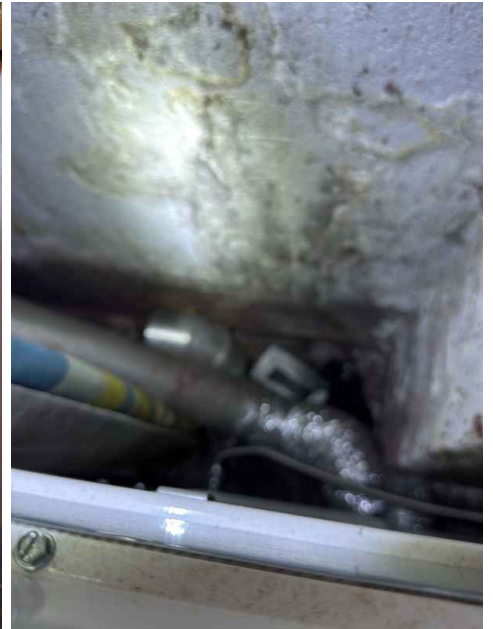
4.5.3 Wall Structure **POSSIBLE LIME MORTAR**

Evidence of possible lime mortar used in masonry. One option is to tuck-point cement mortar in deficient masonry areas. Recommend further evaluation by a qualified masonry contractor.

Recommendation
Contact a qualified professional.

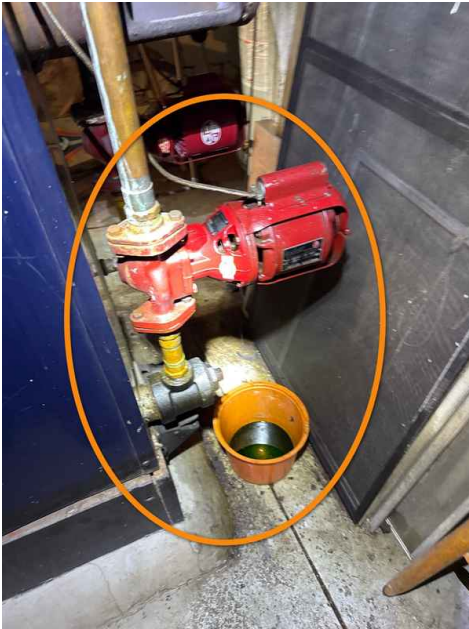
Basement

5.2.1 Equipment
OIL STAINS PRESENT

Oil stains present on line-set. One option is to perform a leak test. Recommend further evaluation by a qualified contractor.

Recommendation
Contact a qualified professional.

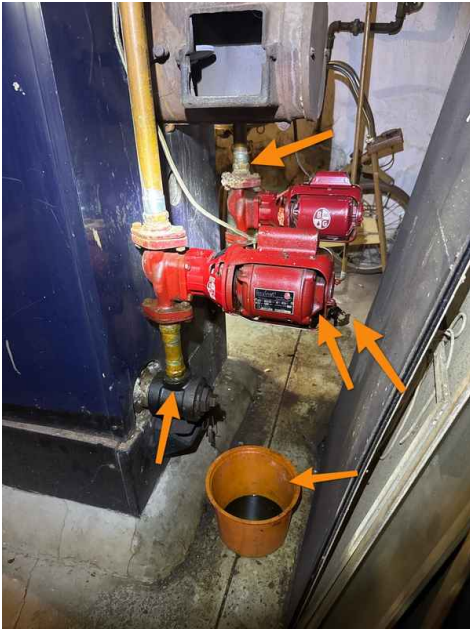
Basement

LEAK OBSERVED IN BOILER PIPING

At the time of the inspection, a small leak was observed in boiler piping. Recommend further evaluation by a qualified HVAC professional.

Contact a qualified professional.

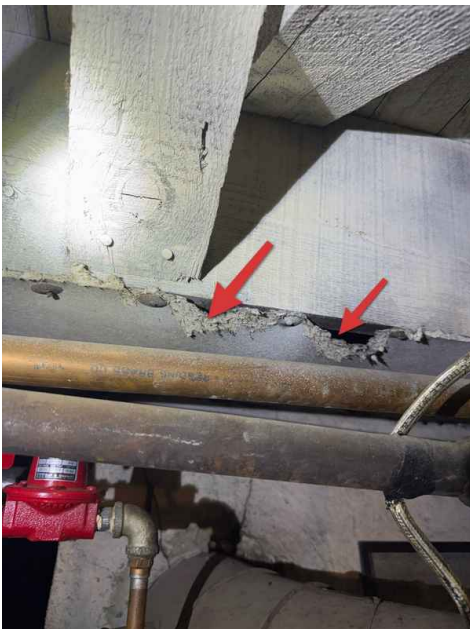
Basement

5.4.1 Distribution Systems
UNKNOWN MATERIAL

Unknown material observed in isolated areas. One option is to have it tested for asbestos like materials. Recommend further evaluation by qualified contractor.

Recommendation
Contact a qualified professional.

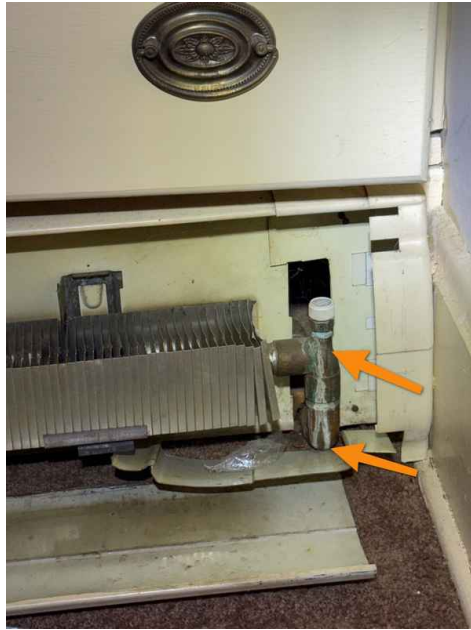
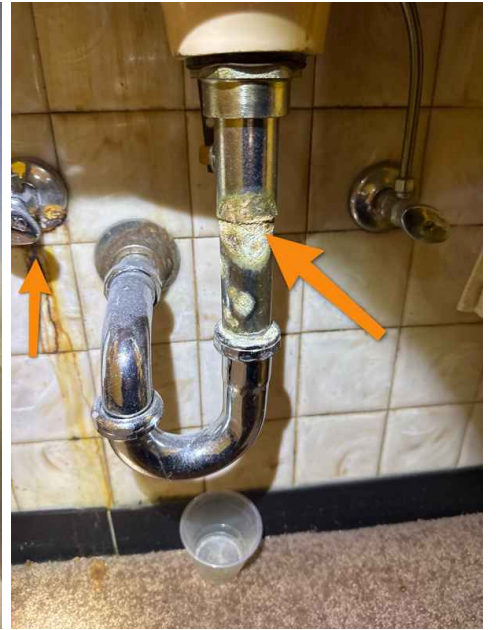
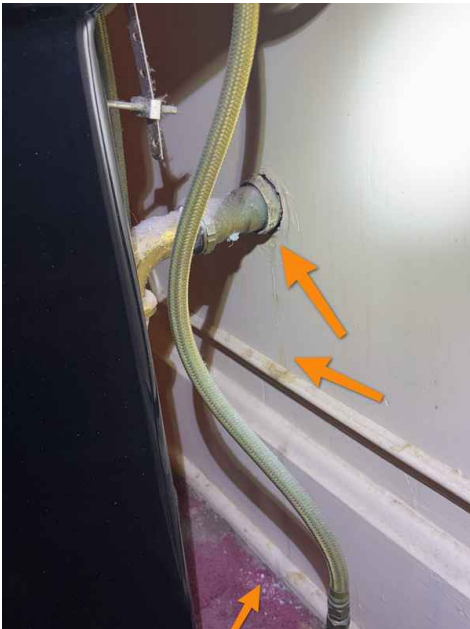
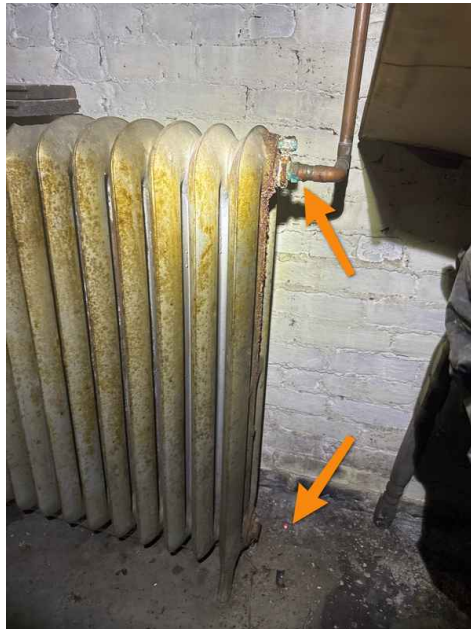
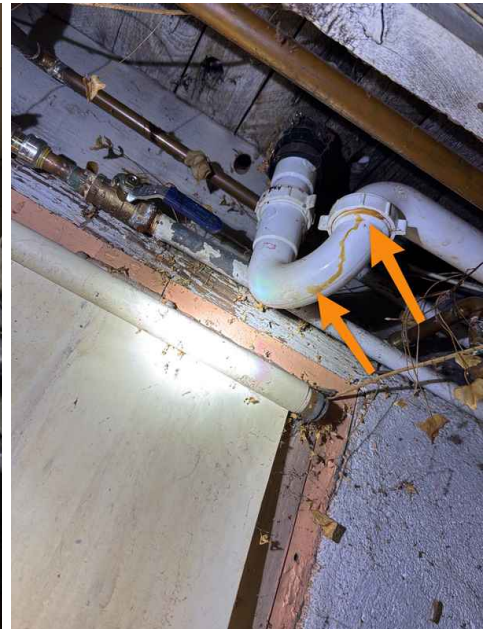
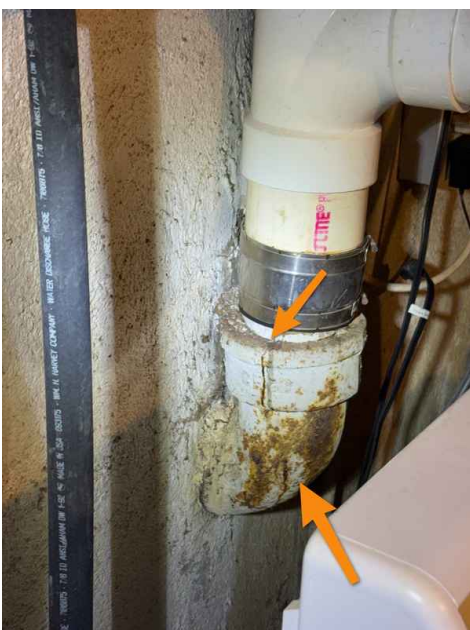
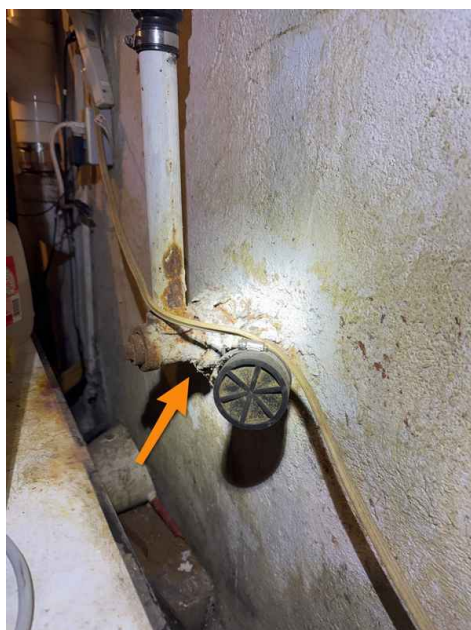
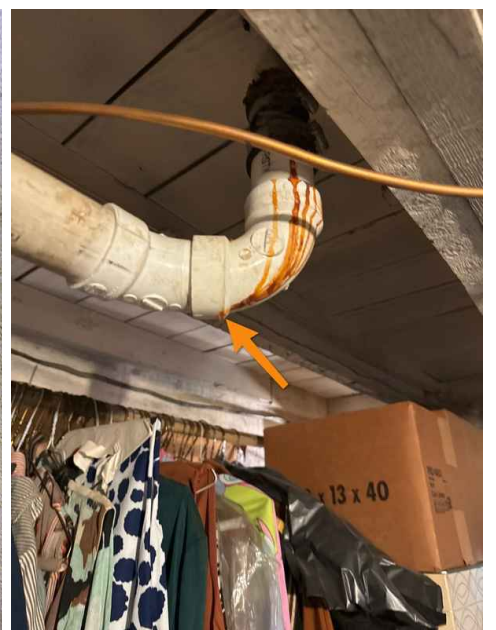
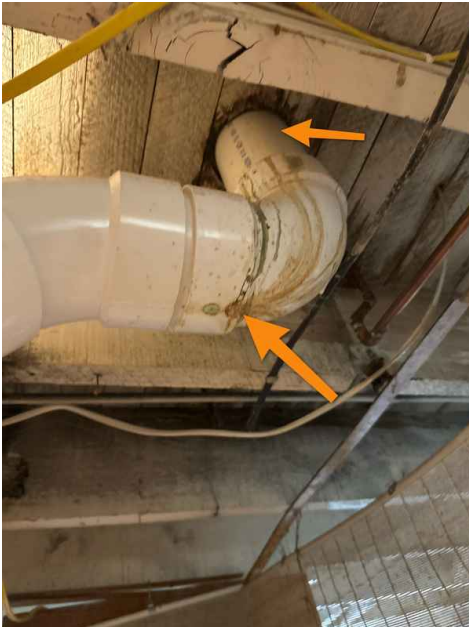
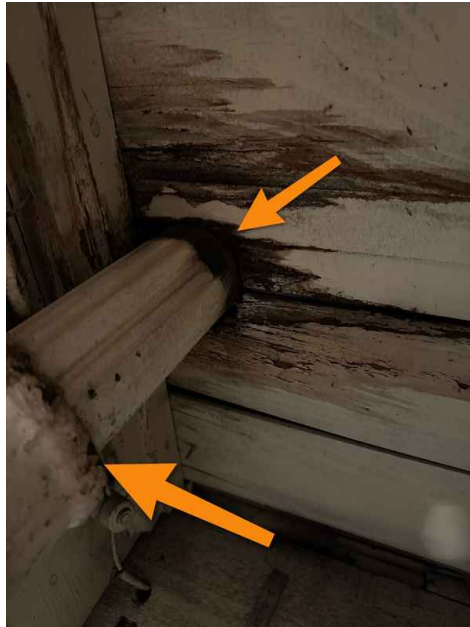
7.3.1 Drain, Waste, & Vent Systems
EVIDENCE OF A LEAK

Evidence of a leak observed during the inspection. One option is to repair plumbing to prevent moisture damage. Recommend further evaluation by a qualified plumber.

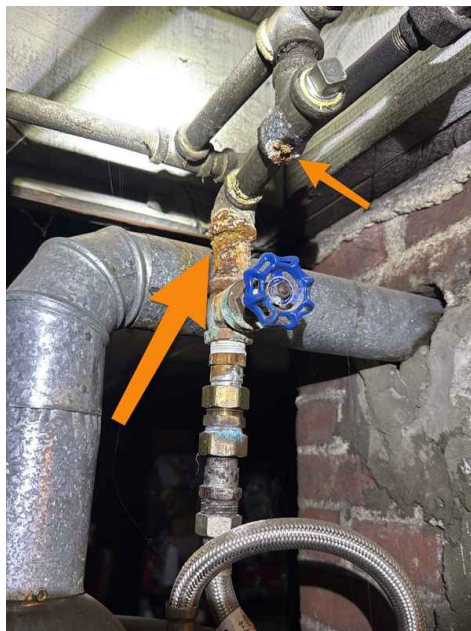
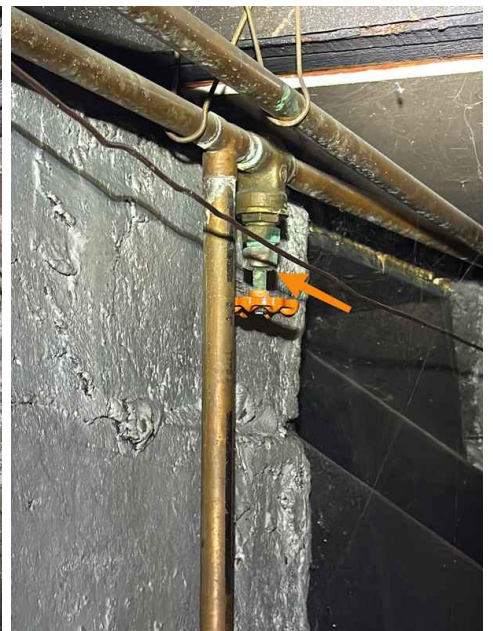
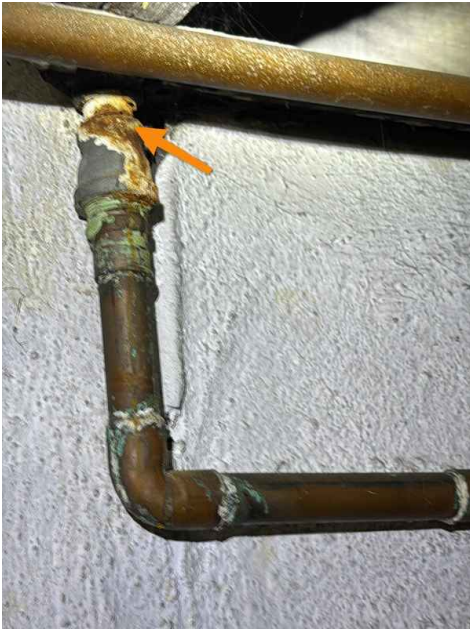
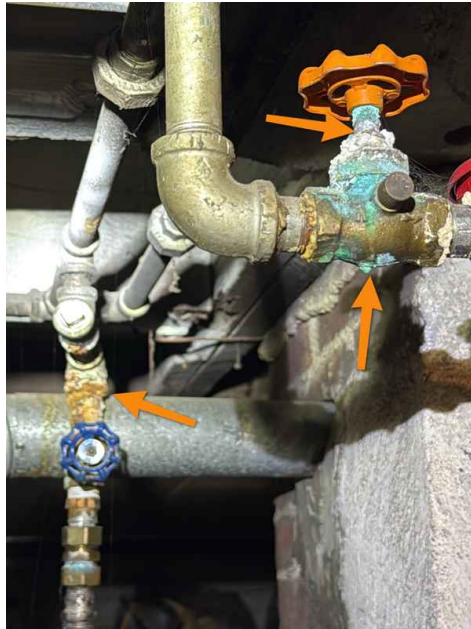
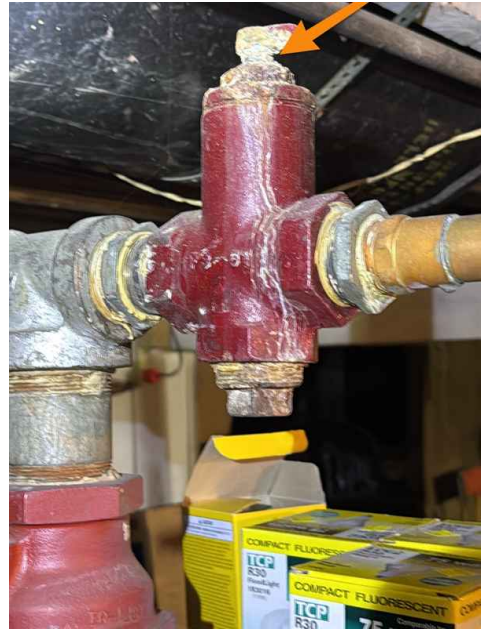
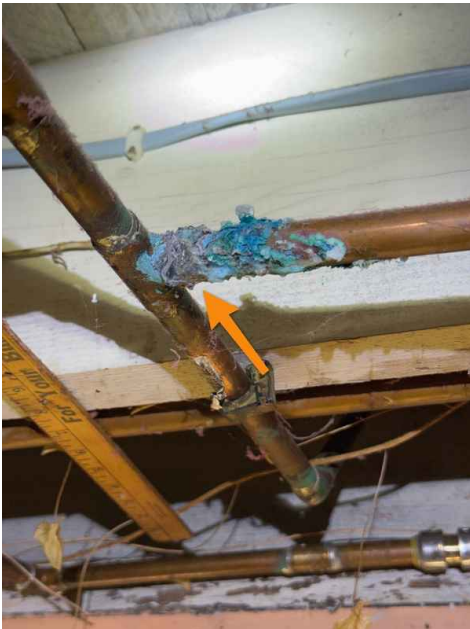
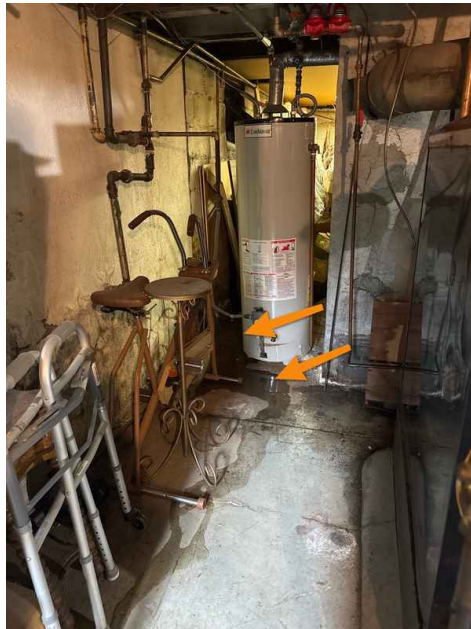
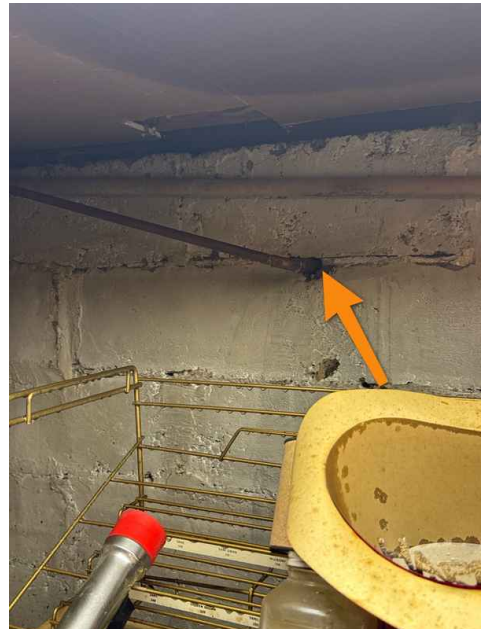
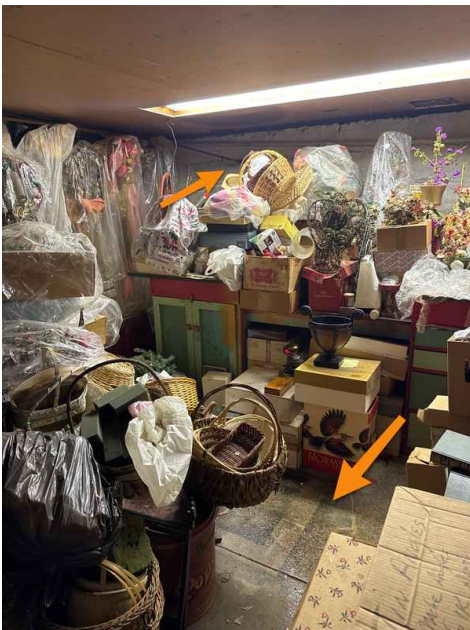
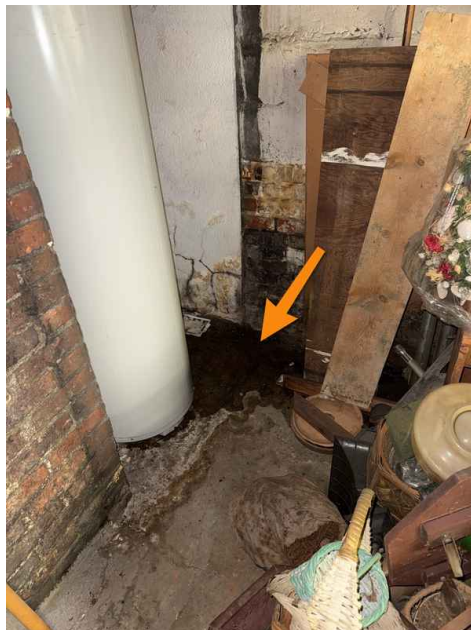
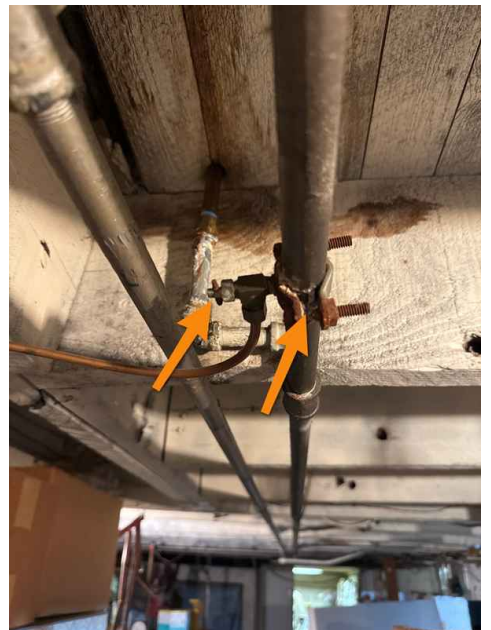
DISTRIBUTION PIPE LEAKING

Distribution pipe leak observed during the inspection. One option is to repair damaged connections and/or pipe material. Recommend further evaluation by a qualified plumber.

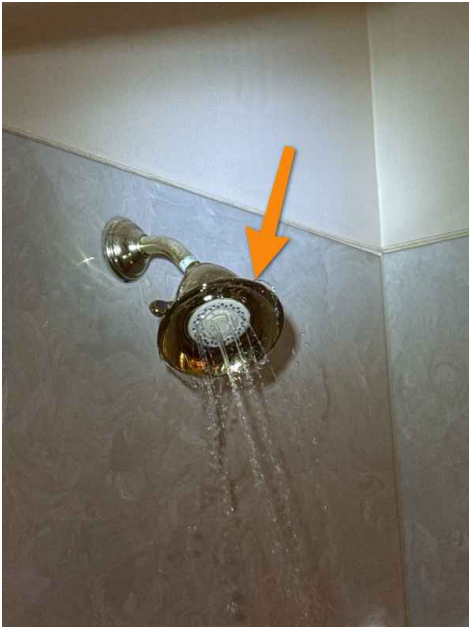
1st Floor South Bathroom

FIXTURE LEAKING

Fixture leaking at the time of inspection. One option would be to properly mount and secure the fixture connections. Recommend further evaluation by a qualified plumber.

Contact a qualified professional.

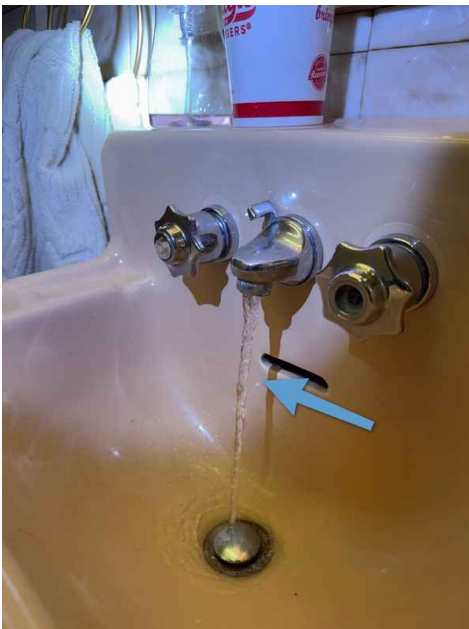
2nd Floor Bathroom

Low water pressure noted for during inspection. One option is to have the local water company check the pressure at the meter. Recommend further evaluation by a qualified contractor.

Contact a qualified professional.

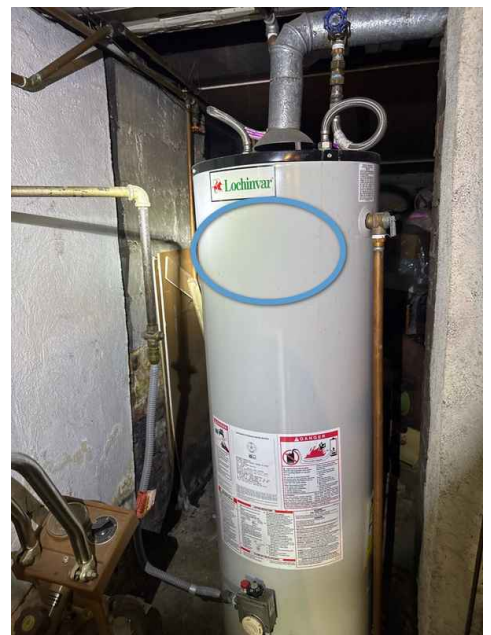
Basement

MISSING STATE (AHJ) INSPECTION STICKER

Missing inspection tag from Authorities Having Jurisdiction(AHJ) providing documentation the unit was inspected by local code enforcement. One option is to inquire with current owner for past documentation of inspection/installation. Recommend further evaluation by a qualified professional.

Recommendation
Contact a qualified professional.

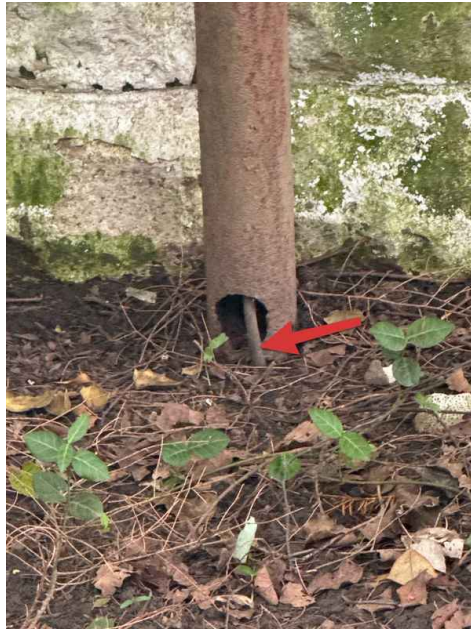
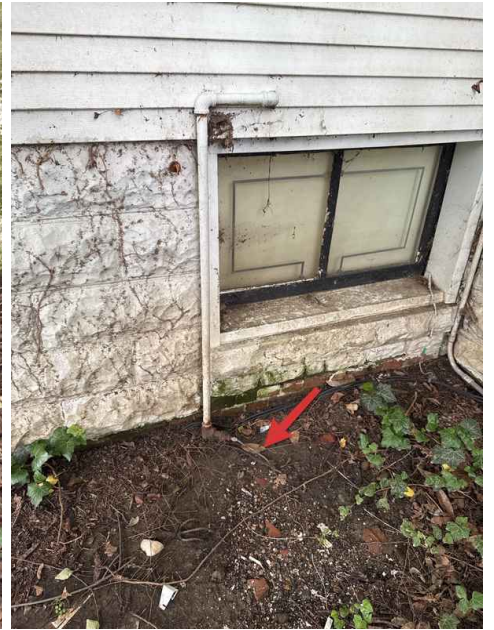
Copper gas line exposed and susceptible to damage by yard maintenance equipment. Recommend further evaluation by a qualified contractor.

Recommendation
Contact a qualified professional.

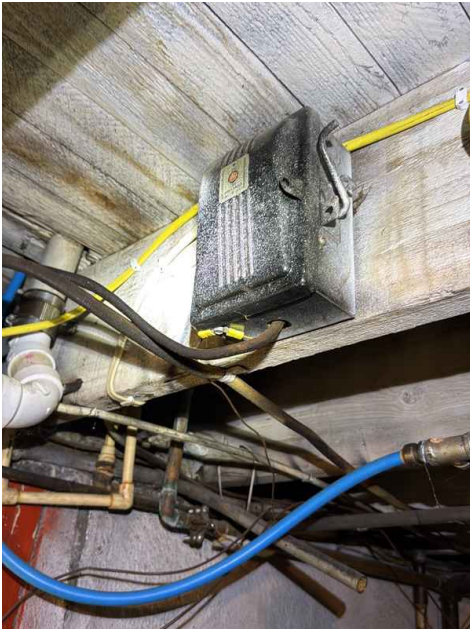
8.3.1 Main & Subpanels, Service & Grounding, Main Overcurrent Device **FUSE PANEL**

Fuse panel observed during inspection. As you perform upgrades to the electrical system, consider upgrading fuse panel to circuit breakers. Recommend further evaluation by a qualified electrician.

Recommendation
Contact a qualified professional.

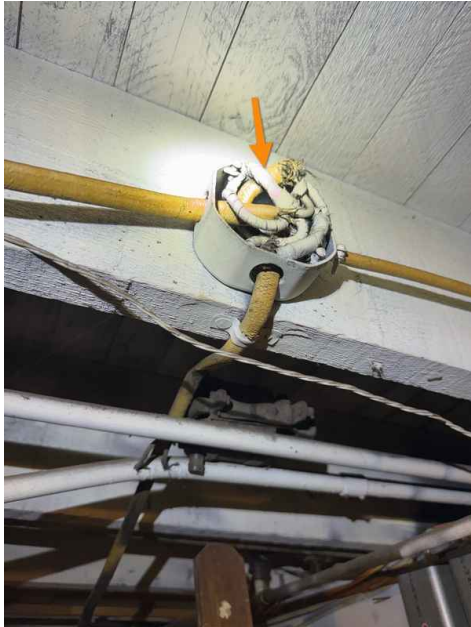
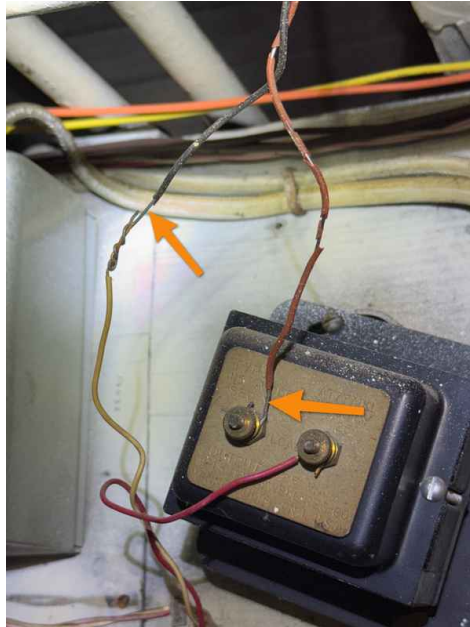
Basement

8.4.1 Branch Wiring Circuits, Breakers & Fuses **ALUMINUM BRANCH CIRCUITS**

Aluminum wire appears to be installed on branch electrical circuits in the subject premises. These single strand, branch circuit aluminum wires were used widely in houses during the mid 1960s and 1970s. According to the U.S. Consumer Product Safety Commission, problems due to expansion can cause overheating at connections between the wire and devices (switches and outlets) or at splices. For further information on aluminum wiring contact the U.S. Consumer Product Safety Commission via the Internet at <http://www.cpsc.gov/> . One option is to update wiring when performing upgrades within the structure. It is recommended that the electrical system be evaluated by a licensed electrician.
