SUMMARY

432 Maple Ave, Owensboro, KY 42301
Mary Bryan Hood Estate Tom Neal Executor
05/08/2025

David Johnson
KY#270106 IN#HI02100119 TN#2494
Bluegrass Home Inspections LLC
2702310825
bluegrasshomeinspectionsllc@gmail.com

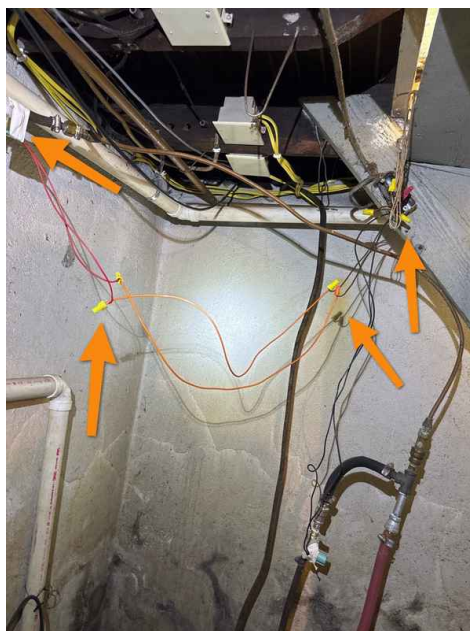
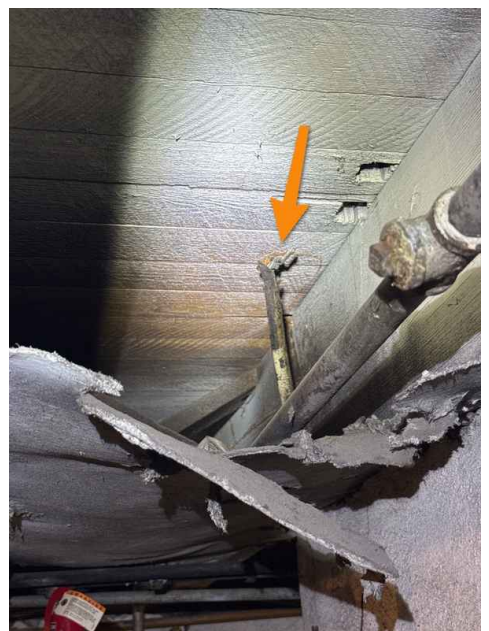
8.4.2 Branch Wiring Circuits, Breakers & Fuses **SPLICE/TERMINATION OUTSIDE JUNCTION BOX**

Branch wiring splice/termination observed outside of junction box in one, or more locations. One option is to properly secure and terminate branch wiring inside a readily accessible junction box. Recommend further evaluation by a qualified electrical contractor.

Recommendation
Contact a qualified professional.

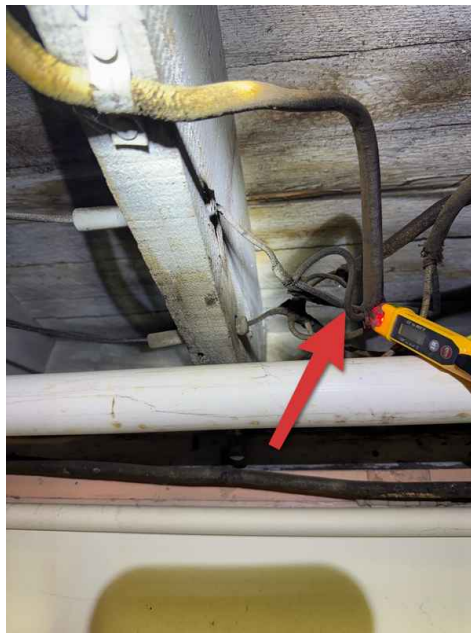
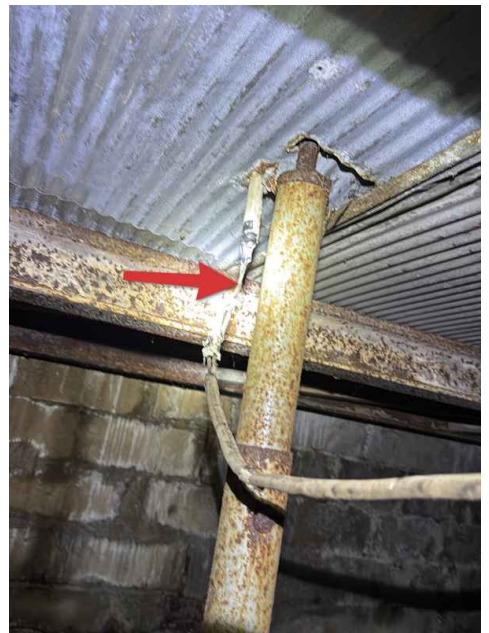
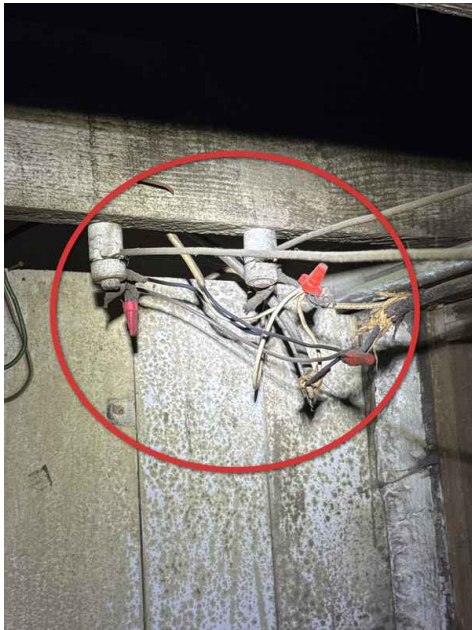
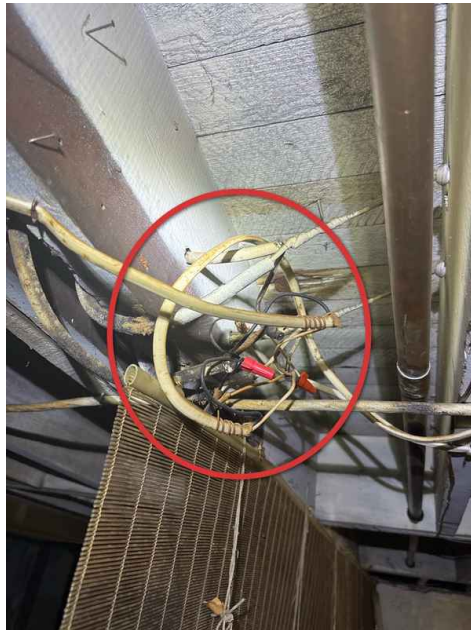
KNOB AND TUBE

"Knob and Tube" (K&T) wiring observed during the inspection in one or more locations. K&T wiring is designed to dissipate heat into free air, and insulation will disturb this process. Insulation around K&T wires will cause heat to build up, preventing heat dissipation. K&T wiring also utilizes a cloth material as wire sheathing. Cloth sheathing generally is nearing the end of its life expectancy and can cause live wiring exposure. The 2008 National Electrical Code (NEC) requires that this wiring system not be covered by insulation. Specifically, it states that this wiring system should not be in hollow spaces of walls, ceilings and attics where such spaces are insulated by loose, rolled, or foamed-in-place insulating material that envelops the conductors. One option is to upgrade wiring. Recommend further evaluation by a licensed electrician.

Recommendation
Contact a qualified professional.

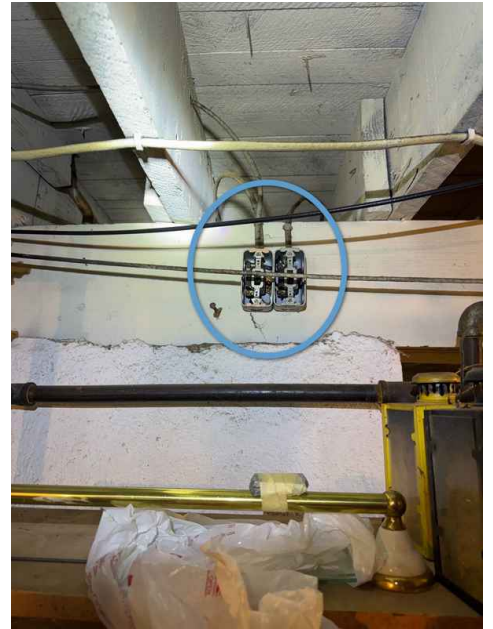
COVER PLATES/HARDWARE MISSING

One or more receptacles/junction boxes are missing a cover plate/hardware. This promotes an electrical short and /or shock risk. One option is to install the correct cover plates. Recommend further evaluation by a qualified contractor.

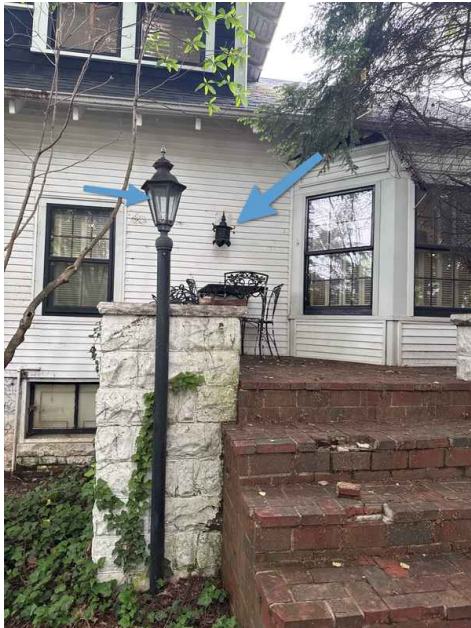
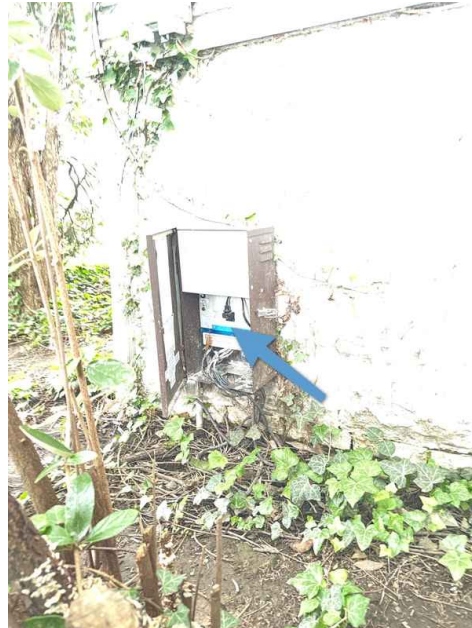
LIGHT INOPERABLE

One or more lights are not operating. New bulb/diode possibly needed. Recommend further evaluation by a qualified contractor.

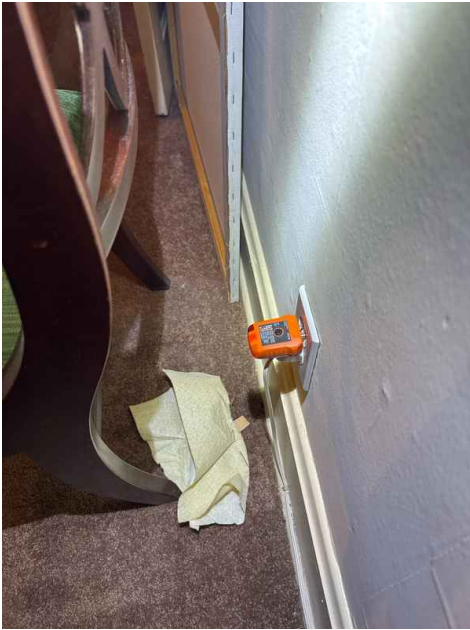
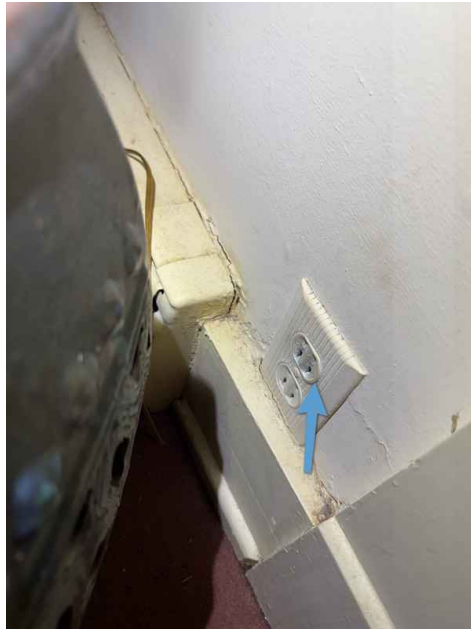
Ungrounded receptacle(s) observed during the inspection. As you perform upgrades, consider installing GFCI receptacles and/or ground connections. Recommend further evaluation by a qualified electrician.

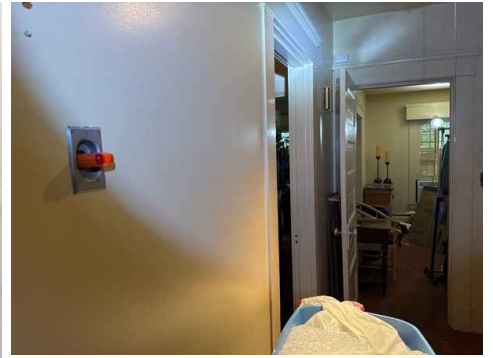
8.6.1 GFCI & AFCI
GFCI PROTECTION

GFCI protection not present in all locations. Recommend a qualified contractor upgrade by installing ground fault receptacles in all locations.

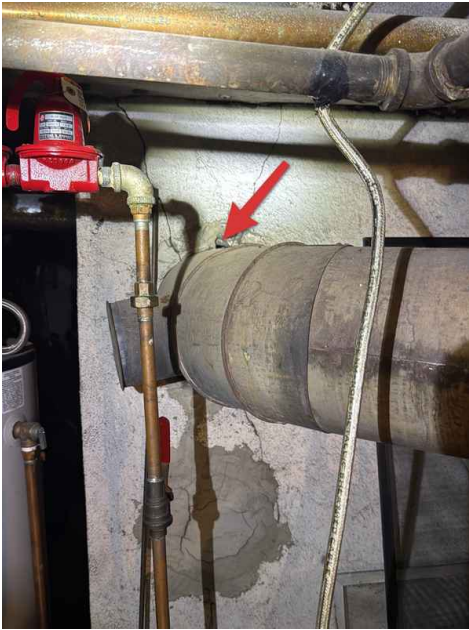
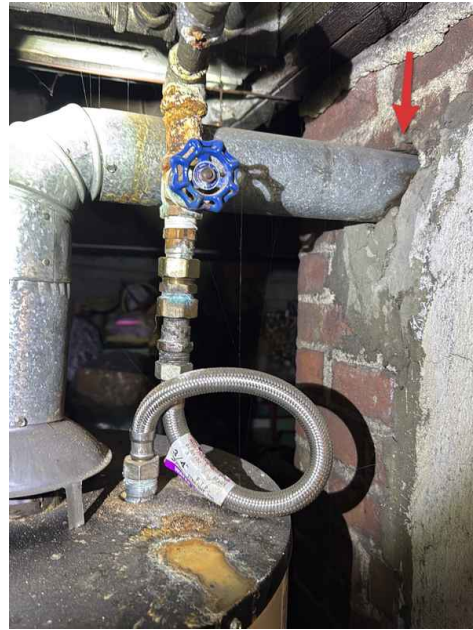
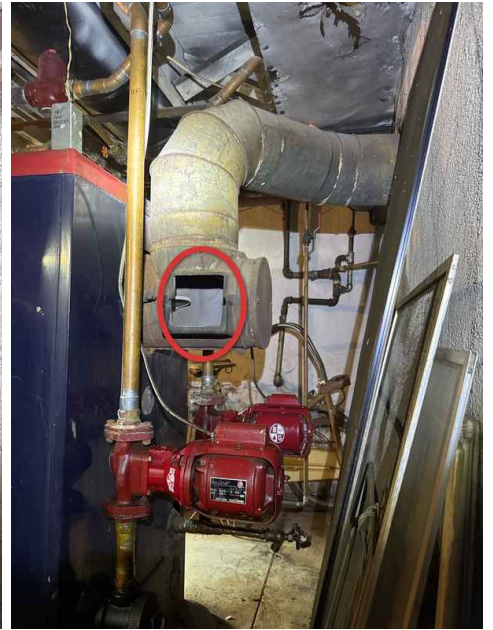
IMPROPER COMBUSTION EXHAUST TERMINATION

Combustion exhaust flue does not terminate to the exterior. This can cause over exposure to combustion exhaust fumes. One option is to terminate combustion exhaust flue to the exterior with the proper clearance. Recommend further evaluation by a qualified contractor.

Contact a qualified professional.

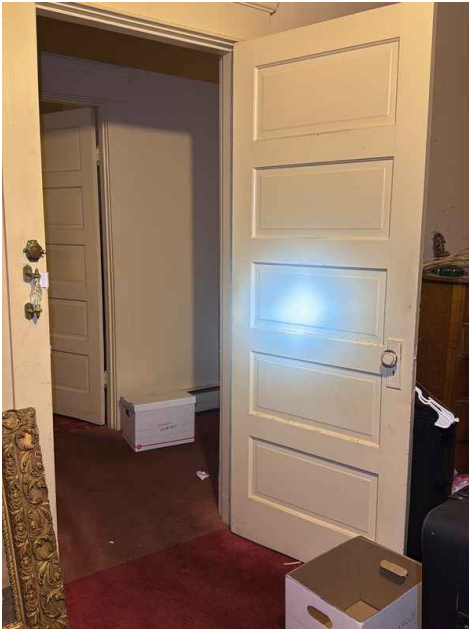
One or more interior doors need adjustments to close and function properly. Recommend further evaluation by a qualified carpenter.

Recommendation
Contact a qualified professional.

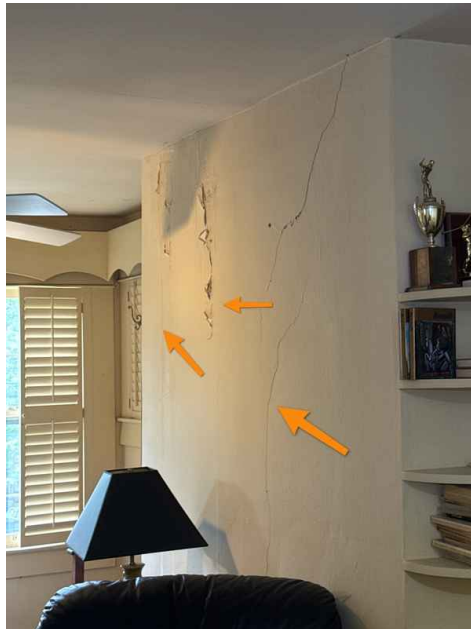
2nd Floor

MAJOR CORNER CRACKS

Cracking visible at the corners of doors and windows. Recommend further evaluation by a qualified contractor.

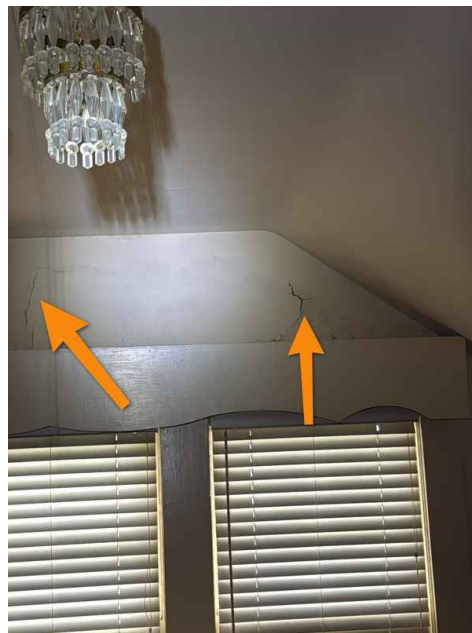
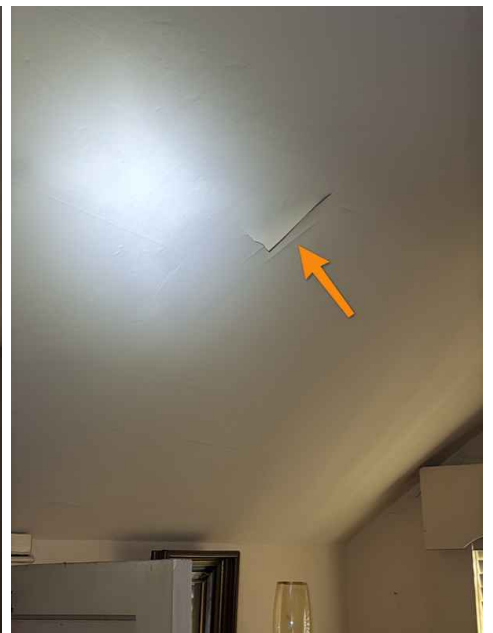
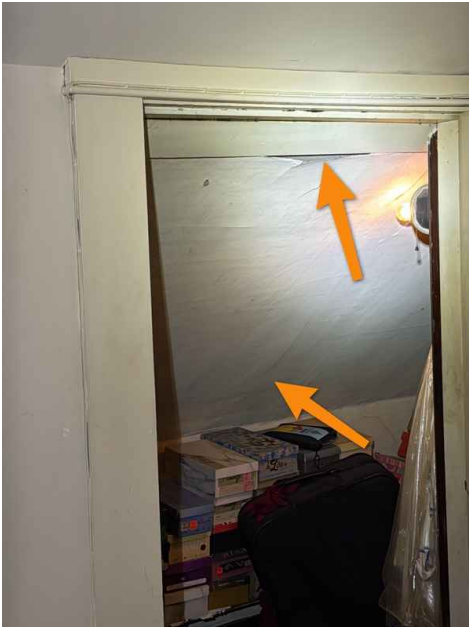
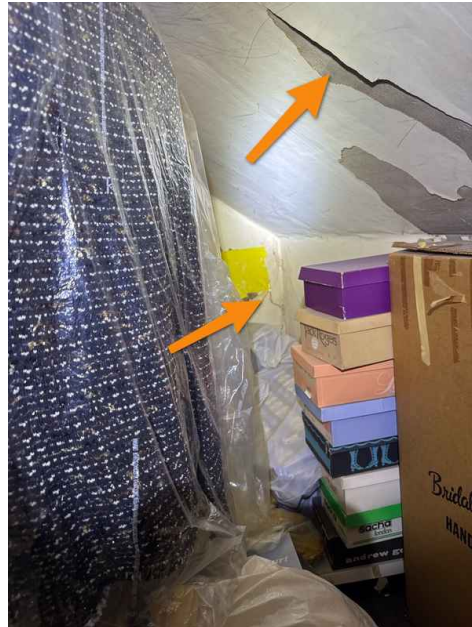
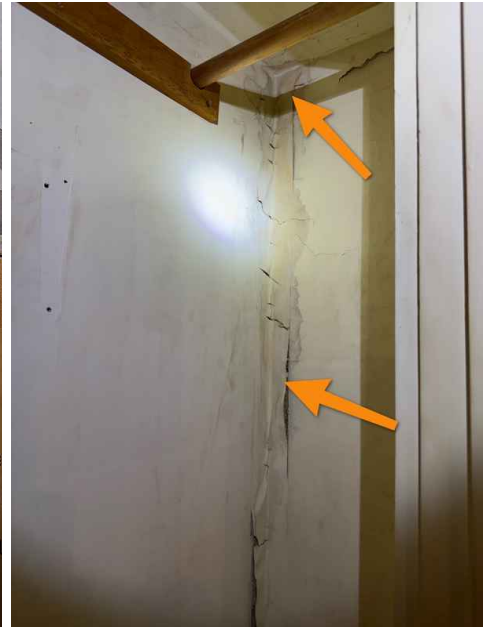
ROOF/EXTERIOR/PLUMBING LEAK DAMAGE

Stains on the interior appear to be the result of roof/exterior/plumbing leaks. The source of leakage should be identified and corrected. Recommend further evaluation by a qualified contractor.

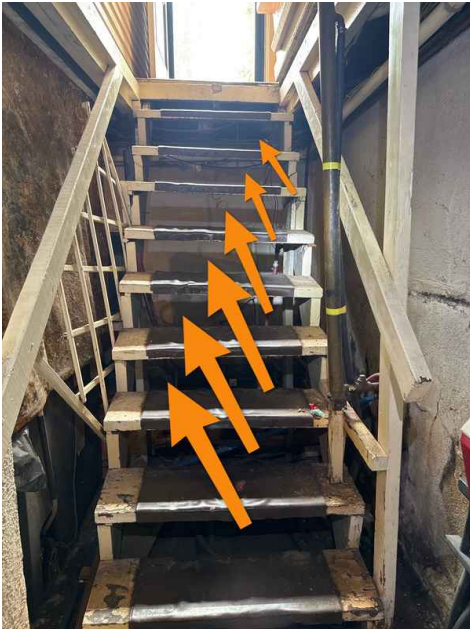
MISSING/DAMAGED RISERS

Missing/Damaged risers observed during inspection. One option would be to install missing or damaged risers. Recommend further evaluation by a qualified carpenter.

Recommendation
Contact a qualified professional.

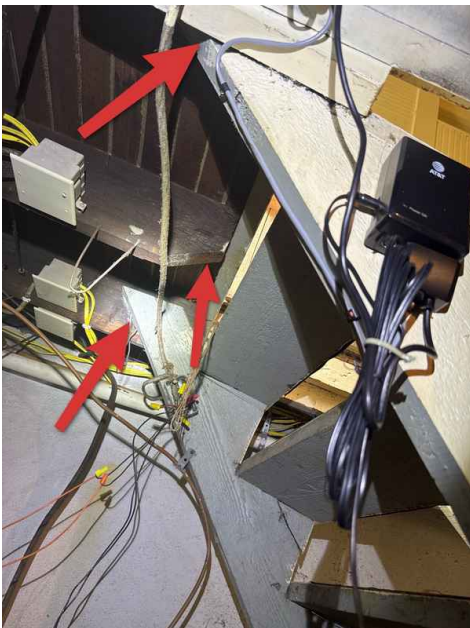
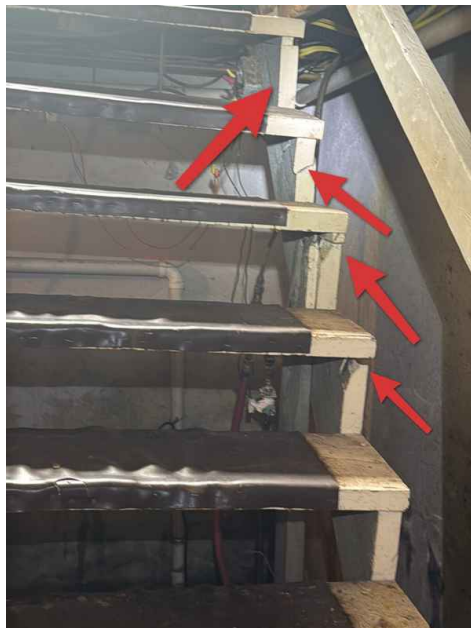
10.7.2 Steps, Stairways & Railings
DAMAGED STAIR SUPPORTS

Damaged stair supports/components observed during inspection. One option is to correct damaged areas. Recommend further evaluation by qualified Carpenter.

Recommendation
Contact a qualified professional.

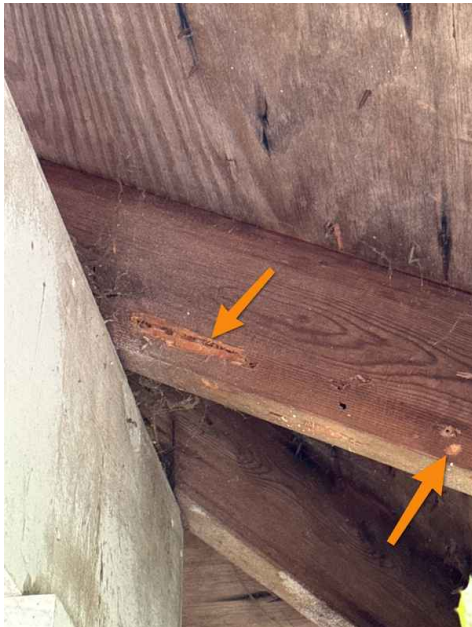
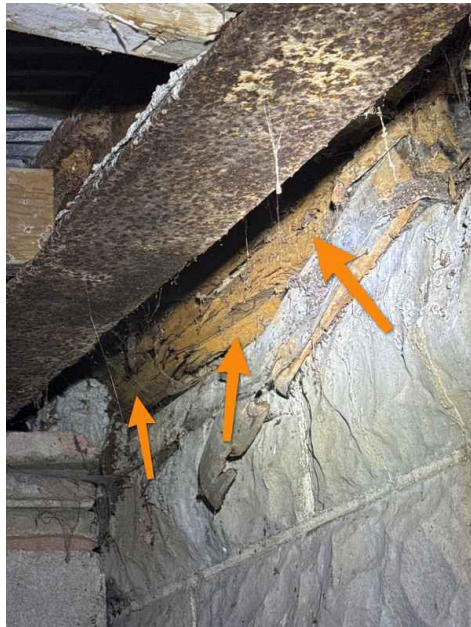
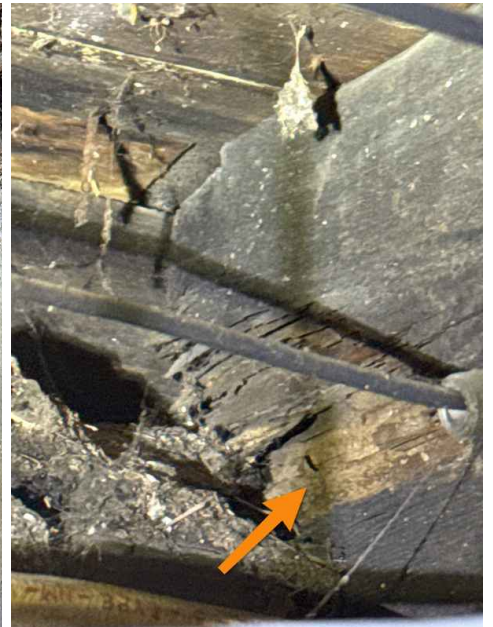
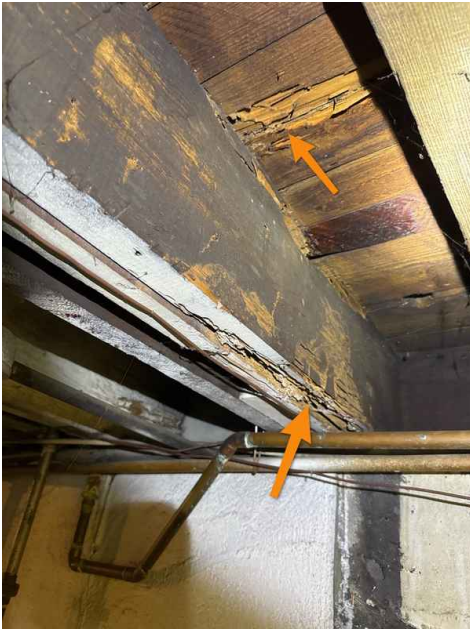
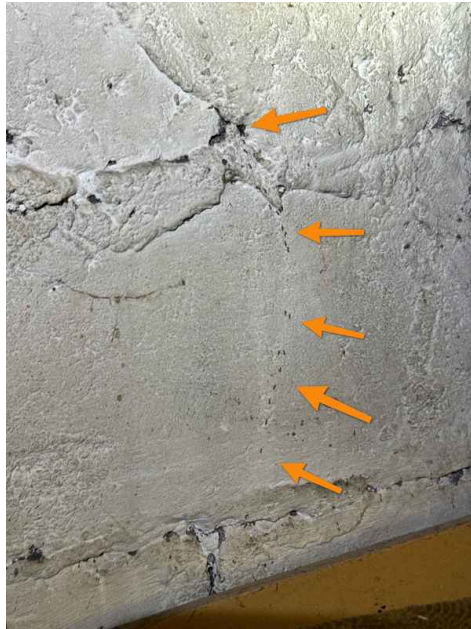
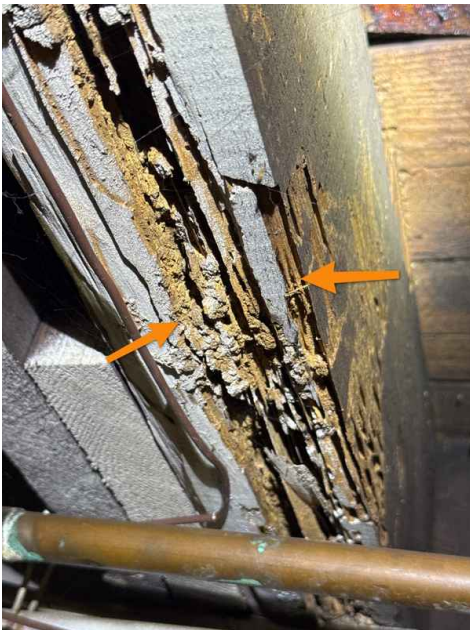
Evidence of wood destroying insects observed during the inspection. One option is to seek past history from current owner, and/or inquire with a Pest Management Company about an effective treatment plan for wood destroying insects. Recommend further evaluation by a qualified pest management/treatment contractor.

Recommendation
Contact a qualified pest control specialist.

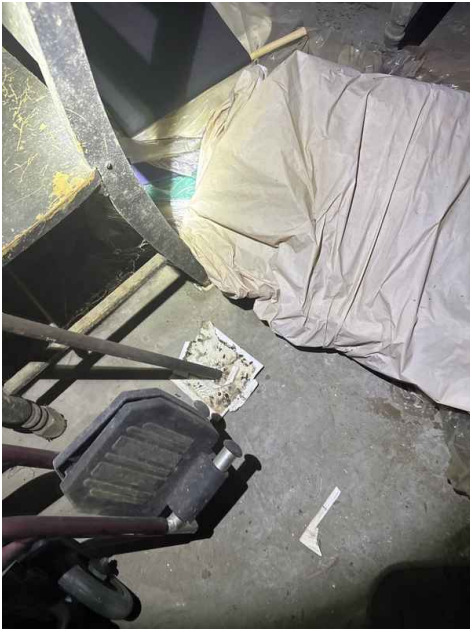
In one or more locations of the house evidence of insects were found. Recommend further evaluation by a pest management company.

Recommendation
Contact a qualified professional.

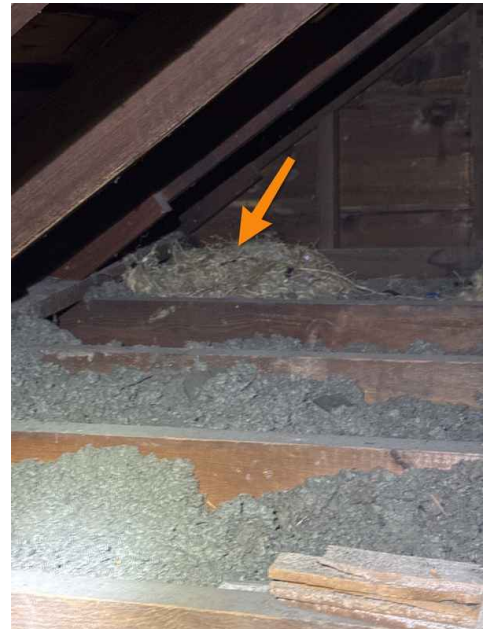
Southeast Attic

ANIMAL INTRUSION

Evidence of current/past animal presence observed during inspection. Recommend further evaluation by pest management company.

Recommendation
Contact a qualified professional.

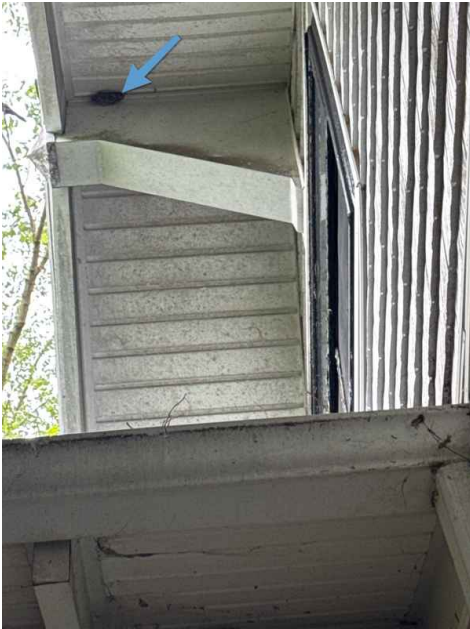
North 2nd Floor

Wasp nest observed during inspection. One option is to remove wasp nest. Recommend further evaluation by a qualified pest management company.

Recommendation
Contact a qualified professional.
