Star Rock Farms' Milk Quality Increases With Help From McLanahan Sand Lane System

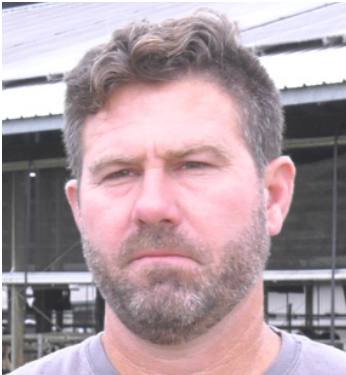
“With the dewatering screen, we definitely see a cleaner, drier sand that we’re able to put back in the stalls.”

With the McLanahan Sand Lane System, the Barleys load the wet sand into a hopper, where an auger conveys it into a dewatering screen. The dewatering screen removes the water by shaking the damp sand, leaving sand the Barleys can take directly off of the dewatering screen and pile up for later use. They also don't have to condition the sand anymore.
