AGA KHAN TRUST FOR CULTURE

Humayun's Tomb - Sundar Nursery - Hazrat Nizamuddin Basti URBAN RENEWAL INITIATIVE

BATASHEWALA MUGHAL GARDEN TOMB COMPLEX

Conservation & Landscape Restoration

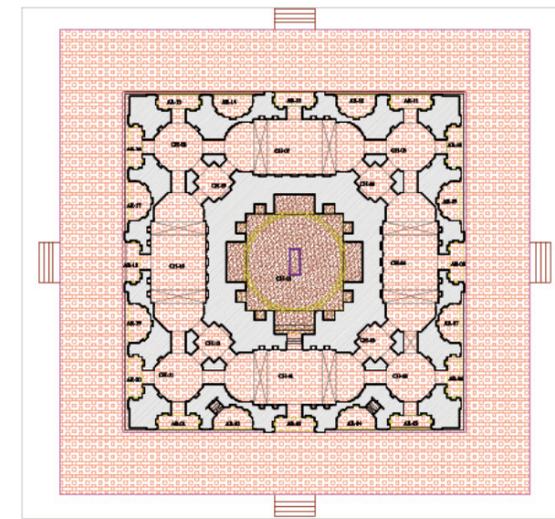
(Top) Plan with Condition Assessment of the Tomb of Mirza Muzaffar Hussain; (Centre) Restoration works on Chota Batashewala Mahal as per the evidences, archival images found, and (Bottom) architectural models created to understand the structure in detail.

Popularly known as the Bada Batashewala Mahal and built in AD 1603, Mirza Muzaffar Hussain's square tomb stands on a raised platform with five half-domed arched entrance bays on each side. Parts of the striking plaster ornamentation have survived on some of the internal wall surfaces, providing the evidence required to restore missing portions. Ornamental plaster medallions and the intricate *muqarna* patterns on the half-domed arched entrance bays symbolise the highest craft traditions of the period. The central grave chamber, several feet below the ground, is surrounded by eight rooms, making this an interesting example of the "hasht-bihist" plan – which represents the eight spaces of paradise as described in the Holy Quran.

The collapsed eastern facade was restored while the southern facade – inappropriately reconstructed only a decade ago – required dismantling and reconstruction as per the original design. Similarly, the roof, which had deteriorated, was required to be re-laid with lime concrete to create an adequate slope.

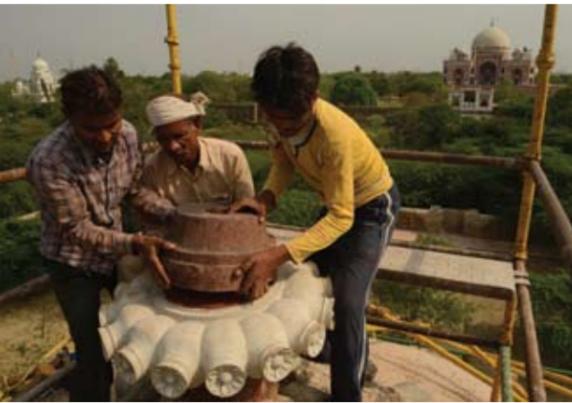
(Top) Finial elements found during conservation works were put back; (Centre) Restoration of ornamented interiors, in which much of the ornamentation had been lost due to neglect, water seepage and inappropriate past repairs wherein plain cement plaster was used on wall and ceiling surfaces that were originally decorated; (Bottom) Mughal Tomb after completion of conservation works and garden restored.
